Re: Monthly Report Summary #2 for the Manning 500/230 kV Substation Project

MANNING 500/230 KV SUBSTATION PROJECT

CPUC SITE INSPECTION FORM

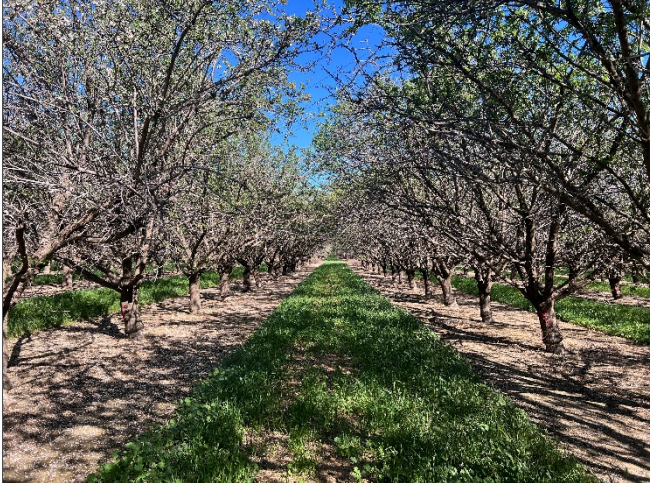
Clearance walk of orchard area.
3/2/26	Orchard Site

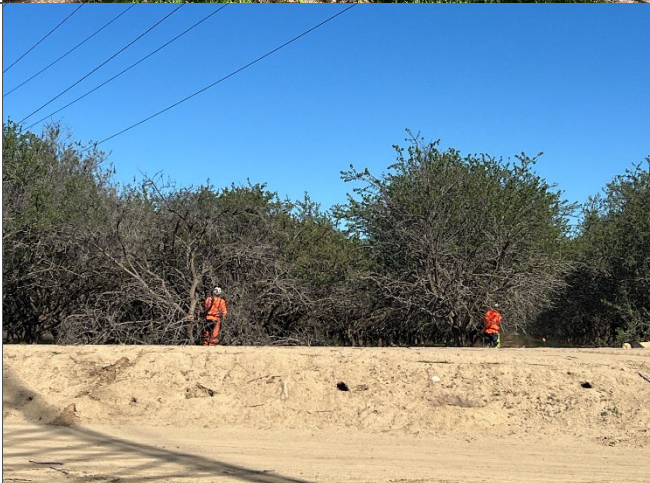
Tree crew starting to cut trees
3/2/26	Orchard Site

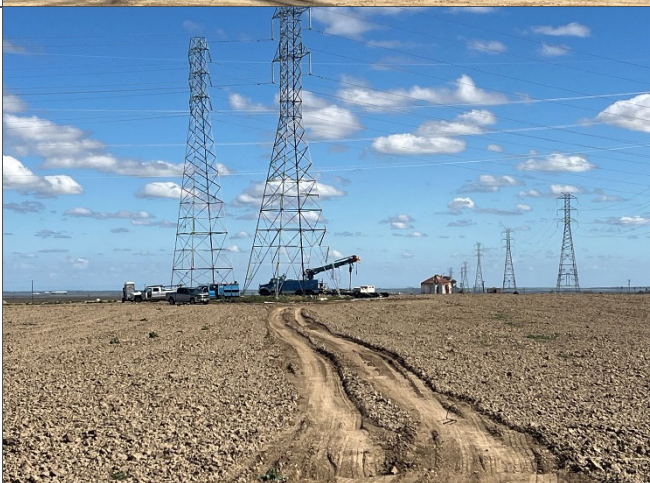
Other PG&E crew working on tower south of orchard area, unrelated to the Manning Substation Project.

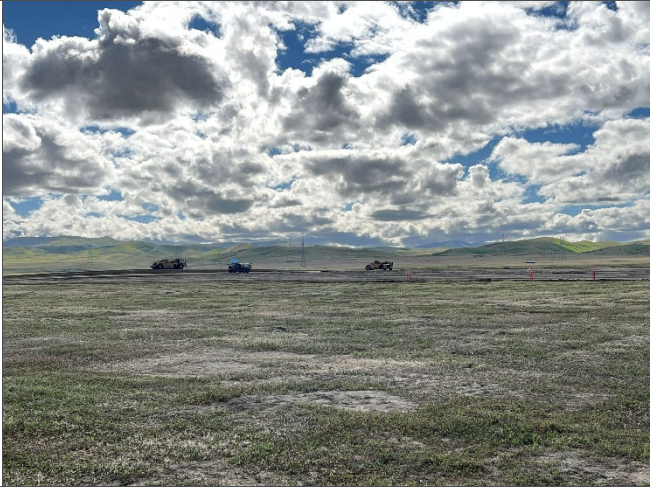
3/2/26	Manning Substation site

Grading continues and water truck continues to spray grading area to minimize volatile dust
3/2/26	Orchard site

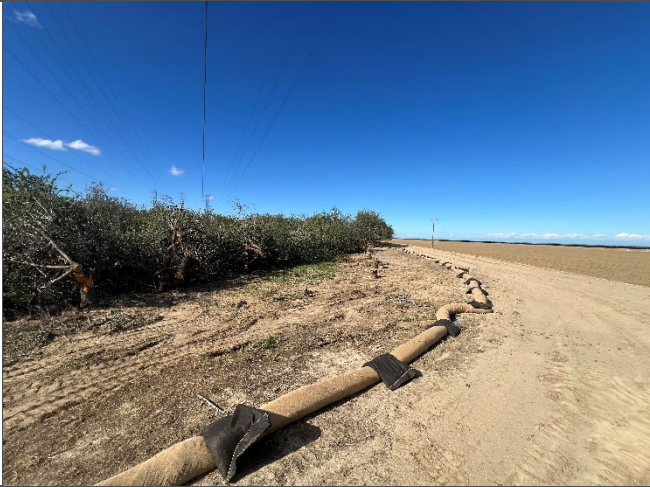
All trees have been felled. Chipping to commence tomorrow and will stay within wattled area.
3/2/26	Manning Substation site

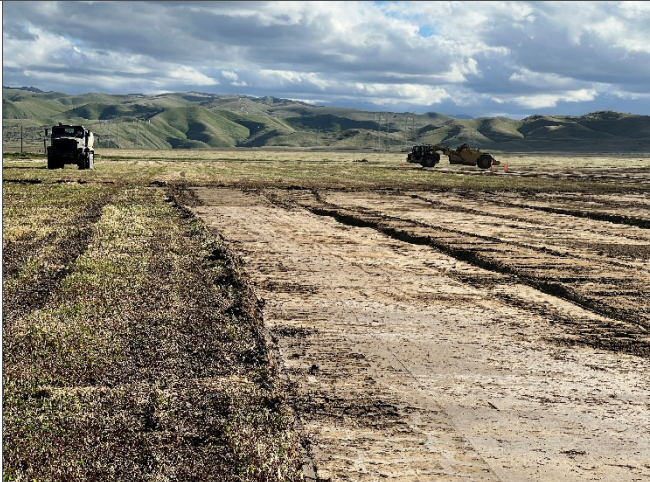
Grading commences over the retention basin area.

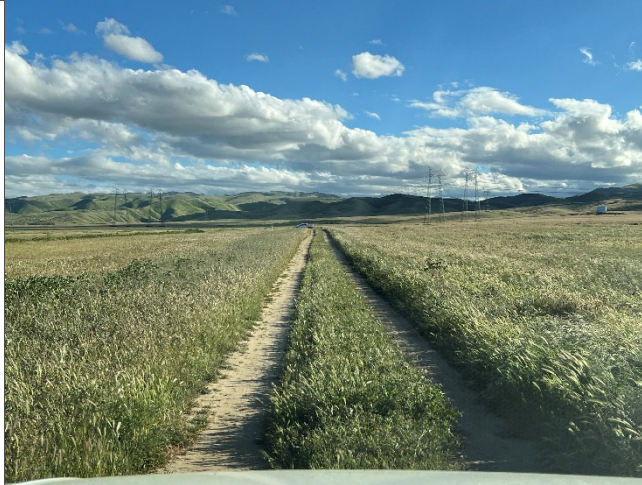
- Went to check on PG&E's Orchard Area, but no one was there. Arrived to the Manning site at 6:30 and participated in the safety tailboard with LS Power and its sub. Conducted a check under construction equipment for wildlife at start of day and found none. Observed water truck spraying work area, new water truck at site. 8:00 am-I went back to look for PG&E's staff or its sub near the orchard. 8:33 – crew with a bobcat arrived on site. PG&E's WEAP and SWPPP training scheduled for 9:00 am. PG&E, Arbor Works, Stantec, Rincon and Ascent present for WEAP and SWPPP training. Another PG&E crew observed heading to tower south of orchard area. Based on Rincon monitor, not related to our work. Crew working on west most tower. 10 am conducted clearance survey for orchard. 10:25 crew started cutting orchard trees. Drove by to check on PG&E tower work and confirmed they are working on west most tower not related to current project. Left orchard at 12:20 pm, tree crew still cutting trees. 12:45 at Manning, crew finishing lunch, a common side-blotch lizard (*Uta stansburiana*) observed near equipment and it is escorted out of traffic area. Conducted walkdown of graded area with LS Power monitor. 2:30 graders start removing grass from retention basin area. 3 pm back at orchard site, all trees have been cut, most crew have left, but one still working and notified that chipping will begin tomorrow. 3:20 back at Manning, grading continues. Followed monitor to water pipe area, veg along road is tall and rental undercarriage hitting veg, recommend mowing access road to lower veg height. 4:30 work ends.

Back road to water pipe, veg along road was hitting the undercarriage of SUV, recommend mowing to minimize fire danger.

Mentioned to Michael (LSPGC Monitor) if he knew if the subcontractor would mow the other access road to the water line since low clearance vehicles would be scraping the vegetation. He said he was told they would, but he will ask again.

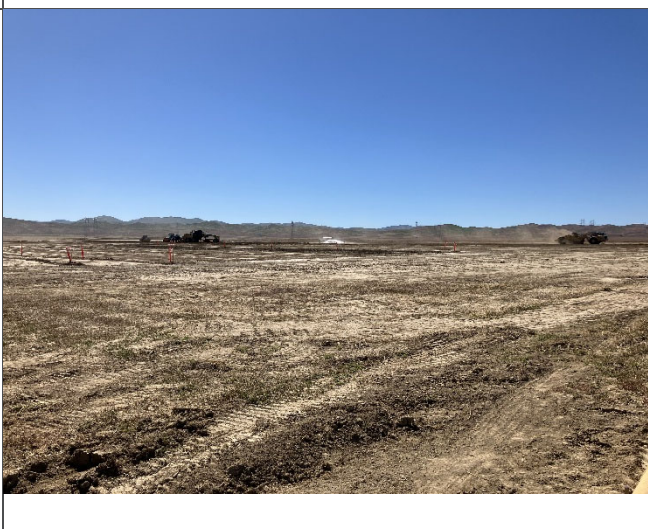
Soil stockpile, water truck, scrapers, grader, and vibratory rollers.
3/11/26	Manning Substation site

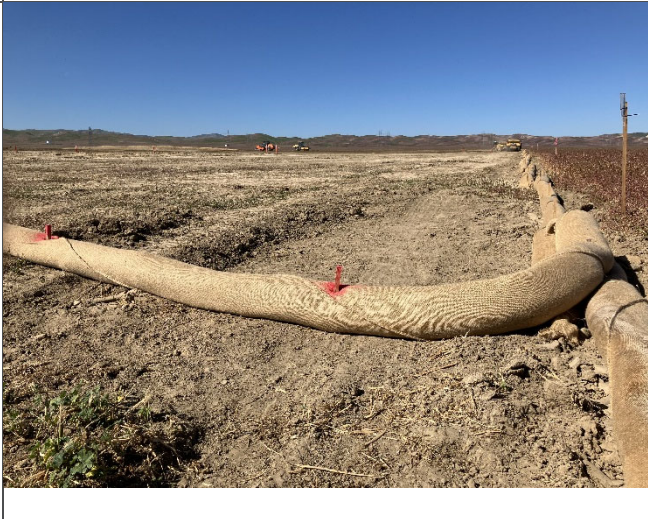
Straw wattles (BMPs), perimeter stakes, rain gauge, scrapers, vibratory rollers, and soil stockpile.
3/11/26	Manning Substation site (water pipe location)

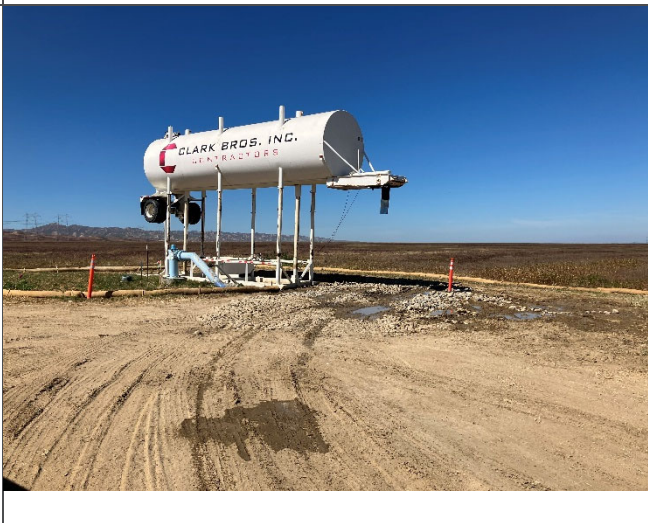
Elevated water tank.

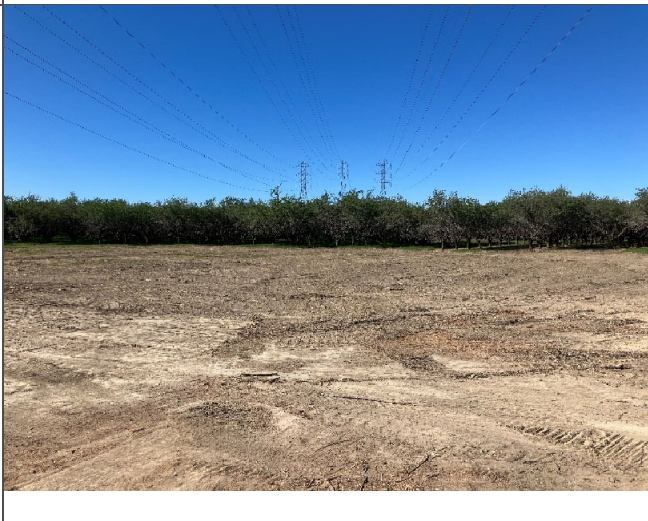
A photograph showing a cleared area of land, likely an orchard, with several large trees removed. The ground is dry and dusty. In the background, there are several high-voltage transmission towers and power lines stretching across the sky.	Tree removal site in orchard under transmission lines.

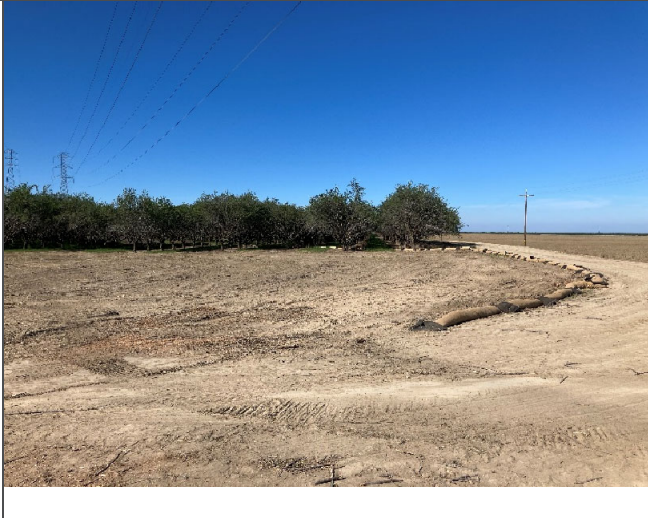
Tree removal site in orchard under transmission lines.
3/11/26	Interconnection site (orchard)

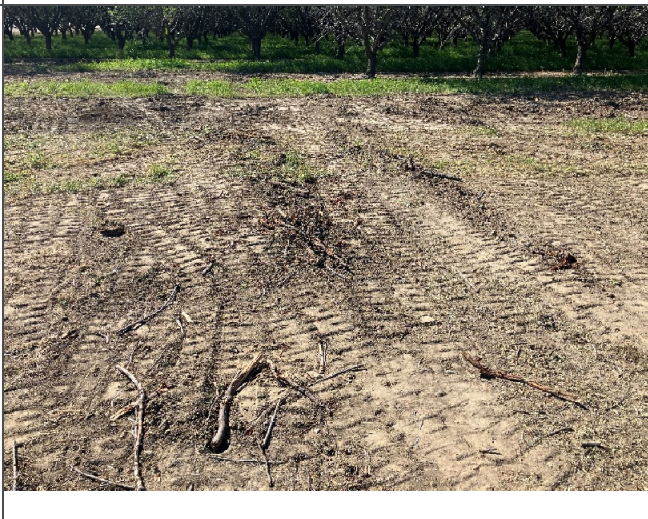
Tree removal site in orchard under transmission lines.
3/11/26	Interconnection site vicinity (across from orchard on power pole along Jerrold Ave)

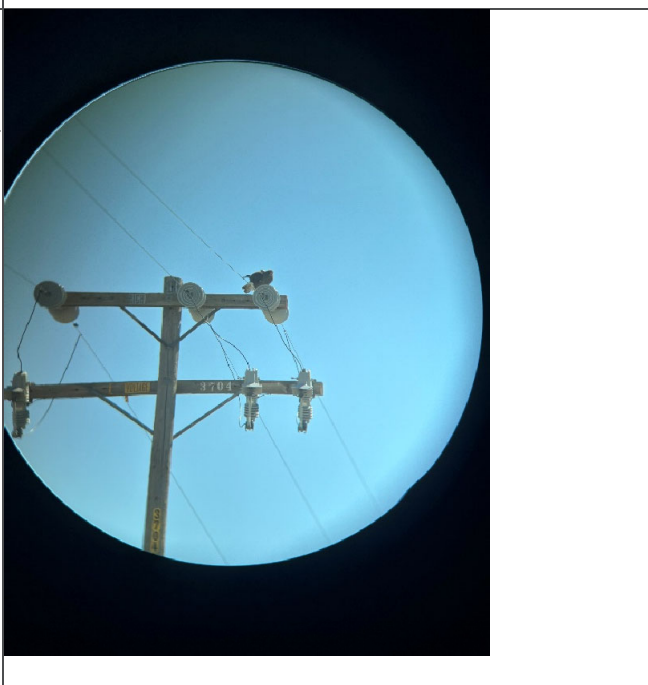
Swainson's hawk perching on power pole.

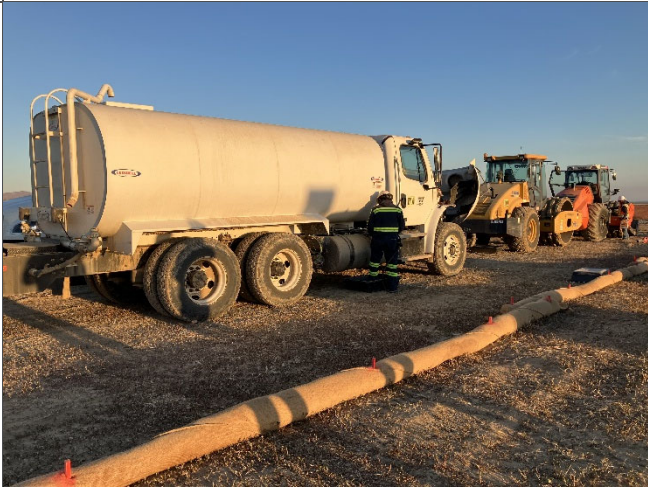
Water truck maintenance and secondary containment.
3/18/26	Manning Substation site	 	Substation site surveys and old irrigation plastic removal.
3/18/26	Manning Substation site

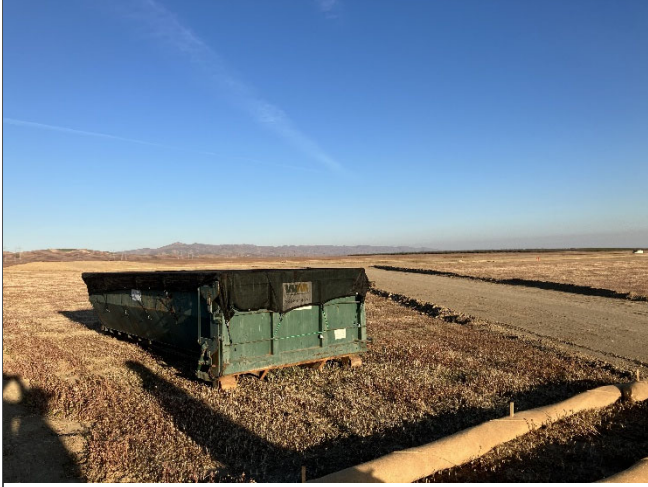
Substation site dumpster with cover.

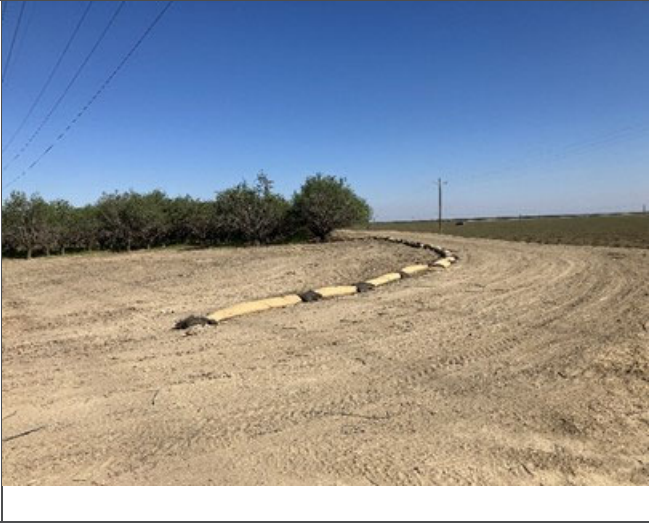
3/18/26	Interconnection site (orchard)

Tree removal site in orchard under transmission lines.
