PROJECT MEMORANDUM

CRESSEY-GALLO 115 kV POWER LINE PROJECT

To: Billie Blanchard, Project Manager, CPUC
From: Vida Strong, Aspen Project Manager
Date: December 12, 2014
Subject: Monitoring Report #3: December 1 to December 7, 2014

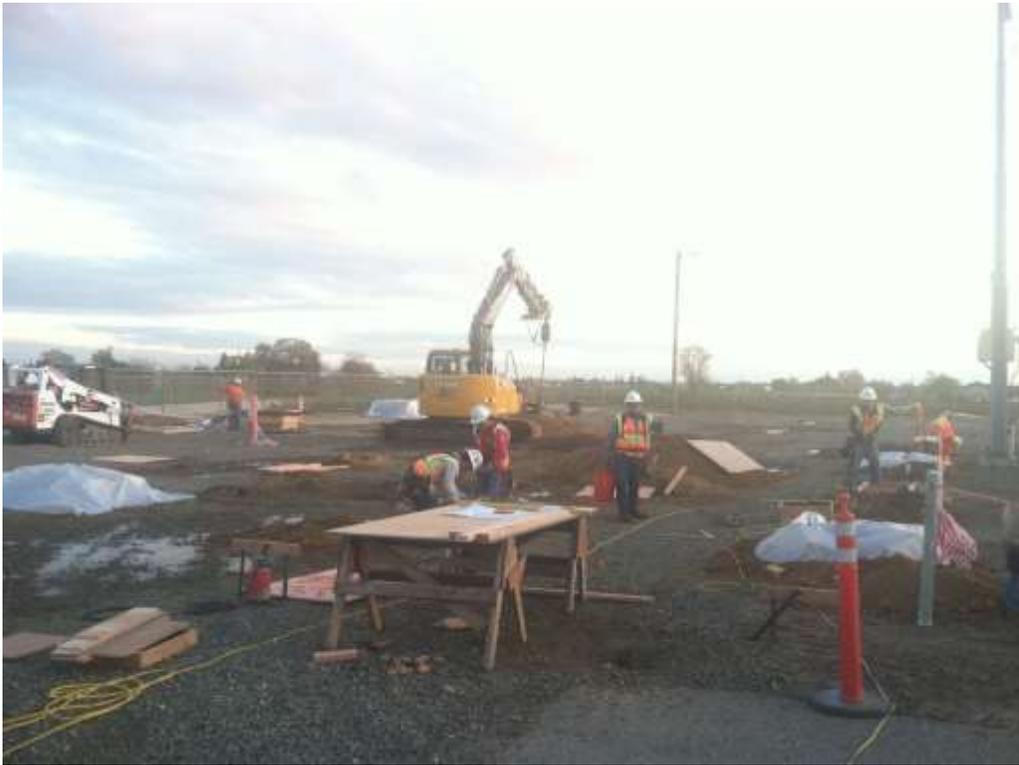
1. Work began at the Cressey Substation during the subject week, including trenching and augering for structural foundations (see Figures 1&2).
2. Preparation of the staging area for the Gallo Substation expansion and overhead line upgrade work is on hold until the coming week when fence installation is scheduled.
3. No work was conducted Saturday or Sunday.

Figure 1 – Work began at the Cressey Substation during the subject week. View southeast, December 4, 2014.

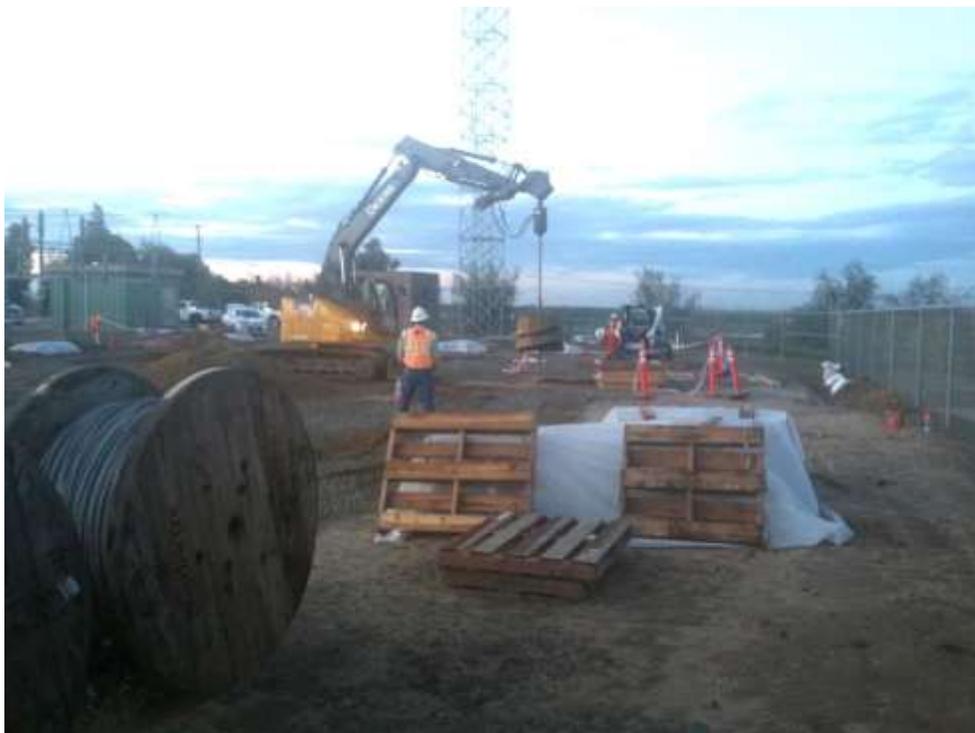
Figure 2 – Augering and trenching at the Cressey Substation occurred during the subject week. View north, December 4, 2014.

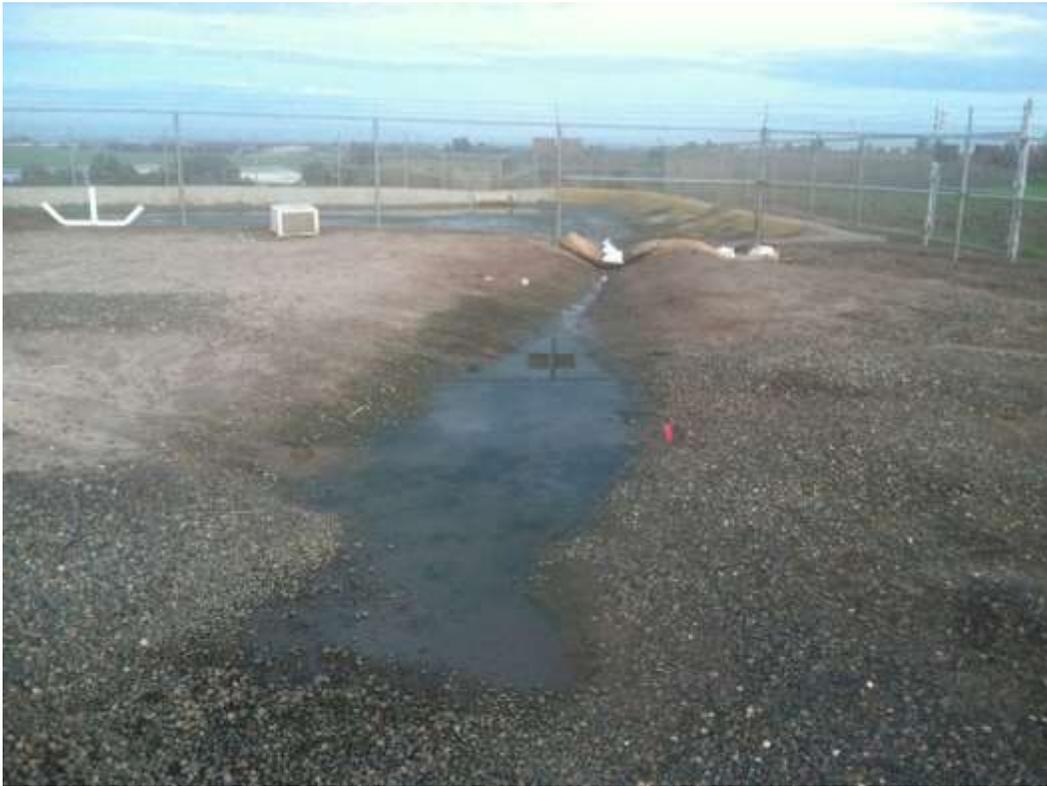
1. Erosion control devices were installed per the Storm Water Pollution Prevention Plan (SWPPP). Rain occurred during the subject week. BMPs were well positioned to capture sediment (see Figures 3,4& 5)

Figure 3 – SWPPP BMPs were installed to control sediment runoff. View east, December 4, 2014.

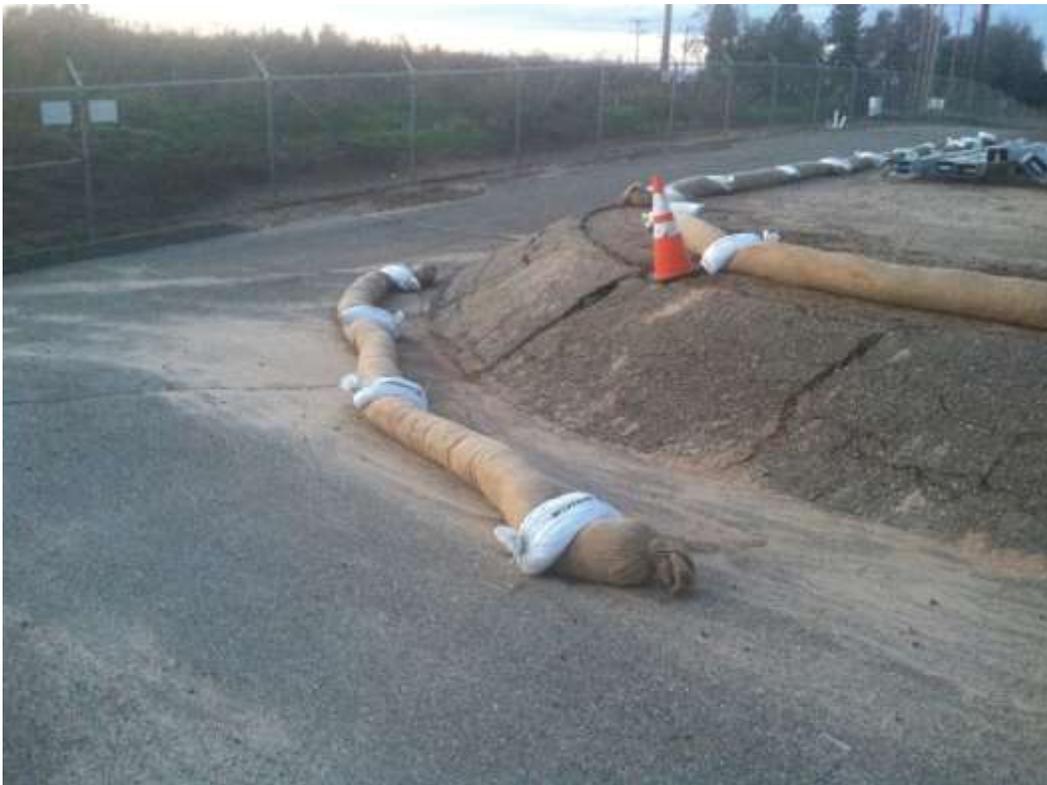
Figure 4 – SWPPP BMPs were installed to control sediment runoff. View northwest, December 4, 2014.

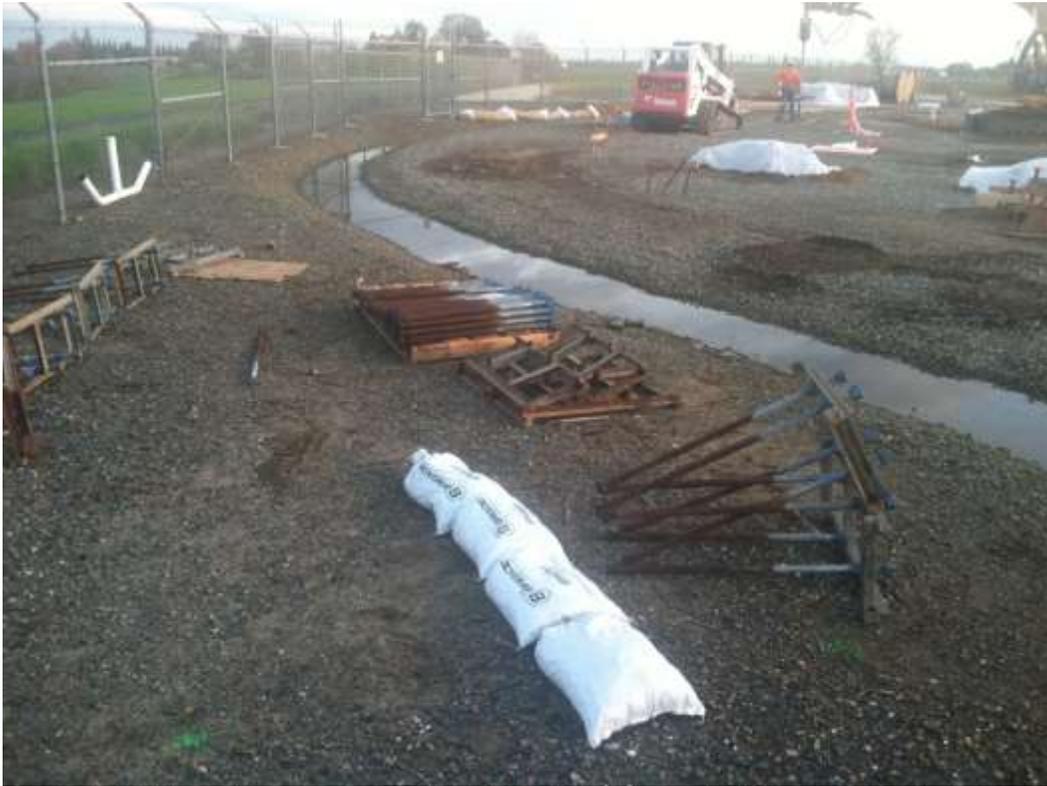
Figure 5 – SWPPP BMPs were installed to control sediment runoff. View southeast, December 4, 2014.

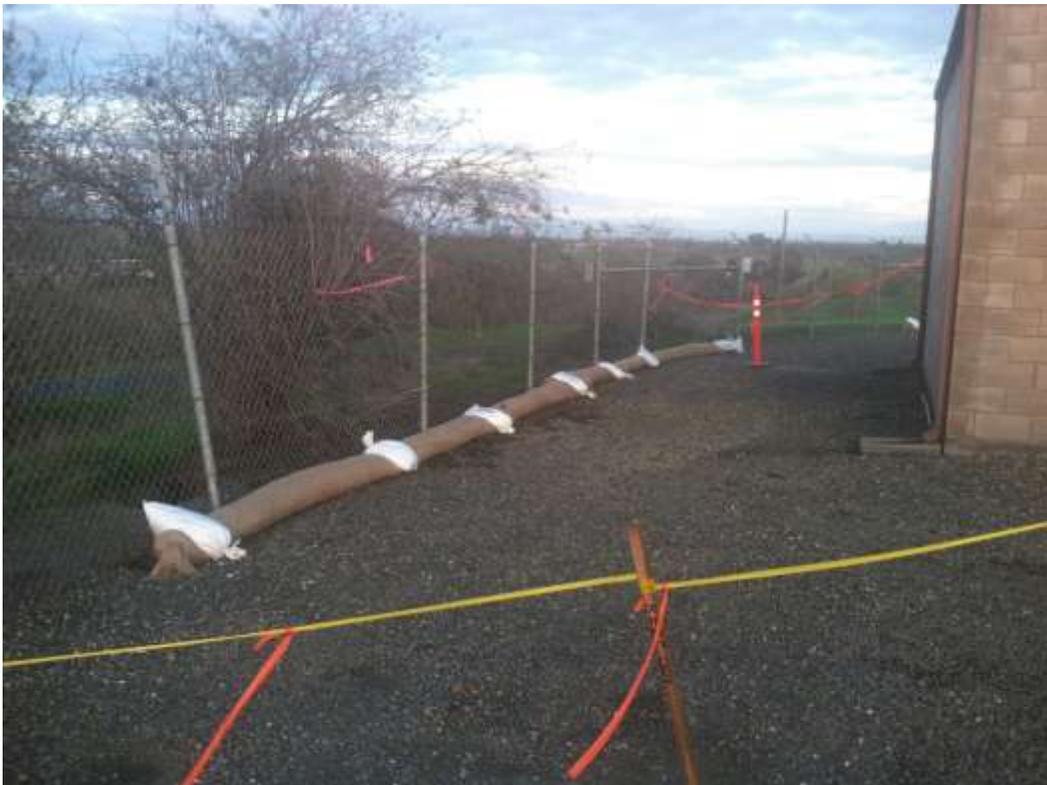
4. Appropriate buffers were in place for sensitive resources at the Cressey Substation (see Figure 6).
5. Excavations and holes were securely covered at the end of the day at the Cressey Substation (see Figure 7).

Figure 6 – A resource buffer was in place around an elderberry plant just outside the Cressey Substation fence line. View east, December 4, 2014.

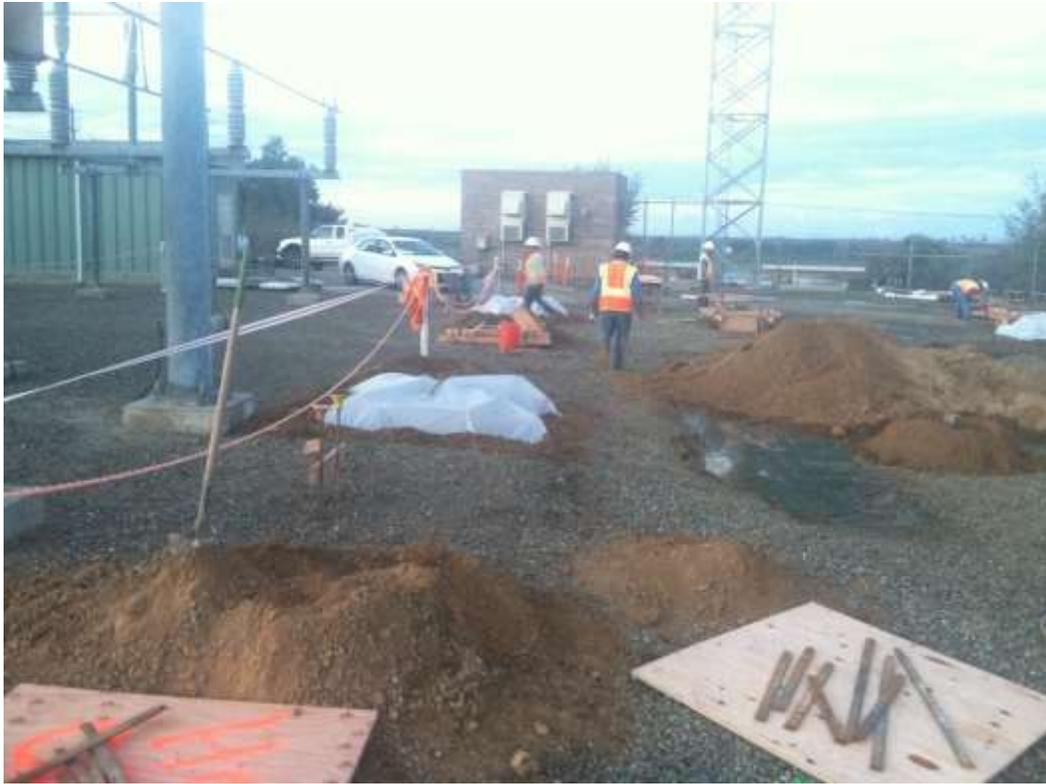
Figure 7 – Holes were securely covered at the end of each working day at the Cressey Substation. View north, December 4, 2014.

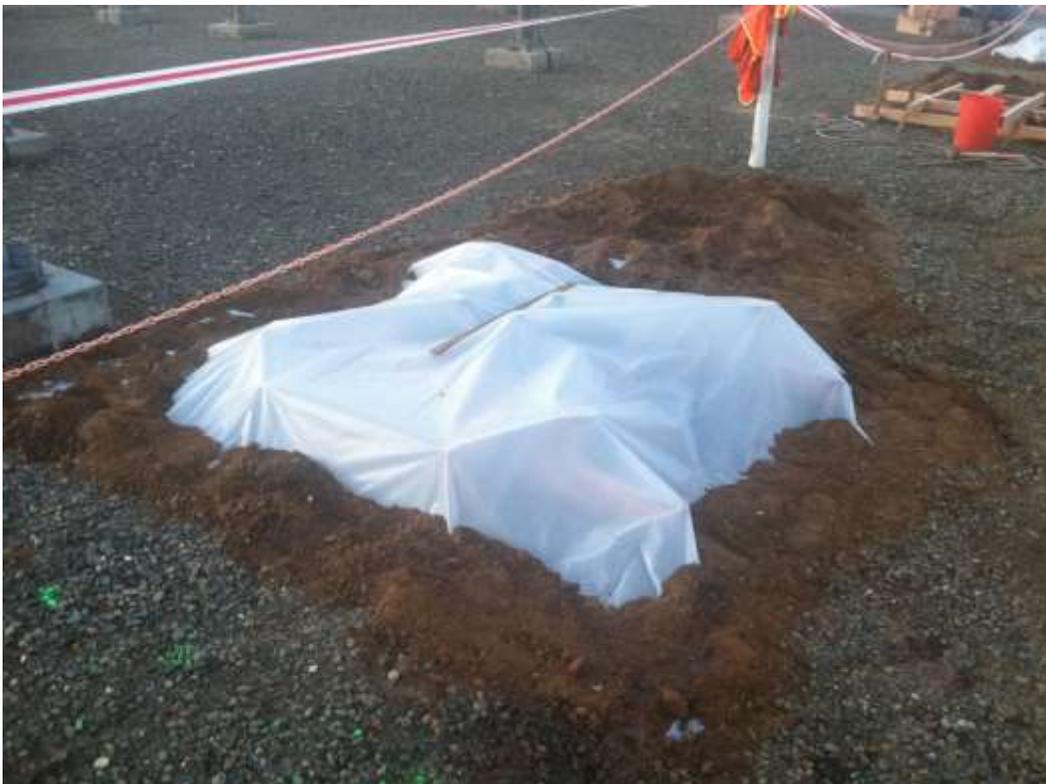
Figure 8 – Holes were securely covered at the end of each working day at the Cressey Substation. View northwest, December 4, 2014.
