PROJECT MEMORANDUM

DOWNS SUBSTATION EXPANSION PROJECT

Subject: Monitoring Report #8: January 12 to 18, 2015

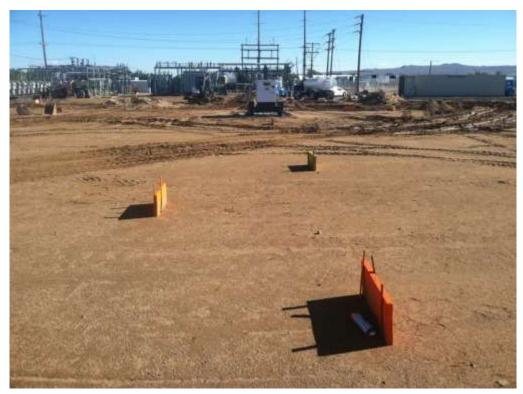
Figure 1 – Surveyor markers have been installed on the substation pad in preparation of structure installation. View east, January 13, 2015.

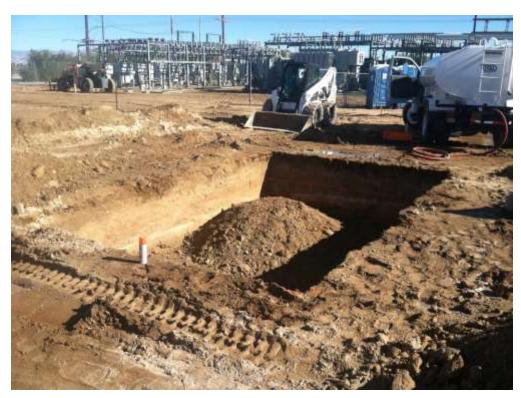
Figure 2 – Trenching occurred at the substation pad during the subject period. View northeast, January 13, 2015.

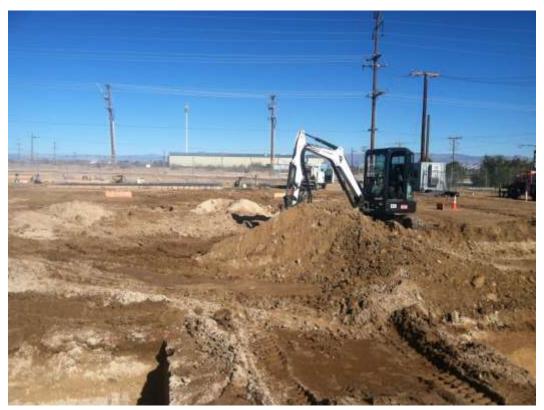
Figure 3 – Trenching occurred at the substation pad during the subject period. View northeast, January 13, 2015.

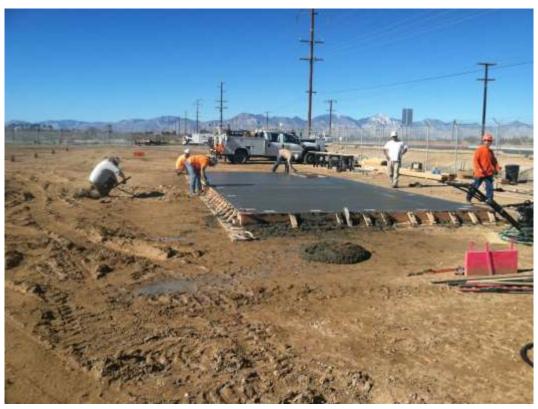
Figure 4 – Pouring of concrete for the MEER building occurred. View west, January 13, 2015.

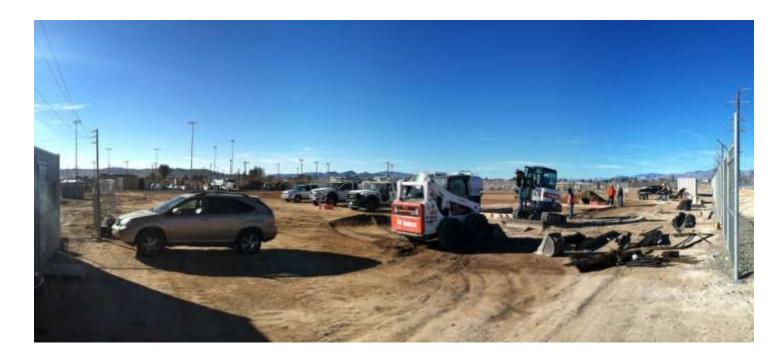
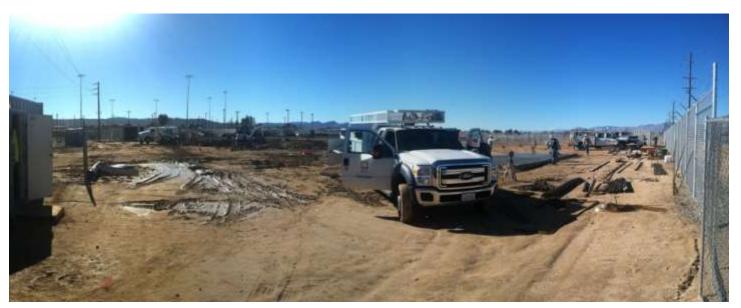
Figure 5 – Installation of a MEER building continued during the subject period. View from the northeast corner of the substation pad. View southwest, 01/08/15 above and 01/13/15 below.

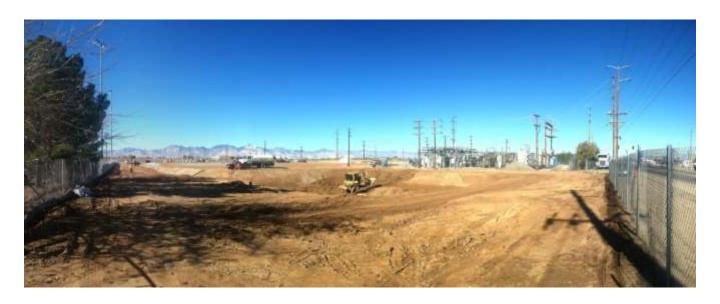
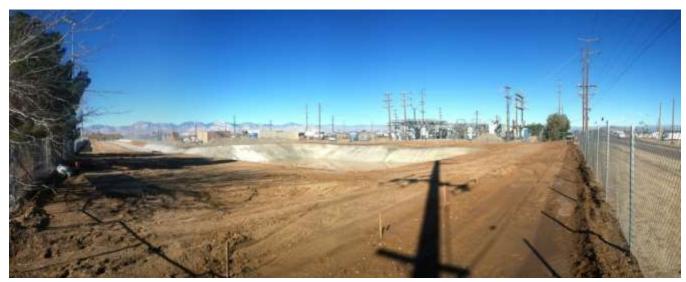
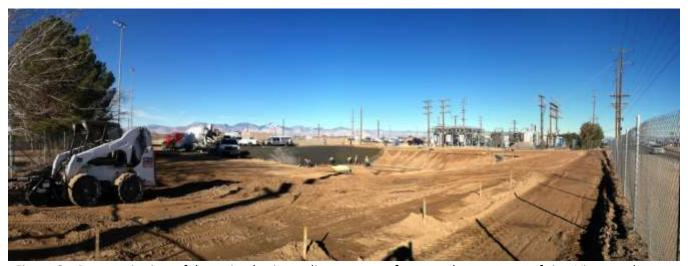
Figure 6 – Panoramic view of detention basin grading progress, from southeast corner of site. View northwest, 12/23/14 above, 01/08/15 middle, and 01/13/14 below.

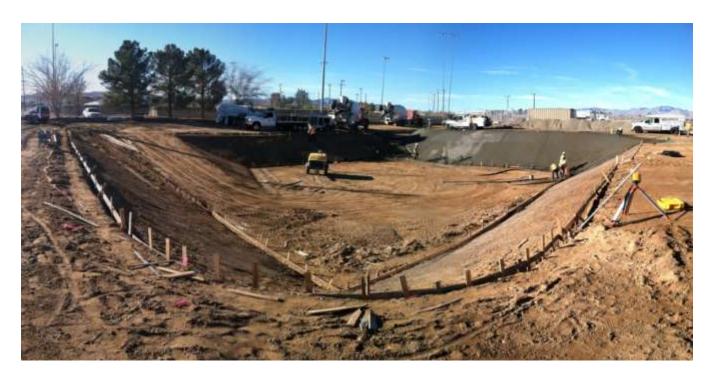
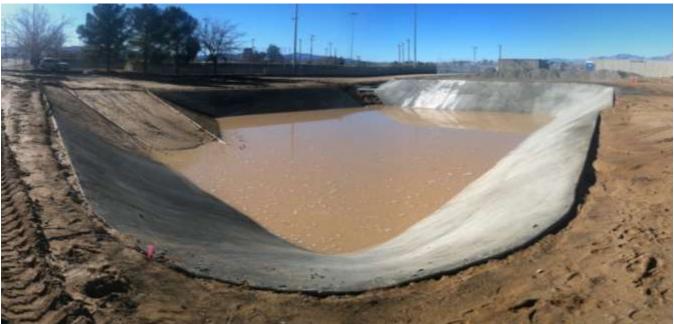
Figure 7 – Installation of the detention basin continued. Weekend rains deposited some water here. View southwest, 01/08/15 above and 01/13/15 below.

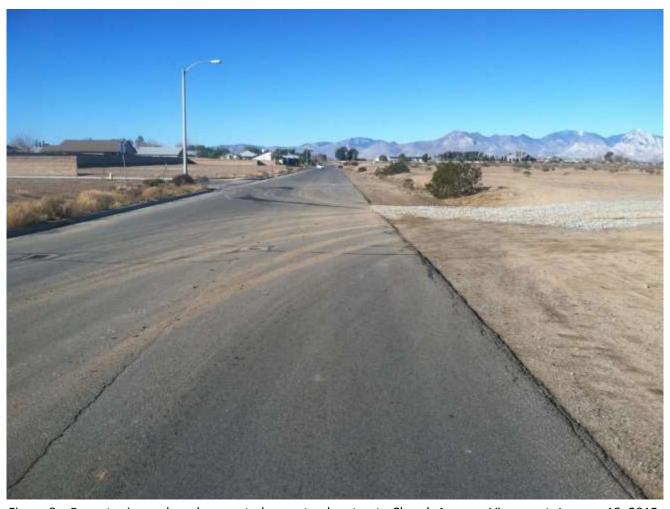
Figure 8 – Recent rains and mud generated some track out onto Church Avenue. View west, January 13, 2015.
