ELDORADO-LUGO-MOHAVE (ELM) SERIES CAPACITATOR PROJECT

Date: January 30, 2025
To: Eric Chiang, Project Manager, CPUC
From: Vida Strong, Aspen Project Manager
Subject: Monitoring Report #33: July, August, and September 2024

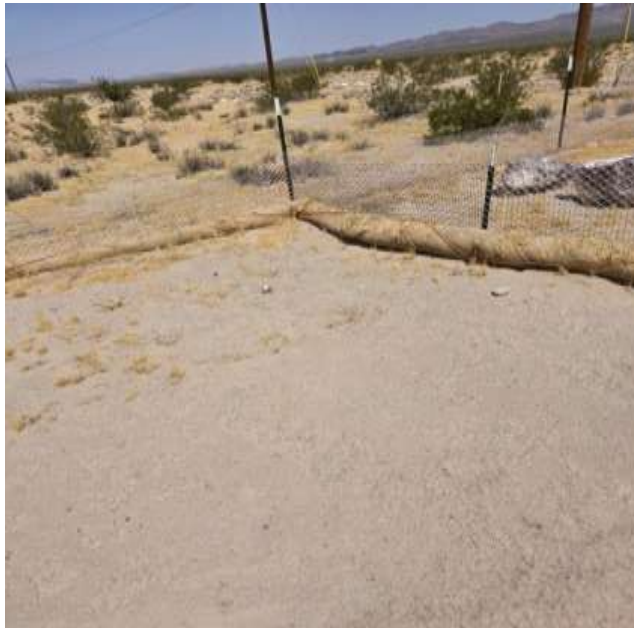
3. SWPPP maintenance items/corrective actions recorded during the reporting period, including the following:
 - QSP July 24th inspections identified several perimeter wattles at both SC2 and SC5 were damaged (large holes) and increasing animal damage (see Photos 1 and 2). Outstanding SWPPP maintenance item/corrective actions recorded.

Photo 1: Slightly damaged perimeter wattles at SC2 (representative of conditions at SC5), with holes as a result of animal damage. Photo curtesy of the July 24, 2024 QSP SWPPP inspection.

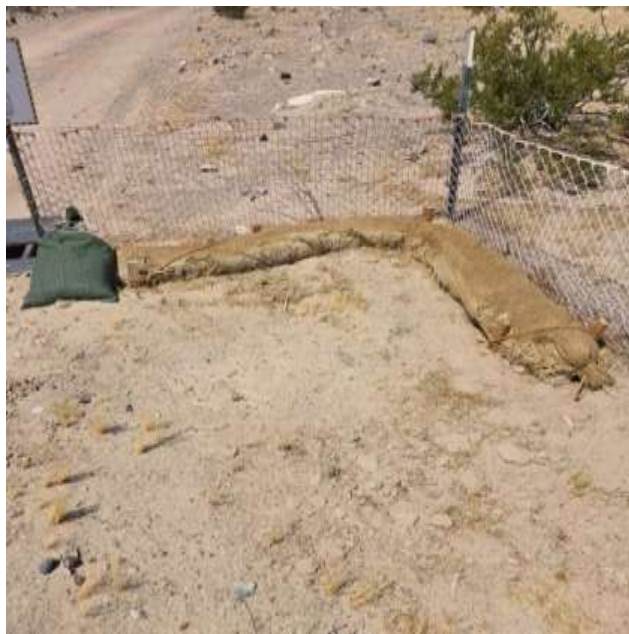
Photo 2: Damage to perimeter wattles, with a large split in the burlap covering at SC2. Photo curtesy of the July 24, 2024 QSP SWPPP inspection.

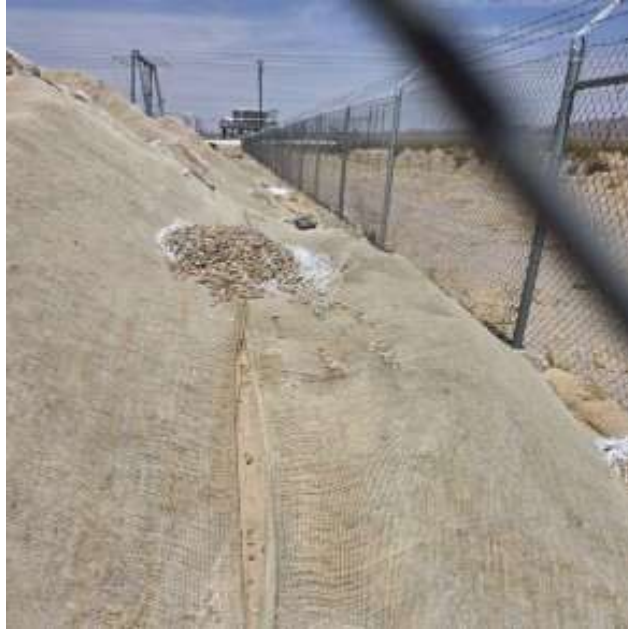
- QSP August 7th inspections identified damaged stockpile coverings (ripped geo-text fabric, exposing stockpiled soil) at SC2. Bags of gravel material have been placed on top of the damaged coverings in specific locations in order to secure the ripped fabric; however, several of the gravel bags also show some damage/disintegration over time (see Photos 3 and 4). Outstanding SWPPP maintenance item/corrective actions recorded.

Photo 3: Damaged/large rip in stockpile covering (containing stockpiled soil) at SC2. Bags of gravel material put in place to secure the damaged covering also disintegrated. Photo courtesy of the August 7, 2024 QSP SWPPP inspection.

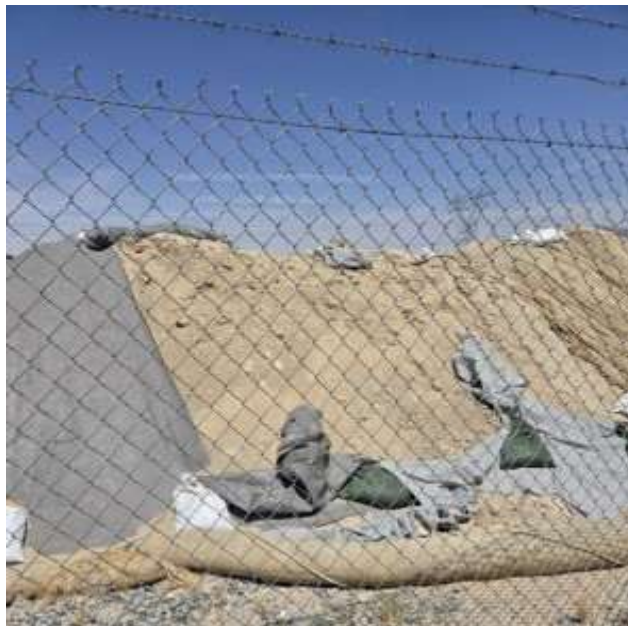
Photo 4: Damaged/large rip in stockpile covering (containing stockpiled soil) at SC2. The geo-tex fabric has torn apart across the top edge of this stockpile. Photo courtesy of the August 7, 2024 QSP SWPPP inspection.

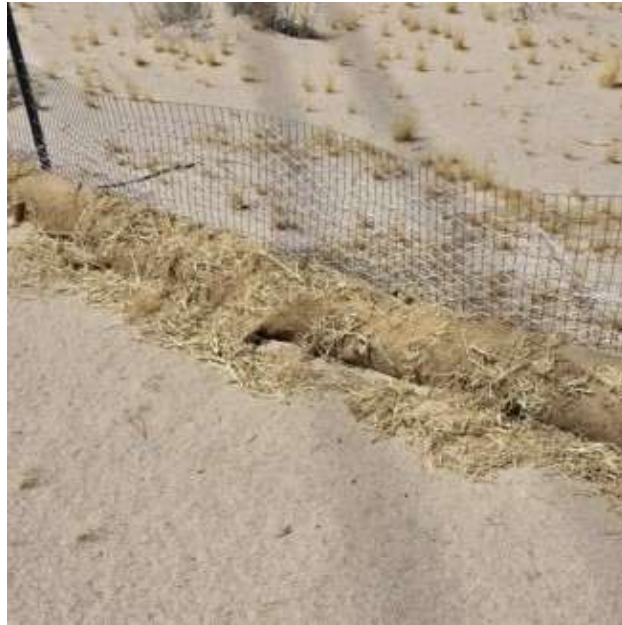
- QSP August 14th inspections identified (for the second time during the reporting period) multiple damaged perimeter wattles at both SC2 and SC5, consisting of large holes and tears, spilling out of straw material, and loss of functionality as an effective BMP. This observation was recorded by the QSP as a Compliance Checklist Deficiency for this week's inspection and recommended the replacement or removal of the ineffective BMP's (see Photo 5). Outstanding SWPPP maintenance item/corrective actions recorded.

Photo 5: Significant damage to perimeter wattles at SC5, with a splits in the burlap covering, spill out of straw material, and loss of functionality as a BMP. Photo courtesy of the August 14, 2024 QSP SWPPP inspection.

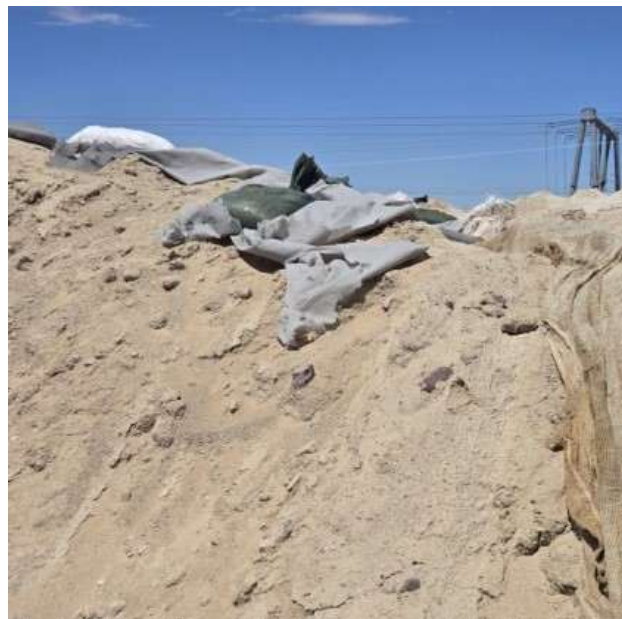
- Weekly QSP inspections throughout the months of August and September 2024 continued to record the previously-identified damaged perimeter BMP's (wattles) originally identified on July 24th at SC2 and SC5, and the damaged stockpile coverings at SC2 as still outstanding and requiring maintenance/corrective actions (see Photos 6 and 7).

Photo 6: Damaged/large rip in stockpile covering (containing stockpiled soil) remains unaddressed at SC2. The geo-tex fabric has torn apart across the top edge of this stockpile. Photo courtesy of the August 21, 2024 QSP SWPPP inspection.

Currently, no BMP maintenance activities are scheduled due to the proximity of the reclamation timeline (reclamation process beginning in the coming weeks).

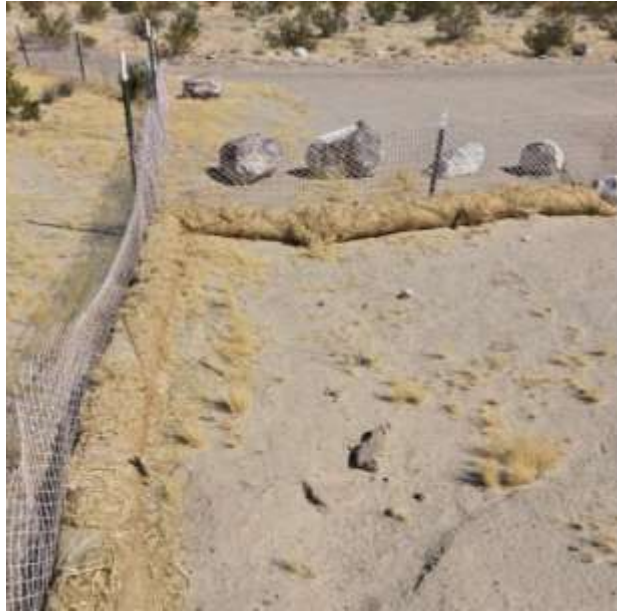
Photo 7: Significant damage to perimeter wattles at SC5, with loss of functionality as a BMP. Outstanding SWPPP maintenance needed/corrective action required. Photo courtesy of the September 25, 2024 QSP SWPPP inspection.
