FAULT HAZARD INVESTIGATION  
STRUCTURE EP257  
SDG&E SUNRISE POWERLINK PROJECT  
IMPERIAL COUNTY, CALIFORNIA

URS PROJECT No. 27661032.04001

**AUGUST 29, 2011**

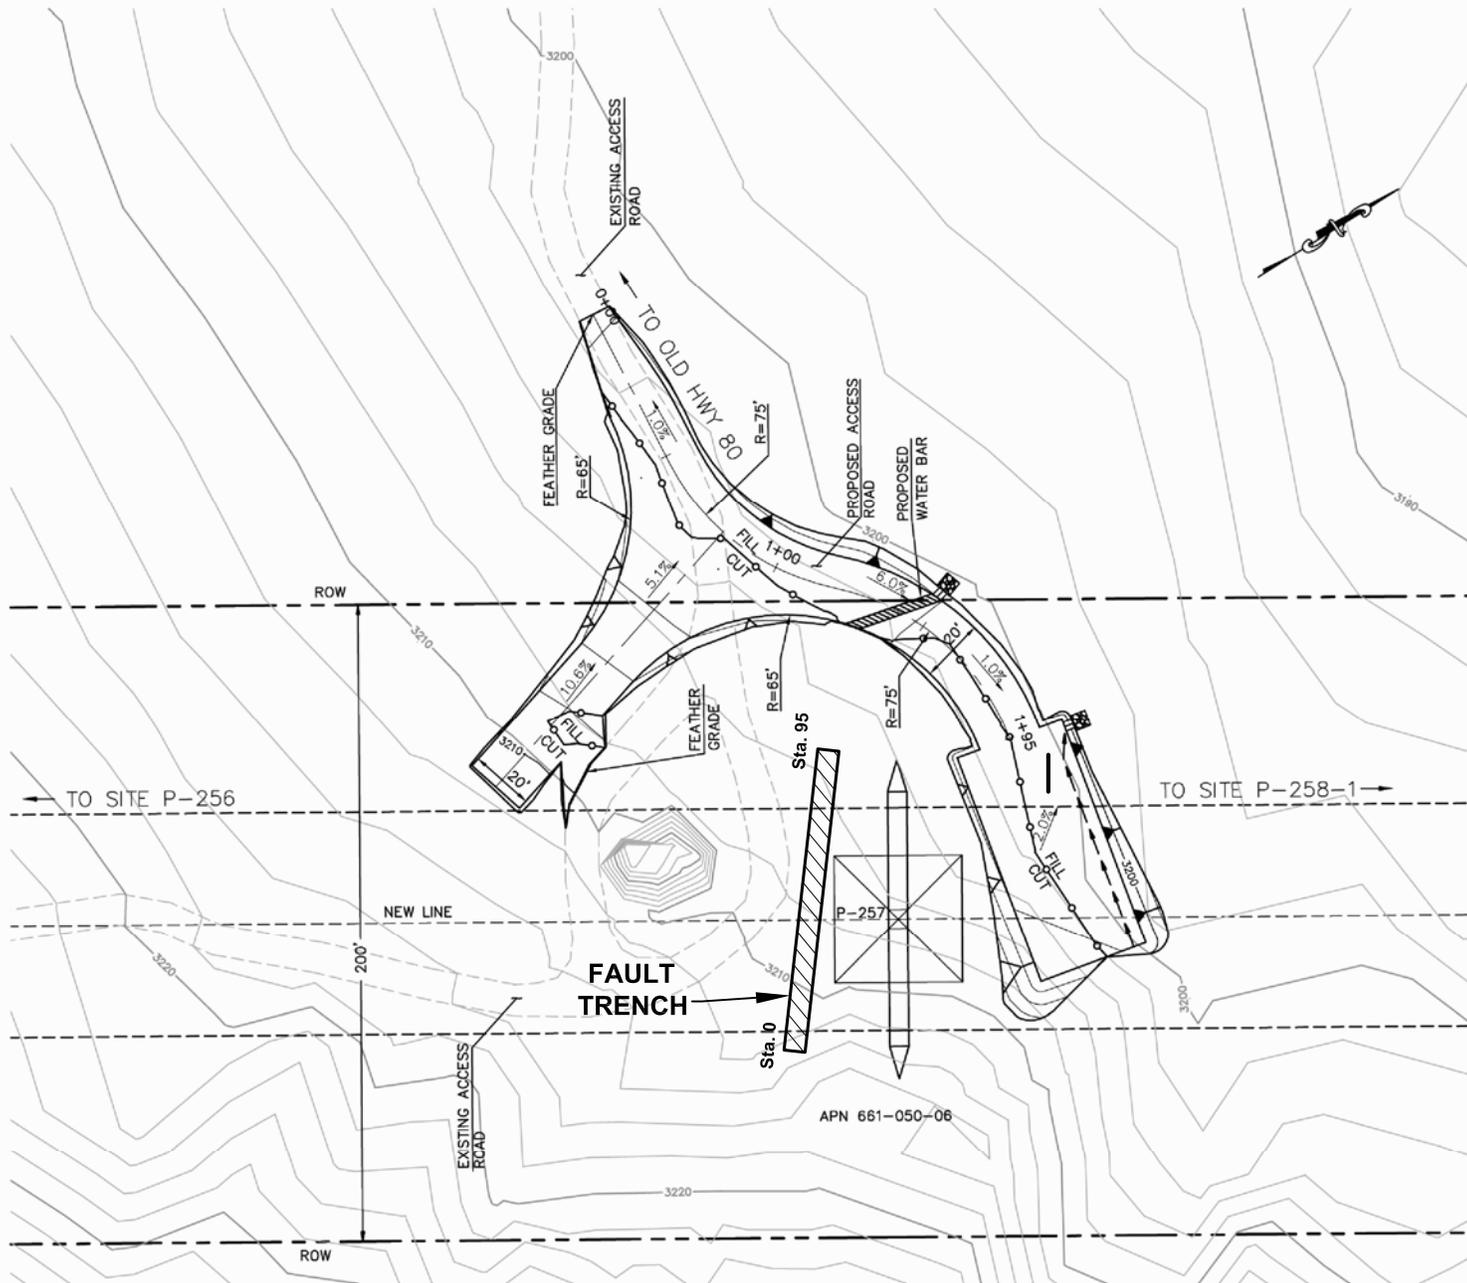
<b>SITE PLAN</b>		FIGURE NO: <b>3</b>
		<b>EP257 FAULT HAZARD INVESTIGATION SUNRISE POWER LINK PROJECT</b>		
		CHECKED BY: MEH	DATE: 08-29-11	
		PM: CRS	PROJ. NO: 27661032.04001

The trench was excavated across the proposed pad area for Structure EP257 as shown on Figure 3. The exposure revealed alluvial and colluvial deposits overlying granitic bedrock. The Quaternary age alluvial deposits thicken to the north as presented on the trench log of the exposure (Figure 4).

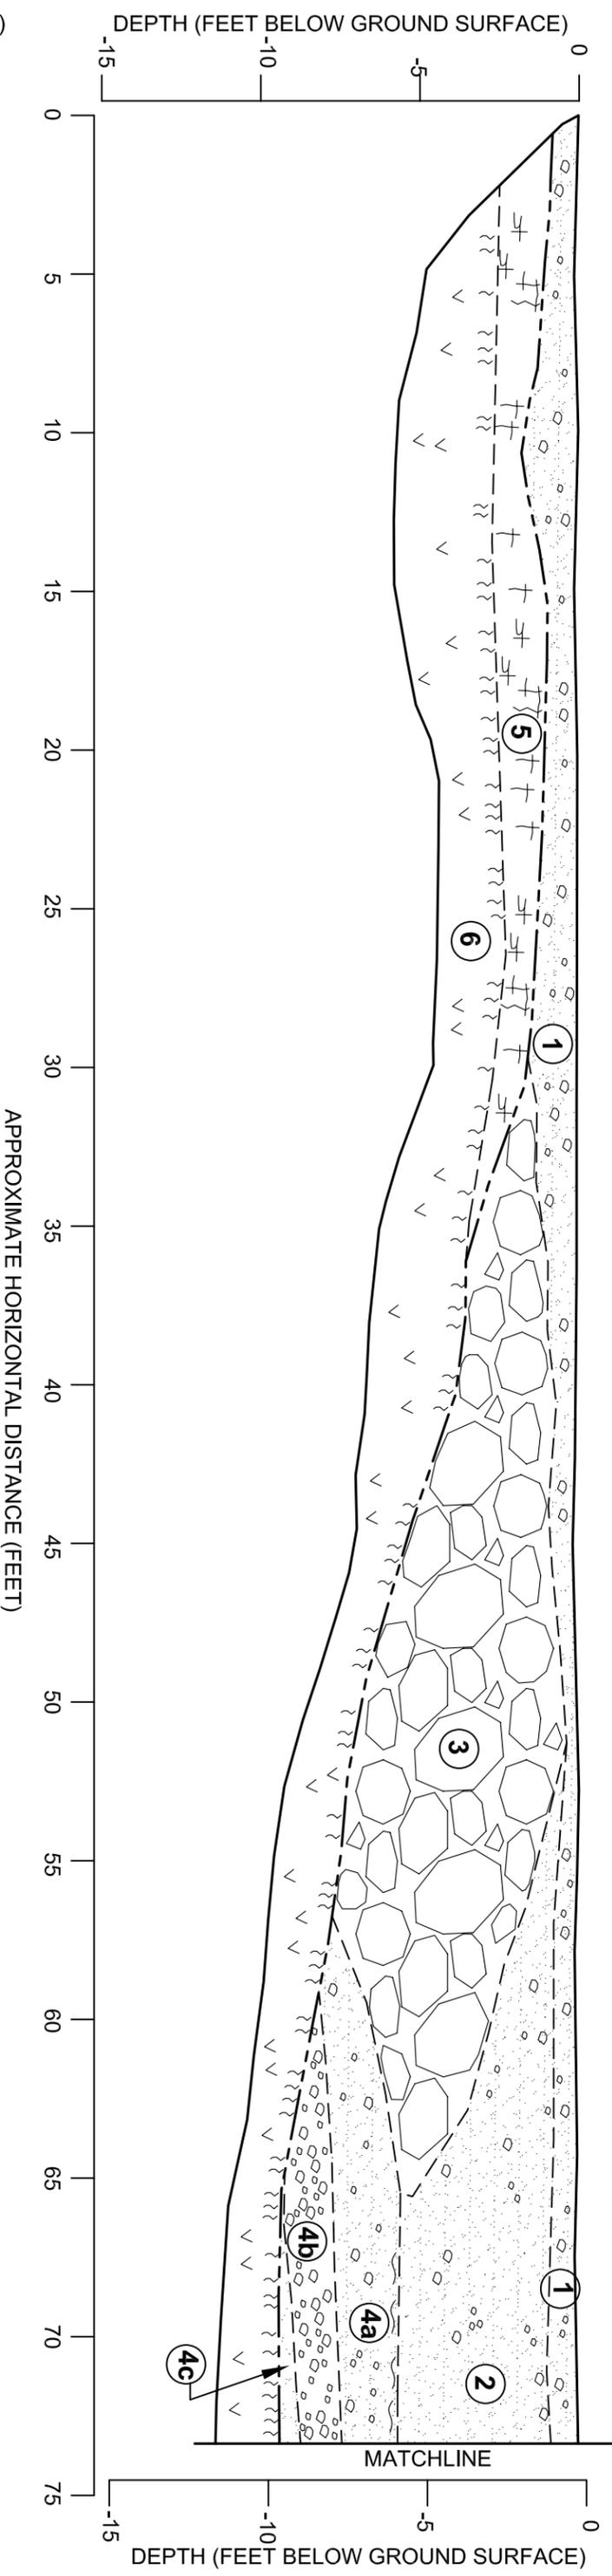
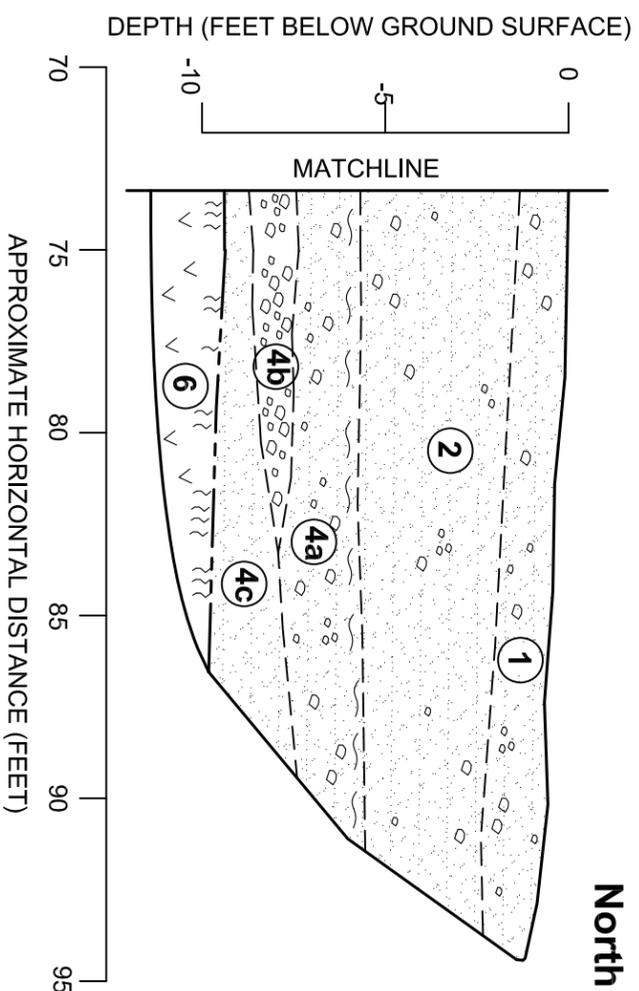
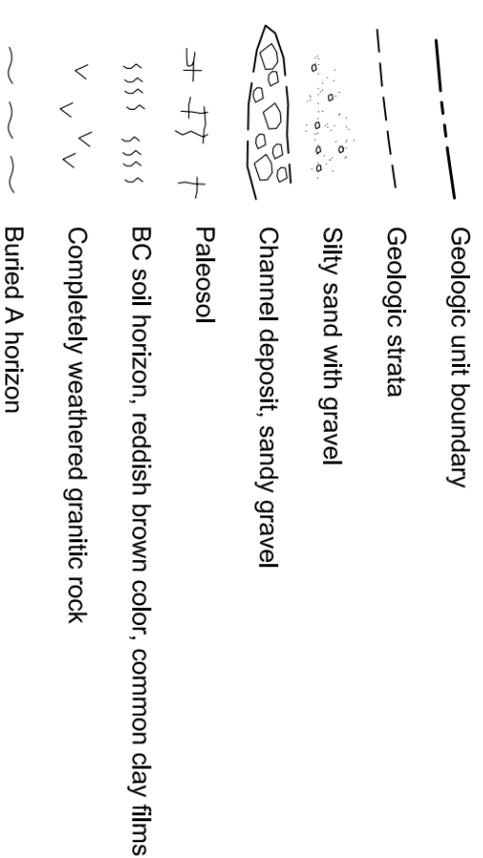
<b>TRENCH LOG</b>			
<b>EP257 FAULT HAZARD INVESTIGATION</b>			
<b>SUNRISE POWER LINK PROJECT</b>			
<b>URRS</b>			
		<b>2.5</b> <b>0</b> <b>2.5</b> <b>5 Feet</b> SCALE: 1" = 5' (H&V)	
CHECKED BY: MEH	DATE: 08-29-11	FIG. NO:	4
PM: JM	PROJ. NO: 27661032.04001

The surficial alluvial deposits include a very coarse-grained channel fill that included boulder sized clasts. The granitic rock exposed is completely weathered and includes a clayey residual soil. This paleosol is overlain by topsoil (A horizon material) at the southern end of the trench and deepens and is buried by an increasing thickness of alluvium to the north.

The alluvium deepens to the north and includes a series of subunits that vary from silty fine to coarse sand, to sandy gravel, and includes the sandy cobble and boulder channel deposit. Weathered granitic rock underlies the alluvial deposits. A well-developed argillic (clay-rich, Bt) soil horizon has formed on the bedrock as exposed in the southern portions of the trench. In the central and northern portions of the trench the argillic horizon has been eroded away by the incising, high-energy channel deposits. Evidence for the ancient weathering profile is still evident in the central and northern portion of the trench. A continuous exposure of unfaulted Cretaceous age bedrock was observed and is presented on the trench log. No faults or shears were exposed in the trench or inferred from the trench stratigraphy.

Following fault trenching and geomorphic evaluations in the area of EP257, it is our conclusion that there are no faults within the footprint of EP257. The fault rupture hazard at this structure is considered to be low and no fault hazard mitigations are warranted for the transmission line in this area.

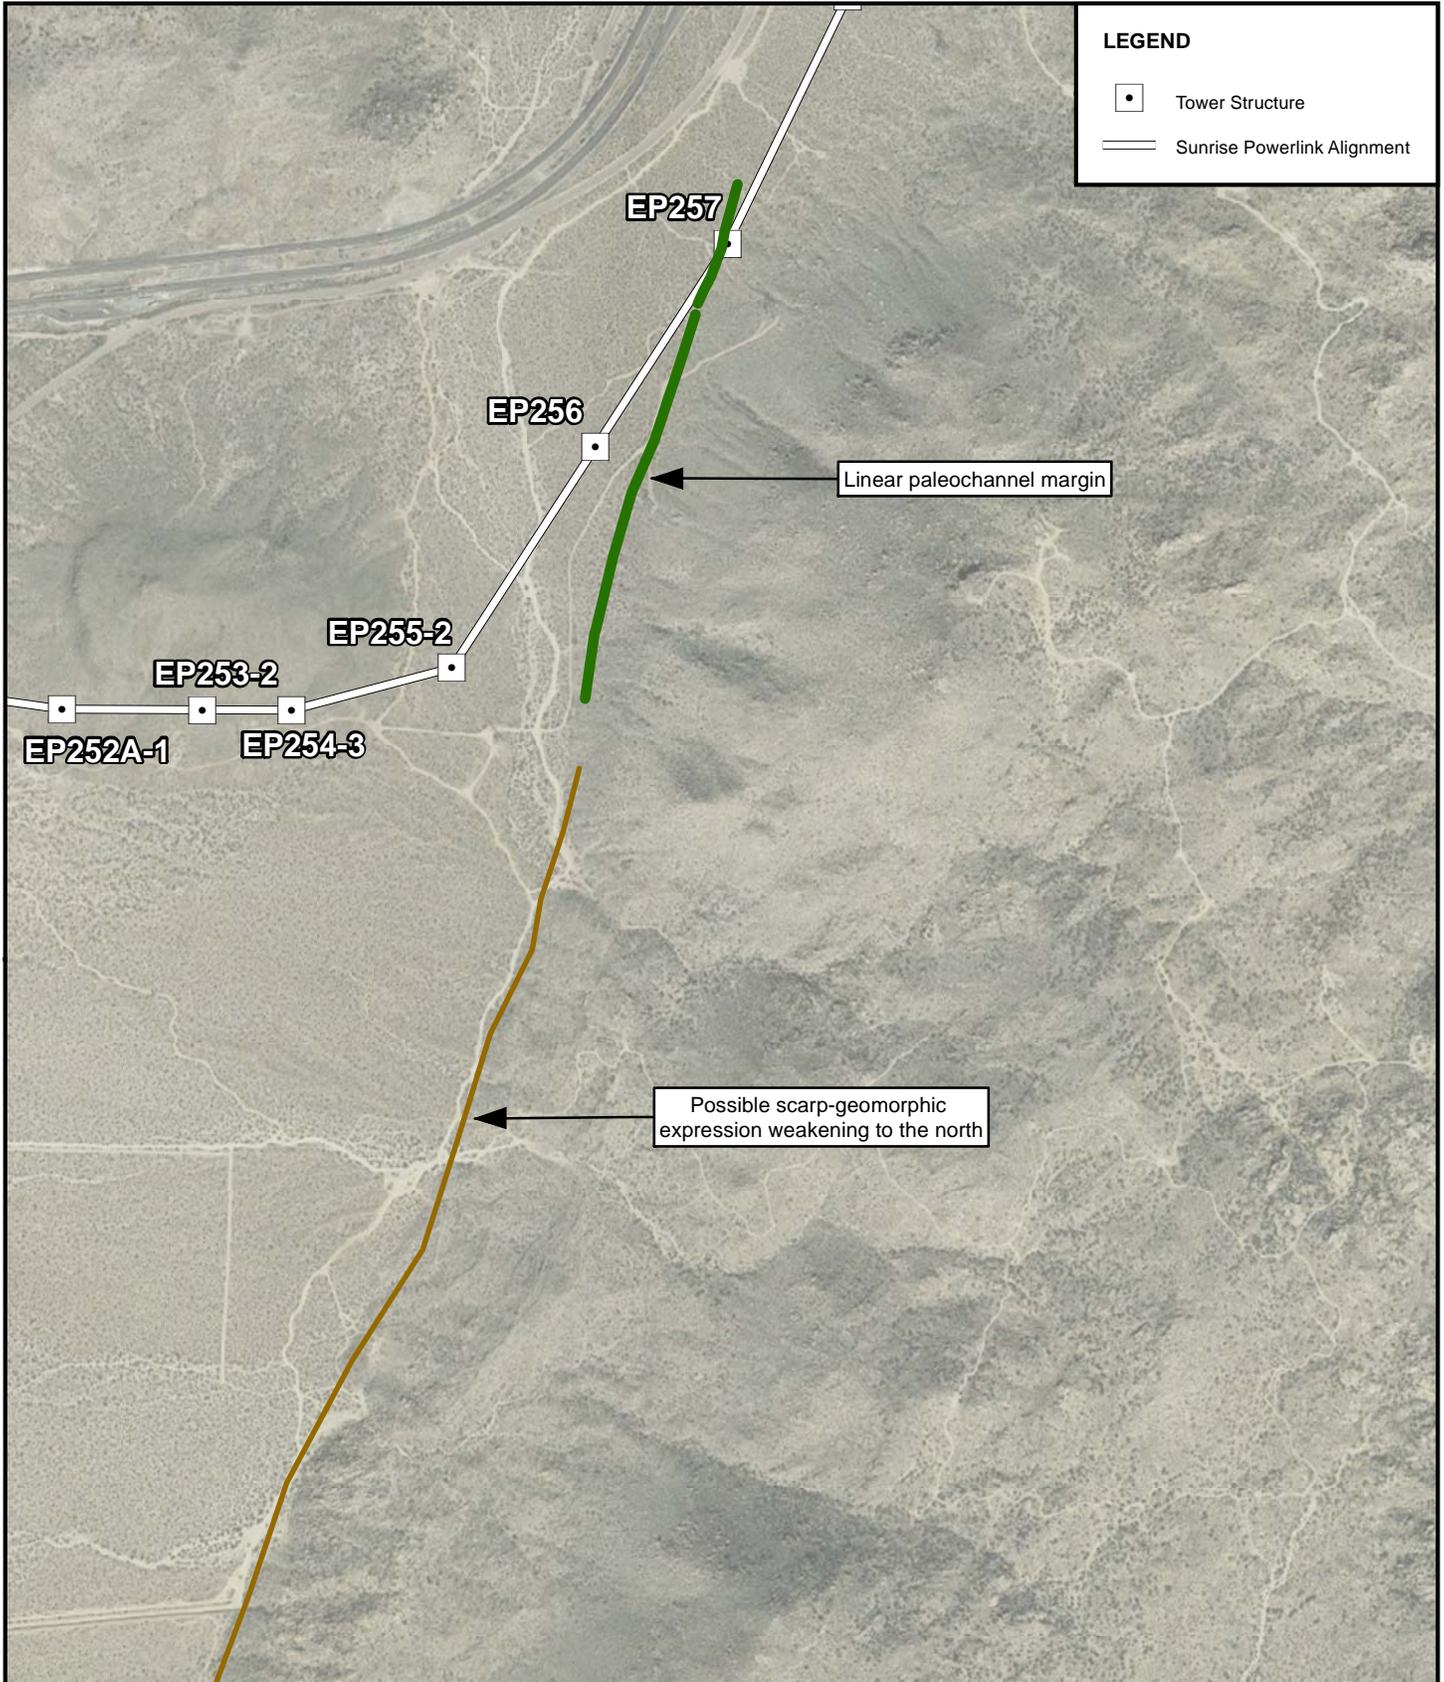
<p>SOURCES: Aerial (USGS, 2008), Sunrise Powerlink Alignment and Tower (SDGE, 2009), Faults (URS 2011).</p>	<p><b>SITE GEOMORPHOLOGY</b> <b>EP 257 - FAULT HAZARD INVESTIGATION</b> <b>SUNRISE POWERLINK PROJECT</b></p>

Fault trenching was performed at EP257 because of the possible presence of a fault identified by microseismicity that has some moderate geomorphic expression to the south of the project area. The geomorphic expression of faulting weakens to the north and the possible eroded scarp noted in the EP257 area is an eroded channel margin and not a tectonic feature indicative of fault rupture in the geologic past. Based on the absence of fault features in the bedrock exposures in the trench, it is apparent that the eroded spur previously identified as a possible scarp is the result of the high energy alluvial paleochannel that was exposed in the trench. Figure 5 presents the location of the possible eroded scarp south of the project area and the location of the lineament previously considered a possible projection of a fault scarp. This feature is interpreted as an eroded channel margin based on the findings of the exploratory trench at Structure EP257.
