**PROJECT MEMORANDUM
SDG&E'S SUNRISE POWERLINK PROJECT**

To: Billie Blanchard, Project Manager, CPUC
From: Vida Strong, Aspen Project Manager
Date: October 22, 2010
Subject: Weekly Report 4 – October 10 to October 16, 2010

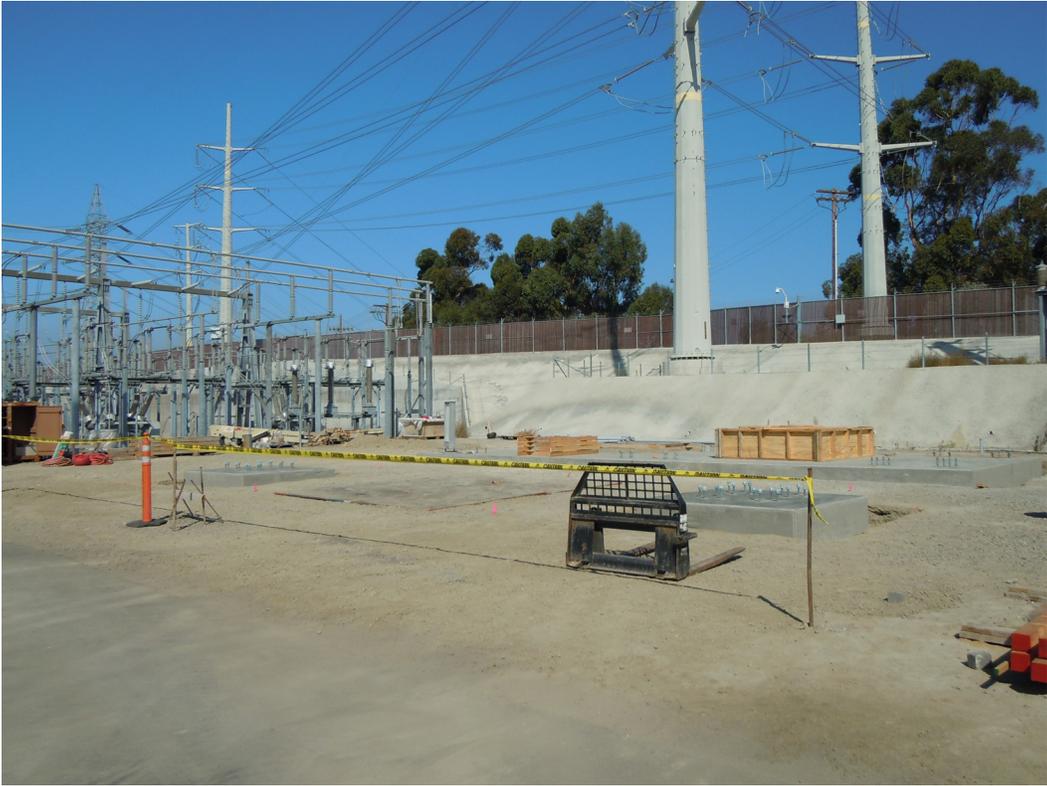
1. Trenching activities were covered and crews worked on building the 69 kV Capacitor Bank at the South Bay Substation.
2. Excavation continues at the San Luis Rey Substation. Stockpiles were contained and no visible track-out was noted (see Figure 1)
3. Construction of the Encina Switchyard commenced on October 11, 2010. Material delivery was conducted, but no ground disturbing activities took place during the reporting period (see Figure 2).

Figure 1: San Luis Substation equipment pad.

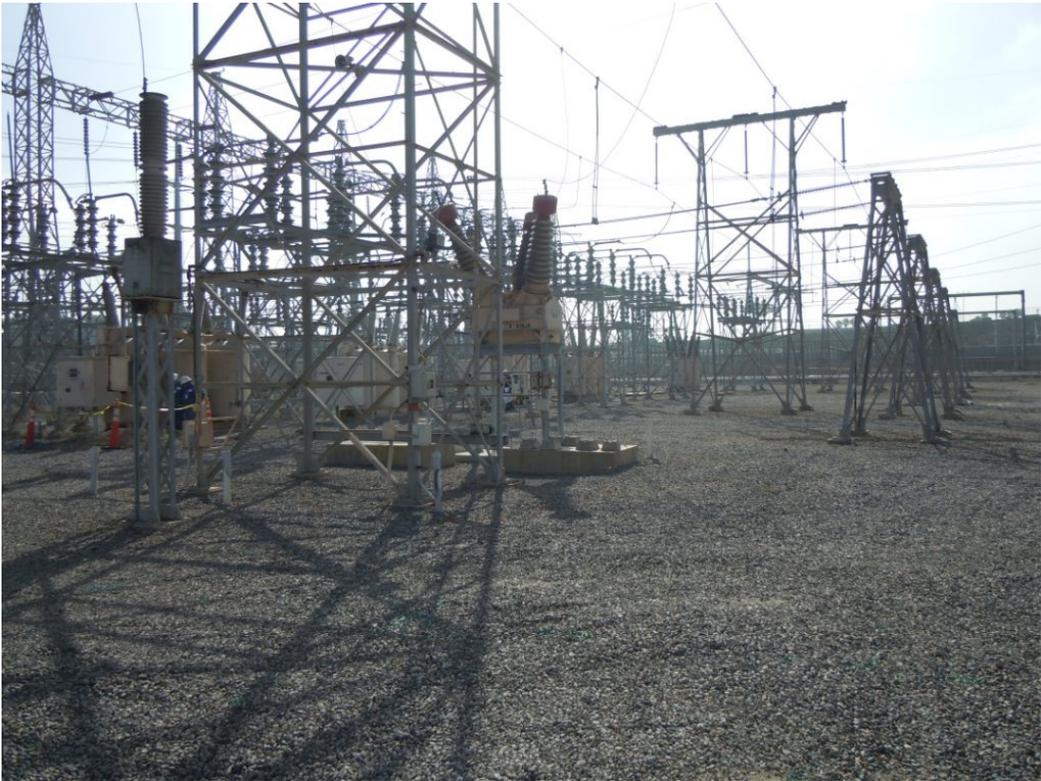
Figure 2: Encina Switchyard.

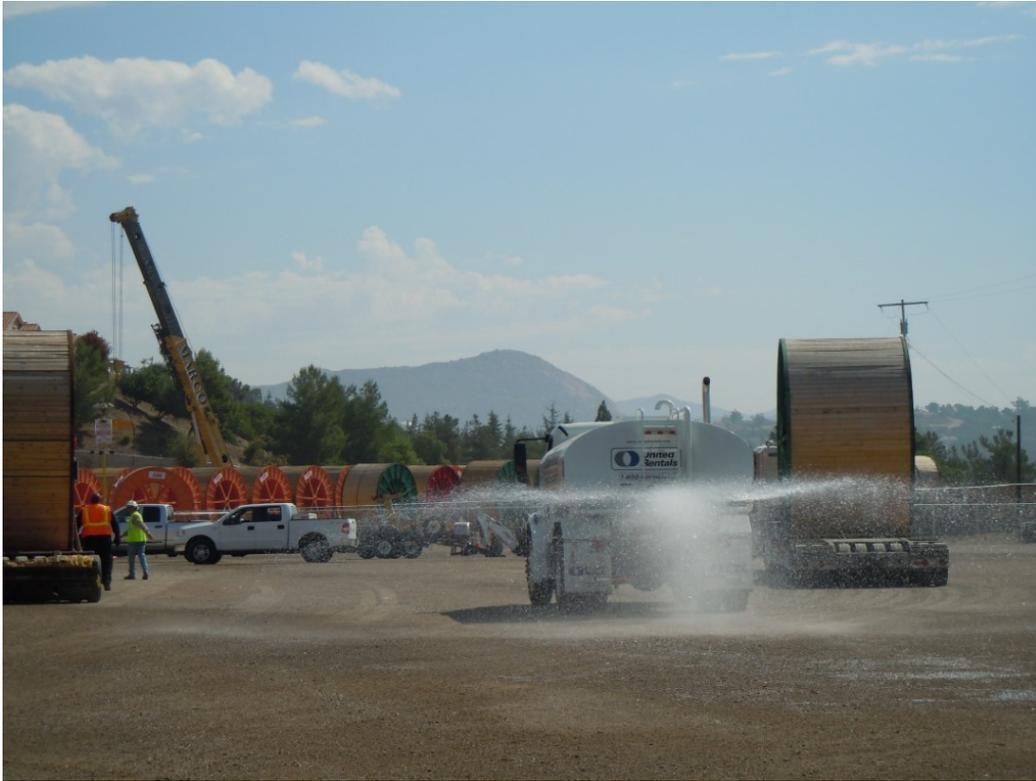
Figure 3: Wire delivery and environmental compliance at the Alpine Construction Yard.

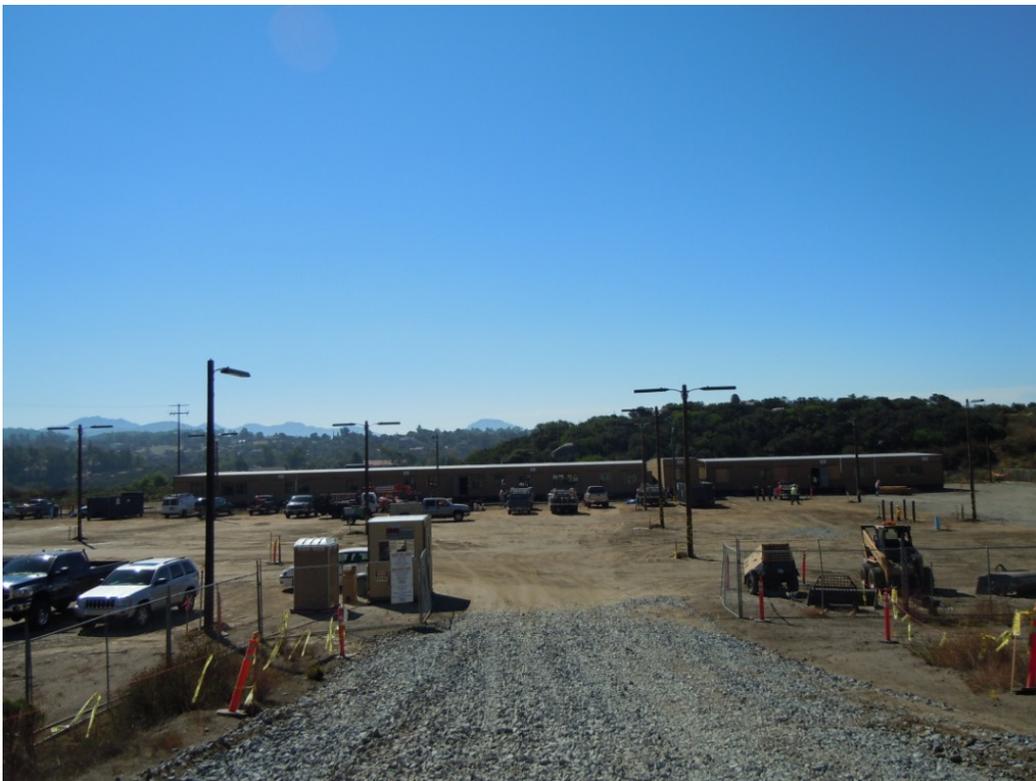
Figure 4: Mobile unit installation at the Alpine Regional Field Office.

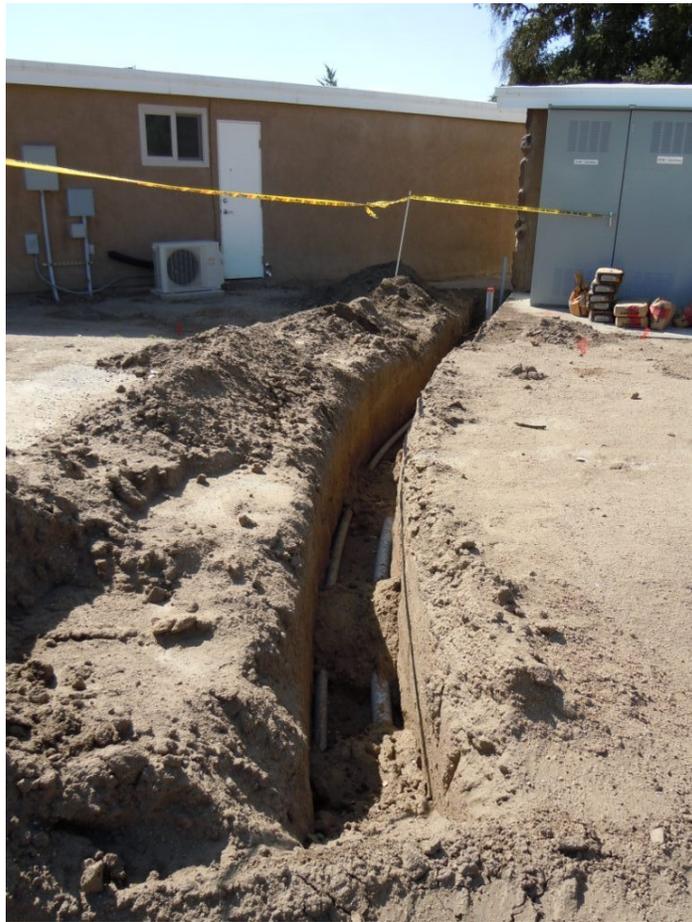
Figure 5: Trenching activities at the Rough Acres Yard.
