**PROJECT MEMORANDUM
SDG&E'S SUNRISE POWERLINK PROJECT**

To: Billie Blanchard, Project Manager, CPUC
From: Vida Strong, Aspen Project Manager
Date: January 7, 2011
Subject: Weekly Reports 14 and 15 – December 19, 2010 to January 1, 2011

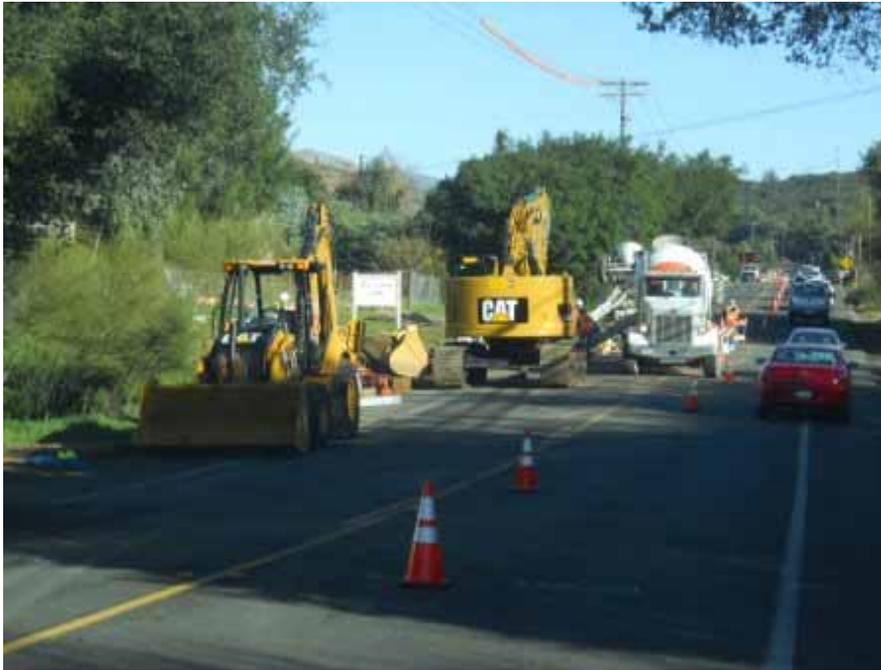
1. Link 4: Activity slowed due to inclement weather. Pot-hole repair was conducted at Vault 9 and 13. Vault 15L and 9L were excavated and set. Excavation preparation was performed at Vault 19L. In and Out trench preparation was performed either side of Vault 18L. Potholing and location trenching was performed at 13L, 14L and between stations 279+00 to 224+00. (See Figure 1)
2. No pre-construction activity occurred during the reporting period.

Figure 1: Alpine Boulevard during underground construction.

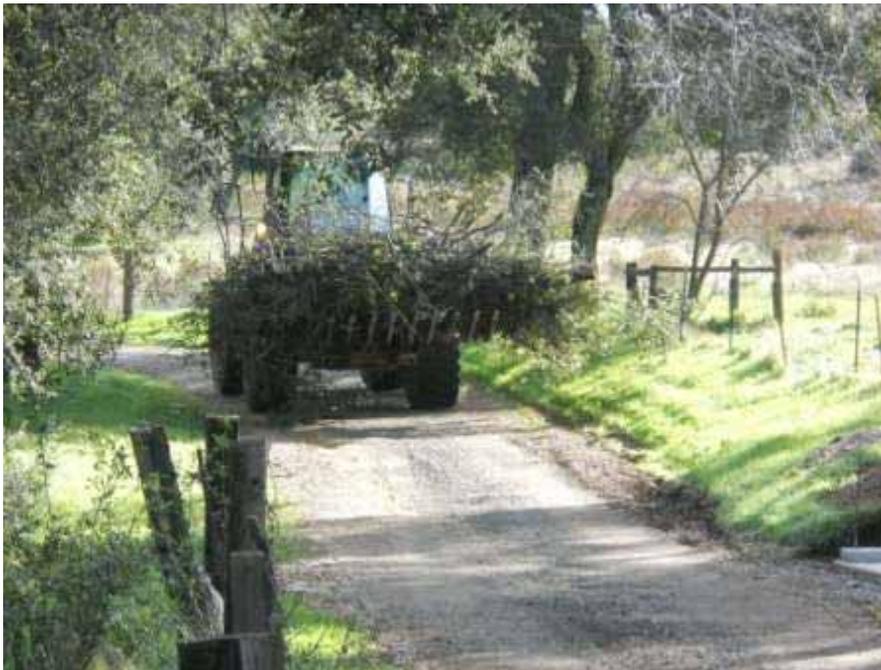
Figure 2: Brush removal at Suncrest Substation.

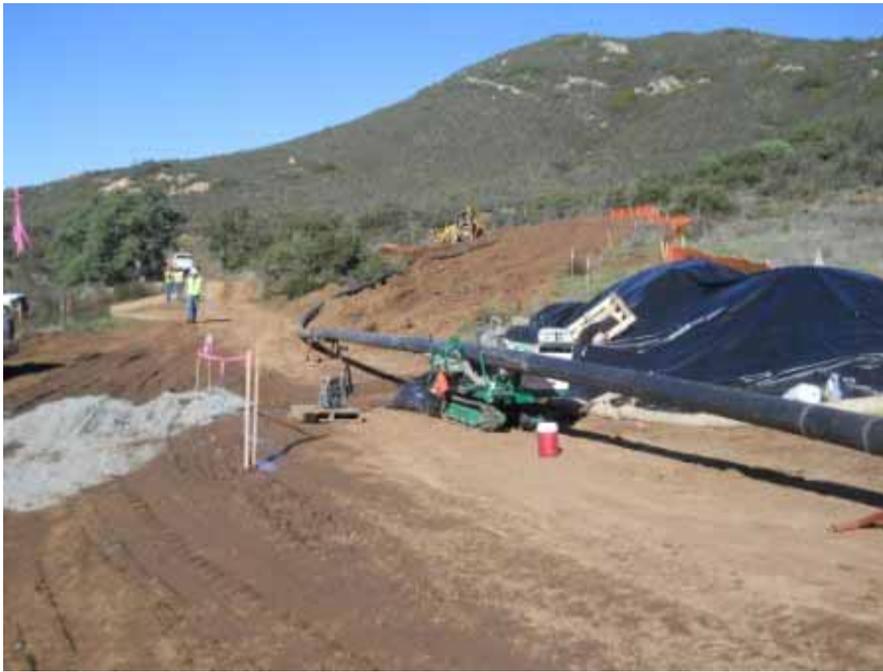
1. Activity was limited during inclement weather at the Suncrest Substation. Vegetation clearing was performed. Tree trimming was performed throughout the Suncrest site in order eliminate potential raptor habitat as identified by qualified biologist. Installation of the high line for the water pad site began. (See Figures 2 and 3)
2. SDG&E crews performed testing within the control room at San Luis Rey Substation.
3. SDG&E crews continue to work at the Encina Switchyard building disconnects. Five core samples were completed on December 31.
4. Work has been completed at the South Bay Substation.

Figure 3: Above ground water line assembly at Suncrest Substation.

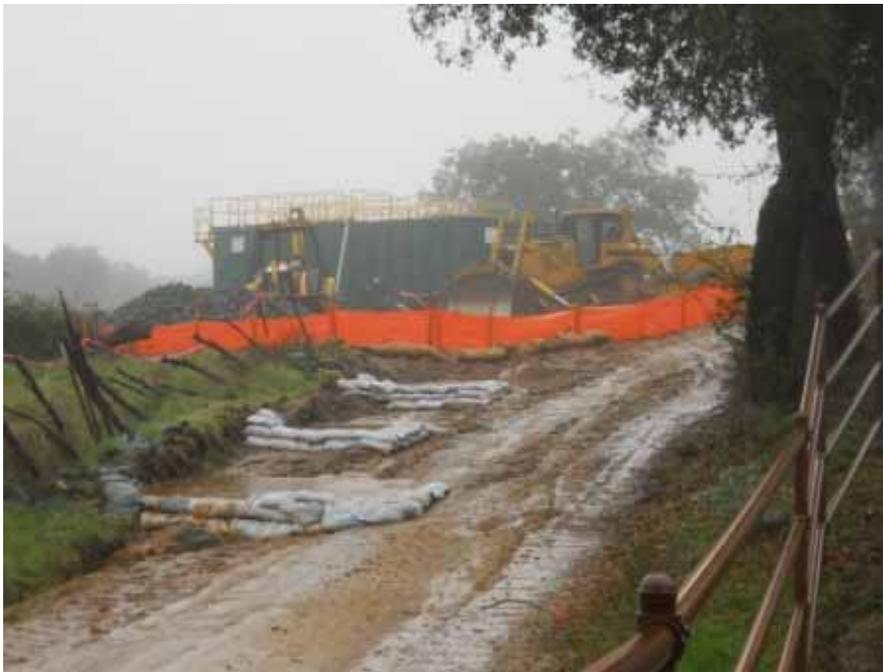
1. Improvements to BMPs were made at Encina after heavy rains in the area revealed deficiencies at a discharge point.
2. BMPs have been installed at the Suncrest Substation and improvements were made as weather moved through the area. (See Figure 4)
3. At the Suncrest Substation, biological monitors have found and relocated multiple non sensitive animals, such as gopher snakes, rats and mice, to areas outside of project disturbance areas.
4. Biological, Cultural and Native American monitors have been present during ground disturbing activities at the Suncrest Substation. Biological Monitors were also present for vegetation clearing activities.

Figure 4: BMPs at Suncrest Substation during rain event.

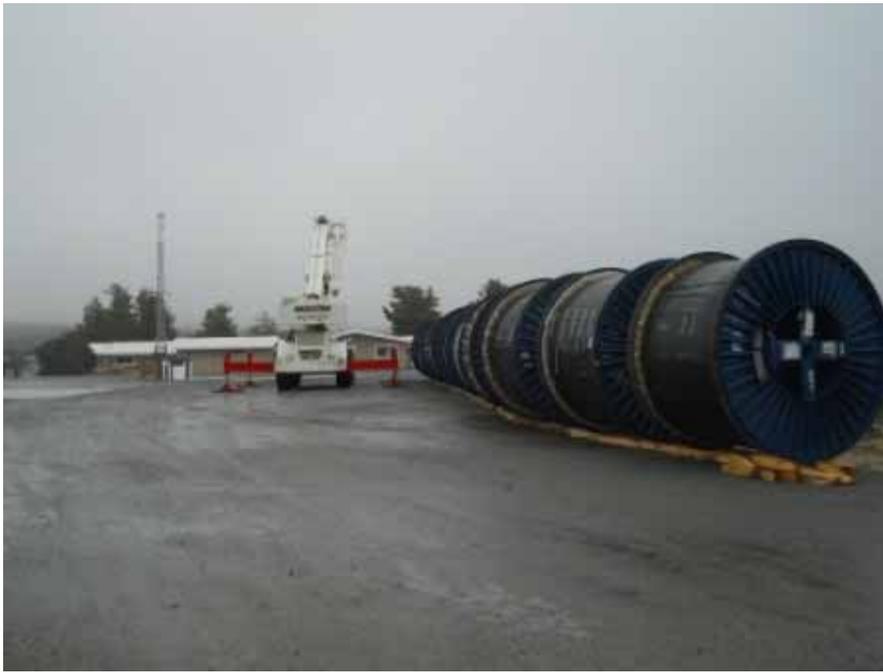
1. Delivery of equipment and wire reels continued at the Alpine Construction Yard.
2. Installation of an additional office modular was conducted at the Alpine Regional Field Office (Alpine RFO).
3. As weather permitted, tower assembly and wire deliveries were conducted within Rough Acres Phase I. The NTP for Phase II was issued by CPUC. Special status plants were flagged pending final approval of the Restoration Plan for Special Status Plants. (See Figure 5)
4. Sorting and moving of steel was conducted at the Thomas Yard.

Figure 5: Wire reel delivered at Rough Acres.
