**PROJECT MEMORANDUM
SDG&E'S SUNRISE POWERLINK PROJECT**

To: Billie Blanchard, Project Manager, CPUC
From: Vida Strong, Aspen Project Manager
Date: March 24, 2011
Subject: Weekly Reports 25 – March 6 to March 12, 2011

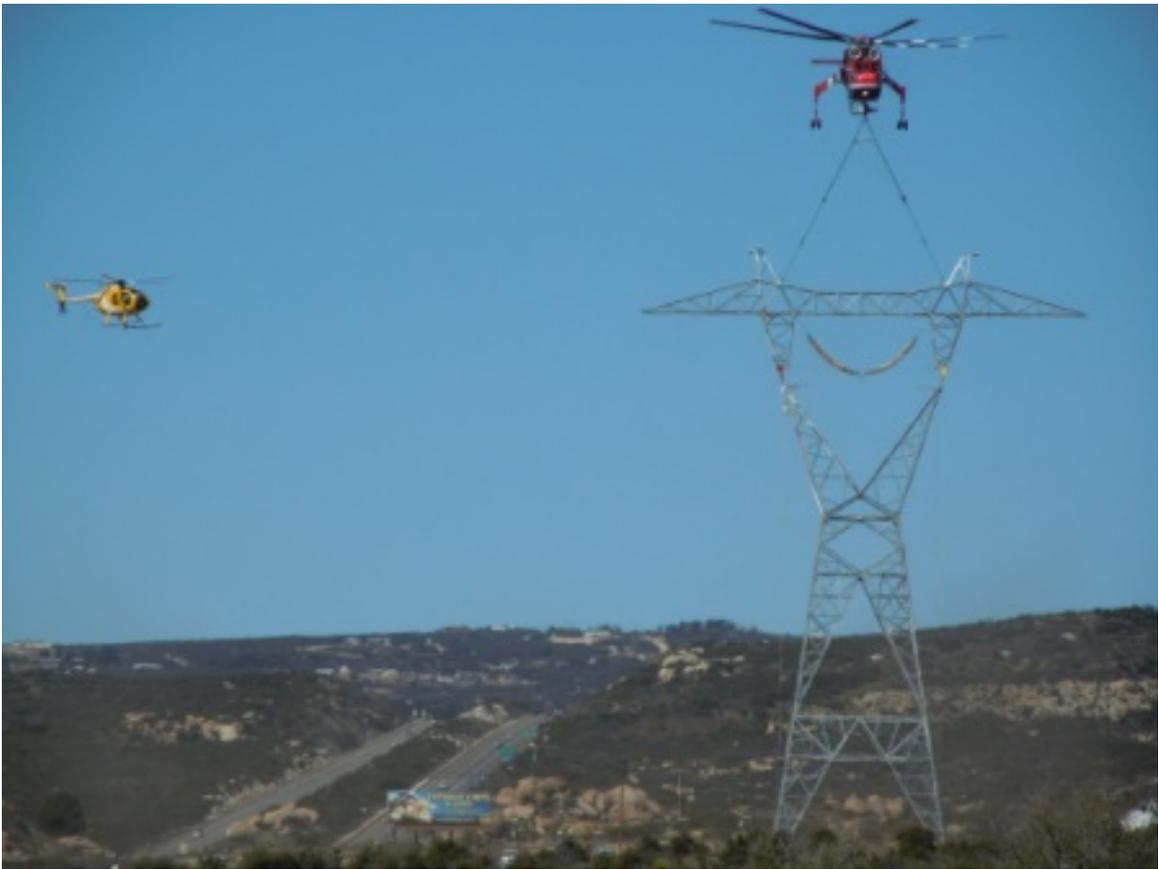
- Helicopter structure assembly took place at EP 227, EP 228, EP 229-1, EP 230-1, EP 231-1, EP 232-1, EP 233-1, EP 234-1, EP 235-1, EP 236-1, EP 237-1, EP 238-1, EP 239-1, EP 244, EP 245-1, EP 246, EP 247, EP 248, EP 249, EP 250, EP 251, EP 194-2, EP 195-1, EP 197-2, and EP 199-3 (see Figure 1).

Figure 1: Air crane is placing the bridge on EP 217, Link 1.

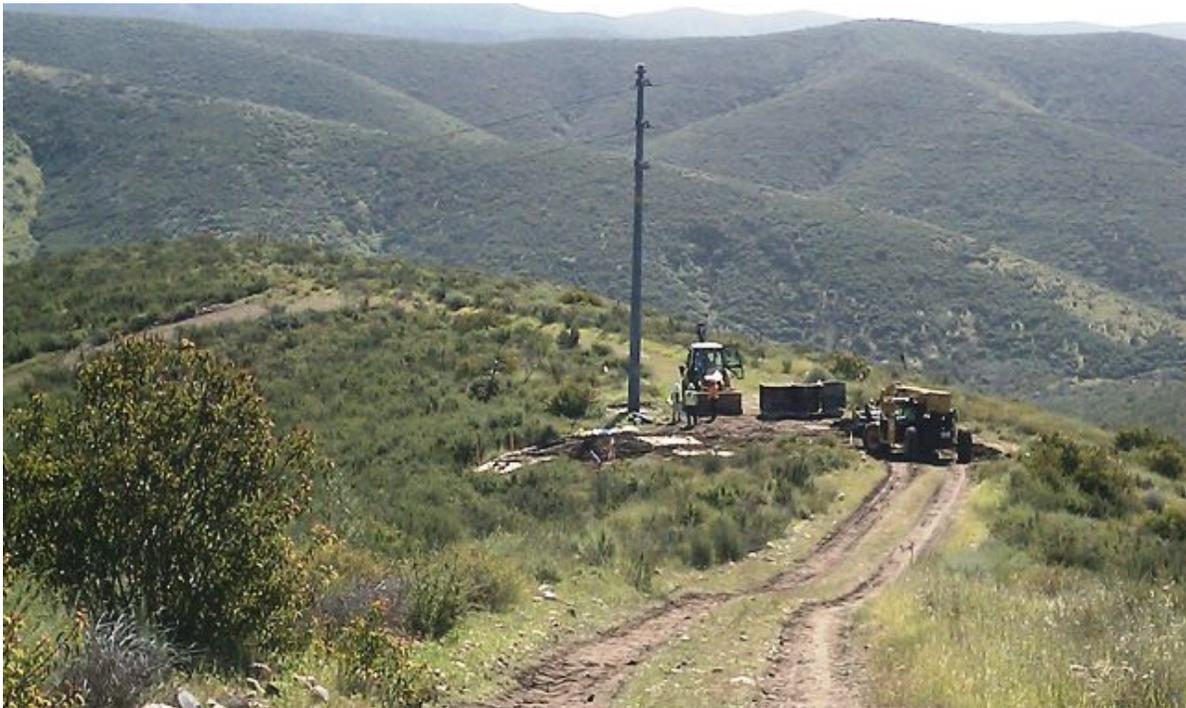
- V17L and V16L were poured and encased.
 - Drilling continues at the south jack-and-bore site.
4. Link 5, 220 kV Overhead Transmission Line:
 - Conventional foundation work occurred at CP 17-1 (see Figure 2).

Figure 2: Drilling operations at CP 17-1, Link 5.

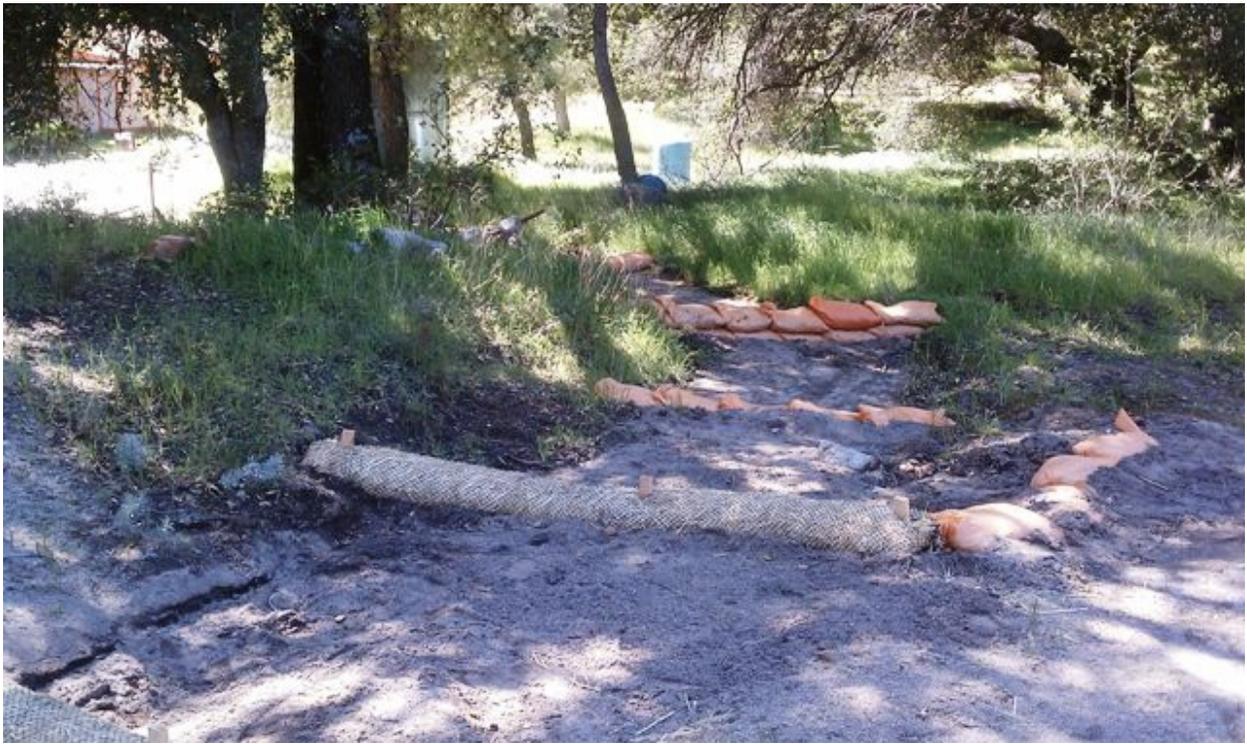
Figure 3: Stormwater BMPs repaired on access road to EP 86, Link 2.

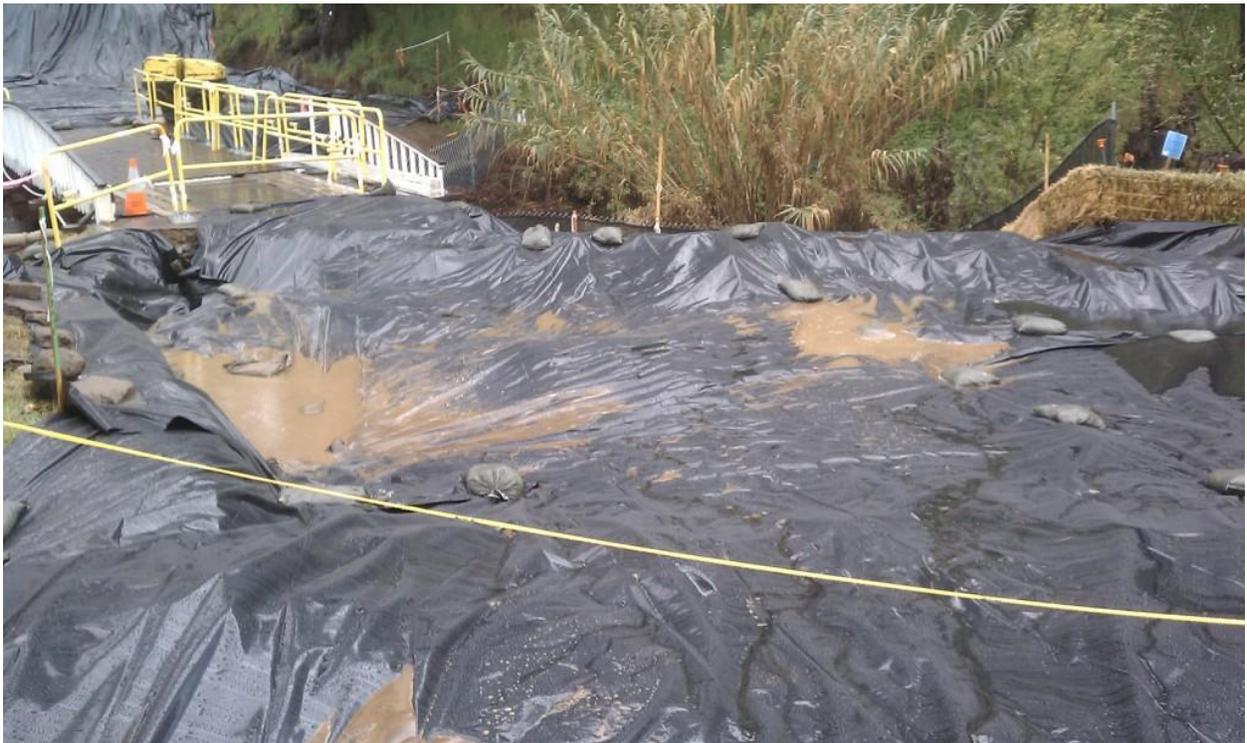
Figure 4: BMPs at Bauer Bridge following the March 7 rain event, Link 4.

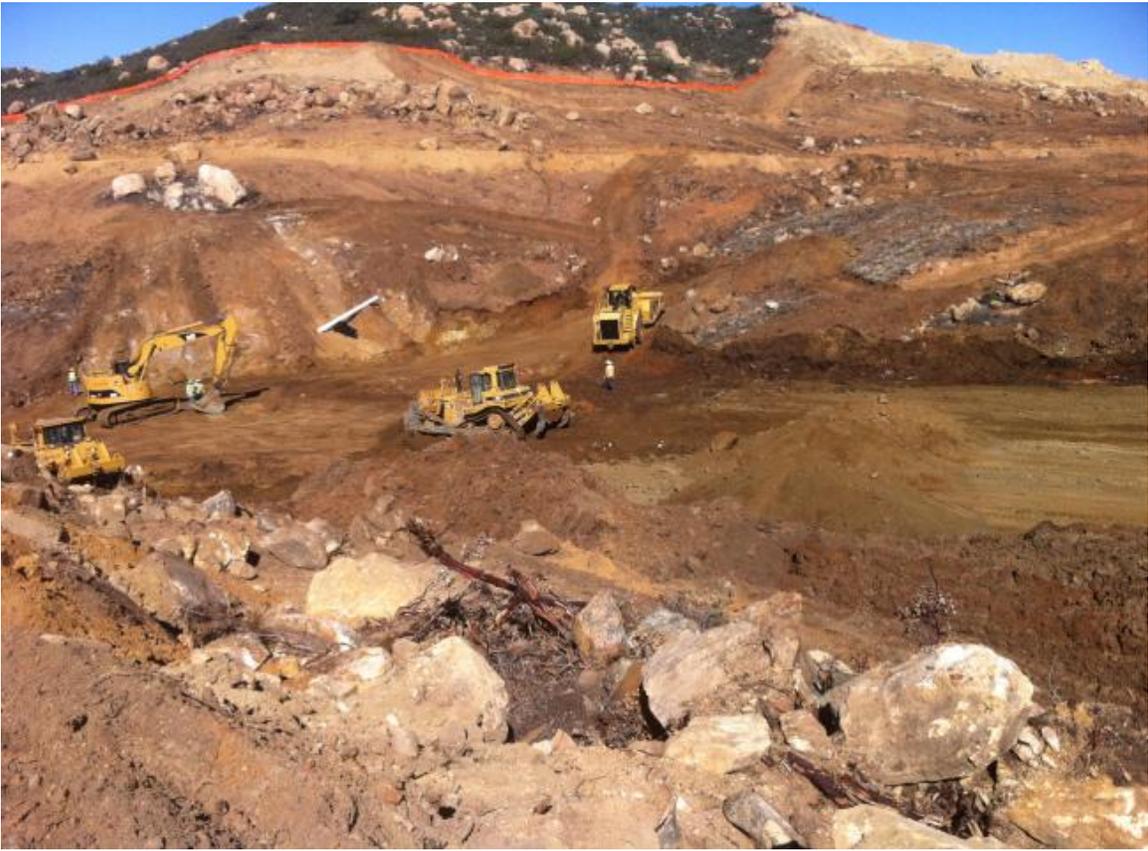
1. Suncrest Substation (Link 3): The canyon drain in the southern drainage area of the pad was installed to collect groundwater (see Figure 5). Drilling and blasting was conducted in several areas on the pad. Rough grading continued on the pad and along the access road. Fill material was hauled in to the low areas in the northern and southern portions of the pad.
2. Imperial Valley Substation Upgrade: The contractor was on site excavating for switch and breaker pads, trenching for electrical conduit, framing, and installing rebar.
3. San Luis Rey Substation: A retaining wall was constructed around 230 kV transformer. Crews were finishing a 69 kV Tie Line and worked within the control room.
4. Encina Substation: A new control shelter, breaker pads, and potential transformer pads were constructed. A drilling crew was on site to drill for switch stands and dead ends.

Figure 5: Grading and drain installation in southern portion of the Suncrest Substation pad site, Link 3.

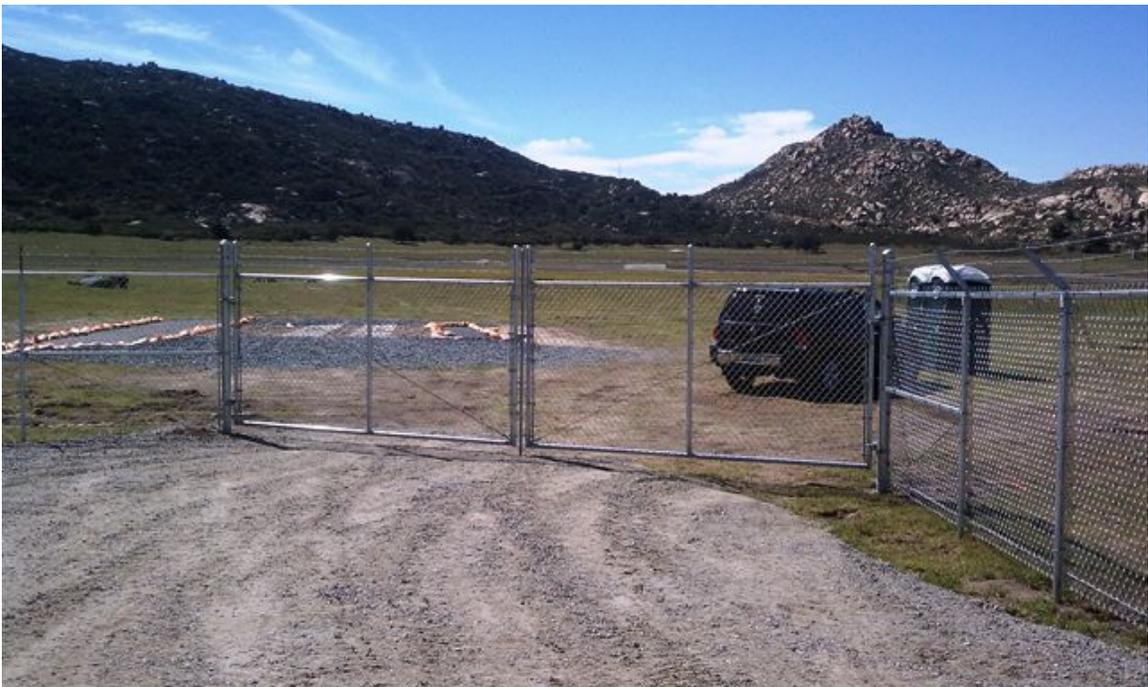
7. Steel delivery and structure assembly occurred at the Helix Construction Yard. An active bird nest affected access to the yard. The weed wash station was completed.
8. Tower assembly and helicopter operations continued at the Bartlett-Hauser Construction Yard.
9. There was minimal activity at the SWAT Construction Yard
10. Fencing and a weed wash station were set up at the Kruetzkamp Construction Yard (see Figure 6).

Figure 6: Weed wash station and fencing installed at Kruetzcamp Construction Yard, Link 2.

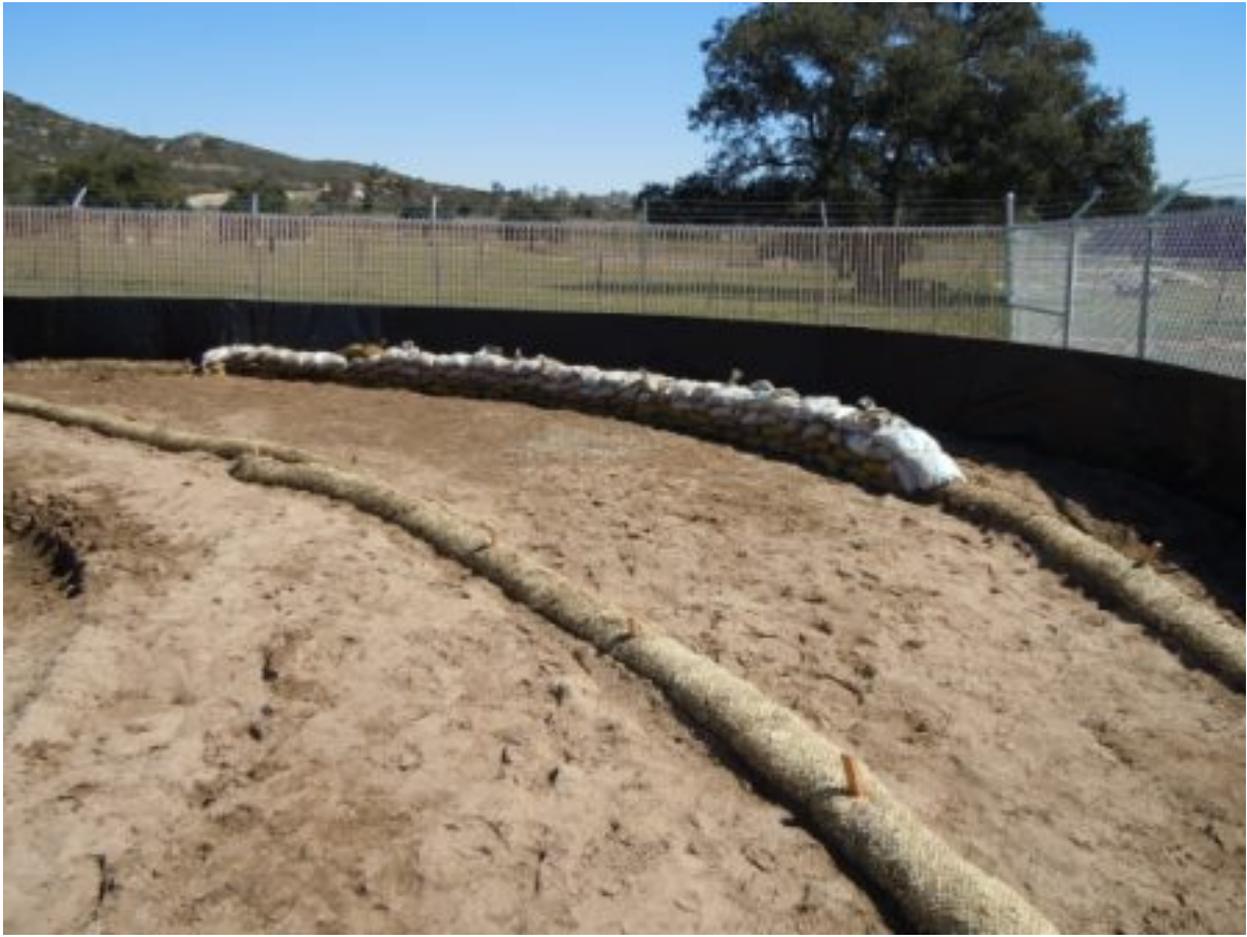
Figure 7: BMPs improvements at Bartlett/Hauser Construction Yard, Link 2.
