**PROJECT MEMORANDUM**  
**PG&E WINDSOR SUBSTATION PROJECT**

**To:** Eric Chiang, Project Manager, CPUC  
**From:** Vida Strong, Aspen Project Manager  
**Date:** December 15, 2016  
**Subject:** Monitoring Report #2 – December 5 to December 11, 2016

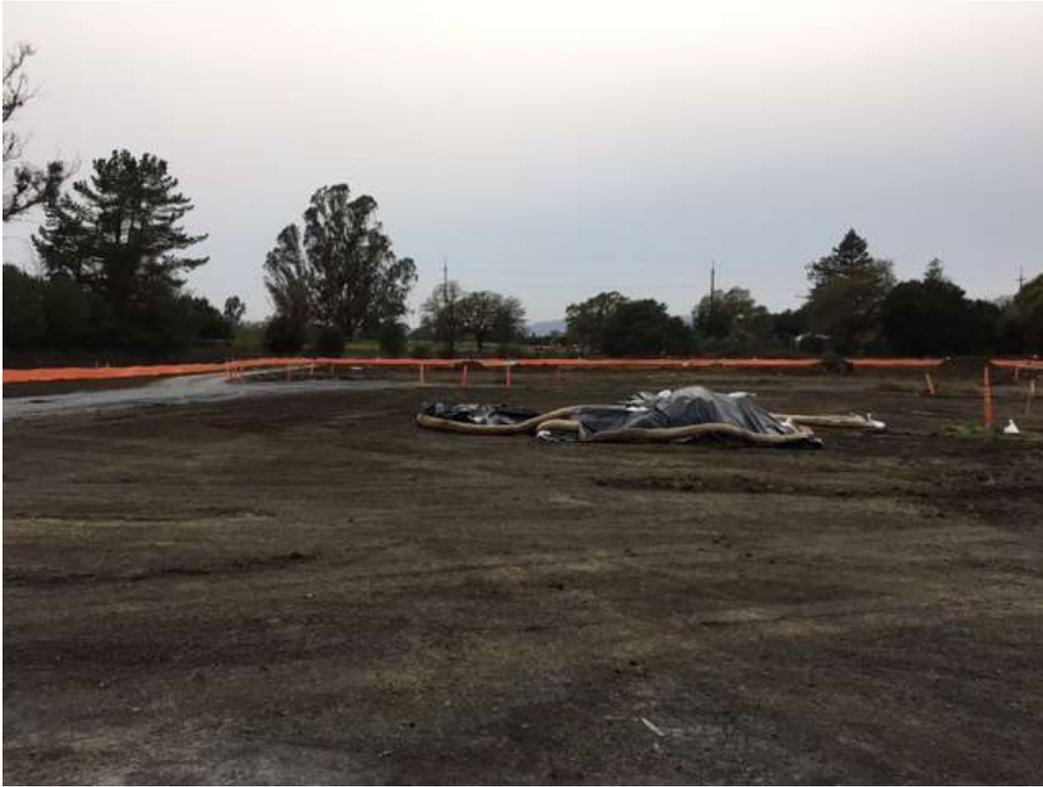
Demolition and excavation activities occurred throughout the week. Demolition activities consisted of removing the concrete pad, the concrete ramp at the northeast corner, portions of the asphalt surface, and concrete rubble buried in the center of the site. Concrete and grubbed vegetation were stockpiled, covered with plastic, and surrounded by fiber rolls, or hauled off site (see Figure 1).

Figure 1 – Substation site with stockpiles covered with plastic and surrounded by fiber rolls, December 7, 2016.

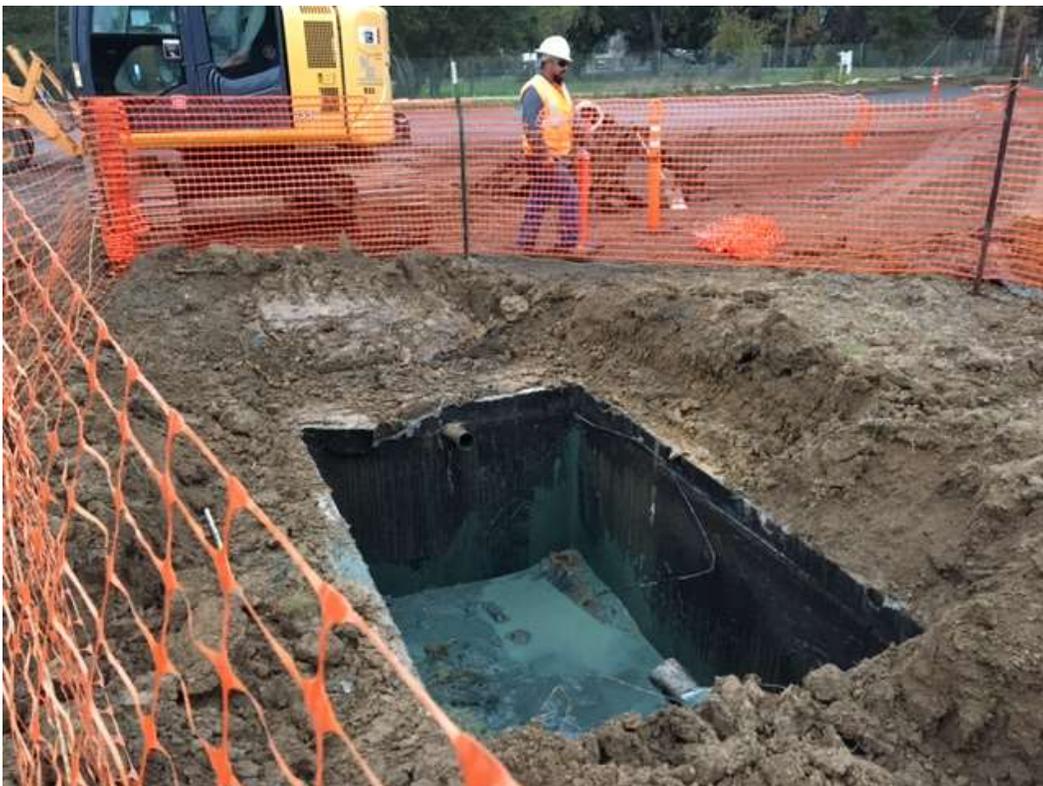
Underground drainage pipes were removed and the trench was compacted. An underground tank, measuring approximately 7 by 10 feet and 6 feet deep, was unearthed (see Figure 2). A septic service pumped fluids from the tank, which was later determined to be a settling tank. As a temporary measure, the tank was covered with plywood and dirt was packed around the perimeter to prevent wildlife entrapment until removal.

Figure 2 – Underground tank encountered, December 7, 2016.

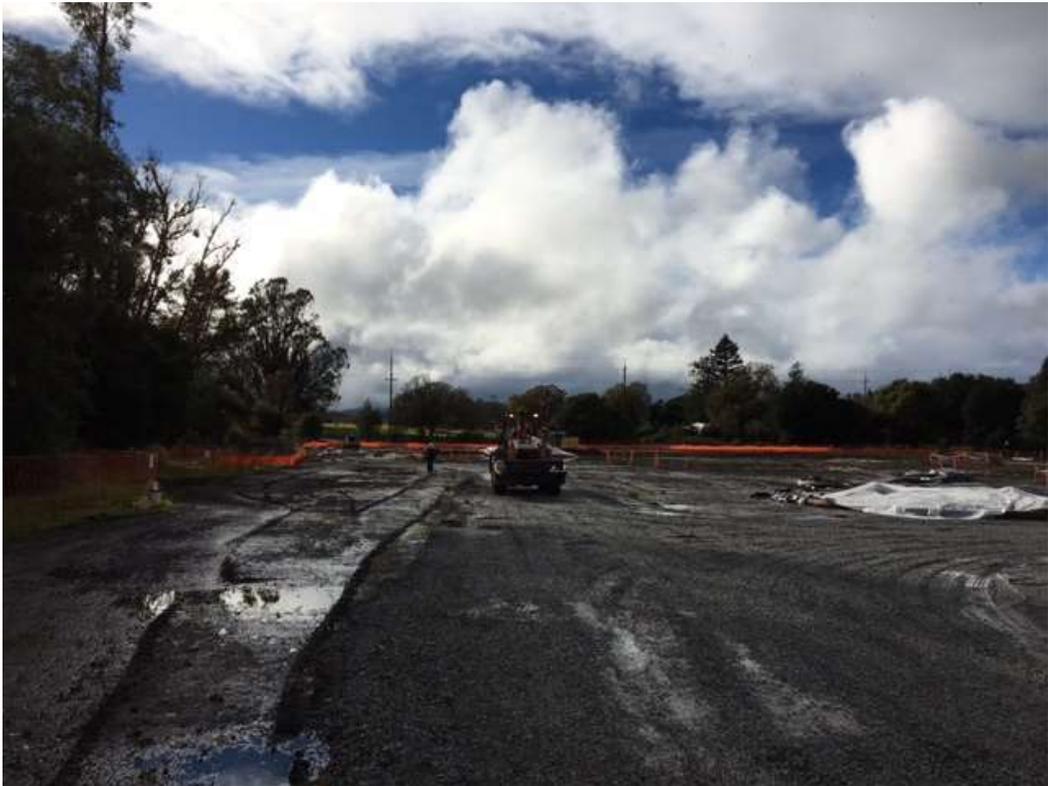
At the time of the CPUC EM’s site visit on Wednesday, December 7<sup>th</sup>, and Friday, December 9<sup>th</sup>, crews were excavating and demolishing concrete (see Figure 3). The area received almost 2 inches of rain between Wednesday and Friday, which resulted in a lot of standing water in the middle of the substation site where excavations were taking place. Storm water from the site was also flowing in the direction of the drainage inlets on the northern perimeter of the site, and BMPs were installed around these drainage inlets (see Figure 4).

Figure 3 – Demolition of existing concrete pads at substation site, December 9, 2016.

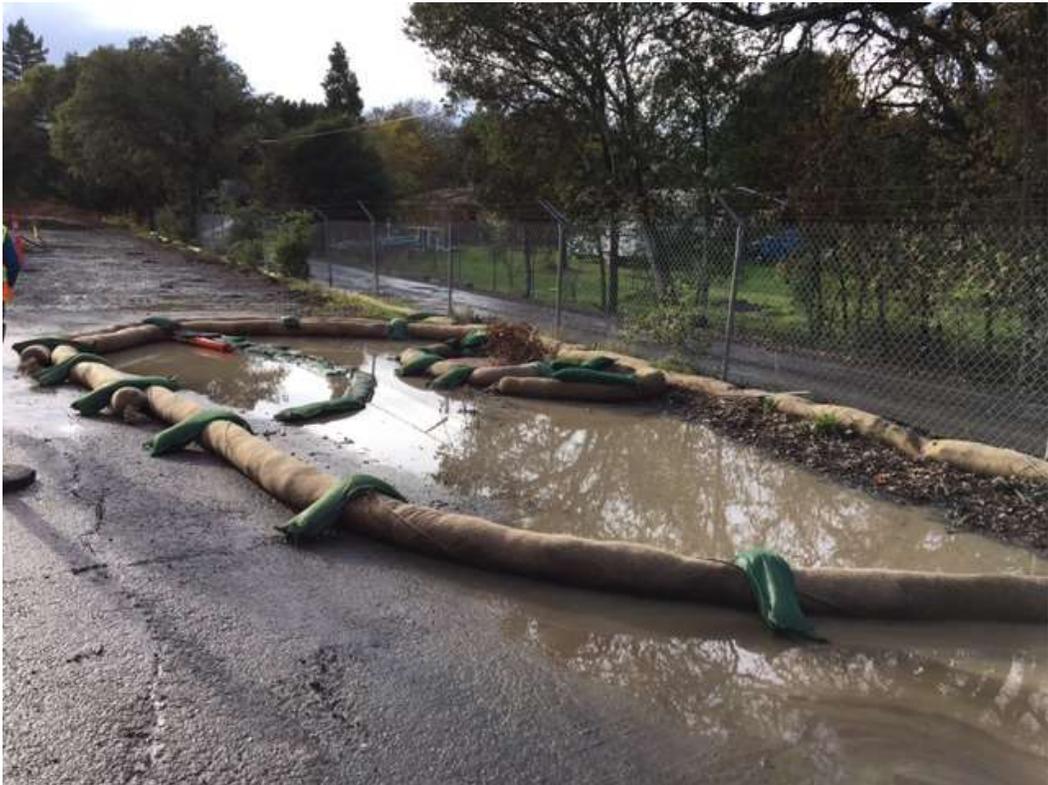
Figure 4 – Drainage inlets with BMPs installed on north side of substation site, December 9, 2016.
