PROJECT MEMORANDUM
PG&E WINDSOR SUBSTATION PROJECT

To: Eric Chiang, Project Manager, CPUC
From: Vida Strong, Aspen Project Manager
Date: June 7, 2017
Subject: Monitoring Report #18 – May 29, 2017 to June 4, 2017

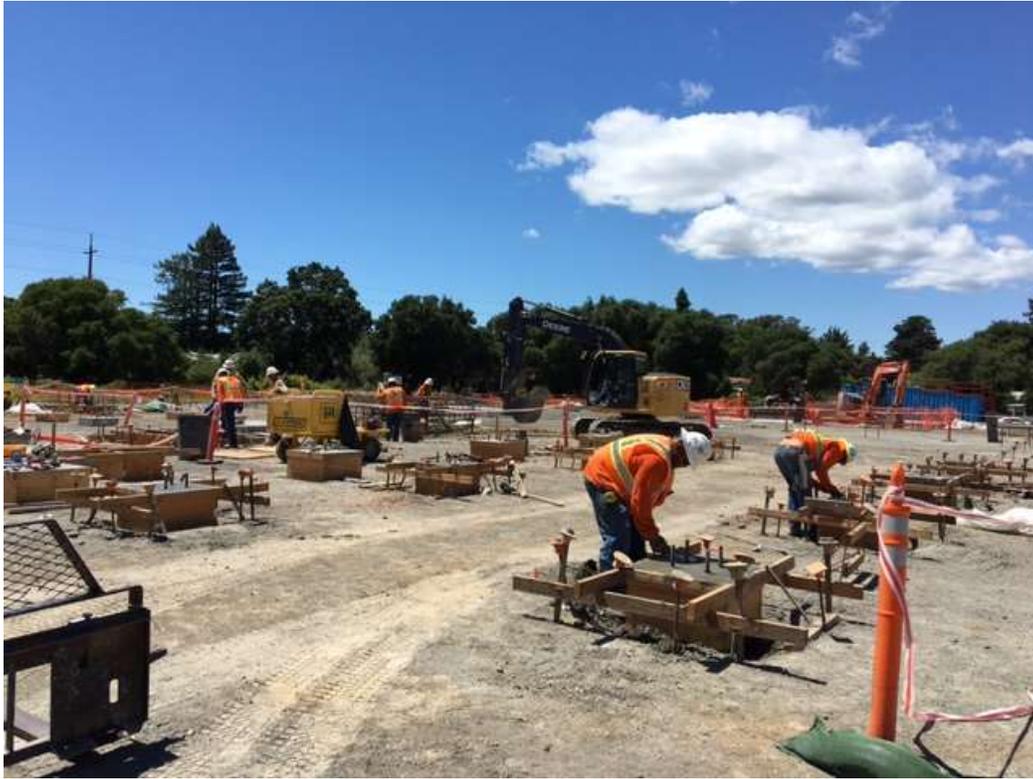
At the time of the CPUC EM's site visit on May 31, crews were drilling pier holes on the south side of the pad and working on the pier foundations and rebar (see Figures 1 and 2).

Figure 1 – Foundation work at substation site – view northwest, May 31, 2017.

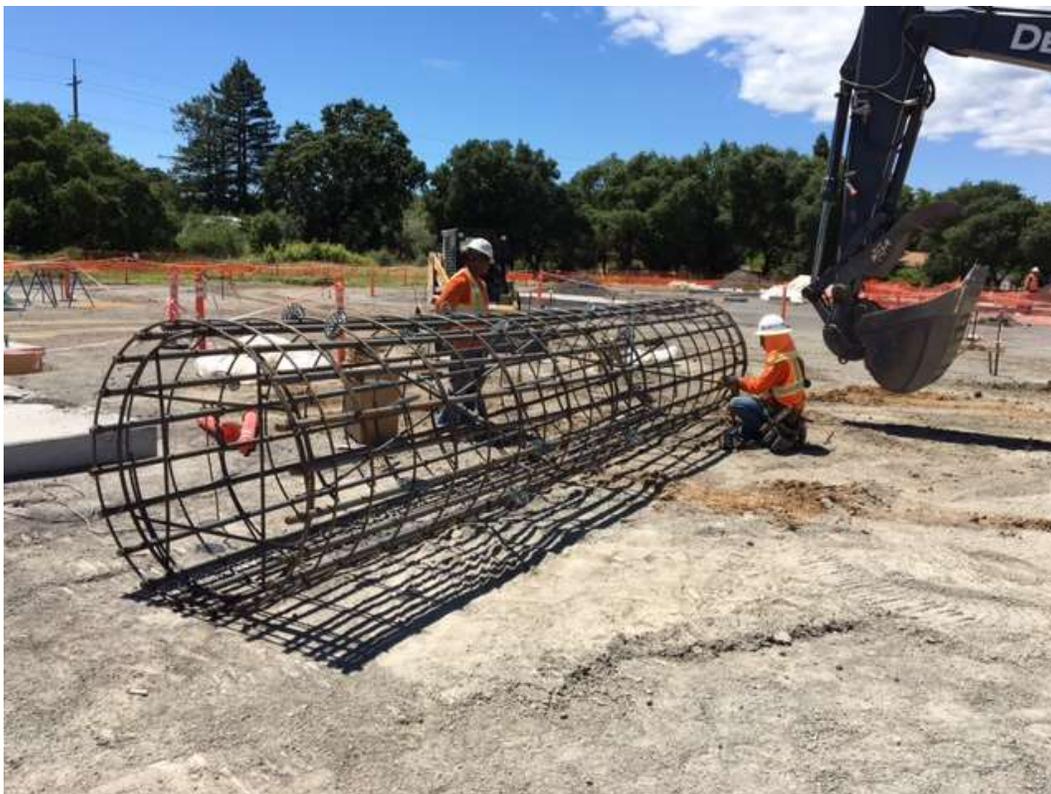
Figure 2 – Rebar work for pier foundations on south side of substation site – view northwest, May 31, 2017.

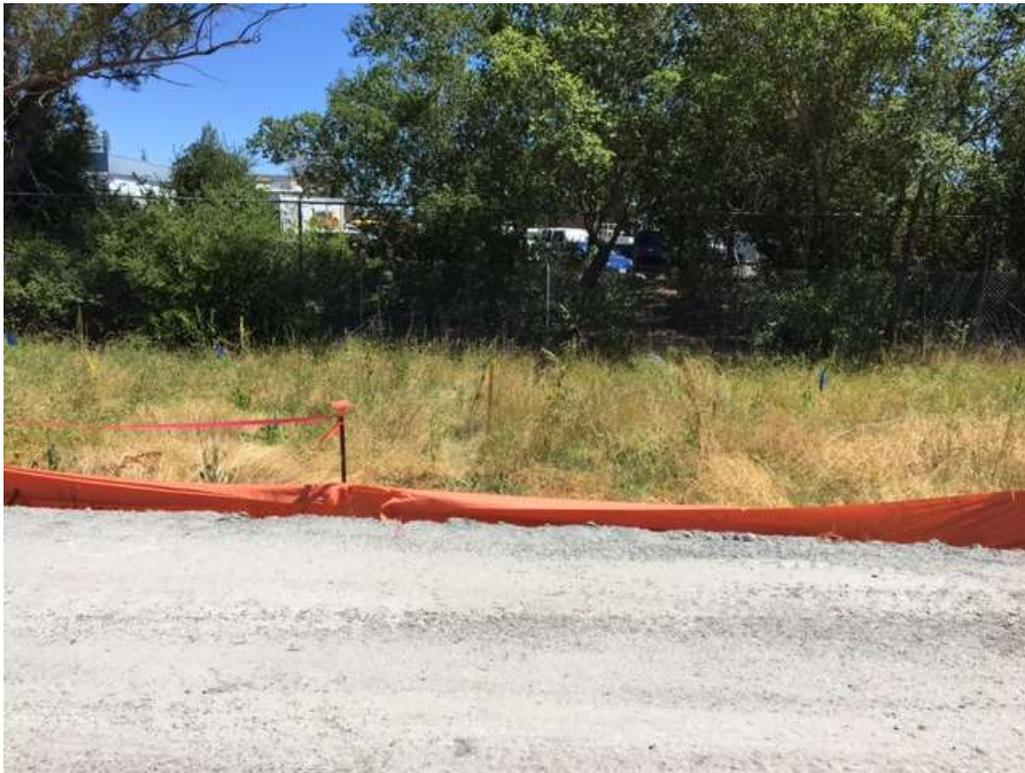
3. On May 31, 2017, the CPUC EM observed that the silt fence on the south perimeter was ripped and pushed down in one location, and base rock pushing up against the silt fence in another location (see Figures 3 and 4). The CPUC EM pointed these issues out to the PG&E Inspector and Project Foreman and reported it to PG&E’s Environmental Inspector. On June 1, zip ties were used to repair the rip in the fence and secure it at its proper height, and the base rock was excavated away from the silt fence.

Figure 3 – Silt fence torn and pushed down on south side of substation site – view south, May 31, 2017.

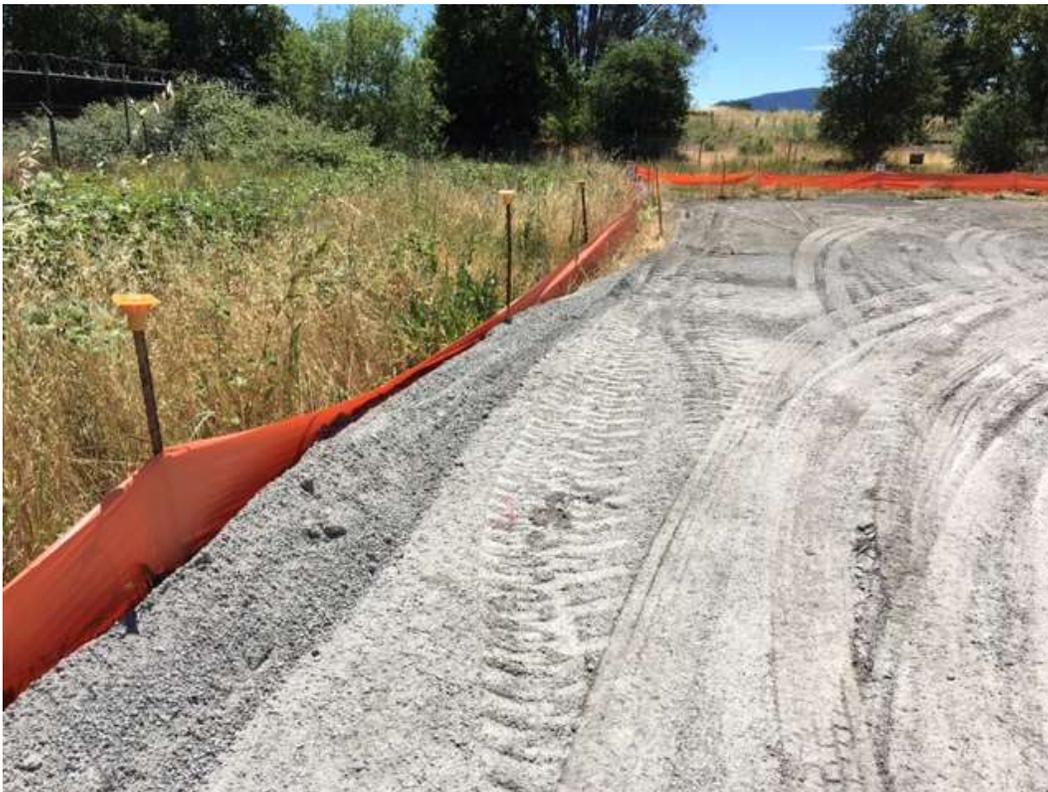
Figure 4 – Base rock pushed up against silt fence on south side of substation site – view west, May 31, 2017.
