PROJECT MEMORANDUM
PG&E WINDSOR SUBSTATION PROJECT

To: Eric Chiang, Project Manager, CPUC
From: Vida Strong, Aspen Project Manager
Date: June 15, 2017
Subject: Monitoring Report #19 – June 5, 2017 to June 11, 2017

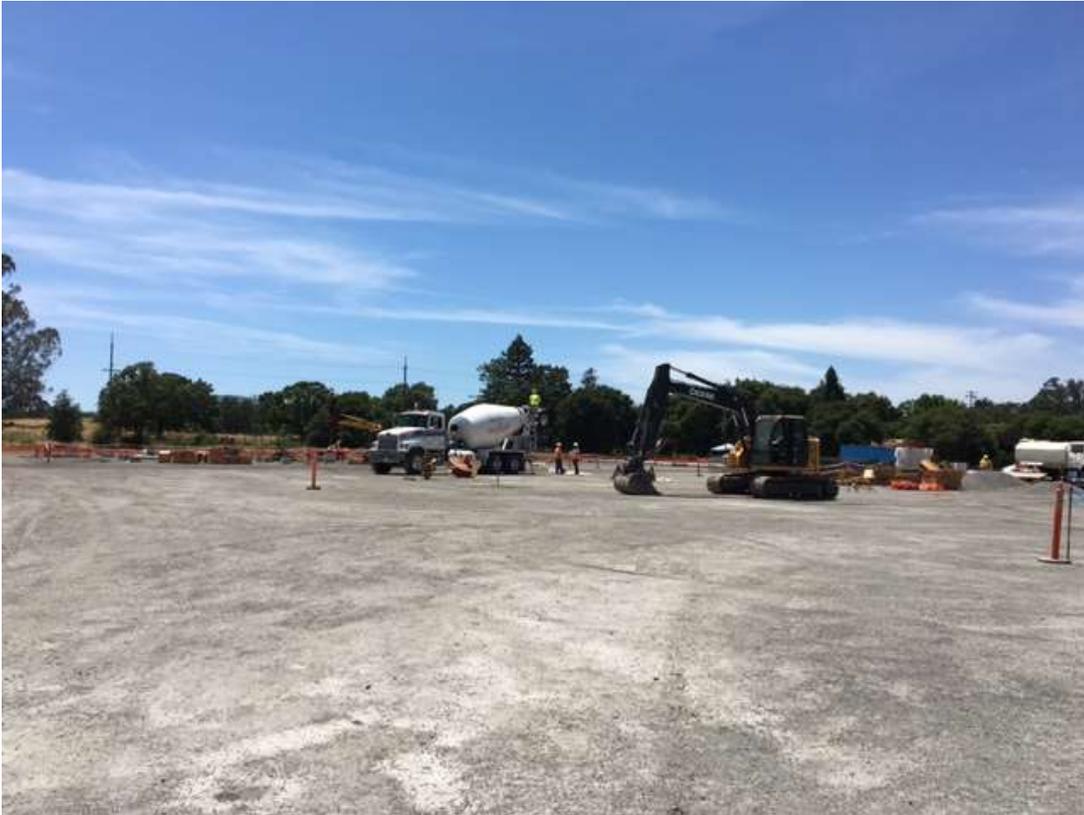
At the time of the CPUC EM's site visit on June 5, crews were excavating for a pull box, conducting foundation work and pouring cement, and watering for dust control (see Figures 1 through 4).

Figure 1 – Work at substation site – view northwest, June 5, 2017.

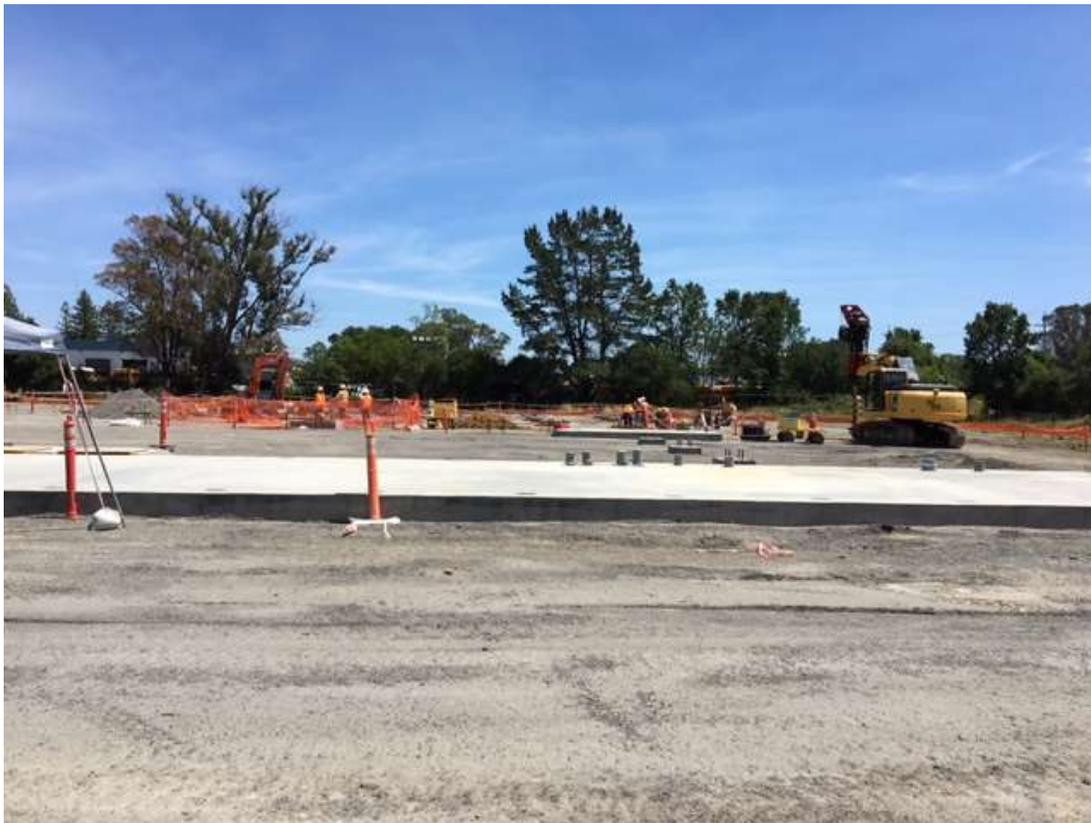
Figure 2 – Switchgear foundation in northwest area of substation site – view south, June 5, 2017.

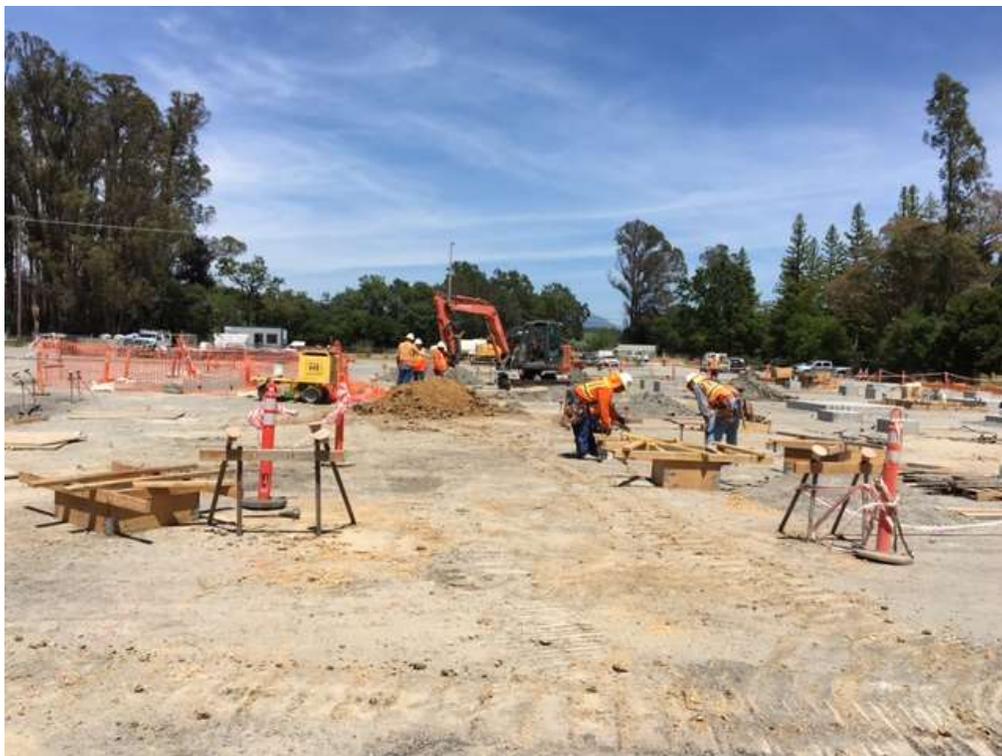
Figure 3 – Foundation work on west side of substation site – view east, June 5, 2017.

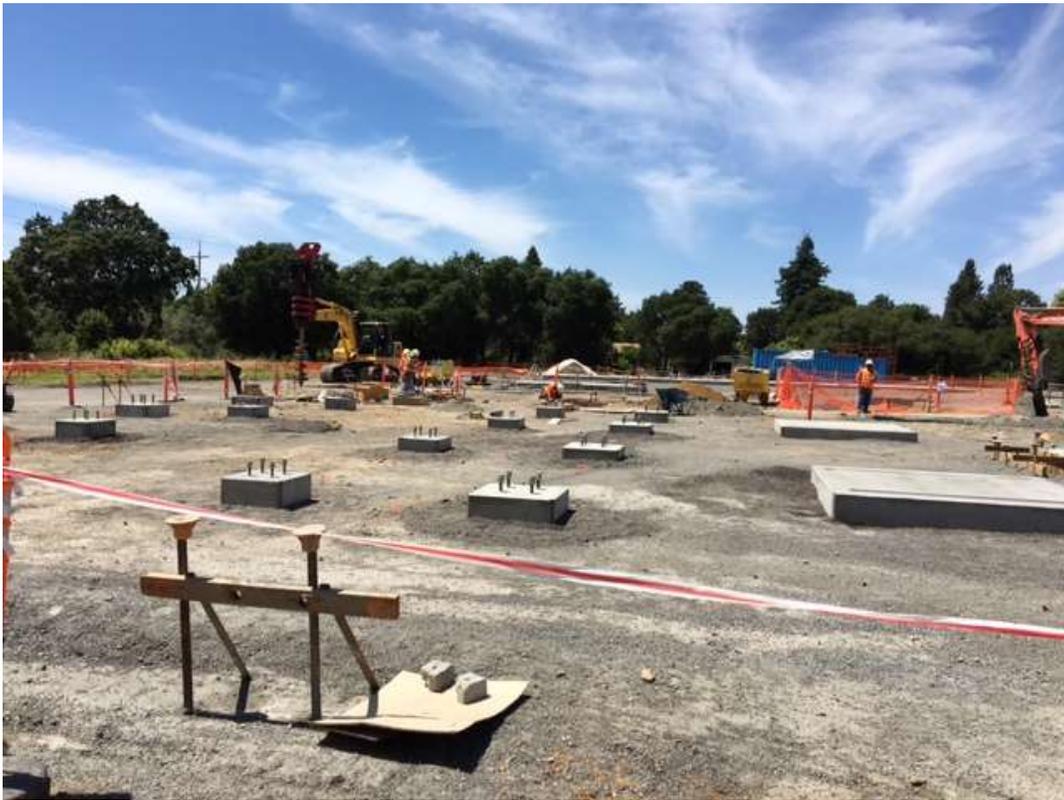
Figure 4 – Foundation work on the southwest side of substation site – view north, June 5, 2017.
