California Public Utilities Commission Mitigation Monitoring, Compliance, and Reporting Program

Tie Line (TL) 637 Wood-to-Steel Pole Replacement Project

Compliance Status Report: 014

August 31, 2014

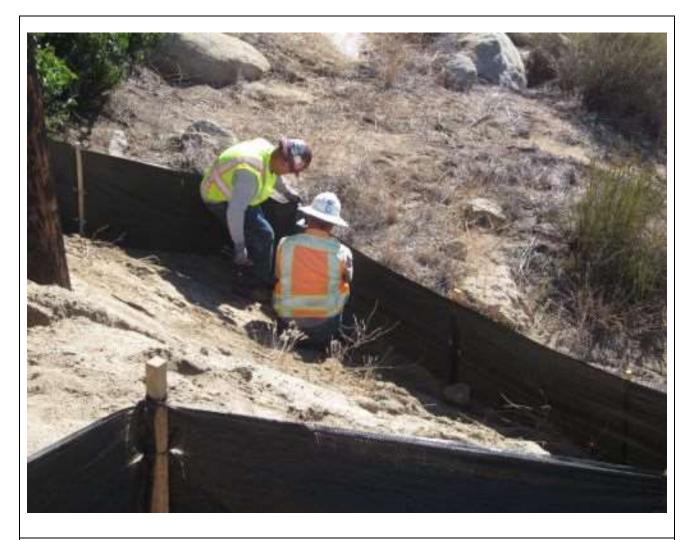
Construction crews were observed inspecting and maintaining Storm Water Pollution Prevention Plan (SWPPP) BMPs along the project right of way (See Photo 1—Attachment A).

Photo 1: Crews were observed monitoring and repairing SWPPP BMPs throughout the right- of-way. Repairs to silt fencing were observed at Location 35.

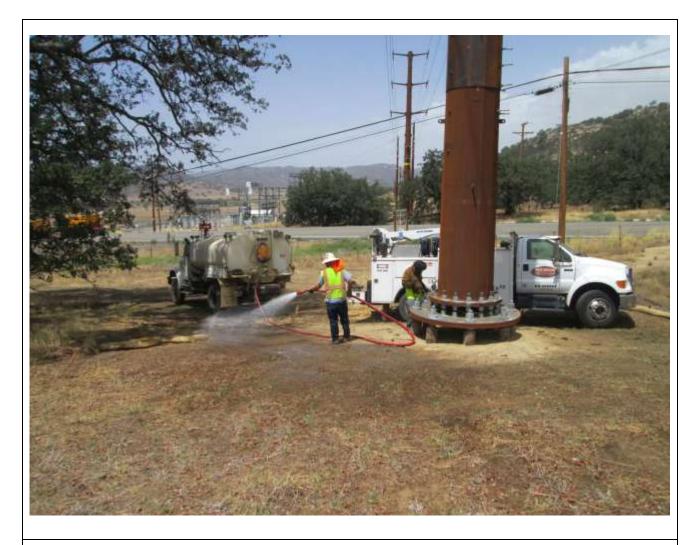
Construction crews continued to work on finishing micro pile foundations this reporting period and were observed welding micro pile foundation nuts at several locations. Prior to and during welding activities, crews were observed watering the area surrounding the welding activity (using a hose connected to a water truck) in order to reduce fire risk in accordance with the Project Fire Plan (APM-HAZ-2) (See Photo 2—Attachment A). At the entrance to these pole locations, temporary orange fencing used to protect sensitive plant species (such as San Diego Gumplant (See Photo 3—Attachment A)) was observed intact and plants were observed avoided in accordance with APM-BIO-1. Construction- related dirt and mud track-out from overland travel was not observed on the pavement of CA-78 or other pole location entrance sites (APM-HYD-1).

Photo 2: During micro pile foundation nut welding at Location 161, crews were observed watering the adjacent area in accordance with the Project Fire Plan (APM-HAZ-2).

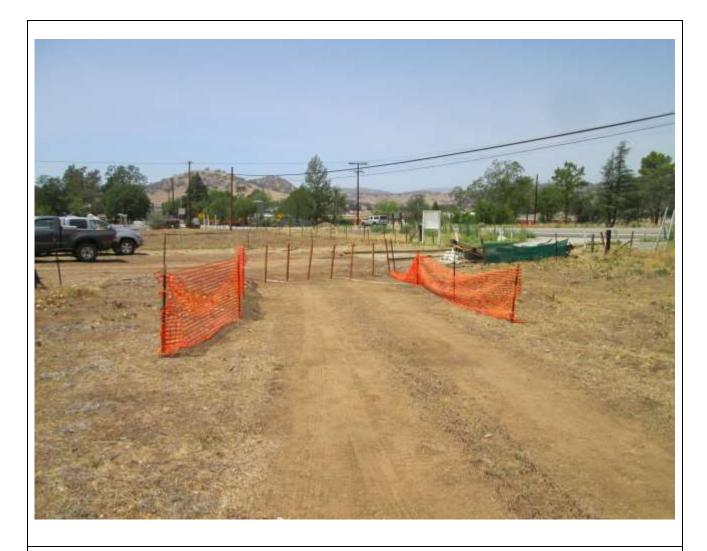
Photo 3: Temporary orange fencing used to delineate avoidance areas for sensitive plants (San Diego Gumplant) was observed intact and plants were avoided by construction crews in accordance with MM-BIO-1.

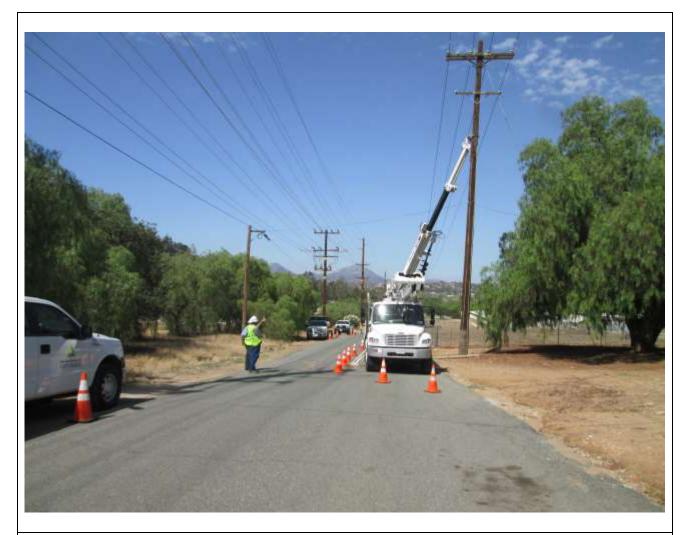
Overhead work (pulling/sagging/clipping/dead-ending) associated with the 12 kV line continued to occur this reporting period. During these activities along Creelman Lane, traffic control measures such as signage, orange cones, and flaggers used to direct traffic were observed implemented in accordance with APM-TRA-1 (See Photo 4—Attachment A). A water tender as well as a fire patrol with a Type 6 fire engine was observed staged adjacent to activities for fire safety in accordance with the Project Fire Plan (APM-HAZ-2), and a biological monitor was observed spot checking activity areas (MM-BIO-2) to make certain that surveys had been completed for nesting birds (MM-BIO-4) (See Photo 5—Attachment A). Sediment control BMPs (APM-HYD-1) were observed intact during overhead work and included straw wattles and/or silt fencing at pole locations.

Photo 4: Crews were observed staging water tenders adjacent to activities associated with the removal of the 12kV line along Creelman Lane in accordance with fire safety practices (Project Fire Plan/APM- HAZ-2) and using traffic control measures in accordance with APM-TRA-1.

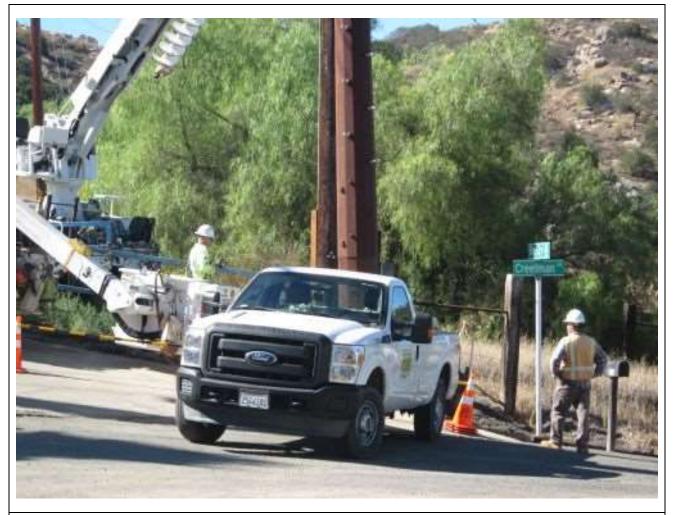
Photo 5: During wire transfer activities along Creelman Lane, biologists were observed monitoring activity in accordance with MM-BIO-2 and ensuring that nesting bird surveys had been completed prior to work occurring at the site (MM-BIO-4).

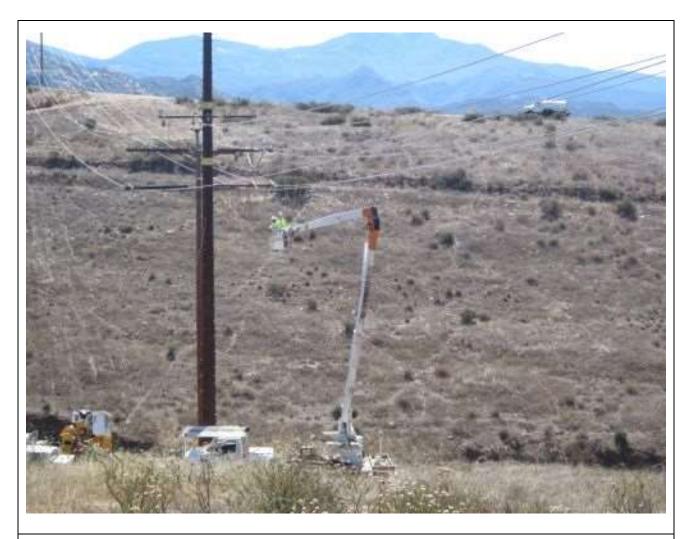
During wire pulling preparation activities in the western portion of the right-of-way, fire patrols and water tenders were observed patrolling work areas to ensure that response time coincided with activity type in accordance with the Project Fire Plan (APM-HAZ-2) (See Photo 6—Attachment A). Crews were observed carrying fire tools (shovels, Pulaski's, 5-gallon water pumps, and fire extinguishers) in all vehicle equipment.

Photo 6: During wire pulling preparation activities (above, Location 28), fire patrols and water tenders (above) were observed monitoring areas along the right- of- way in accordance with the Project Fire Plan (APM-HAZ-2).

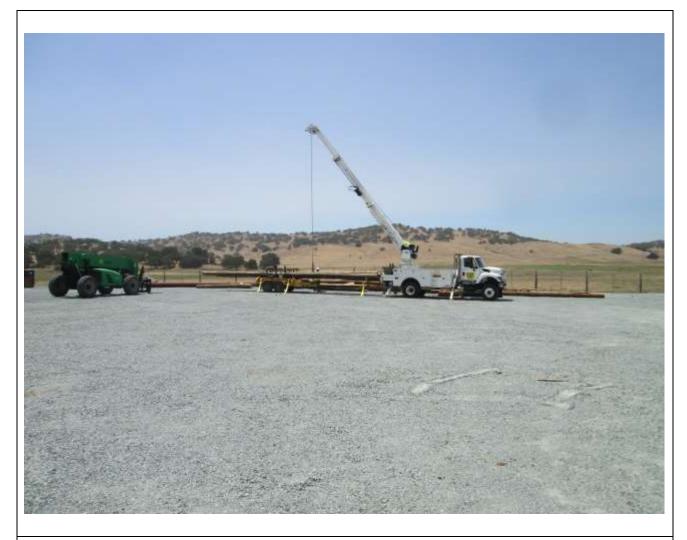
Equipment hauling and reclamation activities were observed at the Santa Ysabel Staging Yard during this reporting period. Crews were observed loading decommissioned wooden poles onto a trailer for off-

Photo 7: At the Santa Ysabel Staging Yard, crews were observed loading decommissioned wooden poles for hauling off site.

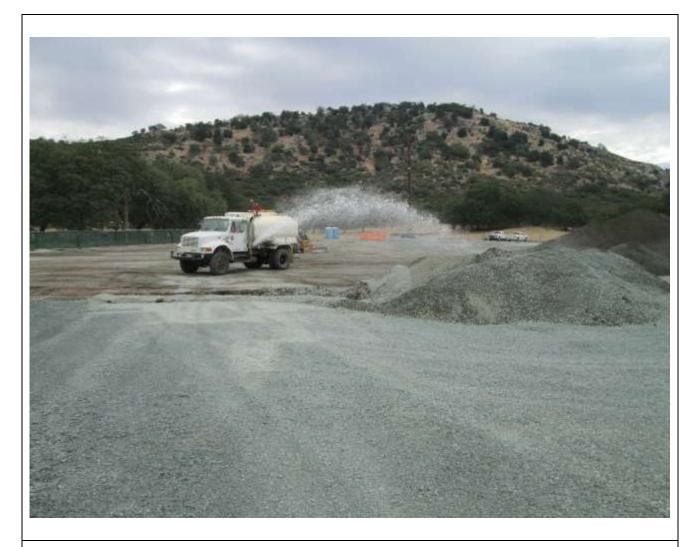
site hauling (See Photo 7—Attachment A) and crews were observed removing the gravel base layer of the staging yard. Water was applied to the gravel prior to movement in order to minimize potential fugitive dust in accordance with APM-BIO-1 (See Photo 8—Attachment A). Visual screening fence along the northern perimeter of the yard remained intact (APM-AES-1). Rattle plates remained at the staging yard point of ingress/egress and no track-out was observed on pavement (Washington Street) in accordance with APM-HYD-1. Perimeter straw wattles used for sediment control were observed in good condition (APM-HYD-1) and drip pans were observed under portable restroom facilities for spill prevention (MM-HAZ-2). Trash was observed contained in dumpsters (APM-BIO-1).

Photo 8: Crews were observed beginning to remove gravel from the Santa Ysabel Staging Yard. Water was applied to the gravel base layer prior to movement to ensure dust was minimized in accordance with MM-BIO-1.
