Re: Monthly Report Summary #23 for Aliso Canyon Turbine Replacement Project

CPUC Site Inspection Reports and Site Visit Report
February 2, 11, 19, and 25, 2016

Aliso Canyon Turbine Replacement Project CPUC Site Inspection Form

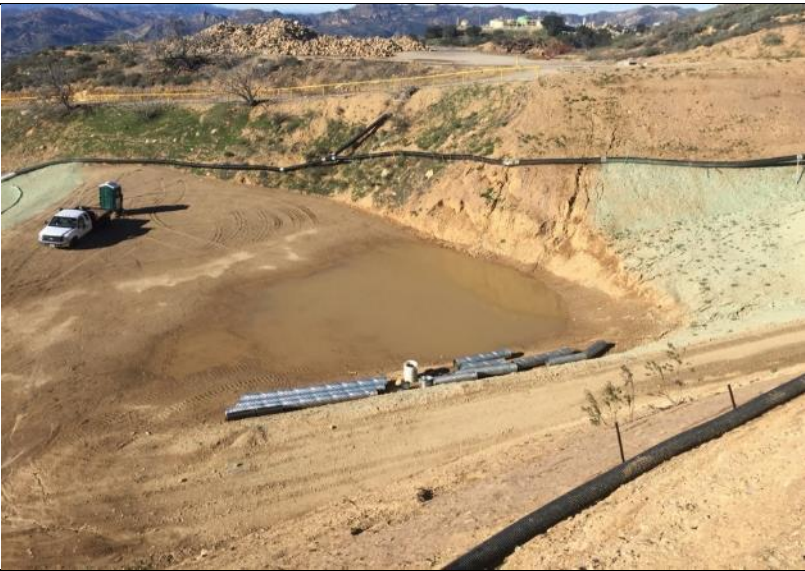
REPRESENTATIVE SITE PHOTOGRAPHS			
Date	Location	Photo	Description
2/2/16	PS-42 Fill Site

Some ponded water on top of the PS-42 Fill Site.
2/2/16	PS-42 Fill Site

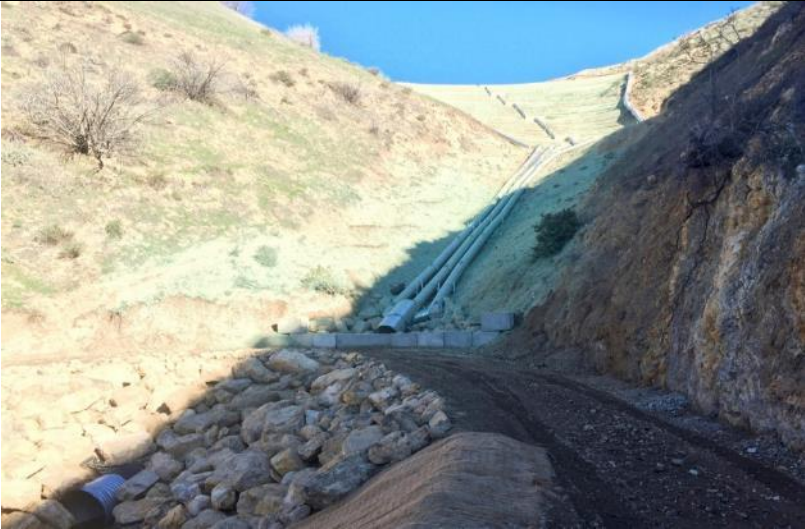
The PS-42 Fill Site remained in good condition following the rain event.
2/2/16	CCS

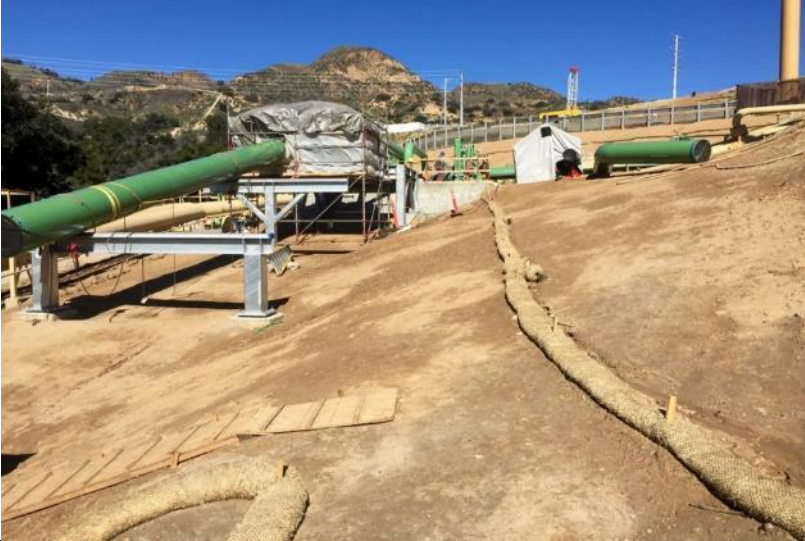
The area between the CCS and the new Admin/IM Building has a substantial amount of exposed soil.
2/2/16	CCS

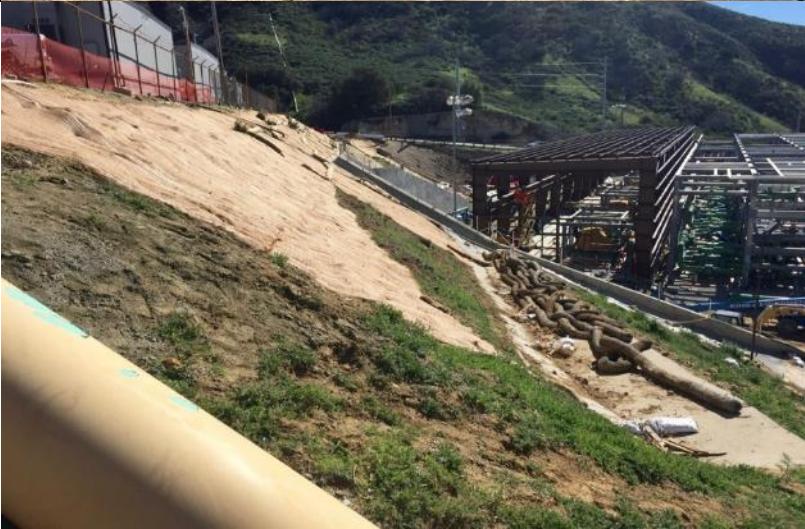
Maintenance on the BMPs continues around the CCS.
2/2/16	New Admin/IM Building

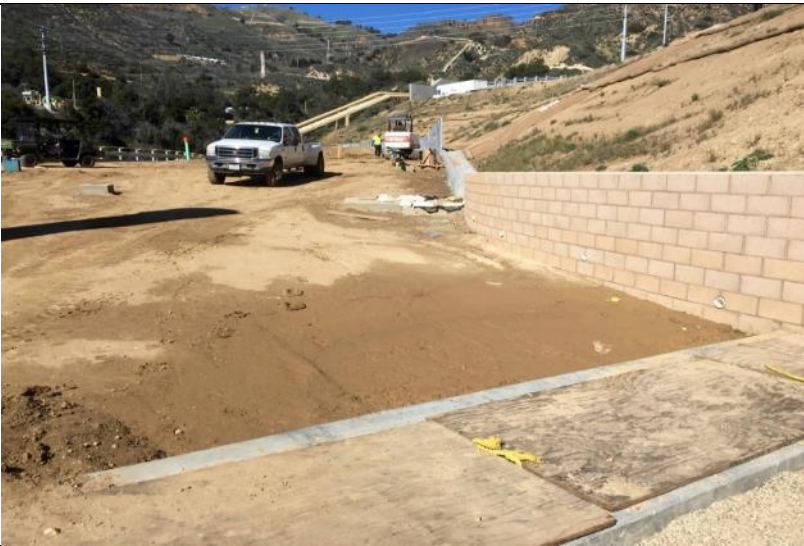
Sediment-laden water ponding at this location drains into a "V" ditch located under the plywood boards. BMPs are suggested for this location.
2/2/16	TSP 26

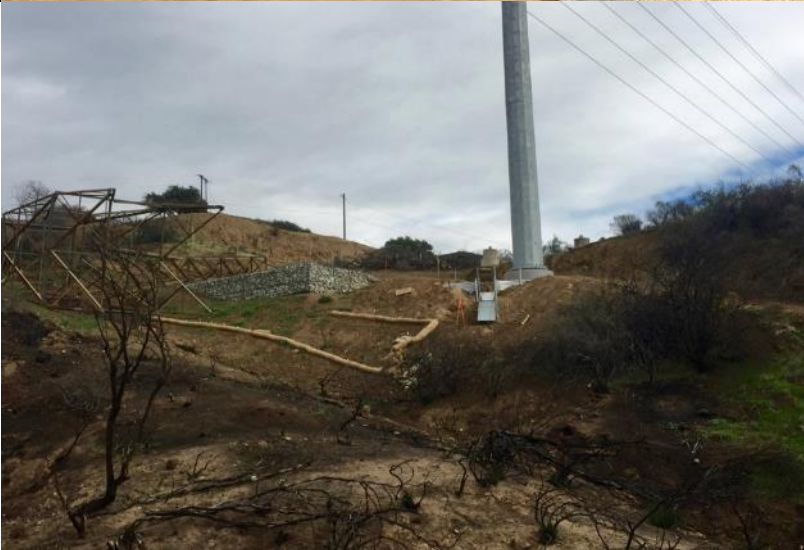
A McCarthy drain and new BMPs have been installed.
2/2/16	TSP 21/22 pull site

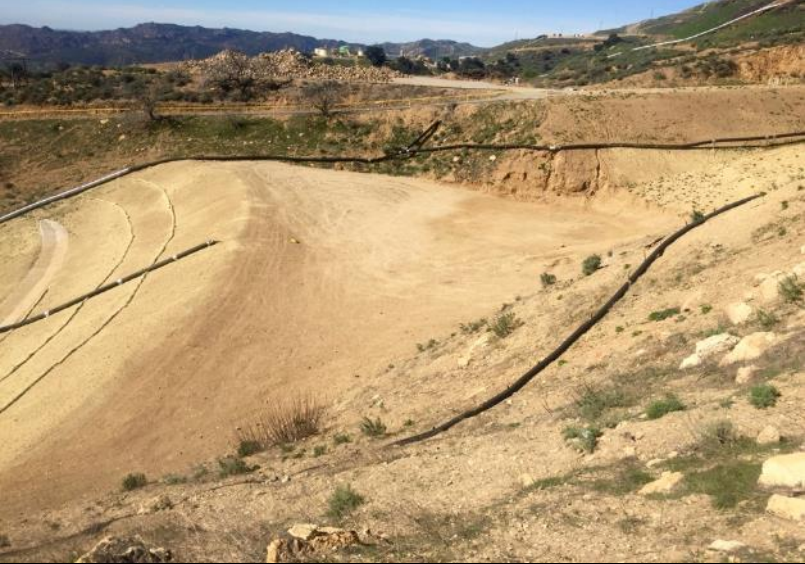
REPRESENTATIVE SITE PHOTOGRAPHS			
Date	Location	Photo	Description
2/11/16	PS-42 Fill Site

The water that was previously ponded on top of the PS-42 Fill Site has dried out.
2/11/16	PS-42 Fill Site

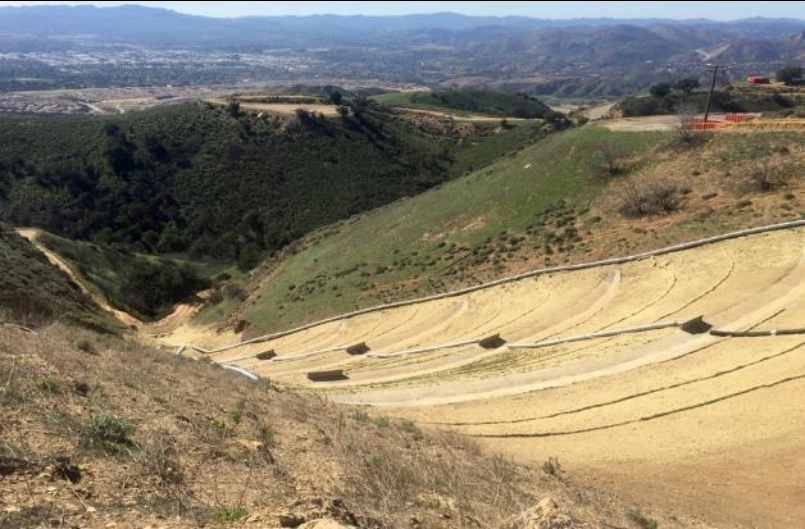
There were no changes to the PS-42 Fill Site. BMPs are in place.
2/11/16	Relief wells and Oak Tree Mitigation Site

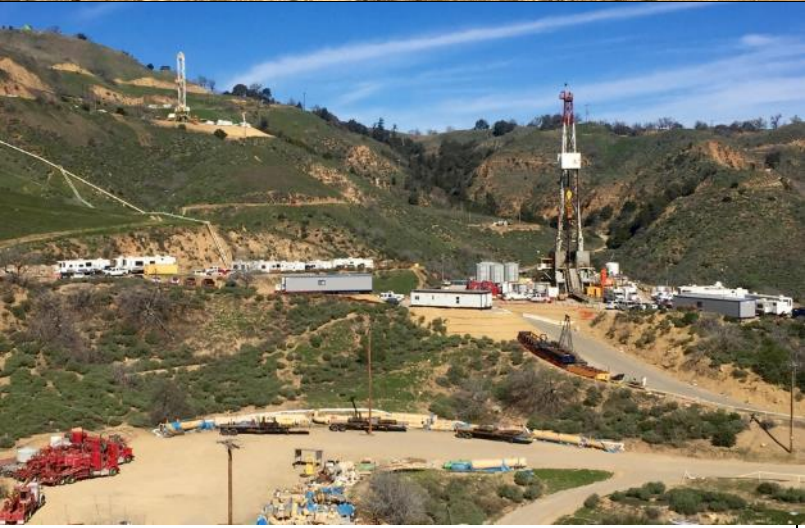
I arrived onsite at the Aliso Storage Field at 0945 and checked in at the office. I spoke with Jim Strader (SCG) about the status of the ongoing gas leak in the area. A relief well drilling rig had been erected near the ACTR Project's Oak Tree Mitigation Site – see photo.

The first relief well associated with an ongoing well leak at the Aliso Storage Field (non-ACTR Project related) can be seen in the foreground. A second relief well drilling rig has now been set up, adjacent to the ACTR Project's Oak Tree Mitigation Site.

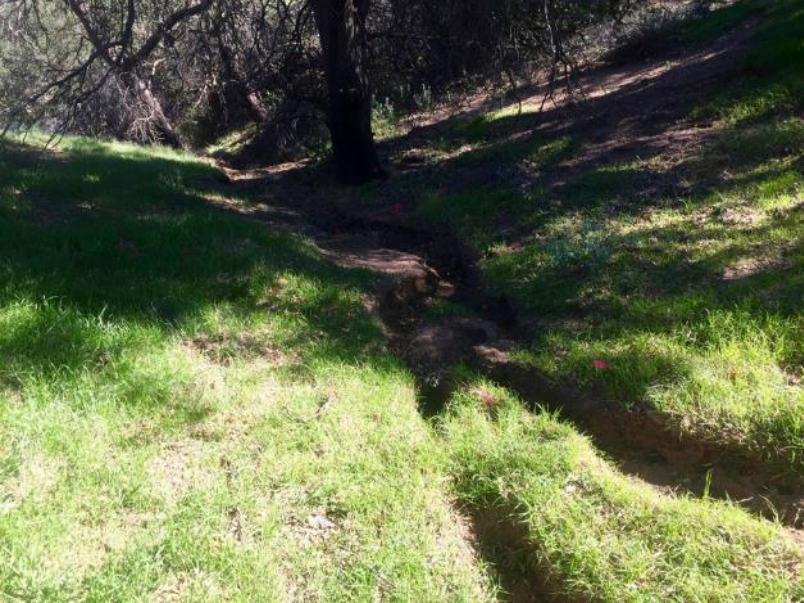
Erosion scars through the oak swale.
2/11/16	CCS

I caravanned with Seth Rosenberg (SCE) to the Natural Substation to look at possible solutions to the erosion within the oak swale. My main recommendation was to find a way to divert some of the water away from the oak swale, and I suggested that water from the access road be captured and directed into the drainage west of the road. We also looked at the erosion rills in the oak swale (see photo) and discussed ways to slow the water flow in the rills and allow sediment to drop out.

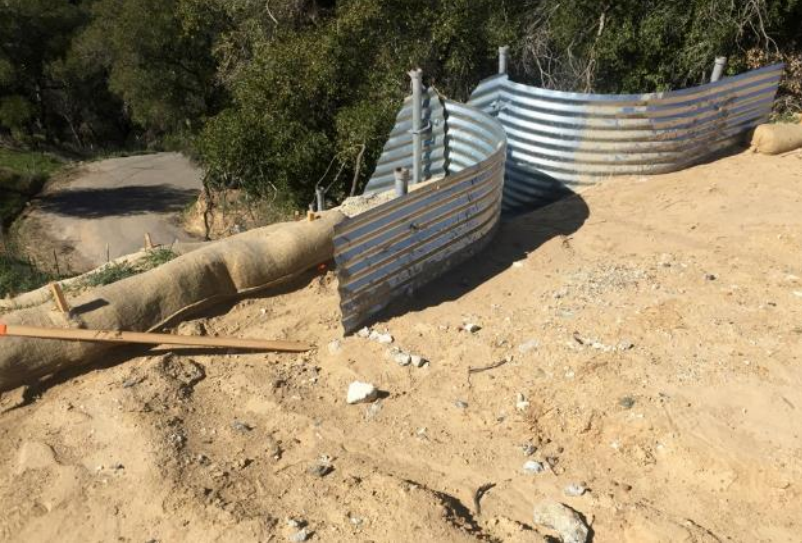
Rainwater runoff is traveling around the McCarthy drain and eroding the slope and under the drain, itself.
2/11/16	TSP 24/25 access road entrance

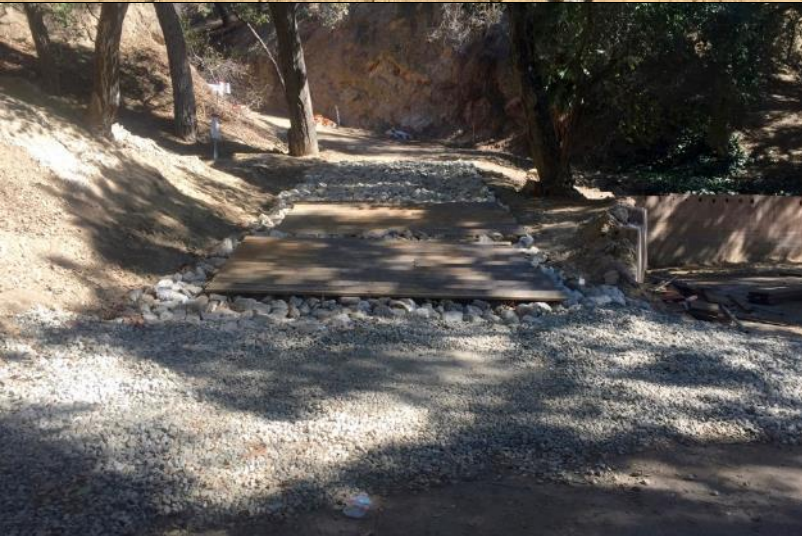
Crews have cleaned up the entrance to the access road and have reinstalled the rumble plates and rock.
2/11/16	Drainage #4 along the TSP 24/25 access road

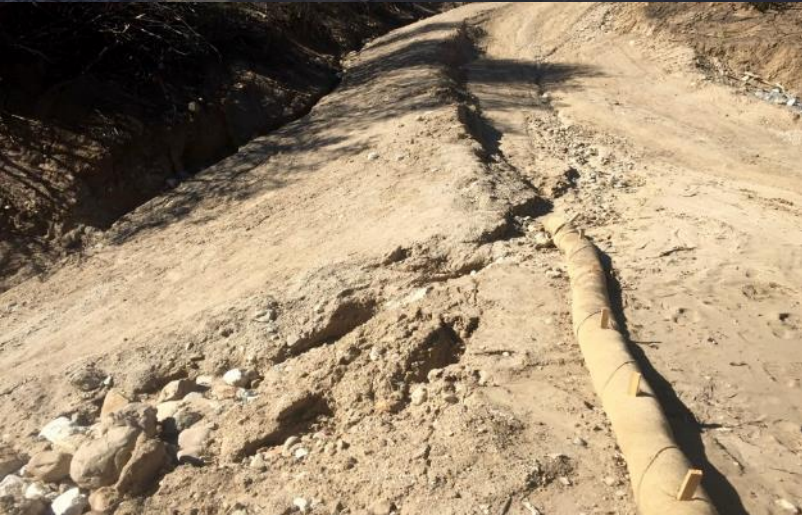
BMP stabilization of this portion of the access road is needed to prevent sediment from running into the drainage.

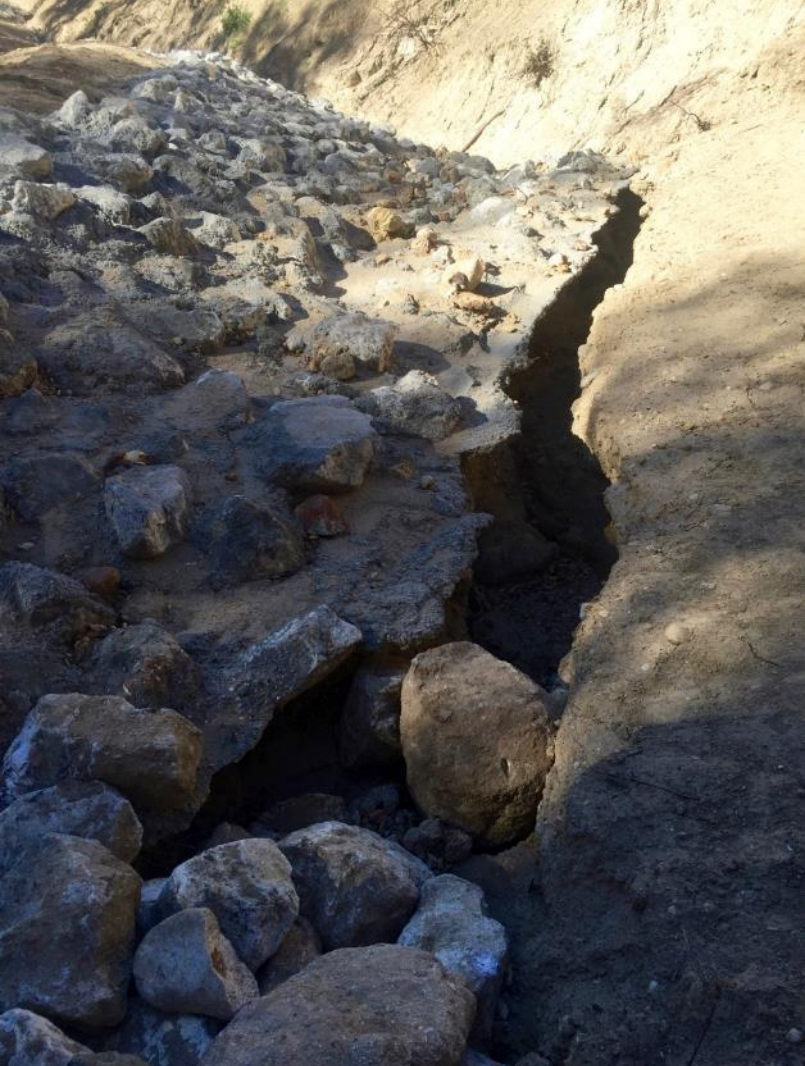
REPRESENTATIVE SITE PHOTOGRAPHS			
Date	Location	Photo	Description
2/11/16	TSP 24/25 access road

<p>The road stabilization riprap is being undermined by rainwater runoff. SCE is planning to repair this.</p>

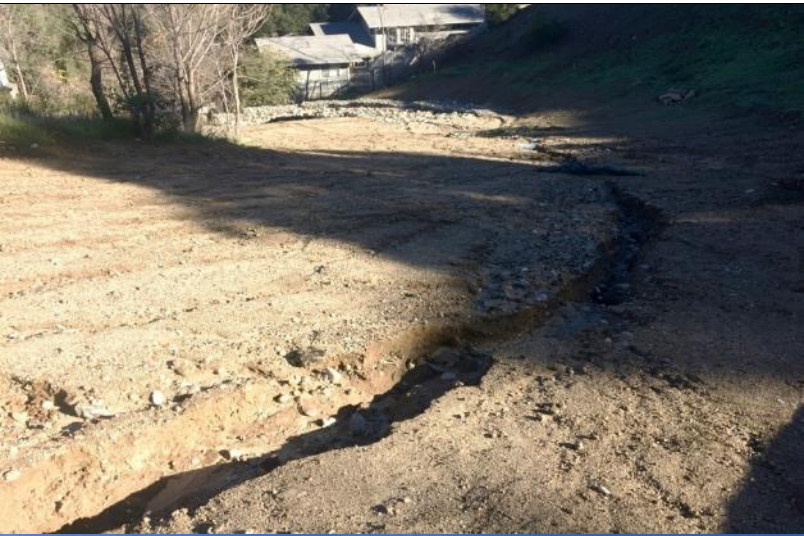
REPRESENTATIVE SITE PHOTOGRAPHS			
Date	Location	Photo	Description
2/19/16	TSP 7 access road

Some significant erosion rills were noted on the steep section of the TSP 7 access road.
2/19/16	TSP 7

Erosion repairs at Drainage #4 along the TSP 24/25 access road, at TSP 7, and at TSP 49 need to be checked.

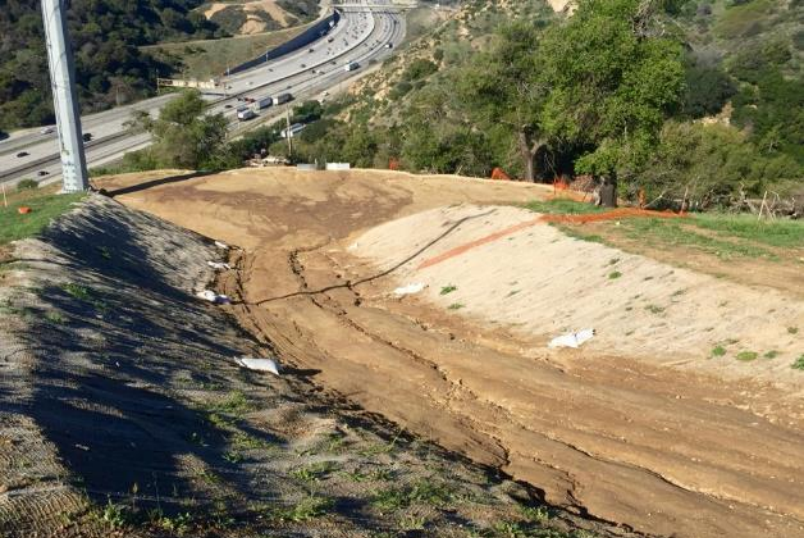
I drove to TSP 32 and noted that rainwater runoff continues to erode the dirt access road and mostly bypasses the McCarthy drain – see photo. At this site and the TSP 7 site, there are numerous metal “T” posts and pieces of exclusion fencing remaining; these items will need to be collected and disposed of (APM PS-1).

Erosion remains an unresolved issue, and rainwater runoff continues to bypass the McCarthy drain.

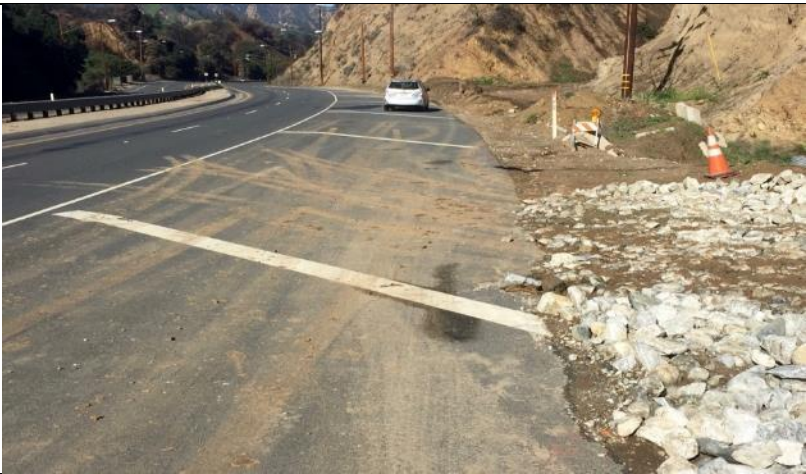
It was too muddy to drive on the access road between TSP 27 and TSP 32. I noted some mud tracked out onto the frontage road below the TSP 26 access road – see photo. I sent a note to Todd White regarding the mud on the frontage road and he stated that Lucy Cortez (SCE) was sending a crew over to take care of the issue. The entrances to the TSP 24/25 and TSP 22-12 access roads were in good condition, with no mud noted on the paved roads (APM AQ-7).

Mud tracked out onto the roadway.
2/19/16	Guard House area

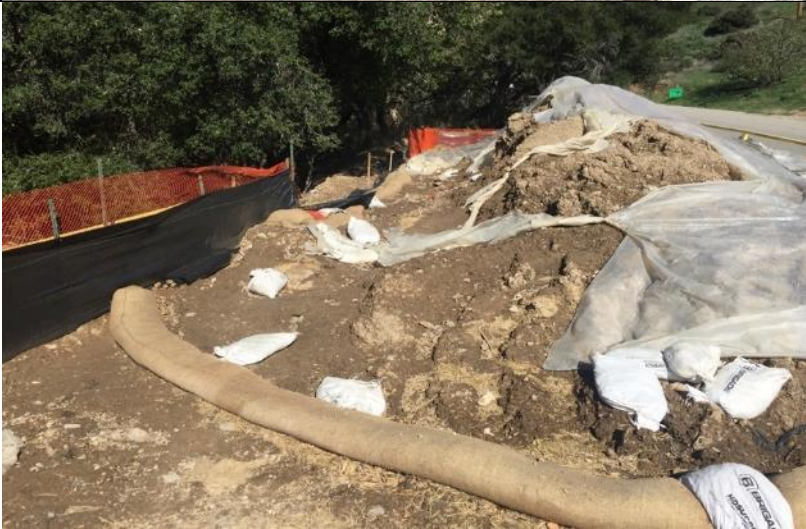
I arrived at the Aliso Storage Field at 1015 and checked in at the office. While driving in past the Guard House, I noted that the spoil pile (pulled from the lower sedimentation basin/newt pond) covering was shredded and portions of the silt fence and orange construction fence were down – see photo. When I checked in with Seth Rosenberg (SCG) at the office, I mentioned my observations to him and he repaired the downed fencing (APM BR-1b). I spoke with both Seth Rosenberg and SCG's lead monitor, Amandeep Singh (AECOM), about ACTR Project status and oversight. Night work had started this week, and the biological monitor provided by AECOM had been conducting work using night vision goggles in order to observe newts in the dark. Amandeep Singh stated that two newts had been captured and relocated by the biological monitor during the recent 0.75-inch rain event (APM BR-7). Amandeep Singh also stated that nesting bird surveys had started; however, only the red-tailed hawk nest along Limekiln Creek appeared to be occupied (APM BR-1c).

The covering over the mud and debris that was removed from the lower sedimentation basin/newt pond is shredded and the silt fencing is down.
2/19/16	Natural Substation

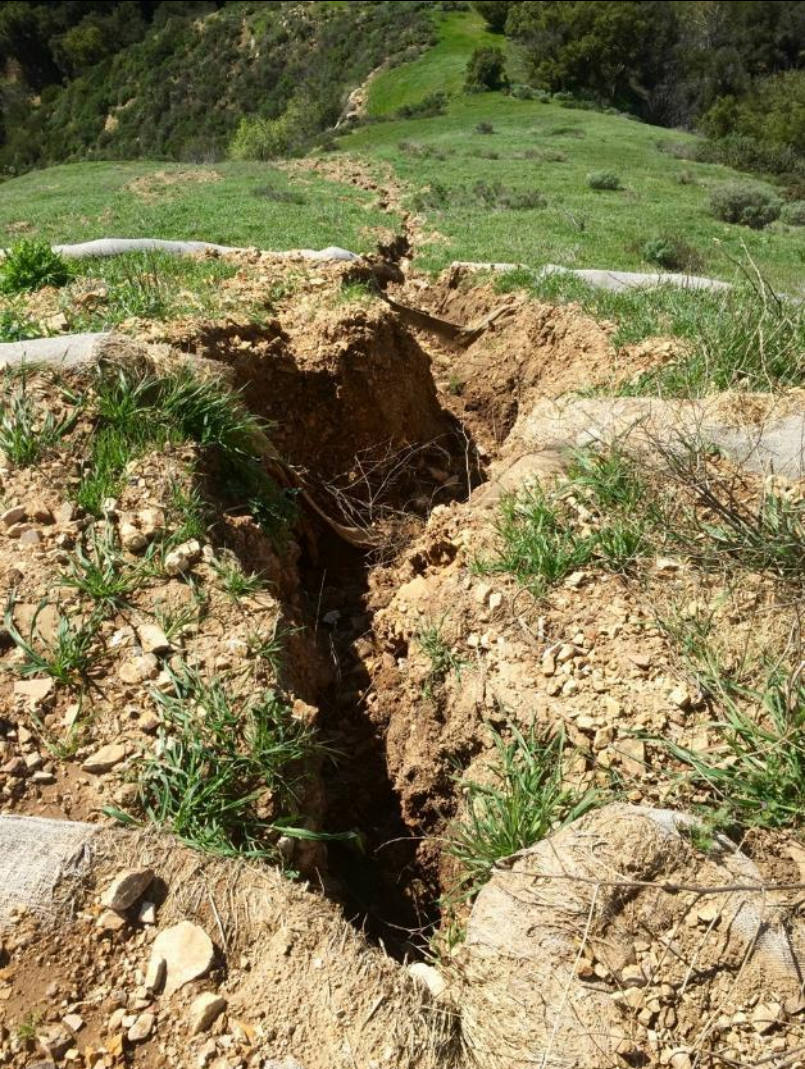
I walked to TSP 49 to check on the erosion issues I had previously noted; these issues remained – see photo. Water traveling down the access road had destroyed some of the BMPs and had created a fairly deep (2 feet) rill down the steep slope below the TSP. It appears that equipment may be needed to fix the erosion; however, no access road to the pole site currently exists.

Erosion channel below the pole.

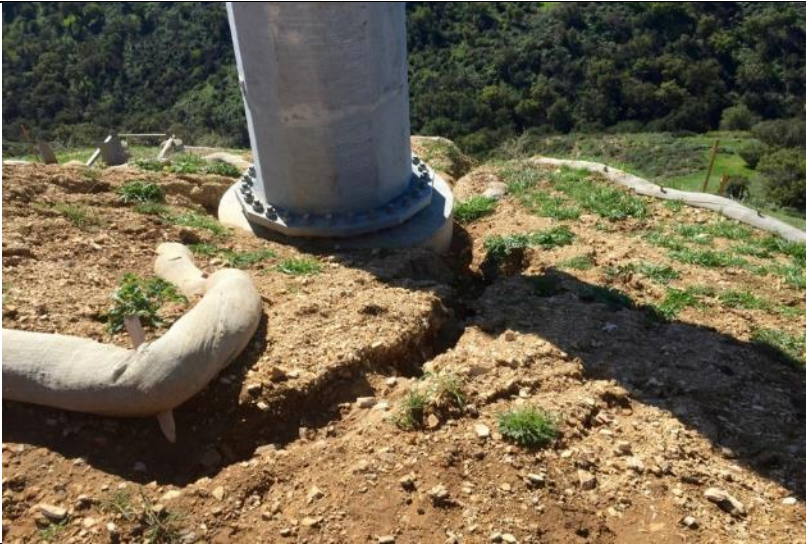
Erosion around TSP 49; BMPs require maintenance and/or upgrades.
2/19/16	Natural Substation access road

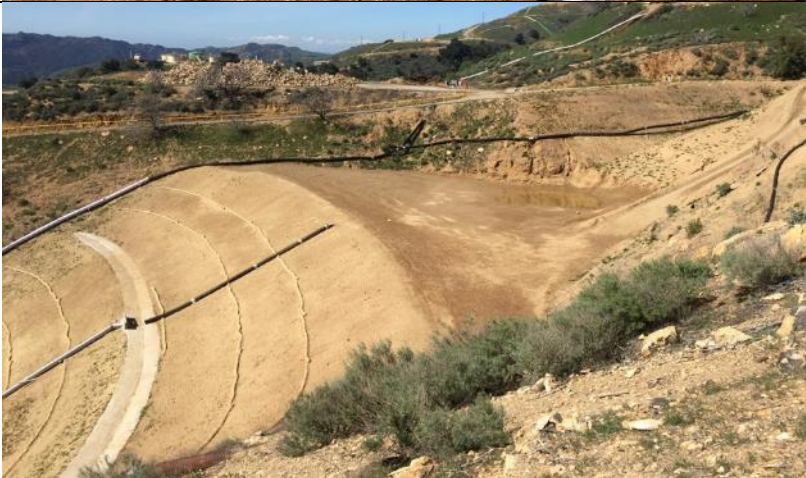
The PS-42 Fill Site remained unchanged since my previous site visit, with no visible damage to the BMPs (APM GE-2); however, ponded water was observed on the top layer after the recent rain event – see photo.

Due to the recent rainfall, there is some ponded water on top of the PS-42 Fill Site.
