**Re: Monthly Report Summary #3 for the Valley-Ivyglen 115-kV Substation (VIG) Project**

CPUC Site Inspection Reports  
September 17 and 30, 2020

## Valley – Ivyglen Subtransmission Project CPUC Site Inspection Form

<b>Project:</b>	Valley – Ivyglen Project	<b>Date:</b>	September 17, 2020
<b>Project Proponent:</b>	SCE	<b>Report #:</b>	VS006
<b>Lead Agency:</b>	California Public Utilities Commission	<b>Monitor(s):</b>	Vincent Semonsen
<b>CPUC PM:</b>	Patricia Kelly, Energy Division	<b>AM/PM Weather:</b>	Hazy sunshine, very warm, slight breeze
<b>CPUC CM (E &amp; E):</b>	Chuck Cleeves	<b>Start/End time:</b>	1400 hrs – 1600 hrs
<b>Project NTP(s):</b>	NTP-1.

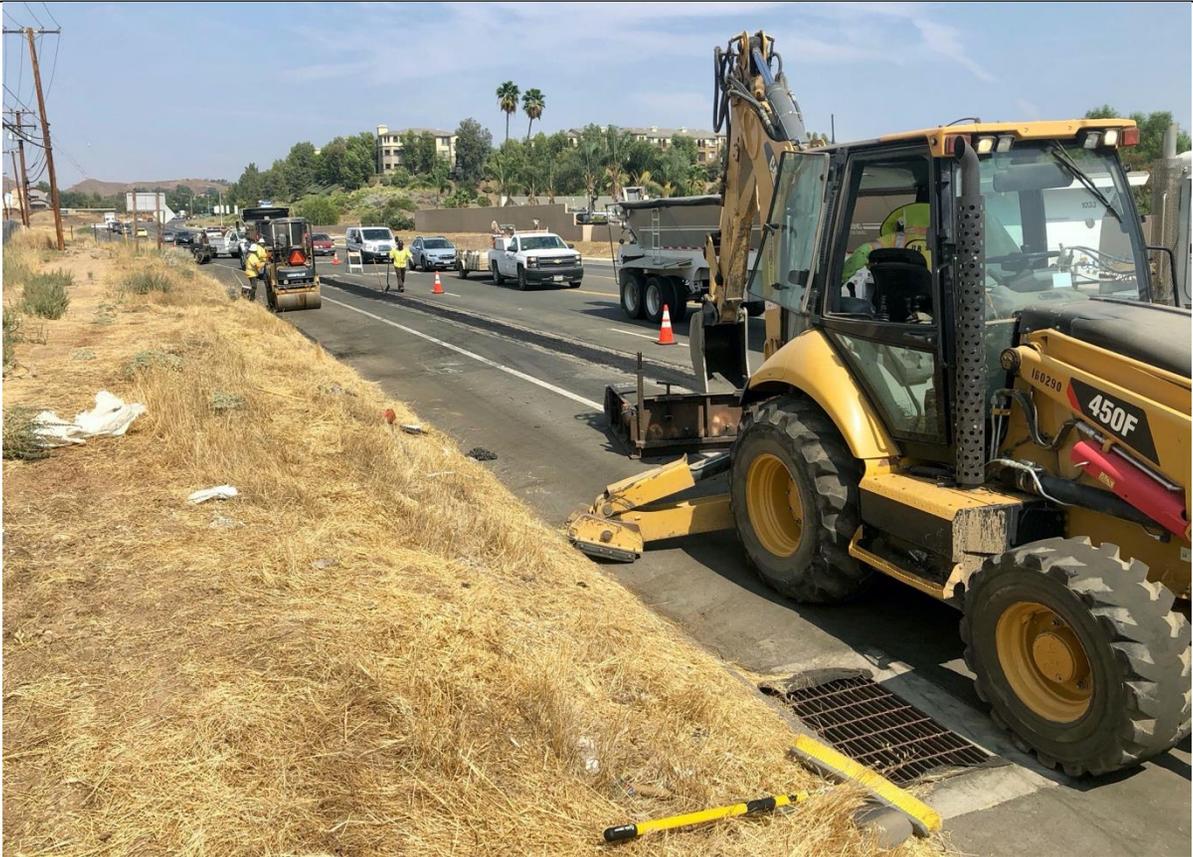
Photo 1 – Paving of the conduit trench along Hwy 74. Photo facing east

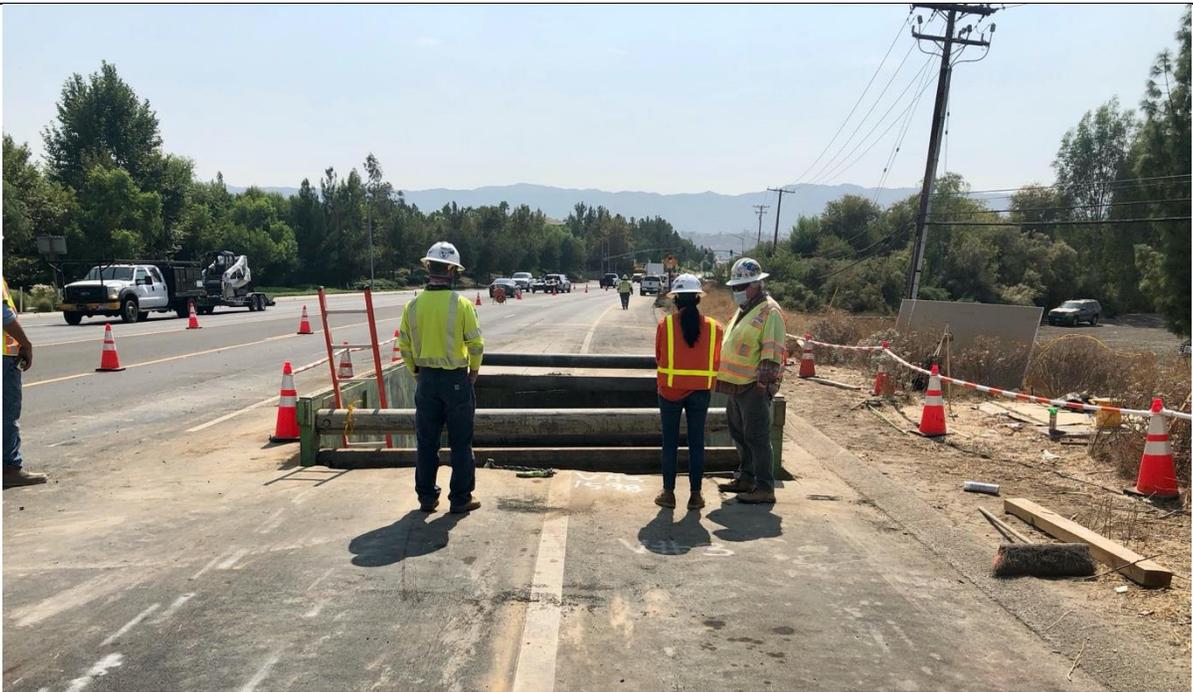
Photo 2 –Open hole waiting for vault #3 to be installed. Photo facing west

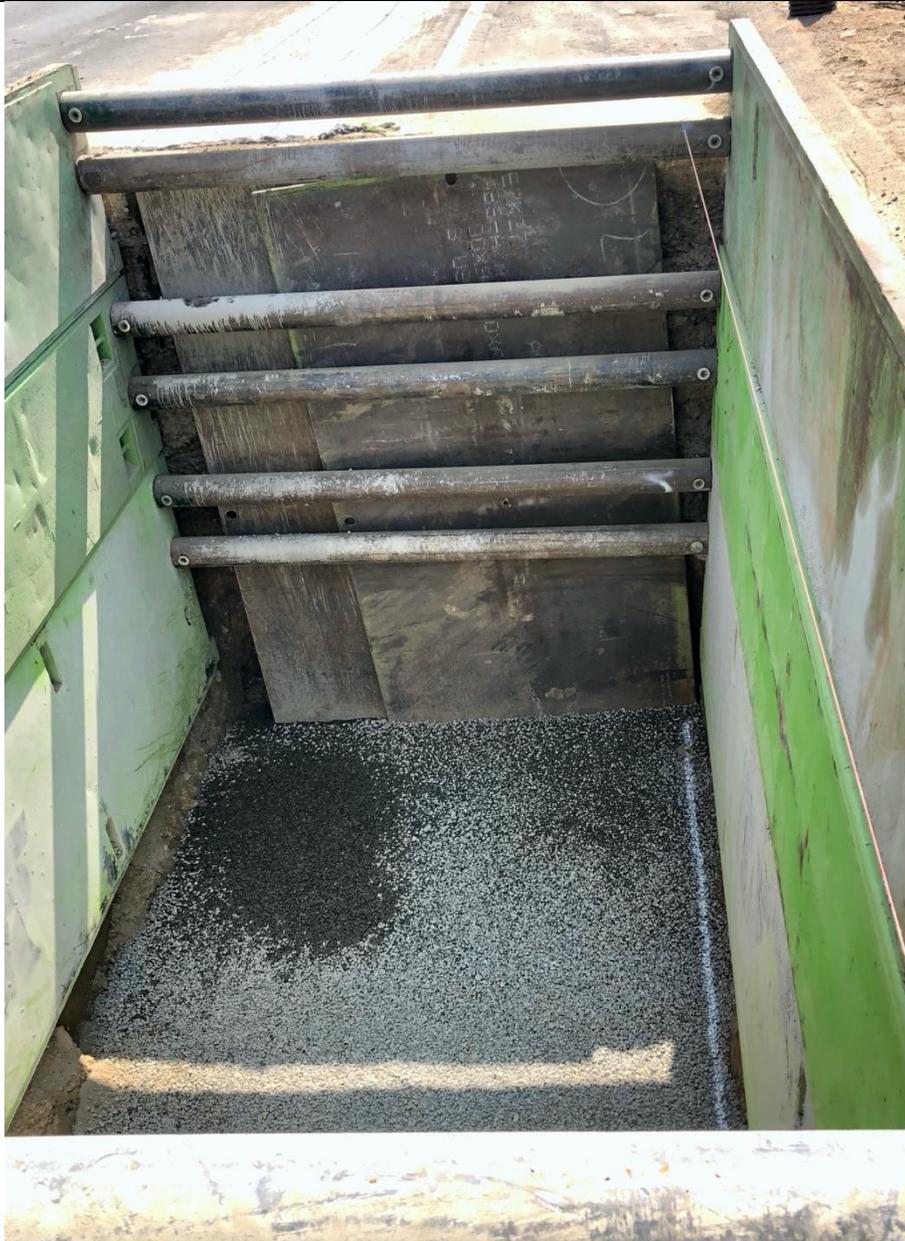
Photo 3 – The  
shored vault  
excavation.

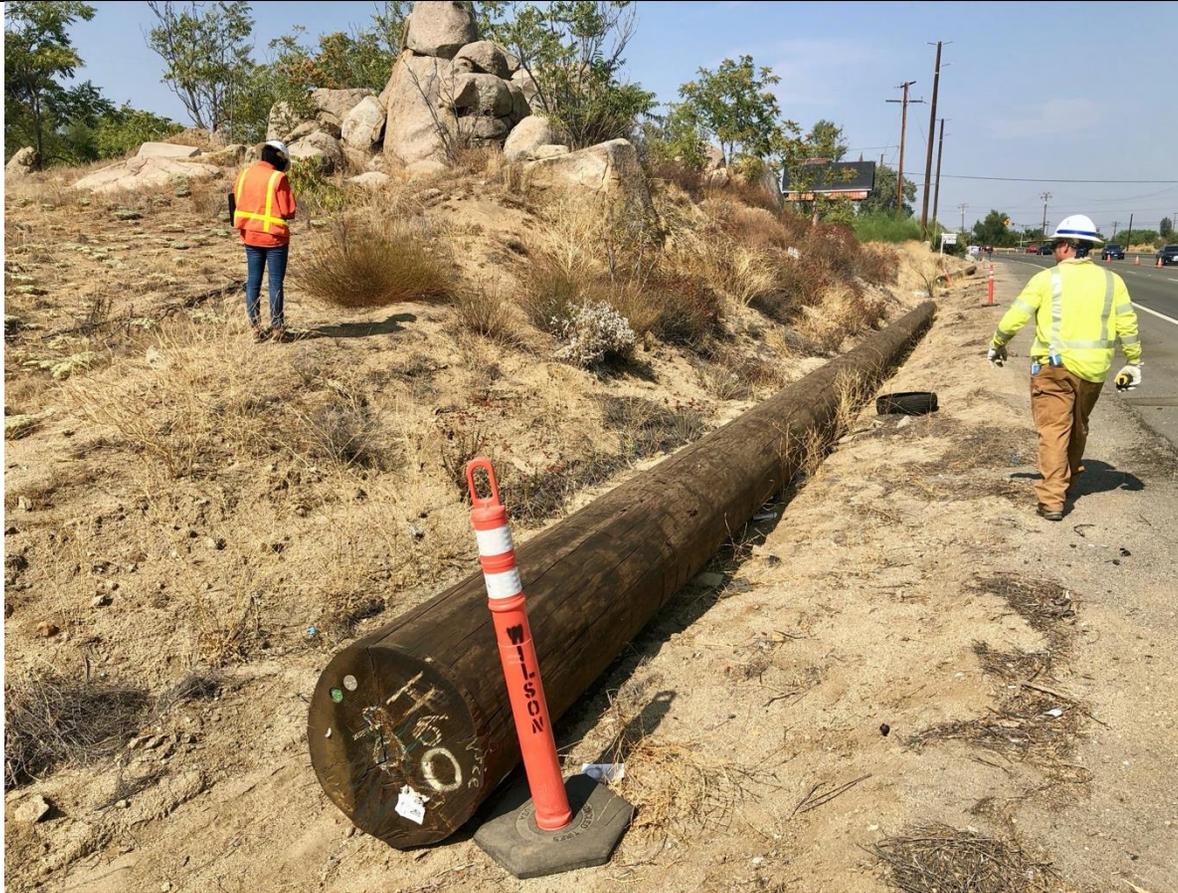
Photo 4 – Wooden poles placed along Highway 74 in Segment 2. Photo facing east

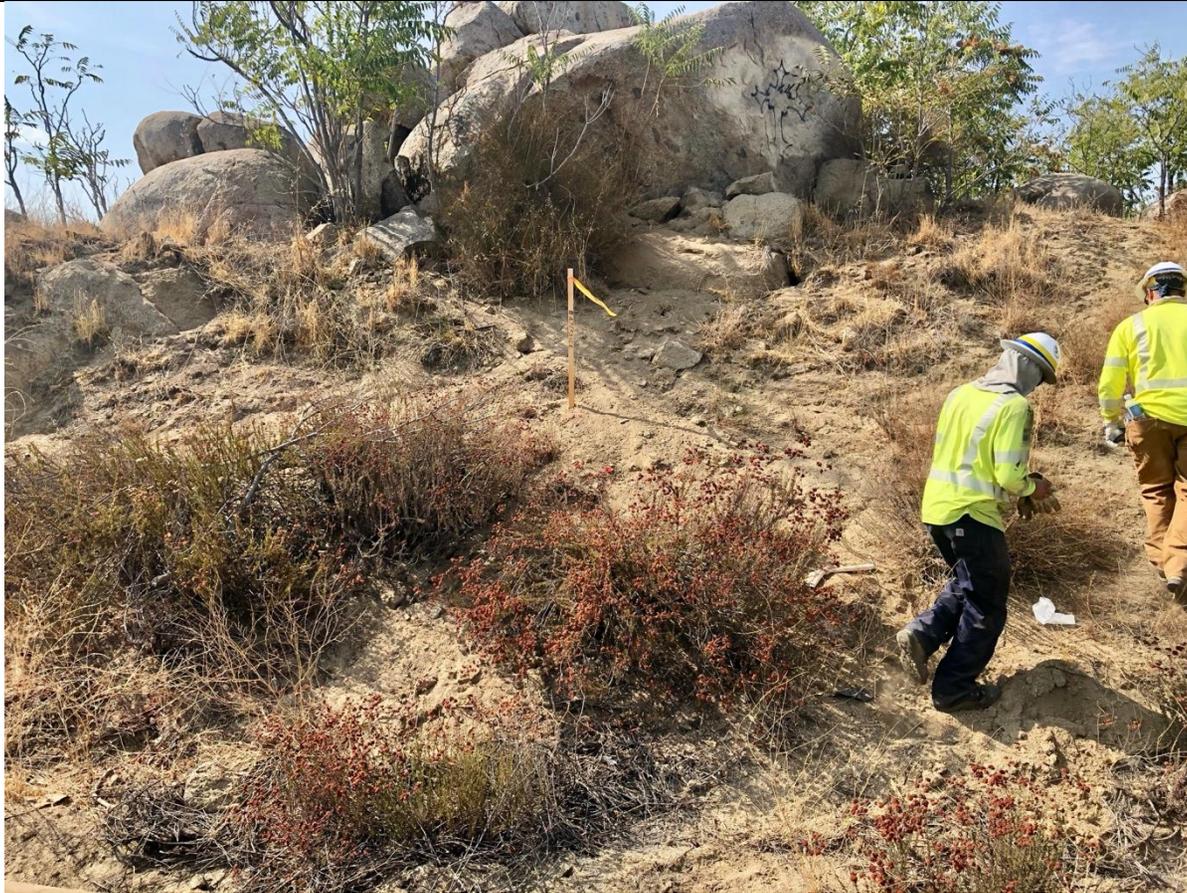
Photo 5 – Lath stake indicates the pole location – the crew may move this pole site to avoid the rock. Photo facing north

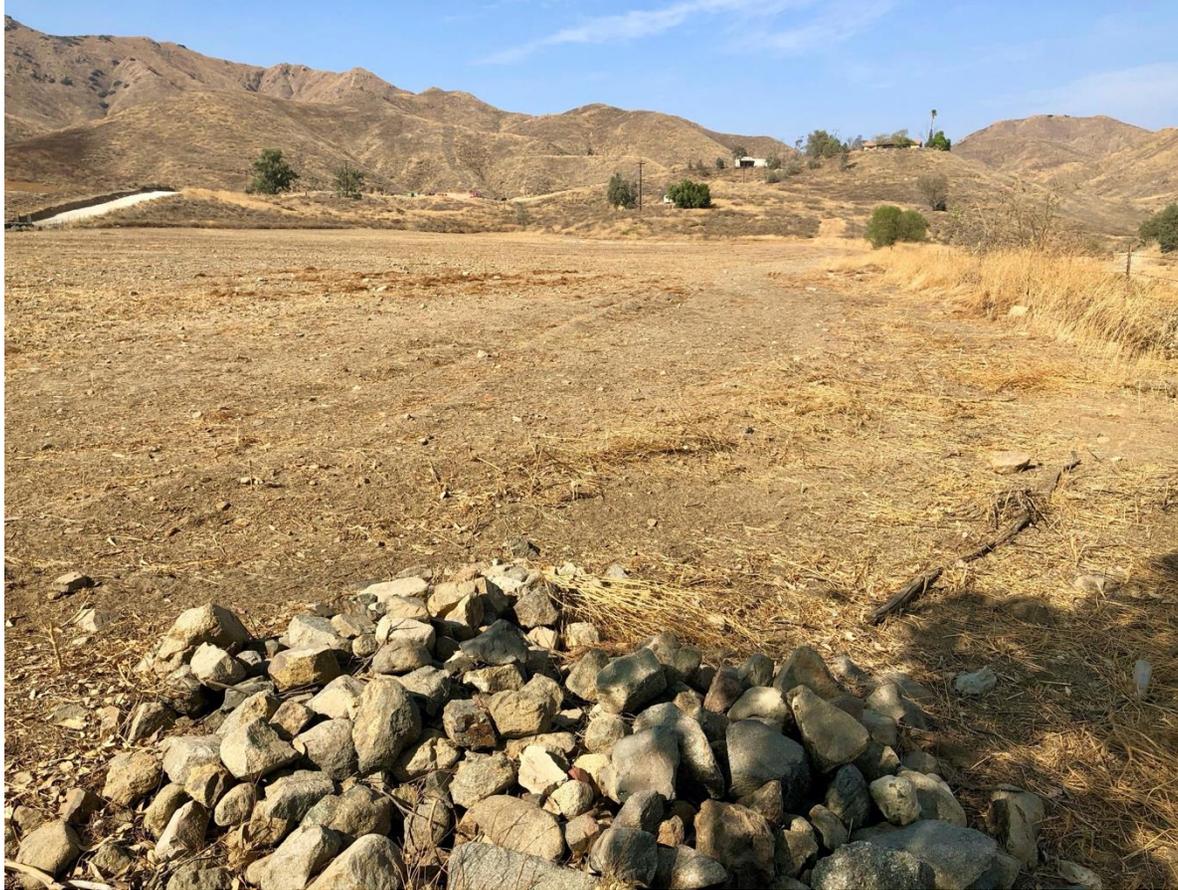
Photo 6 – Laydown yard along Hwy 15 up near the Ivyglen substation – it has recently been disc'd. Photo facing east

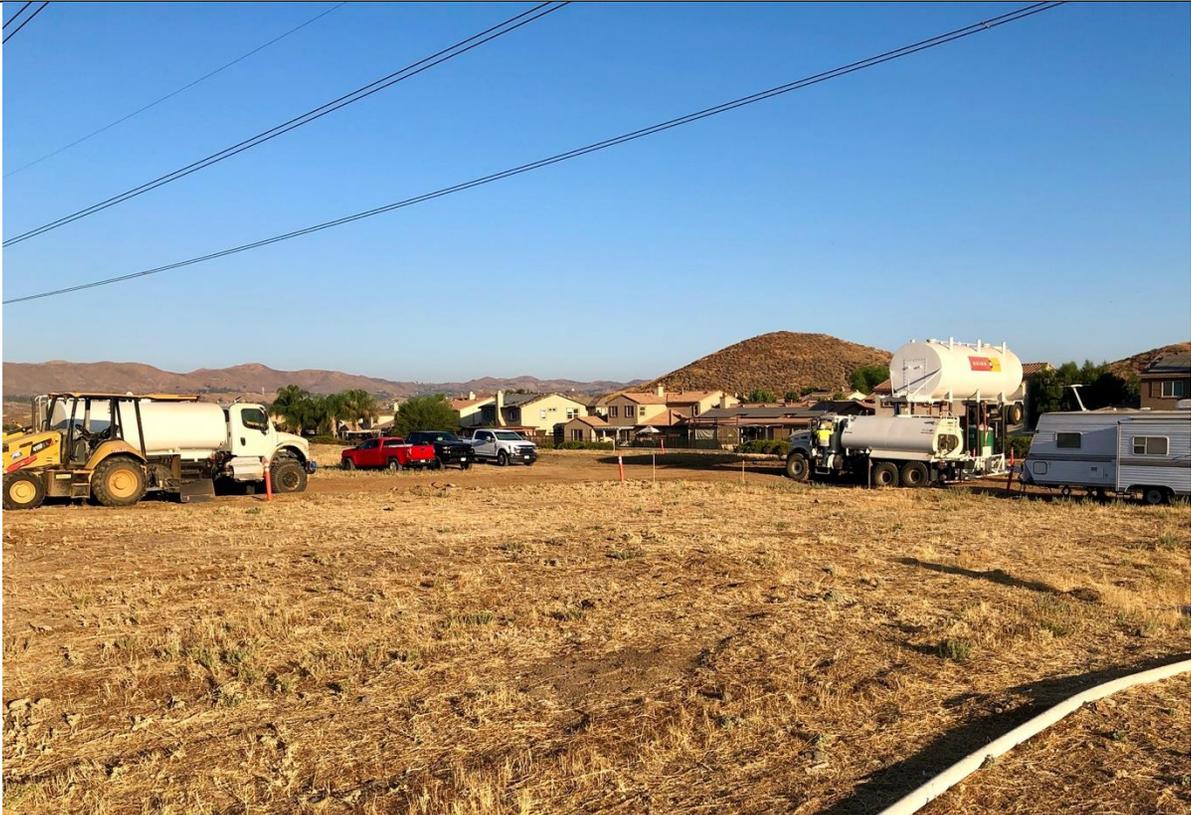
Photo 1 – Road construction staging area. Photo facing northwest

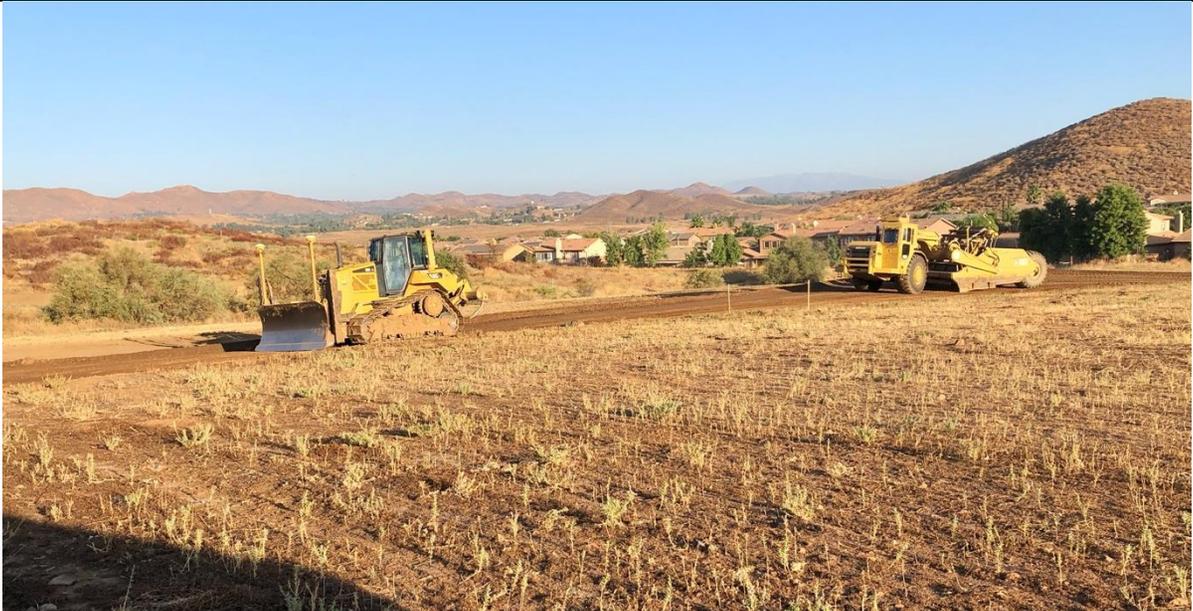
Photo 2 –Equipment working the access road. Photo facing northwest

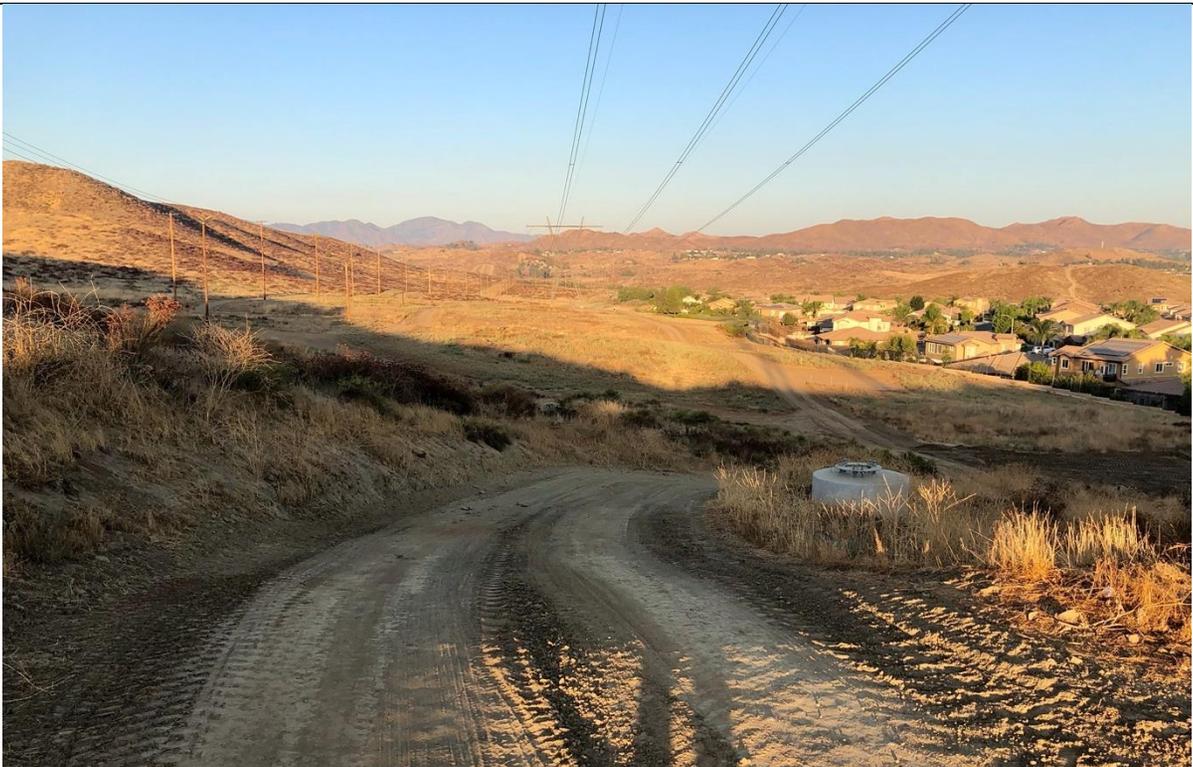
Photo 3 – Segment 1 transmission corridor looking west.

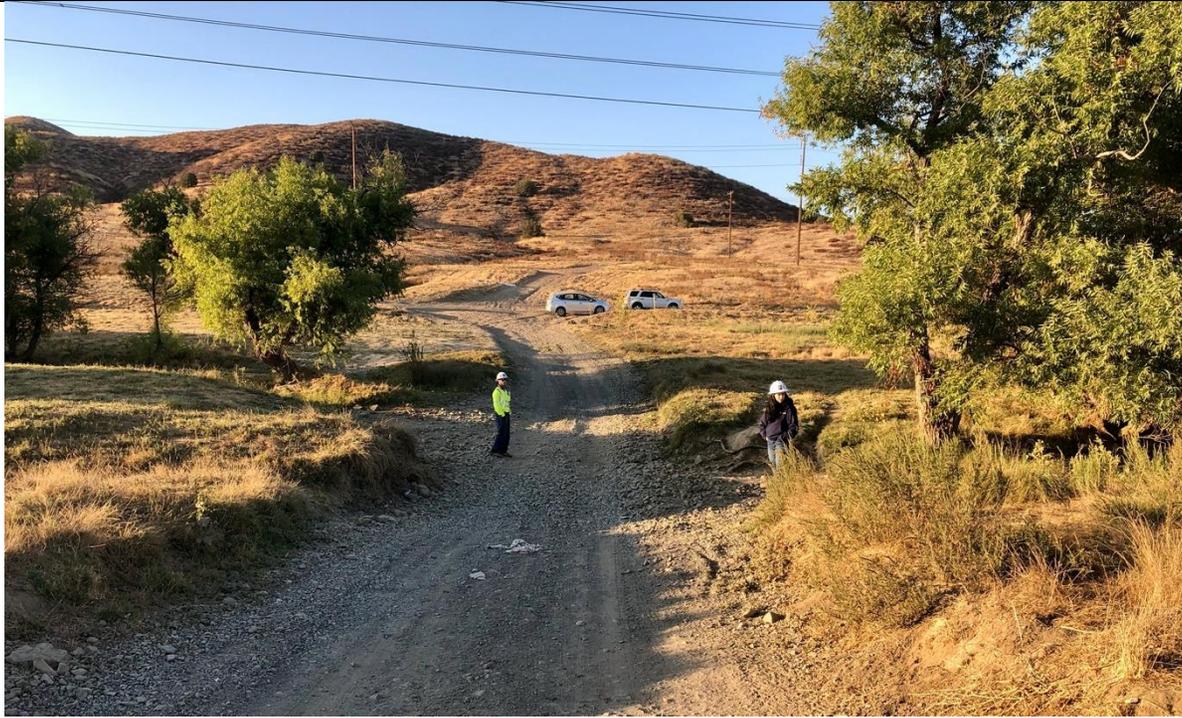
Photo 4 – San Jacinto Creek crossing within the transmission corridor. Photo facing north

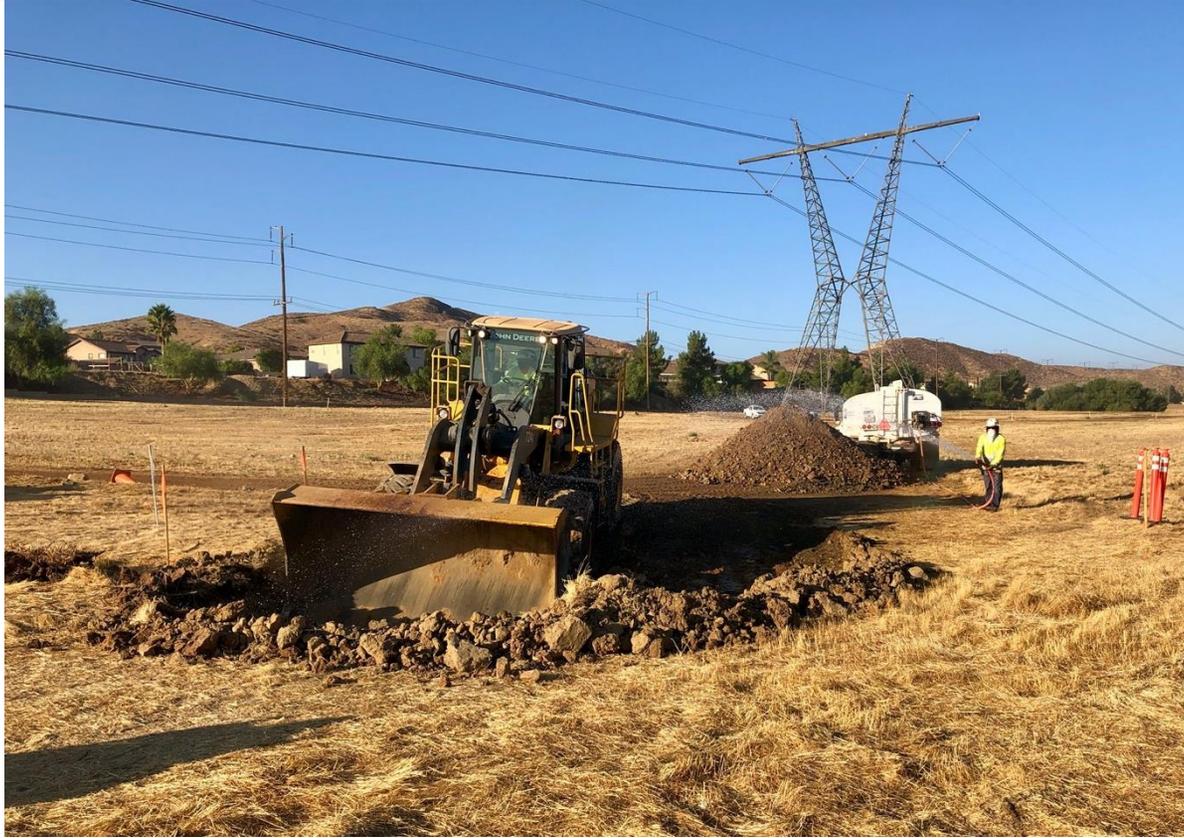
Photo 5 –  
Excavation work for  
Gabion cages to be  
installed along the  
project access road.  
Photo facing  
southwest

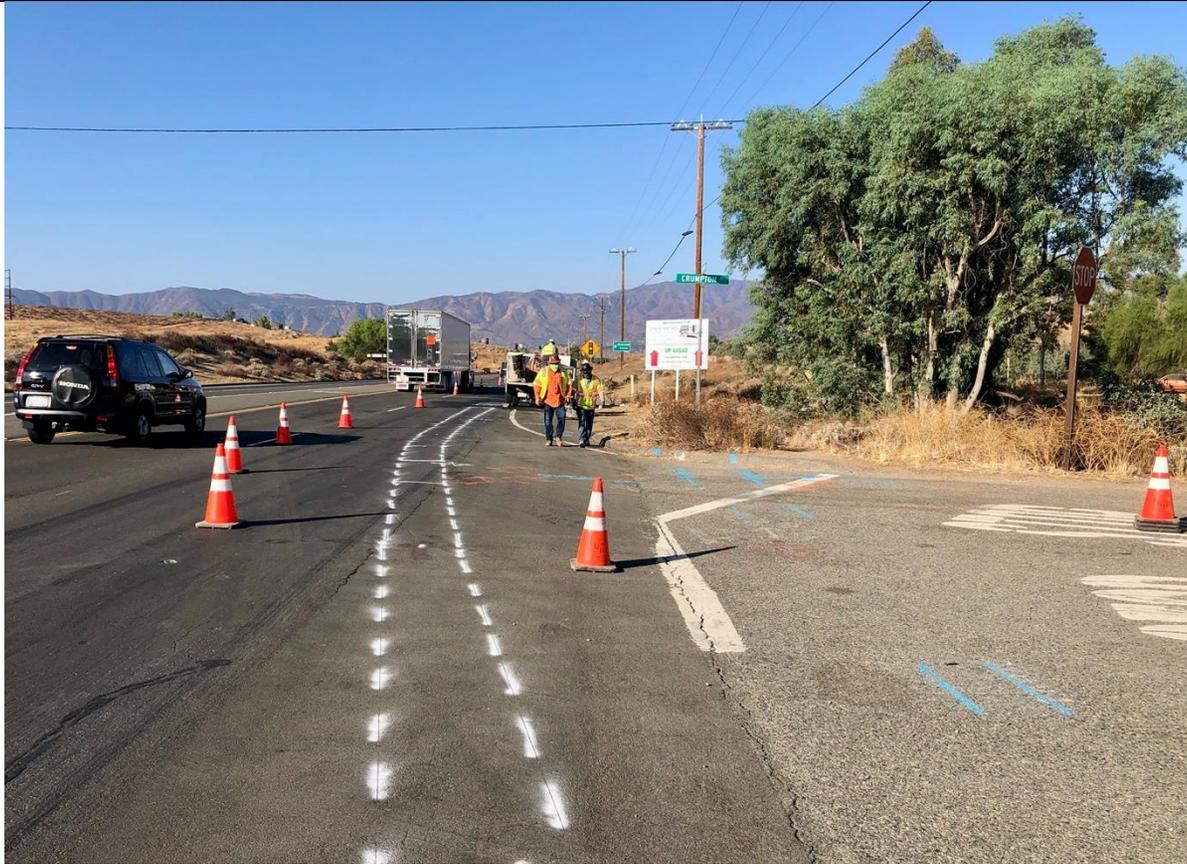
Photo 6 –  
Underground  
conduit installation  
along Hwy 74 near  
pole site 245. Photo  
facing west

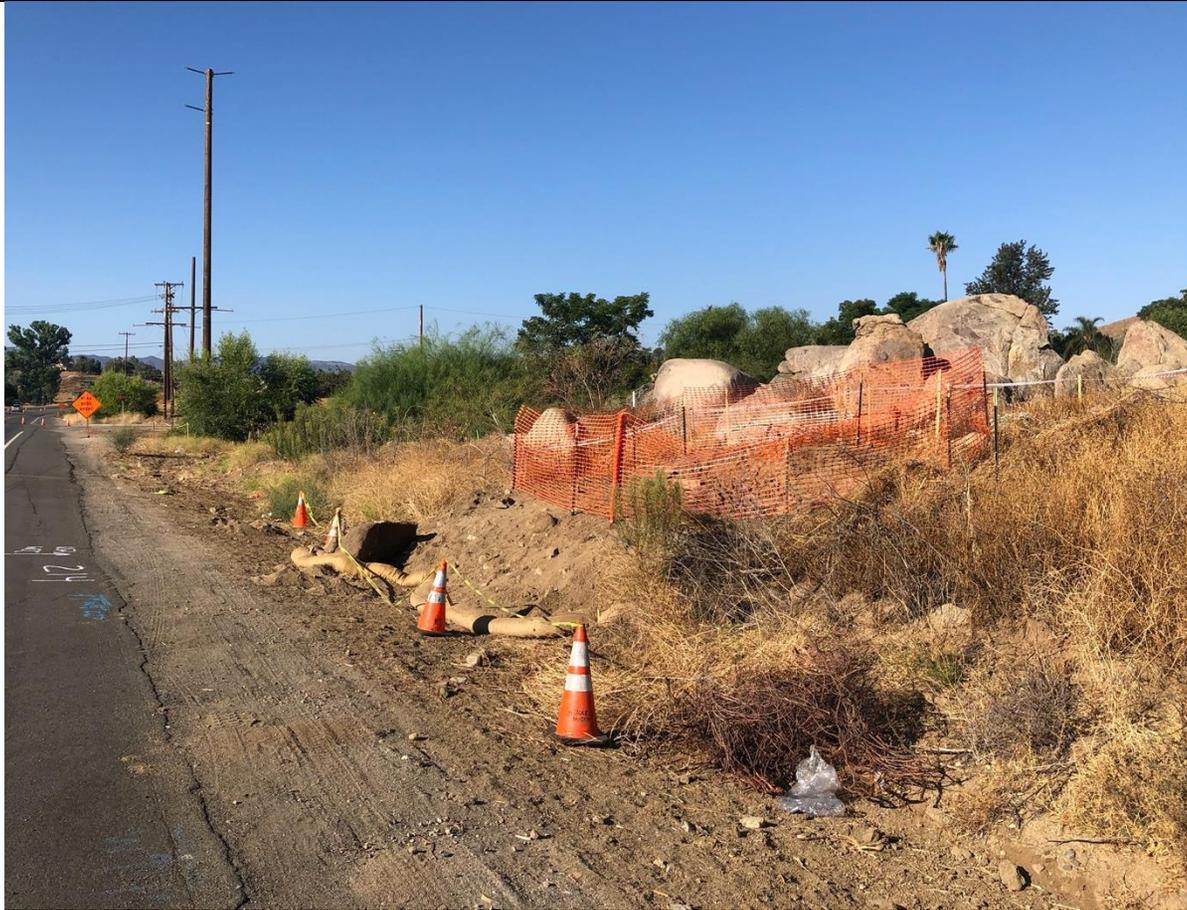
Photo 7 –  
Excavation site for  
wooden pole #213.  
Photo facing west

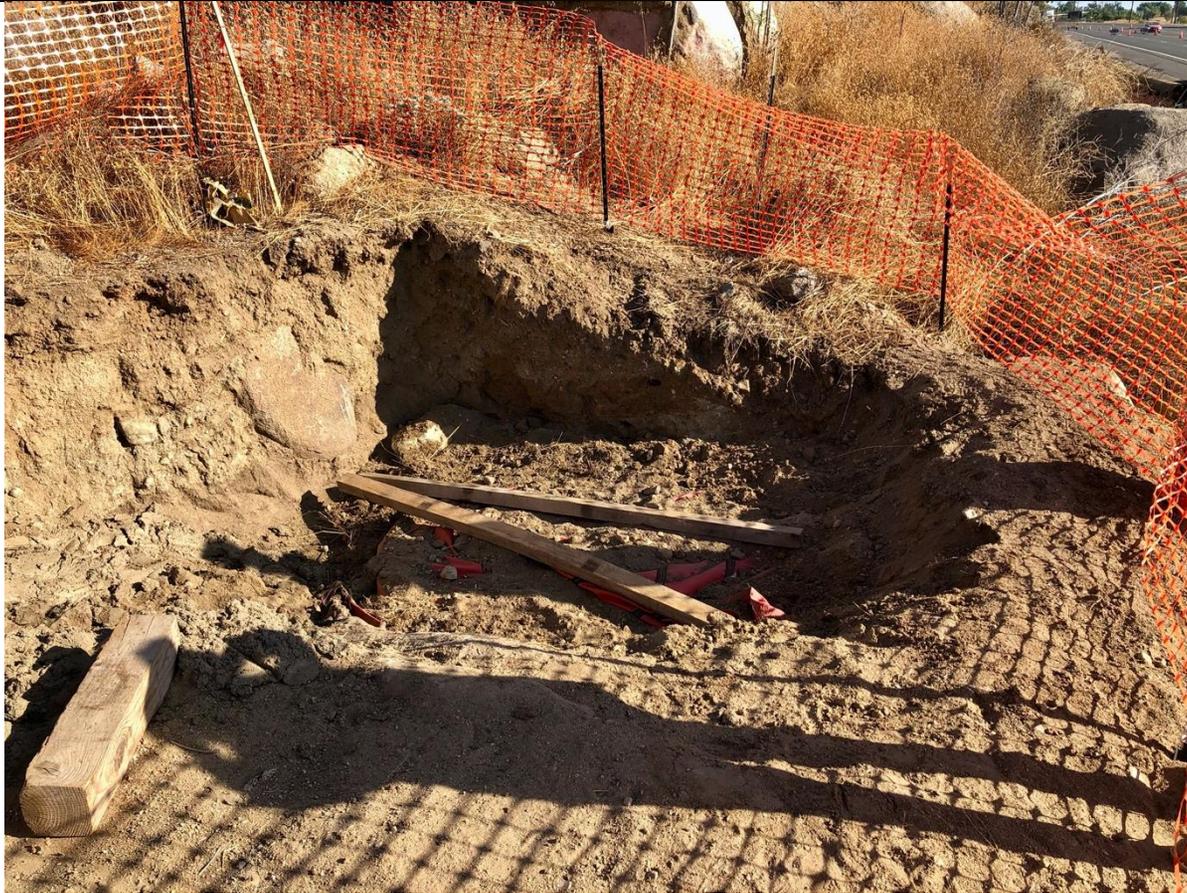
Photo 8 –  
Excavation hole for  
pole #213 that's  
been covered with  
wood and dirt.  
Photo facing east
