## PROJECT MEMORANDUM SYCAMORE-PEÑASQUITOS 230-KV TRANSMISSION LINE PROJECT

Date: March 19, 2018  
To: Billie Blanchard, CPUC Project Manager  
From: Sheila Hoyer, CPUC Monitoring Supervisor  
Subject: Weekly Report #62 – March 5 to March 10, 2018

## SDG&E Sycamore-Peñasquitos 230-kV Transmission Line Project: Daily Inspection Report

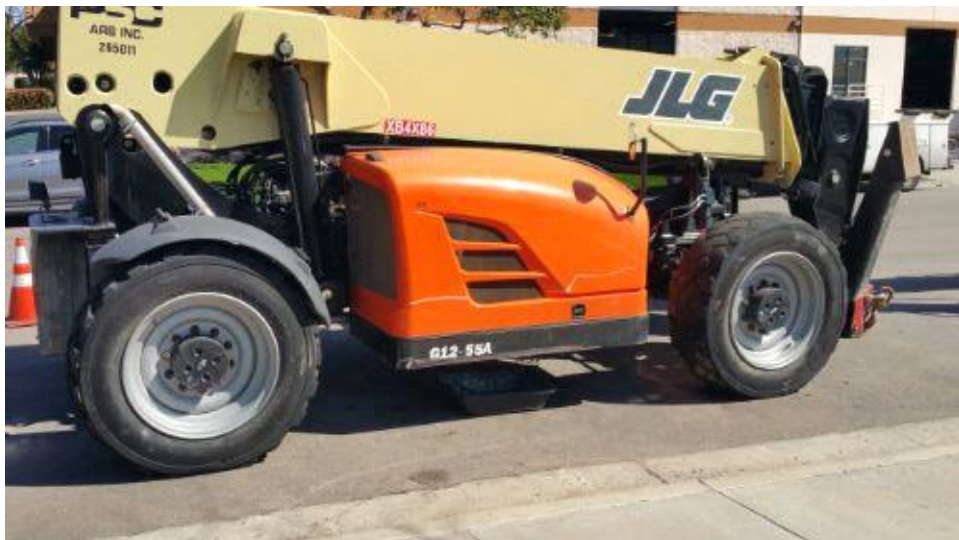
Caption Drip pans in place at Padgett Road staging area.

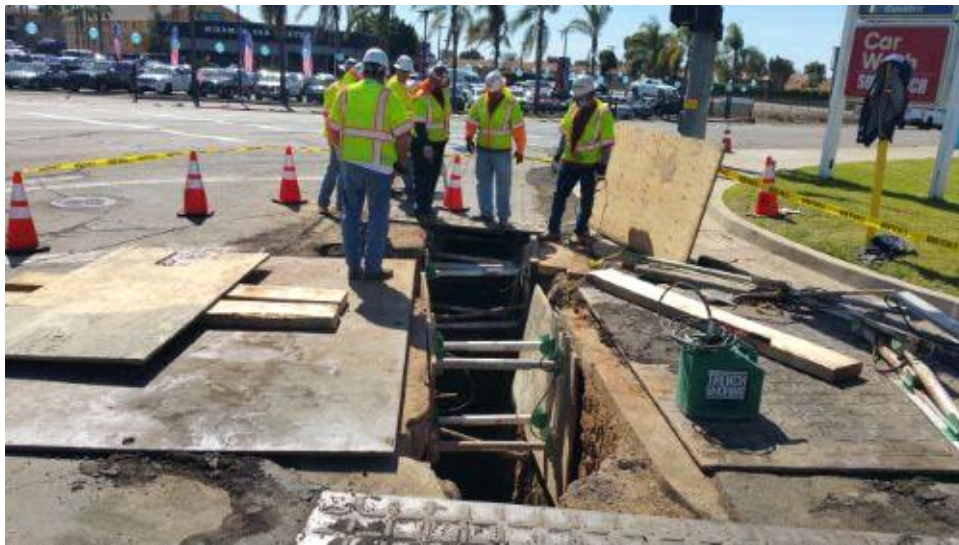
Caption Shoring trench at Kearney Mesa Road.

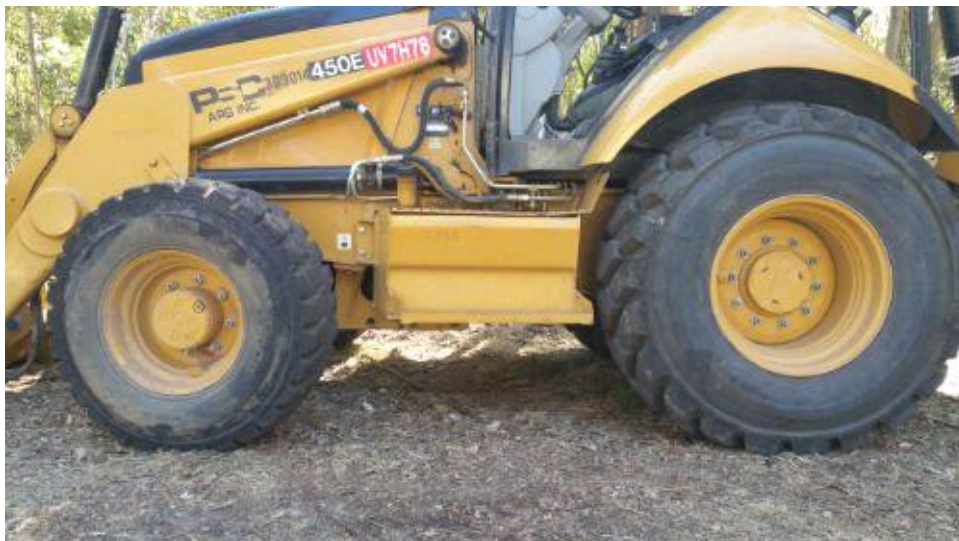
Caption No drip pan beneath parked equipment in Pomerado Road staging area. Foreman assures me drip pans will be in place beneath all equipment at end of shift.

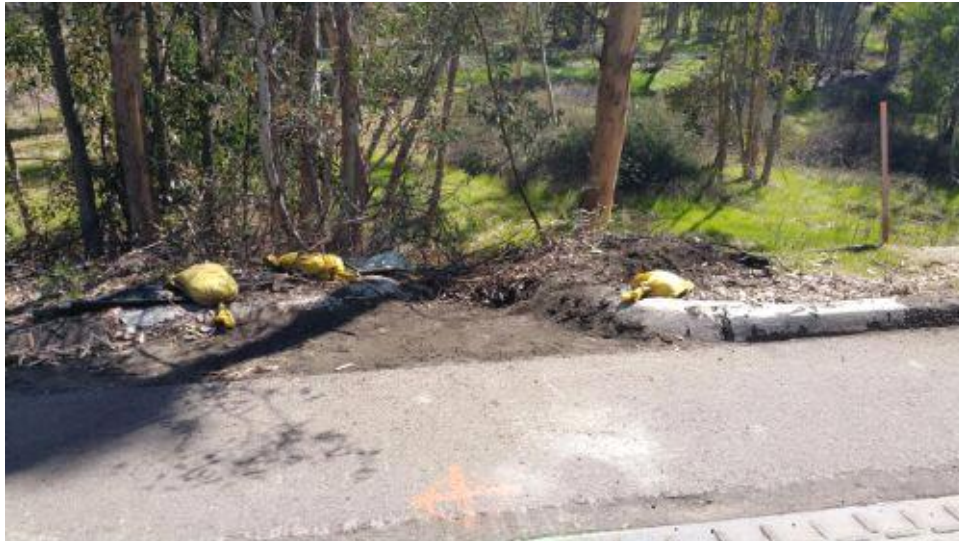
Caption Erosion control BMPs not in place at Station 435+00 on Pomerado Road.

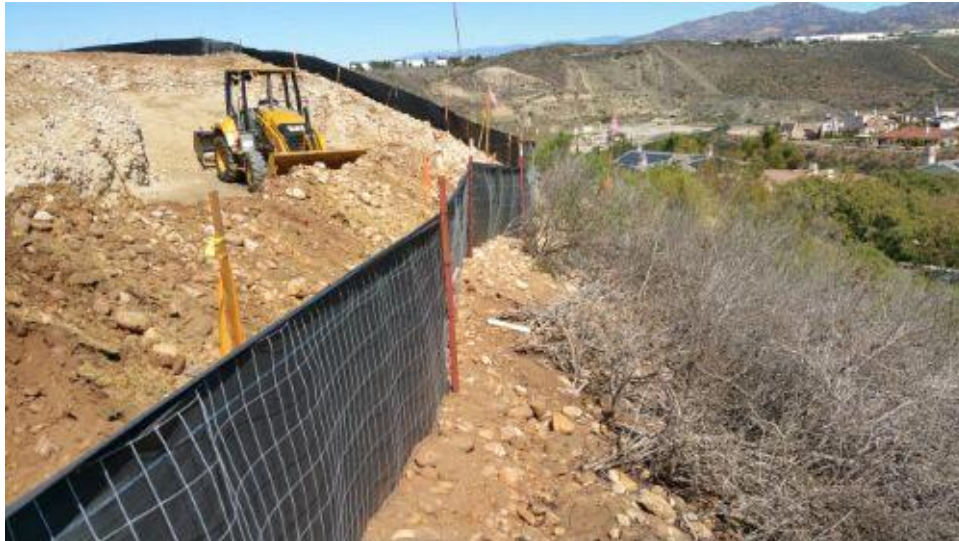
Caption Silt fencing intact at PO5.

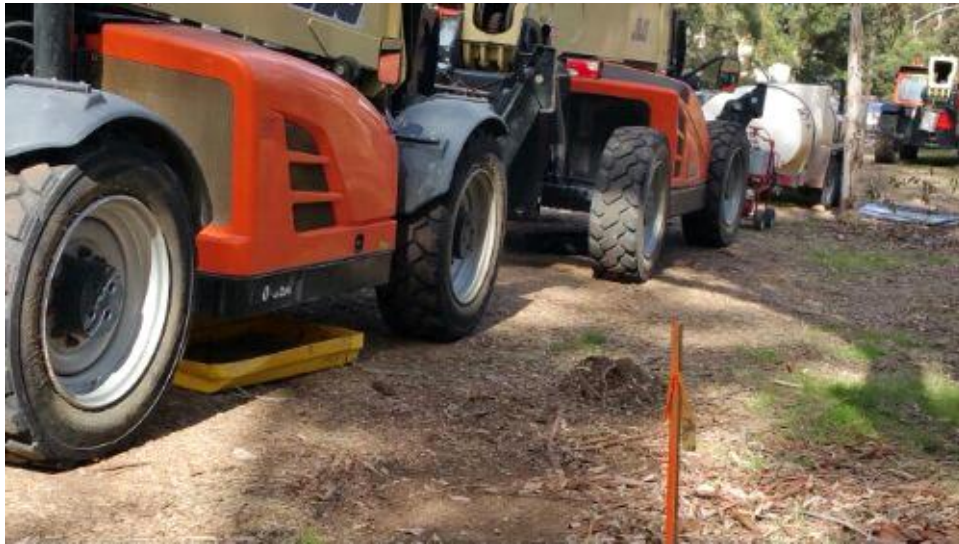
Caption Drip pans in place, Pomerado Road staging area.

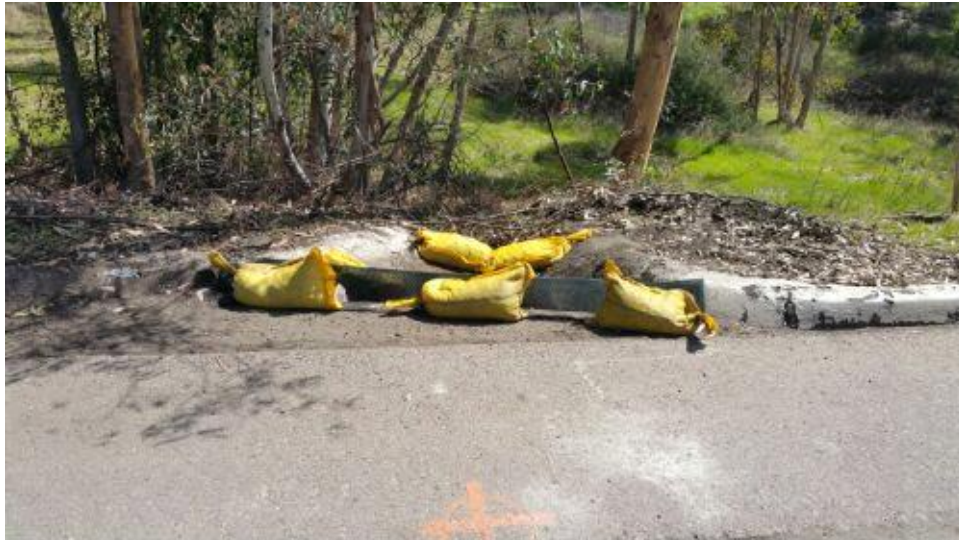
Erosion control BMPs in place at Station 435+00 on Pomerado Road.

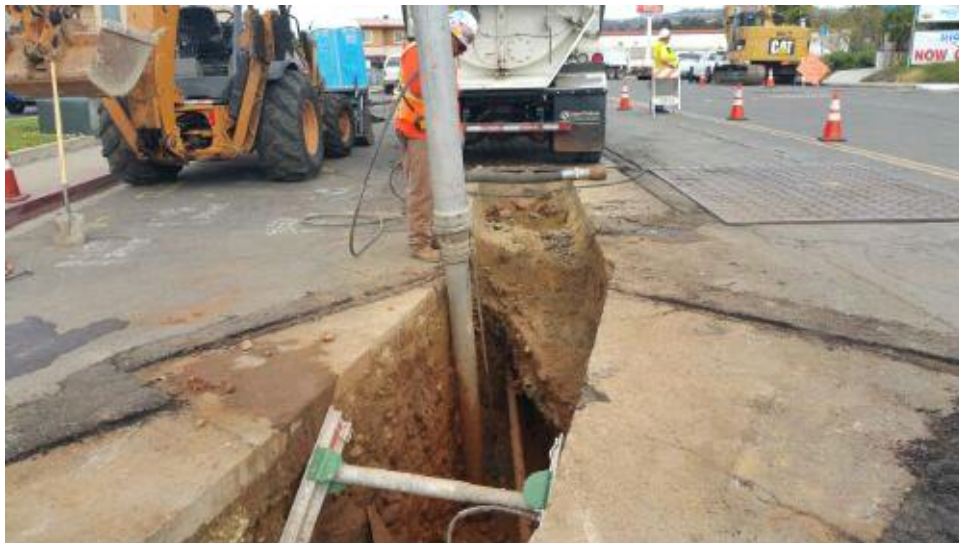
Caption Excavating around gas line on Kearney Mesa Road.
