ELDORADO-LUGO-MOHAVE (ELM) SERIES CAPACITATOR PROJECT

To: Eric Chiang, Project Manager, CPUC From: Vida Strong, Aspen Project Manager

Subject: Monitoring Report #34: October, November, and December 2024

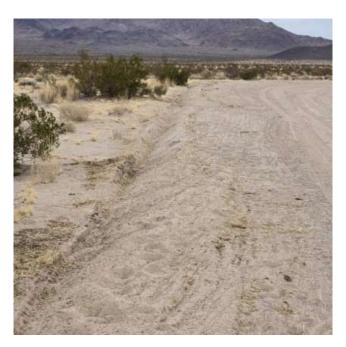
Photo 1: Post-reclamation activity at SC5, with removal of desert tortoise fencing and perimeter BMP's. Photo curtesy of the December 12, 2024 QSP SWPPP inspection.

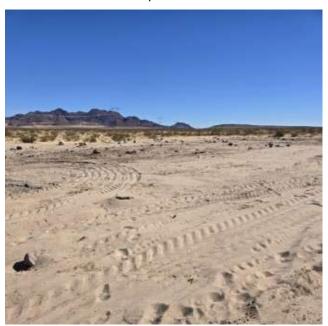
Photo 2: Post-reclamation activity at SC5, previous laydown yard shown after removal of staged containers/stockpiled materials. Photo curtesy of the November 7, 2024 QSP SWPPP inspection.

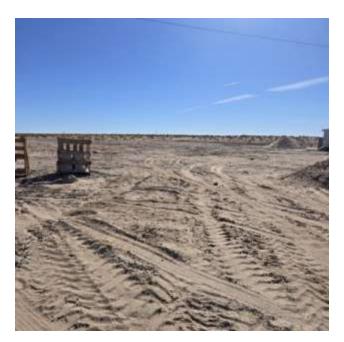
Photo 3: Post-reclamation activity at SC2, previous laydown yard shown after removal of staged containers/stockpiled materials Photo curtesy of the November 14, 2024 QSP SWPPP inspection.

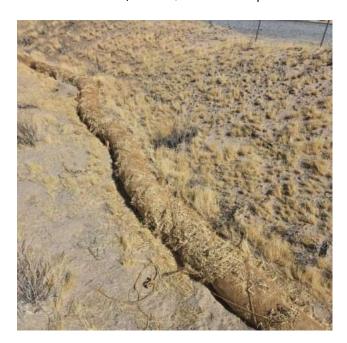
- 3. SWPPP maintenance items/corrective actions recorded during the reporting period, including the following:
 - QSP October 1st inspections identified multiple damaged perimeter wattles at both SC2 and SC5, consisting of large holes and tears, spilling out of straw material, and/or sand accumulation exceeding the 50% burial limit, and overall loss of functionality as effective BMPs. This observation was recorded by the QSP as a Compliance Checklist Deficiency for this week's inspection and recommended the replacement or removal of the ineffective BMP's (see Photos 4 and 5). Additionally, October 1st inspections identified damaged stockpile coverings (ripped geo-tex fabric, exposing stockpiled soil) at SC2. Outstanding SWPPP maintenance item/corrective actions recorded.

Photo 4: Damage to perimeter wattles at SC5, with a splits in the burlap covering, spill out of straw material, and loss of functionality as a BMP. Photo curtesy of the October 1, 2024 QSP SWPPP inspection.

- Subsequent QSP October 22nd and October 31st inspections noted both outstanding SWPPP BMP deficiencies mentioned above (perimeter wattles at SC2/SC5, and stockpile coverings at SC2) as resolved, with the initiation of site reclamation work (which included the removal and/or replacement of damaged perimeter wattles, and the spreading/removal of stockpiled material) (see Photos 6 and 7).

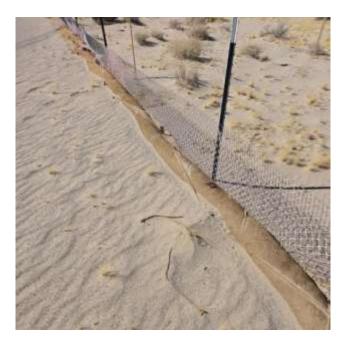
Photo 5: Significant sand accumulation/build-up, exceeding the 50% burial limit at perimeter wattles at SC5. Photo curtesy of the October 1, 2024 QSP SWPPP inspection.

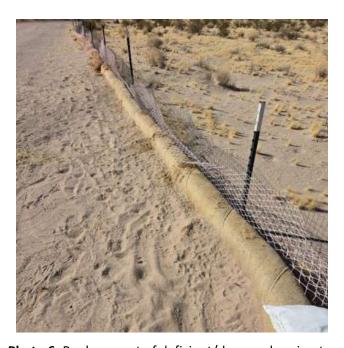
Photo 6: Replacement of deficient/damaged perimeter wattles with new/refurbished, temporary wattles at SC5 during reclamation. Photo curtesy of the October 22, 2024 QSP SWPPP inspection.

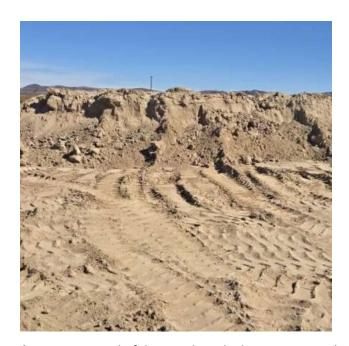
Photo 7: Removal of damaged stockpile coverings and spreading of stockpiled material during reclamation work at SC2. Photo curtesy of the October 31, 2024 QSP SWPPP inspection.
