PROJECT MEMORANDUM PG&E NORTHEAST SAN JOSE TRANSMISSION REINFORCEMENT PROJECT

Subject: Weekly Report #28: December 2, 2002 – December 8, 2002

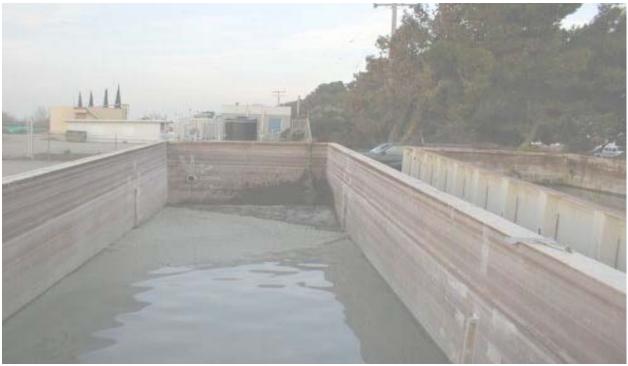
The CPUC EM conducted a site visit of the Overhead Segment and Pole #17 area in the afternoon. Construction crews had set up several Baker tanks at that site for dewatering foundation pits (see Figure 1). The CPUC EM inspected the Baker tanks and noted that the water coming in was very silty and muddy, and there was a sheen on top of the water. The CPUC EM spoke with the Essex Environmental Inspector (EI) about the dewatering issue. He informed her that they are not dewatering into the storm drains at this time. They are collecting all the water in the Baker tanks and they plan to reuse it to help stabilize the sides of the foundation pits. The Essex EI is working with construction management on a plan for final dewatering which will not include release to the storm drains. Next, the CPUC EM conducted a site visit of Pole #16 area. Crews were just finishing pouring the foundation for Pole #16 (see Figure 2). They plan to wait awhile to let the foundation cement set-up, and then later in the evening, they plan to move their drilling equipment and other machinery over to the Pole #17 area.

Figure 1
Baker Tanks at the Pole #17 Area
December 3, 2002

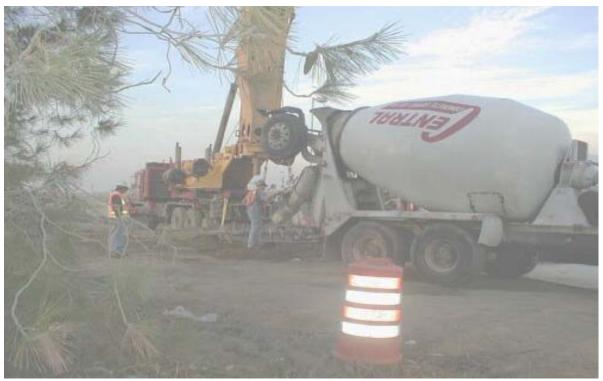
Figure 2
Pouring Foundation for Pole #16
December 3, 2002

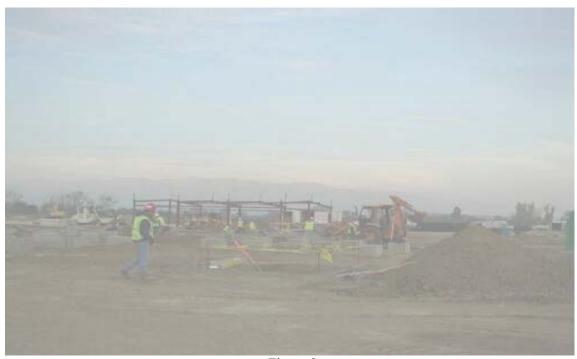
Later in the afternoon, the CPUC EM conducted a site visit of the Los Esteros Substation, where the steel frame for the Operations Building has been set up (see Figure 3). The CPUC EM spoke with Jeff Jensen of OCI who said that some of the pre-fabricated steel roof supports were not designed right for the roof, so they will have to be replaced. Crews were working on the erection of more steel pole structures. The office trailers for OCI and Fullerton-Pacific have been moved to the southwest corner of the property. The CPUC EM observed that the site was neat and clean.

Figure 3
Los Esteros Substation: Operations Building Structure
December 3, 2002

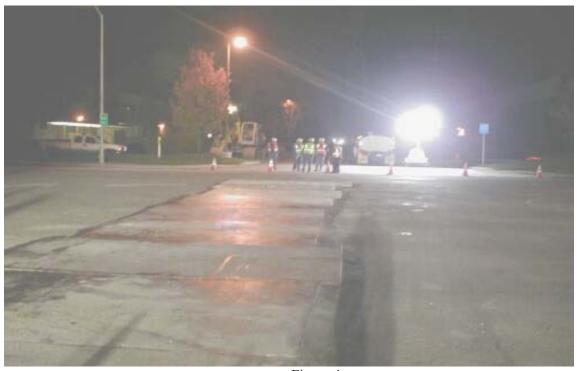
Throughout the evening and night, the CPUC EM conducted several site visits of the underground construction route. At Gateway Boulevard (see Figure 4), crews were setting up traffic controls in preparation to trench across the road. The asphalt grinding machine came on site to cut the asphalt before trenching started. Crews began to trench on the left line from approximate Station 91+94 to 92+90. At the man-hole vaults #8 area, two crew members were working on re-paving the area by the cap and grind method. At the south end of the underground route, trenching activities were in progress. Crews were trenching south on the right line from approximate Station 135+66 and P&P crews were pouring cement slurry from that point north. Later in the night, the CPUC EM observed crews doing landscape work on the Pinole property where they had trenched.

Figure 4
Crews setting up to trench across Gateway Boulevard.
December 5, 2002
