#### PROJECT MEMORANDUM SDG&E'S SUNRISE POWERLINK PROJECT

To:	Billie Blanchard, Project Manager, CPUC			
From:	Vida Strong, Aspen Project Manager			
Date:	November 2, 2010			
Subject:	Weekly Report 5 – October 17 to October 23, 2010

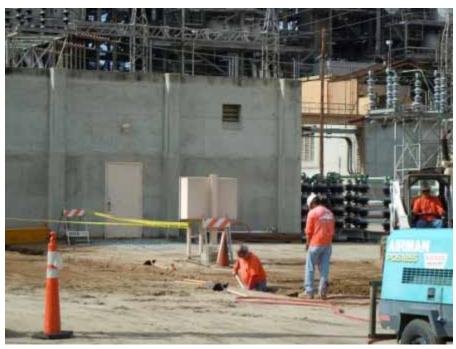
- 1. Trenching for the control cable was conducted at the South Bay Substation (see Figure 1).
- 2. Work was conducted at the capacitor bank at the San Luis Rey Substation.
- 3. Best Management Practices (BMPs) were installed and footing repair on existing towers began at the Encina Substation.

Figure 1: Trenching continues at the South Bay Substation.

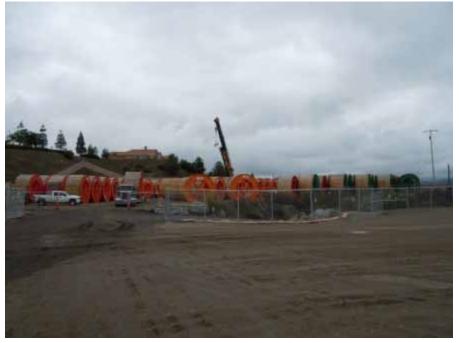
- 1. Delivery of wire reels continued throughout the week at the Alpine Construction Yard (see Figure 2).
- 2. Class II base was applied at the Alpine Regional Field Offices (Alpine RFO). Office modular installation and driveway improvements continued, as well (see Figure 3).
- 3. BMP installations were conducted at the Rough Acres Yard. Casings for micro-pile work have been delivered and stored on site.

Figure 2: Wire reel delivery installations continued at the Alpine Construction Yard.

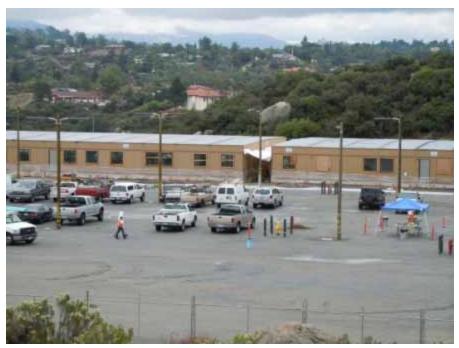
**Figure 3**: Alpine RFO with Class II base installed and continued installation of modulars.

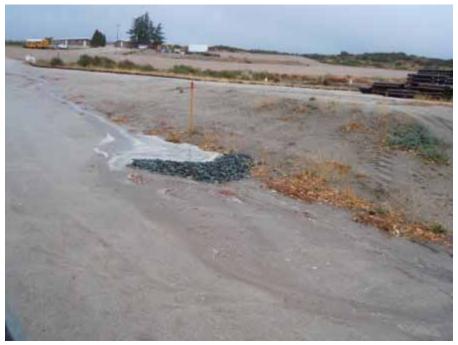
- 1. Biological Monitors have been present during all construction and delivery activities at the yards.
- 2. A metavolcanic biface and two metavolcanic interior flakes were discovered at the Rough Acres Yard by the Native American representative for the Campo Band of Mission Indians. No concern was expressed in relation to this find.
- 3. Environmentally Sensitive Area (ESA) fencing remains in place which clearly delineates approved construction areas within the construction yards of the Alpine RFO and the Alpine Construction Yard.
- 4. BMPs at the yards were found to be sufficient at all yards during the rain event on October 19, 2010 (see Figure 4).

Figure 4: BMPs at the Rough Acres Yard.
