PROJECT MEMORANDUM PG&E – TRI-VALLEY 2002 CAPACITY INCREASE PROJECT

To:Jensen Uchida, CPUCFrom:Vida Strong, Aspen Project ManagerDate:November 22, 2006Subject:Final Walk-Through Report: October 13, 2006 & October 17, 2006

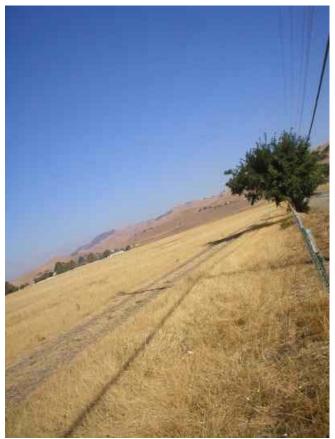
The October 13th tour began at the Cayetano Substation and progressed north along the underground alignment. Along the alignment between Vaults 2 and 4 the backfill of the eastern trench and vault areas show poor vegetative cover (see Figure 1). The areas appear to have been over-compacted during construction and stringing operations. PG&E committed to disc the area. The CPUC EM confirmed that the area had been disced during the follow up visit conducted on October 17th (see Figure 2).

Figure 1 – Underground trench alignment showing poor grass growth, October 13, 2006.

- The area surrounding vaults and access points between Vaults 2 and 5 will be decompacted (disced). The final success of vegetative cover will be assessed after the rainy season.
- The non-serviceable silt fence along Road 5 will be removed. However, the remaining silt fencing along Road 5 will be left in place during the rainy season and will be removed in the spring.

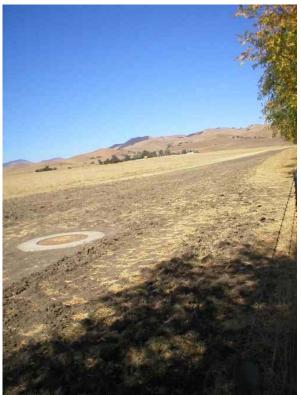
Figure 2 – Recently disced Vault 2 and extended underground alignment area, October 17, 2006.

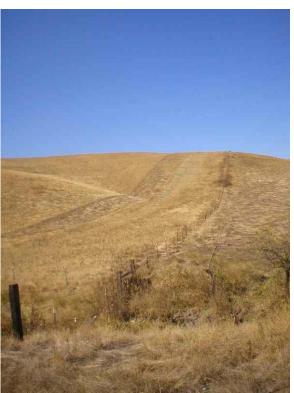
Grass seeding had occurred last year after installation of the underground line. However, some areas appeared to need additional seeding prior to the next rainy season. NVC hand seeded some areas including the steep slope west of Vault 5 (see Figure 3).

Figure 3 – Hand-seeded trench line extending up from the Vault 5 area, October 13, 2006.

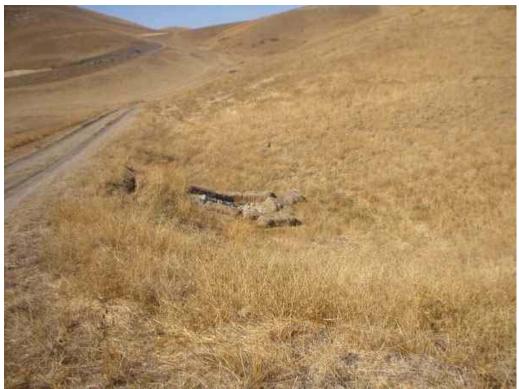
The October 13th tour progressed along Road 7 where hay bales previously installed to protect culvert areas were still in place the time of the tour (see Figure 4). PG&E agreed to cut and remove the bailing, and will let the bales disintegrate in place. The Vault 6 pad, which lies along Road 7, showed pour cover at the time of the tour and PG&E provided that it will be de-compacted and seeded (see Figure 5). The cut slope above Vault 7 also showed poor cover. A decision was made to leave the installed straw wattles in place over the next rainy season for slope stability. The area will also be reseeded (see Figure 6).

Figure 4 – Intact hay bales protecting a culvert area along Road 7, October 13, 2006.

- Hay bales located near culvert inlets/outlets throughout the project area will be broken down and spread out.
- The recently installed straw wattle located near the Road 6 crossing of Cayetano Creek will be removed.

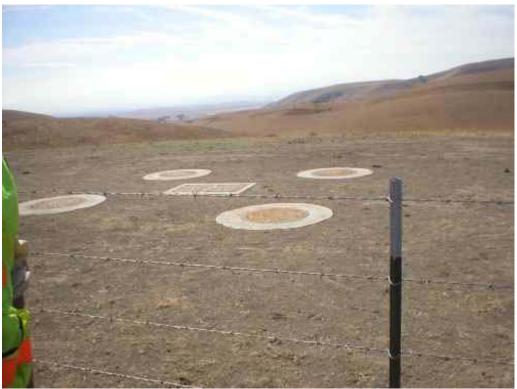
Figure 5 – Vault 6 area along Road 7, October 13, 2006.

- end of Road 7 (Vault 6 area)
 - large slope cut along Road 7 (above Vault 7)
 - area near Road 6 crossing of Cayetano Creek
 - two small areas between Cayetano Creek and the hill on Road 6

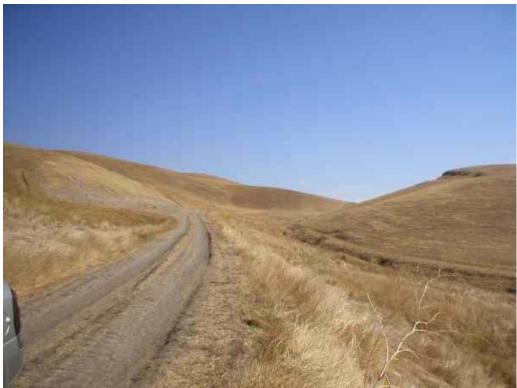
Figure 6 – Cut slope above Vault 7 along Road 7, October 13, 2006.

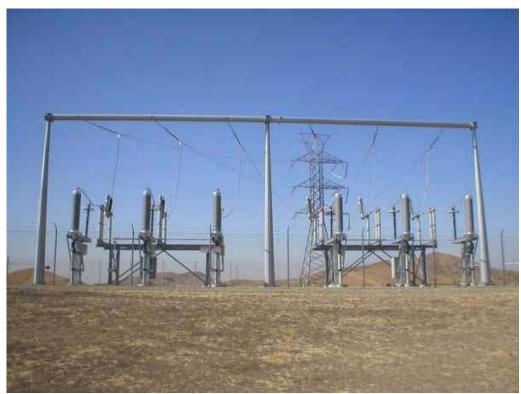
The October 13th tour progressed up Road 6 which ends at the Transition Station (see Figure 7). The CPUC EM noted that areas directly off Road 6 which had been used as approved staging locations appeared disturbed. PG&E provided that they will restore the areas. During early October, NVC crews removed a large number of wattles installed prior to last winter along Roads 6 and 7. A dumpster was brought onsite for the used materials and will be hauled off. Some wattles were purposely not removed and will remain in place along a swale downslope of Road 6 through the winter. PG&E will continue to inspect the project areas for erosion throughout the nest rainy season. Erosion controls will be maintained and removed as needed.

Figure 7 – Transition Station, October 13, 2006.

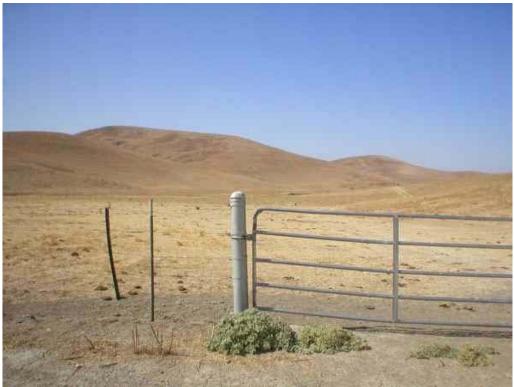
The tower staging and assembly laydown yard off Doolan Canyon Road was also inspected (see Figure 8). The laydown area looked good and PG&E noted that the population of invasive star thistle appears reduced compared to pre-construction. A star thistle abatement program is active in the area and many of the property owners participate.

Figure 8 – Staging area location along Doolan Canyon Road, October 13, 2006.

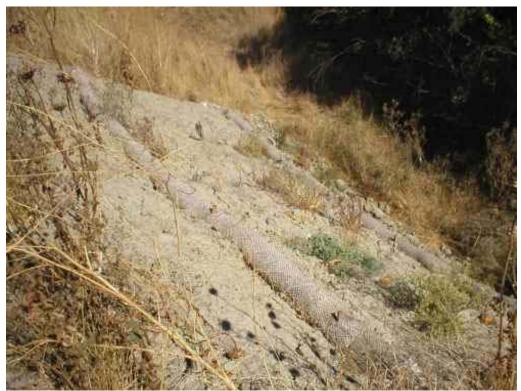
The October 13th tour progressed along Moller Road. NVC crews have removed a spoils pile along Moller Road and plan to seed and project straw over the area. Most of the erosion controls have been removed. During the follow up tour on October 17th an area downslope of Moller was identified where erosion controls should remain in order to protect a slope in close proximity to Tassajara Creek (see Figure 9). The PG&E EM provide that the area will be seeded and a non-monofilament mat will most likely be installed for stabilization. During the October 13th tour, PG&E provide that NVC will hydro seed the area around the substation wall that was disturbed during irrigation line and landscape installation. Crews were seeding the area during the follow up tour on October 17th (see Figure 10). The area around Tower #1 was recontoured and on October 17th the area was also seeded (see Figure 11).

Figure 9 – Area downslope of Moller Road, October 17, 2006.

- Silt fence and straw wattles near small wetland on Moller Road will be removed.
- Hydroseeding will be conducted at the following areas (straw will be spread on top where appropriate):

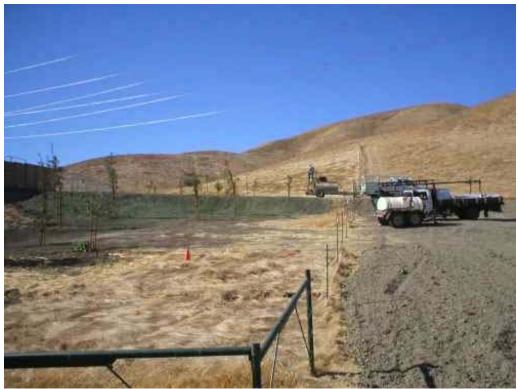
Figure 10 – NVC crews hydro-seeding the area around the North Dublin Substation pad, October 17, 2006.

- area near slope repair areas on Road 6
 - areas lacking vegetation surrounding the North Dublin Substation
 - area where crane pad was located beneath Tower 1

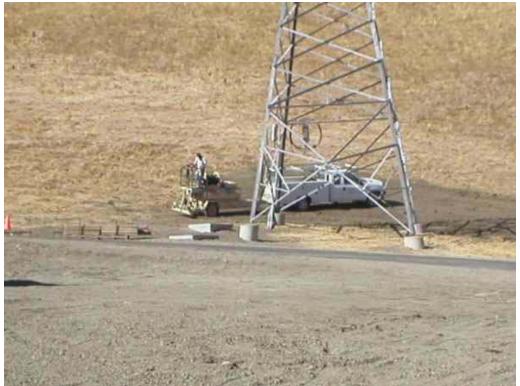
Figure 11 – NVC crews hydro-seeding the graded pad area around Tower #1, October 17, 2006.

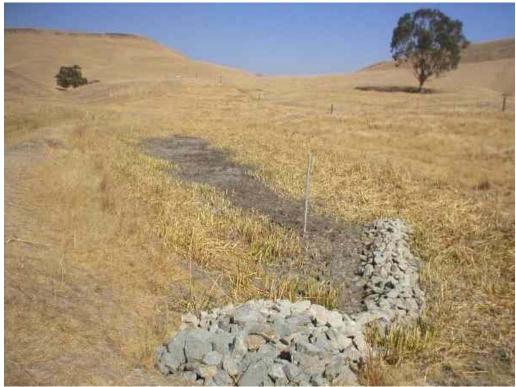
The October 13th tour progressed along the mitigation site access road. The engineered pond at the mitigation site is now dry (see Figure 12).

Figure 12 –Mitigation Pond, now currently dry, October 13, 2006.
