PROJECT MEMORANDUM
SDG&E VINE 69/12-kV SUBSTATION PROJECT

To: Eric Chiang, Project Manager, CPUC
From: Vida Strong, Aspen Project Manager
Date: January 10, 2017
Subject: Monitoring Report #9: November 20 to December 24, 2016

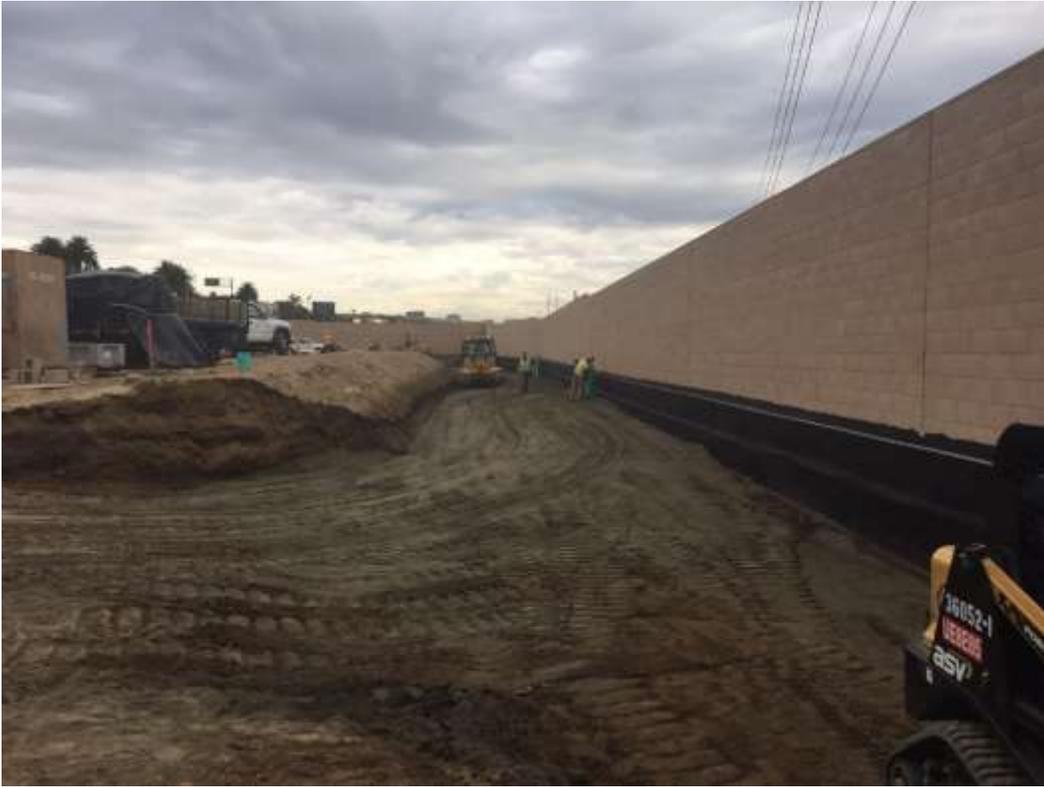
2. Major grading at the substation site was not conducted during the subject period.
3. Construction activities associated with the construction of the perimeter block wall (material delivery and wall assembly) has been completed at the substation (see Figure 1).

Figure 1 – The completed perimeter wall surrounding the substation.

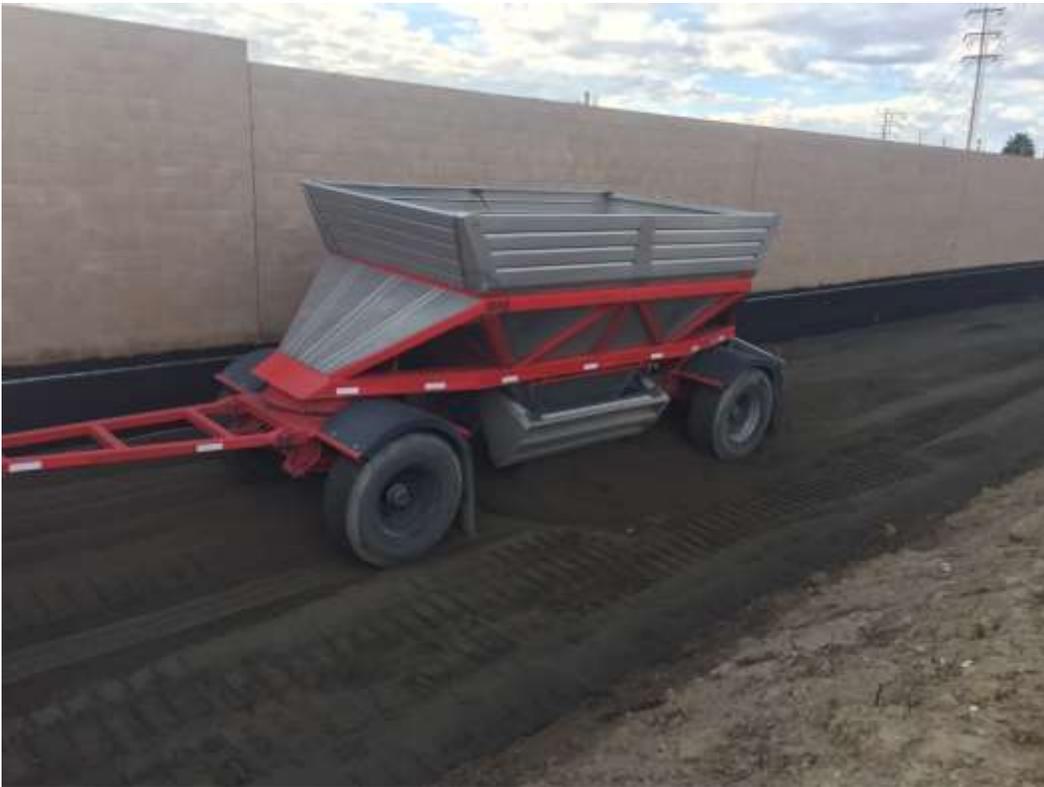
4. Waterproofing of the perimeter block wall was conducted.
5. Fill import and compaction took place along the southwest border to backfill the perimeter wall foundation (see Figure 2).

Figure 2 – Backfill and compaction along the southwestern site boundary.

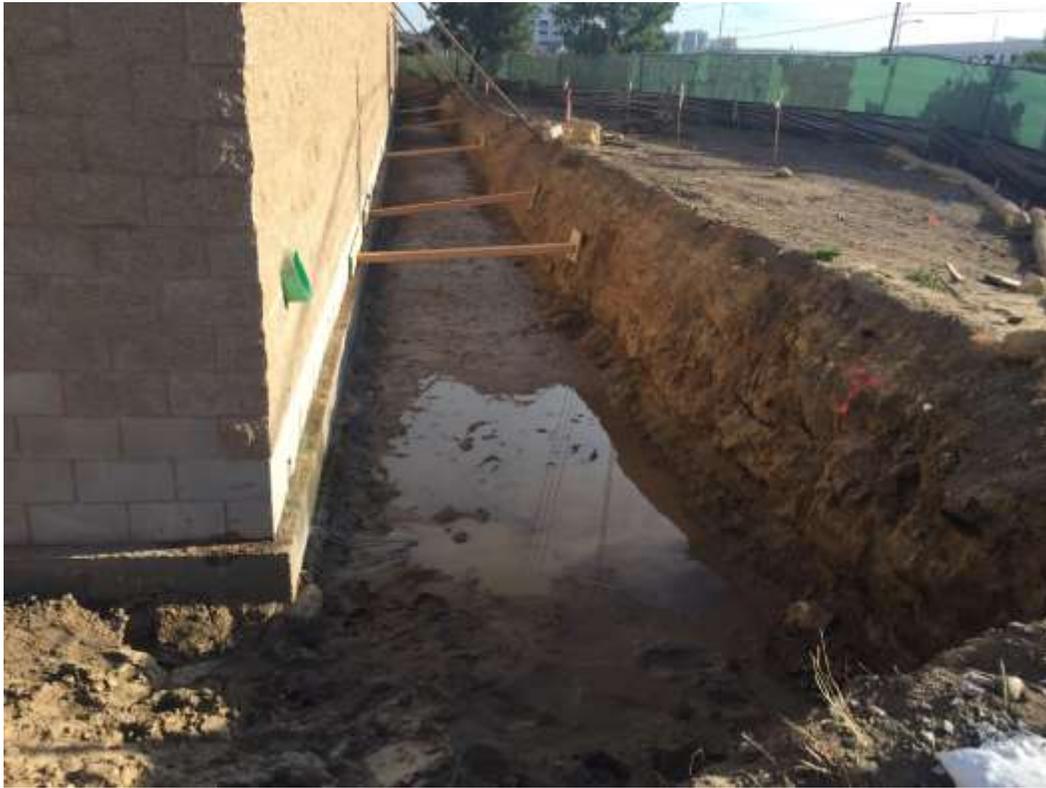
6. Approximately 1.75 inches of rain was recorded during a storm event between December 21 and 24. Nuisance water from the leaking storm drain continued to discharge storm water onto the site on the outside of the perimeter wall (see Figures 3 and 4). The contractor pumped the water into a containment area surrounded by berms (see Figure 5). Some of the water was pumped into the water truck and spread on site. The remaining water was hauled off site for disposal.

Figure 3 – Location of the discharge from the damaged storm drain to the project site adjacent to the block wall footing (prior to storm event).

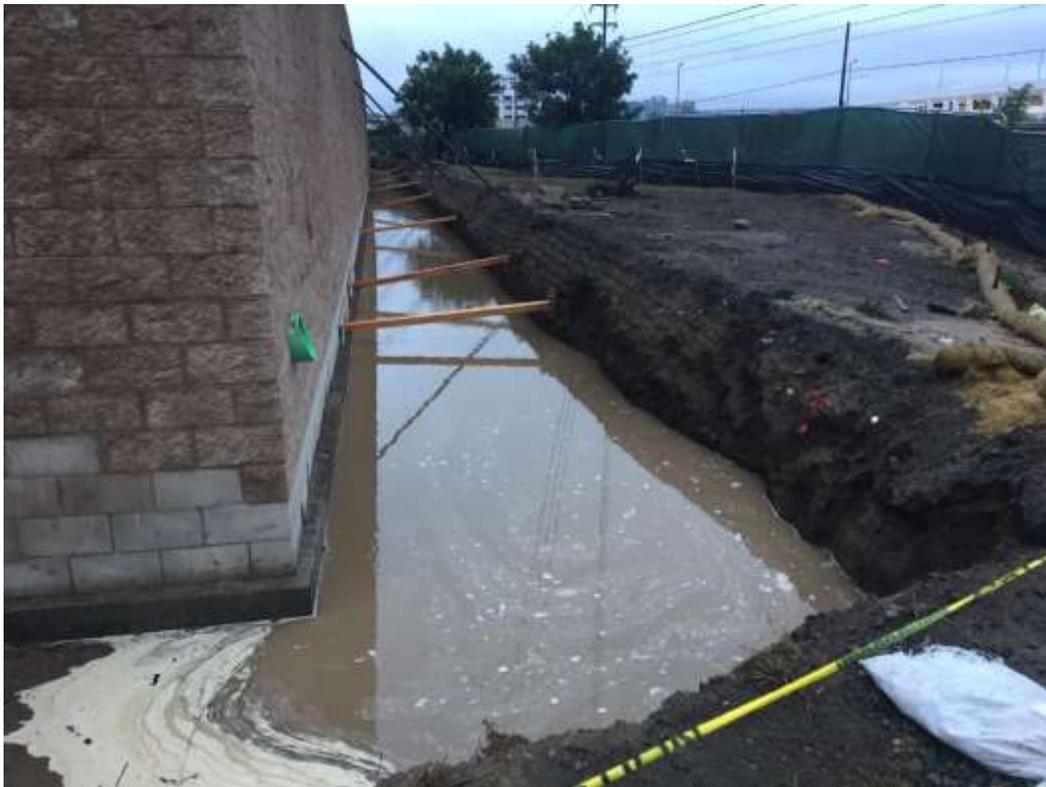
Figure 4 – Location of the discharge from the damaged storm drain to the project site adjacent to the block wall footing (post storm event).

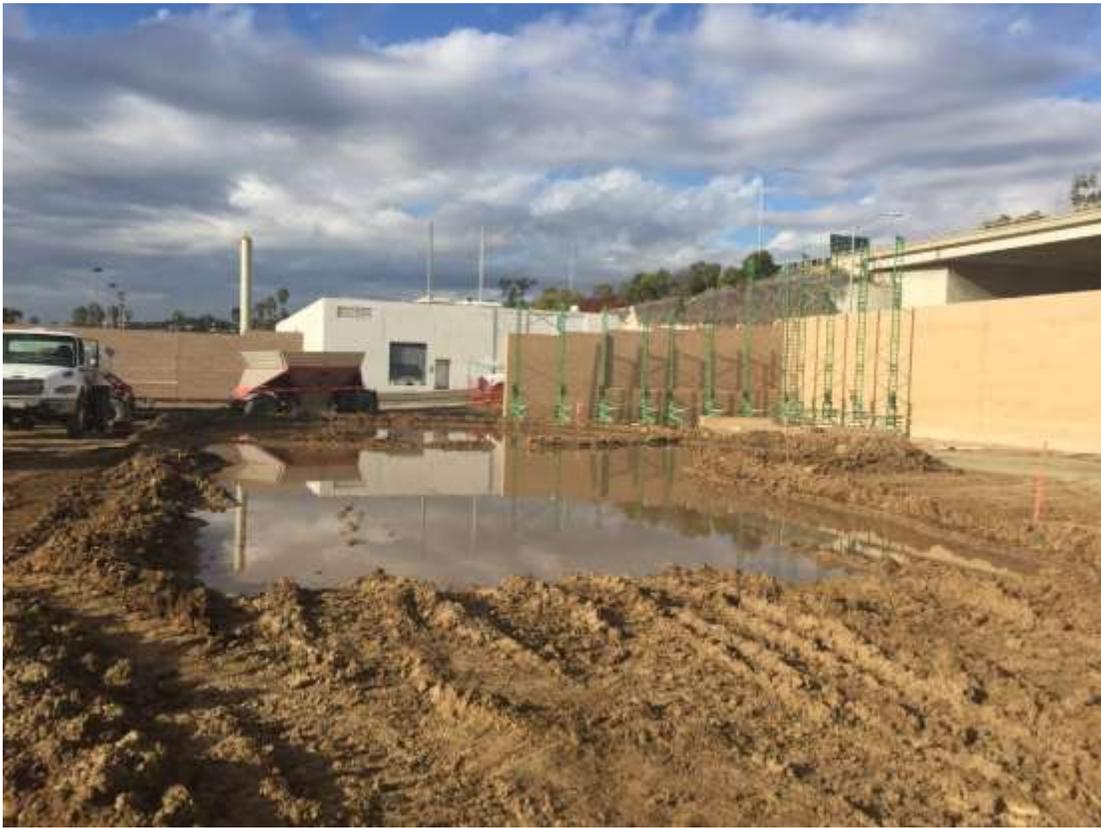
Figure 5 – Water containment area was constructed to hold water until it could be removed from the site.
