PROJECT MEMORANDUM
PG&E WINDSOR SUBSTATION PROJECT

To: Eric Chiang, Project Manager, CPUC
From: Vida Strong, Aspen Project Manager
Date: December 7, 2016
Subject: Monitoring Report #1 – September 26 to December 4, 2016

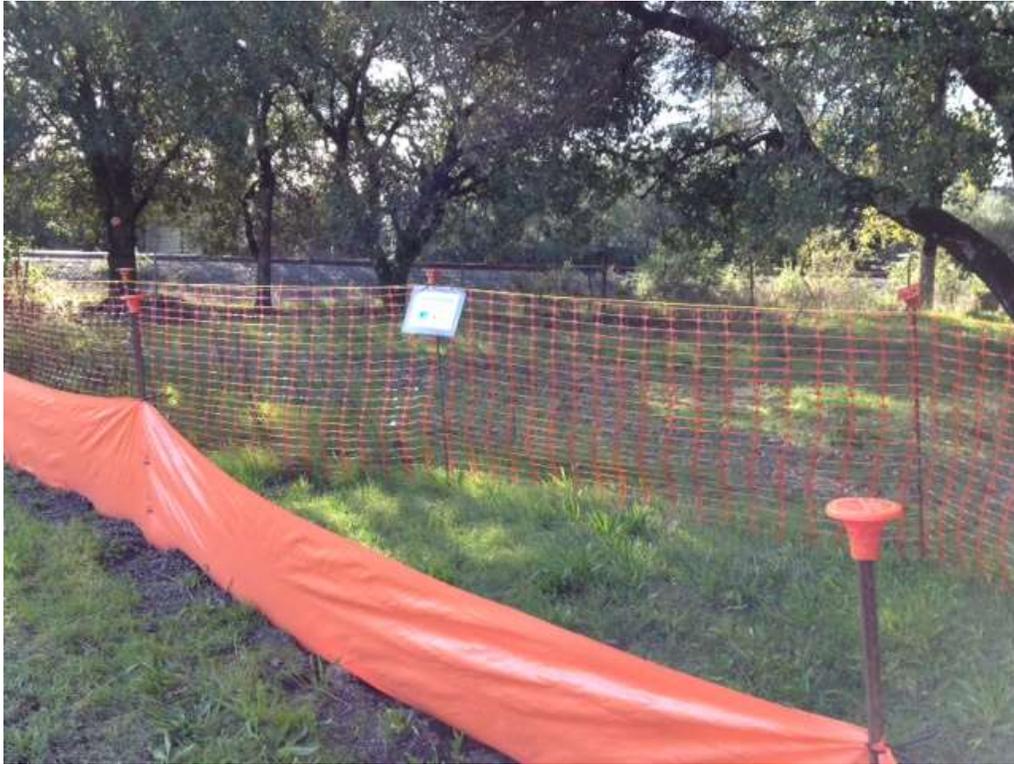
On Friday, November 4th, a walk-behind trencher was used to install silt fence along the west and south perimeters of the substation work area and "wetland boundary" signage was placed along the fence (see Figure 1). The silt fence provides at minimum a 7-foot buffer for all wetland areas. Straw wattles were installed along the northern fence line, and rumble plates were placed at the entrance gates. BMPs (straw wattles) were stockpiled at the site. Contact information on the sign at the substation site for air quality was corrected.

4. The CPUC EM observed that the site was neat and clean, and that SWPPP measures were in place. Silt fencing was installed around the wetland areas on the west and south sides of the substation site and was in good working condition. ESA fencing was also installed around oak trees for protection. All observed work activities were in compliance with mitigation measures (MMs), Applicant Proposed Measures (APMs), and other permit requirements.
5. The CPUC EM observed two special-status species while conducting monitoring, including a red-tailed hawk and Peregrine falcon flying over the project site.

Figure 1 – Silt fence and ESA fencing installed at substation site, November 28, 2016.

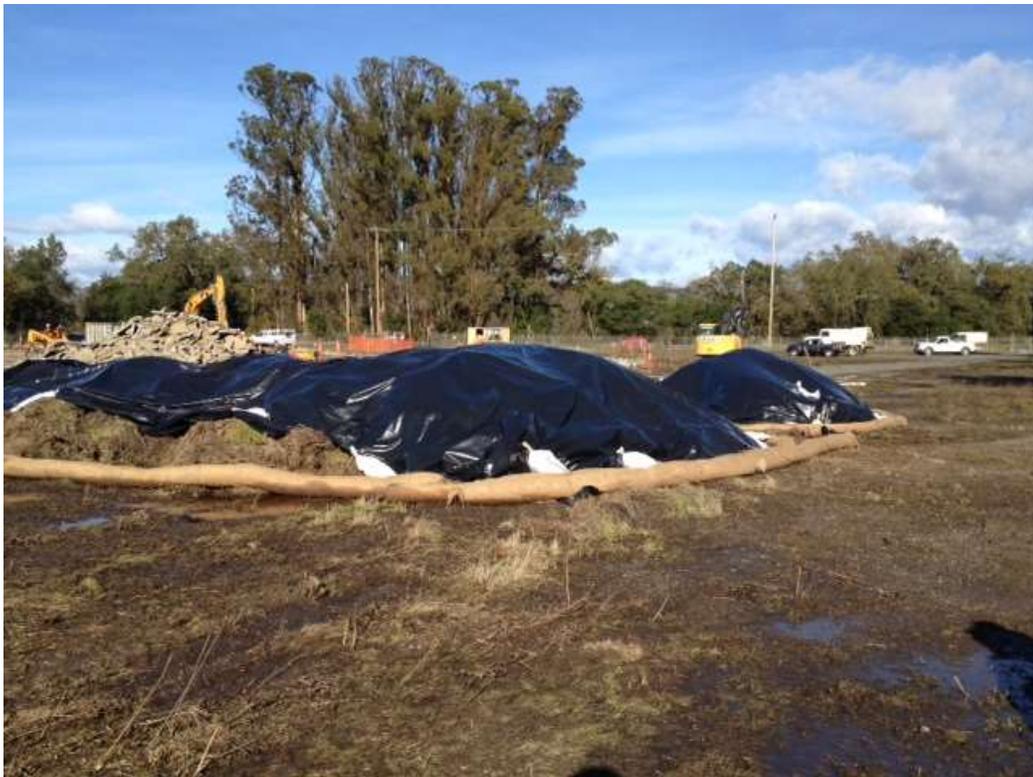
Figure 2 – Substation site vegetation grubbed and graded with stockpiles covered in plastic and surrounded with straw wattles, November 28, 2016.

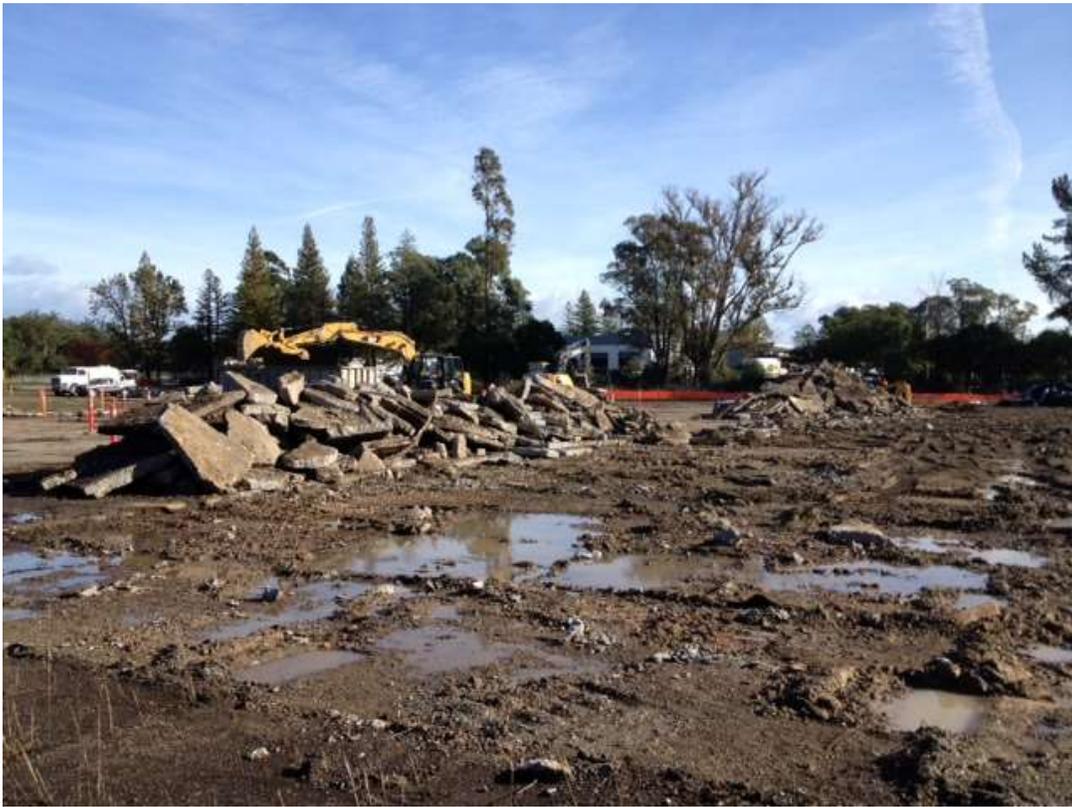
Demolition and grading work were performed throughout the week by Hot Line Construction, Inc. The contractor continued using excavators to break-up the concrete pad (see Figure 3). The concrete was stockpiled and the metal rails were separated for recycling prior to the debris being hauled off site (see Figure 4). A portion of plastic drain pipe was excavated and removed.

Figure 3 – Demolition of existing concrete pads at substation site, November 28, 2016.

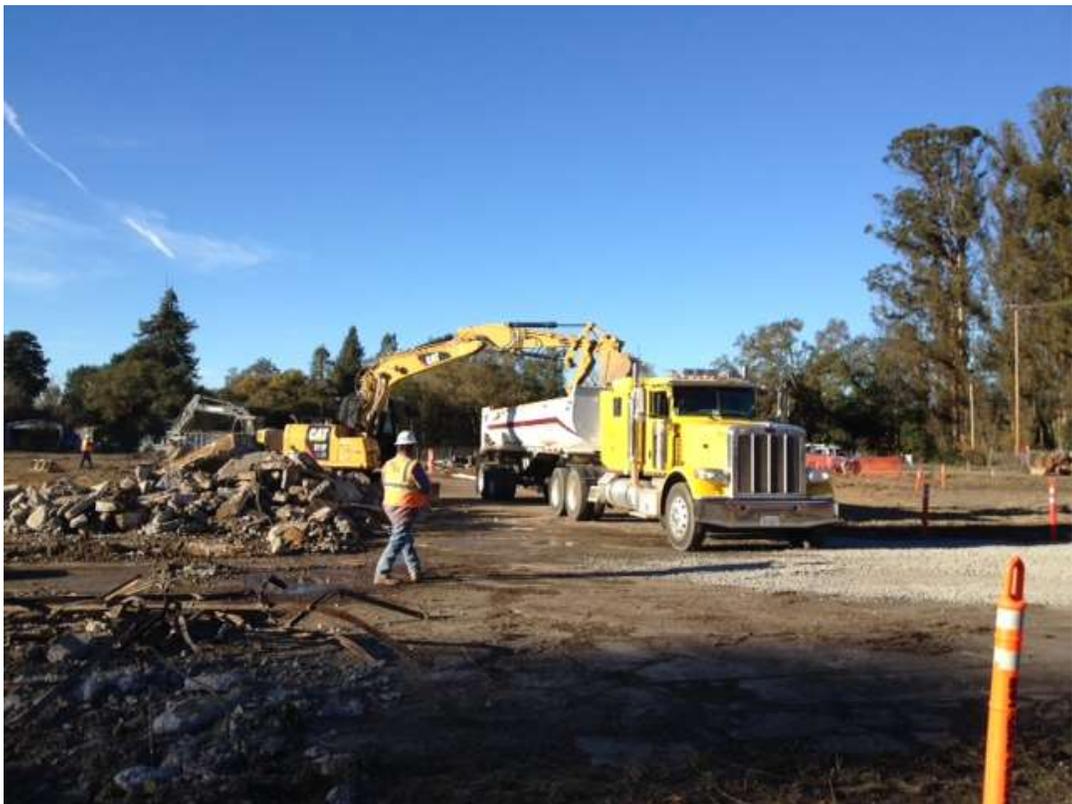
Figure 4 – Demolished concrete and debris being loaded into haul truck at substation site, December 1, 2016.
