PROJECT MEMORANDUM
PG&E WINDSOR SUBSTATION PROJECT

To: Eric Chiang, Project Manager, CPUC
From: Vida Strong, Aspen Project Manager
Date: May 4, 2017
Subject: Monitoring Report #13 – April 24, 2017 to April 30, 2017

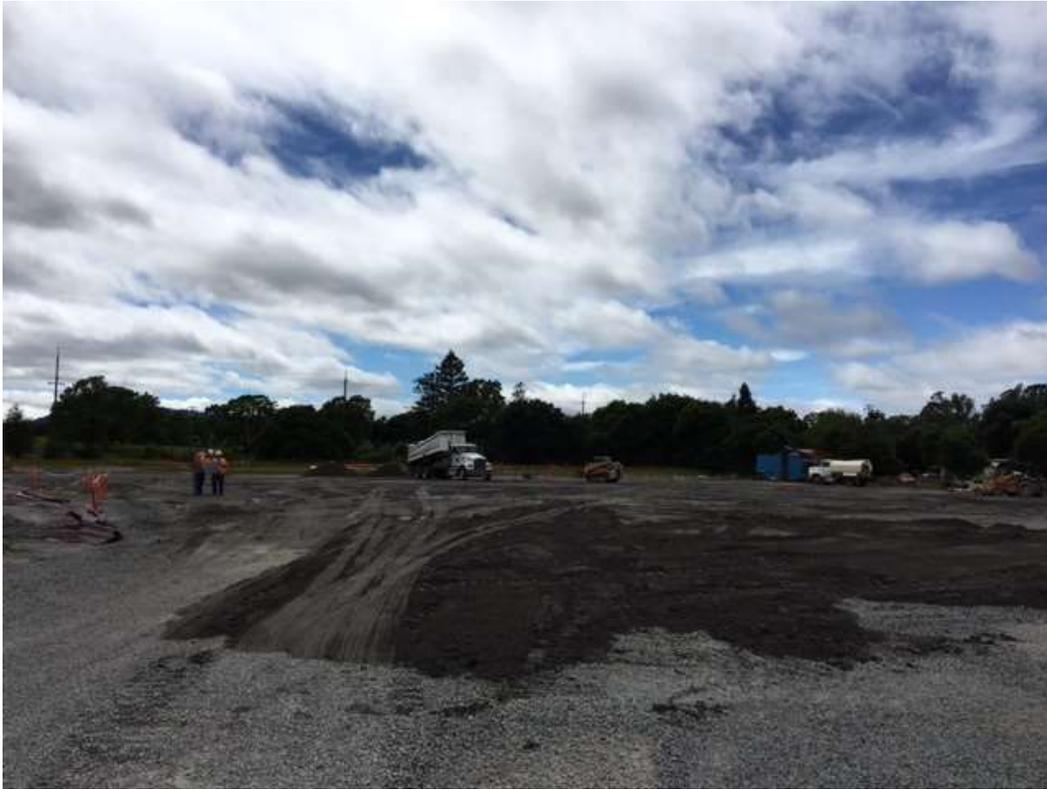
Figure 1 – Base rock being delivered, spread, and compacted at substation site – view northwest, April 26, 2017.

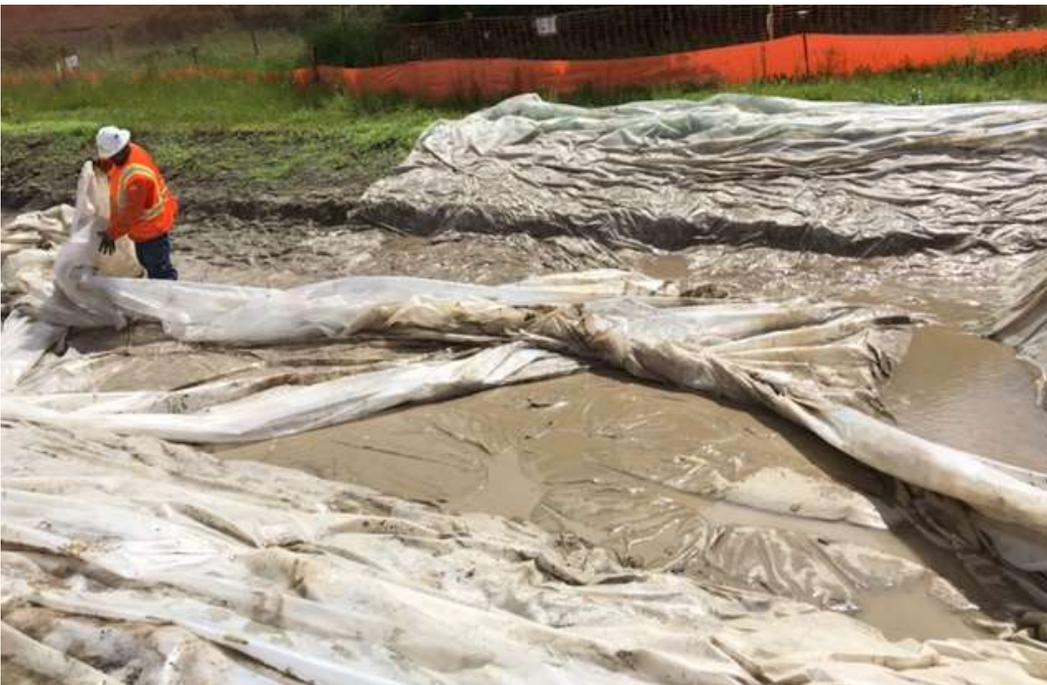
Figure 2 – Removing plastic lining from stormwater ponds at substation site – view southwest, April 26, 2017.

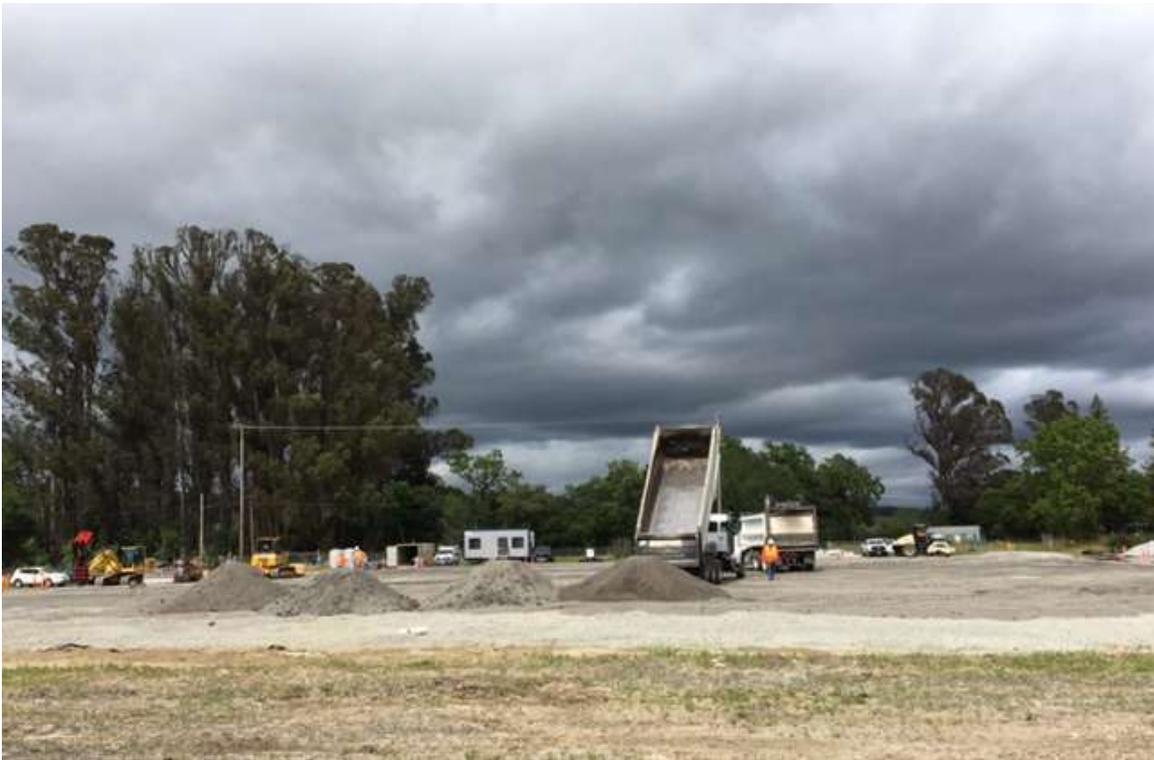
Figure 3 – Base rock delivery at substation site – view east, April 26, 2017.

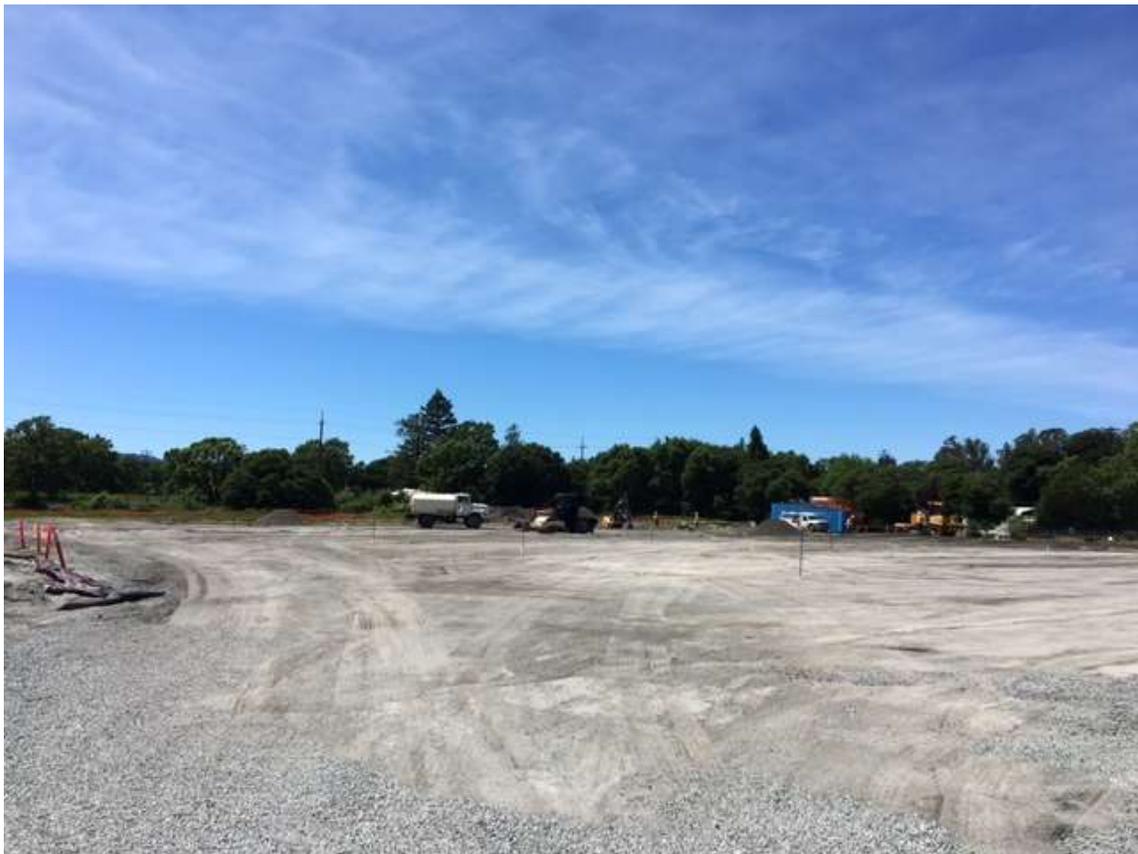
Figure 4 – Spreading and compacting base rock at substation site – view northwest, April 28, 2017.

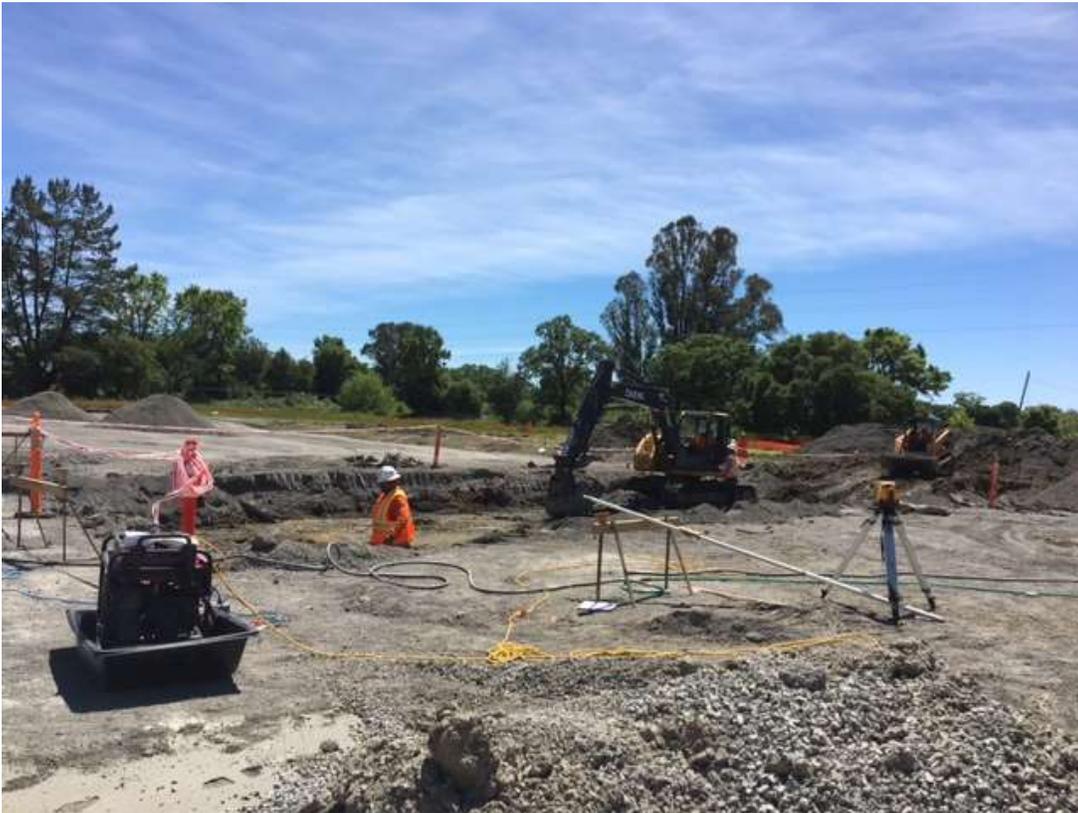
Figure 5 – Excavating for switchgear foundation at substation site – view southwest, April 28, 2017.

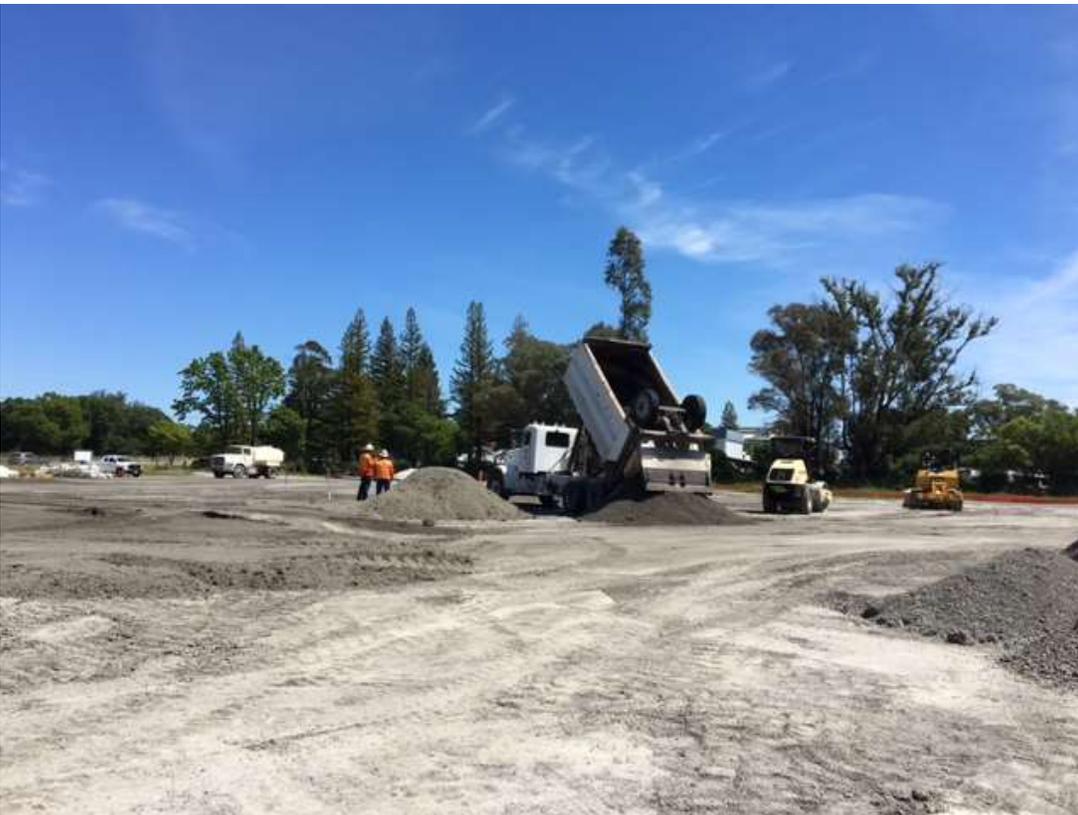
Figure 6 – Deliver of base rock at substation site – view southeast, April 28, 2017.
