**SAN DIEGO GAS & ELECTRIC COMPANY  
CLEVELAND NATIONAL FOREST  
POWER LINE REPLACEMENT PROJECTS  
ACCESS ROAD CONDITION EVALUATION AND  
REPAIR DESIGN REPORT**

**DECEMBER 2016**

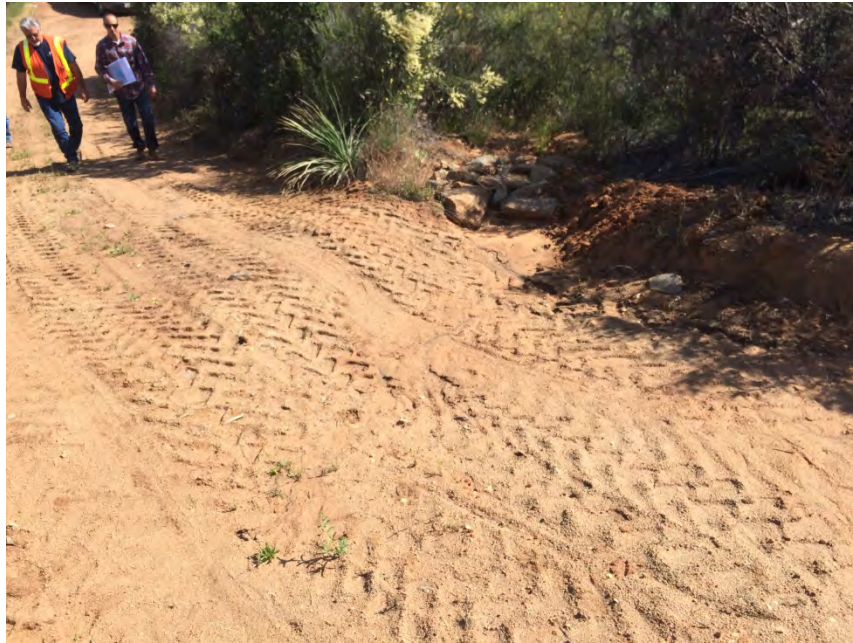
TL625B-07b - 300 feet north of Pole Z272854, typical waterbar in good condition

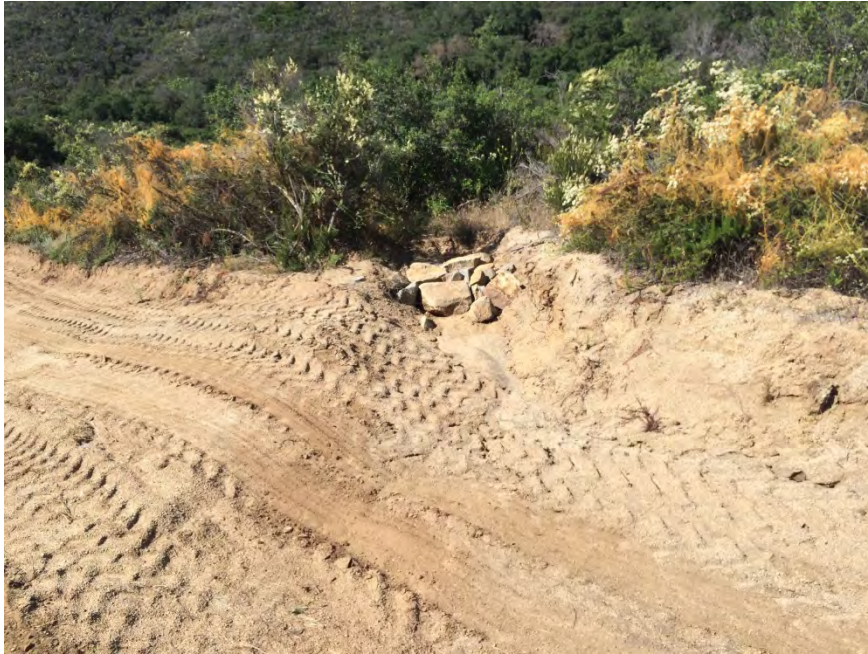
TL625B-10d - 115 feet north of Pole Z272855, waterbar outlet in good condition

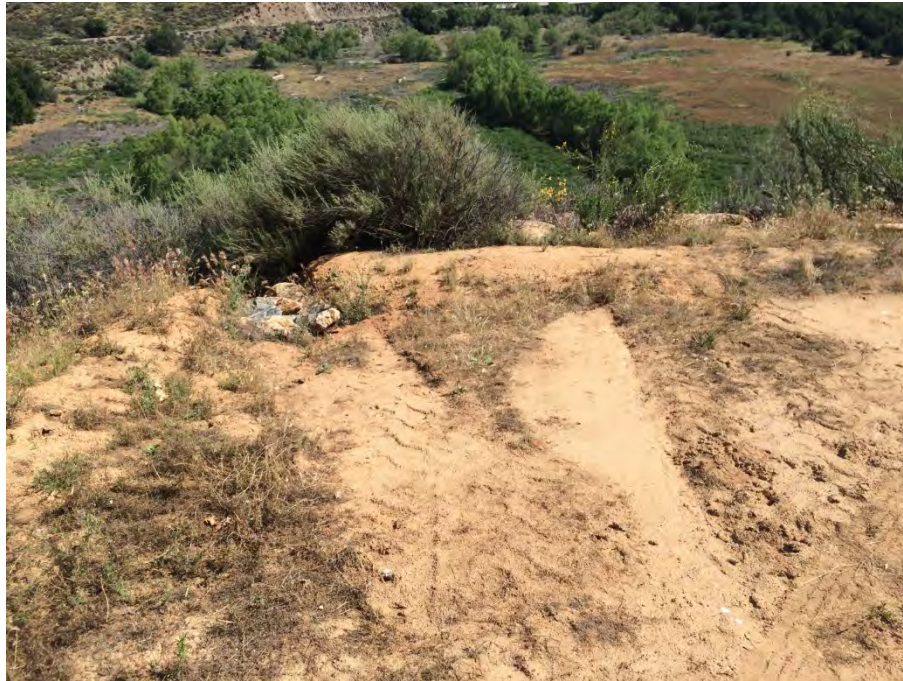
TL625B-13b – Riprap at outlet from west side of pad at Pole Z272860, in good condition

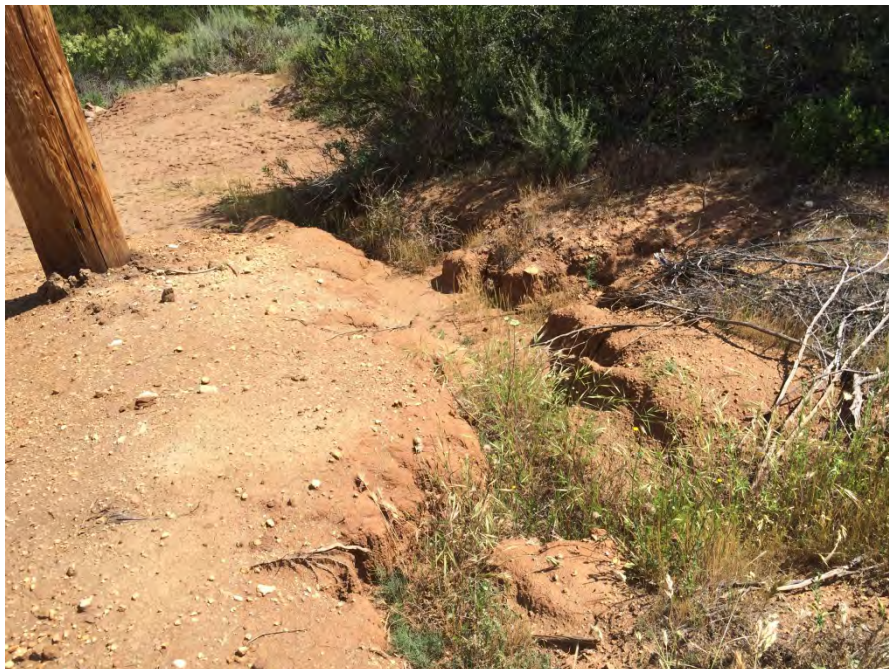
TL625B-15e – Midway between Poles Z272866 and Z272867, rilling noted near existing pole slated for removal. Pad area to be restored through Habitat Restoration Plan

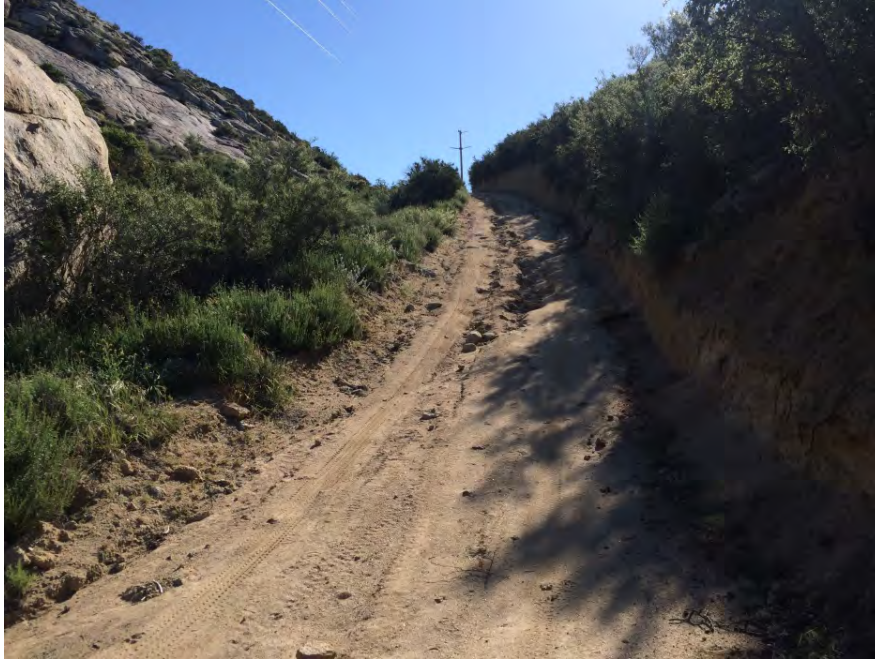
TL629E-03b - 300 feet east of Pole Z44165 looking east, rilling to be repaired and waterbar added during construction

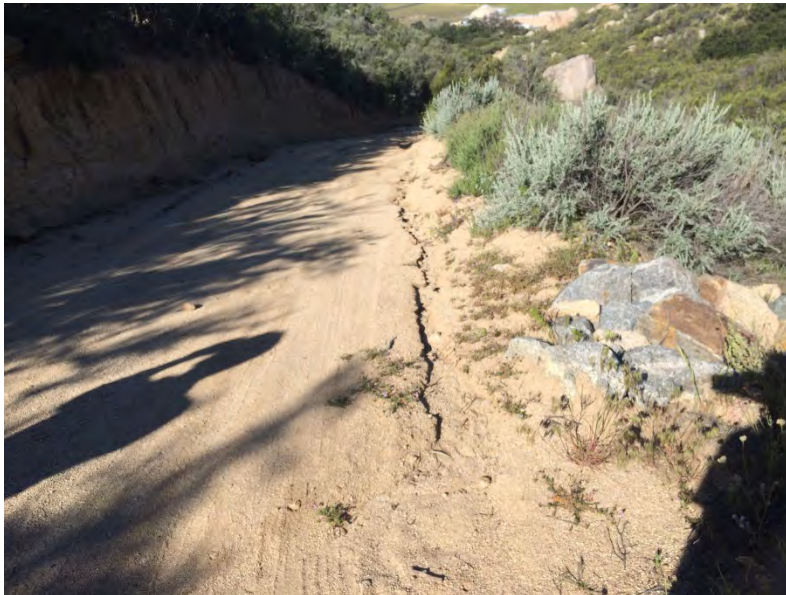
TL629E-03c - 490 feet east of Pole Z44165 looking east, waterbar to be lowered to allow runoff to exit the roadway

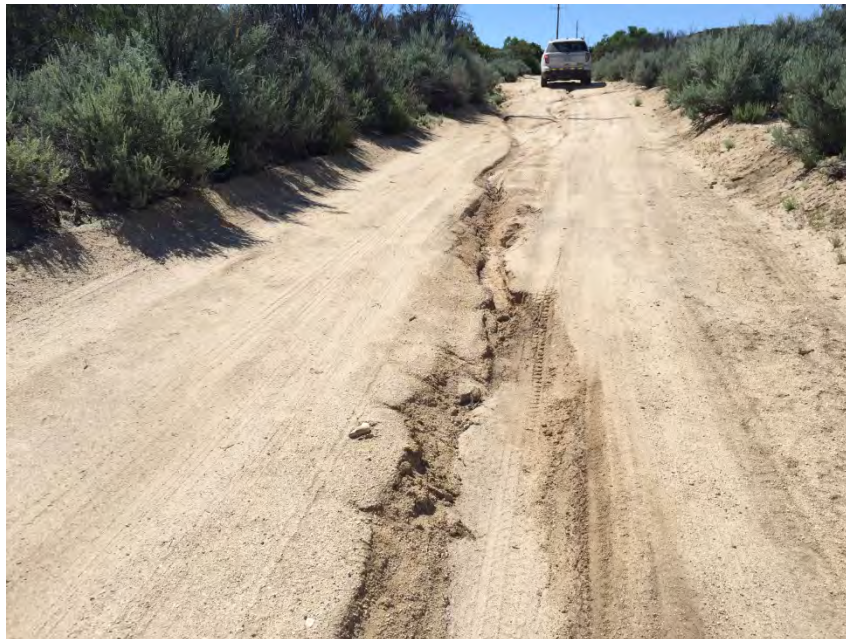
TL629E-10d - 140 feet north of Pole Z44187 looking south, runoff causing rilling across the road.  
Would be alleviated by improvement/repair to waterbar upstream

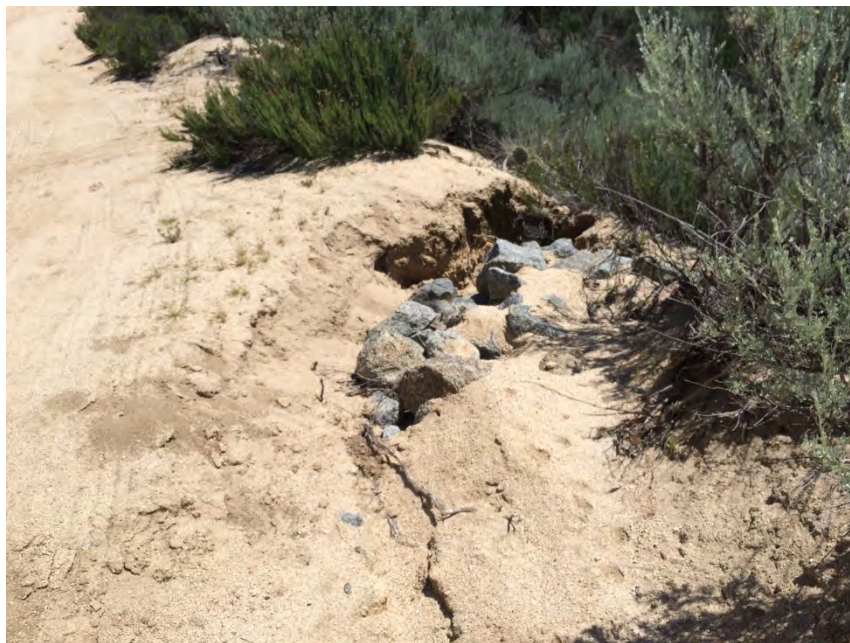
TL629E-12d – Waterbar 365 feet northeast of Pole Z44209, rilling and incision noted. Riprap to be added

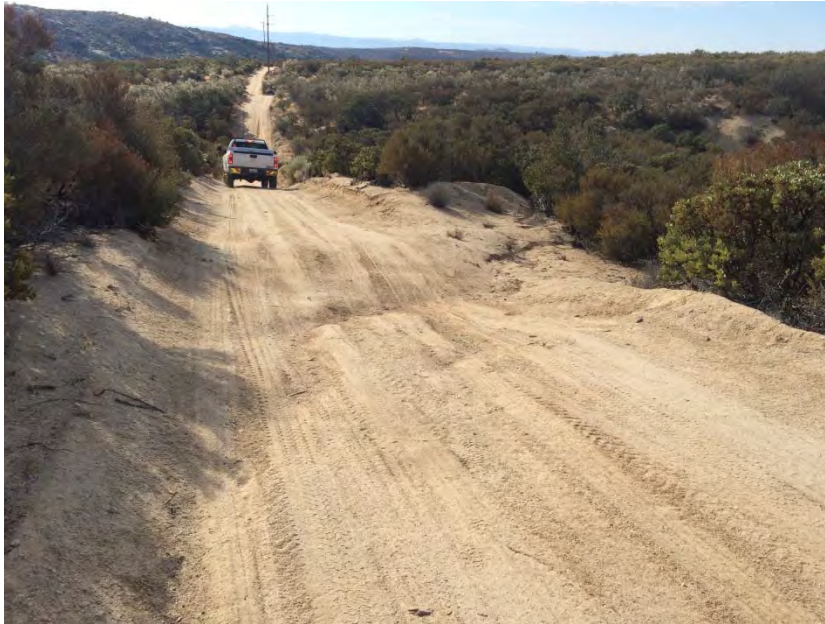
TL6931-01a – 60 feet southeast of Pole Z44241, looking southeast. Recommend adding rock at outlet of waterbar to capture runoff

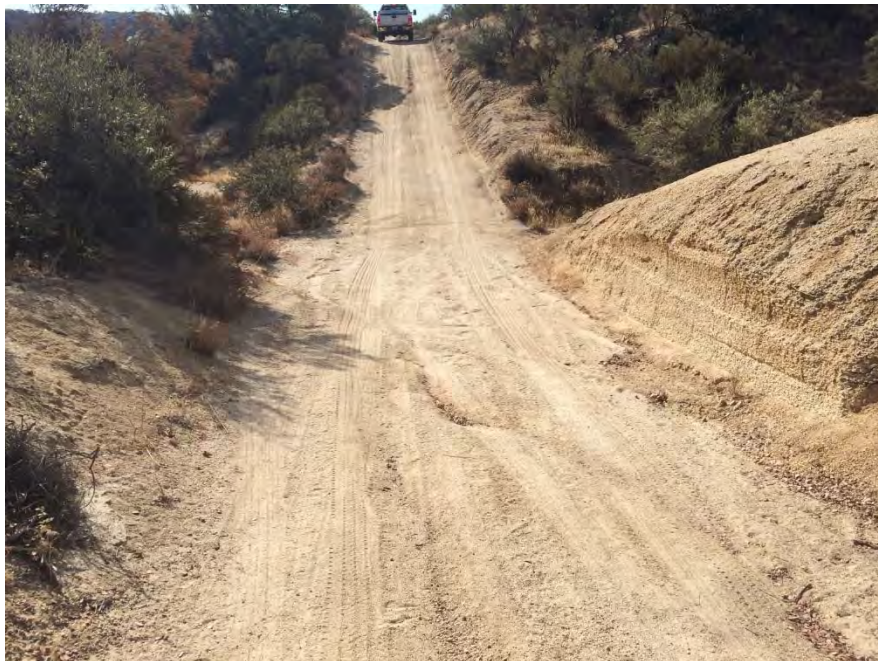
TL6931-01b – 200 feet southeast of Pole Z44241, looking southeast, minor rilling noted

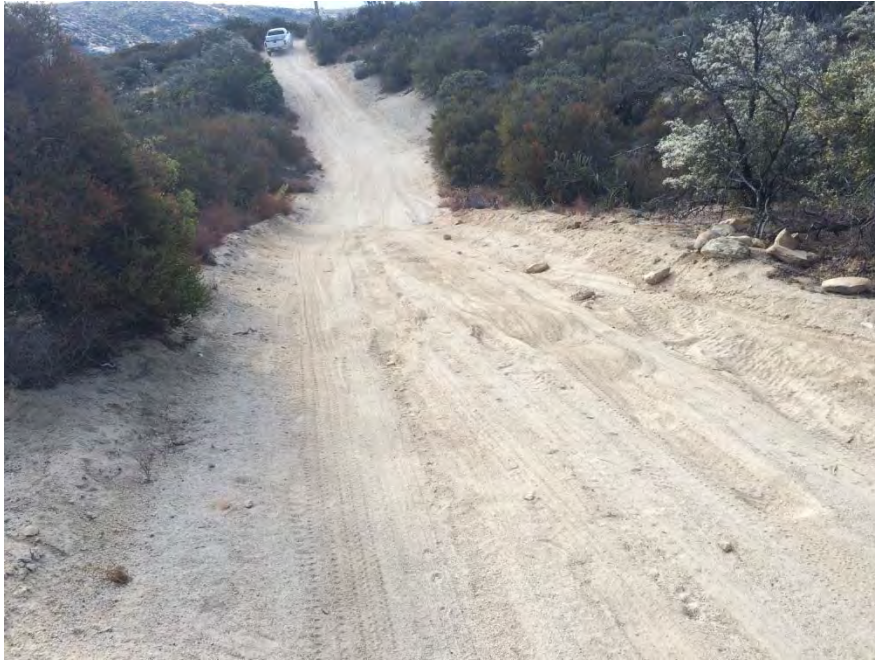
TL6931-02a – 135 feet southeast of Z44242 looking southeast, minor rilling noted

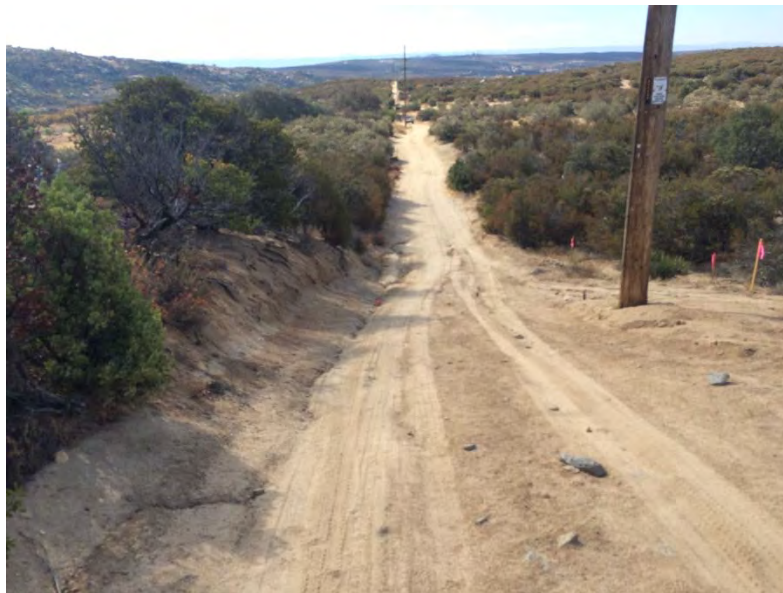
TL6931-03b - Near Pole Z44244 looking southeast, minor rilling noted

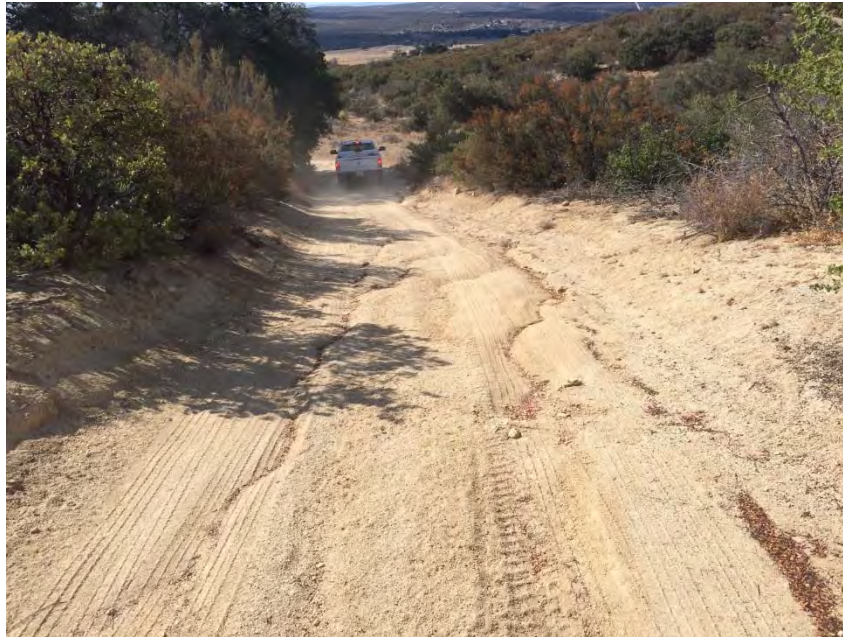
TL6931-04a – Along access road 900' west of tie-line/Pole Z44248, 160' south of road intersection, looking south, minor rilling noted

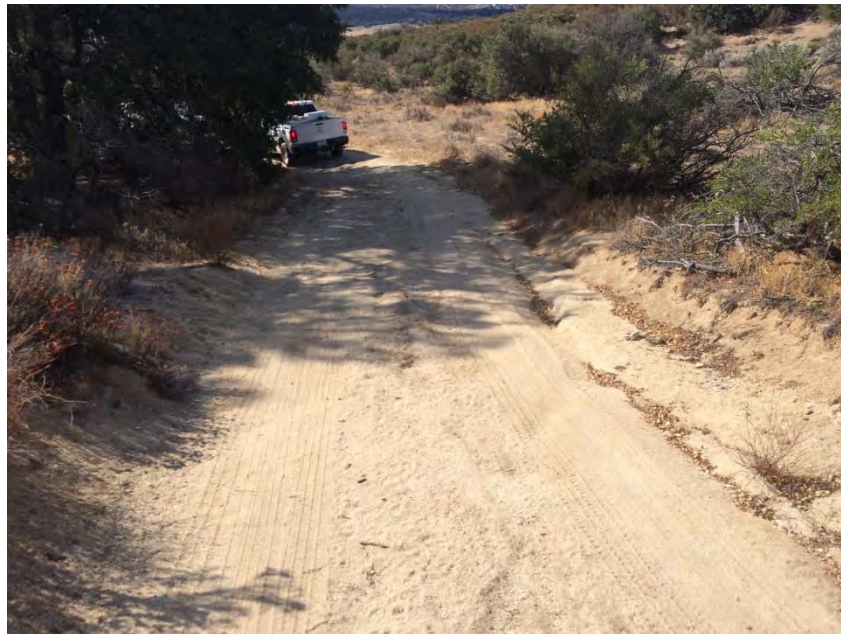
TL6931-04b – Along access road 900' west of tie-line/Pole Z44248, 200' south of road intersection, looking south, minor rilling noted

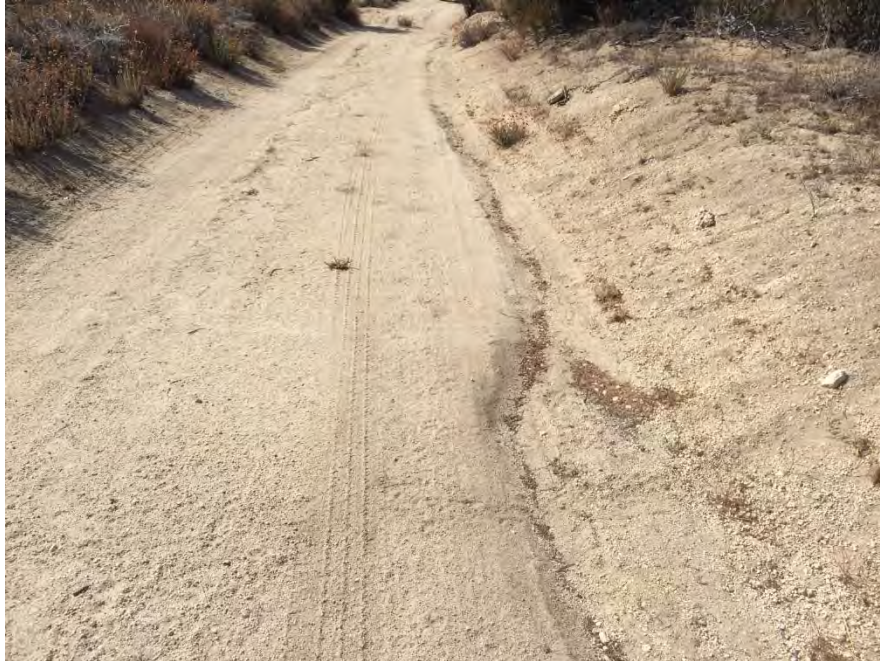
TL6931-05a – 120 feet south of Pole Z44248 looking south, minor rilling noted

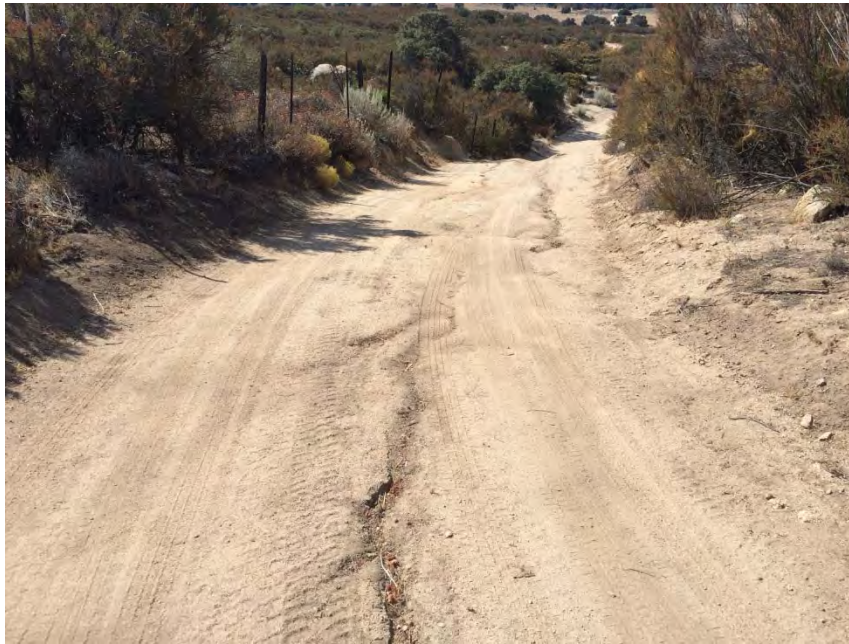
TL6931-06a – Along access road 130' west of tie-line, opposite midpoint between Poles Z44252 and Z44253, looking south, minor rilling noted

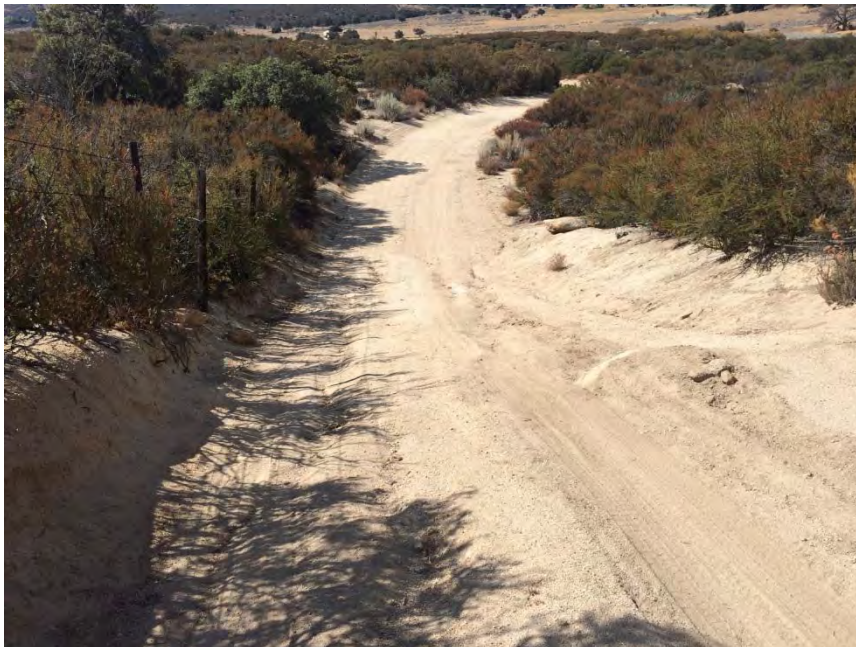
TL6931-06b – Continuing along access road 130' west of tie-line, opposite midpoint between Poles Z44252 and Z44253, looking south, minor rilling noted

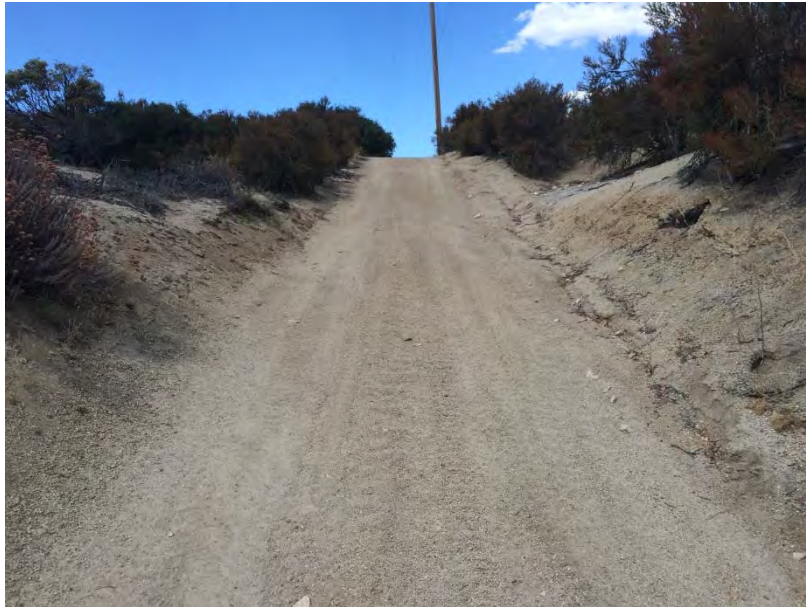
TL6931-07a – 80 feet east of Pole Z44272 looking west, minor rill noted

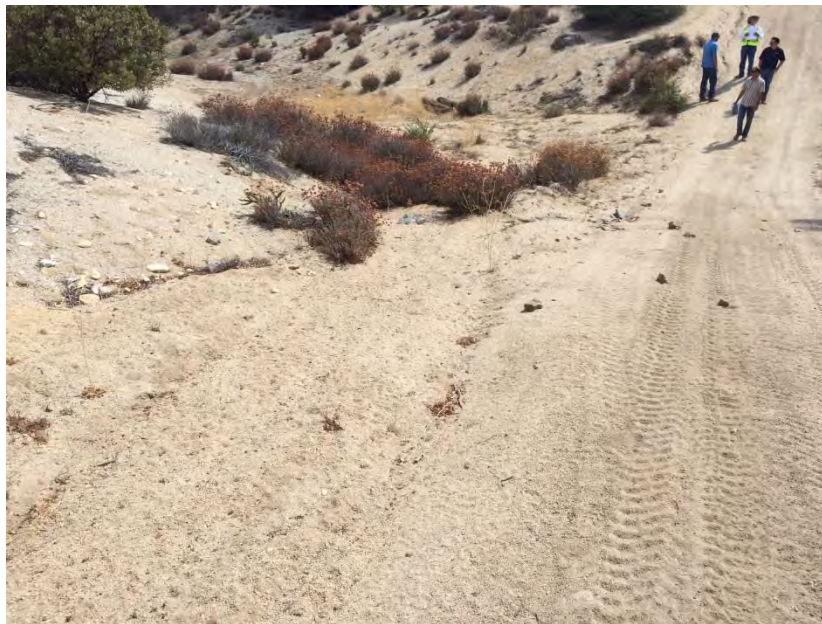
TL6931-07b - 140 feet east of Pole Z44272 looking east, sediment accumulation on north side of road at riprap noted and in need of cleanup

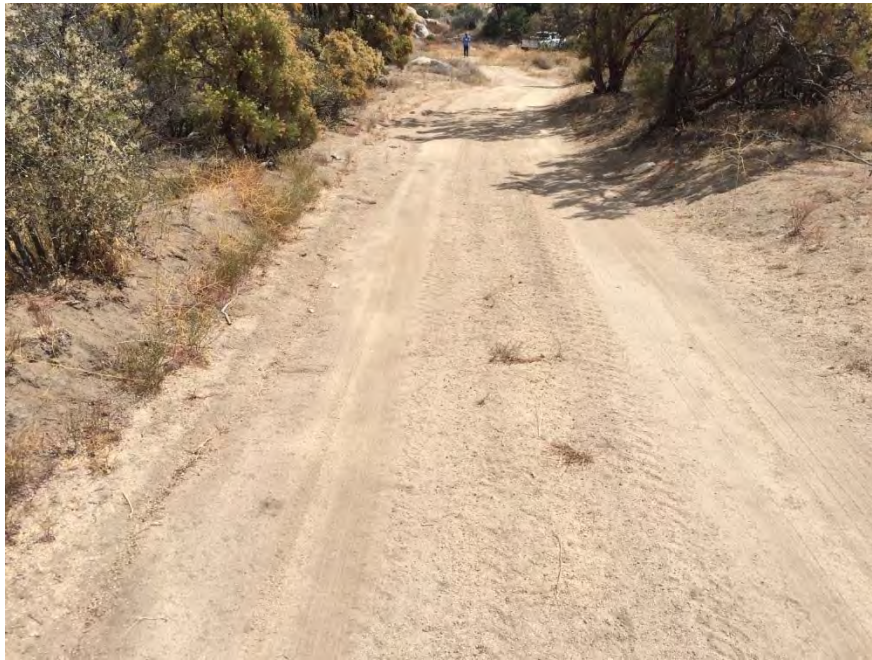
TL6931-09a - Along access road 390 feet south of tie-line between Pole Z44276 and Z44277, looking east, road in good condition with very minor rill on north side

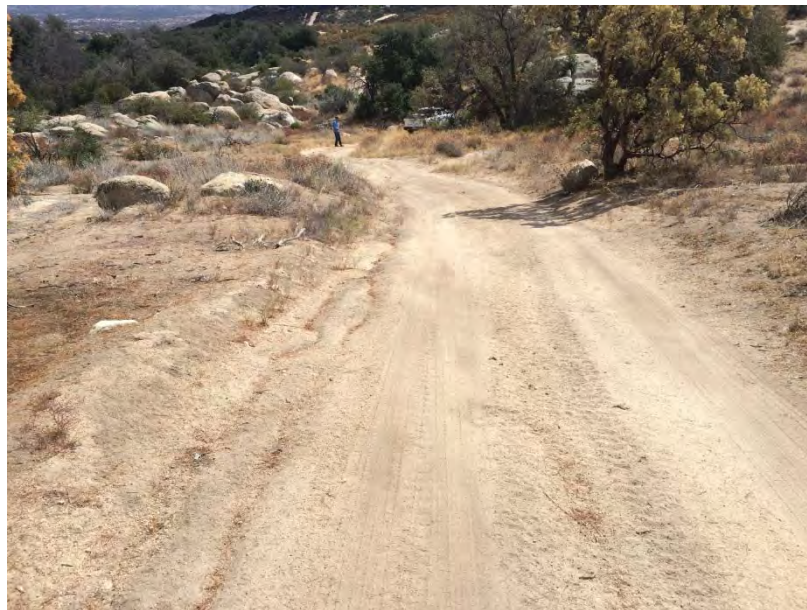
TL6931-09b - Along access road 390 feet south of tie-line between Pole Z44276 and Z44277, midway along road reach looking east, road in good condition with very minor rill on north side

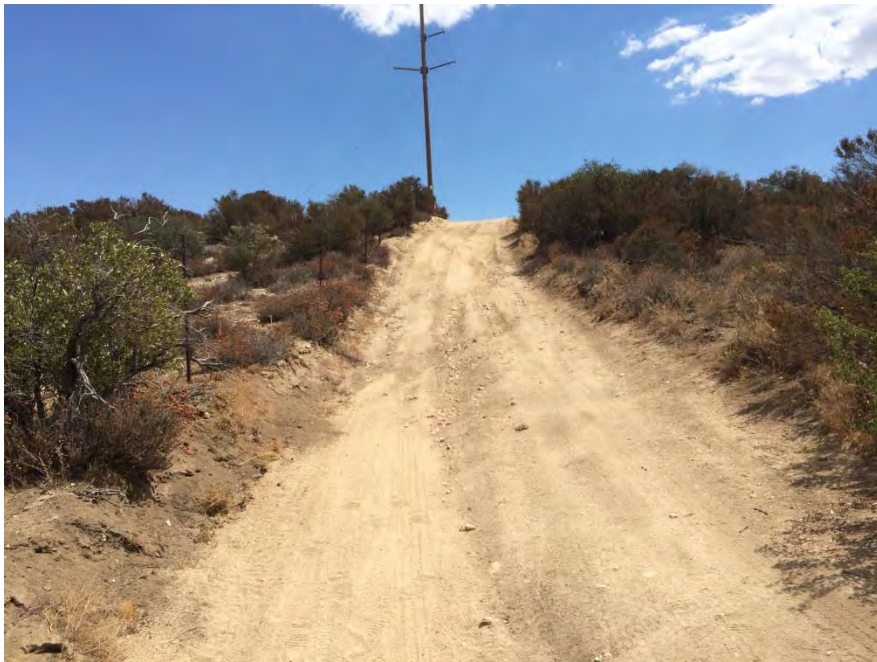
TL6931-10b – 150 feet west of Pole Z44284\_85 looking east minor rill noted in center of road

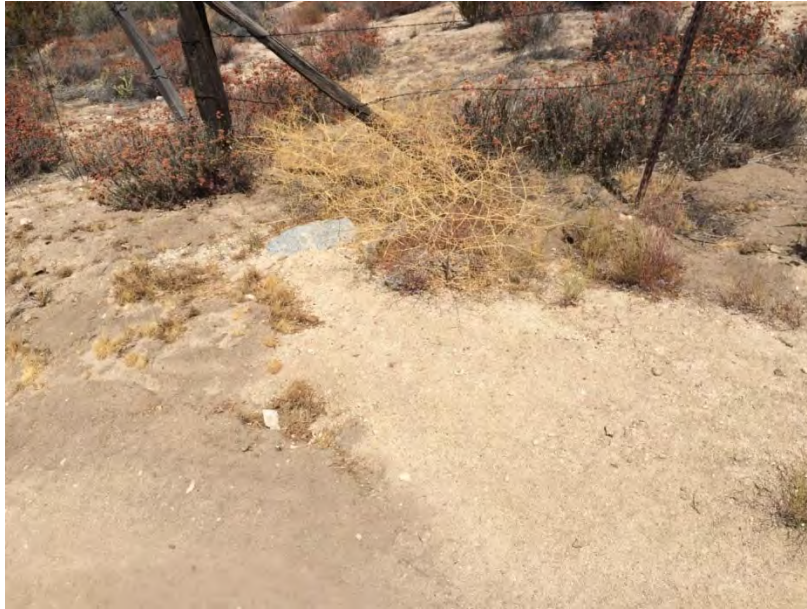
TL6931-10c – 35 feet east of Pole Z44282\_83 looking west, sediment accumulation downstream of evaluated road reach, recommendation to clean out of waterbar

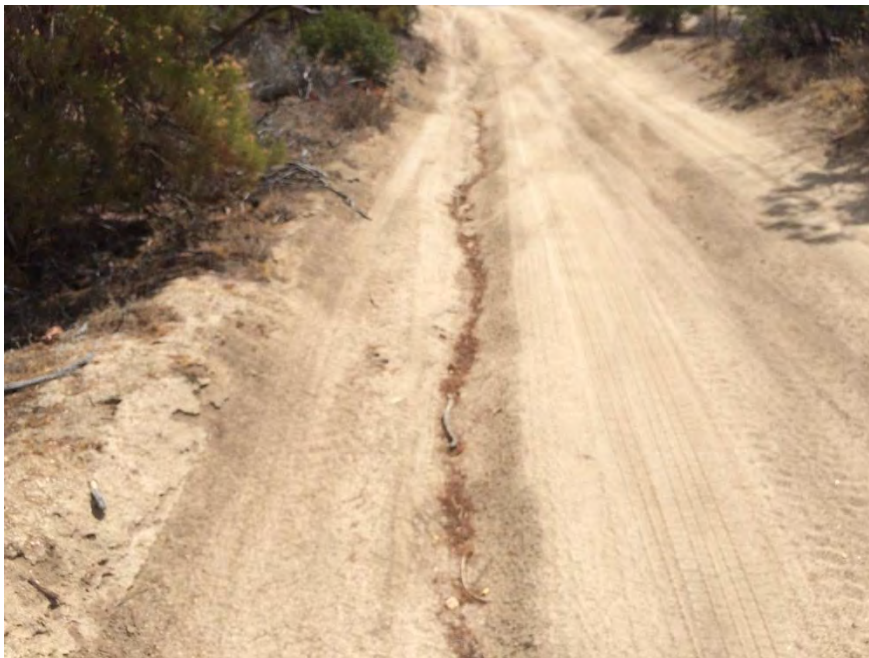
TL6931-11a – 230 feet west of Pole Z44281 looking east, minor rill in road

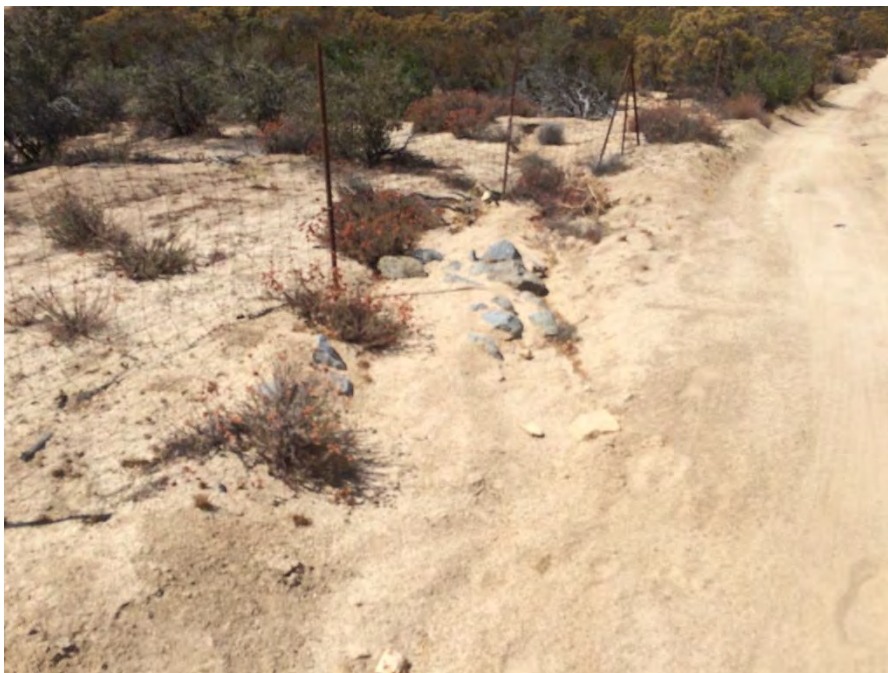
TL6931-11c - 65 feet west of Pole Z44281, sediment accumulation in waterbar on south side of the road, recommend cleaning out

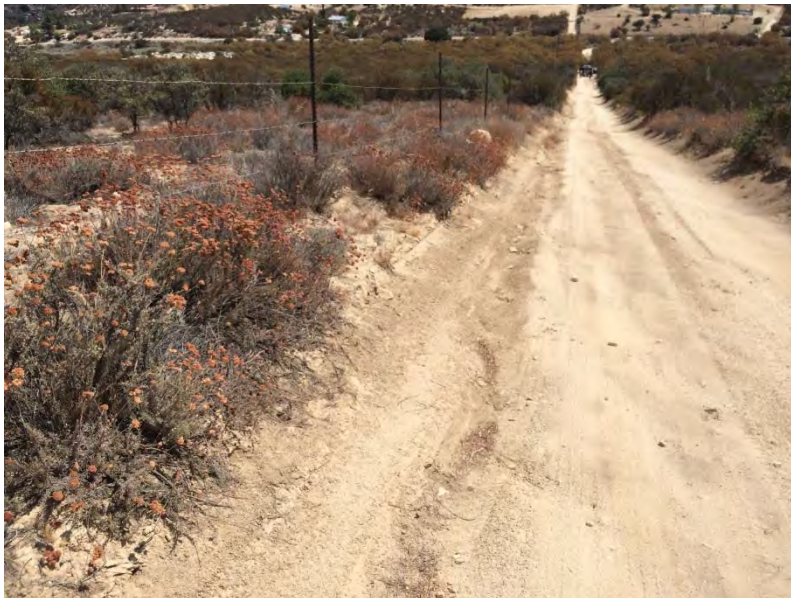
TL6931-12b - 150 feet east of Pole Z44281 looking east, road in good condition with minor rill along north side

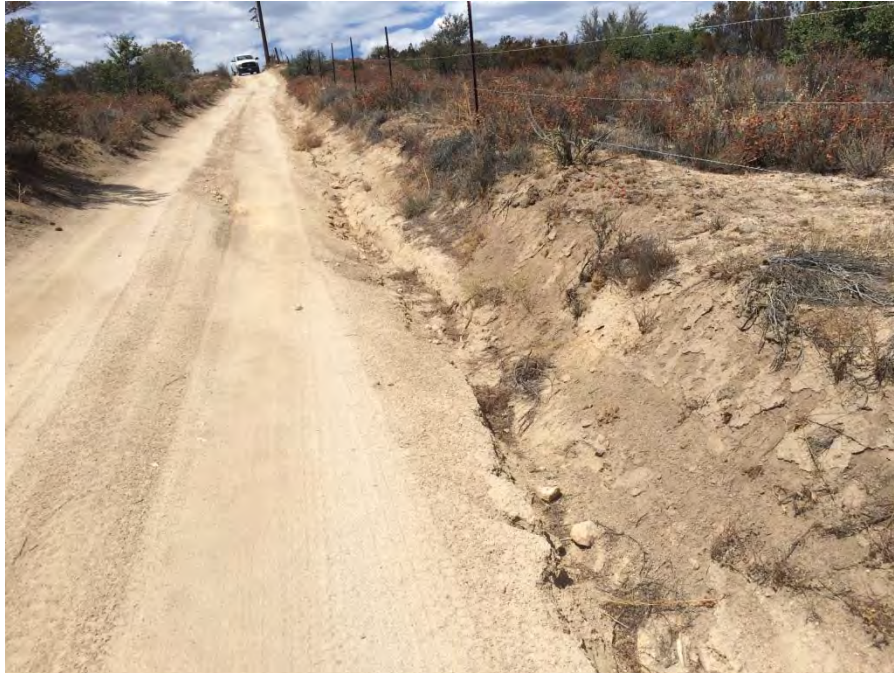
TL6931-12c - 290 feet east of Pole Z44281 looking west, road in good condition with minor rill along north side

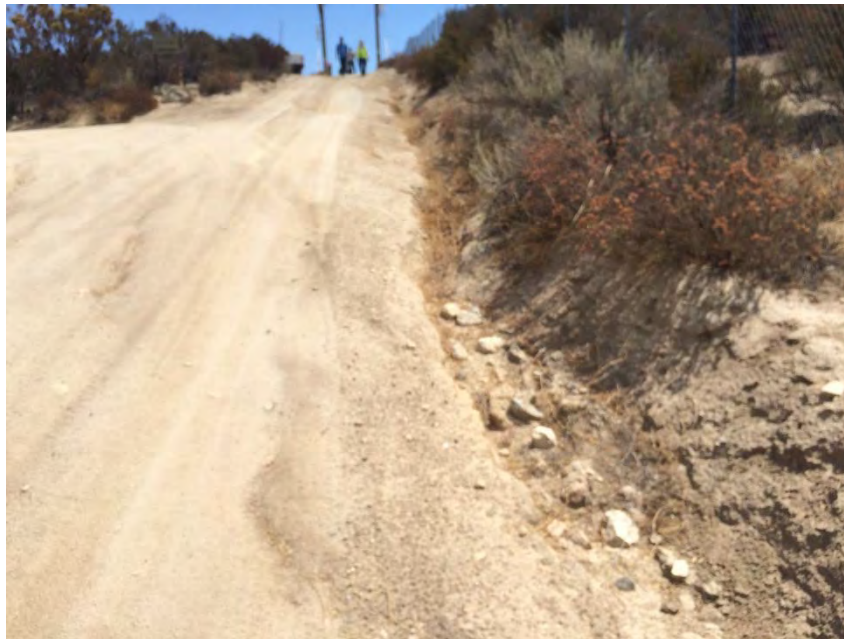
TL6931-13a - 210 feet west of Pole Z44284\_85 looking east, road in good condition with minor rill along south side

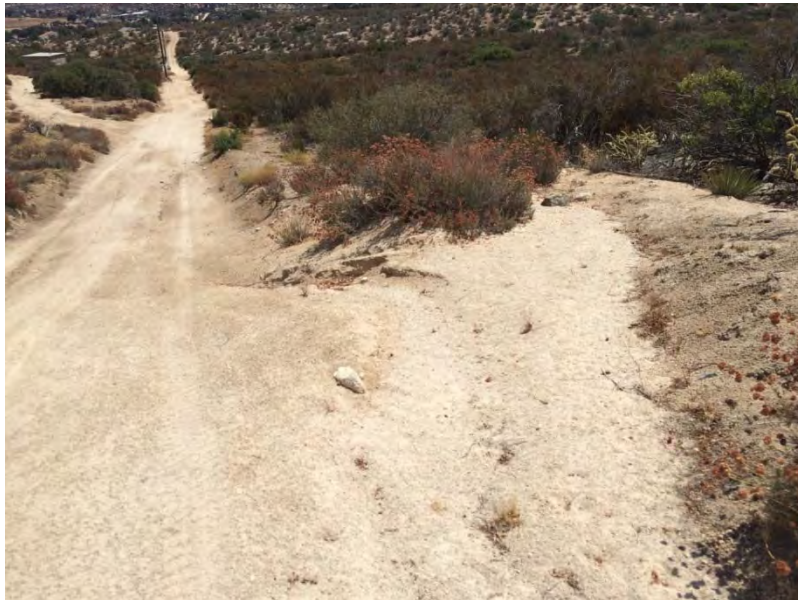
TL6931-14c – 140' east of Pole Z44284\_85 looking east, sediment accumulation in waterbar and recommend cleaning out
