California Public Utilities Commission Mitigation Monitoring, Compliance, and Reporting Program

Cleveland National Forest Power Line Replacement Projects

Compliance Status Report: 008

January 8, 2017

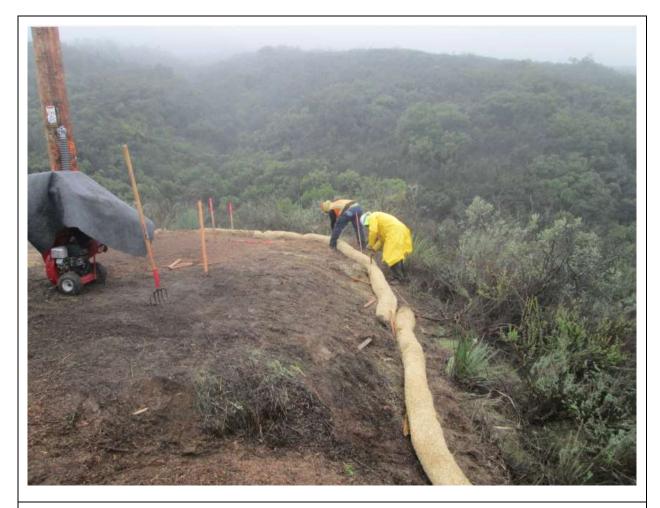
Activities occurring along TL 625B this reporting period included SWPPP BMP inspections and maintenance, and trimming vegetation within work areas (see Photos 1 and 2—Attachment A). In accordance with MM BIO-3, biological monitors were observed present during vegetation removal activities and work limits were observed clearly delineated and being adhered to by crews per MM BIO-1. During vegetation removal observations along TL 625B, a 5 gallon backpack pump, round point shovel, Pulaski, and 2A10BC fire extinguisher were within 50 feet of the vegetation chipping activities in accordance with the fire prevention matrix in the Construction Fire Prevention/Protection Plan (CFPPP) (MM FF-1). Crews were observed using traffic control measures such as cones and flagpersons during vegetation removal activities in accordance with APM TRANS-02.

Photo 1: Crews were observed installing and maintaining SWPPP BMPs along TL 625B (fiber rolls at Pole Z272883, above).

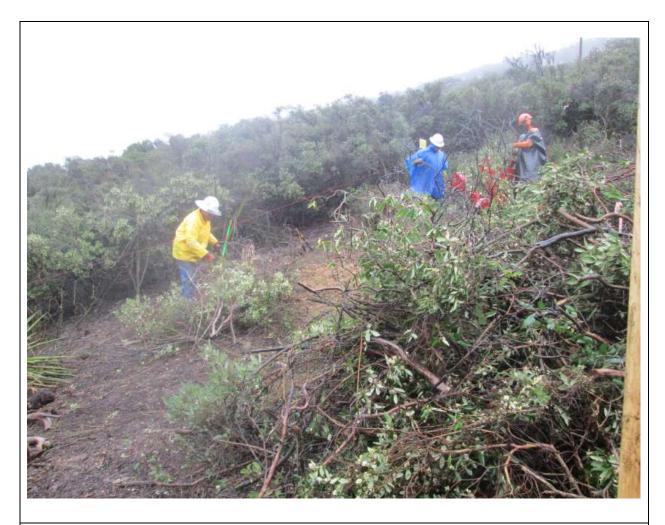
Photo 2: Vegetation trimming within delineated work limits (MM BIO-1) along TL 625B.

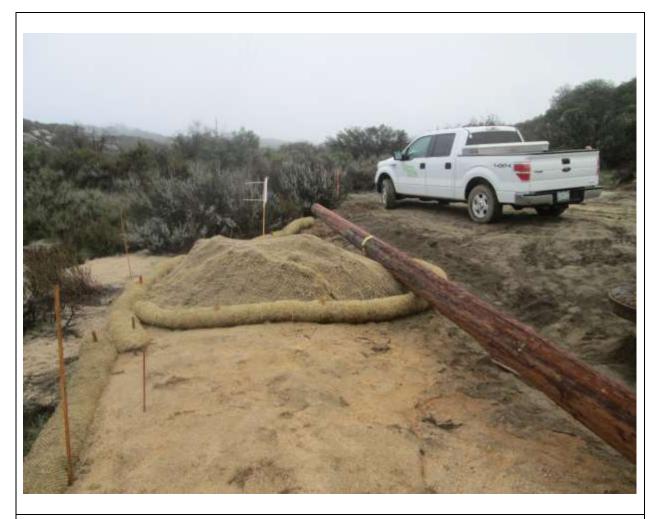
Biological monitors were observed conducting pre-construction sweeps and monitoring during micropile activities (MM BIO-22). Work limits were adhered during work in accordance with MM BIO-1. Topsoil that was previously salvaged was observed stockpiled along the edge of the work area and secured with erosion and sediment controls (such as natural fiber covering and fiber rolls per the SWPPP) in order to minimize sediment transport and to ensure topsoil was preserved for future restoration efforts in accordance with MM BIO-4 and the Habitat Restoration Plan (See Photo 4—Attachment A). During inspections of other work areas along TL 629E, protective measures for arroyo toad (*Anaxyrus californicus*) were observed in place in accordance with the Streambed Alteration Agreement and protective signage for other sensitive areas was observed in place per MM BIO-13, 14, and 16.

Photo 3: Topsoil was salvaged and secured within pole work area Z44184 (TL 629E), utilizing jute netting and straw wattles in accordance with the Erosion Control Plan and SWPPP as specified in the Habitat Restoration Plan (MM BIO-4).

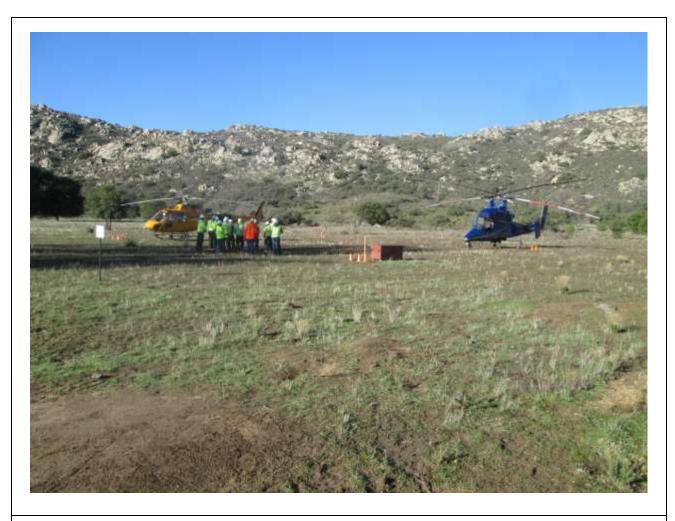
Helicopter activities supporting micropile installations was observed this reporting period, which included transporting micropile equipment to sites not accessible by land. Prior to the work day, personnel involved in helicopter operations were observed participating in the morning briefing in accordance with the Aviation Safety Plan (MM PHS-5) (See Photo 3—Attachment A). During helicopter deliveries in certain micropile areas, archaeological monitors were observed monitoring activities in accordance with MM CUL-3 and Environmentally Sensitive Areas (ESAs) were observed marked (See Photo 4—Attachment A). Additionally, fire patrols were observed monitoring in areas where micropile equipment was delivered by helicopter in accordance with the CFPPP (See Photo 5—Attachment A).

Photo 4: Prior to commencing work involving helicopter activities, crews were observed attending the morning helicopter brief at the Kitchen Creek Fly Yard (TL 629E) in accordance with the Aviation Safety Plan (MM PHS-5).

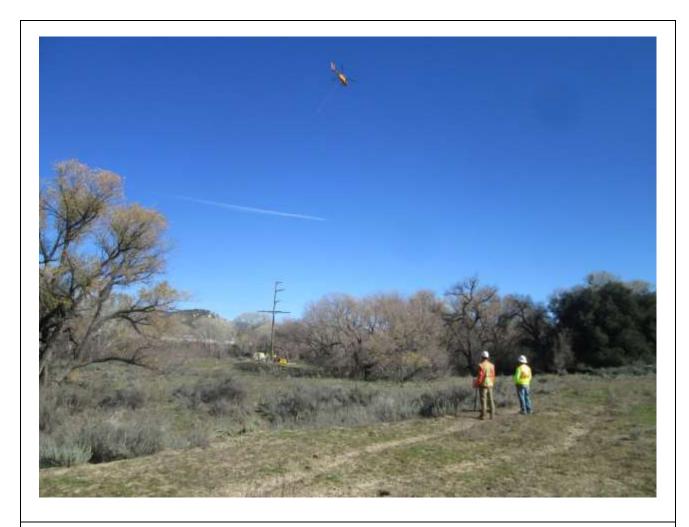
Photo 5: Archaeological monitoring occurred during helicopter activities along TL 629E.

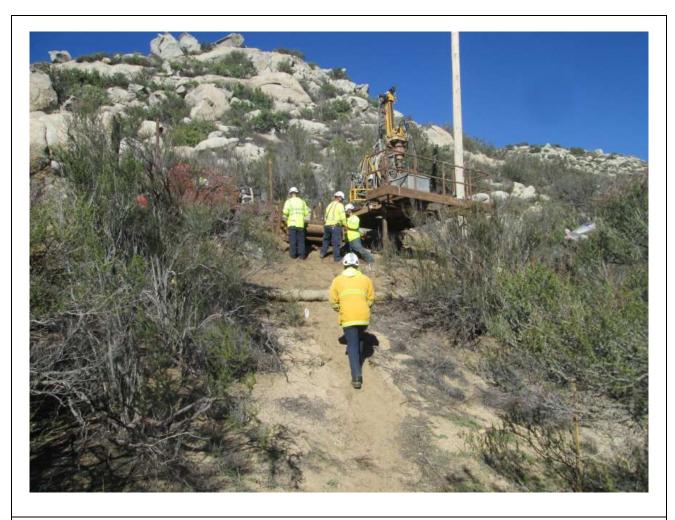
Photo 6: During equipment delivery to a helicopter micropile site along TL 629E (Pole Z44166, above), fire patrols were present in accordance with the CFPPP (MM FF-1).
