California Public Utilities Commission Mitigation Monitoring, Compliance, and Reporting Program

Tie Line (TL) 637 Wood-to-Steel Pole Replacement Project

Compliance Status Report: 006

May 11, 2014

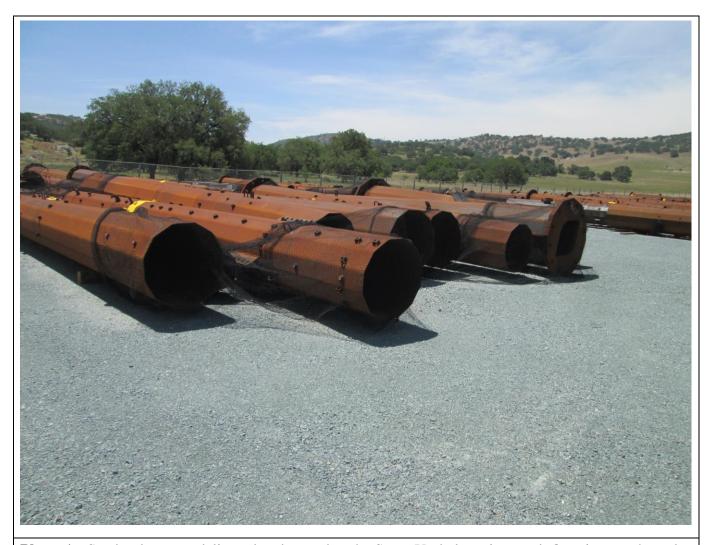
Delivery and staging of steel poles and construction material continued at the Warnock and Santa Ysabel Staging Yards during this reporting period (see Photo 1 – Attachment A).

In order to prevent wildlife entrapment (MM BIO-3), construction materials and staged steel poles in staging yards were covered with nets to prevent nesting activity in the crevices provided (see Photo 1—Attachment A). Additionally, drilled micropiles were covered with visqueen and drilled pole holes were covered with plywood to prevent wildlife entrapment (see Photo 7 – Attachment A). Measures to prevent attracting wildlife near the project area were observed employed, such as stationed trash bags in construction areas to prevent littering and covered waste containment units at the laydown yards (Applicant Proposed Measure (APM) BIO-1).

Photo 1: Steel poles were delivered and staged at the Santa Ysabel staging yard. Openings to the poles were covered with nets to prevent wildlife entrapment (MM BIO-3) or prevent bird nesting activities in crevices.

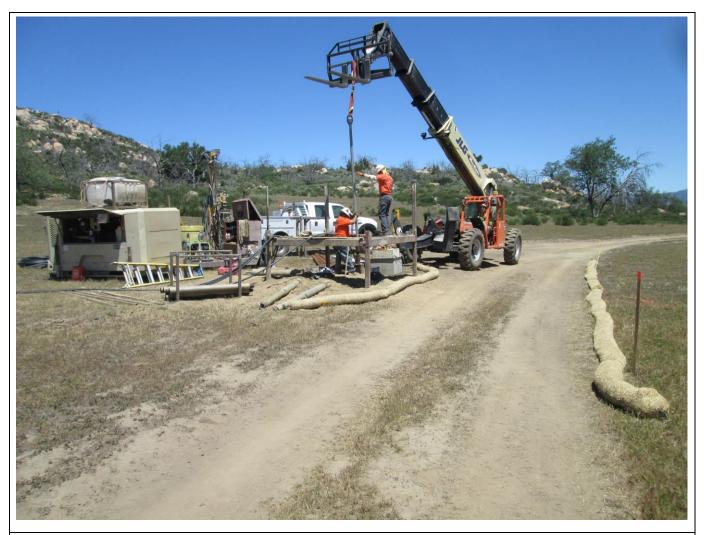
At micropile drill sites, construction crews were observed setting up and demobilizing equipment at pole locations, drilling micropile foundation holes, installing rebar (see Photo 2 – Attachment A), grouting, testing and trimming at structures, and capping.

Photo 2: Micropile construction crews were observed drilling, setting bar (pictured), and grouting during this reporting period. Straw wattle BMPs were installed around project activities at this location in accordance with the project SWPPP.

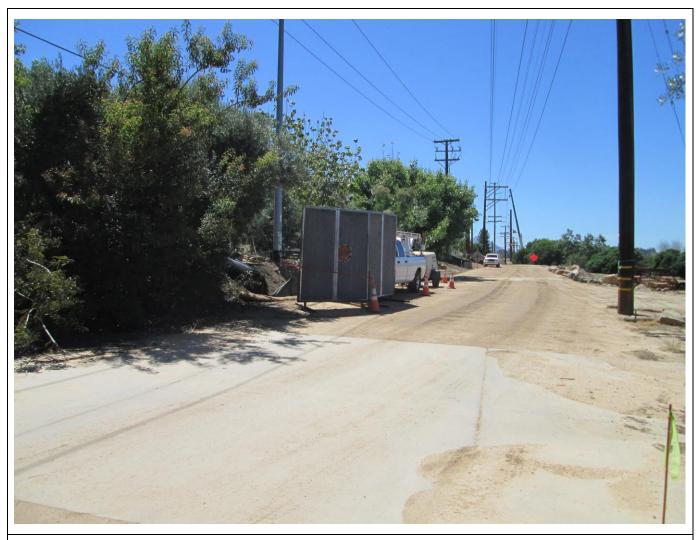
At conventional drill sites, construction crews were observed machine auguring and hand digging pole holes (see Photo 3 – Attachment A); spreading wire and preparing to set steel poles; setting steel poles and transferring wire to newly erected steel poles (see Photo 4 – Attachment A).

During wood pole replacement activities, CPUC third-party monitors observed biological monitors working with construction crews to minimize or prevent impacts to biological resources in accordance with mitigation measure (MM) BIO-2. In accordance with MM-BIO-4, CPUC approved biologists were observed conducting pre-construction nesting bird surveys along access roads, and at pole replacement work sites, stringing sites, and helicopter landing zones (see Photo 6 – Attachment A). Biological monitors marked nest locations with green-painted wooden stakes, to mark buffer areas for avoidance by construction personnel (as shown during hand-digging activities in Photo 3 – Attachment A).

Photo 3: Noise meters and sound barriers were installed during hand digging activities at Location 8 along Creelman Lane in order to ensure that noise limits did not exceed mitigation thresholds and noise was reduced near sensitive receptors (MM NOI-2). Green flagging (bottom right) was installed subsequent to nesting bird surveys in order to ensure crews adhered to buffer requirements around these areas (MM BIO-4).

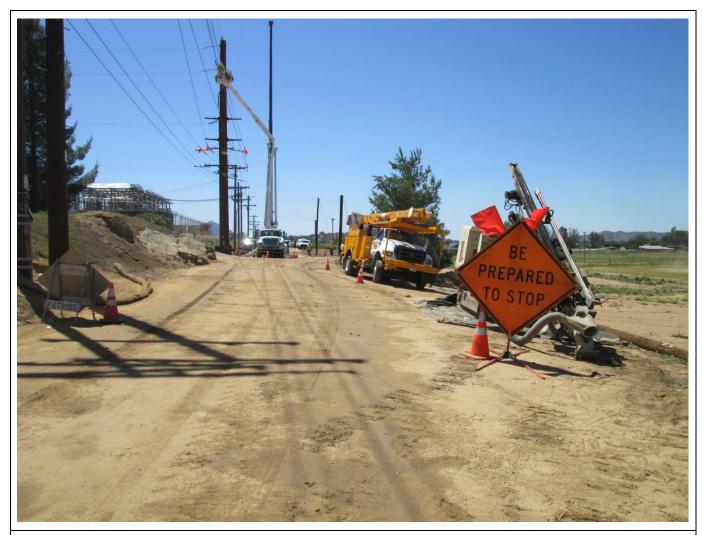
Photo 4: Crews worked to transfer wire onto newly erected steel poles along Creelman Lane. Signage, cones, and traffic personnel were mobilized to direct traffic past pole replacement construction sites in accordance with APM TRA-1.

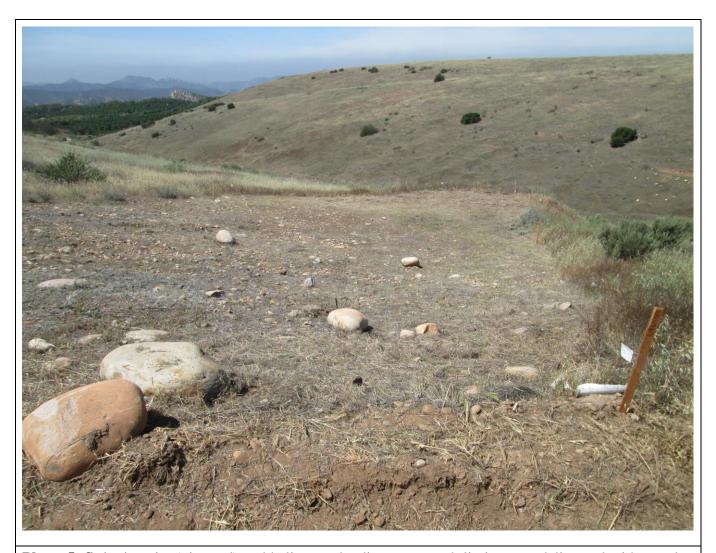
Construction crews were observed trimming vegetation along access roads, pole replacement work sites, stringing sites (see Photo 5 – Attachment A), and helicopter landing zones; installing and/or maintaining sediment control BMPs (i.e. silt fencing, fiber rolls/straw wattles, stockpile management, etc.) at pole replacement work sites; and refreshing access roads.

Photo 5: Stringing site (pictured) and helicopter landing zone work limits were delineated with wooden stakes in accordance with APM BIO-1 and vegetation trimming occurred only within the delineated work limits.

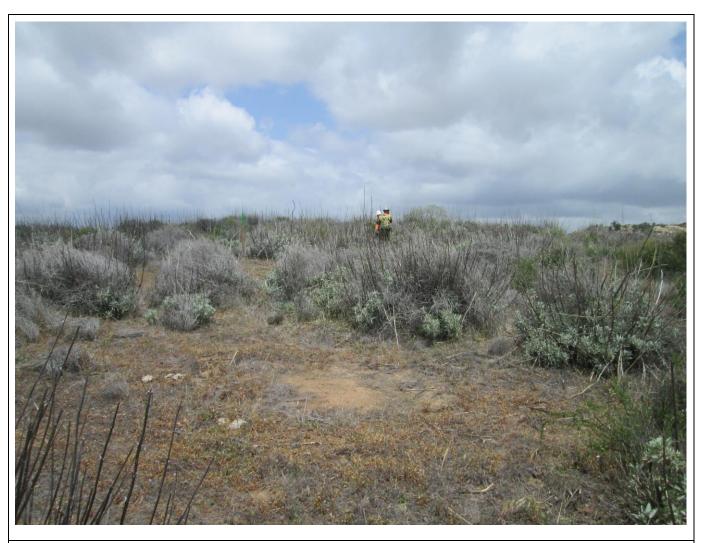
Photo 6: Biological monitors were observed conducting nesting bird surveys prior to vegetation trimming activities at stringing sites and helicopter landing zones (pictured) in accordance with MMBIO-4.

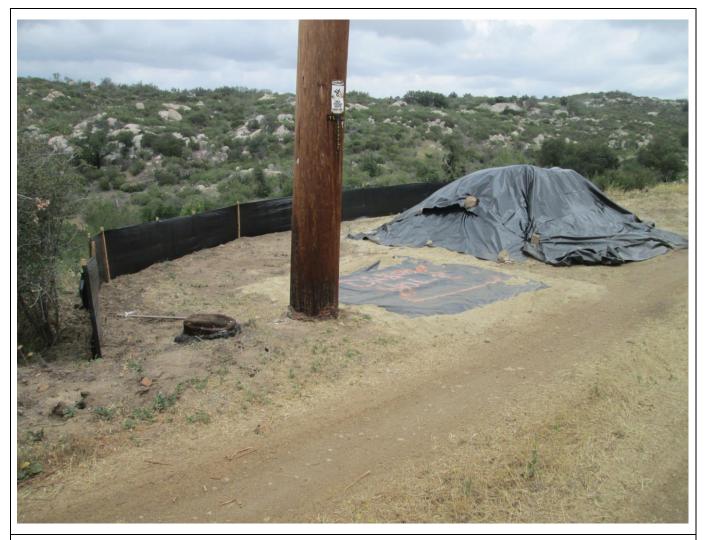
Photo 7: Previously drilled pole holes were covered to prevent wildlife entrapment in accordance with MM BIO-3. Stockpiles were observed covered with visqueen and silt fencing used for sediment control was found installed and in good condition in accordance with the Project SWPPP (APM-HYD-1).

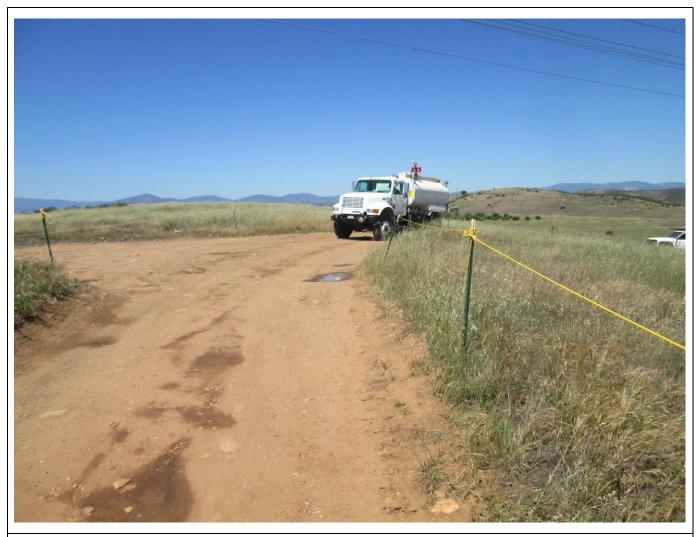
Crews were observed implementing measures identified in the Project Fire Plan (APM HAZ-2) in order to minimize fire risk during project construction. Construction crews were observed carrying required fire tools (i.e. backpack pump, fire extinguisher, shovel, and Pulaski) during activities, and fire extinguishers were observed staged next to or mounted on internal combustion engines. Fire patrols were observed along the project alignment overseeing fire safety measures being implemented, and standing-by to aid in extinguishing possible fire starts. Water tenders were observed within 2 minutes travel time of construction activities where equipment could become energized, and were utilized to wet access roads (see Photo 8 – Attachment A).

Environmentally sensitive areas were observed delineated in the field and roped off for construction personnel avoidance (see Photo 8 – Attachment A). In accordance with APM-CUL-3, archeological monitors were observed monitoring construction activities that occurred near the sensitive resources and crews were observed respecting avoidance buffers.

Photo 8: Environmentally sensitive areas were observed delineated in the field and roped off for construction personnel avoidance. In accordance with APM CUL-3, archeological monitors were observed monitoring construction activities that occurred near the sensitive resources and crews were observed respecting avoidance buffers.
