<p>California Public Utilities Commission <i>Mitigation Monitoring, Compliance, and Reporting Program</i></p>
	<p>East County (ECO) Substation Project</p> <p>Compliance Status Report: 034</p> <p>July 20, 2014</p>

SUMMARY

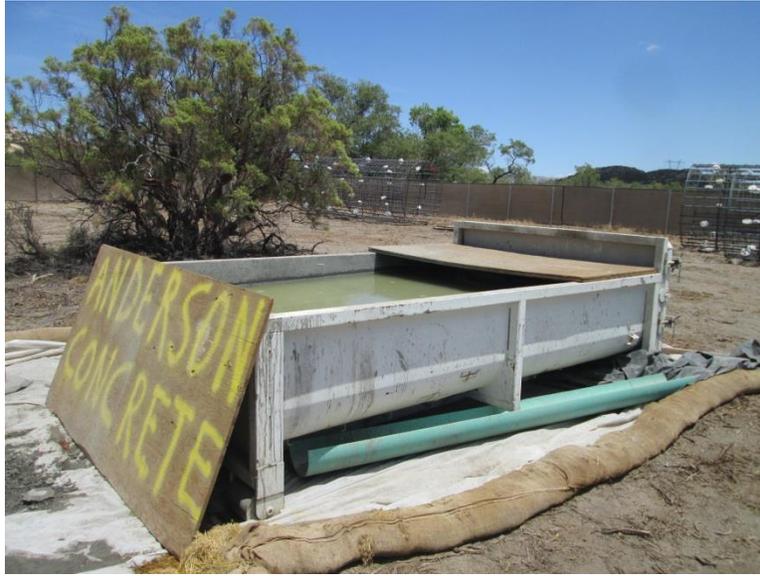
During this reporting period, CPUC third-party monitors observed construction crews staging equipment used in foundation hole drilling at the Domingo Lake Construction Yard. A concrete washout basin was observed in good condition in accordance with MM HYD-1 (See Photo 1—Attachment A). Spill kits with spill cleanup tools (MM HAZ-1a) were observed staged at the Construction Yard. Fire safety equipment was observed on-site in accordance with MM FF-1. Visual screening surrounding the yard required per MM VIS-3a, was observed to being maintained.

Photo 1: Concrete washout basins were observed in good working order in accordance with the project SWPPP and MM HYD-1.

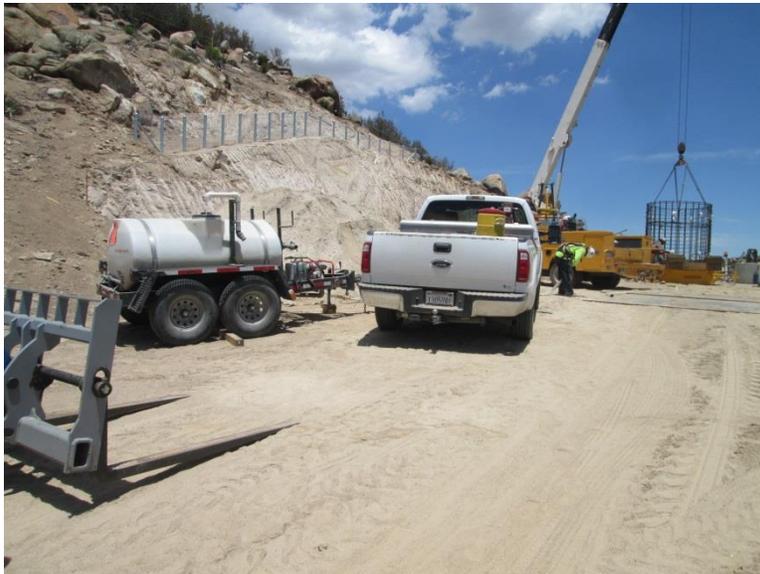
Construction crews were observed removing drilling equipment from SP-44, finishing a concrete foundation at SP-43, and installing a rebar cage at SP-42. At SP-42, water was observed being utilized for dust control (MM AQ-1 and BIO-4a) (see Photo 2—Attachment A) =. At SP-43, concrete spoil was observed being placed on plastic (MM HAZ-1a) in order to prevent any potential soil contamination. At SP-44, the foundation hole was covered to prevent wildlife entrapment (MM BIO-7a) and drill spoil stockpiles were being watered to minimize fugitive dust (MM AQ-1, BIO4a). SWPPP BMPs, including straw wattles installed along the fill slope, applied hydromulch, and silt fencing are being utilized to minimize the potential for off-site sediment transport (See Photo 3—Attachment A).

Photo 2: During rebar cage installation at Steel Pole 42, water was utilized for dust suppression (MM AQ-1) and fire safety tools (Pulaski, shovel, etc.) were observed staged on site in accordance with MM FF-1.

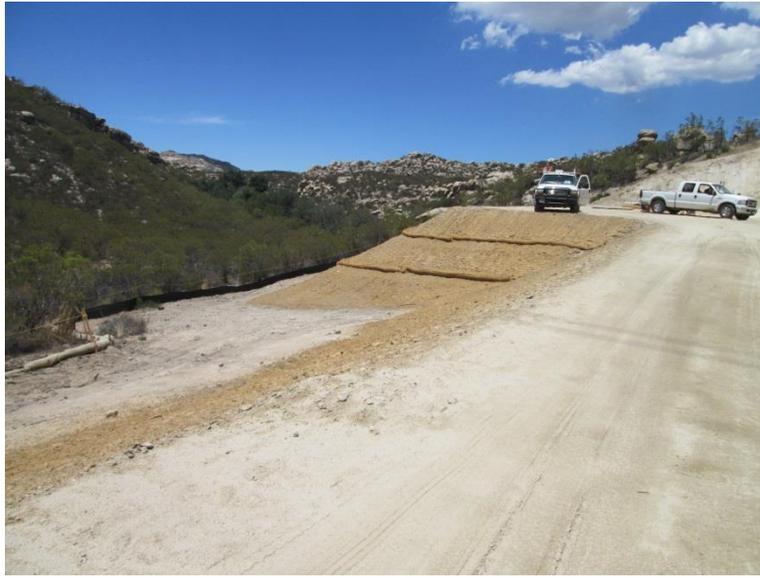
Photo 3: SWPPP BMPs (MM HYD-1), including straw wattles and silt fencing were observed in good working condition at Steel Pole 42.

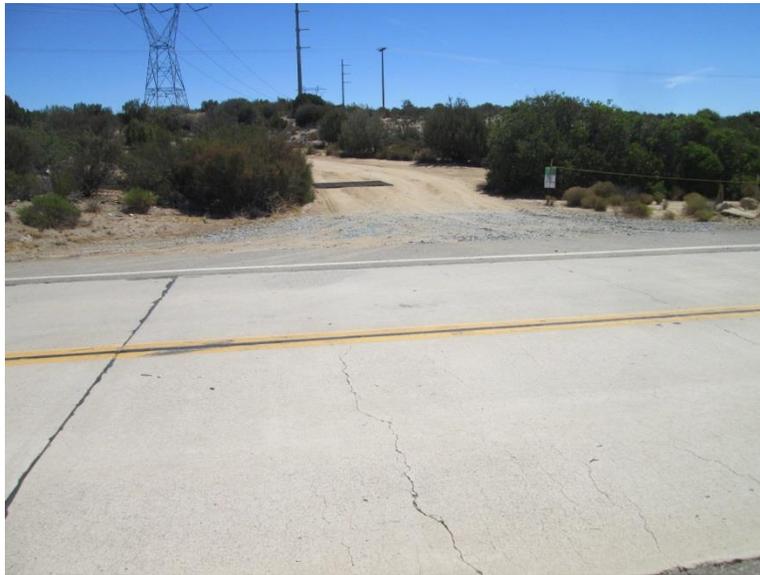
During ground wire and rod installation activities at SP-67 and SP-69, a water truck was used for dust control in the work area and during trenching (MM AQ-1 and BIO-4a). Erosion and sediment controls included the use of straw wattles along the work area perimeter and hydro-mulch on graded slopes (MM HYD-1). The work area was observed clearly delineated (MM BIO-1a) and a biological monitor was observed monitoring the work activity in both locations (MM BIO-1c). A rattle plate remains at the access road ingress/egress to Old Highway 80, and the paved highway was observed free of track-out in accordance with MM AQ-1, MM BIO-4a, and MM HYD-1 (See Photo 4—Attachment A).

Photo 4: Rattle plates were observed being maintained at the point of ingress and egress to Old Highway 80 (SWPPP and MM HYD-1).

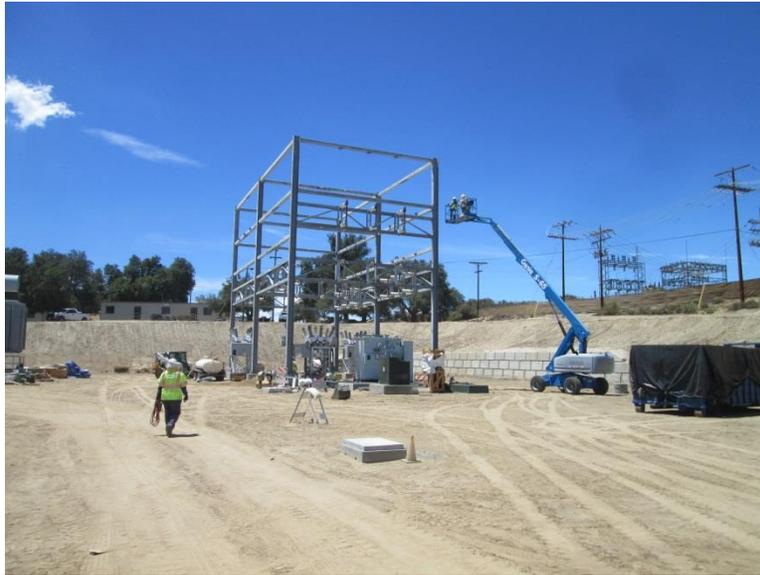
At the Boulevard substation rebuild site construction, crews were observed conducting framing activities around the 69 kV circuit breakers and building foundations. Visual screening of the work area was in good condition in accordance with VIS-3a (see Photo 5—Attachment A). Trash was not observed on site during this reporting period, and a large trash container was observed covered to minimize wildlife attractants in accordance with BIO-7d (see Photo 6—Attachment A).

Photo 5: Crews were observed working on the 69kV Circuit Breaker Frame at the Boulevard Substation Rebuild. Visual screening was observed in good working order in accordance with MM VIS-3a.

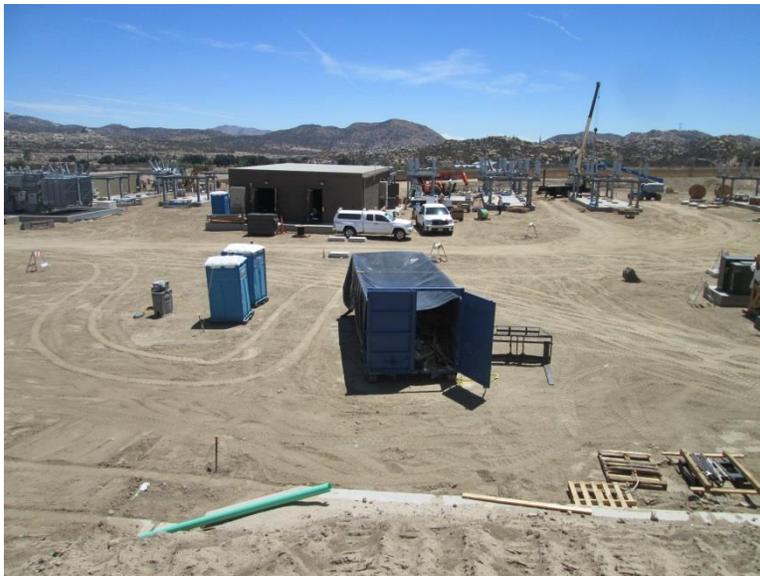
Photo 6: Trash was observed to be contained in covered trash bins in order to reduce attractants for wildlife attraction in accordance with MM VIS-3a.
