<p>California Public Utilities Commission <i>Mitigation Monitoring, Compliance, and Reporting Program</i></p>
	<p>East County (ECO) Substation Project</p> <p>Compliance Status Report: 001</p> <p>February 25, 2013</p>

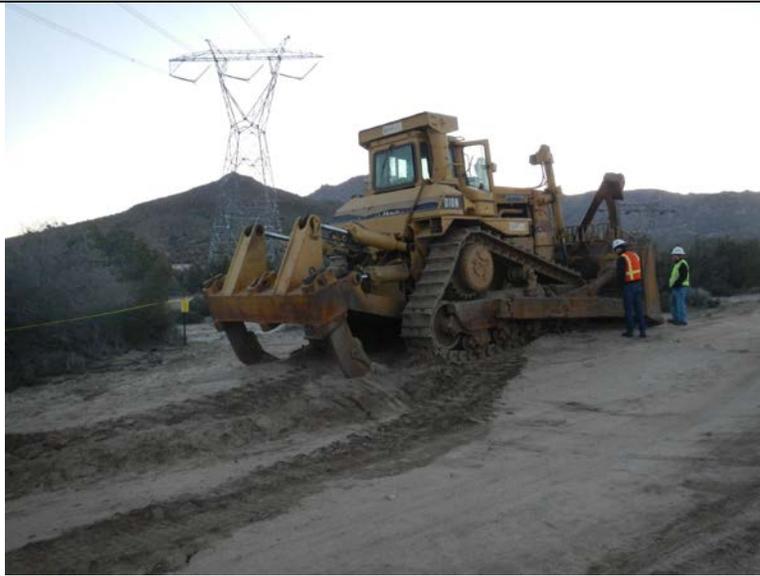
construction equipment to the ECO Substation site on February 6, 2013. The construction contractor mobilized equipment on February 6, 2013, to the ECO Substation site prior to notifying SDG&E and the associated environmental monitors. A piece of construction equipment was unloaded at the ECO Substation site along an access road prior to environmental monitors being present (see Photo 1 – Attachment A). See further discussion below under Compliance.

Non-Compliance No. 001 – On February 6, 2013, the SDG&E Lead Environmental Inspector was notified that a piece of construction equipment had been mobilized to the ECO Substation Project site prior to notifying environmental monitors. The SDG&E Lead Environmental Inspector and Lead Archaeological Monitor followed-up to conduct an assessment to evaluate whether environmental resources were impacted from mobilizing the equipment to the site prior to an environmental monitor being present. Based upon the observations made by the SDG&E Lead Environmental Inspector and Lead Archaeological Monitor, no impacts to environmental resources occurred as a result of this incident, as the piece of construction equipment was unloaded along an existing disturbed roadway. Following the environmental resource assessment, the construction equipment was demobilized by SDG&E.

The mobilization of construction equipment to the project site as described above was not in compliance with the following environmental measures required by CPUC to minimize potential impacts to environmental resources: (1) Notice to Proceed No. 3 conditions of approval that require an archaeological monitor to be present when construction equipment is mobilized to the site when adjacent to ESAs, and (2) Construction equipment had not been cleaned prior to mobilizing to the site in accordance with the Noxious Weeds and Invasive Species Control Plan (Mitigation Measure BIO-3A).

Photo 1: Construction equipment is mobilized to the ECO Substation site prior to notification being provided to the SDG&E Lead Environmental Inspector. See discussion regarding Non-Compliance No. 001.

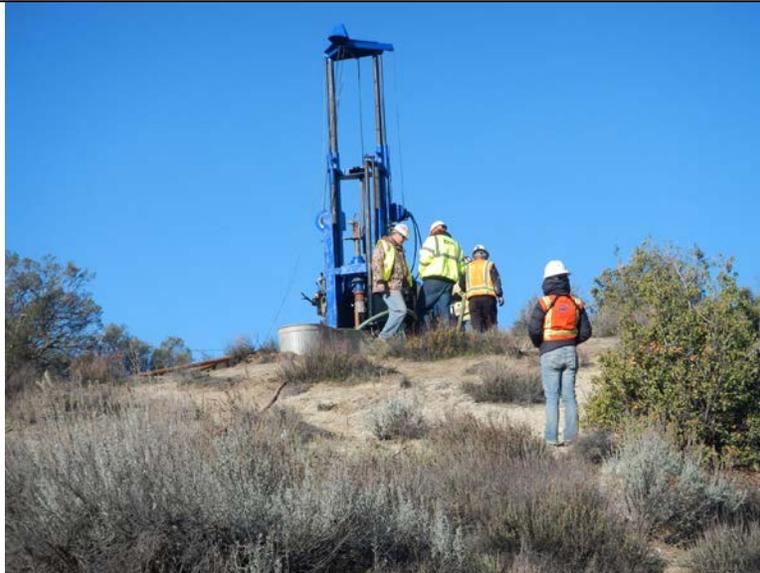
No grading or clearing of vegetation was required to obtain access to the geotechnical boring locations. Each of the geotechnical borings were backfilled following drilling activities and returned to pre-construction conditions. A truck-mounted drill rig was used to drill all boring locations along existing roadways and a tracked drill rig was used for a single boring (GEO-11a) located approximately 100 feet from an existing roadway. An SDG&E biological and archaeological monitor was present during all geotechnical activities in accordance with the MMCRP (see Photo 2 – Attachment A).

Photo 2: SDG&E archaeological and biological monitors observed construction crews using a tracked drill rig to conduct a geotechnical boring at site GEO-11a.

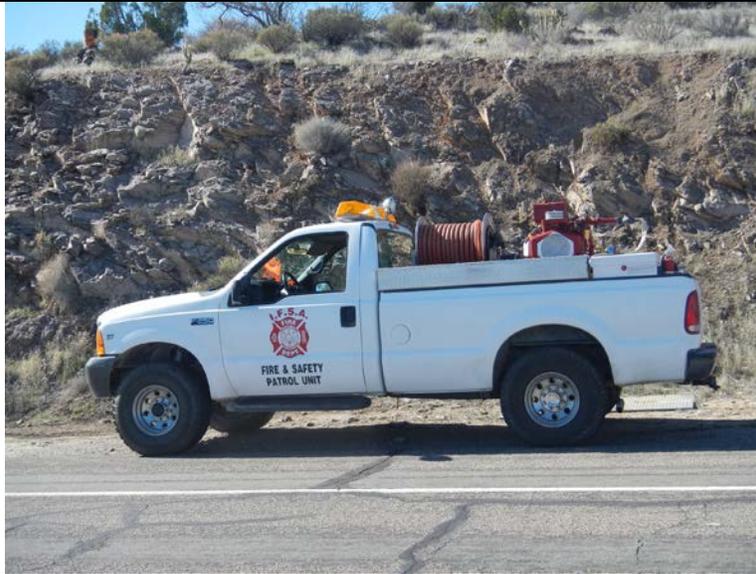
In accordance with Mitigation Measure FF-1, SDG&E is providing ongoing fire patrols during construction hours and for 1 hour after the end of daily construction. In addition, construction vehicles were observed to be equipped with fire suppression equipment as required in the Construction Fire Prevention/Protection Plan (see Photo 3 – Attachment A).

Photo 3: In accordance with Mitigation Measure FF-1, SDG&E is providing ongoing fire patrols during construction hours and for 1 hour after the end of daily construction.

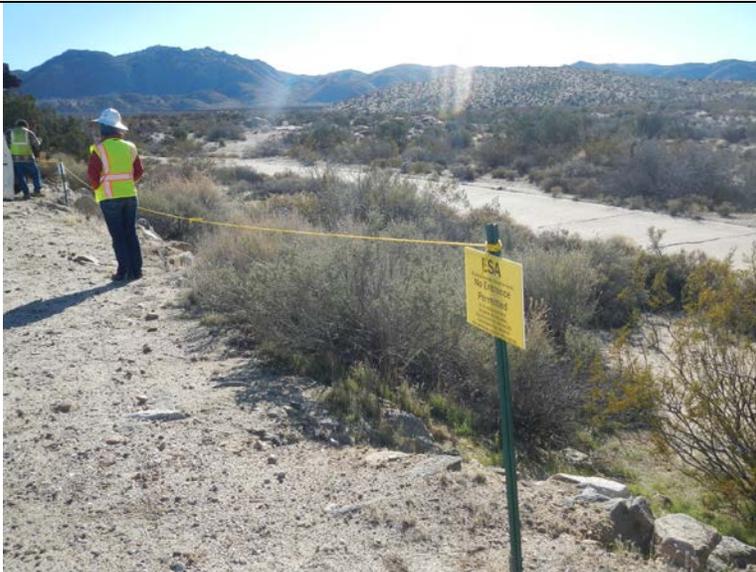
Water trucks were observed watering down access roads in accordance with Mitigation Measure BIO-4a and the associated Dust Control Plan. Exclusion fencing has also been placed within areas adjacent to the approved work limits and environmentally sensitive areas (ESAs) to minimize the potential for impacts to sensitive habitat and cultural resources (see Photo 4 – Attachment A).

Photo 4: Environmentally sensitive areas (ESAs) have been flagged in the field prior to completing geotechnical work in accordance with Mitigation Measure CUL-1.

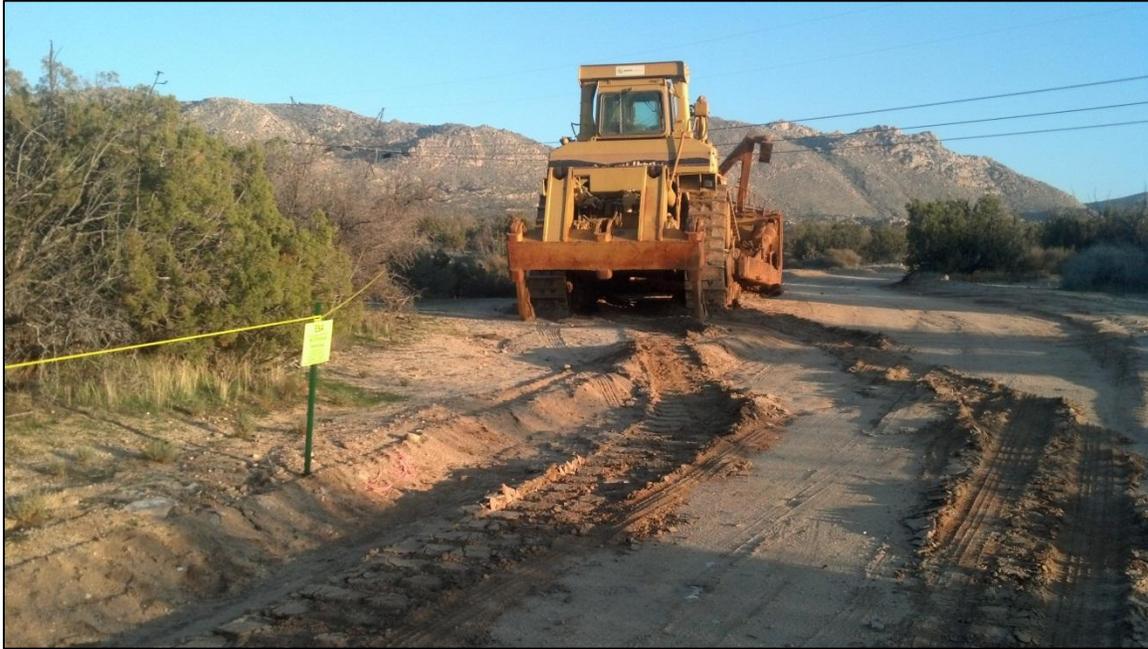
The bulldozer was tracked and parked immediately adjacent to a cultural ESA. Notice to Proceed (NTP) #3 requires that an archaeological monitor be present when large equipment travels down existing access roads north of the ECO Substation site when adjacent to ESAs. No archaeological monitor or Native American representative was present at the time the bulldozer travelled down the road adjacent to the ESA.

Photograph 1: Bulldozer parked within a widened portion of an access road facing west toward the ECO Substation.

On the evening of February 6, the Project environmental team recommended that the bulldozer be demobilized for cleaning. The bulldozer was removed from the Project site on February 7 so that it can be cleaned of dirt and vegetative debris before returning to the Project area. Best Management Practice installation and vegetation clearance activities that were planned to commence at the ECO Substation site were cancelled until clean equipment can be mobilized to the Project area and the required avian surveys can be replicated in accordance with the requirements of the Nesting Bird Management Monitoring and Reporting Plan. SDG&E will conduct an additional pre-construction meeting to discuss required compliance measures prior to beginning work at the ECO Substation location.

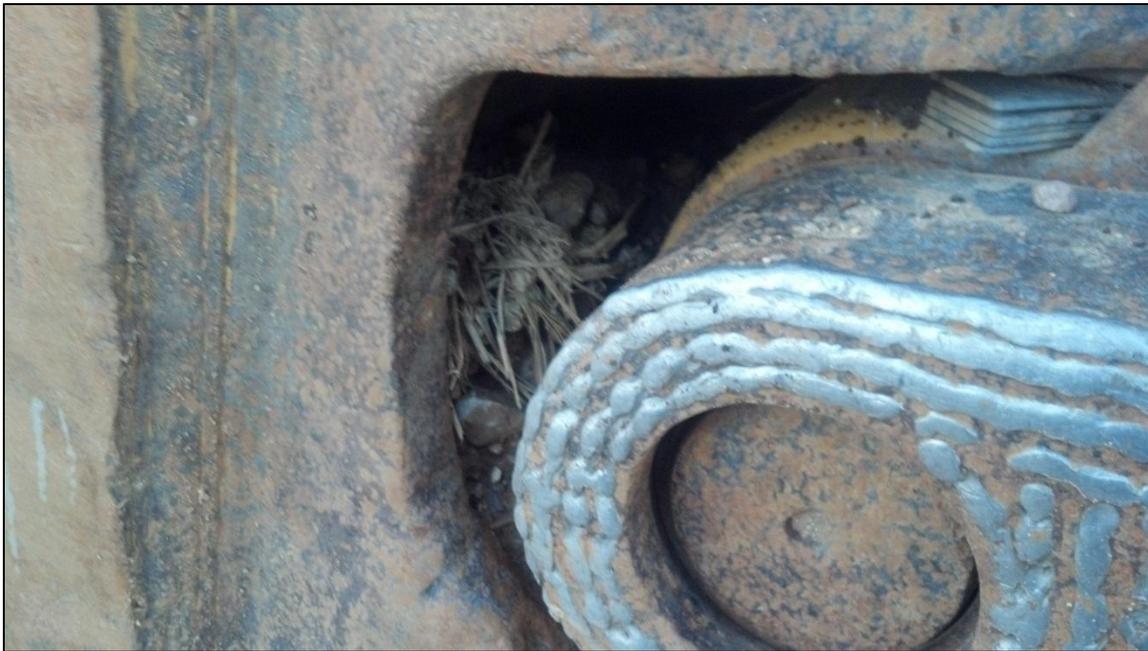
The bulldozer had been unloaded and tracked approximately 100 feet along an access road. Existing dirt and vegetative debris were present on the equipment. Mitigation Measure BIO-3a and the Noxious Weeds and Invasive Species Control Plan require that vehicles and equipment that are mobilized to the Project area be free of dirt and vegetative debris.

Photograph 2: Vegetative debris present in the tracks of the bulldozer.

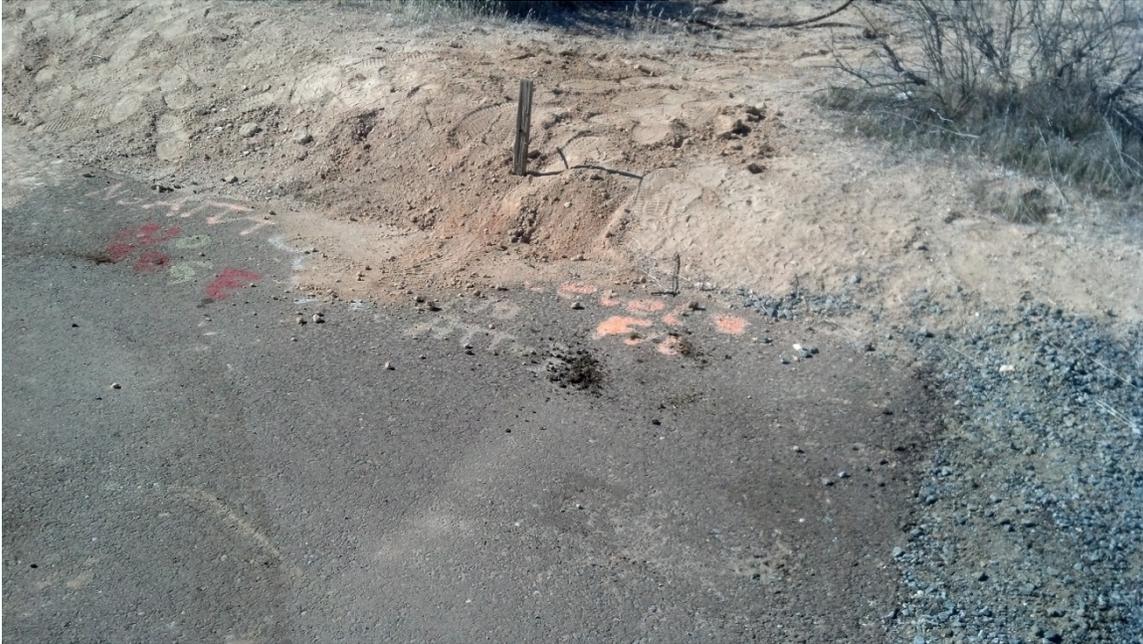
Nicole Morgan (Cultural Resource Specialist, SDG&E), Isabel Cordova (Archaeologist, ASM Affiliates), and the LEI conducted an investigation of the bore location on February 14, 2013. The bore location was confirmed to be located just within the boundary of an unmarked Environmentally Sensitive Area (ESA), in the previously disturbed shoulder of the adjacent paved roadway. The road shoulder is an existing Southwest Powerlink (SWPL) and Sunrise Powerlink (SRPL) access route. The road was mitigated for cultural resources under SWPL (Townsend 1984) and improved during SRPL where the amount of paved access was extended to the north. No subsurface deposit was found to be present within the area during the Townsend evaluation and data recovery. This area was also subject to a micro-mapping study in 2012 (Williams, report pending), and no artifacts or features were previously recorded at this location. The portion of the site boundary that the boring took place is in a buffer zone kept in the legacy site data to preserve the interior site components and inform management decisions. No soil discoloration indicating a subsurface anthrosol was identified in the tailings or during the boring. No cultural resources were identified in the vicinity of the bore hole, and no impacts were observed. No further cultural resources work is recommended. No rare plants, special-status species, jurisdictional waters, or vegetation were impacted as a result of the incident.

The boring operation had been conducted in a location that had not been authorized by an NTP. The boring activities were conducted within the boundary of an unmarked ESA. This incident was recorded as a Non-Compliance as there was potential for resource damage to occur. In addition, Mitigation Measure BIO-1a of the Project's Mitigation Monitoring, Compliance, and Reporting Program requires that all construction-related activities be limited to approved work limits and both CPUC NTP #3 and BLM NTP #1 specify that all geotechnical activities should be conducted within the approved work limits identified in the NTP requests.

Photograph 1: View of the unauthorized boring location.

As previously discussed, a verification that the boring location was within an ESA was conducted and further assessment of potential resource damage was conducted by SDG&E, ASM Affiliates, and the LEI by the end of the day. In addition, the LEI met with Kirstie Reynolds and Nicole Morgan to discuss this Non-Compliance at approximately 1500 to discuss the incident. A follow-up meeting will be held internally between SDG&E and its Contractors within one week (by February 21) to develop Quality Control/ Quality Assurance procedures to ensure that all staking is confirmed in the field prior to construction activities. SDG&E's Contractors will also evaluate the existing procedures for adequacy, assess if any procedures were not properly implemented, as well as develop new procedures, as necessary, within one week (by February 21) to ensure a similar incident does not occur in the future.

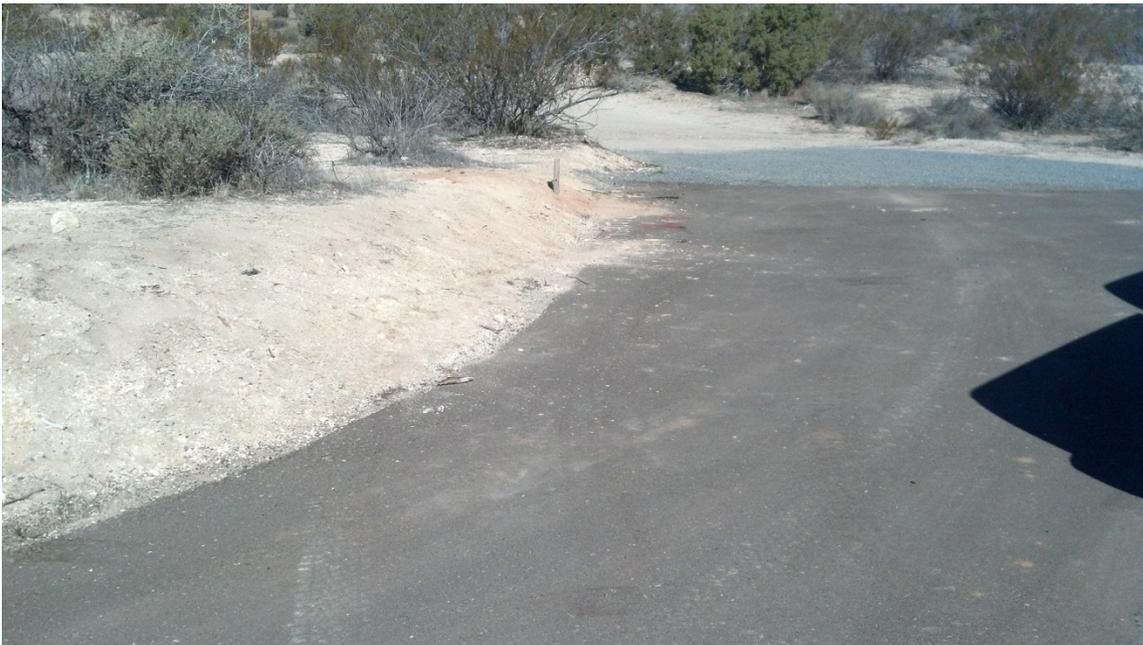
On February 14, 2013, the Lead Environmental Inspector (LEI, Insignia Environmental) Larry Butcher was notified by Jeffry Coward (Environmental Field Supervisor, Insignia Environmental) at approximately 0900 that during geotechnical boring operations on February 13, 2013, one bore had been conducted in a location that had not been authorized by a Notice to Proceed (NTP). Two NTPs (California Public Utilities Commission [CPUC] NTP #3 and Bureau of Land Management [BLM] NTP #1) have been obtained for geotechnical boring activities; however, the location of this bore was not identified in either of the NTPs. This location was located approximately 250 feet north of the approved site and was determined to be within a portion of Old Highway 80 that is within the BLM property limits. The LEI conducted an inspection of the location at approximately 1000. The boring activities had been conducted at the edge of a paved access road apron, in the disturbed road shoulder.

Photograph 2: View of the unauthorized boring location and previously disturbed road shoulder.
