<p>California Public Utilities Commission <i>Mitigation Monitoring, Compliance, and Reporting Program</i></p>
	<p>East County (ECO) Substation Project</p> <p>Compliance Status Report: 024</p> <p>March 2, 2014</p>

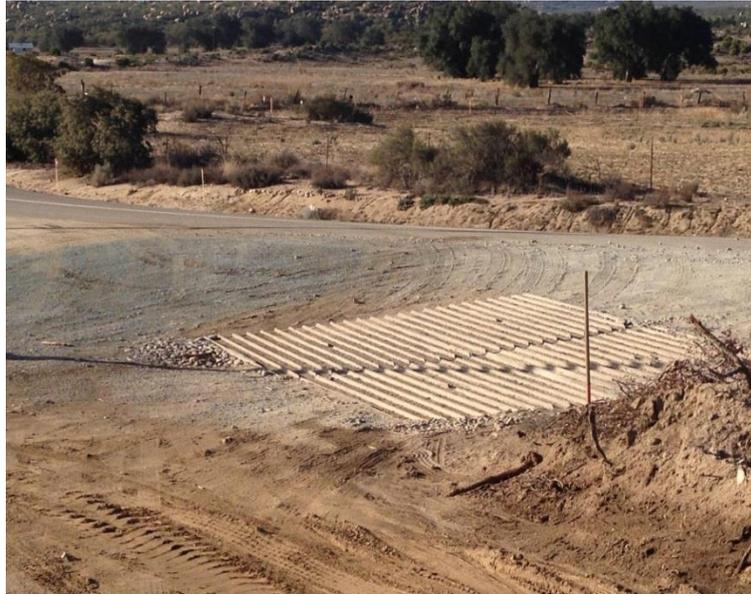
Intersections between underground activities and publicly accessed paved roads were equipped with rumble plates to minimize the potential for trac-out along paved surfaces in accordance with MM-HYD-1 and MM-BIO-4a (see Attachment A - Photo 1). Trac-out observed along paved surfaces was observed being cleaned on a regular basis in accordance with the Dust Control Plan and MM-BIO-4a.

Photo 1: Intersections between unpaved access roads and publicly accessed paved roads were equipped with rumble plates to minimize trac-out.

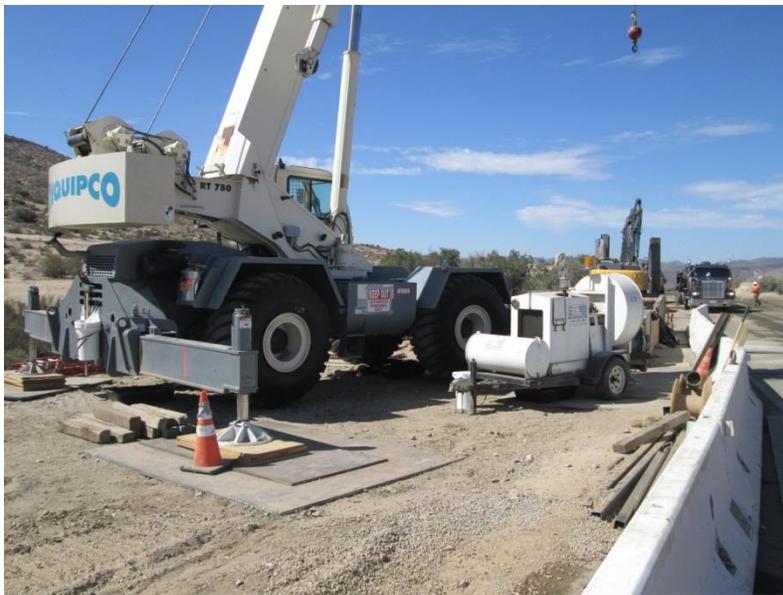
Spill kits were observed on site and securely attached to construction equipment to ensure materials are readily accessible for clean-up of small spills per MM-HAZ-1a. Crews were observed cleaning-up any minor spills that occurred during construction activities per the project requirements. Crews were also observed effectively managing construction debris by placing any trash within sealed designated trash bins. Equipment being staged along the ROW and portable restroom facilities associated with the jack-and-bore drilling site were observed to have containment bins in accordance with MM-HAZ-1c (see Attachment A - Photo 2).

Photo 2: Staged equipment and portable restroom facilities were observed to have containment bins in accordance with MM-HAZ-1c.

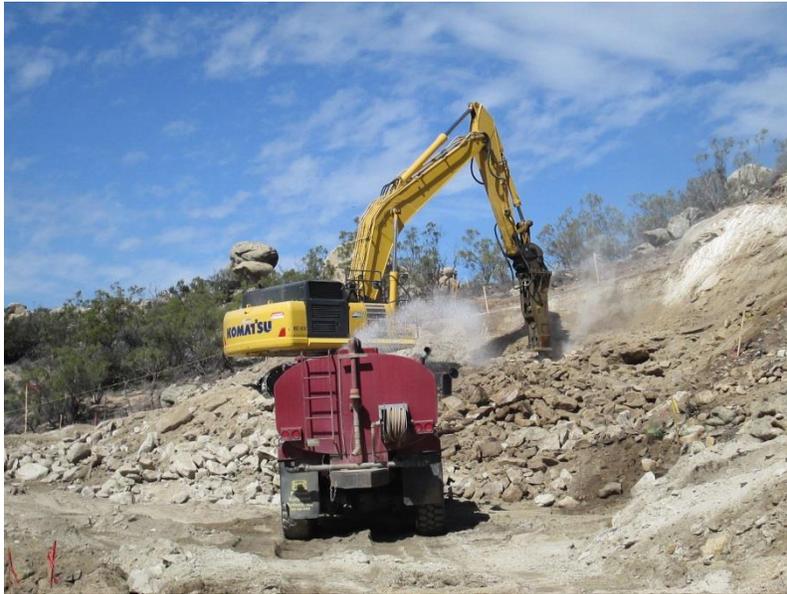
As required by MM-BIO-4a and MM-AQ-1, water trucks were observed suppressing fugitive dust emissions in areas of active construction and along unpaved access roads (see Attachment A - Photo 3). In areas of difficult access, water buffaloes or truck-based hoses were utilized for dust suppression.

Photo 3: As required by MM-BIO-4a and MM-AQ-1, water trucks were utilized to minimize fugitive dust emissions in areas of active construction.

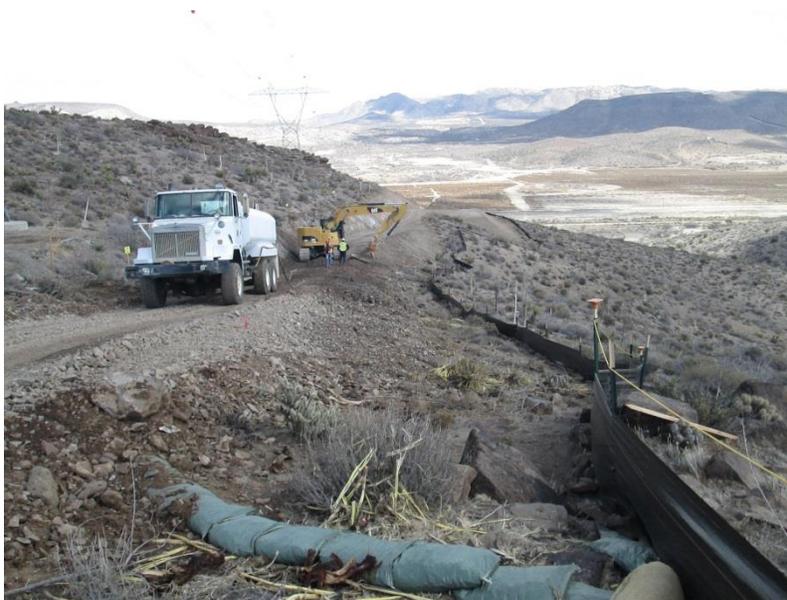
Erosion control devices including silt fence were installed along the work limits to minimize the potential for discharges to occur beyond the project work limits in accordance with the SWPPP and MM-HYD-1 (see Attachment A - Photo 4).

Photo 4: Erosion control devices including silt fencing, gravel bags and straw wattles are being utilized along the right-of-way in accordance with MM-HYD-1 and the SWPPP.

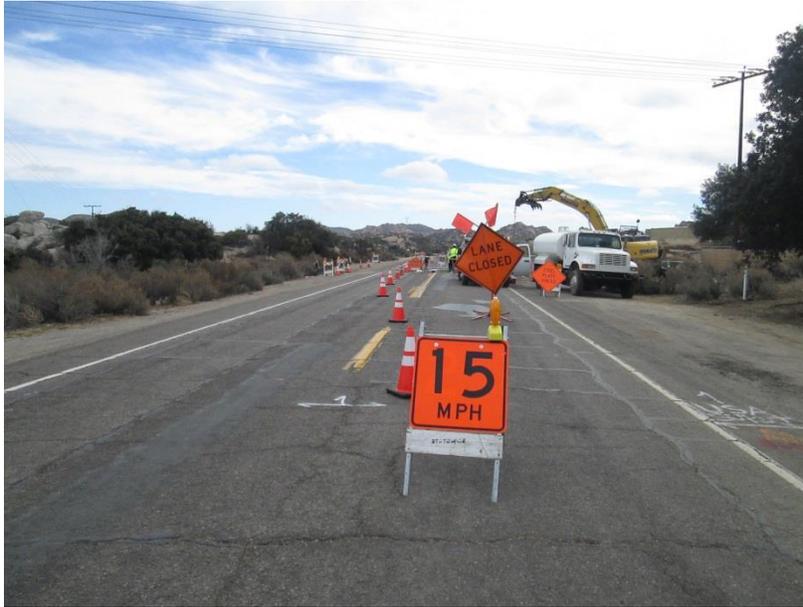
In accordance with MM TRA-1, traffic flaggers and posted signage were utilized along Old Highway 80 to ensure safe passage for motorists (see Attachment A - Photo 5).

Photo 5: In accordance with MM TRA-1, traffic flaggers and posted signage were utilized along Old Highway 80 to ensure safe passage for motorists.

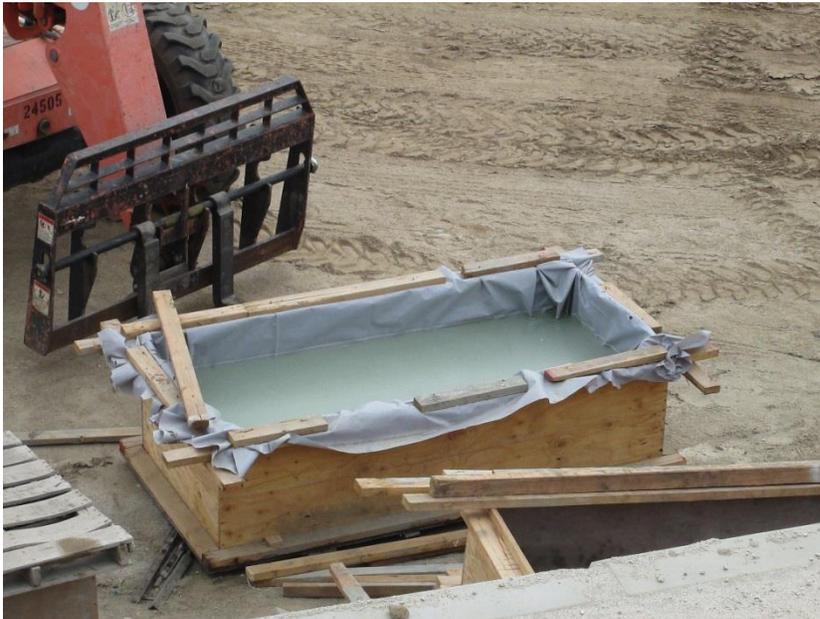
Photo 6: As stipulated in the project's Hazardous Materials and Waste Management Plan and MM-HAZ1-a, concrete wash out bins are utilized to contain concrete waste debris.

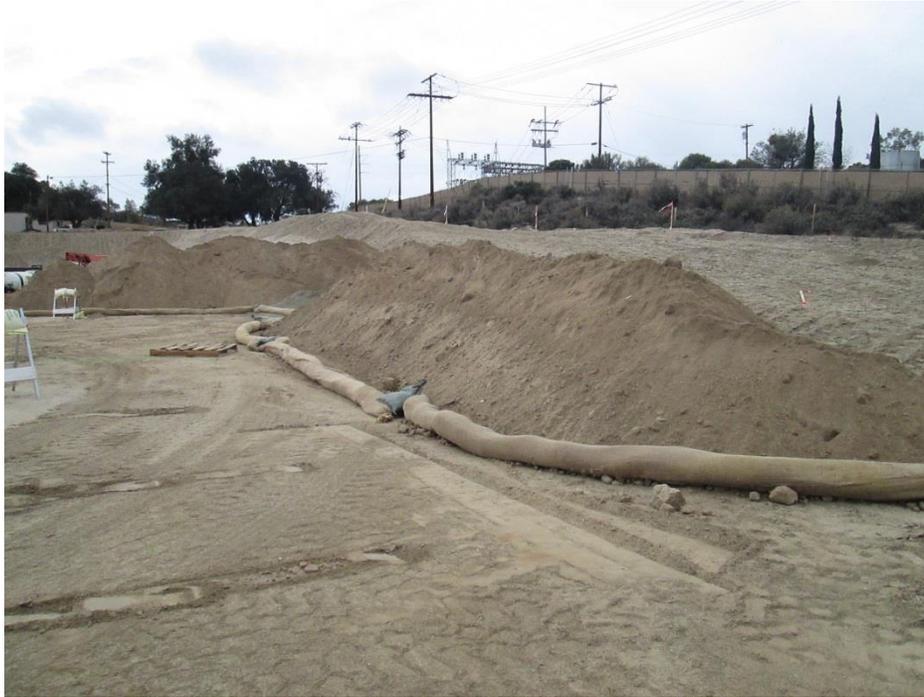
As stipulated in the project's Hazardous Materials and Waste Management Plan and MM-HAZ1-a, concrete wash out bins throughout the site were used to properly contain concrete waste (see Attachment A - Photo 6). Stockpiled soil within the substation was equipped with perimeter erosion control devices including straw wattles in order to minimize the potential for run-off (see Attachment A - Photo 7).

Photo 7: Stockpiled soil was equipped with perimeter erosion control devices in accordance with MM-HYD-1 and the SWPPP.

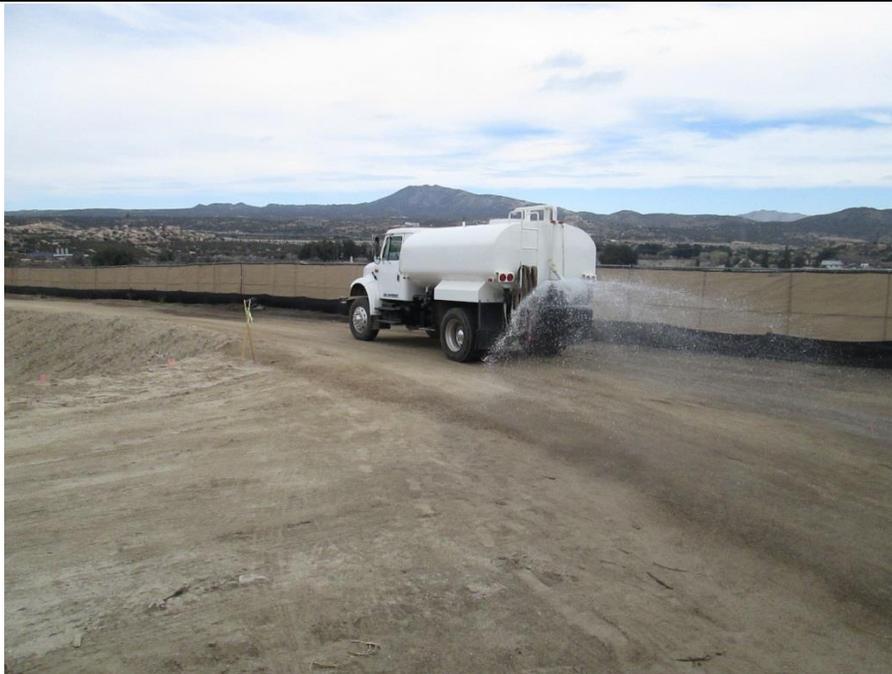
Water trucks were used to minimize fugitive dust emissions as required per MM-BIO4-a and MM-AQ-1, (see Attachment A - Photo 8).

Photo 8: In an effort to minimize dust emissions, water trucks were utilized to apply water in areas of active construction at the Boulevard Substation Rebuild site.
