Re: Monthly Report Summary #22 for Aliso Canyon Turbine Replacement Project

Aliso Canyon Turbine Replacement Project CPUC Site Inspection Form

Project:	Aliso Canyon Turbine Replacement	Date:	January 7, 2016
Project Proponent:	Southern California Gas Company and Southern California Edison	Report #:	VS086
Lead Agency:	California Public Utilities Commission	Monitor(s):	Vince Semonsen
CPUC PM:	Andrew Barnsdale, Energy Division	AM/PM Weather:	Partly cloudy and cool with a slight breeze.
E & E CM:	Lara Rachowicz	Start/End time:	0800 to 1000 SCE work. 1030 to 1400 at the Aliso Storage Field.
Project NTP(s):	Guard House and Road Widening (NTP-1). The new Admin/IM Building (NTP-2) and Central Compressor Station (CCS) (NTP-3). P-41 Fill Site (NTP-2), PS-42 Fill Site, P-32 Fill Site (NTP-3), and the Natural Substation (NTP-3, NTP-A). TSPs 2 through 42 (NTPs A, C, and D) and the SCE 210 Freeway Yard. Telecommunications Route 2 (NTP-E).

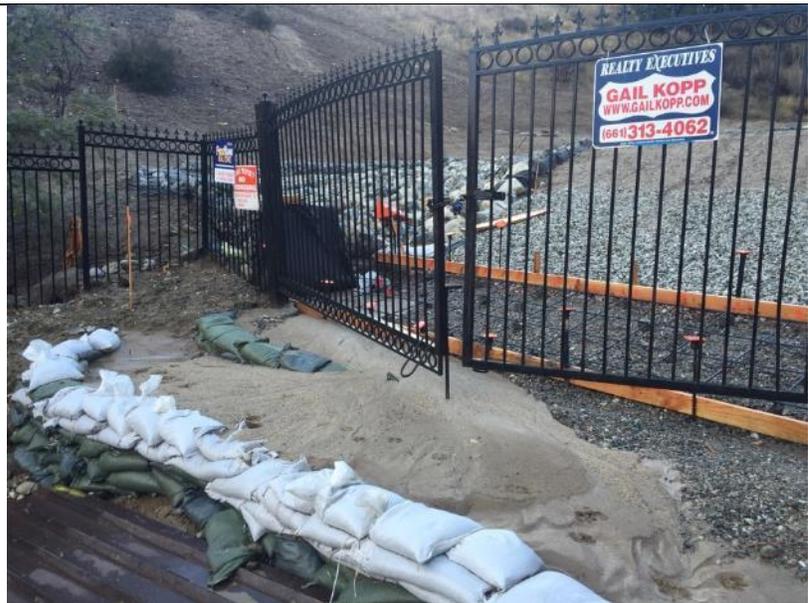
Date	Location	Photo	Description
1/07/16	TSP 7 access road

Entrance to the TSP 7 access road with gravel bag catch basin.
1/07/16	TSP 11

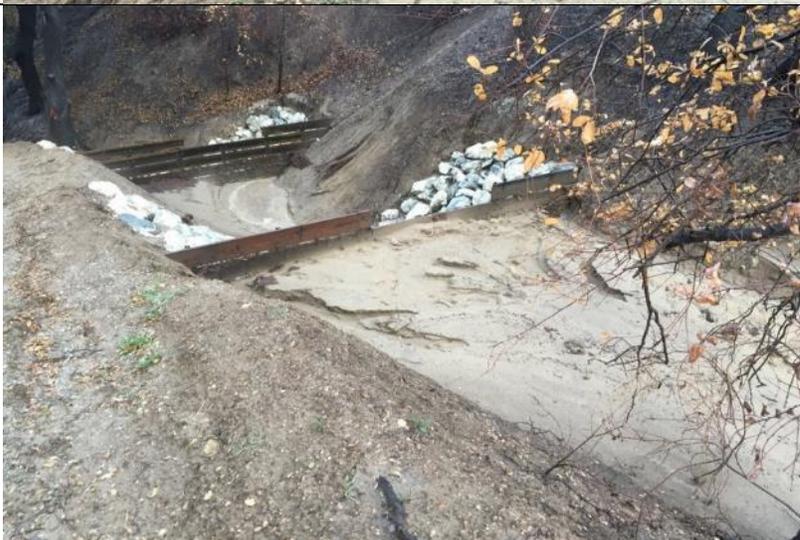
LA County's debris barriers filled to capacity along the TSP 24/25 access road.

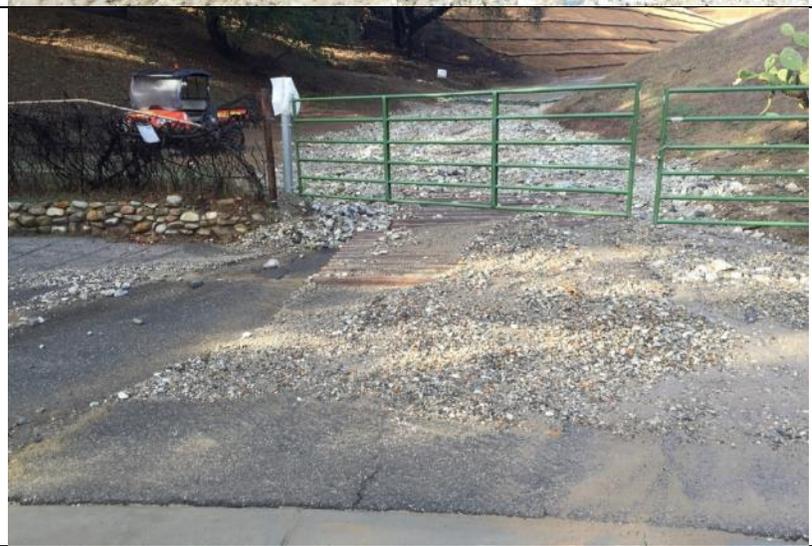
The access road entrance for TSPs 12 through 22 had minor amounts of mud and rock on the paved road. The stabilized fill slopes below the pole and pull sites were in good condition, with only minor erosion problems – see photos. The access road was deeply rilled and appeared to be the main source of sediment exiting the site; installation of additional straw wattles on the steep portion of the access road may help stabilize and reduce erosion in the future. I was not able to check the remainder of the access road out to TSP 12. Todd White (Arcadis) said SCE was going to fly over this portion of the Aliso Storage Field to verify that BMPs had been adequate.

Entrance with minor debris washed down onto the paved roadway.

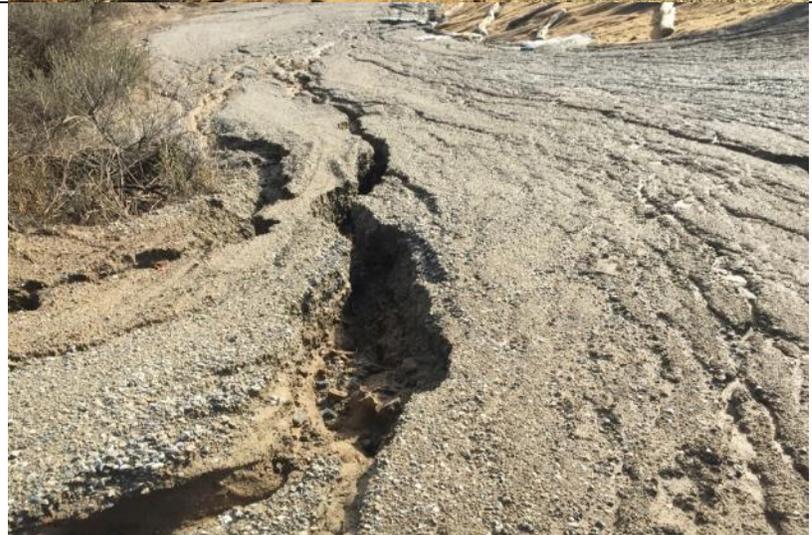
Rills in the access road below the TSP 21 site.
1/07/16	Drainage #4 TSP 24/25 access road

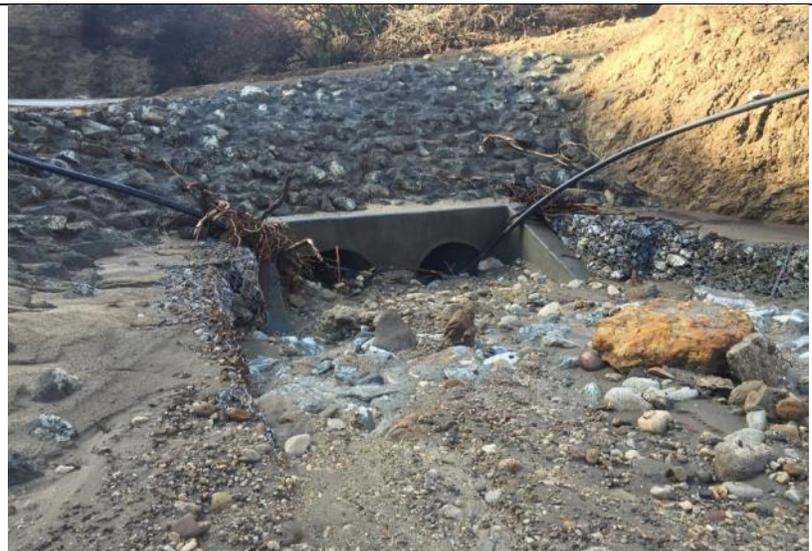
I walked up Drainage #4 to the TSP 24/25 access road where most of the road stabilization work had been completed. A large amount of debris had washed down the drainage from the burned watershed and had partially clogged the new culverts with mud and rock – see photos. Some of the plastic water piping used by the crews had washed downstream, including on piece of pipe that had washed through the culverts and had eventually been lodging in some trees approximately 50 yards downstream of the roadway. Some large rills developed on the access road; installation of some wattles is recommended.

Road culvert with debris and water piping.
1/07/16	Drainage #4 TSP 24/25 access road

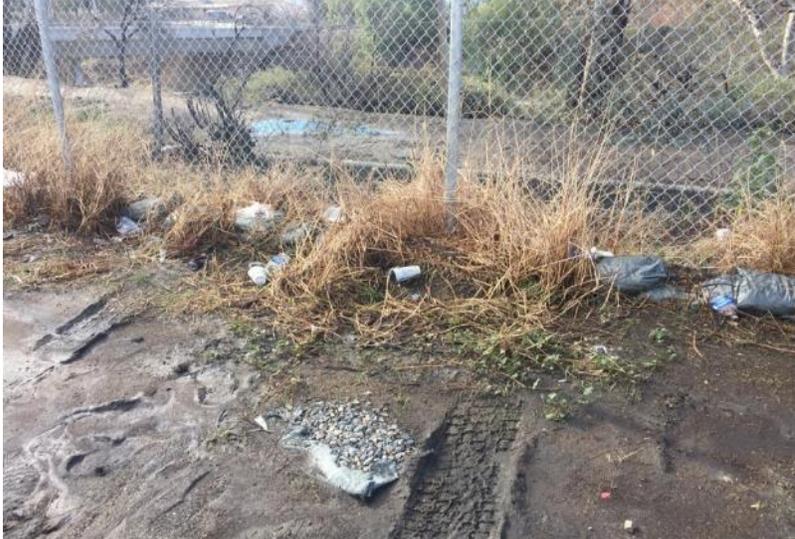
Trash along the perimeter fence.
1/07/16	Limekiln Creek near the Guard House

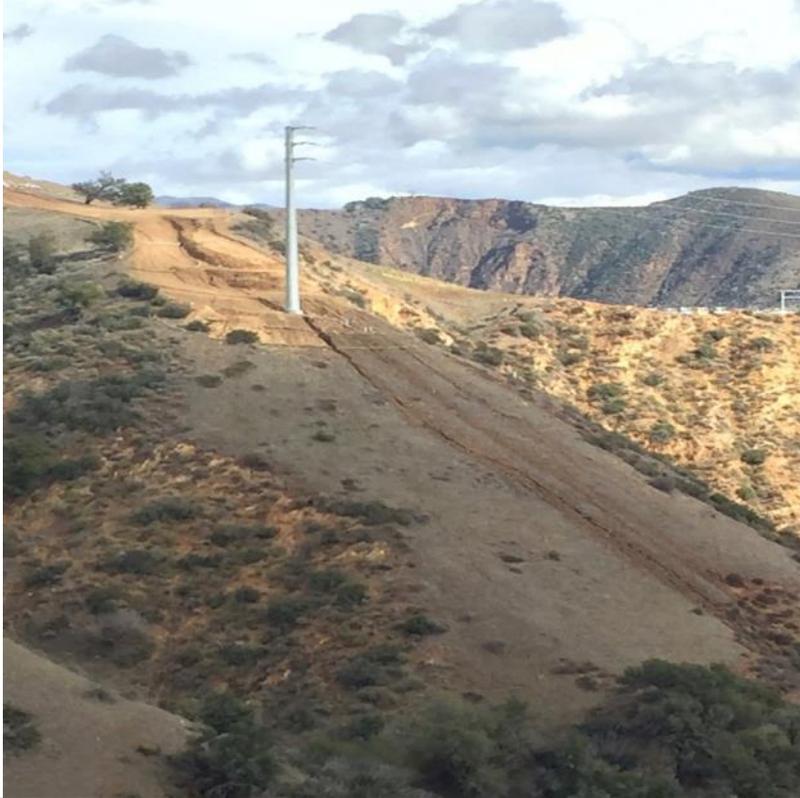
A large erosion rill was noted below the TSP 49 site – see photo.

Erosion rill noted below the pole site.
1/07/16	PS-42 Fill Site

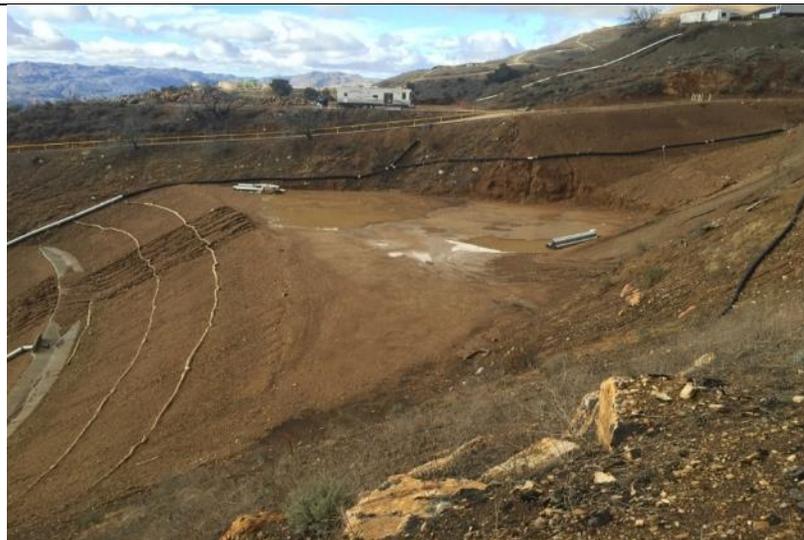
Ponded water on the upper fill key.
1/07/16	PS-42 Fill Site

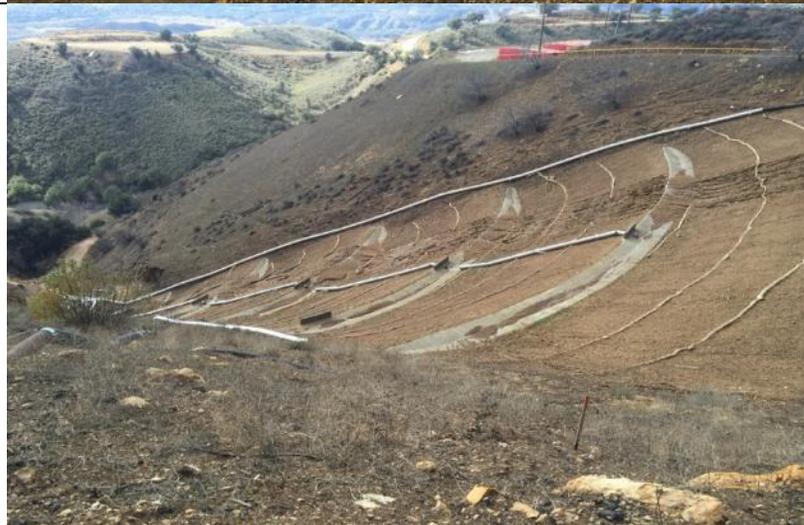
During visits to the Aliso Canyon Natural Gas Storage Field (Aliso Storage Field), Vince Semonsen documented significant BMP failures at the PS-42 Fill Site, PS-42 Well Pad, below the Natural Substation access road, and below the CCS. Multiple levels of stormwater BMPs at the PS-42 Fill Site were overwhelmed when a welding crew (associated with an ongoing well leak at the Aliso Storage Field) working on the PS-42 Well Pad directly upslope from the fill site punched a hole through a berm intended to retain stormwater on top of the well pad. Stormwater then drained down the slope and flowed into the retention area on the fill site's top tier. According to SCG, this additional water caused the retention basin to exceed its maximum capacity. As a result, stormwater overtopped the retention basin and ran down the

center of the PS-42 Fill Site slopes, creating a large swath of erosional rills. The sediment laden stormwater flowed to the bottom of the PS-42 Fill Site and onto the access road below, and then flowed over a gravel bag catchment basin before dislodging and flowing under straw wattles on its way into the drainage downslope of the access road. SCG stated that the welding crew did not coordinate with ACTR personnel prior to breaching the PS-42 Well Pad berm and that BMP failures would not have occurred without the berm breach.

Erosion down the face of the PS-42 Fill Site.
1/07/16	PS-42 Fill Site

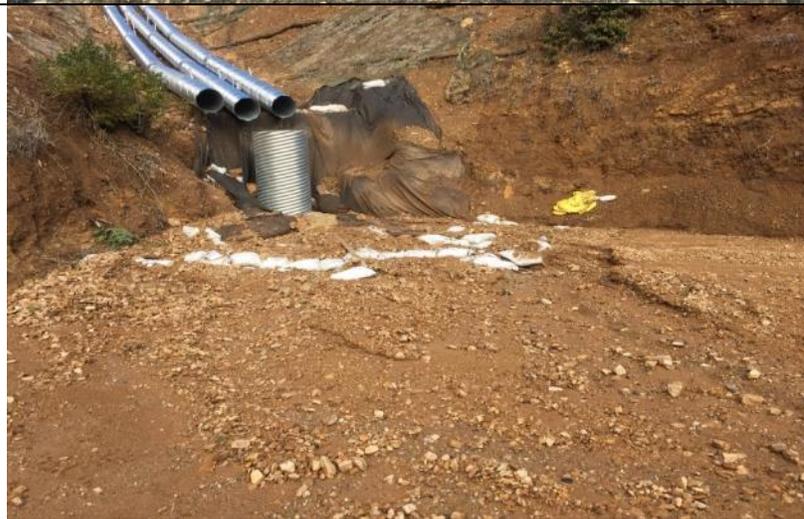
Sediment accumulated on the access road below the PS-42 Fill Site.

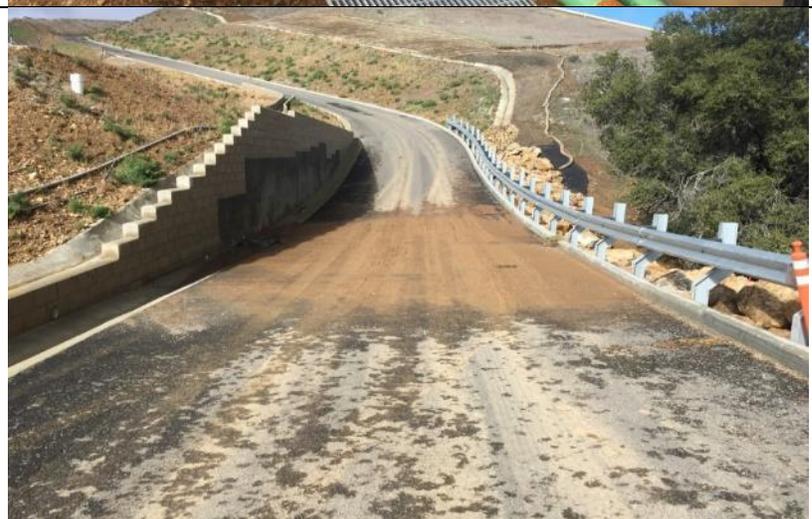
There was no activity at the Natural Substation; the site was extremely muddy. It was obvious that extensive amounts of water had traveled down the access road and off of the Natural Substation project site; the water had ponded and overflowed the roadway at its low point near the oak swale – see photos. The BMPs below the roadway were blown out, and I noted numerous areas of additional erosion through the oak swale. Later in the day, I hiked to the bottom of the oak swale drainage where it was obvious that extensive amounts of water and rock came down the steep drainage and had eroded deep rills on the banks of Limekiln Creek – see photos. I took B.J. Lukins (SCG) to the site and we discussed what could be done to keep this kind of erosion from occurring in the future. Large amounts of debris had entered the creek just upstream of the upper sedimentation basin/newt pond, and the pond was partially filled with sediment – see photo.

Mud and water ponded at this location, over topping the curb and running down into the oak swale.

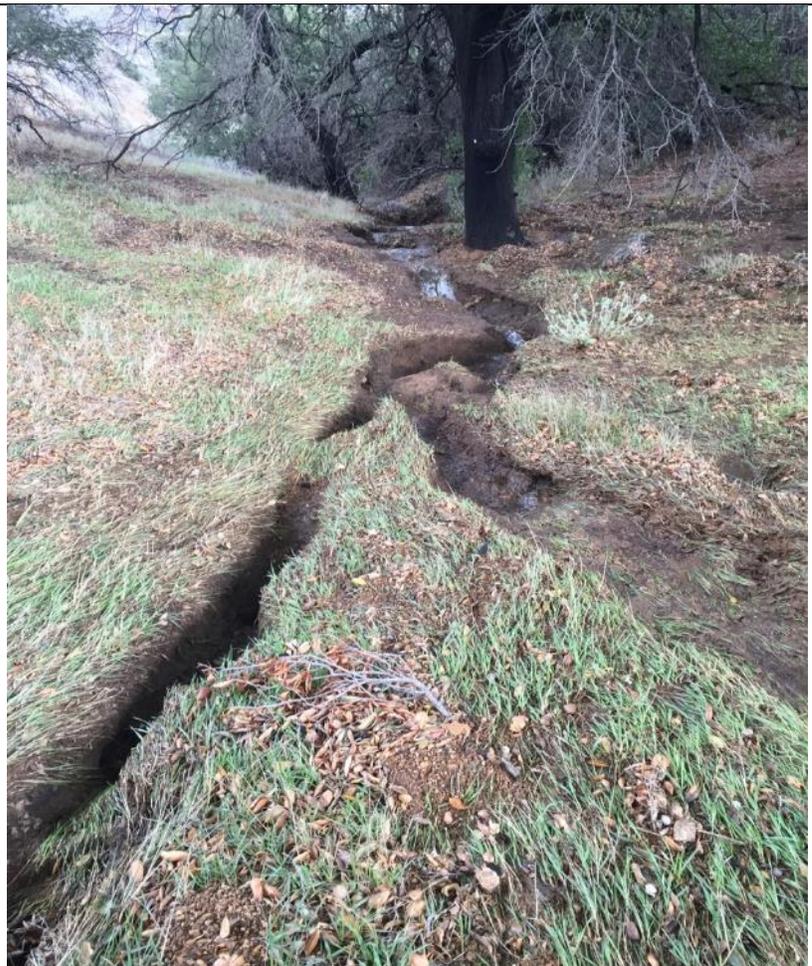
Erosion rills through the oak swale.
1/07/16	Oak swale drainage

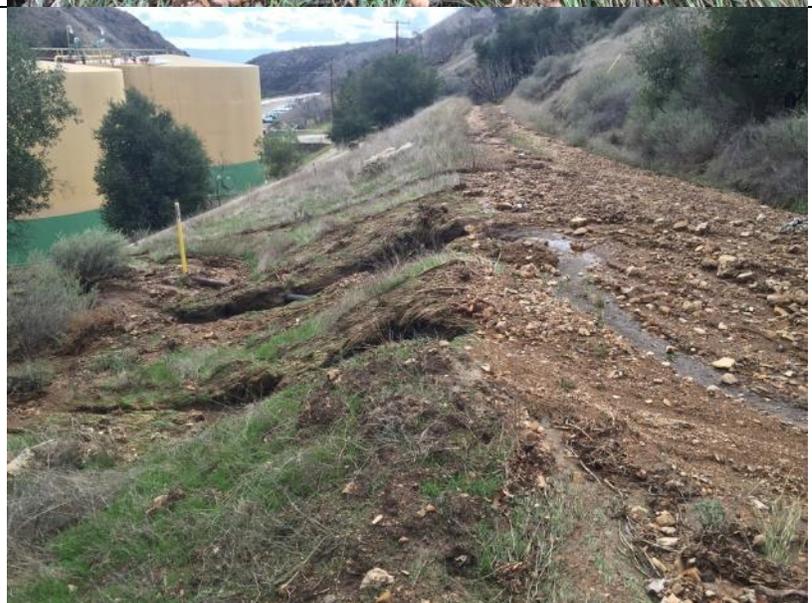
Sediment and erosion at the base of the oak swale drainage.

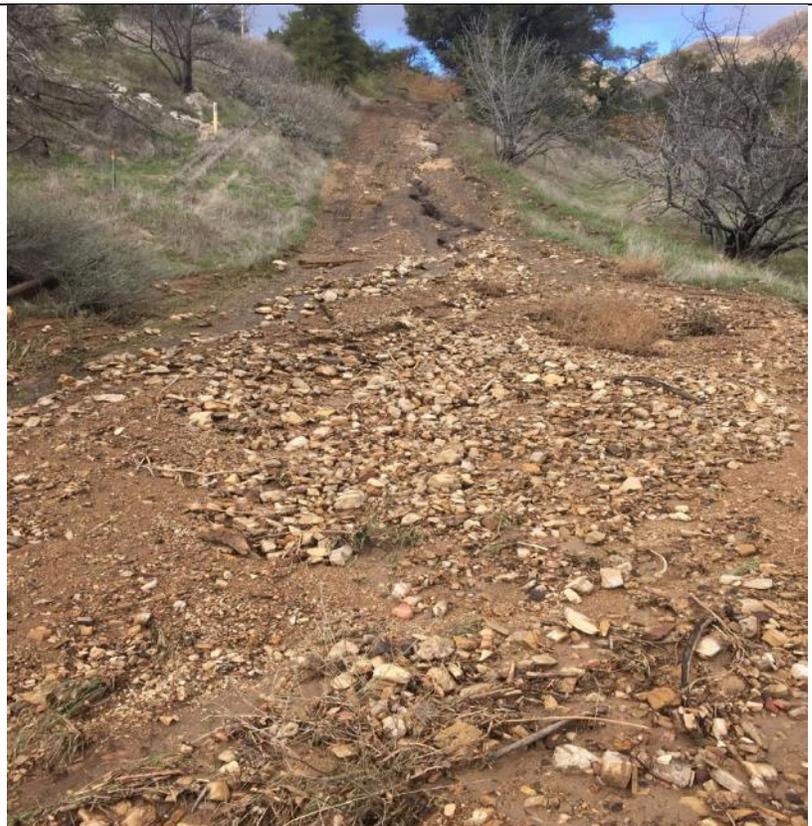
Sediment and erosion at the base of the oak swale drainage.
1/07/16	Oak swale drainage

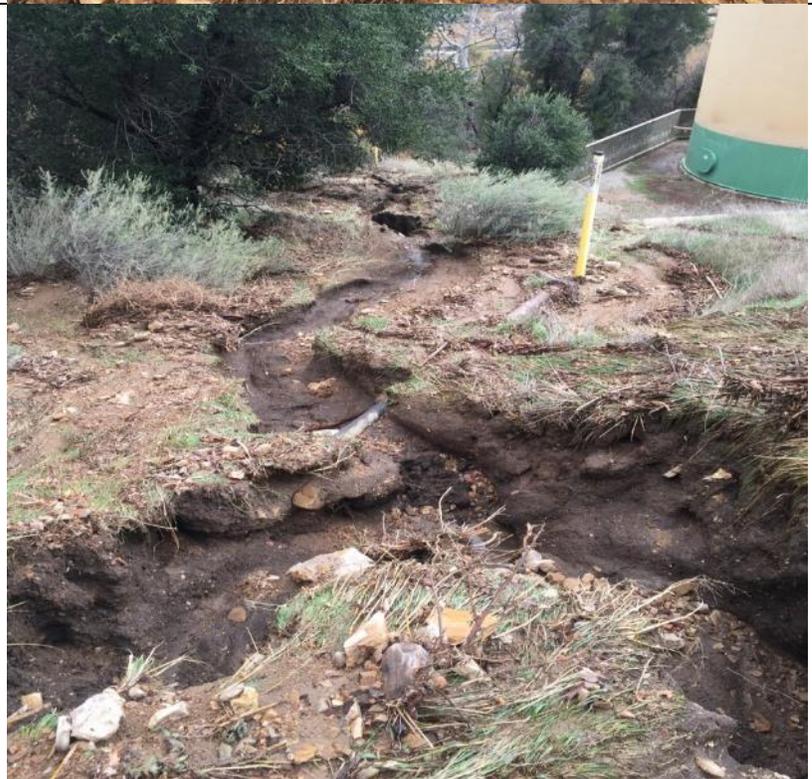
Erosion rills below the oak swale drainage on the banks of Limekiln Creek.

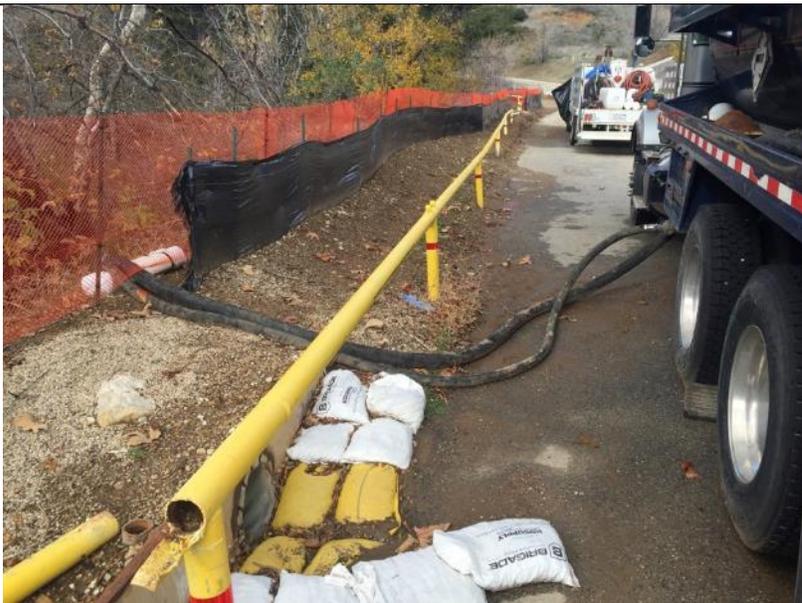
Vacuum truck near the Guard House with hoses leading into the creek.

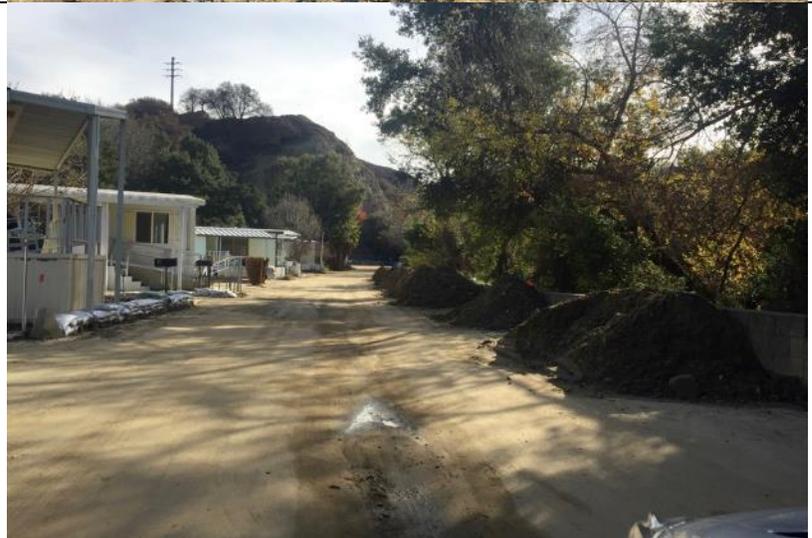
I drove into the Mobile Estates and noted numerous large piles of mud stacked along the paved road leading into the community; it is unknown who piled the mud – see photo. The access road entrance for TSPs 12 through 22 had been cleaned, including the rumble plates – see photo. It appeared that some additional erosion control measures had been installed up the access road, but not near the top of the steep road.

Muddy sediment is piled up along the paved road within the Mobile Estates.

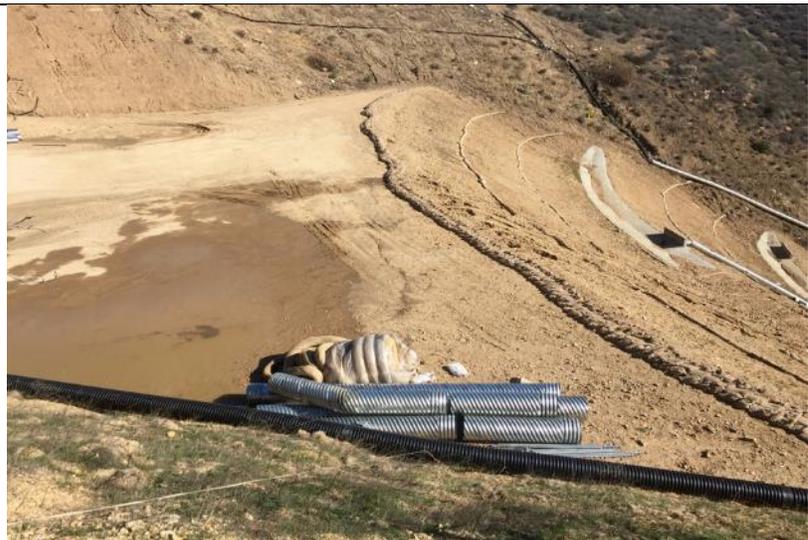
I drove to the PS-42 Fill Site where crews had been working on repairs for the fill site BMPs – see photo. Crews had placed gravel bags along the edge of the top fill key and removed the sediment from the roadway below the PS-42 Fill Site. Crews had also installed some angle pipe on the diversion piping in order to redirect stormwater runoff into the roadway culvert – see photo. I noted large amounts of rock and sediment in the roadway culvert below the diversion piping and in the pipe where it exits into the rip rap below the roadway – see photo. It is assumed that this material reached the culvert by entering the diversion piping and flowing through the piping onto the roadway culvert. No new BMPs have been installed on the roadway; I spoke with Seth Rosenberg (SCG) about this issue later in the day.

<p>Repairs (new gravel bags) made to the BMPs at the top of the PS-42 Fill Site.</p>
1/13/16	PS-42 Fill Site

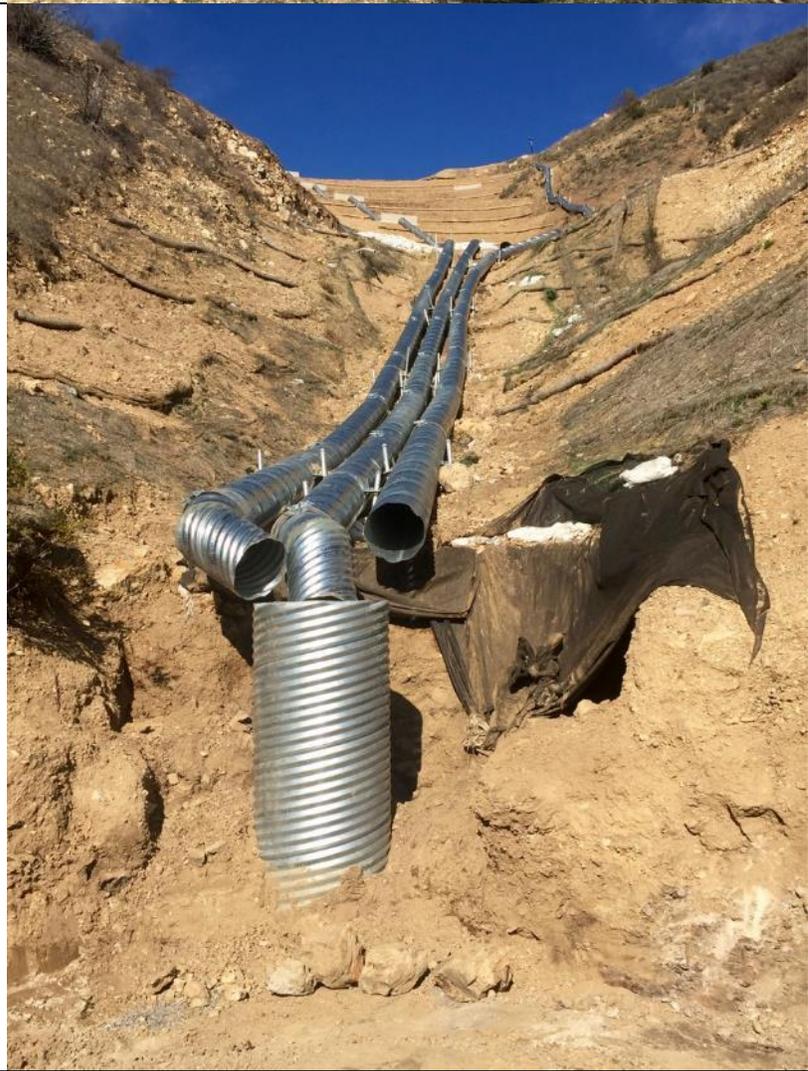
<p>Sediment was removed from the roadway and 45 degree angles were attached to two of the diversion pipes. No new BMPs were installed on the roadway.</p>

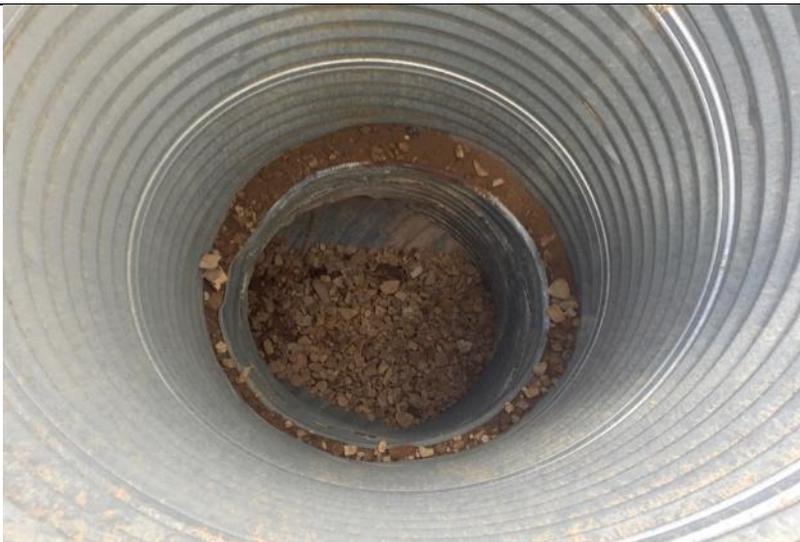
Looking down in the roadway culvert; a large quantity of rock and sediment that came down the diversion pipes is visible.
1/13/16	Culvert outfall under the access road below the PS-42 Fill Site

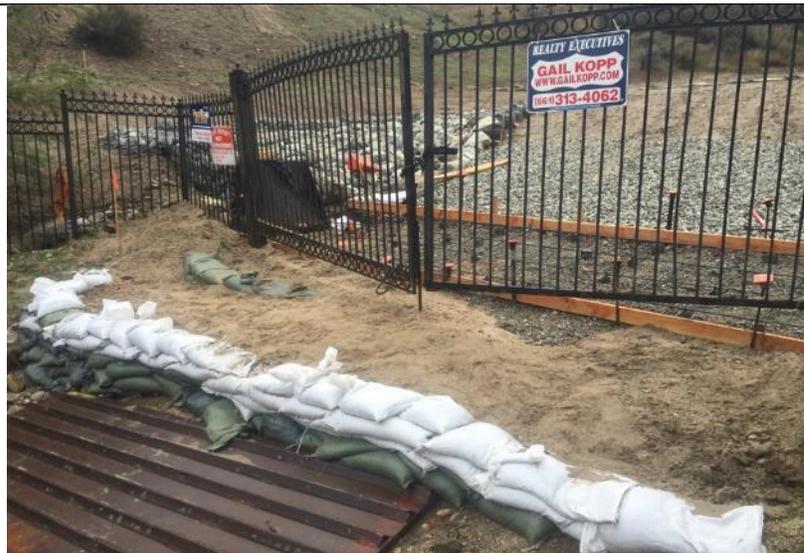
Date	Location	Photo	Description
1/20/16	TSP 7 access road

<p>Entrance to the TSP 7 access road with gravel bag catch basin. Maintenance (i.e., sediment removal) of the BMPs is needed.</p>
1/20/16	Access road entrance for TSP 24/25

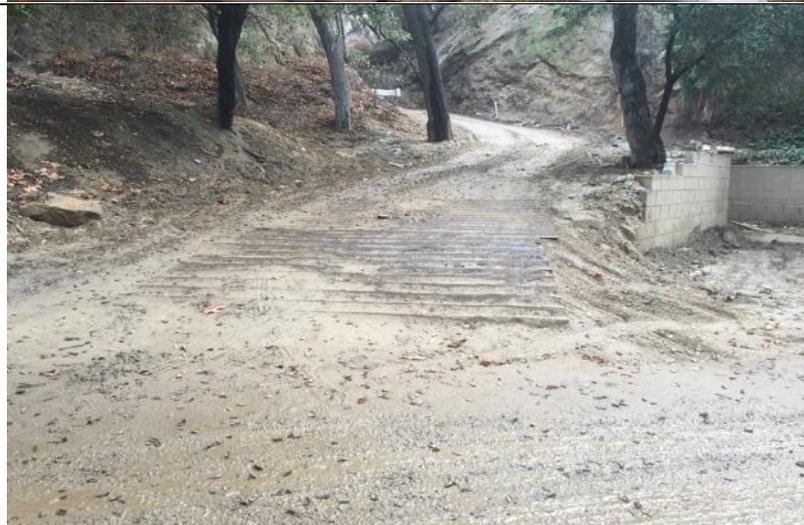
The entrance to the TSP 24/25 access road remained muddy, mostly attributable to project activities; now that the crews are using the road again, the exit/entrance system (i.e., rumble plates and rock) should be reestablished and cleaned – see photo. The access road, itself, has been regraded, and the erosion rills have been repaired. There were some moderate-sized erosion rills coming off of the access road and flowing into Drainage #4 on both sides of the culvert outfall; a temporary or permanent BMP fix should be considered for this location – see photos.

<p>The entrance to the TSP 24/25 access road; maintenance of the rumble plates and road cleaning is needed.</p>
1/20/16	Drainage #4

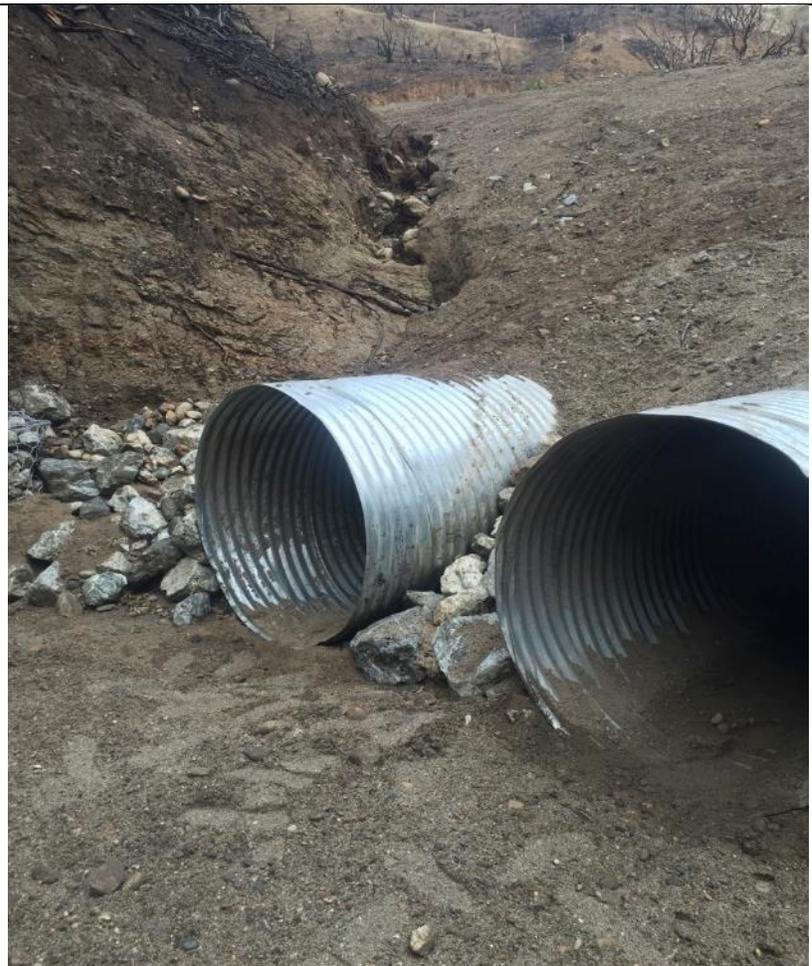
I walked up Drainage #4 to check the TSP 24/25 access road stabilization work and noted that a short piece of old water piping was lodged in the creek near the frontage road – see photo. The culverts have been cleaned out – see photo – but the accumulated sediment was just smoothed out in the drainage. This material was essentially left in the drainage and will flow downstream with the next storm. Ideally, trapped sediment should be removed so that it does not immediately return to the drainage or become trapped behind the BMPs.

Culverts in Drainage #4 were cleaned out; an erosion rill can be seen behind the culverts.
1/20/16	Access road to TSP 24/25 and Drainage #4

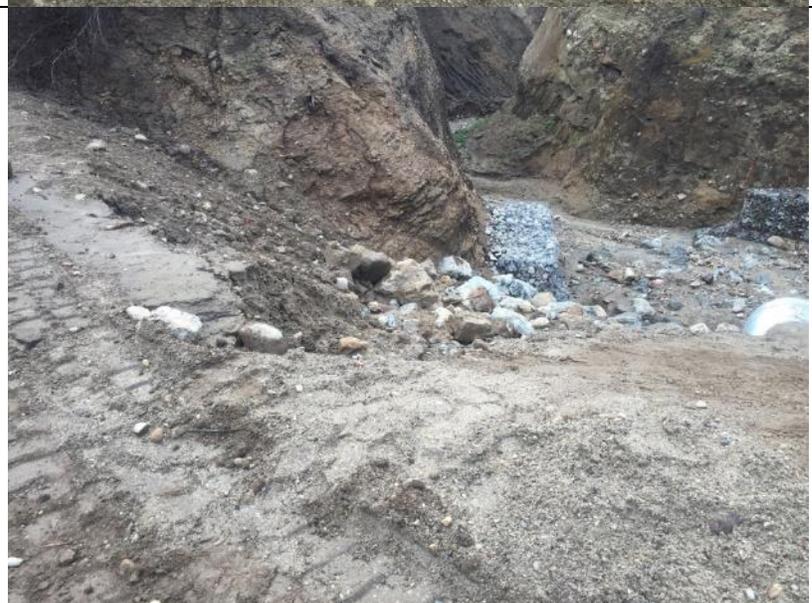
The slope above the culvert outfalls needs temporary or permanent erosion protection measures.

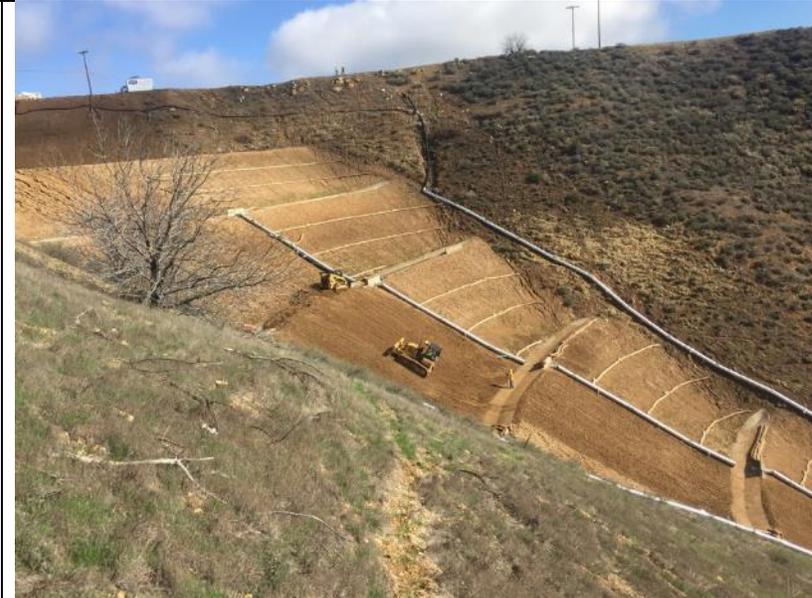
I drove to the PS-42 Fill Site where crews were repairing the erosion problems at the fill site. A crew was reworking the slopes of the PS-42 Fill Site and another crew was building the box culvert at the base of the fill site – see photos. I spoke with Able (the foreman for the construction crew) who said they hoped to be done by Friday. One of the crew members was removing sediment from the culvert pipe.

Crews are reworking the slopes of the PS-42 Fill Site.

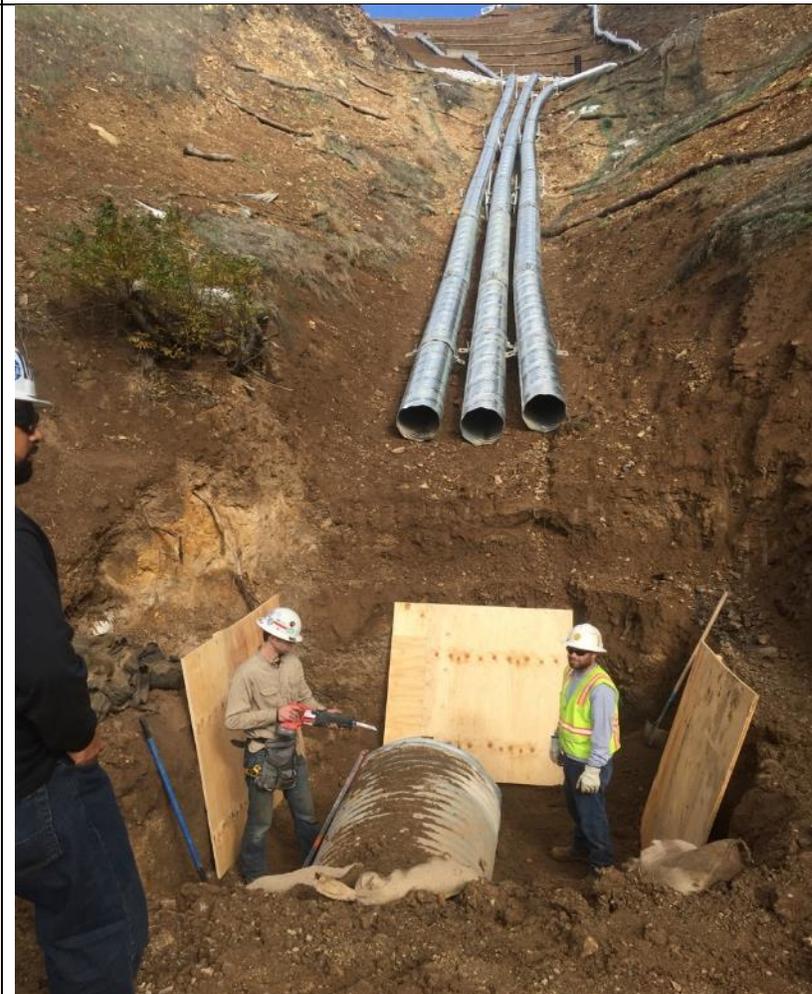
<p>Work on the culvert box has begun; diversion piping will be directed into the box.</p>
1/20/16	Natural Substation access road

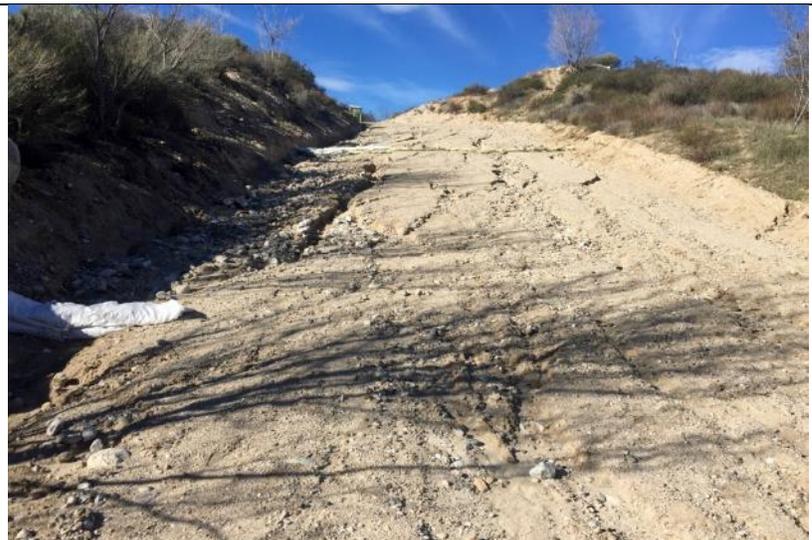
Date	Location	Photo	Description
1/29/16	TSP 7 access road

Access road at TSP 7; some BMPs have been installed, but the road is steep and easily erodes.
1/29/16	TSP 27

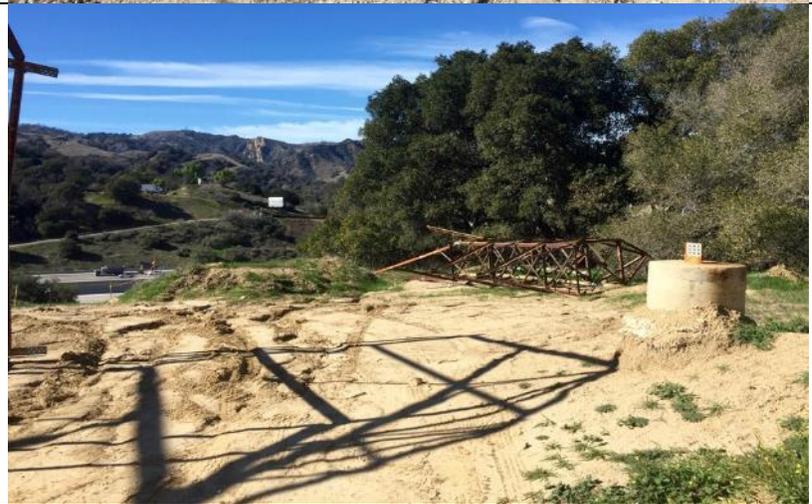
Old tower material and foundations remain at the TSP 27 site.
1/29/16	TSP 28

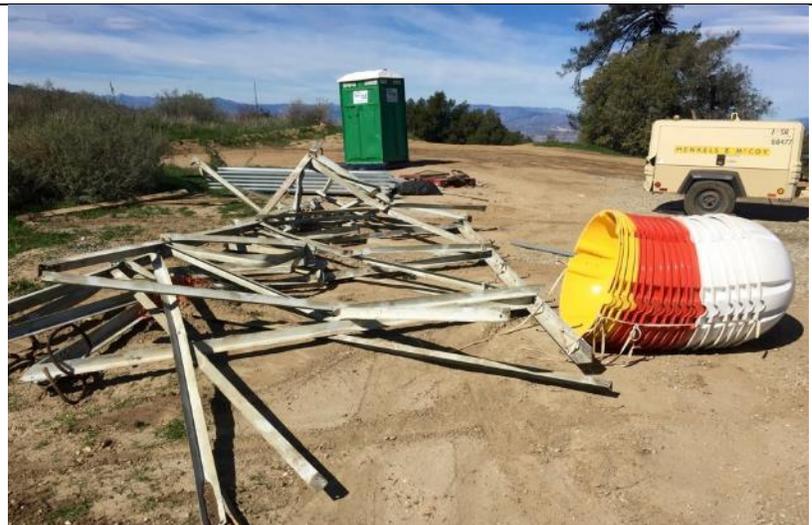
Trash and equipment are stored on the helipad above TSP 30.
1/29/16	Access road to TSP 30

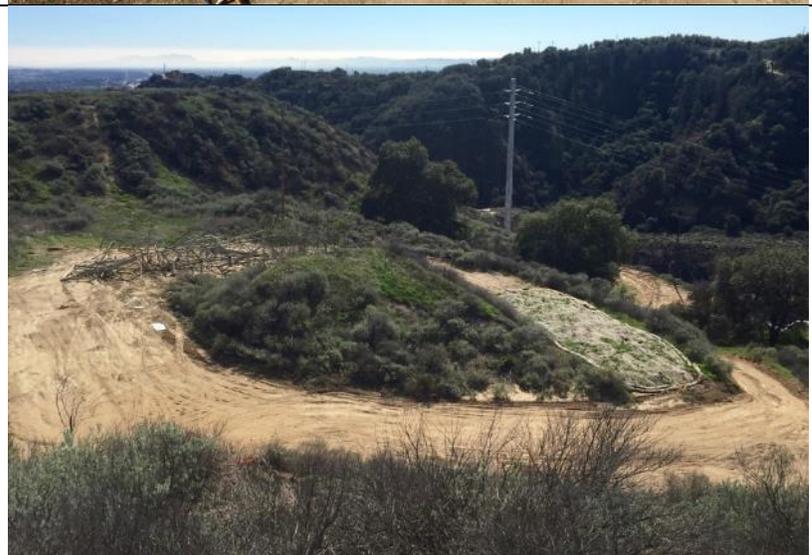
A staging area for the TSP 30 work still has old tower material and stockpiled topsoil. SCE is planning to restore this site.
1/29/16	Access road to TSP 32

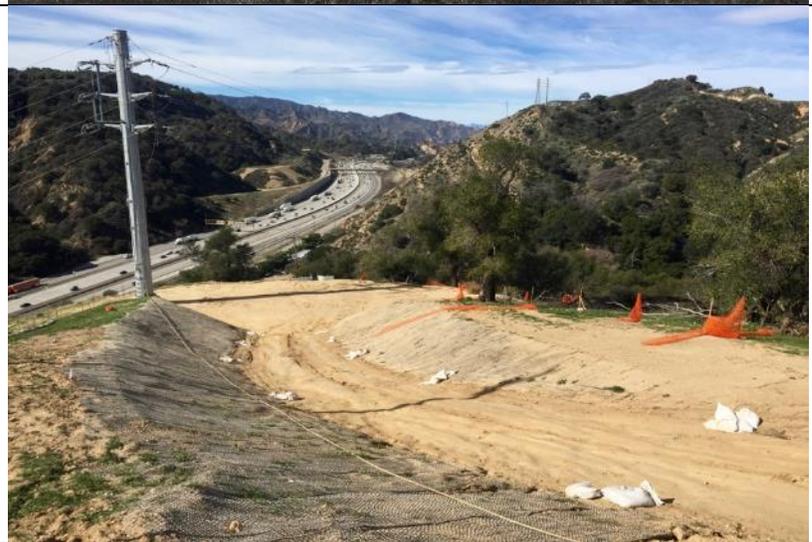
Work area around TSP 32 requires cleanup of construction materials and BMP maintenance.
