Re: Monthly Report Summary #30 for Aliso Canyon Turbine Replacement Project

CPUC Site Inspection Reports
September 1, 8, 14, and 22, 2016

Aliso Canyon Turbine Replacement Project CPUC Site Inspection Form

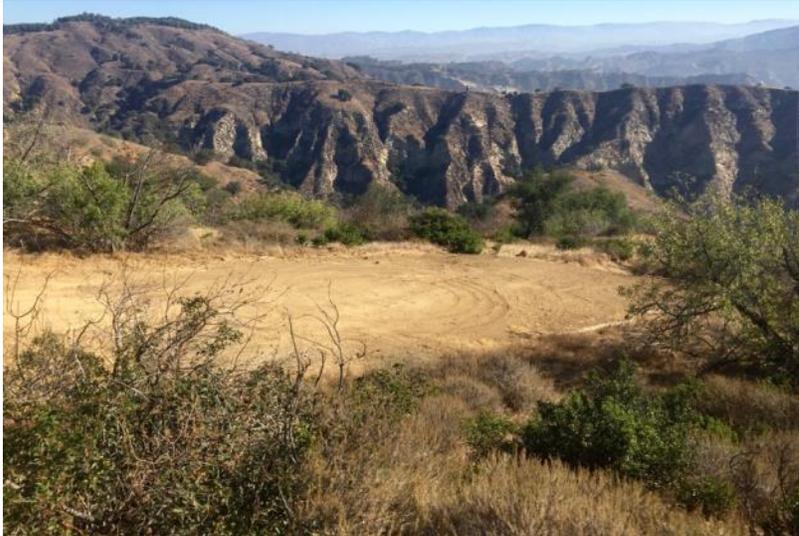
Most of the area appeared to be in good condition, including the access roads, the road shoulders, and the TSP pads. At the end of the access road, just below TSP 39, work crews had stockpiled topsoil (Photo 1). The topsoil was restored, but this location remained devoid of vegetation and it appeared that rainwater runoff flows through this spot; some additional best management practices (BMPs) should be considered before the next rainy season. Photo 2 shows a very steep portion of the access road shoulder that is located just above the topsoil stockpile area. This area has been stabilized with erosion blankets, but straw wattle upgrades are recommended.

Photo 1 – Topsoil stockpile area near TSP 39. Additional BMPs should be considered before the next rainy season.
9/01/16	TSP 39 Access Road

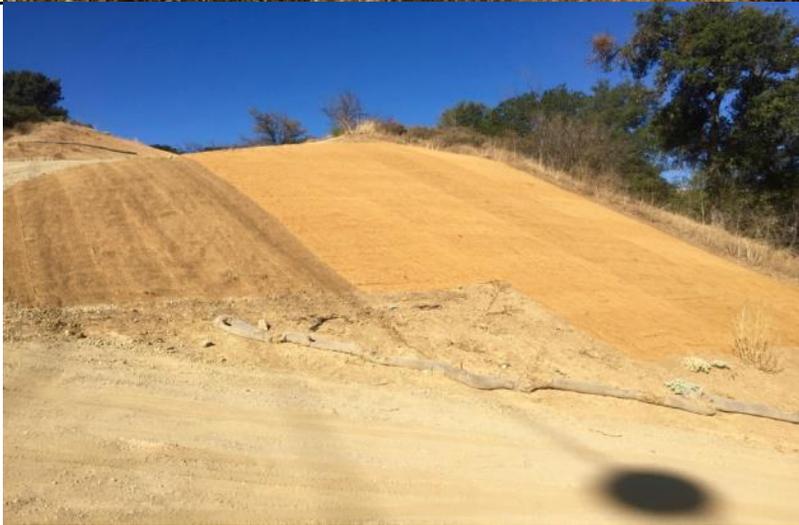
Photo 2 – Steep slope along the access road near TSP 39.
9/01/16	TSP 39

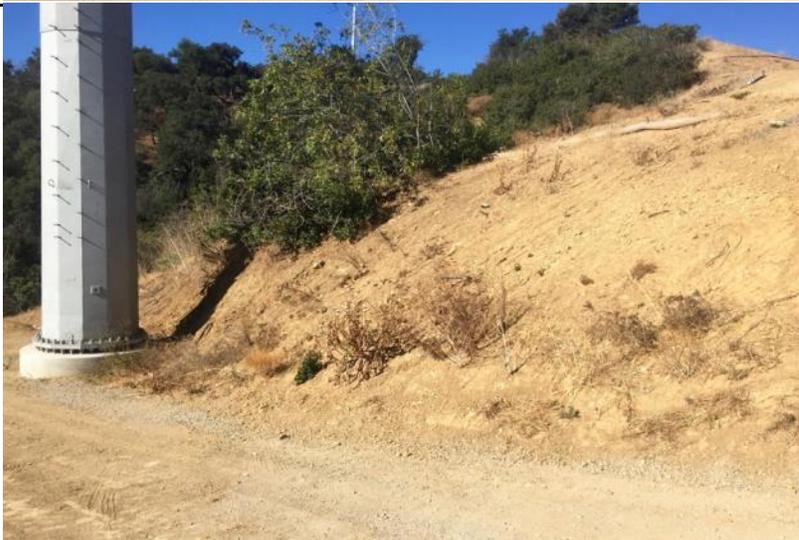
The TSP 39 site appeared to be in good condition; no construction material remained at the site, but a small amount of orange construction fencing was noted just west of the TSP. A steep slope next to the TSP appeared vulnerable to erosion (Photo 3) and may require BMPs prior to the rainy season. The steep portion of the access road along TSP 41 and up toward TSP 42 (Photo 4) appeared to be in good condition with well-built water bars that drained into rock energy dissipaters. The road shoulders were also well vegetated along this portion of the road, with minimal weed growth.

Photo 3 – Steep slope next to the pole may need some additional BMPs.

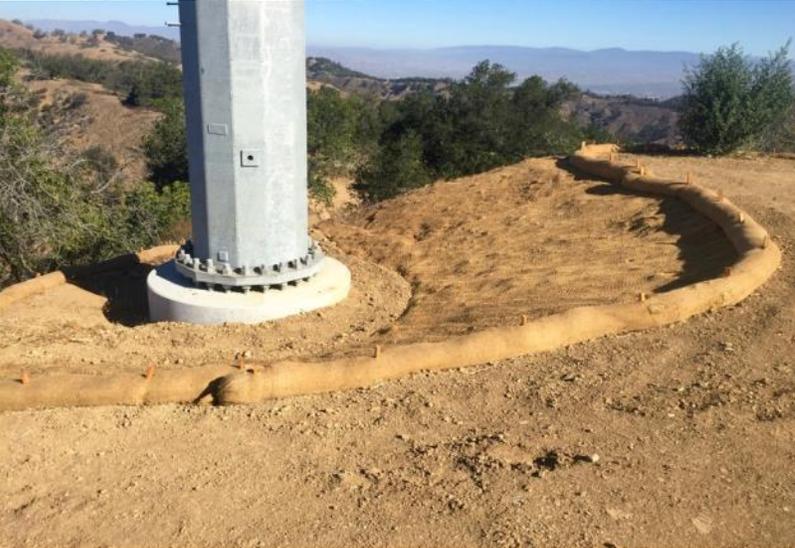
The TSP 42 pad had been stabilized with erosion blankets and straw wattles that appeared to be in good condition (Photo 5). The access road to TSP 42 was also in good condition (Photo 6), although I noted some construction trash along this stretch of the road. Photo 7 shows the flagging and the metal labels identifying lilies below the TSP site.

Photo 5 – Restoration around the base of TSP 42.
9/01/16	TSP 42 Access Road

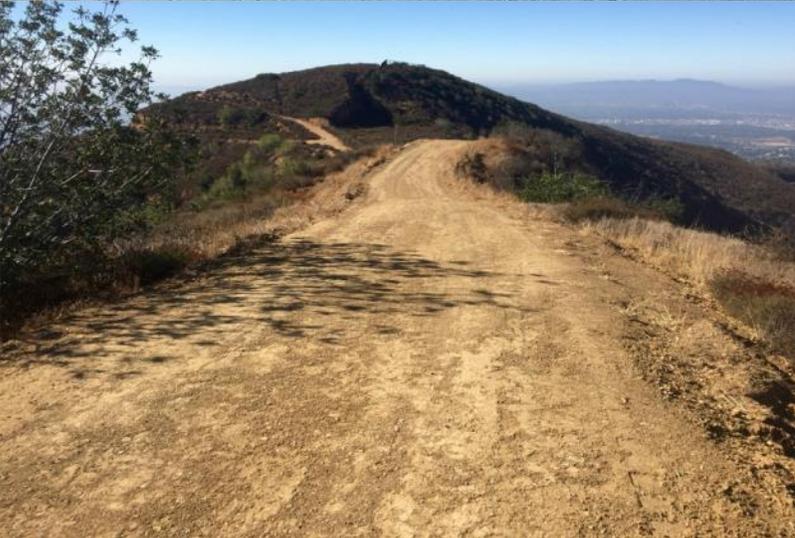
Photo 6 – TSP 42 access road.

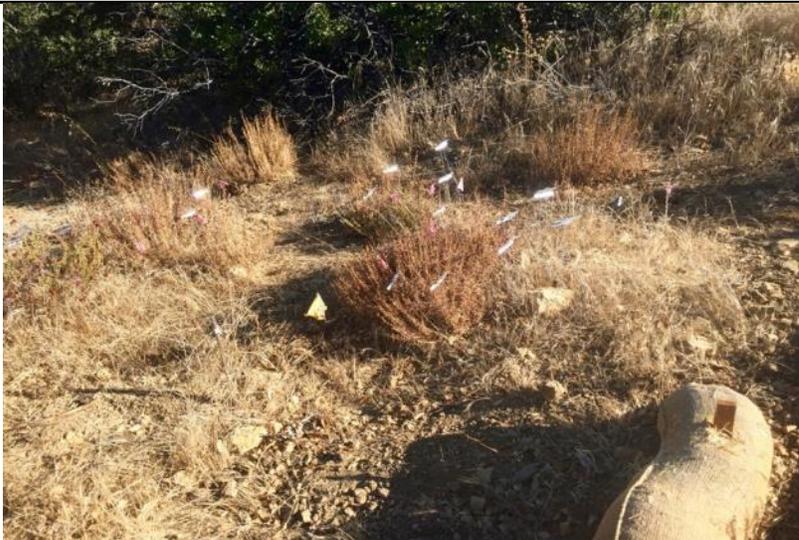
Photo 7 – Lily locations below the TSP site are flagged.
9/01/16	Access Road Just Before TSP 42

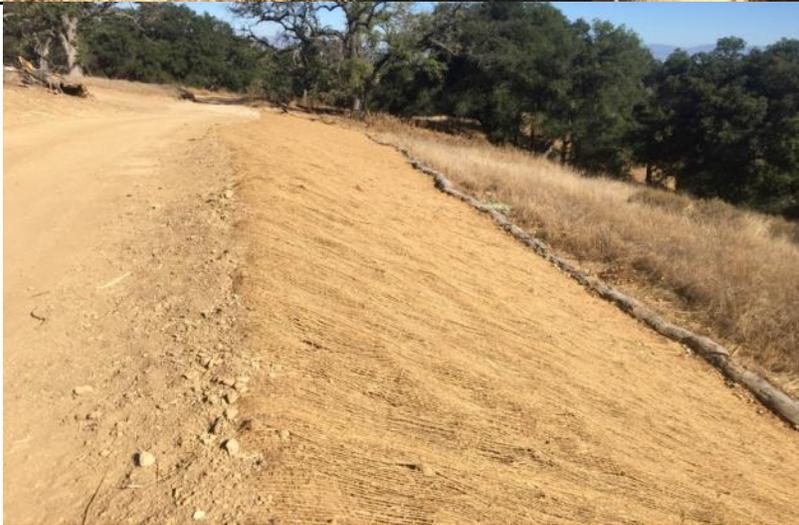
Topsoil had been restored to some of the access road shoulder in the area just before reaching TSP 42 (Photo 8). The work was done well, with the topsoil securely covered with erosion blankets. We finished checking this area and traveled back through the six gates. Klaus Wojak took me to my car.

Photo 8 – Portion of the access road where topsoil was restored to the road shoulder.
9/01/16	PS-42 Fill Site

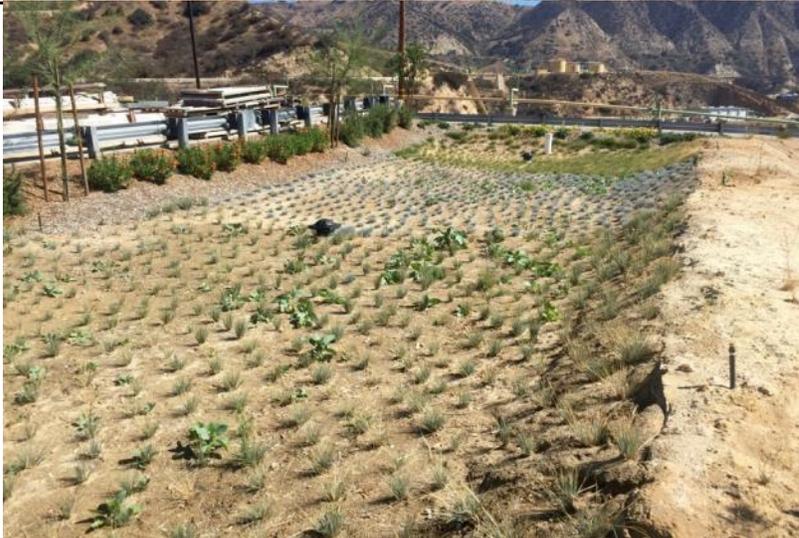
At the new Admin/IM Building, progress was being made (Photos 10 and 11). I noted quite a bit of tree tobacco growing within the bioswale (Photo 12); it is recommended that these plants are removed before they become larger and well-established.

Photo 12 – The new Admin/IM Building bioswale has extensive amounts of tree tobacco coming in.

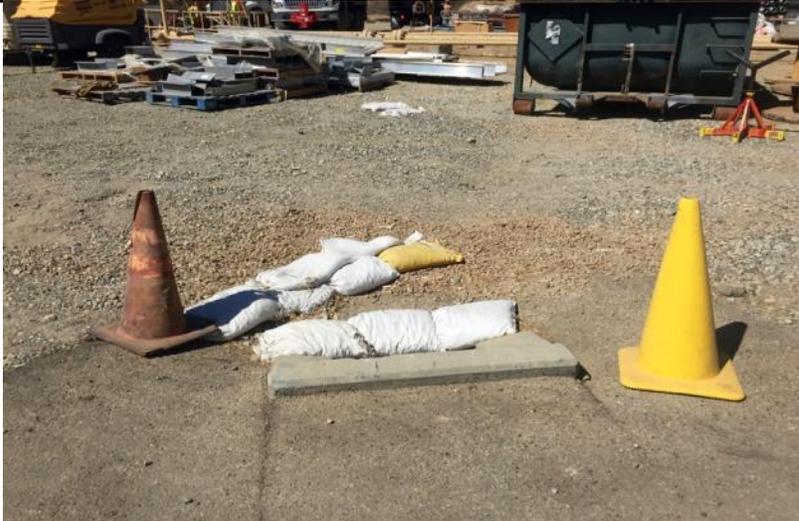
I drove past the P-37 Kiewit staging area to look at the second drain inlet (Photo 14). This drain had gravel bags placed around it, but they are unlikely enough to contain sediment.

Photo 14 – A drain within the P-37 Kiewit staging area with some gravel bags around it.
9/01/16	Guard House

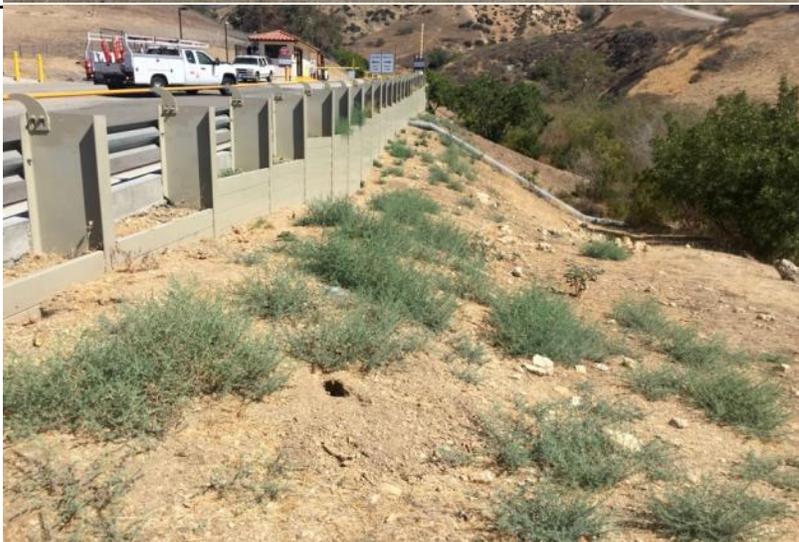
Photo 15 – Russian thistle is growing along the creek side of the Guard House.

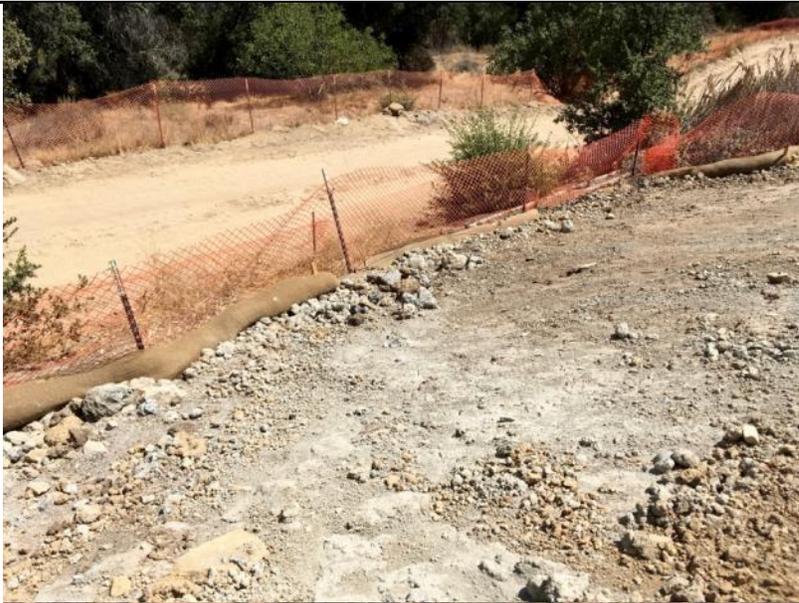
Photo 11 – Restored slope below the A2 12-kV TSP; needs some additional work.
9/08/16	CCS

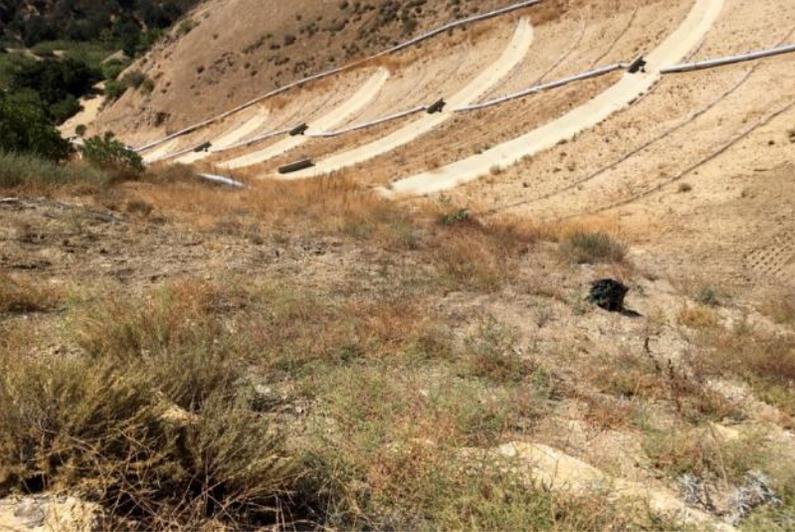
Photo 2 – Russian thistle removal is taking place on the eastern slope of the PS-42 Fill Site.
9/14/16	PS-42 Fill Site

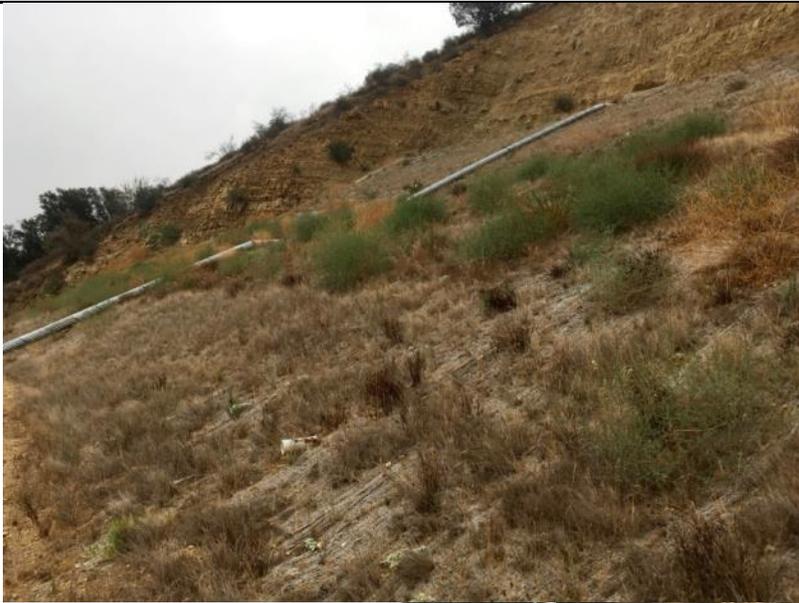
I stopped at the P-41 Fill Site and noted that quite a bit of Russian thistle was growing on the lower slope site (Photo 4). There was also a long line of plastic covered straw wattle at the base of the P-41 Fill Site near the "V" ditch (Photo 5). The straw is breaking down within the wattles leaving the plastic netting exposed and able to trap animals (Photo 6). Since the P-41 Fill Site slopes appeared to be stable, this wattle may not need to be replaced, but the plastic covering should be removed.

Photo 4 – Russian thistle on the slopes of the P-41 Fill Site.
9/22/16	P-41 Fill Site

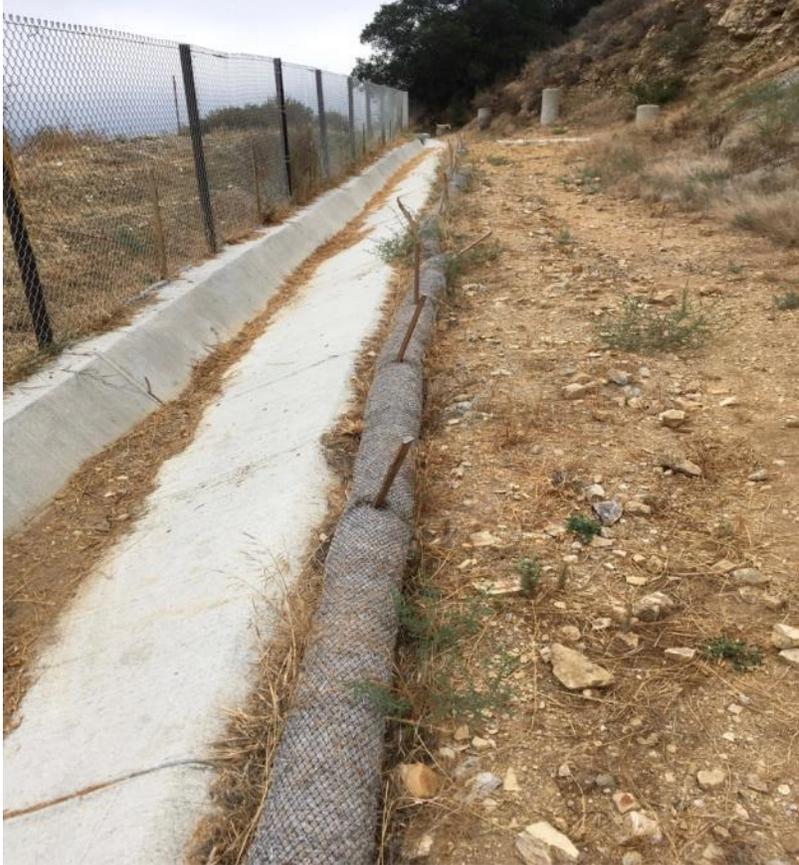
Photo 5 – Plastic covered straw wattles along the “V” ditch at the base of the P-41 Fill Site.

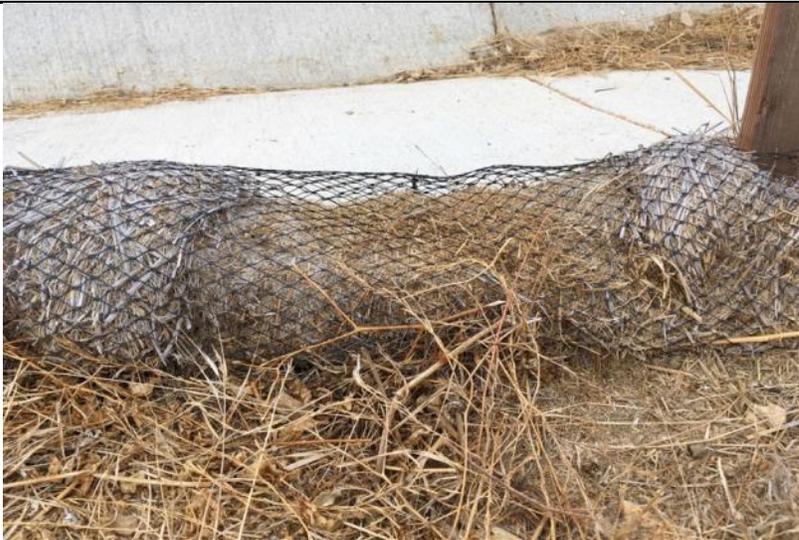
Photo 6 – Straw within the old wattles is breaking down and opening up the plastic netting allowing access to animals attempting to crawl in or through it
9/22/16	Upper Sedimentation Basin/Newt Pond in Limekiln Creek

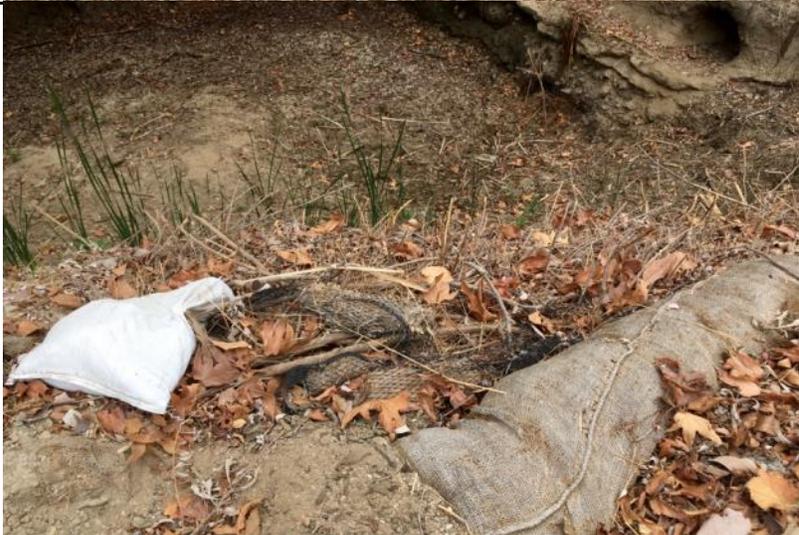
I walked by the upper sedimentation basin/newt pond in Limekiln Creek located just west of the CCS. The creek was dry, and I noted several lines of the old plastic covered straw wattle near the creek and some very deteriorated wattle along the edge of the creek bank (Photo 7). This plastic wattle material should be removed as soon as possible, since it is within the riparian corridor.

Photo 7 – Some degraded, plastic covered, straw wattle was noted along the edge of the upper sedimentation basin/newt pond. No animals were observed as being trapped in the plastic.
9/22/16	CCS

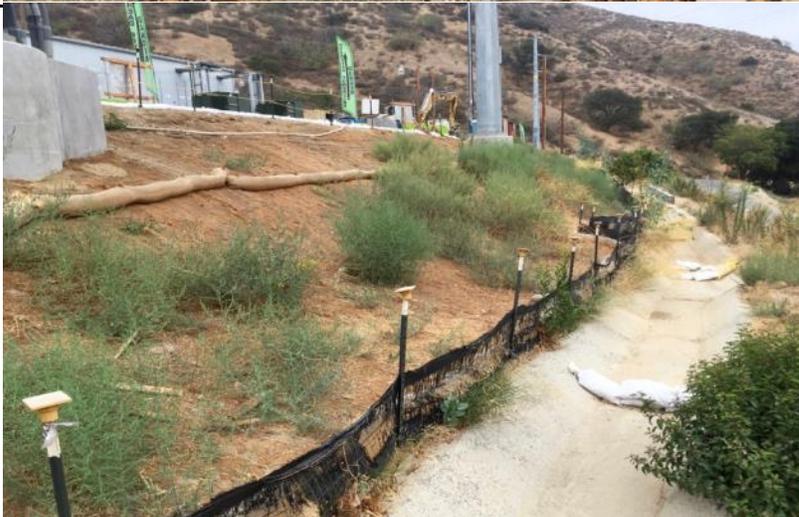
The west slope of the CCS was supporting a stand of Russian thistle, and the silt fencing was shredded by the elements (Photo 8). Within the CCS, the biofiltration pond has been dug and shaped (Photo 9). A trench within the CCS remained open and covered by steel plates, with a sloped exit ramp (Photo 10). Photo 11 shows some of the ongoing construction activities within the CCS. There are numerous locations in and around the CCS where old plastic covered straw wattles are still in place (Photos 12 and 13); these need to be removed and/or replaced.

Photo 8 – The west facing slope of the CCS has large quantities of Russian thistle, and the silt fencing BMPs are in need of repair or removal.

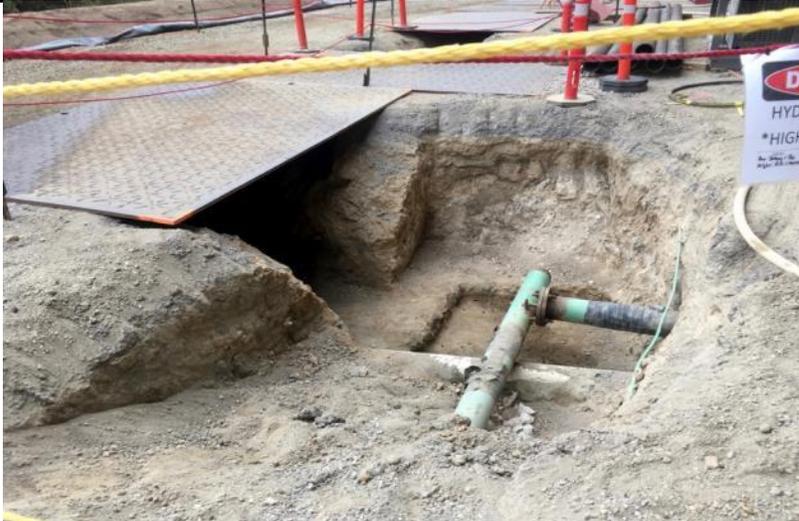
Photo 10 – Trench within the CCS is covered with steel plates and has an exit ramp at the south end.
9/22/16	CCS

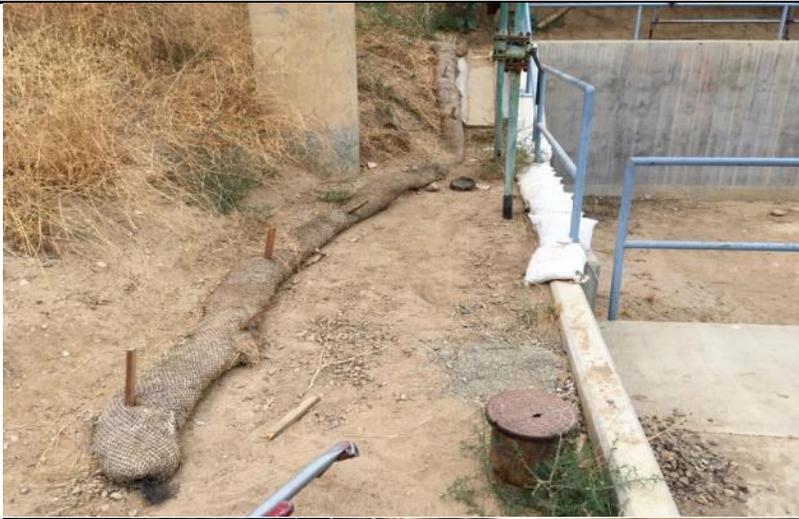
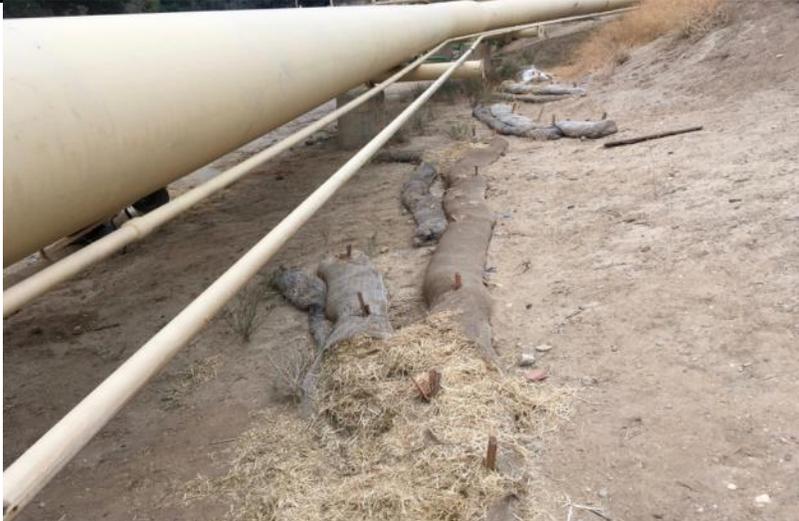
Photo 12 – Old straw wattle.
9/22/16	CCS

Photo 13 – Old straw wattle.
9/22/16	New Admin/IM Building

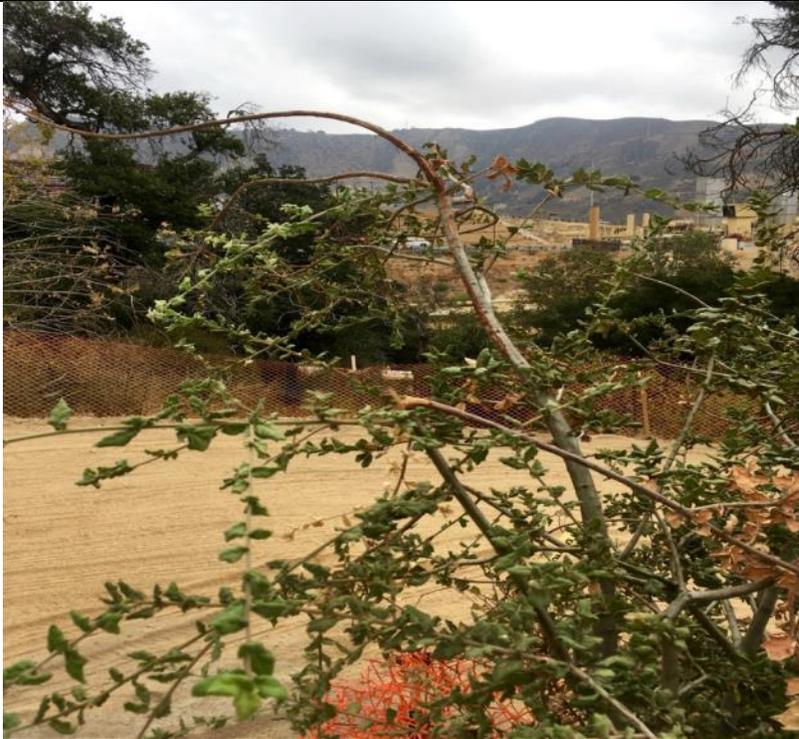
Photo 16 – Sapling oak tree next to the access road and crane pad that could likely benefit from trimming.
