**Re: Monthly Report Summary #10 for Aliso Canyon Turbine Replacement Project**

## Aliso Canyon Turbine Replacement Project CPUC Site Inspection Form

Project:	Aliso Canyon Turbine Replacement	Date:	January 8, 2015
Project Proponent:	Southern California Gas Company and Southern California Edison	Report #:	VS039
Lead Agency:	California Public Utilities Commission	Project Phase/NTP:	Guard House and Road Widening Component (NTP-1). The New Admin/IM Building (NTP-2) and Central Compressor Site (NTP-3). P-41 and P-43 fill sites (NTP-2). PS-42 Fill Site and the PS-42 Rock Site and Temporary Fill Site. P-32 fill site (NTP-3) and the Natural Substation (NTP-3, NTP-A). TSP-45, San Fernando Substation and Wiley Canyon (NTP-A).
CPUC PM:	Andrew Barnsdale, Energy Division	AM/PM Weather:	Sunny with mild temps (68 degrees F), clear with a temp of 65 degrees F. Temp up to 72 degrees by mid afternoon.
E & E CM:	Lara Rachowicz	Start/End time:	0900 hrs to 1245 hrs within the Aliso gas field, 1300 hrs arrive at the San Fernando Substation, 1400 hrs arrive at Wiley Canyon.

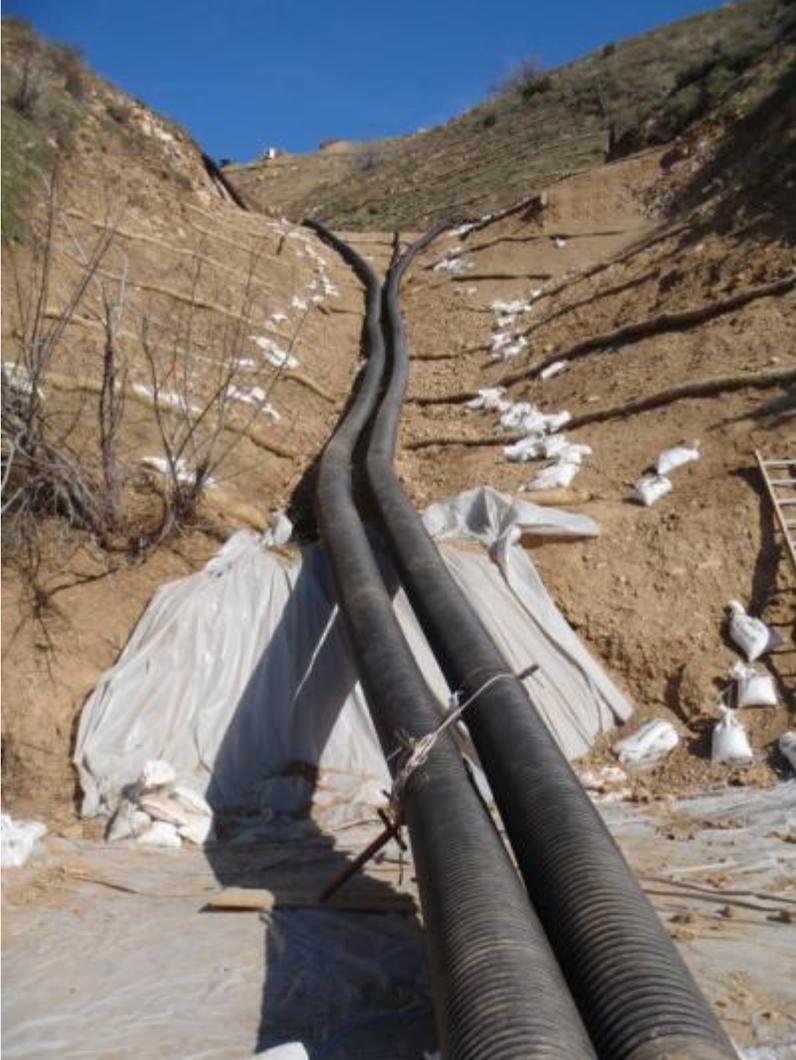
Date	Location	Photo	Description
1/08/15	PS-42 Fill Site

At the PS-42 Fill Site a crew is removing the plastic from the slope below the fill key – see photo – and replacing it with fiber matting. While I was onsite the fiber matting was being delivered to the site. Later in the day I discussed with Amandeep my concern with the erosion below the access road. We agreed that the fiber matting may alleviate the problem since the fiber will reduce and slow the amount of water coming off of the slope. The plastic piping seems to have shifted down by the access road and may need some additional stabilization.

The plastic sheeting is being removed and replaced by fiber matting. Note in the picture the piping has shifted as indicated by the stabilizing bar.

Continue to evaluate the effectiveness of the temporary BMPs at PS-42 after rain events.

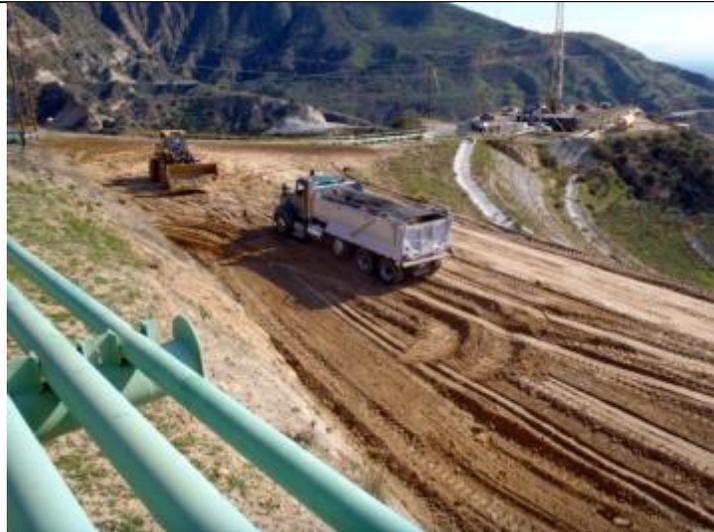
<p>1/08/15</p>	<p>P-32 Fill Site</p>

<p>Dirt from the CCS site is being brought to the P-32 fill site. The soil is dumped and then compacted.</p>
<p>1/08/15</p>	<p>Natural Substation</p>

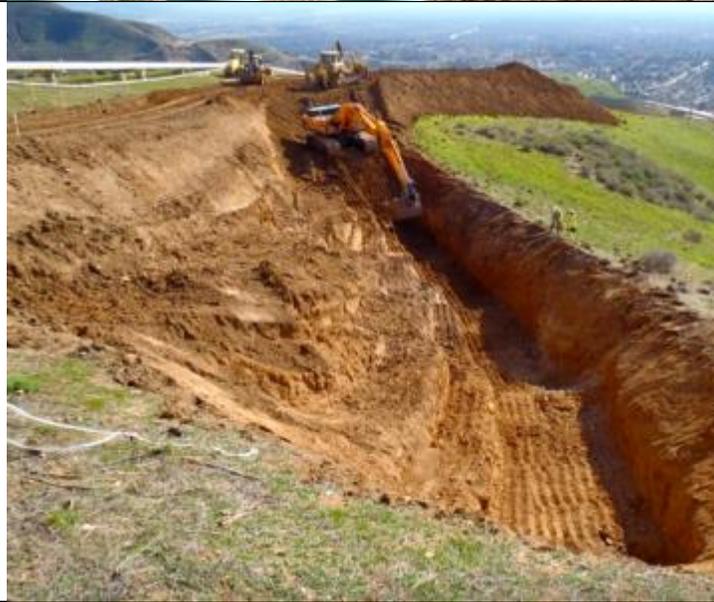
<p>Excavation and grading have begun on the Natural Substation access road.</p>
<p>1/08/15</p>	<p>Natural Substation</p>

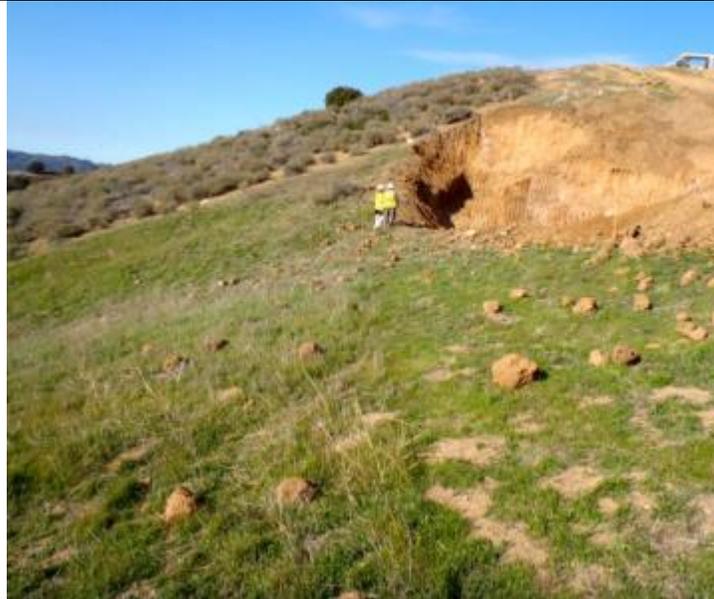
<p>Dirt clods can be seen outside of the access road easement.</p>

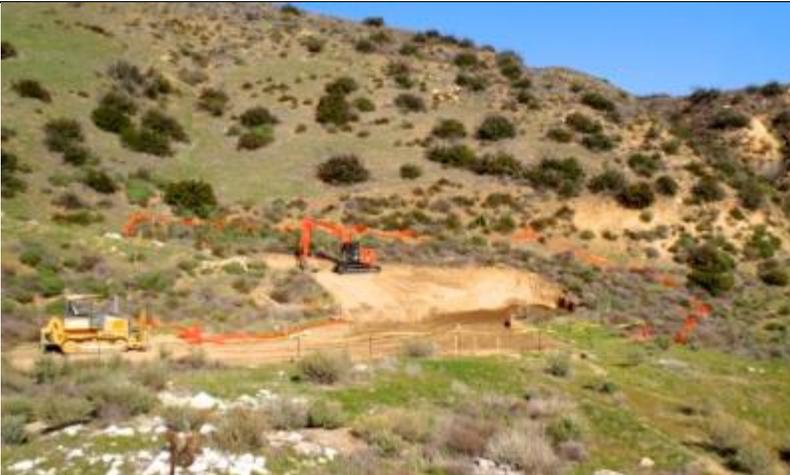
1/08/15	TSP 45

Backfill and compaction of soil into the pull station continues.
1/08/15	New Admin/IM Building

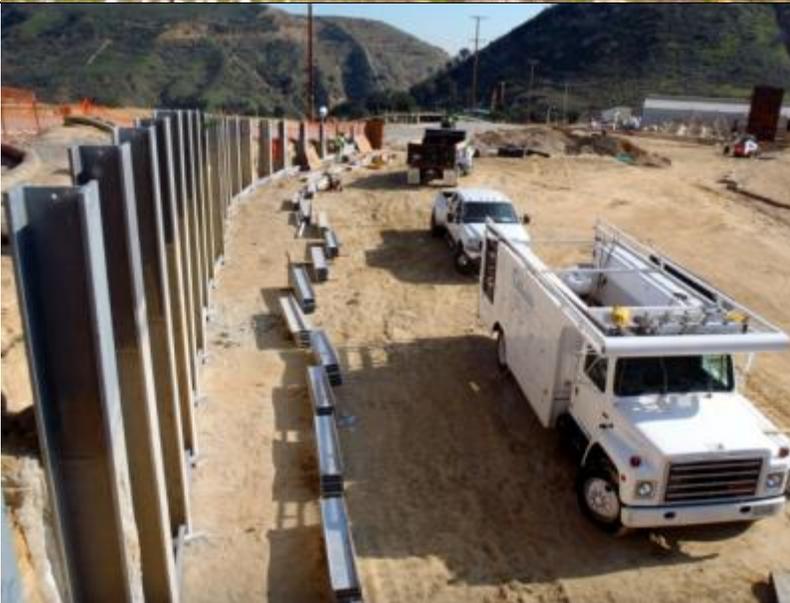
At the New Admin/IM area, a crew is working on the caissons – see photo – all looks good.

Work is being done on the caissons.
1/08/15	Central Compress-or Station

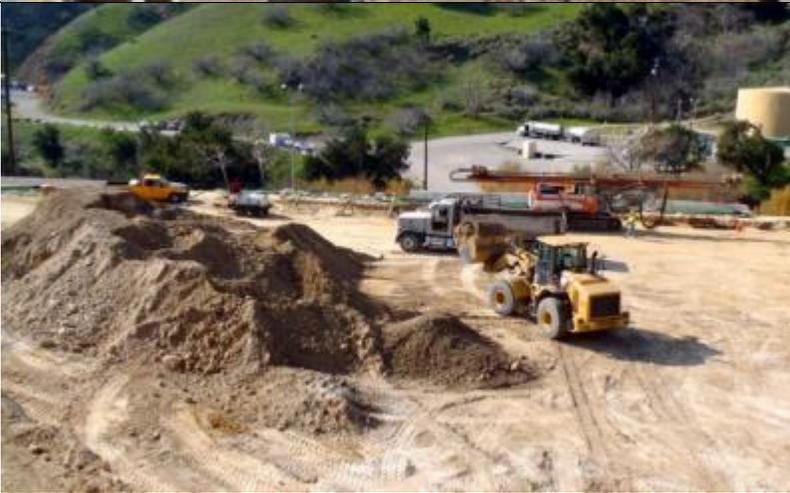
Soil is being loaded up for transport to the P-32 fill site.

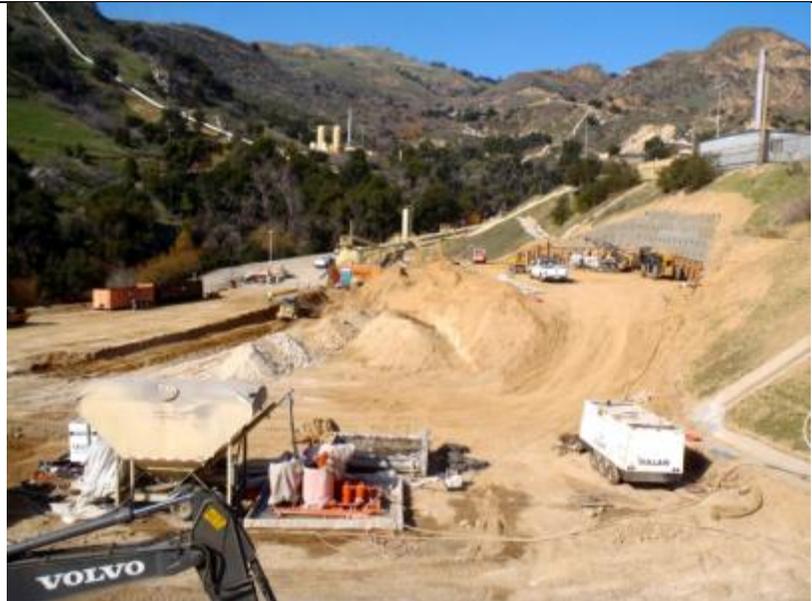
1/08/15	Central Compress- or Station

Soil compaction and work on the retaining walls continues within the CCS site.
1/08/15	Guard House

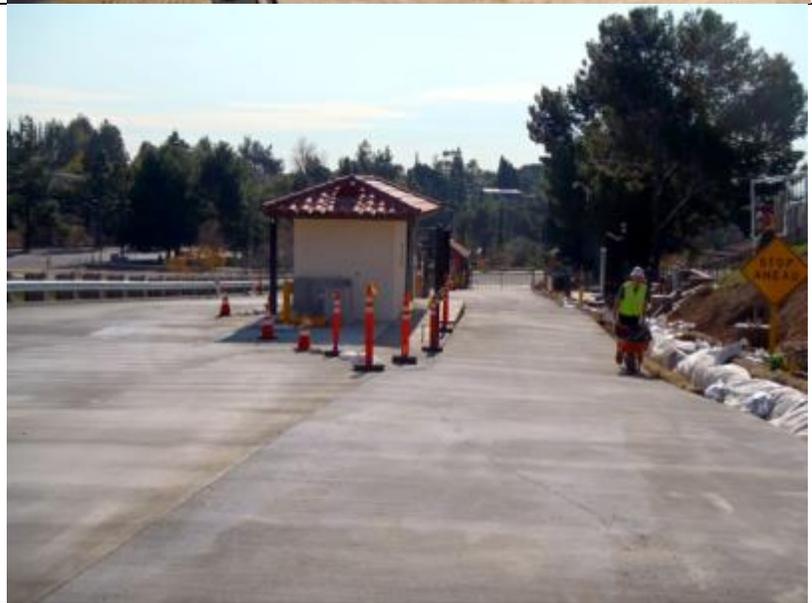
The road work has been completed at the Guard House.

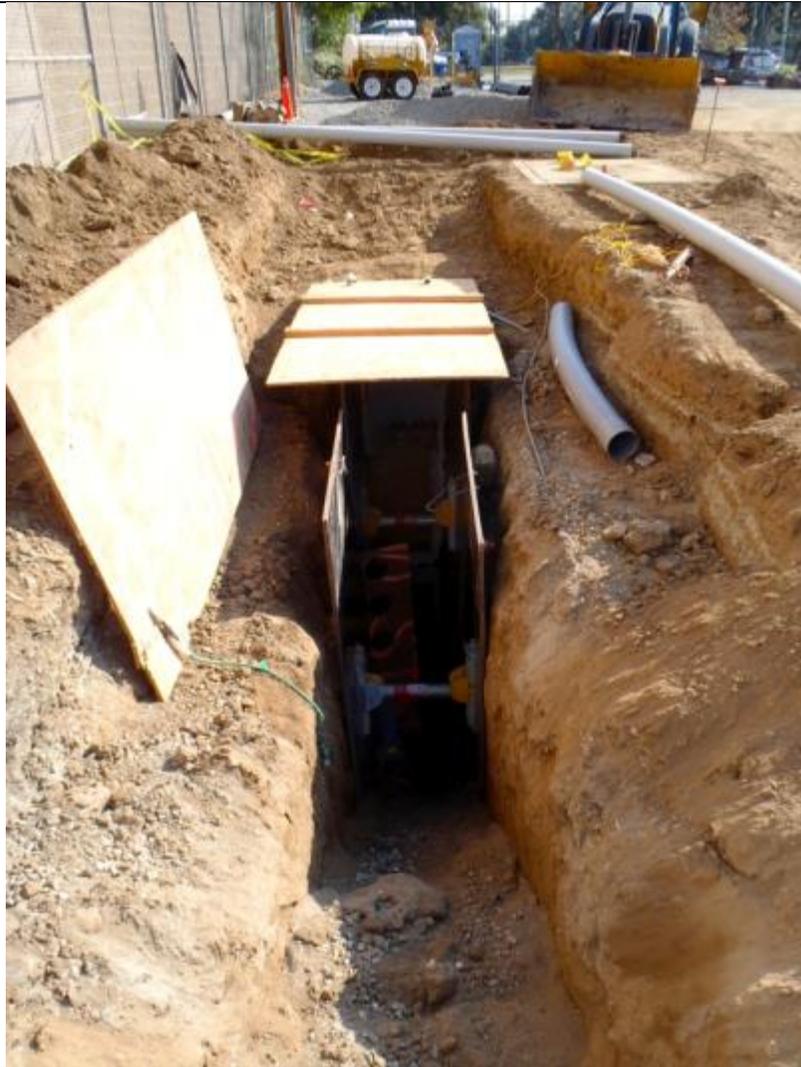
San  
Fernando  
Substation

Trenching continues  
for the conduit.

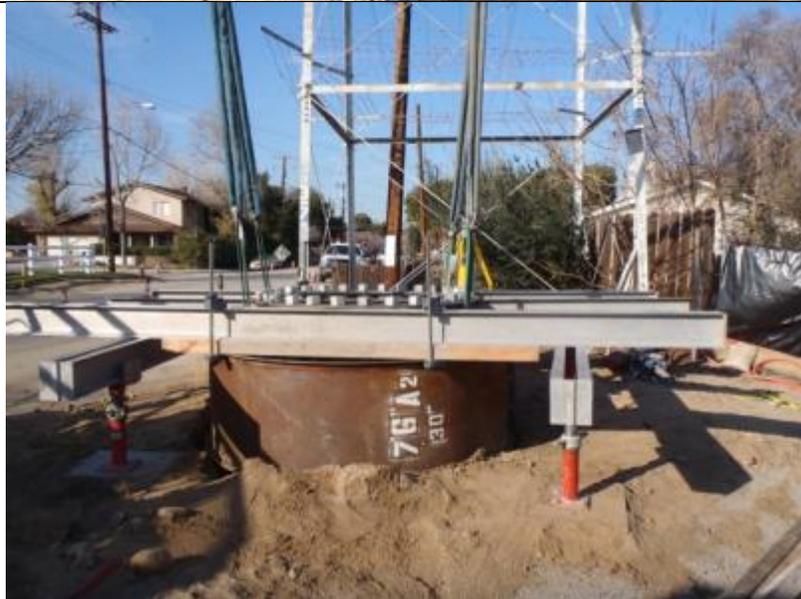
Wiley  
Canyon  
TSP 6

The site has been  
bored, the cage  
installed, and the  
forms set. Crews were  
waiting for the  
concrete trucks.

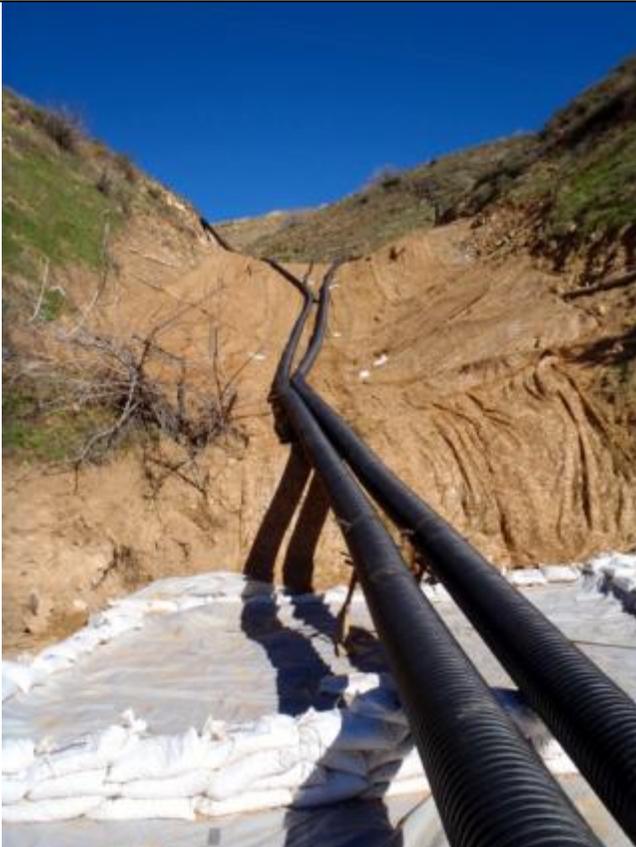
Date	Location	Photo	Description
01/15/15	PS-42 Fill Site

Fiber matting has been installed, replacing the plastic sheeting below the fill key. The site recently received 1.25 inches of rain.
01/15/15	PS-42 Fill Site

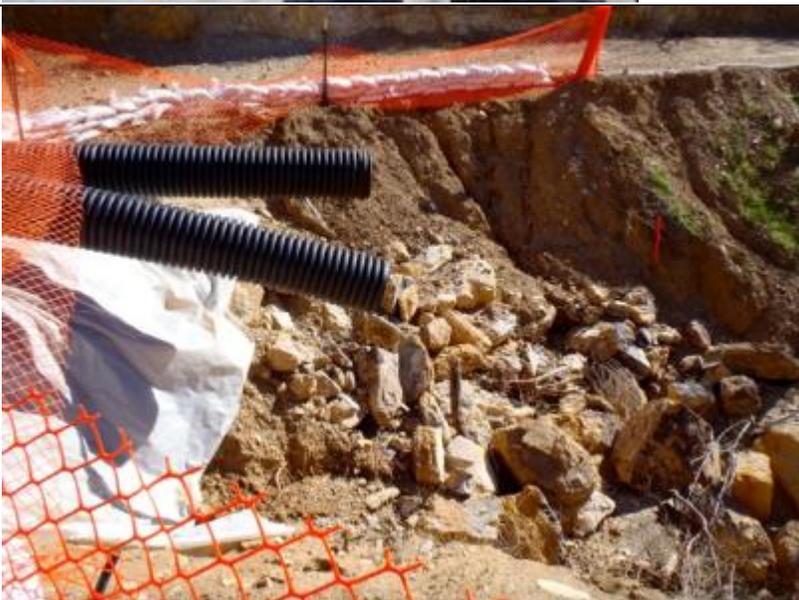
The diversion pipe in the foreground has been shortened.

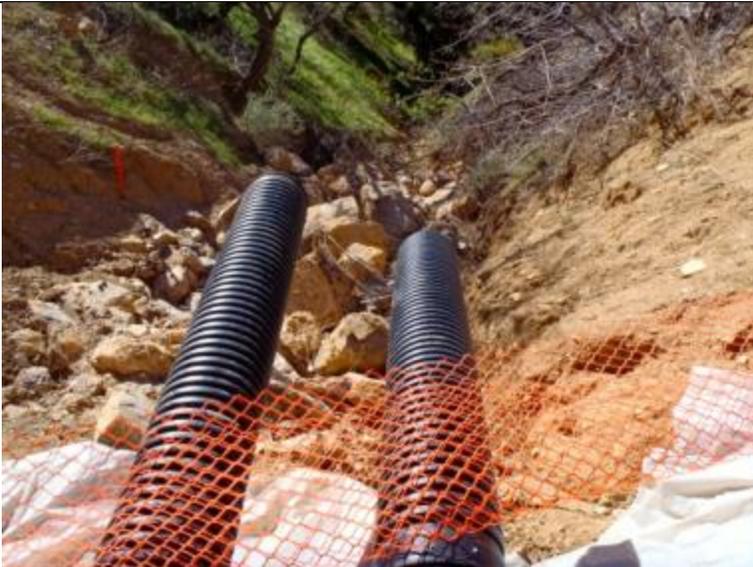
01/15/15	PS-42 Fill Site

<p>The shortened pipe looks like it has been moved and is now pointing more toward the edge of the riprap; it should point more toward the center of the riprap.</p>
01/15/15	Natural Substation

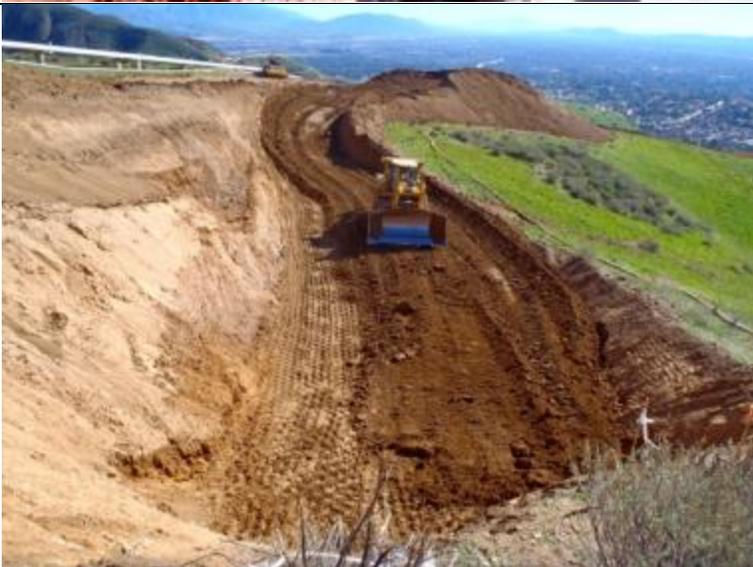
<p>A crew is recompacting soil into the access road up toward the top of the slope. Note that straw wattle has been installed downslope of the earthwork.</p>
01/15/15	Natural Substation

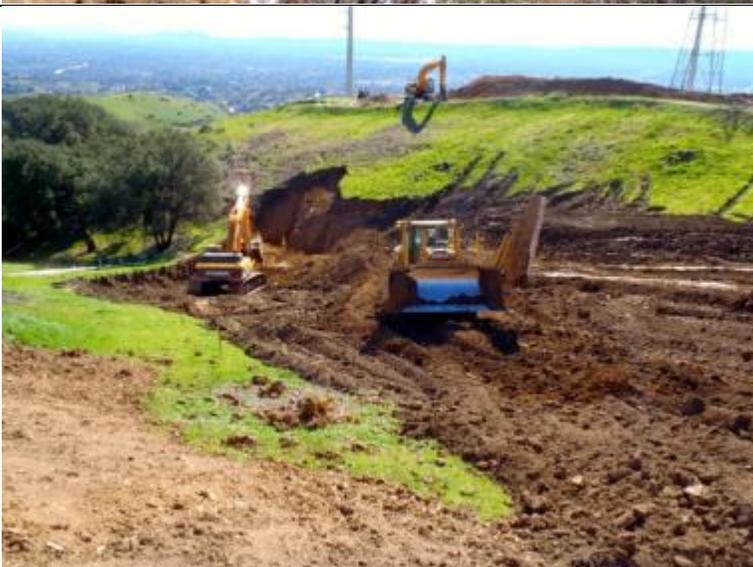
<p>An excavator and bulldozer are excavating a portion of the access road within a small swale near the oak trees.</p>

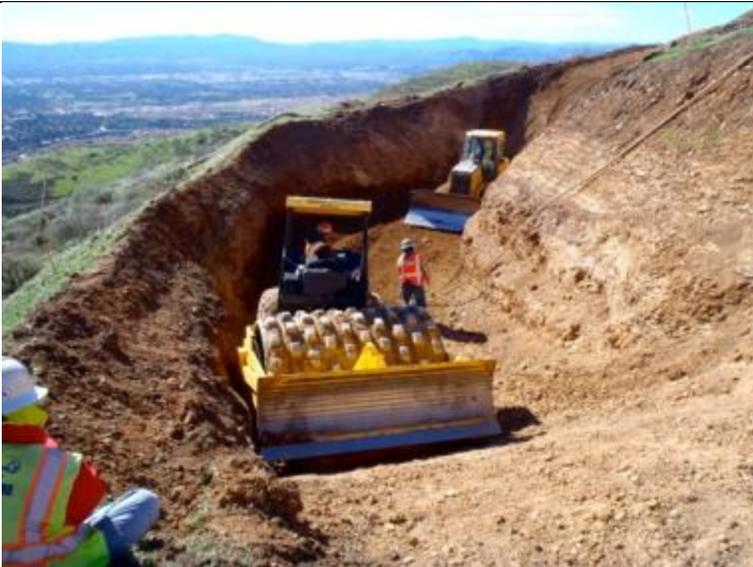
01/15/15	Natural Substation

<p>Another crew is digging out a fill key below the substation, to the south of the TSPs.</p>
01/15/15	TSP 45

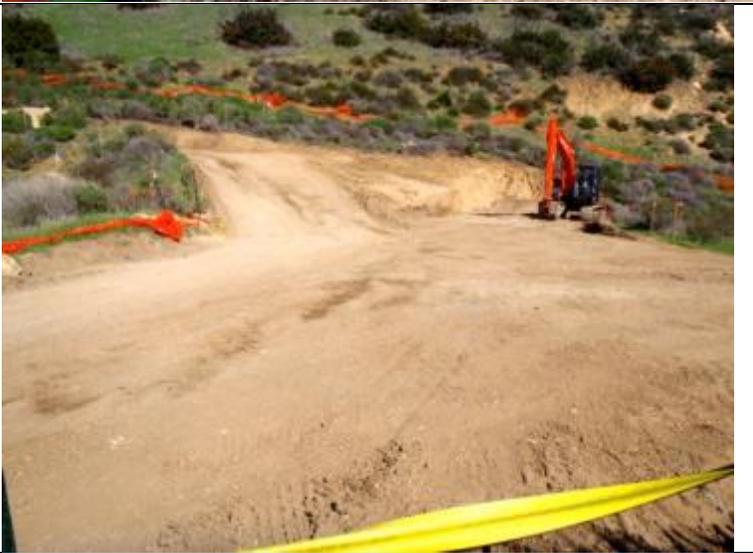
<p>Crews are finishing up the work on the pull site at TSP 45.</p>
01/15/15	TSP 45

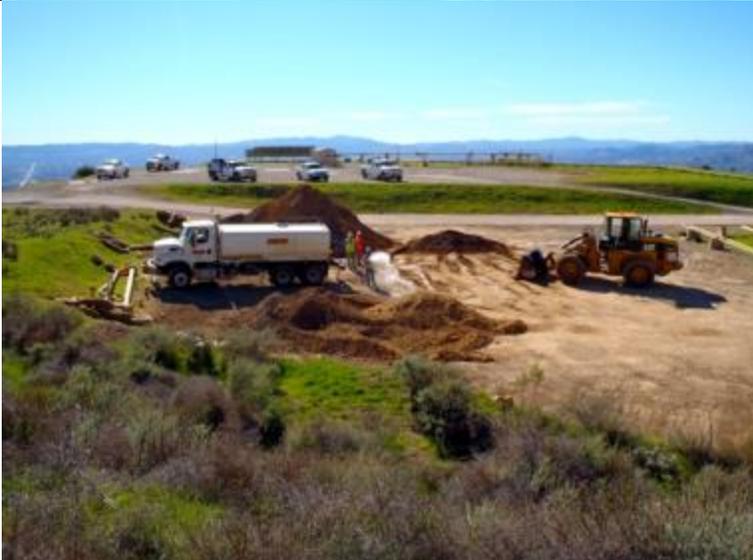
<p>Soil management at the TSP 45 pull site.</p>

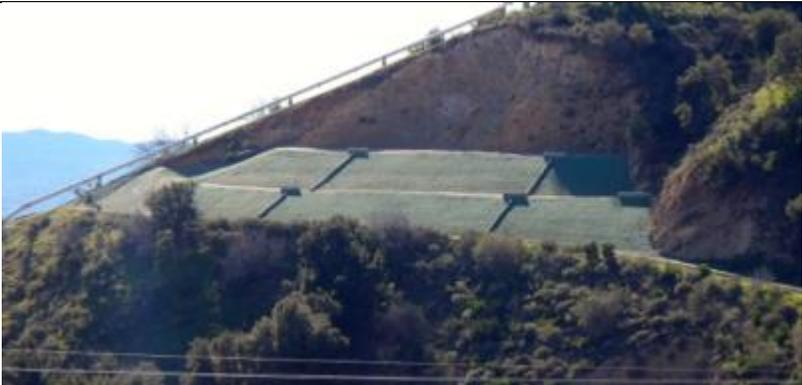
01/15/15 P-43

The P-43 fill site was hydroseeded earlier in the week.

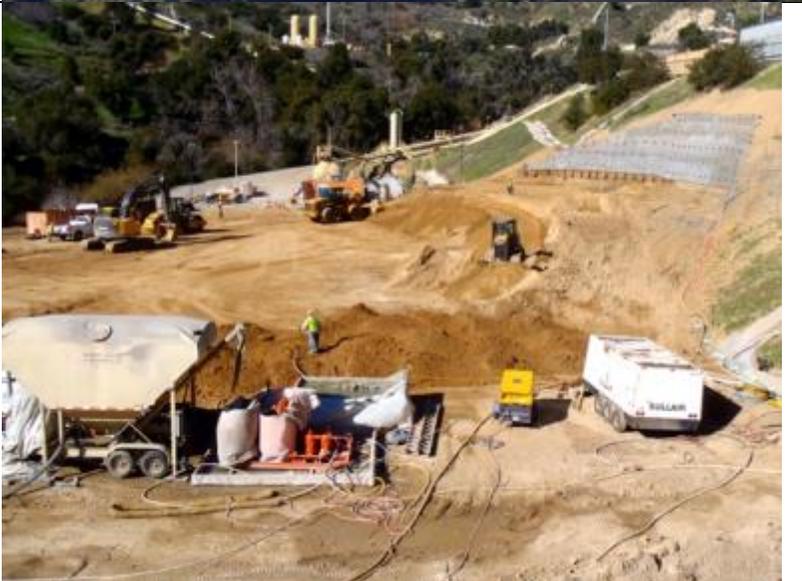
01/15/15 Central Compressor Station

Excavation continues at the site.

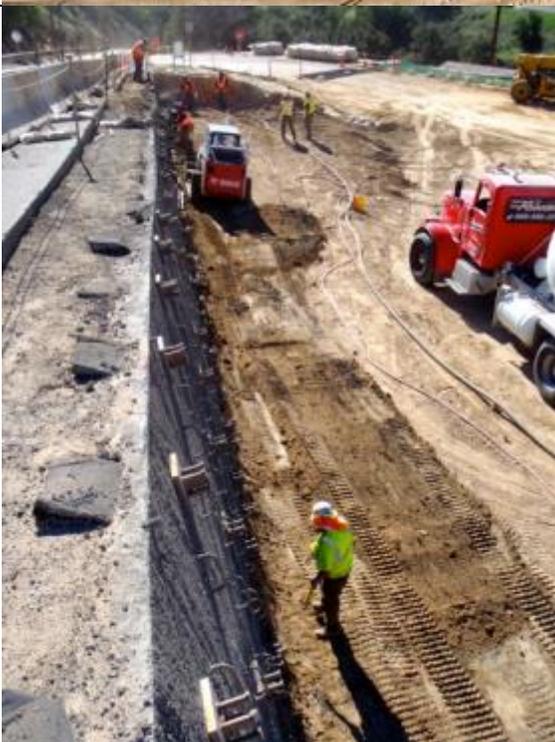
01/15/15 Central Compressor Station

Crews are stabilizing the cut banks with gunite, a sprayed on cement.

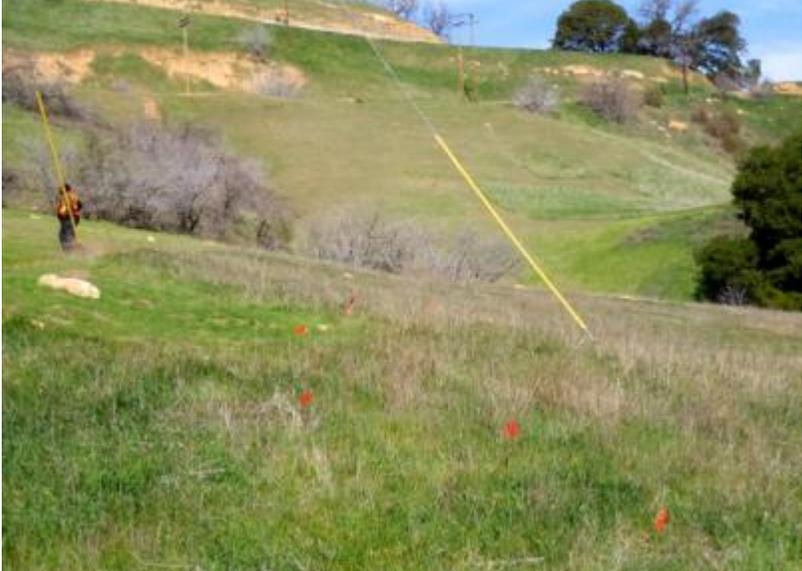
Date	Location	Photo	Description
01/22/15	Oak Mitigation Site

<p>Work within the oak mitigation site has begun with flagging of natives, soil sampling, and weed wacking of the non-native vegetation.</p>
01/22/15	Natural Substation

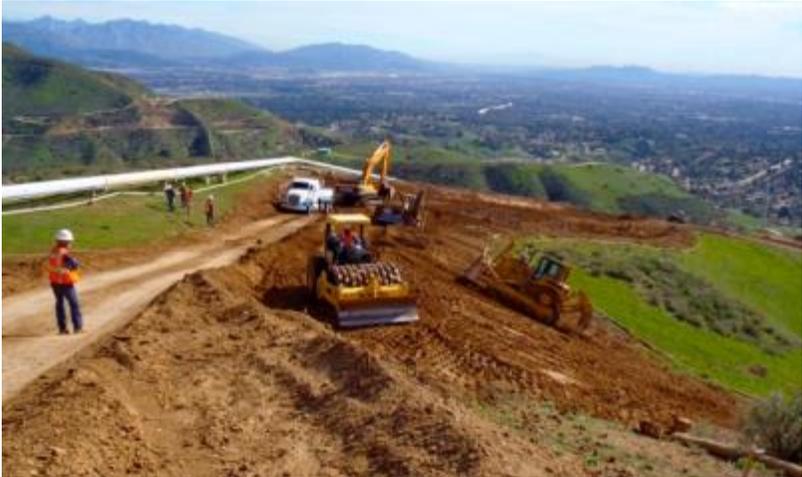
<p>Equipment is working on the access road to excavate and recompact the roadway.</p>
01/22/15	P-41

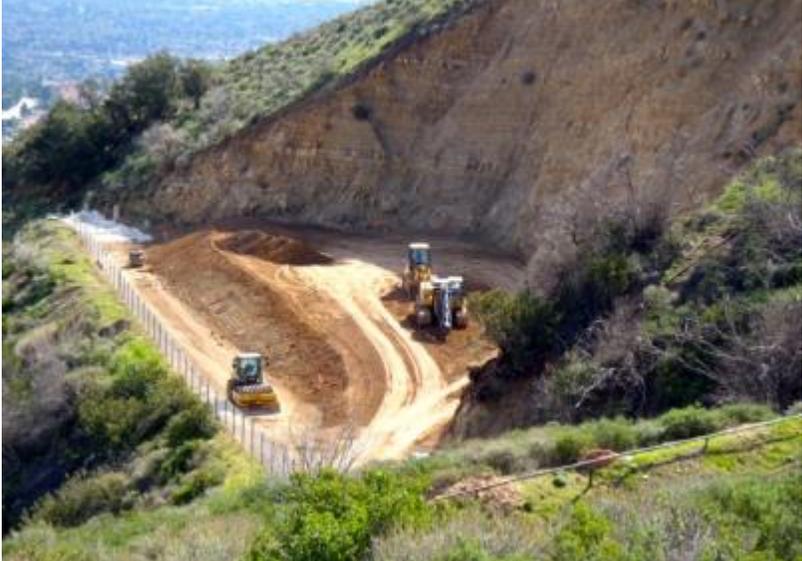
<p>Soil is being brought to the fill site from the Natural Substation access road work.</p>

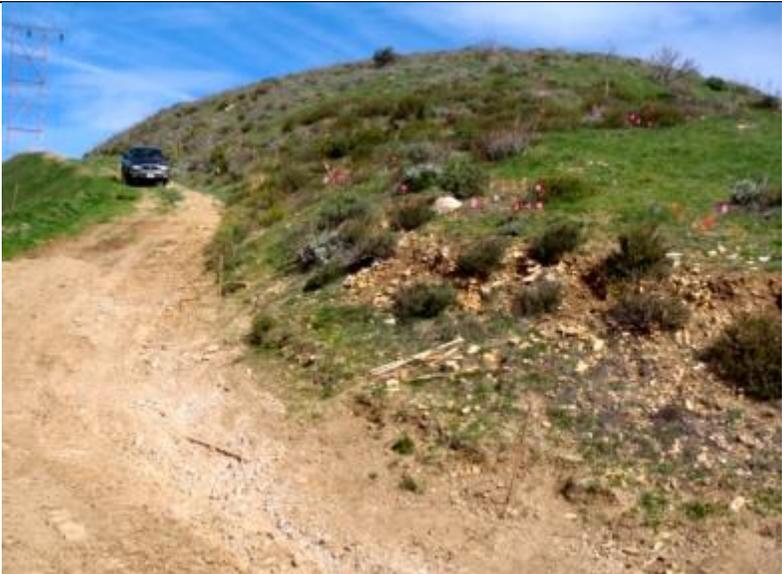
01/22/15	TSP 45

<p>Crews are grading the access road to TSP 45. Sensitive vegetation has been surveyed and flagged along the road and around the pad.</p>
01/22/15	Central Compressor Station

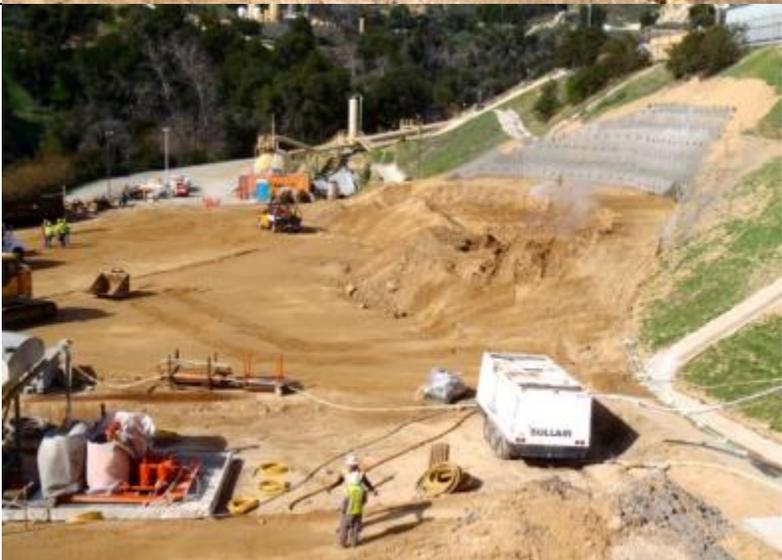
<p>Excavation work continues at the site along with the slope stabilization.</p>
01/22/15	New Admin/IM Building

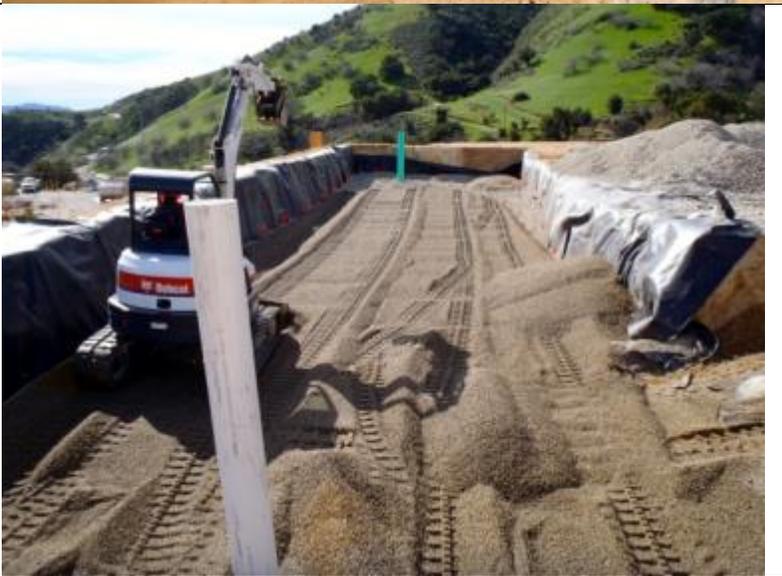
<p>Crews are backfilling the biofiltration basin with pea gravel.</p>

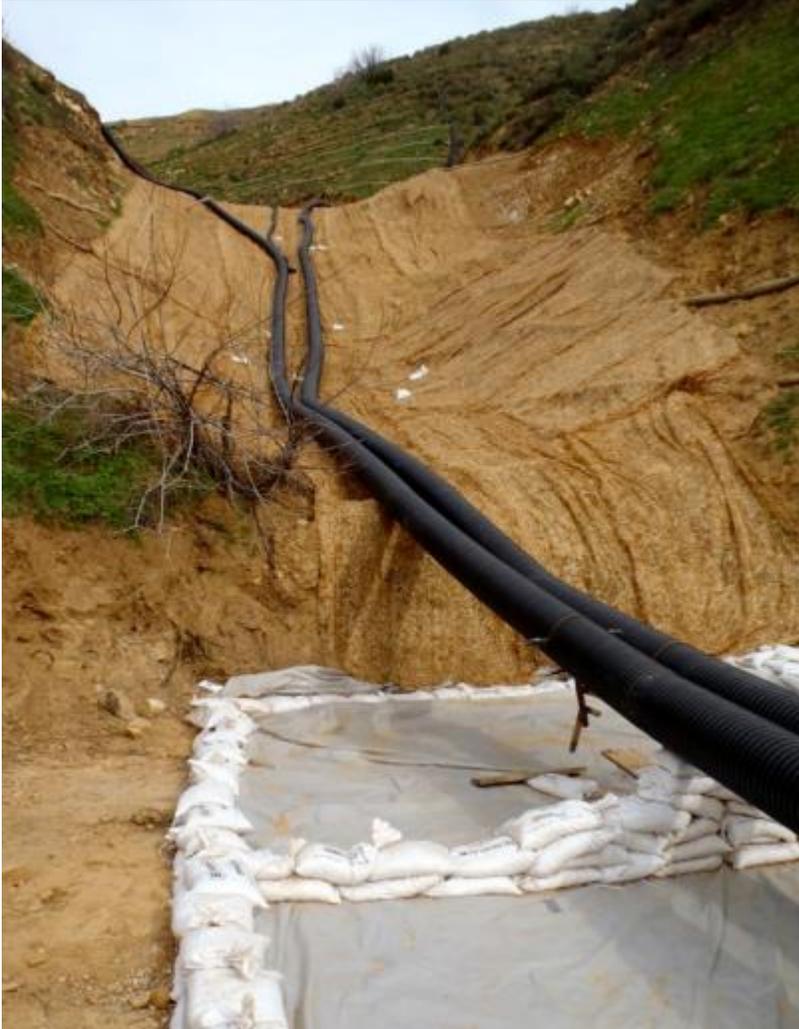
Date	Location	Photo	Description
01/26/15	PS-42 Fill site

No work at the fill site but some basic maintenance of the BMPs has been completed.
01/26/15	Natural Substation Access Rd.

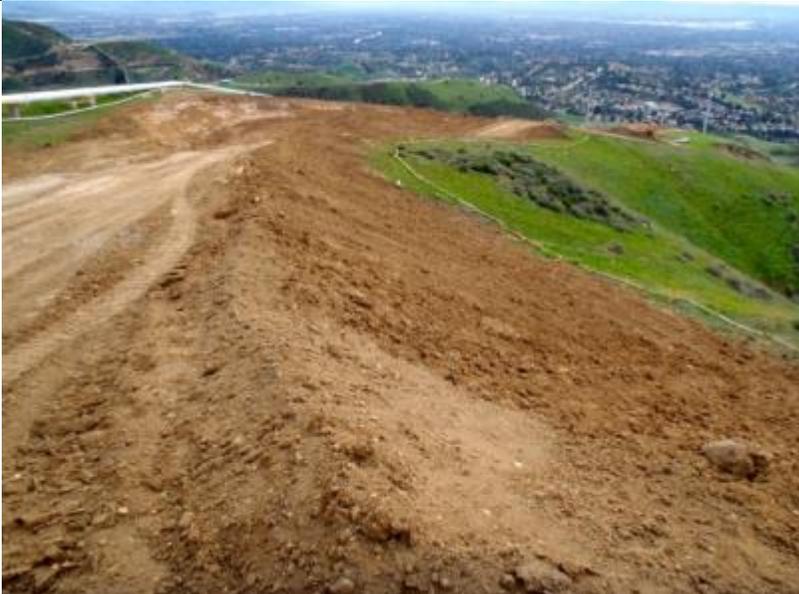
No equipment is working on the upper portion of the access road, as they have backfilled the fill key.

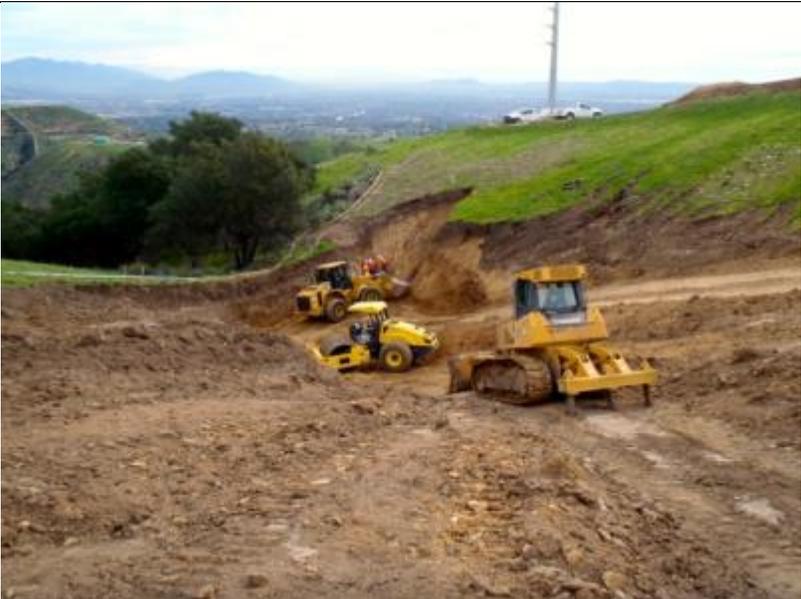
01/26/15	Natural Substation Access Road

Work on the access road fill key continues in the small swale down near the oak trees.
01/26/15	Natural Substation

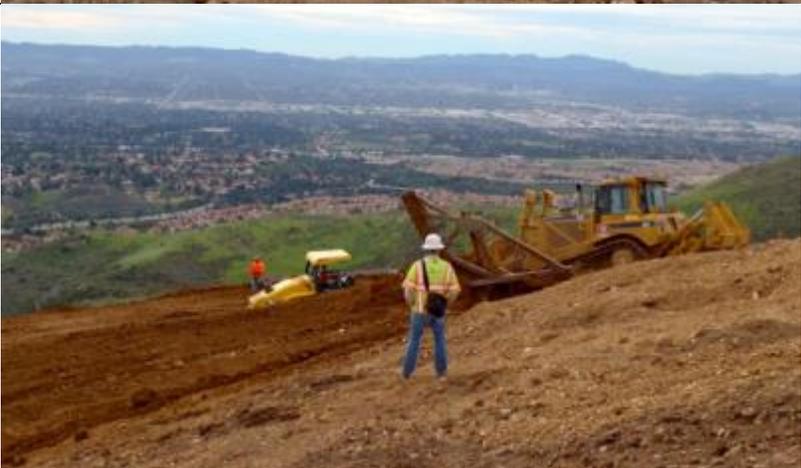
Backfill and compaction of the fill key below the TSPs continues.
01/26/15	P-41

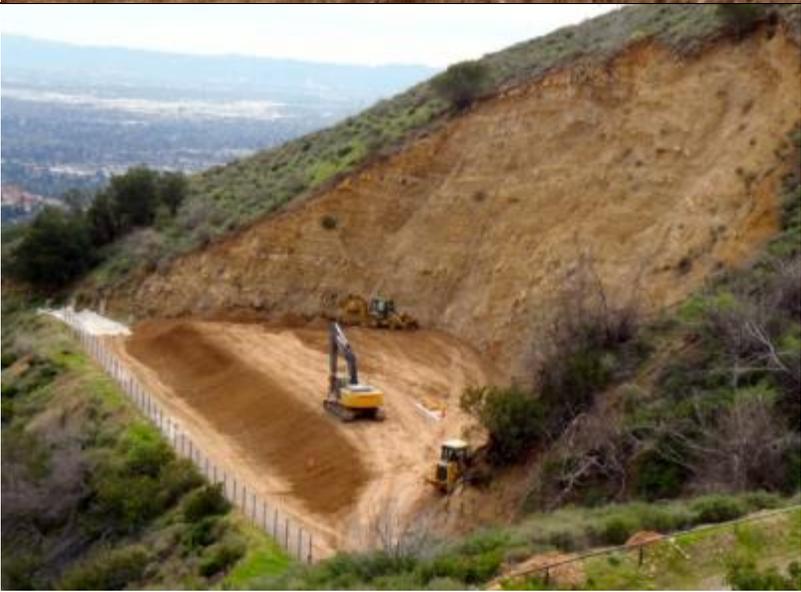
No soil is being brought to the fill site as crews are preparing to install a subdrain.

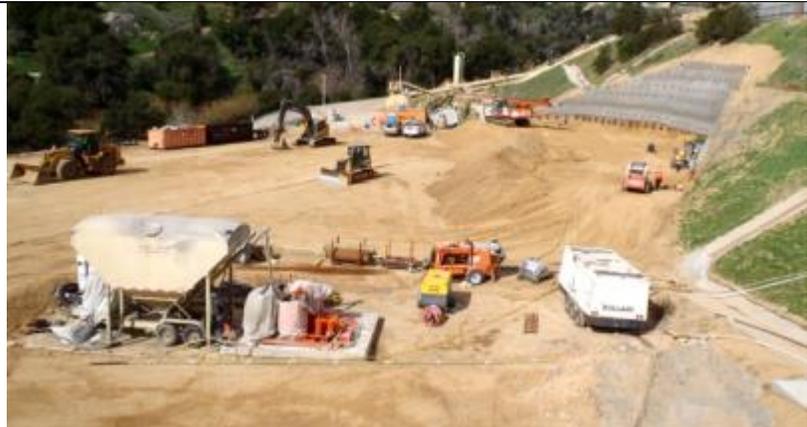
01/26/15	Central Compressor Station

Excavation work continues at the site along with slope stabilization.
01/26/15	New Admin/IM Building

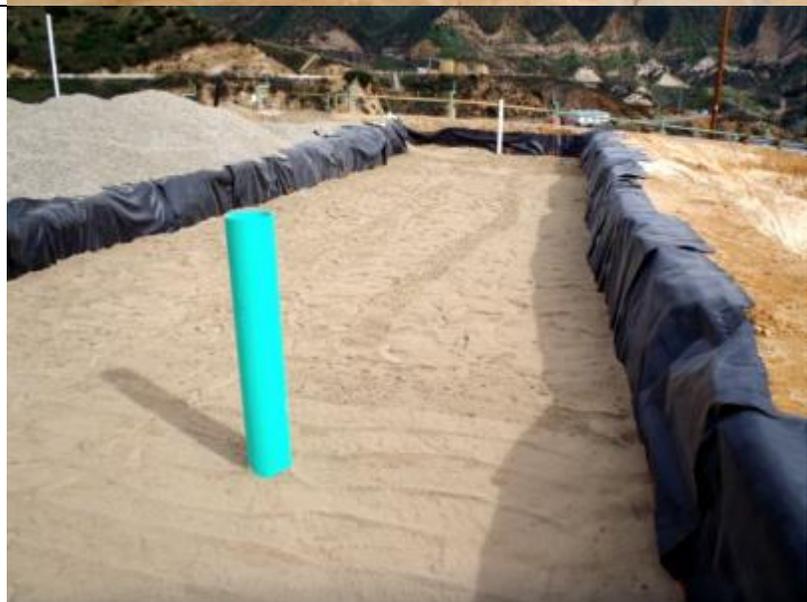
Crews continue to backfill the biofiltration basin. Crews are now putting in sand.
01/26/15	San Fernando Substation

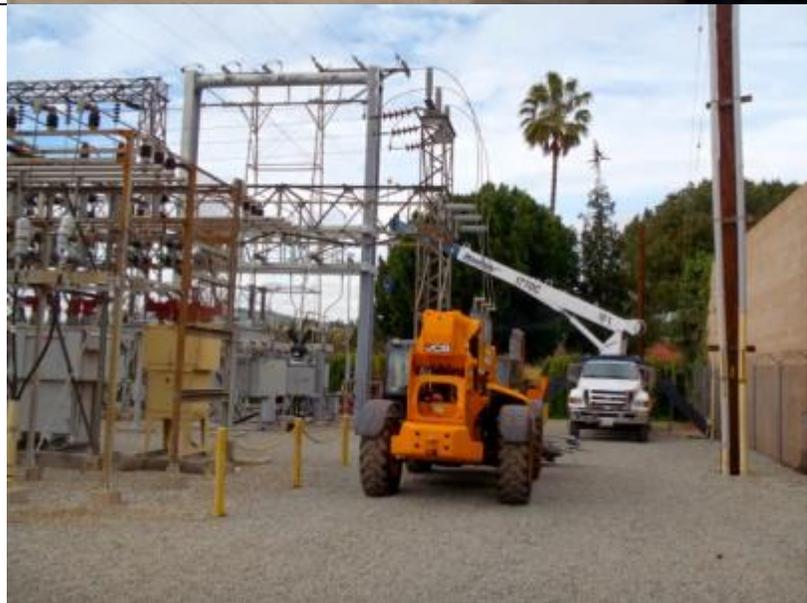
Installation of the above ground structures is ongoing.
