**Re: Monthly Report Summary #14 for Aliso Canyon Turbine Replacement Project**

## Aliso Canyon Turbine Replacement Project CPUC Site Inspection Form

Project:	Aliso Canyon Turbine Replacement	Date:	May 7, 2015
Project Proponent:	Southern California Gas Company and Southern California Edison	Report #:	VS054
Lead Agency:	California Public Utilities Commission	Project Phase/NTP:	Guard House and Road Widening (NTP-1), the New Admin/IM Building (NTP-2), and Central Compressor Site (NTP-3). P-41 Fill Site (NTP-2), PS-42 Fill Site, P-32 Fill Site (NTP-3), and the Natural Substation (NTP-3, NTP-A). TSPs 2-46 (NTP-A, NTP-C), and the Oak Tree Mitigation Site.
CPUC PM:	Andrew Barnsdale, Energy Division	AM/PM Weather:	Overcast, cool (64 degrees), and blustery. Some rain predicted for later in the day.
E & E CM:	Lara Rachowicz	Start/End time:	0700-0930 hrs. in Wiley Canyon. 1015-1300 hrs. at the Aliso Storage Field.
Monitor(s):	Vince Semonsen		
Project Component(s):	Storage Field components, 66-kV Subtransmission Line, Telecommunications route

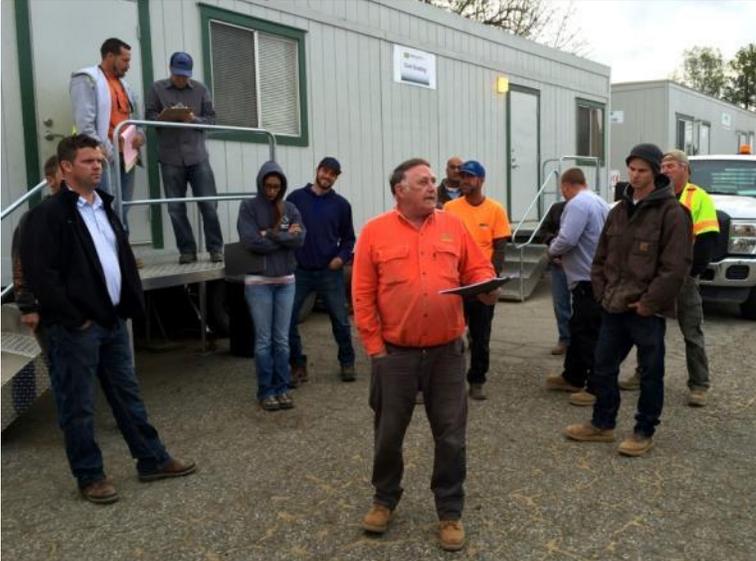
Date	Location	Photo	Description
5/07/15	SCE 210 Yard

Tailgate meeting at the SCE 210 yard.
5/07/15	Mobile home park

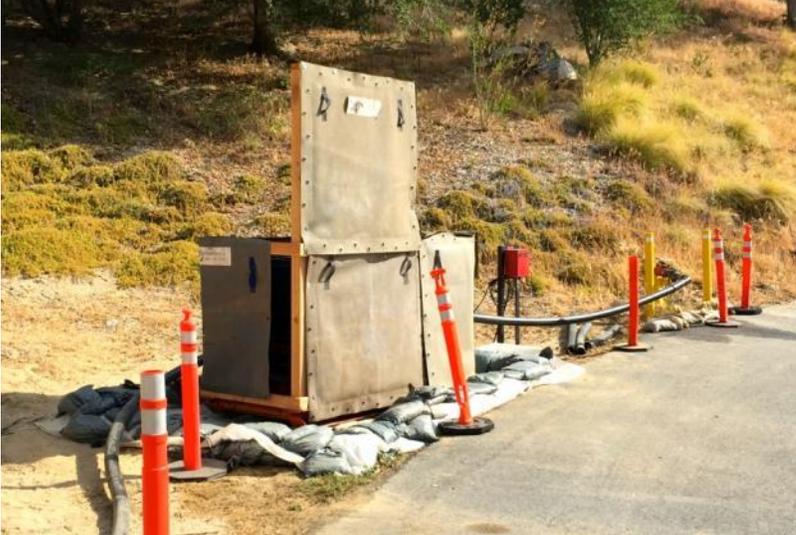
Generator within the mobile home park near TSP 22 has been covered to decrease the noise level.
5/07/15	Wiley Canyon – TSP 19

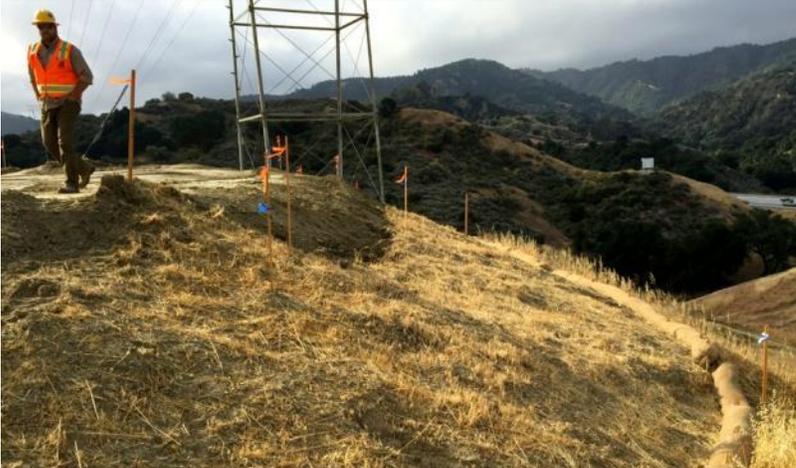
The area around TSP 19 has been cleared, BMPs have been installed, and the pad has been graded.

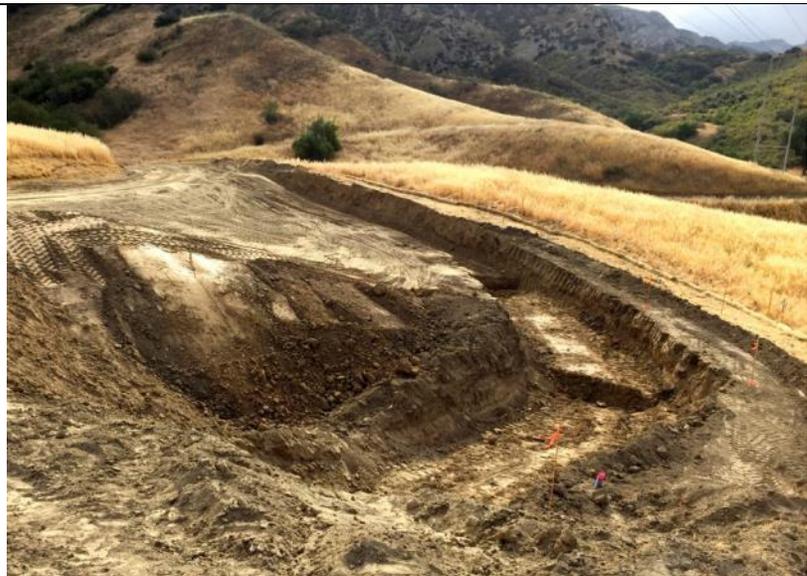
5/07/15	TSP 16

A key way has been excavated at TSP 16 – SCE said they are waiting on fill material to backfill.
5/07/15	TSP 15

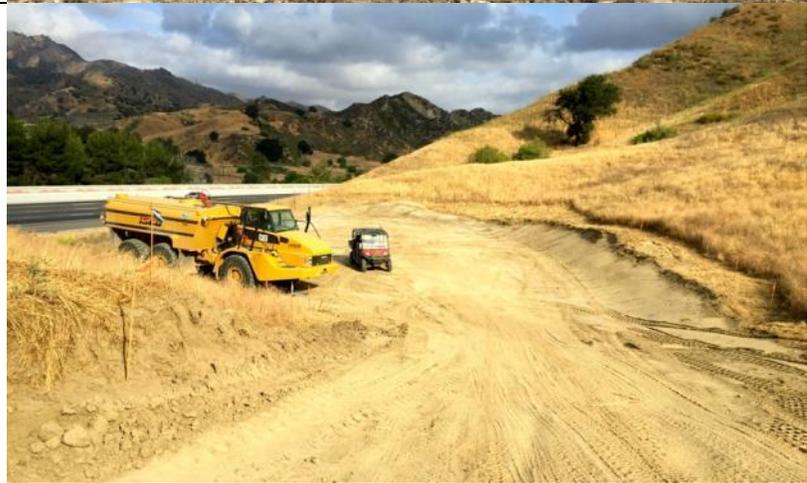
Pull site at TSP 15 where grading work has been completed.

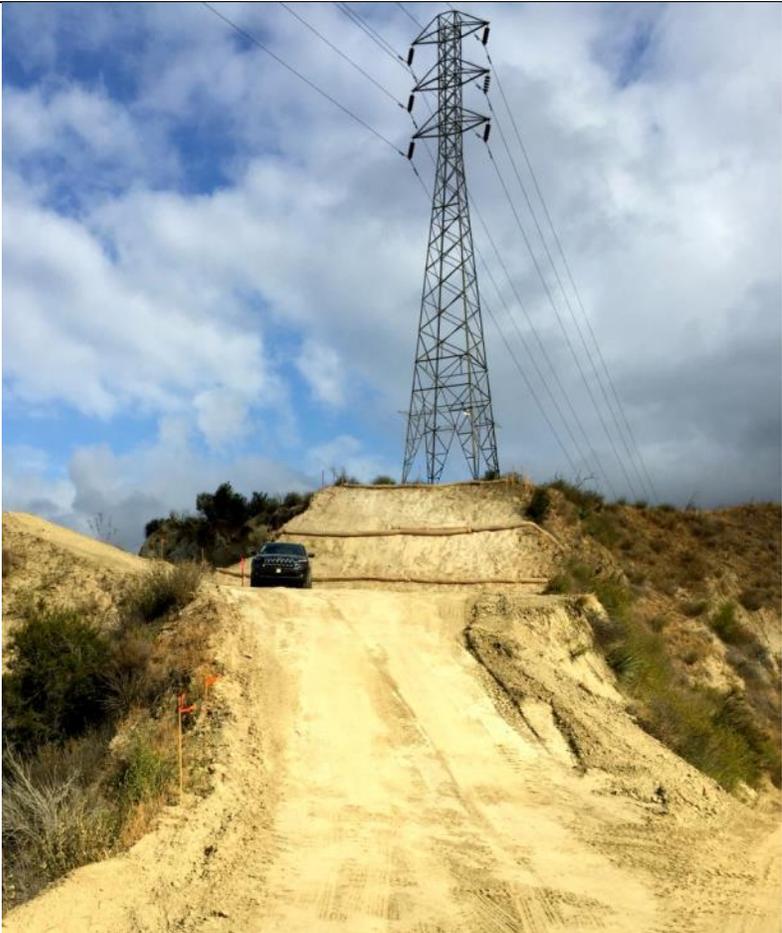
5/07/15  
TSP 13  
access road

Additional grading and installation of BMPs have been completed at TSP 13.

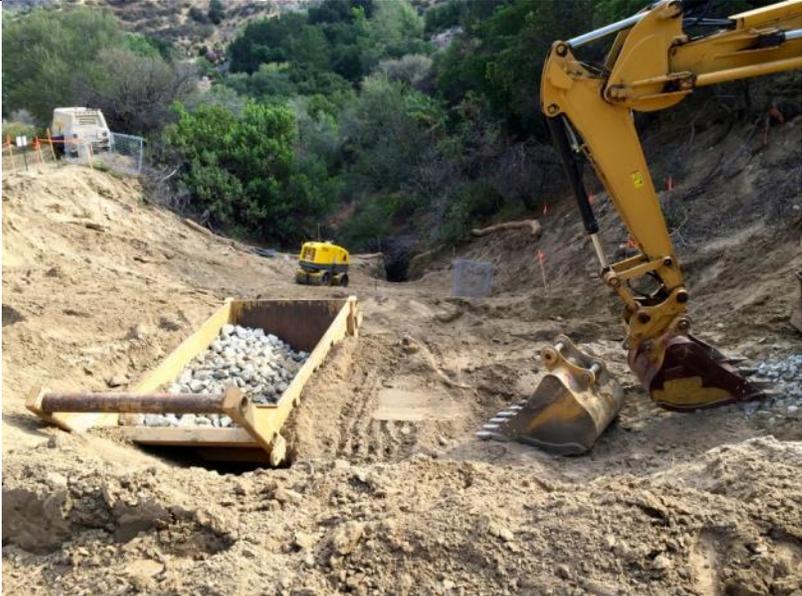
5/07/15  
Wiley  
Canyon  
access road

Work continues on the shoring and culvert installation along the access road between TSPs 12 and 13.

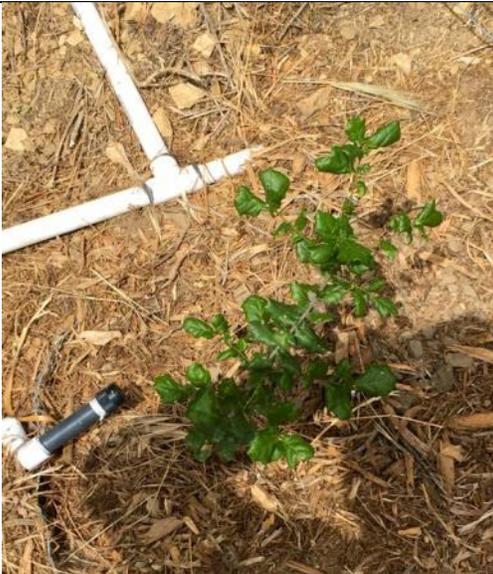
5/07/15	Aliso Canyon Oak Mitigation Site

Oak seedlings are growing.
5/07/15	PS-42 Fill Site

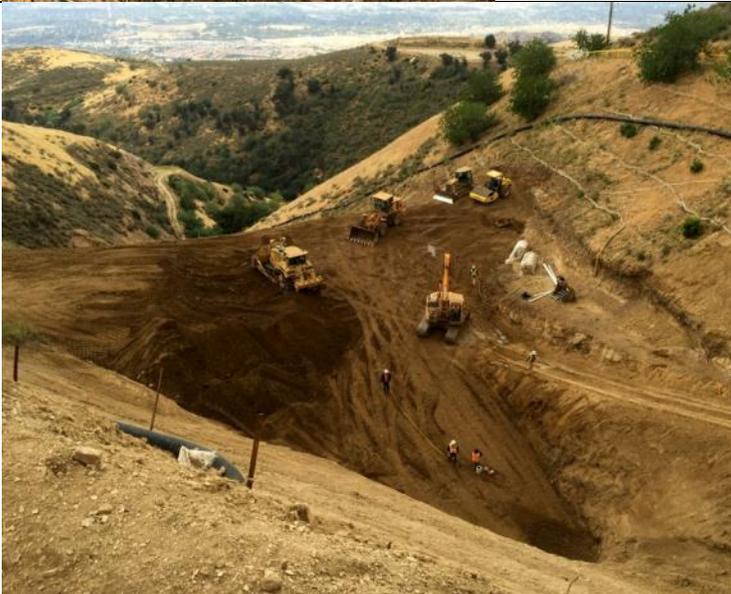
Equipment continues to work the imported soil.
5/07/15	Natural Substation

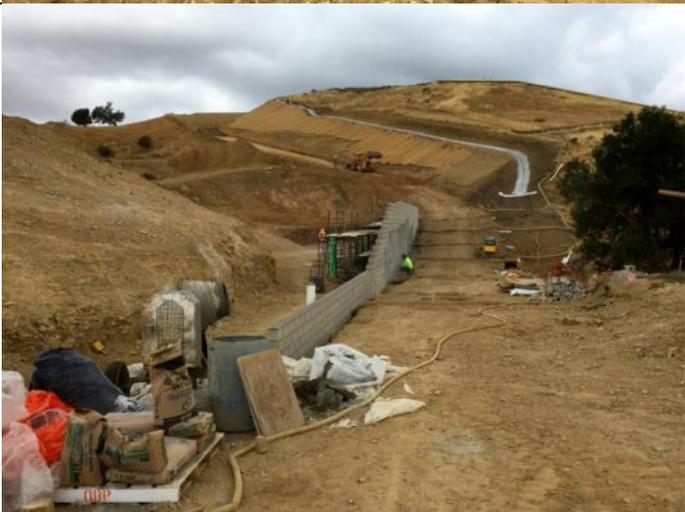
Looking up along the access road from the Natural substation. Work is nearly done on the retaining wall.

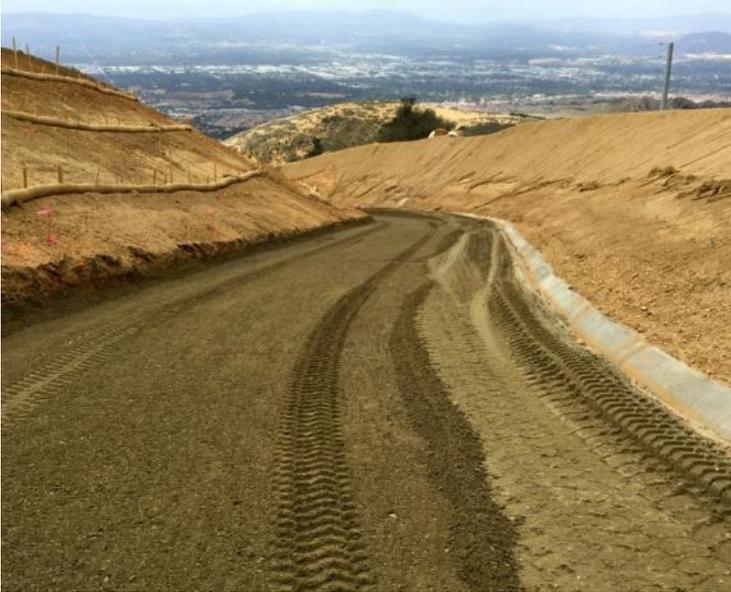
5/07/15	Natural Substation Access rd.

Road base is being laid down on the access road.
5/07/15	P-41 Fill Site

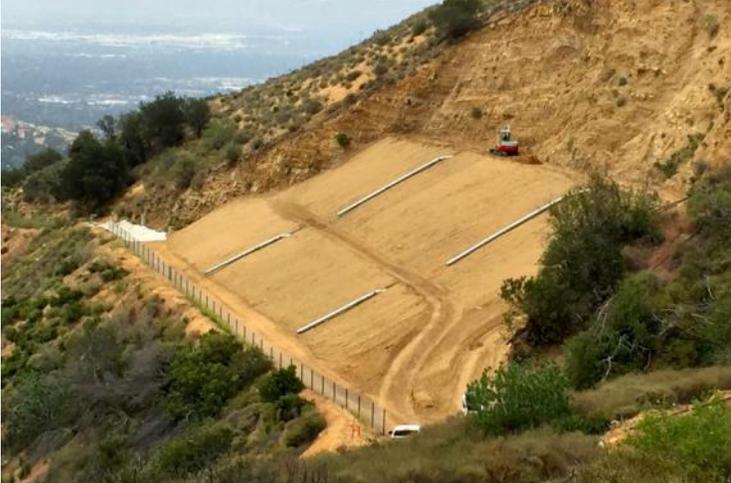
Final work on the fill site includes cutting the "V" ditches and drain installation.
5/07/15	Central Compressor Station

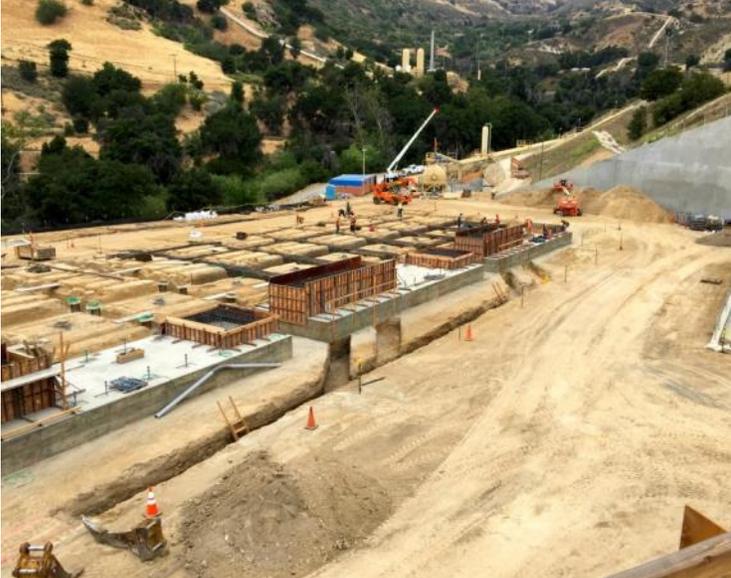
At the Central Compressor Station crews continue their work on the compressor foundations – see photo. Biological Monitor Anna Lohr (APM BR-1d & APM BR-6) was spot-checking the construction activities in the lower portion of the Aliso field. Archeological/Paleontological Monitor Olivia Tierk (MM CR-1, MM CR-3, MM CR-6 & MM CR-8) was spot checking the excavation activities.

Compressor foundation work continues – soil continues to be exported to P-32.

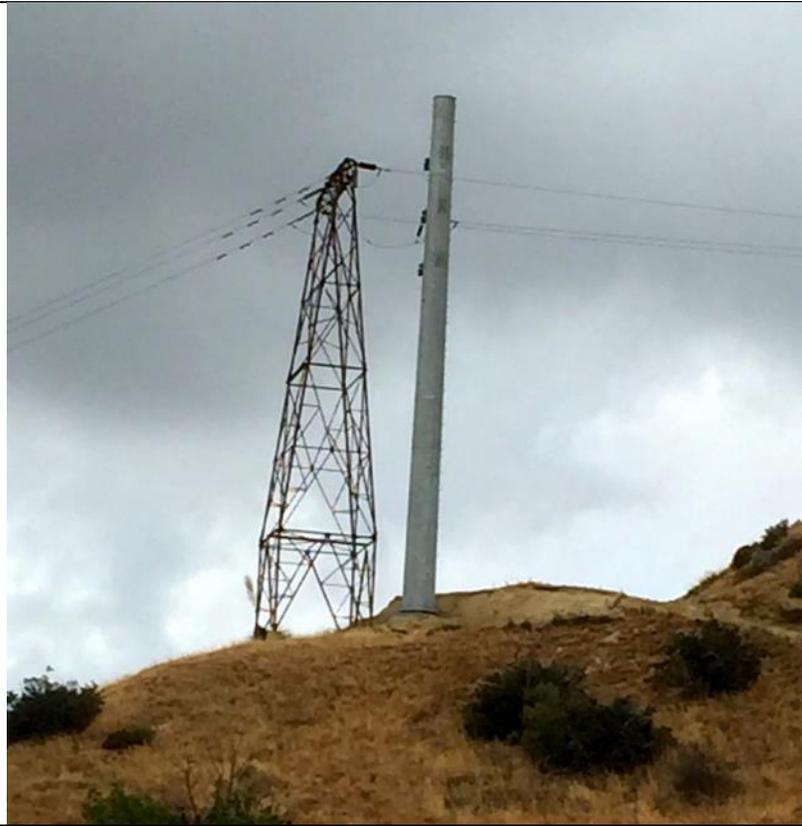
TSP 45

The TSP has been installed at site 45.

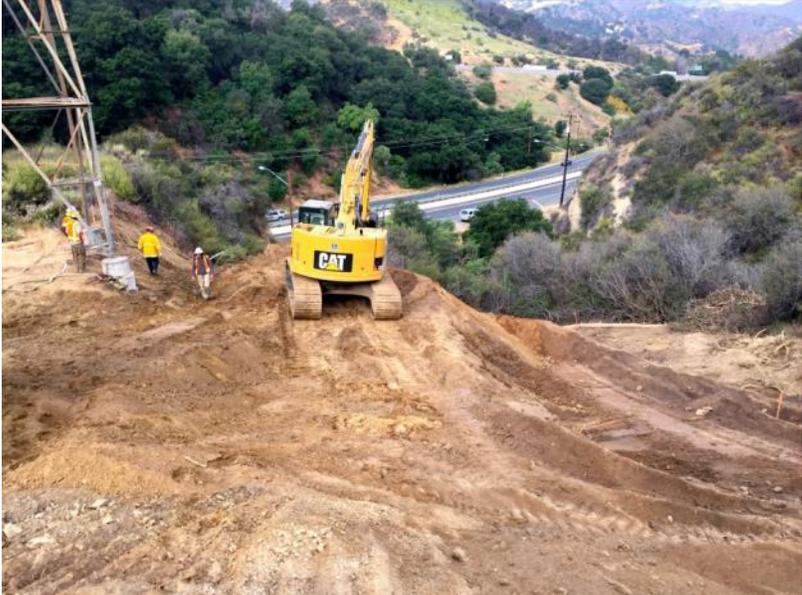
Date	Location	Photo	Description
5/14/15	Wiley Canyon TSP 26

<p>Access road work in preparation for replacing TSP 26. Cleared area next to the excavator will have gabions installed to shore up the road bank.</p>
5/14/15	TSP 2

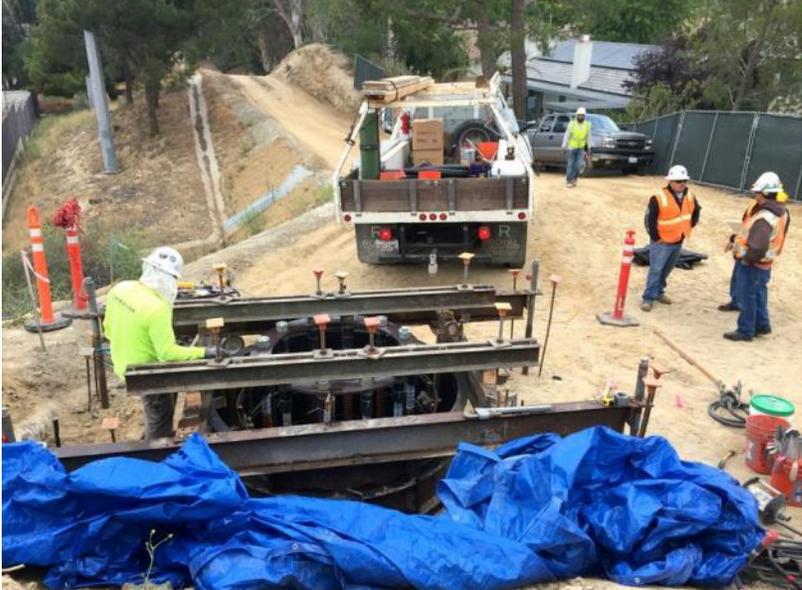
Todd and I drove to TSP 2 where crews had drilled the foundation hole and installed the rebar – see photo. Concrete trucks were on their way to pour the TSP foundation. Nesting bird buffers exist along the access road but crews are allowed to drive through; the work areas are outside of the buffers. Crews were keeping the public roads free of dirt and Lucy Cortez (SWPP inspector) was onsite to look over the BMPs.

<p>Foundation hole has been drilled and the rebar cage is in place. SCE crews are preparing to pour the foundation.</p>
5/14/15	Wiley Canyon – TSP 7

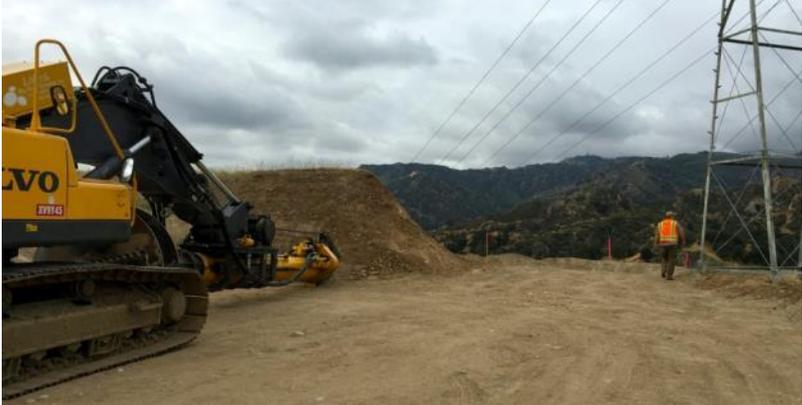
At TSP 7 the work on the access road and pad had been completed several weeks ago and crews were waiting to drill the foundation hole; the drill rig was already onsite – see photo. A nesting bird survey had to be completed before construction could begin. Todd and I met with Brian Carpmen who was performing the survey. The survey was finished around 10:30 and Todd called to give the go ahead to the construction team.

<p>Drill rig is onsite – crews are waiting on a nesting bird survey. The site was previously cleared and a pad constructed.</p>

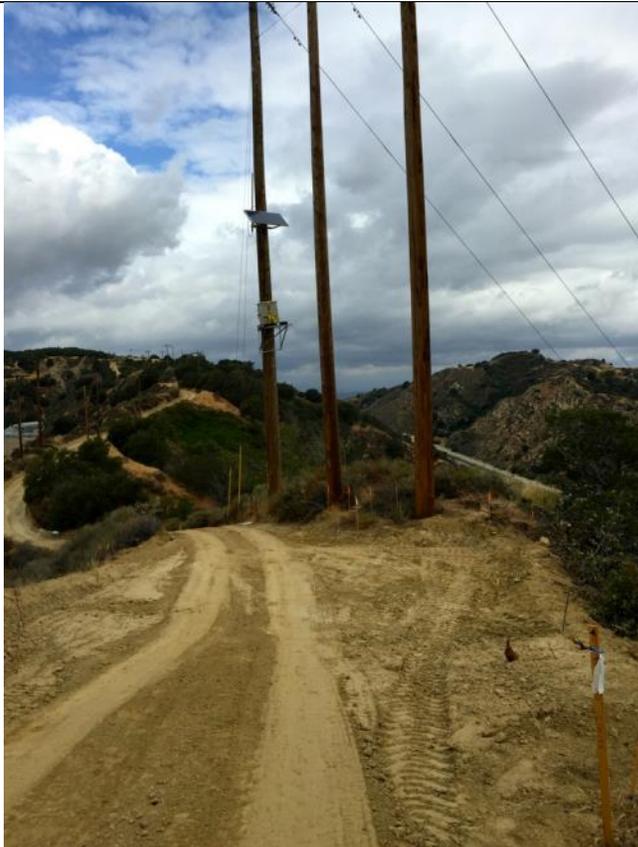
5/14/15 TSP 36

We drove to TSP 36 – see photo – and noted the cleared area for the new pole foundation. Todd identified some Mariposa lilies along the access road and he took a GPS location – see photo.

A small pad has been graded for TSP 36 – it is quite steep on either side of this pole location.

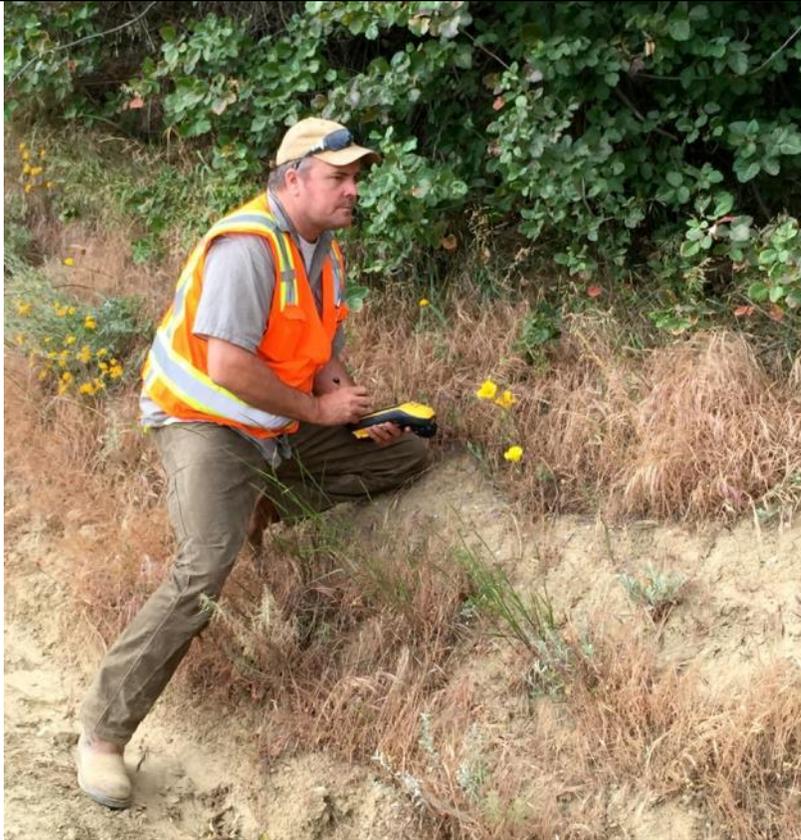
5/14/15 TSP 36 access road

Todd White is getting GPS locations on Mariposa lilies noted along the TSP 36 access road.

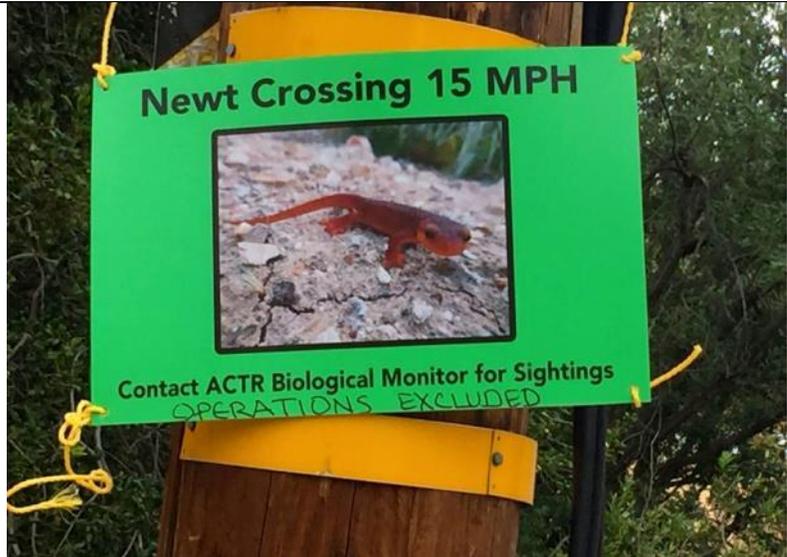
I arrived at Aliso Canyon Storage Field around 11am and met with Jennifer Campbell, SCG Environmental Coordinator, at the offices. On the way in I noted the newt crossing signs – see photo. I also met briefly with Biological Monitor Juan Miranda who is taking several AECOM SWPPP inspectors around the site. It began to rain as we headed up to the PS-42 fill site. Crews had stopped work and were installing BMPs in preparation for the storm system – see photo. Straw wattles had been installed on the fill dirt down toward the lower access road – see photo. It did appear that the diversion pipes still need to be realigned where they dump out onto the riprap below the access road, but because they were inside a bird buffer, would have to wait. Other than at the PS-42 site, BMPs were installed according to SWPPP requirements.

<p>One of the many new Newt Crossing signs.</p>
<p>5/14/15</p>	<p>PS-42 fill site</p>

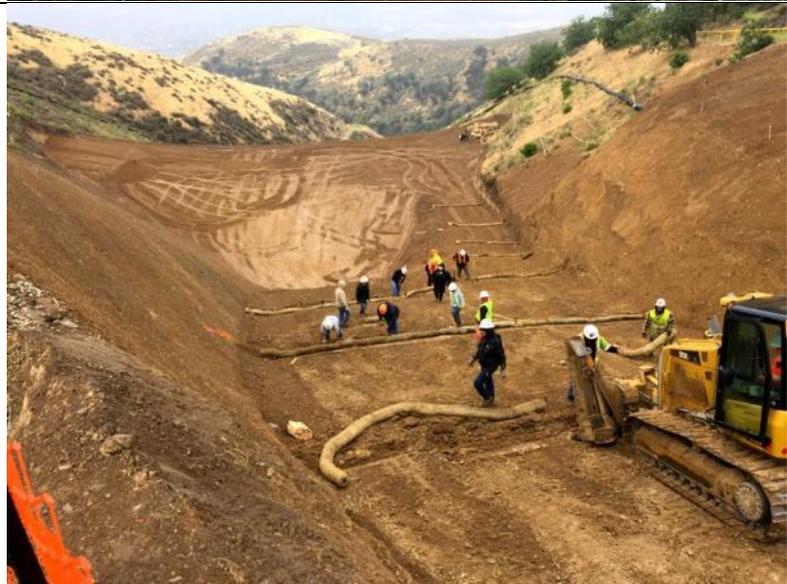
<p>Crews are putting in BMPs as rain approaches the site.</p>
<p>5/14/15</p>	<p>PS-42 fill site</p>

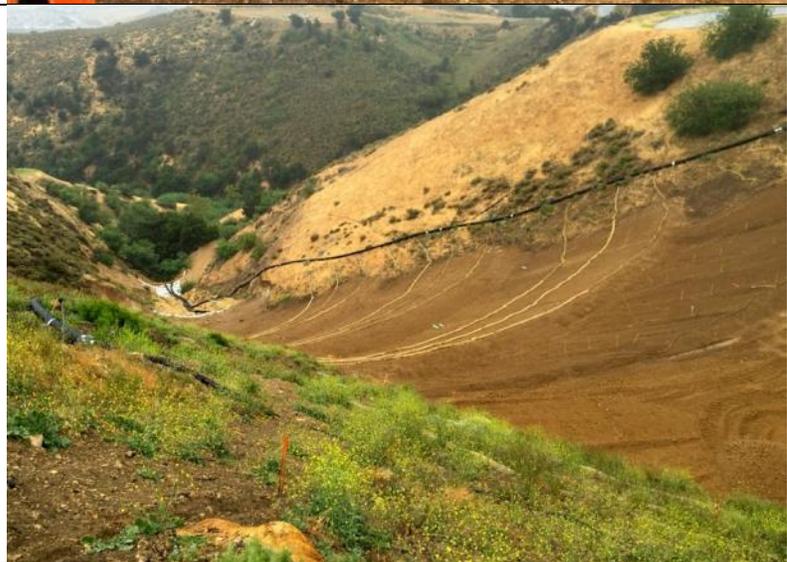
<p>The lower portion of the fill site has had BMPs installed</p>

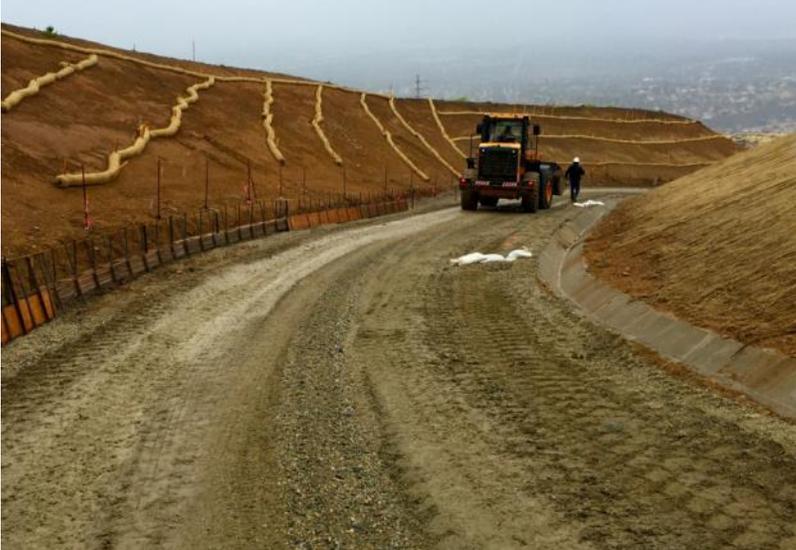
5/14/15	Natural Substation access road

Road base has been installed with some of the forms for the road curbs now in place. A crew was installing gravel bag chevrons along the road.
5/14/15	Natural Substation and access road

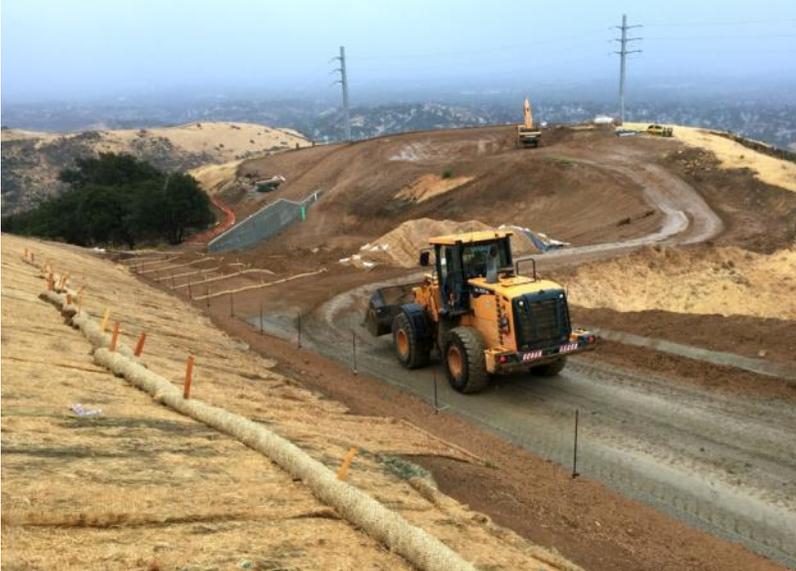
BMPs are in place – crews have gone home for the day.
5/14/15	P-41 fill site

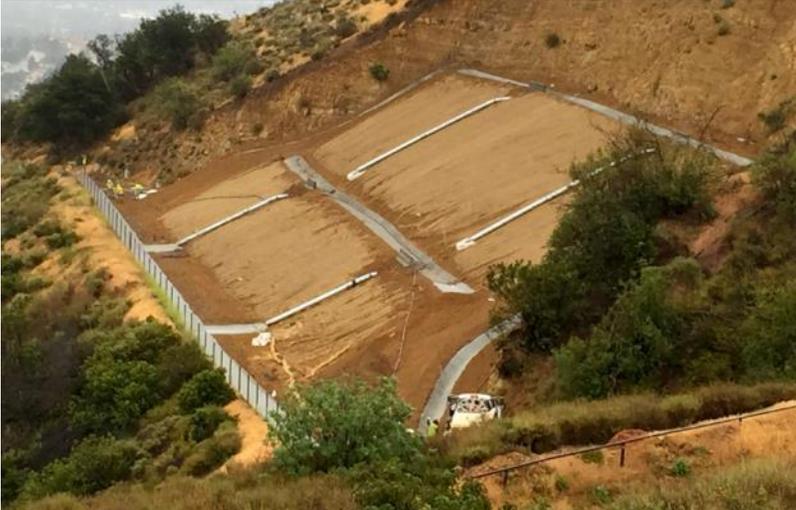
Crews continue to close up the fill site with concrete “V” ditches being poured. A concrete washout location has been set up in the staging area.

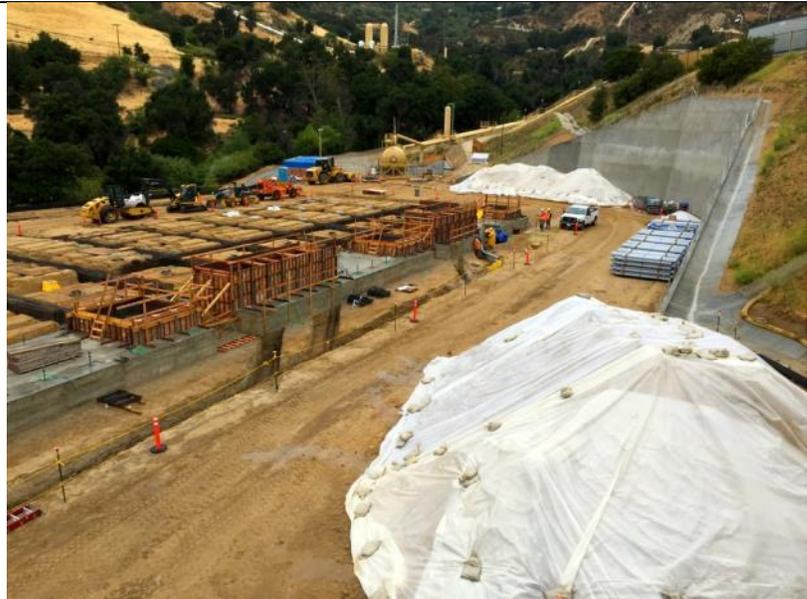
<p>Crews are installing conduit although most of the workers have finished for the day. BMPs are in place as a storm is approaching the project site.</p>
<p>5/14/15</p>	<p>Central Compressor Station</p>

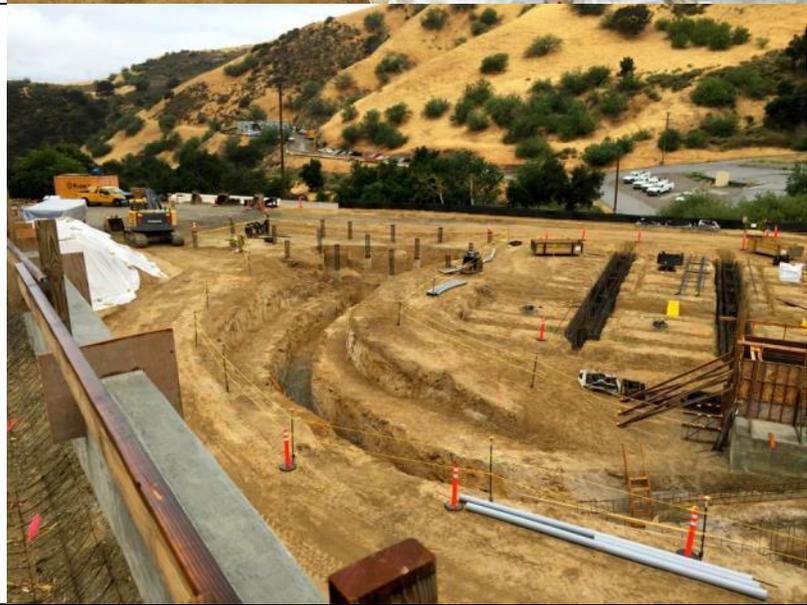
<p>Additional trenches have been dug within the CCS – soil piles have been covered.</p>

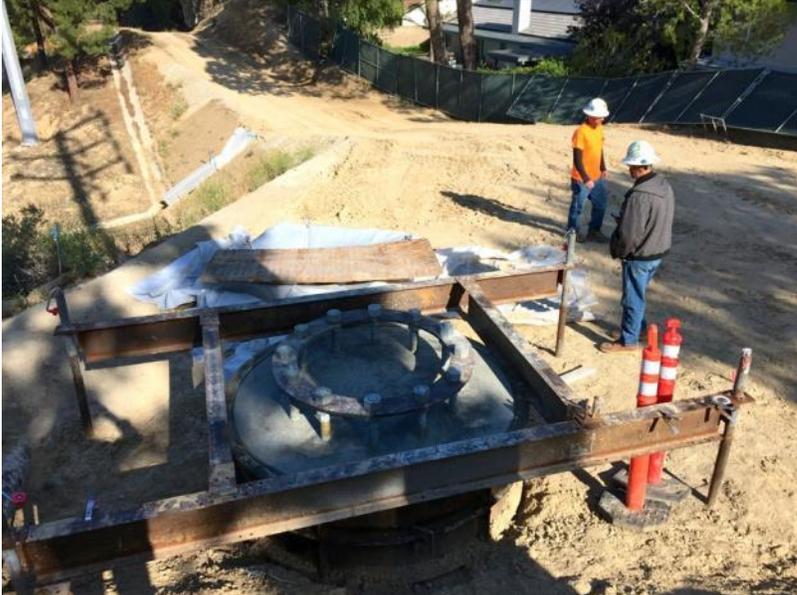
I looked at TSP 2 where they have poured the foundation, the site is buttoned up and the concrete washout container is covered – see photo. A SWPPP crew stopped in to check the site.

TSP 2 has been poured.
5/19/15	TSP 7

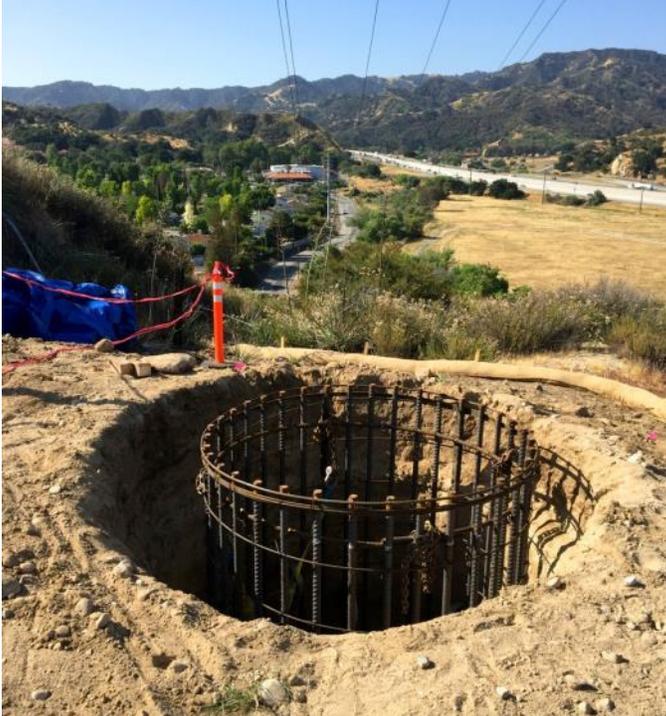
Met with Todd White at TSP 7 where a crew is preparing the site for pouring the foundation. The site was drilled and the cage was set yesterday – see photo. I asked about how they covered up the hole and Todd said they put a steel plate over it, followed by tarps, straw wattles, and gravel bags. All the nesting birds have fledged around the area except for one bushtit toward the back of the staging area. Topsoil is covered with jute netting within the staging area – see photo.

TSP 7 was drilled and the cage dropped into the hole on 5/18. According to the crew the hole is 34 feet deep. It was covered overnight with steel plates and a tarp.
5/19/15	TSP 7

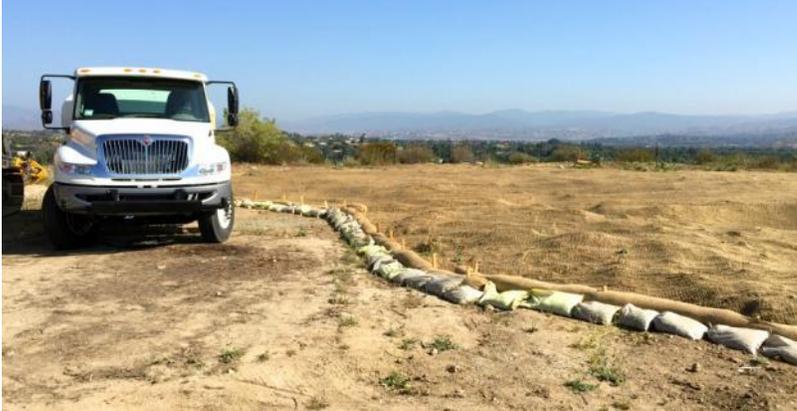
Topsoil stored in the stockpile area above the TSP 7 pole location.

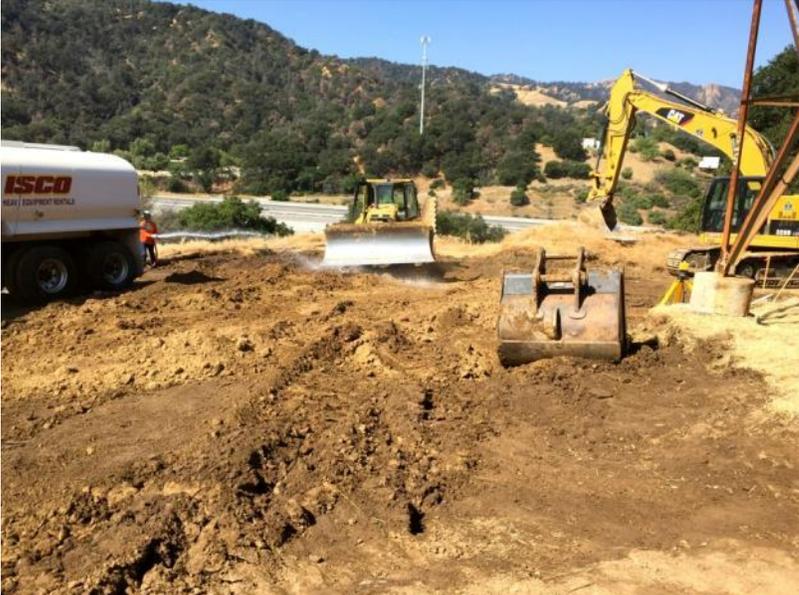
I went to TSP 27 where the crew had removed topsoil yesterday. According to Shay Lawrey they found a skink and a night snake during the work – both were caught and relocated and were uninjured. Monitors were onsite along with a water truck and a fire crew. The crew began preparing the pad for the TSP work – see photo. Nesting bird buffers were up at several locations along the access road. They were hoping to move up to TSP 28 soon.

<p>Crews have removed the topsoil and are preparing the site for drilling the new TSP location.</p>
5/19/15	TSP 26

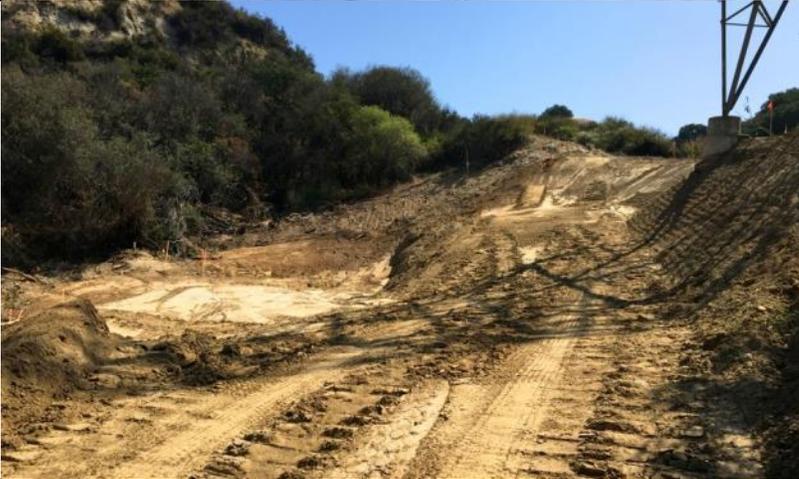
I checked TSP 26 – no one was onsite. According to Todd the crew putting in the gabion cages near TSP 12 were coming to TSP 26 after they finish up at TSP 12. No rainwater runoff issues and no dirt on the public roads were observed.

<p>Dirt work at TSP 26 is waiting for a crew to come in and place gabion cages to stabilize the road bank.</p>
5/19/15	Access road to TSPs 11-24

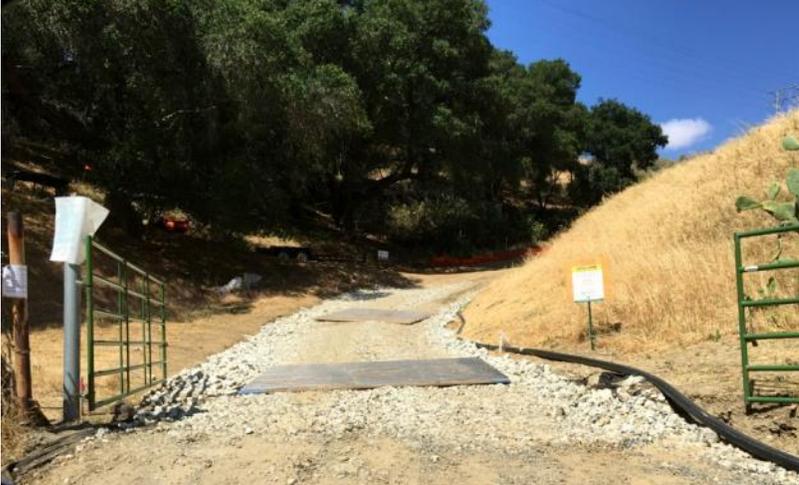
<p>Entrance gate within the mobile home park – no mud had been tracked onto the paved roadway.</p>

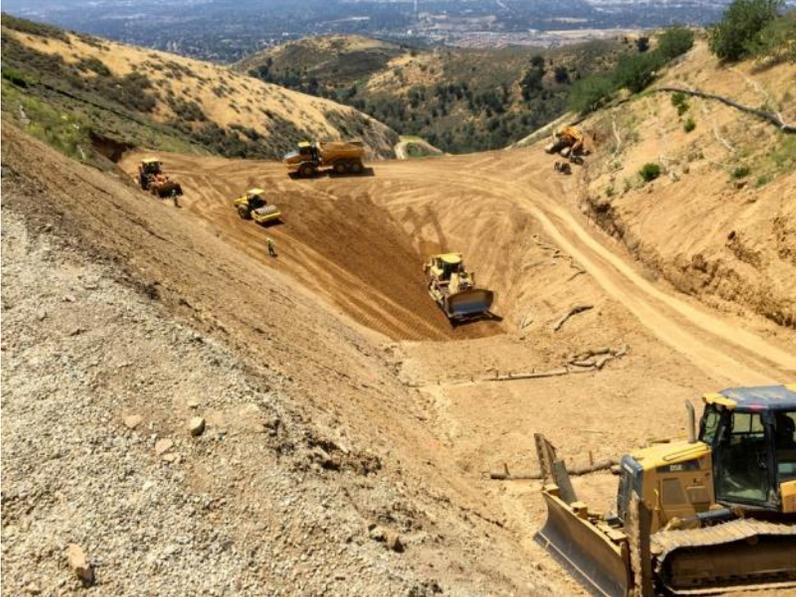
Dirt is coming from the Natural Substation and equipment is compacting it into the fill site.
5/19/15	Staging area for the Natural Substation access road

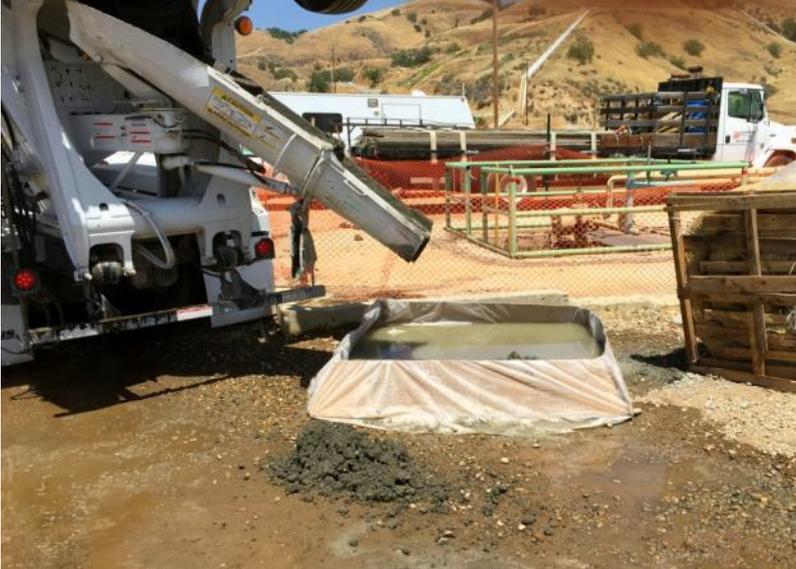
Concrete washout location for trucks pouring the Natural Substation access road curb.
5/19/15	Natural Substation

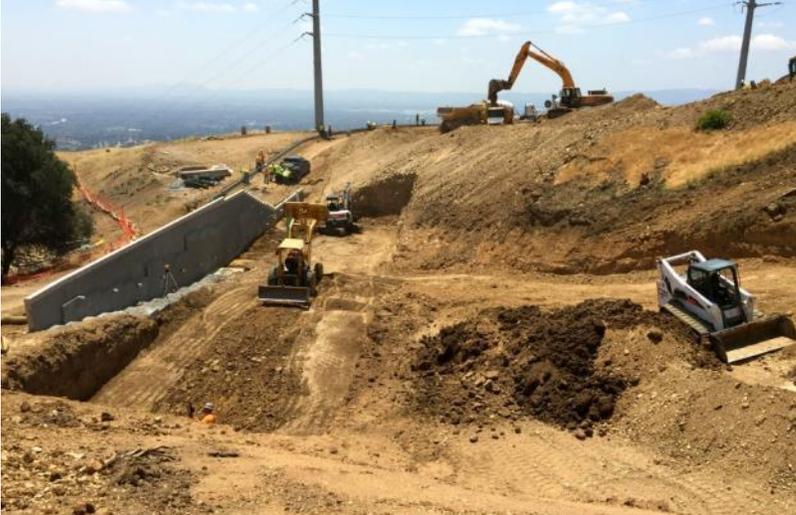
Dirt work inside the retaining wall where the bio-filtration structure will go.

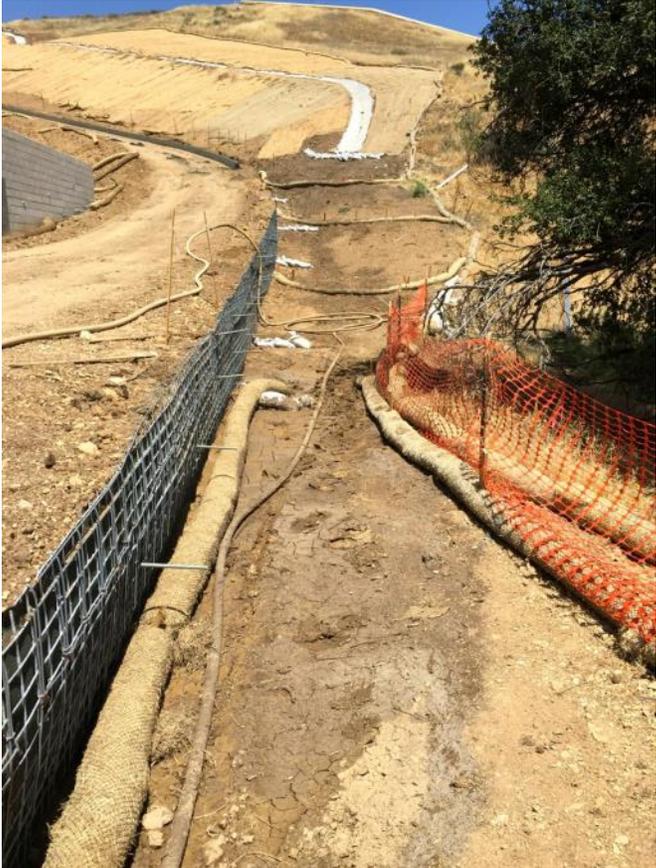
Photo showing some of the ponded rainwater runoff along the access road wall.
5/19/15	Natural Substation

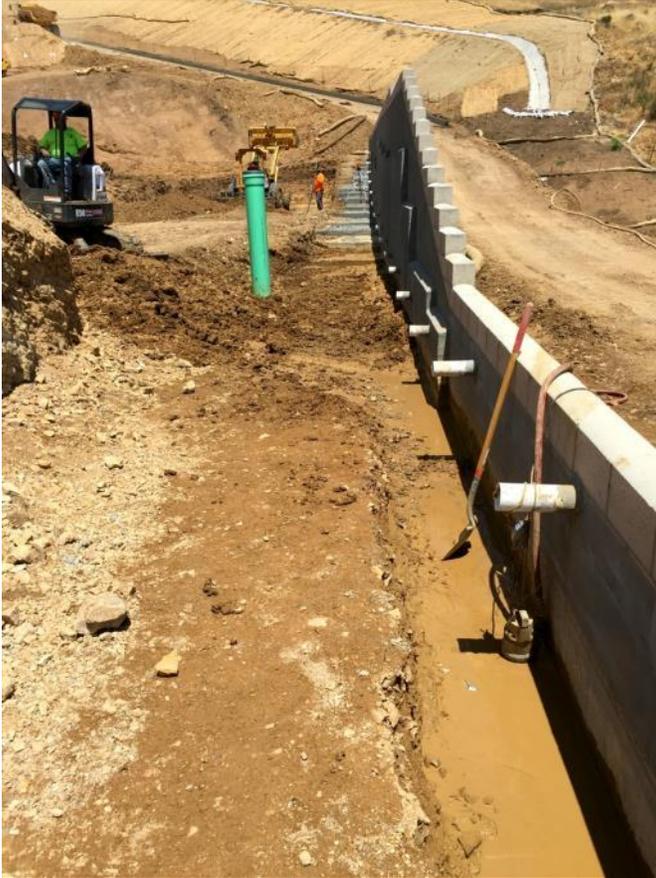
Rainwater runoff ponded behind the bio-filtration retaining wall.

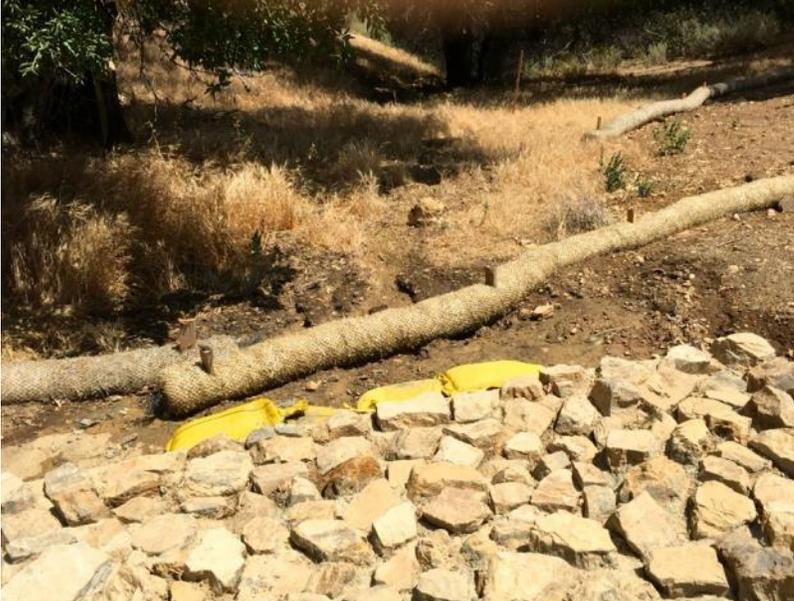
Biofiltration energy dissipation exit point. Pounded storm water was poured onto this structure after the storm event.
5/19/15	Natural Substation

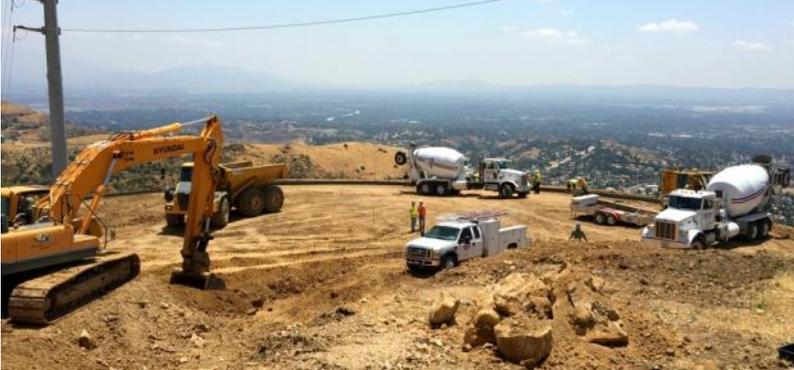
Excavation of dirt from the substation and pouring of the curb around the facility.
5/19/15	P-41 fill site

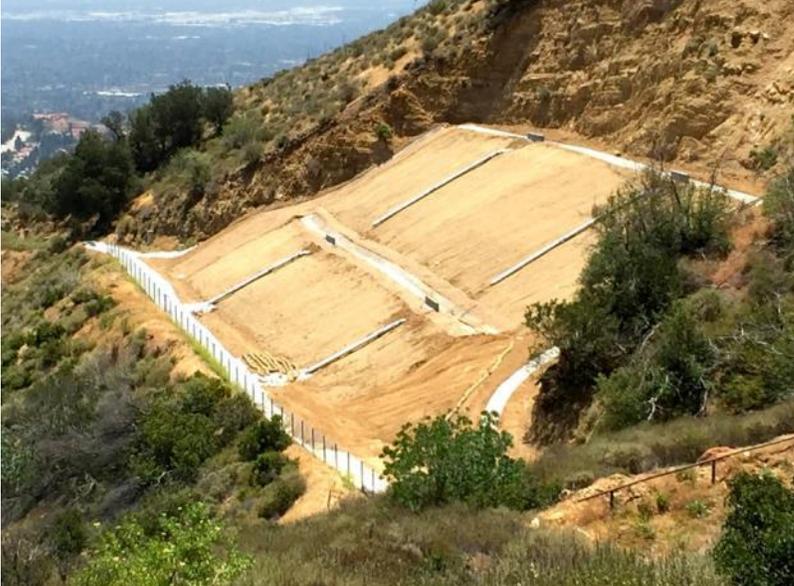
Final buttoning up of the fill site.

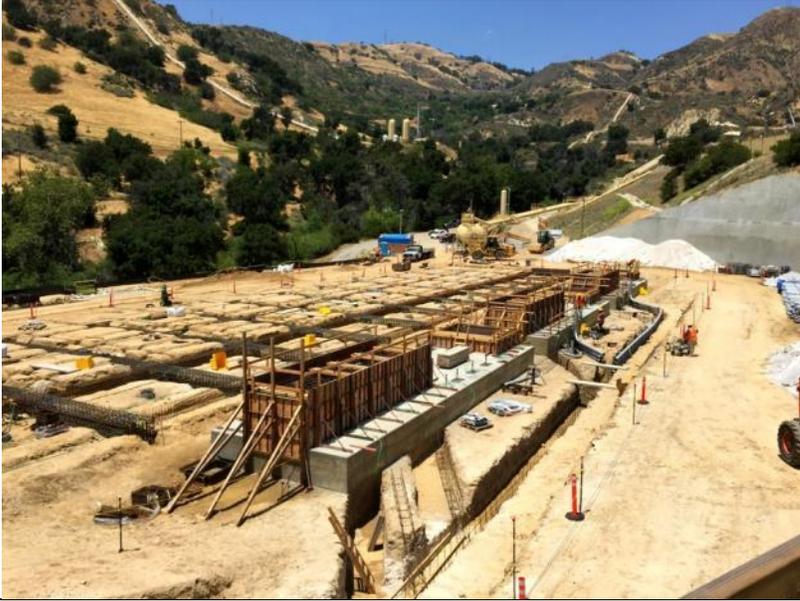
At the CCS, crews were working on foundations and conduit throughout the site. A Kiewit (SCG's contractor) supervisor approached us and I asked if he had any ponded rainwater in his trenches. He said he did and they pumped it out, using it for dust suppression.

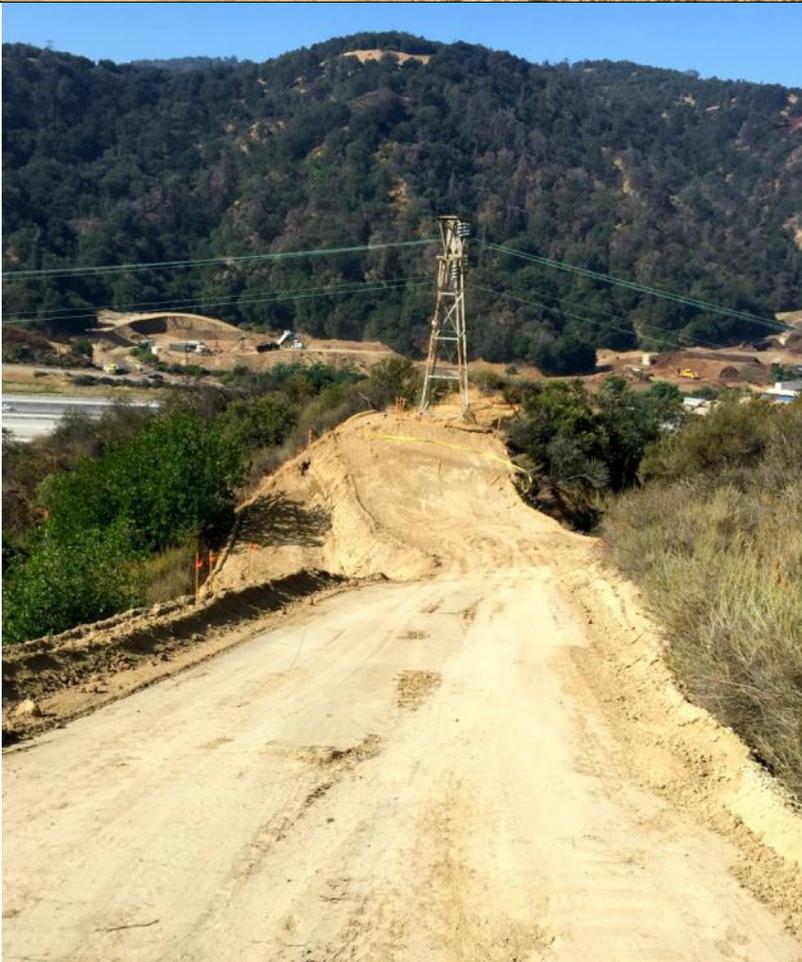
<p>TSP 28 site has also been cleared and prepared for drilling.</p>

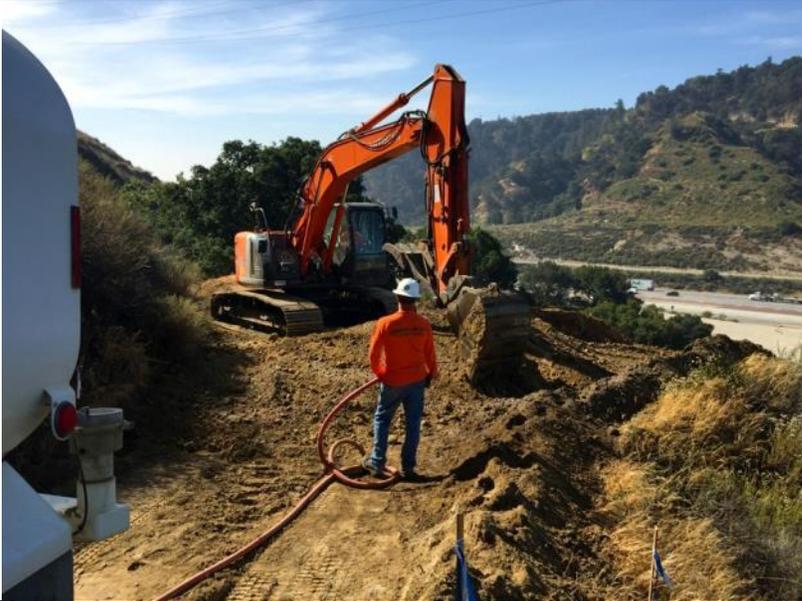
<p>TSP 29 is being prepared for the new pole installation. Monitors were onsite.</p>
5/28/15	Access road for TSPs 27-32
