**Re: Monthly Report Summary #14 for Aliso Canyon Turbine Replacement Project**

## Aliso Canyon Turbine Replacement Project CPUC Site Inspection Form

Project:	Aliso Canyon Turbine Replacement	Date:	May 7, 2015
Project Proponent:	Southern California Gas Company and Southern California Edison	Report #:	VS054
Lead Agency:	California Public Utilities Commission	Project Phase/NTP:	Guard House and Road Widening (NTP-1), the New Admin/IM Building (NTP-2), and Central Compressor Site (NTP-3). P-41 Fill Site (NTP-2), PS-42 Fill Site, P-32 Fill Site (NTP-3), and the Natural Substation (NTP-3, NTP-A). TSPs 2-46 (NTP-A, NTP-C), and the Oak Tree Mitigation Site.
CPUC PM:	Andrew Barnsdale, Energy Division	AM/PM Weather:	Overcast, cool (64 degrees), and blustery. Some rain predicted for later in the day.
E & E CM:	Lara Rachowicz	Start/End time:	0700-0930 hrs. in Wiley Canyon. 1015-1300 hrs. at the Aliso Storage Field.
Monitor(s):	Vince Semonsen		
Project Component(s):	Storage Field components, 66-kV Subtransmission Line, Telecommunications route

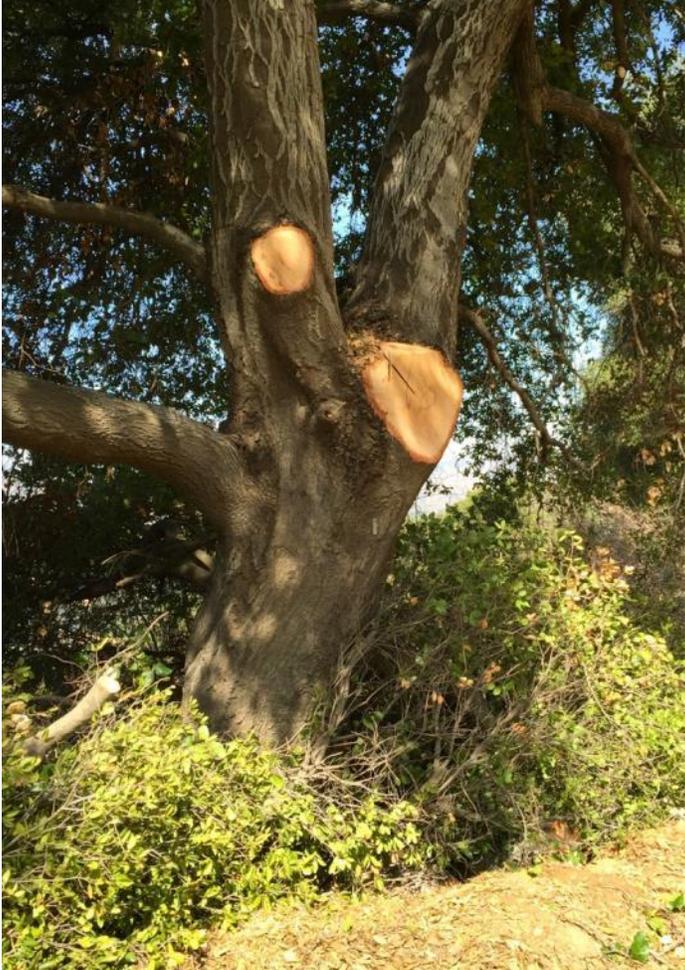
<p>Oak tree pruning was done with SCE/Arcadis Botanist Mary Carroll before the crews moved in with equipment.</p>

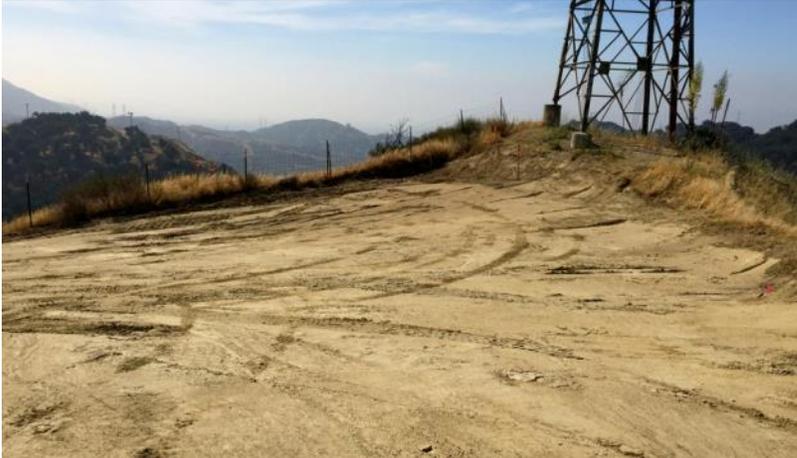
Site has been prepared for drilling.
5/28/15	TSP 32

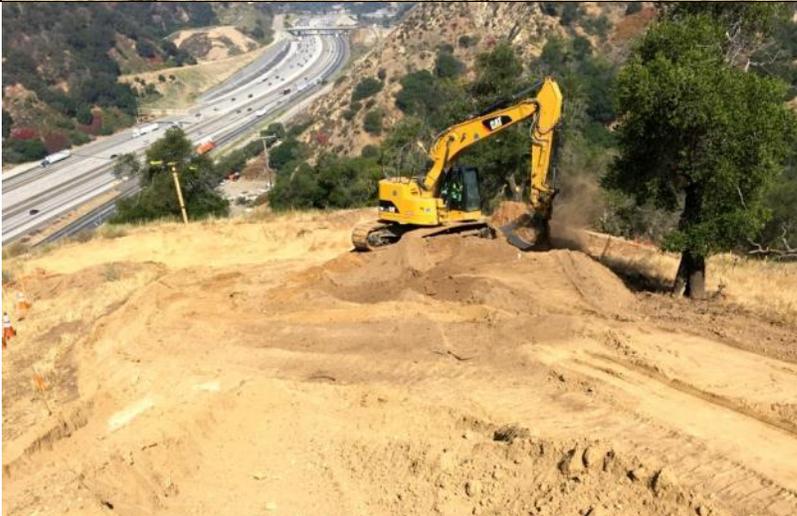
On May 28, CPUC Compliance Monitor Vince Semonsen visited the TSP 32 work area, where he observed an excavator digging without the required biological monitor and paleontological monitor present. Mr. Semonsen was accompanied by SCE/Arcadis Lead Monitor, Todd White. Mr. White immediately stopped the work and waited for monitors and the safety/fire crew to arrive. Upon arrival, the monitors assessed the area for impacts. After determining that no impacts occurred during the excavation of approximately 10 cubic yards of soil, work resumed with monitors present. Mr. Semonsen provided a description of this event and a photograph in his May 28 Site Inspection Report submitted to the CPUC (Attachment 1), and a Level 1 Non-Compliance was issued in the Site Inspection Report. Subsequent to Mr. Semonsen's site visit, SCE self-reported this event via an e-mail on June 4 to the CPUC. SCE reported that they emphasized to the equipment operator and all staff the importance of ensuring that required monitors and safety personnel are present during ground disturbing activities.

When I arrived onsite at TSP 32, I observed an excavator working but no monitors, no fire crew, and no personnel operating a water truck were present – see photo. Todd White shut down the equipment until the crews and monitors arrived. Todd said they had to remove 5 oaks at this location. Bird nest buffers were in place. A Level 1 Non-Compliance is being issued for this incident (see below).

Excavator working at TSP 32; no monitors were present.
5/28/15	TSP 26

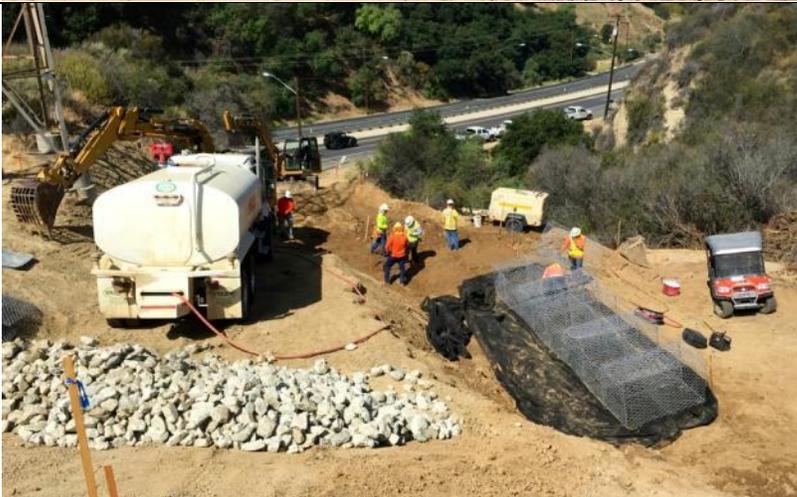
Dirt work at TSP 26 is waiting for a crew to come in and place gabion cages to stabilize the road bank.

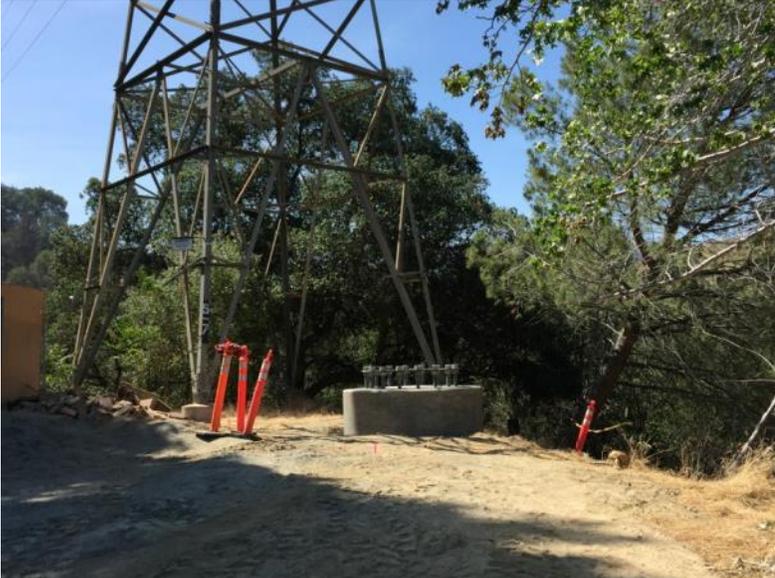
<p>The pole foundation has been drilled and poured. It is located within the mobile home park.</p>
5/28/15	TSP 19

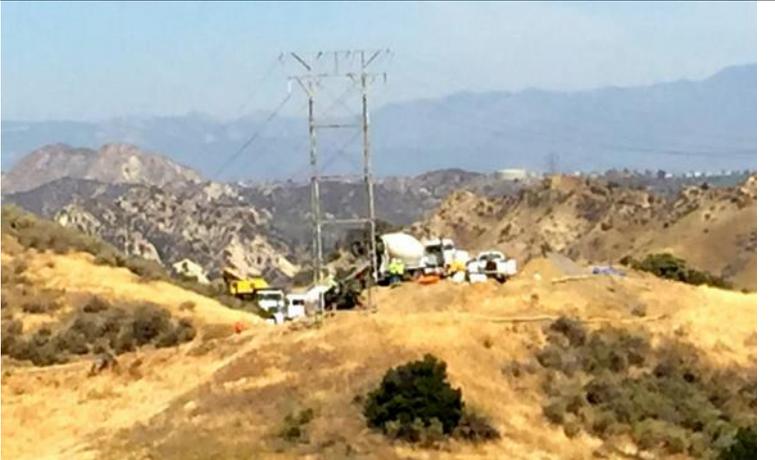
<p>Concrete trucks are at TSP 19 pouring the pole foundation.</p>
5/28/15	P-32 Fill Site

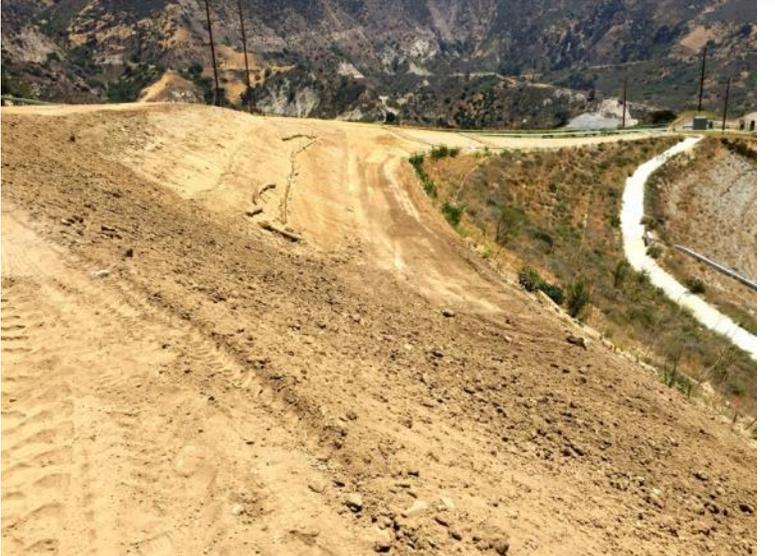
<p>Dirt continues to be brought to the fill site from the CCS area.</p>

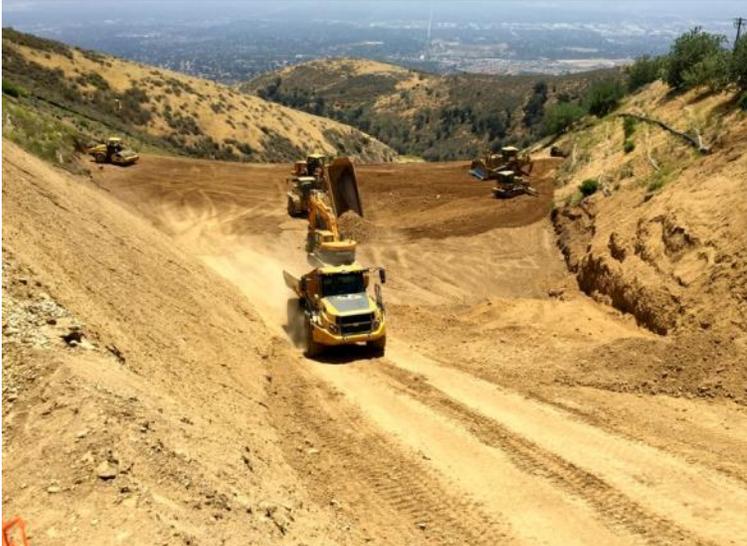
Dirt is coming from the Natural Substation and equipment is compacting dirt into the fill site.
5/28/15	Substation access road

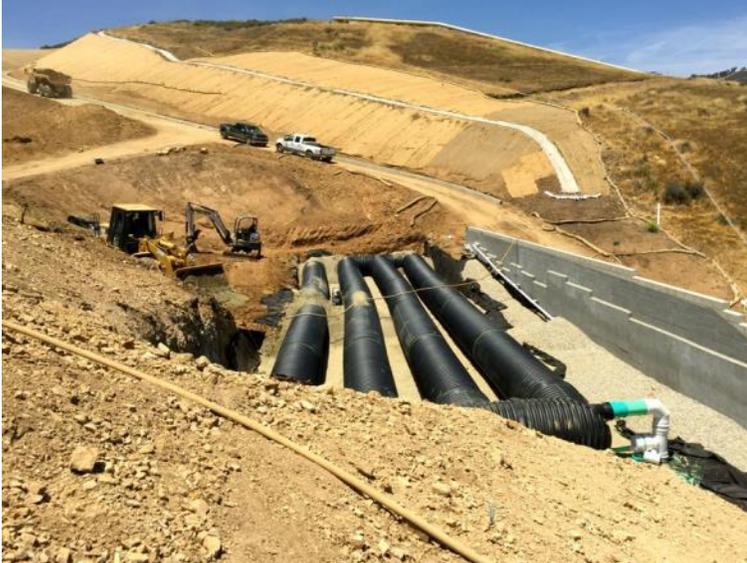
The biofiltration infrastructure is in place and is being backfilled with gravel.
5/28/15	Natural Substation

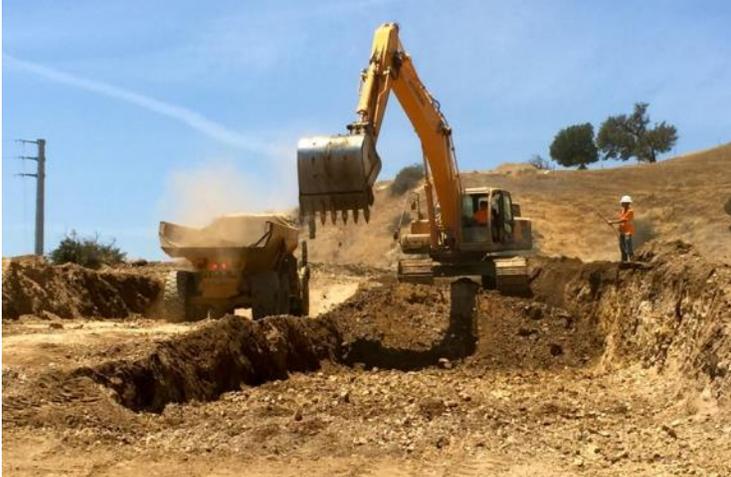
An excavator is filling the haul trucks.

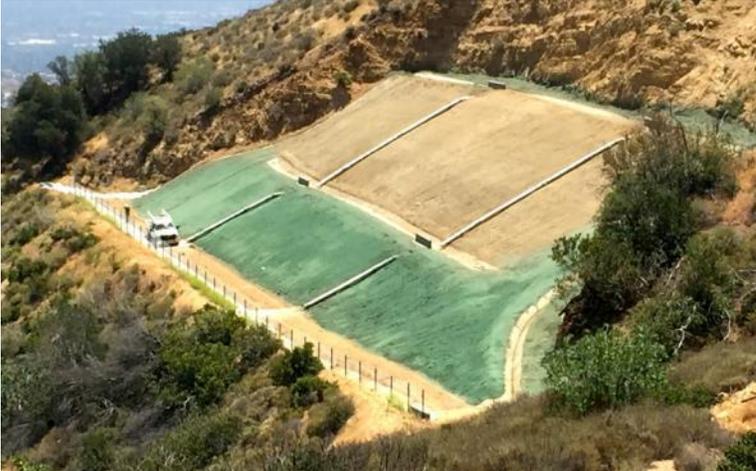
The final hydroseeding of the fill site had just been completed; some "V" ditch work remains.
5/28/15	CCS

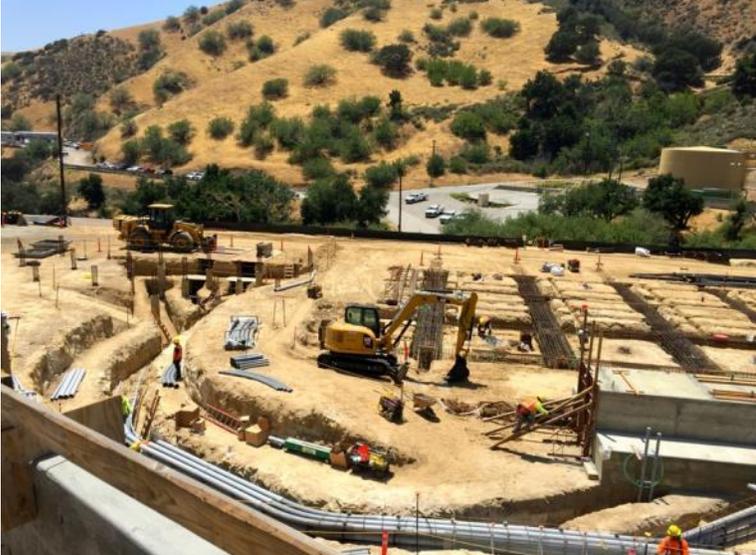
Foundation work and conduit installation continues.
5/28/15	CCS

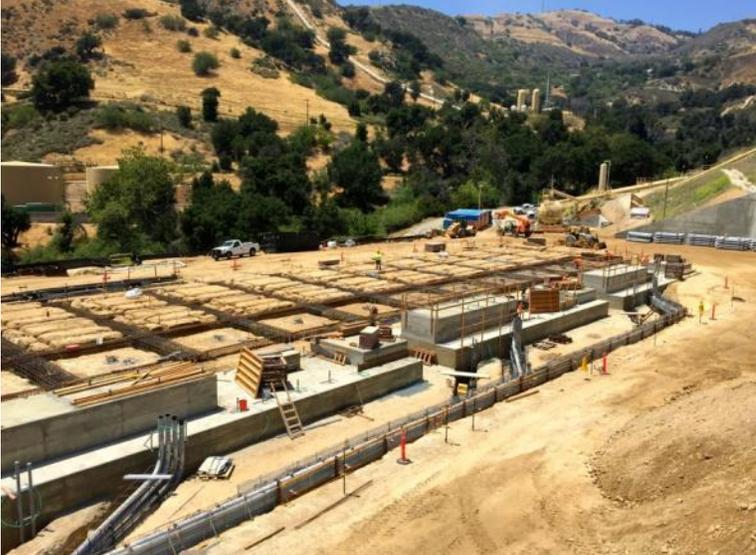
Foundation work.

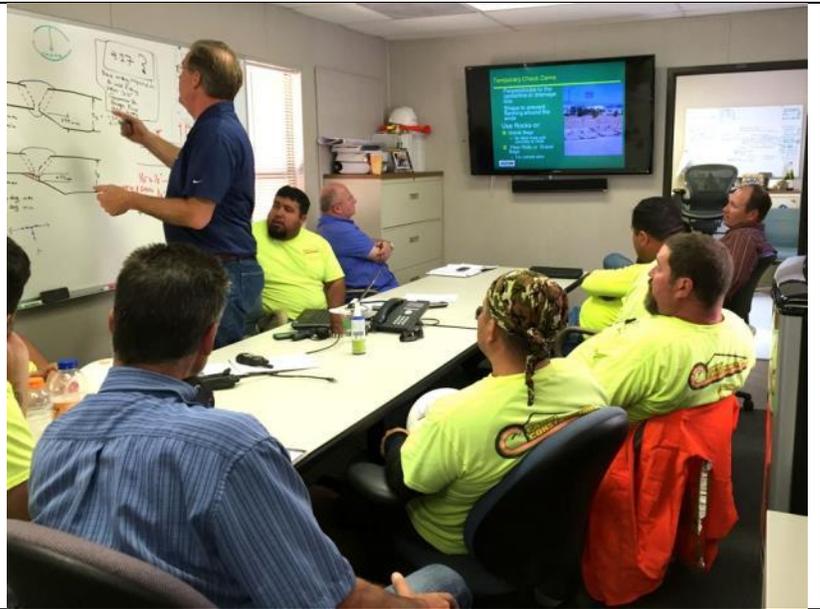
Attended the SWPPP retraining.
