Re: Monthly Report Summary #15 for Aliso Canyon Turbine Replacement Project

Aliso Canyon Turbine Replacement Project CPUC Site Inspection Form

Project:	Aliso Canyon Turbine Replacement	Date:	June 4, 2015
Project Proponent:	Southern California Gas Company and Southern California Edison	Report #:	VS058
Lead Agency:	California Public Utilities Commission	Monitor(s):	Vince Semonsen
CPUC PM:	Andrew Barnsdale, Energy Division	AM/PM Weather:	Overcast, slight drizzle, light breeze, and cool temperatures (60 °F).
E & E CM:	Lara Rachowicz	Start/End time:	0730 - 1030 within Wiley Canyon 1045 - 1330 at the Aliso Storage Field
Project NTP(s):	Guard House and Road Widening (NTP-1). The New Admin/IM Building (NTP-2) and Central Compressor Station (CCS) (NTP-3). P-41 Fill Site (NTP-2), PS-42 Fill Site, P-32 Fill Site (NTP-3), and the Natural Substation (NTP-3, NTP-A, NTP-D). TSPs 2 through 45 and the SCE 210 Freeway Yard (NTP-A, NTP-C, NTP-D).

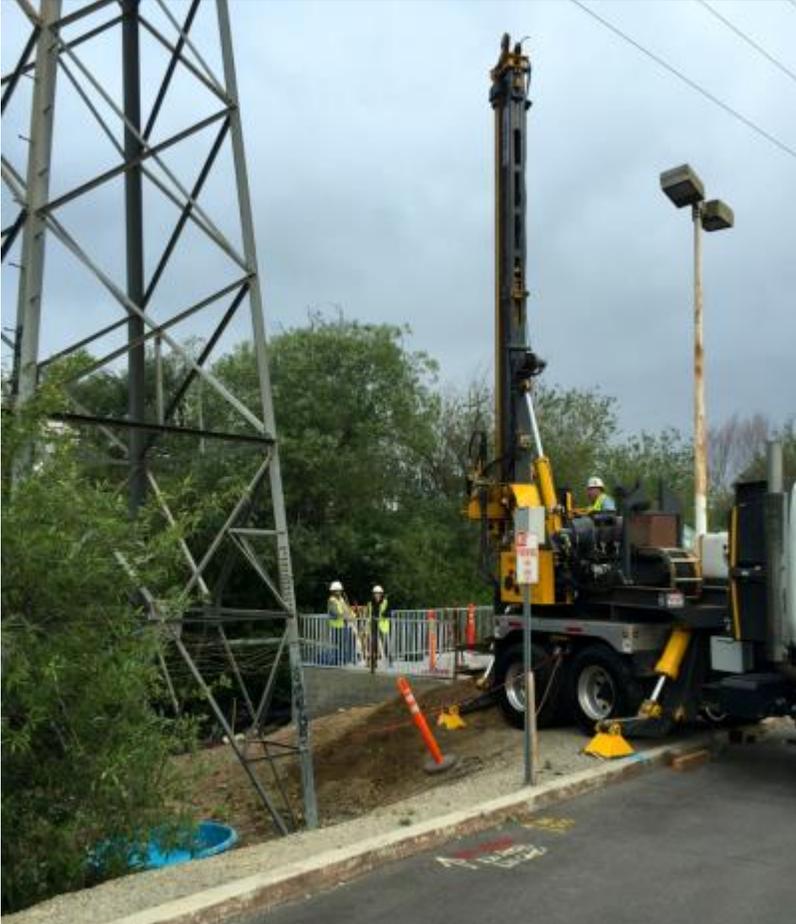
Crew is drilling for the TSP 11 foundation.
6/04/15	TSP 27

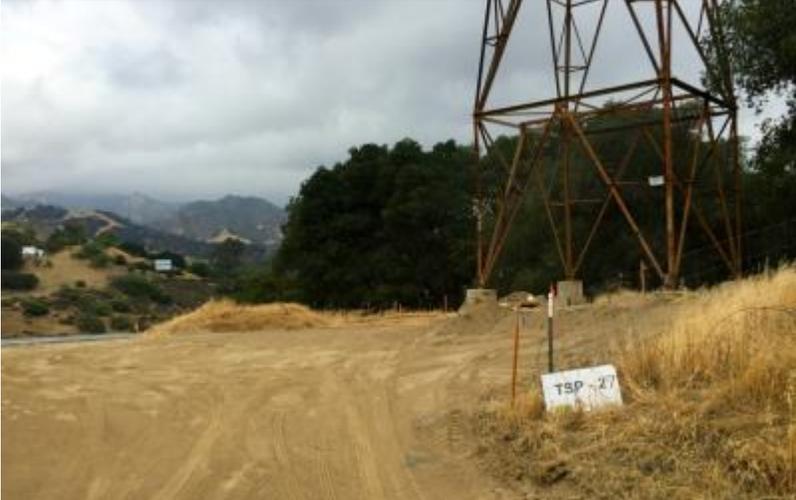
TSP 27 site has been prepared for drilling. Stockpiled soil has been removed.

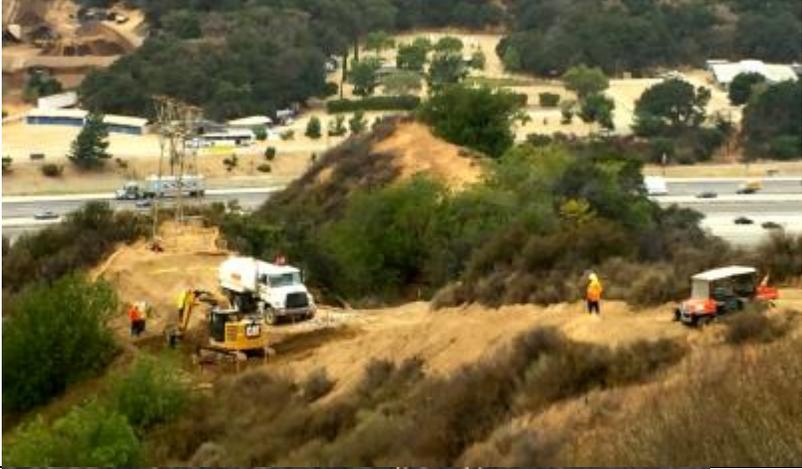
Crews are installing rock gabions at the TSP 28 site.
6/04/15	TSP 29

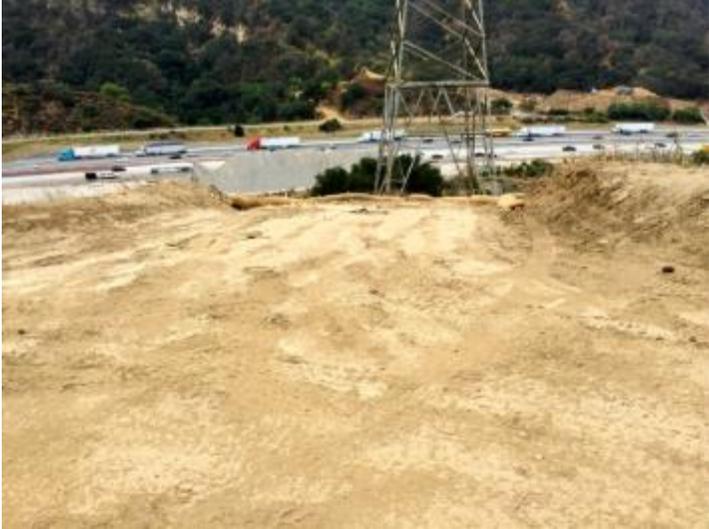
TSP 29 has been prepared for the new pole installation.
6/04/15	TSP 32

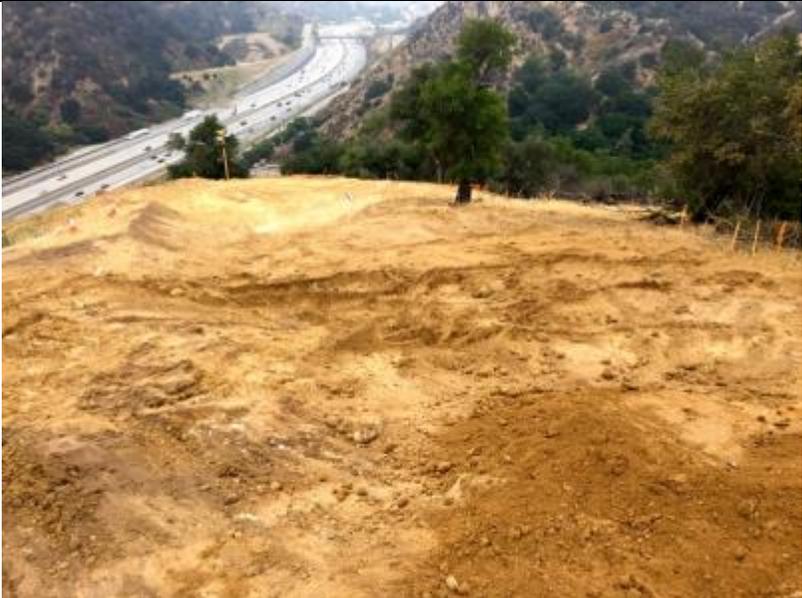
At TSP 32, an excavator is continuing to prepare the site with oversight by paleontological/archeological monitor Cecilio Garcia and biologist Shannon Dye – see photo. The nesting bird within the TSP 32 staging area successfully fledged its young, and equipment is now stored at this location. The excavator is working very close to several oak trees, and I discussed with Todd whether some exclusion fencing might prevent damage to the trees. Todd said these trees were scheduled to be removed; however, the trees were able to remain in place with some pruning. Todd felt comfortable without using any fencing because excavation work is being conducted so close to the trees that fencing would actually impede work; in addition, there is close oversight by the biological monitor.

Site preparation at TSP 32.

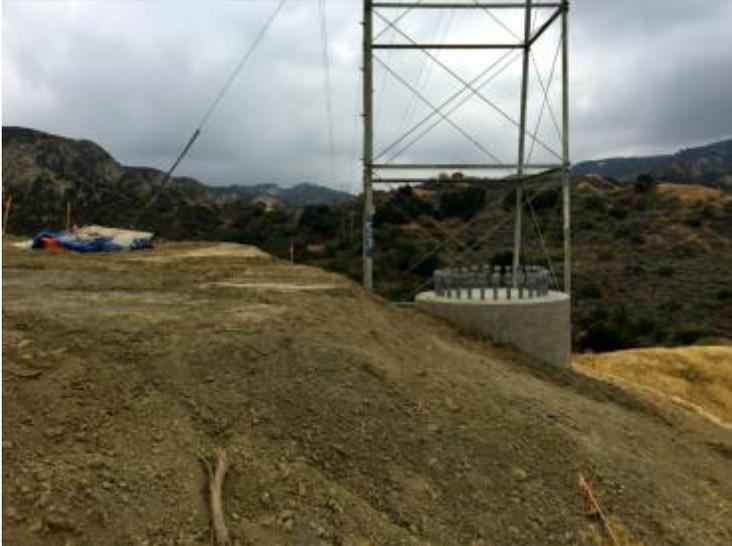
The pole foundation has been poured at TSP 19.
6/04/15	TSP 18

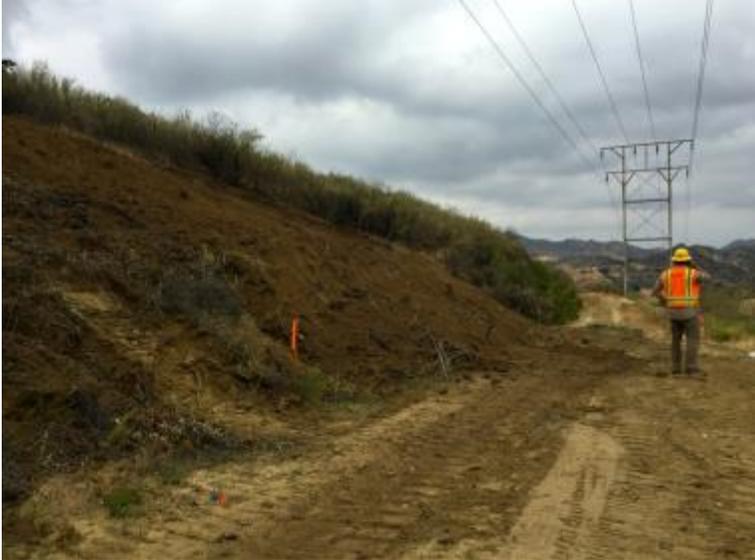
Topsoil is being salvaged.
6/04/15	PS-42 Fill Site

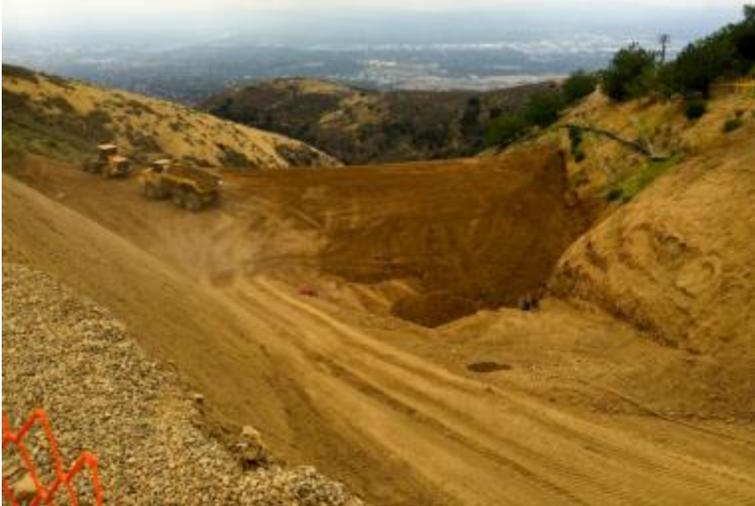
Soil is coming from the Natural Substation and equipment is compacting the soil into the PS-42 Fill Site.

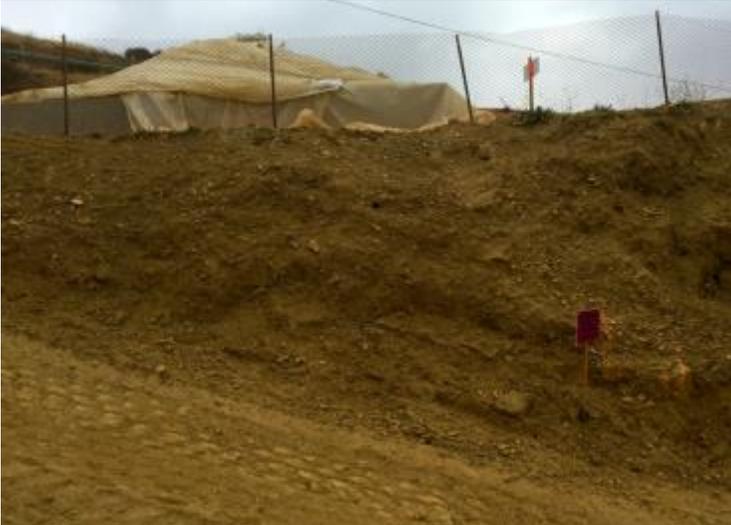
<p>Rock wren nest in the cut bank of the PS-42 Fill Site access road. A very small buffer has been delineated – the birds seem unconcerned with the haul truck traffic.</p>
6/04/15	Natural Substation access road

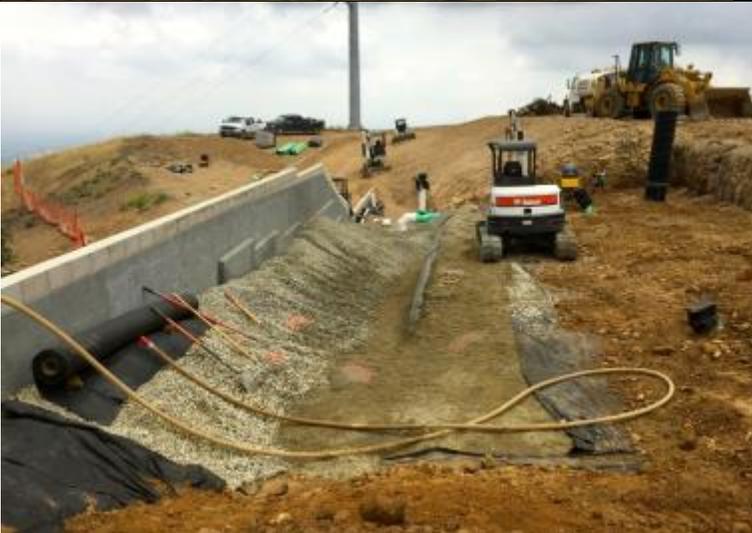
<p>The biofiltration infrastructure is being backfilled with gravel.</p>
6/04/15	Natural Substation

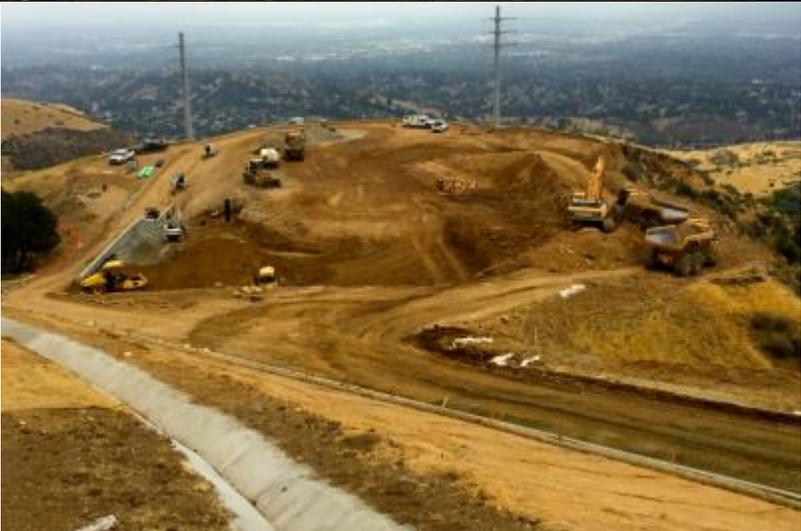
<p>Overview of the Natural Substation work. An excavator is filling the haul trucks.</p>

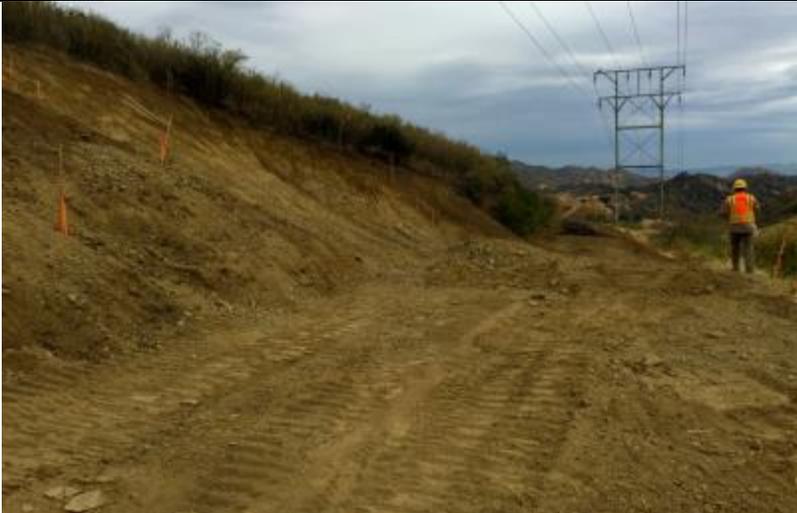
Topsoil was salvaged and the grading is almost done.
6/09/15	TSP 16

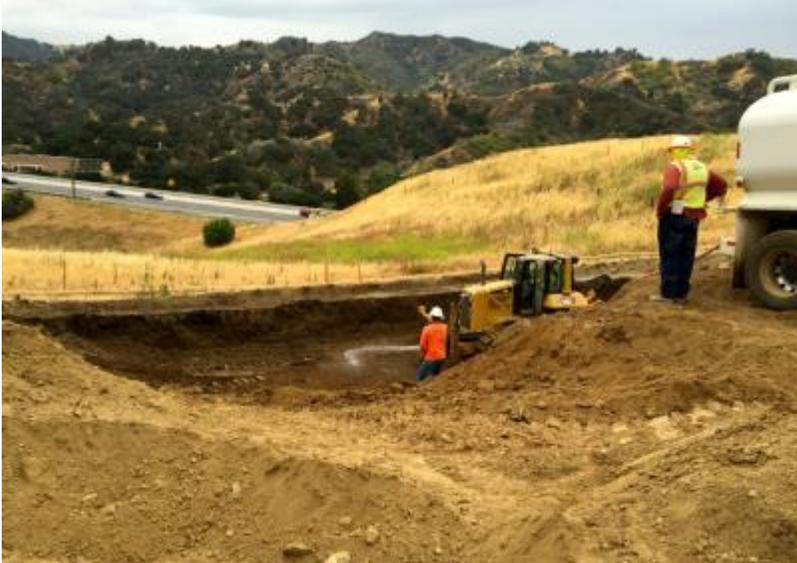
A crew is backfilling the fill key.
6/09/15	TSP 15

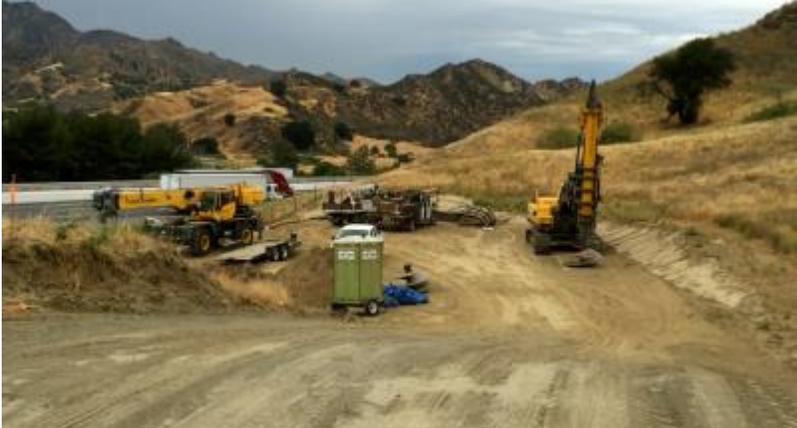
Northern staging area

No construction activity was taking place at TSP 15, but numerous equipment and materials were being stockpiled in the cleared pull sites – see photos. A crew was present at TSP 13 and preparing to install the TSP. At TSP 26, concrete trucks were onsite and pouring the pole foundation – see photos. Small wading pools were being used to manage concrete washouts and seemed to be adequate. The gabion wall had been finished prior to drilling and pouring operations.

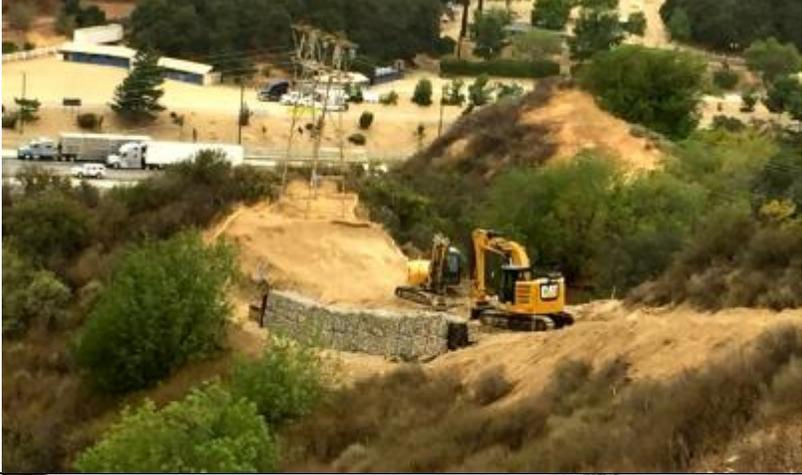
Rock gabions at the TSP 28 site have been installed and the site is ready for drilling.
6/09/15	TSP 30

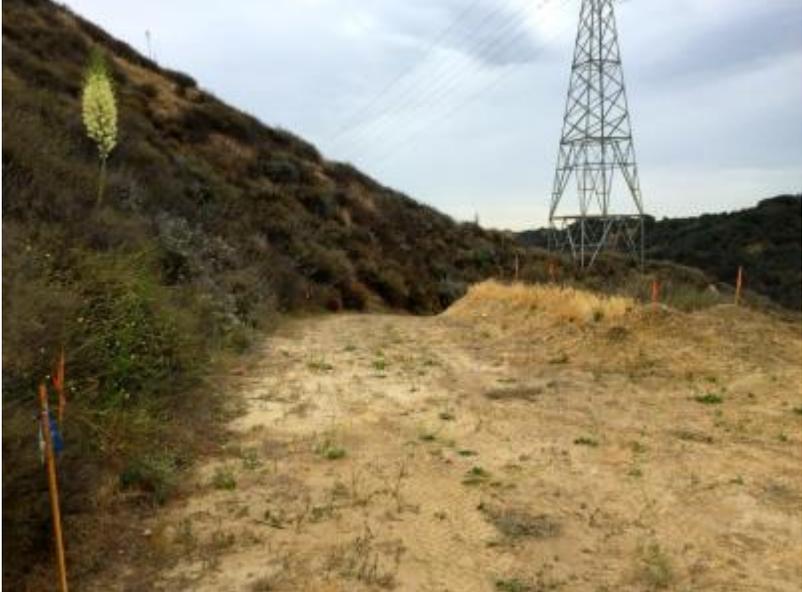
Approximate location of the TSP 30 pole site.

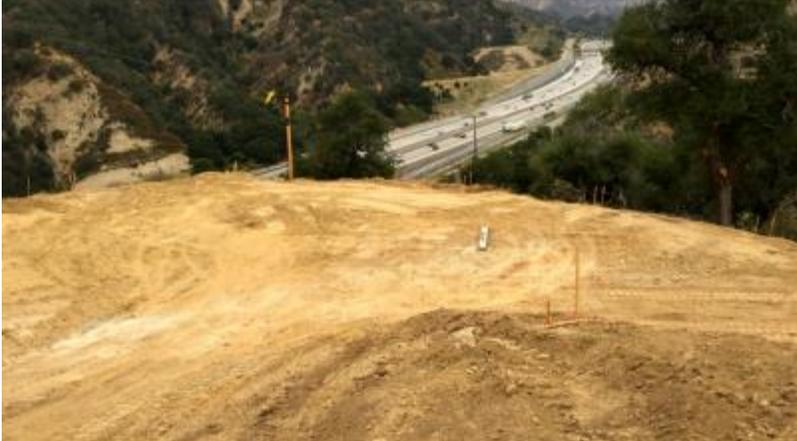
Site preparation is nearly complete at TSP 32.
6/09/15	TSP 26

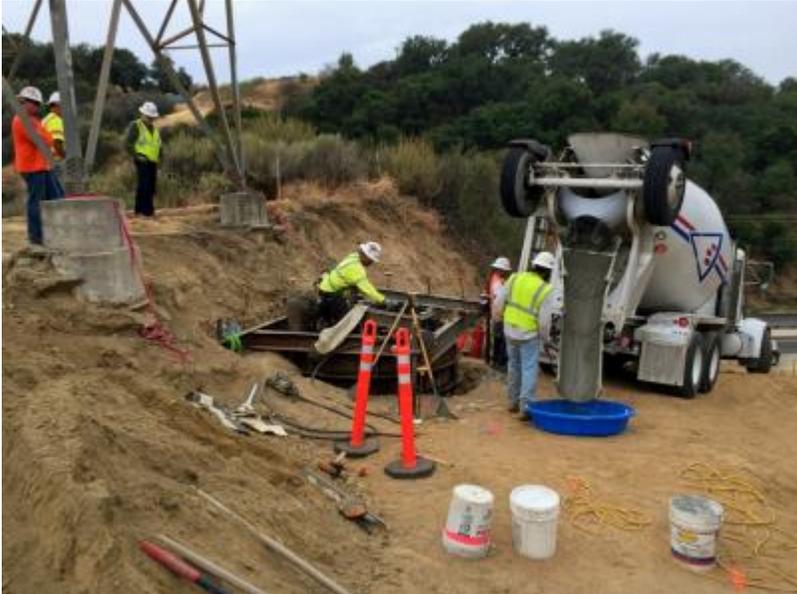
A crew is pouring the foundation for TSP 26.
6/09/15	TSP 26

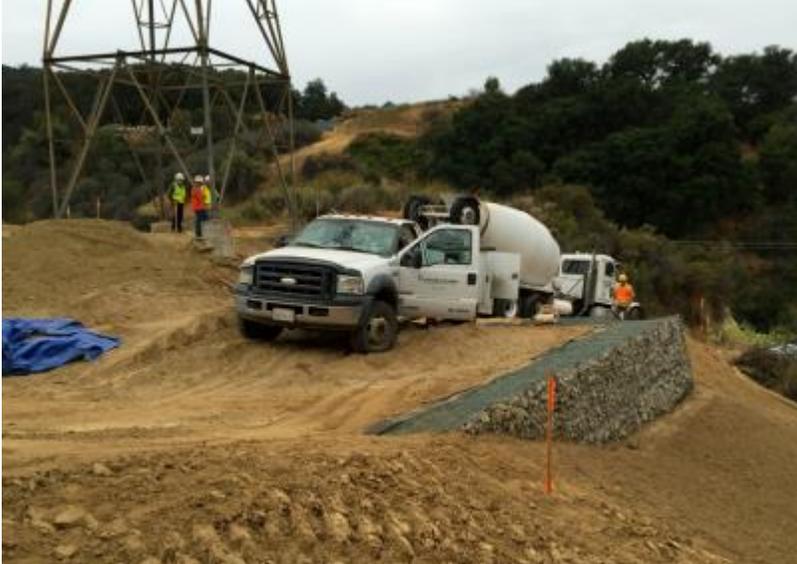
Photo shows the rock gabion at TSP 26.

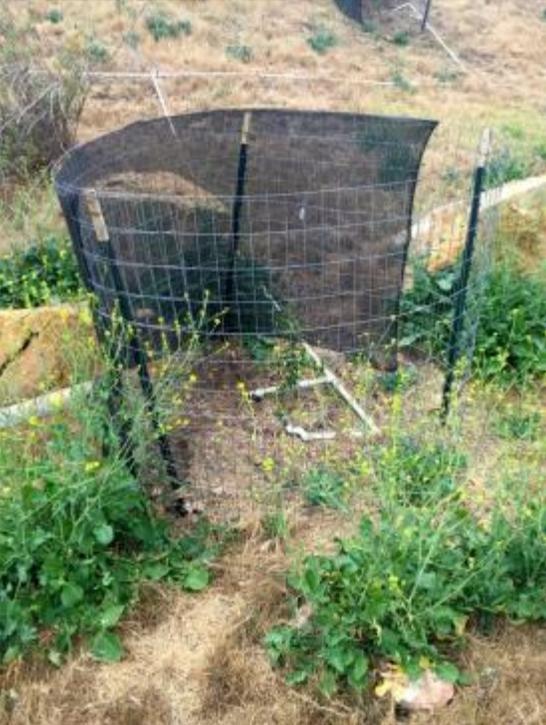
Oak tree with exclusion fencing - Note the mustard coming up around the cage.
6/09/15	PS-42 Fill Site

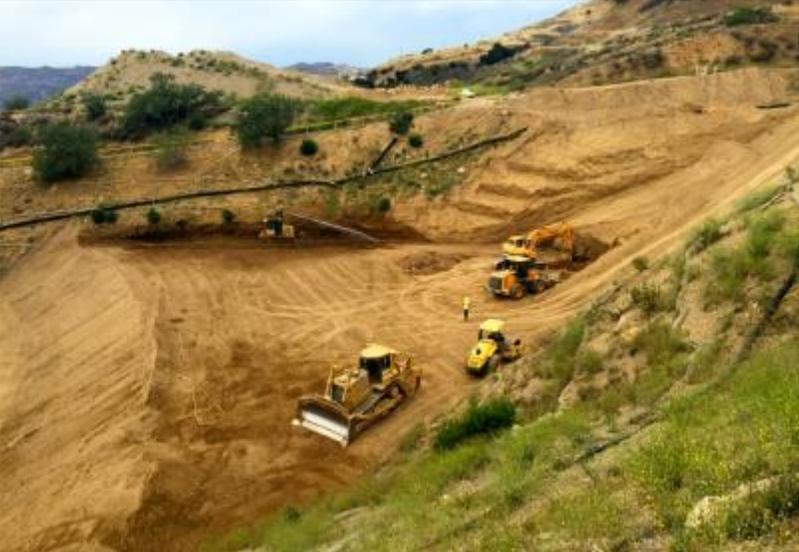
Soil is coming from the Natural Substation and equipment is compacting the soil into the PS-42 Fill Site.
6/09/15	PS-42 Fill Site

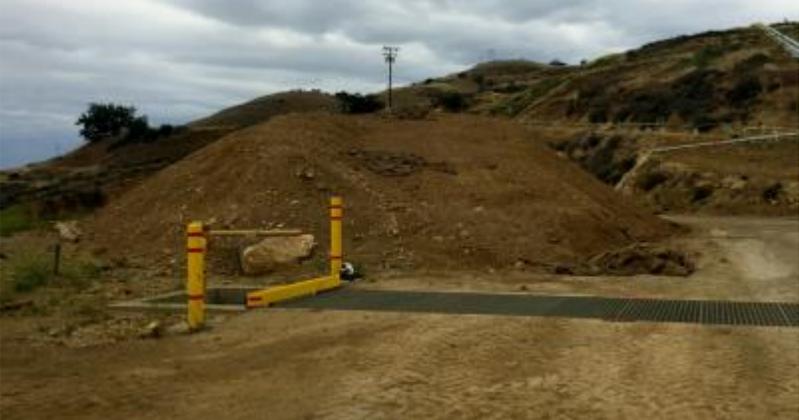
Soil stockpiles are being uncovered in preparation for their import into the PS-42 Fill Site.

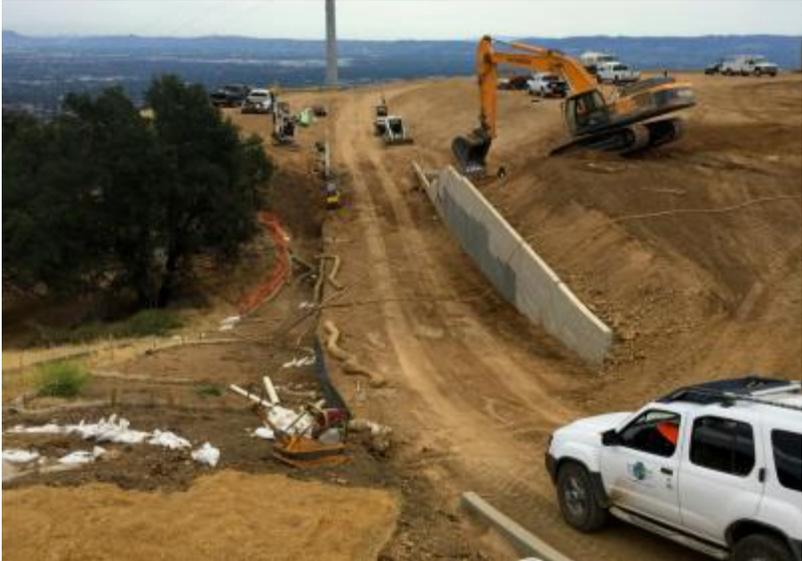
Clean-up of the area along the access road is underway, with final backfilling of the biofiltration structure being completed.
6/09/15	Natural Substation

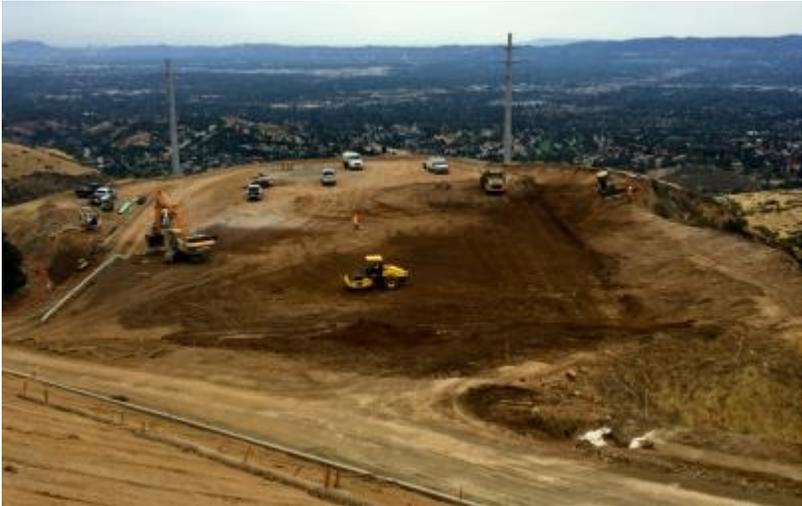
Overview of the Natural Substation work. Earthwork at the site is nearly complete.
6/09/15	P-32 Fill Site

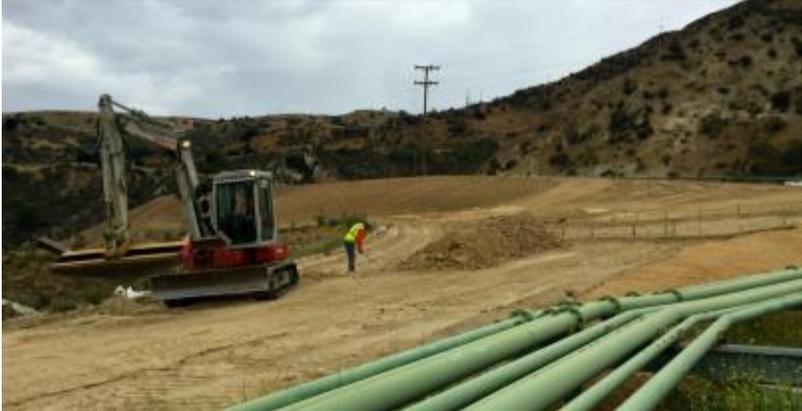
A crew is cutting a "V" ditch at the P-32 Fill Site.

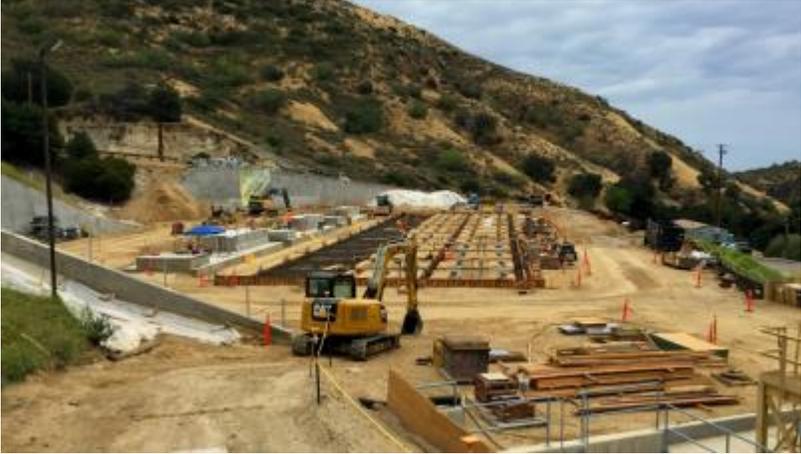
Foundation work and conduit installation continues.

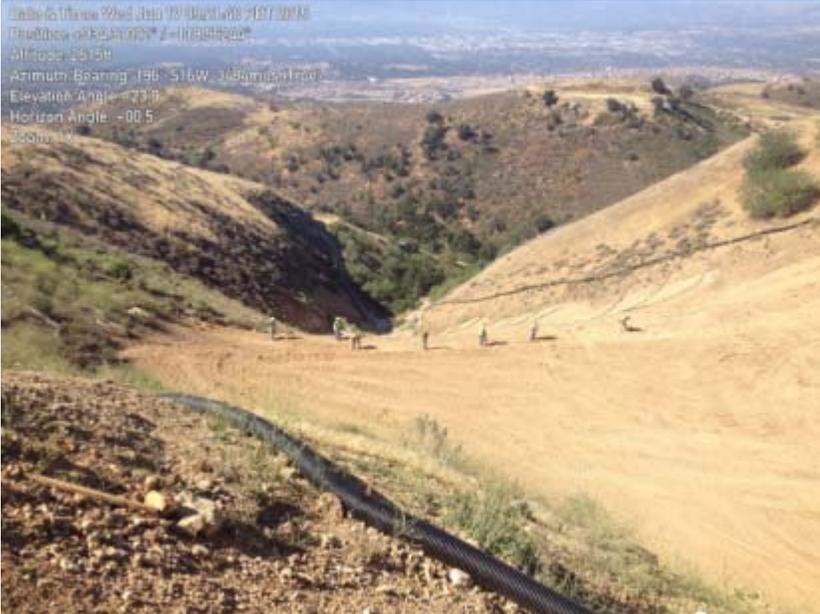
Crews preparing the PS-42 Fill Site to install V-ditches.
6/15/2015	Natural Substation	<p> Date & Time: Wed Jun 10 09:35:36 PDT 2015 Position: 33.653400° N -112.688800° W Altitude: 2550 ft Azimuth Bearing: 330.262W - 456mm/s/1rad Elevation Angle: -09.6 Horizon Angle: -01.2 Zoom: 1x </p>

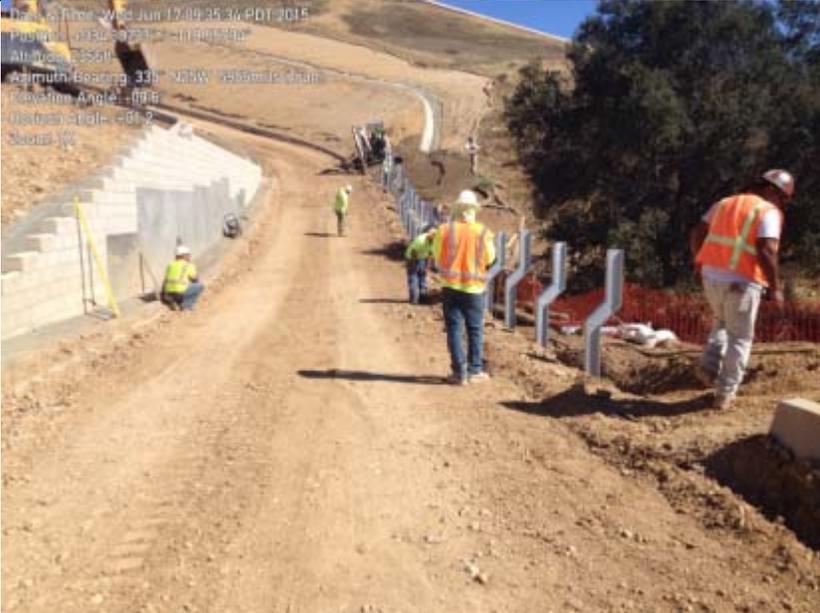
Crews finishing the hilfiker wall at the Natural Substation.

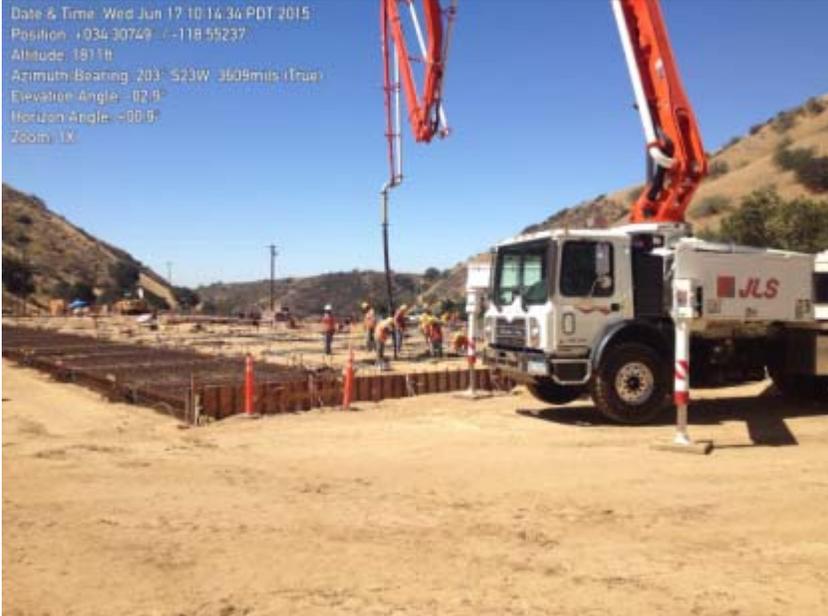
Crews pouring concrete for conduit and foundations.
6/17/2015	CCS	<p data-bbox="467 852 787 999">Date & Time: Wed Jun 17 10:06:40 PDT 2015 Position: +035 30710 / -118 55230* Altitude: 1800ft Azimuth/Bearing: 100° S00E 3000mils (True) Elevation Angle: -63.5° Horizon Angle: -61.5° Zoom: 1X</p>

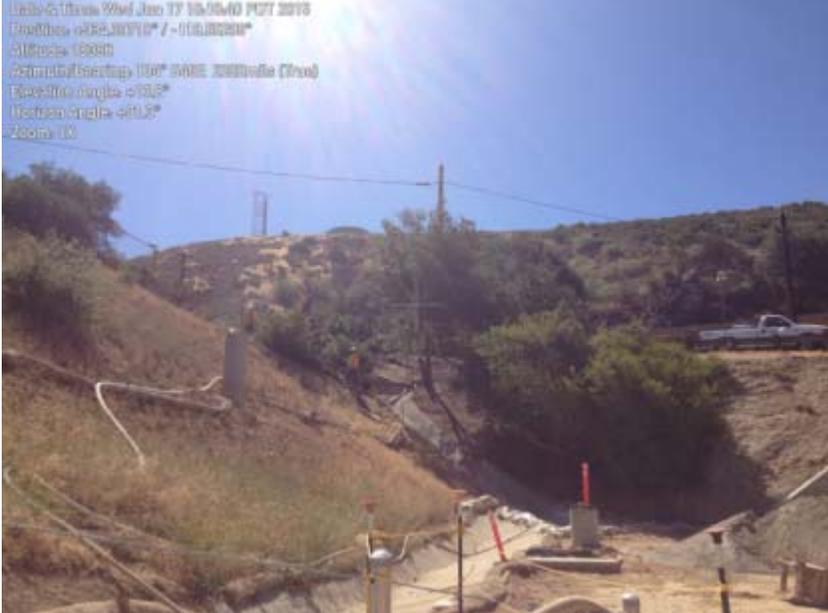
Crews removing several oak trees along the edge of the CCS to make room for the blowdown line.

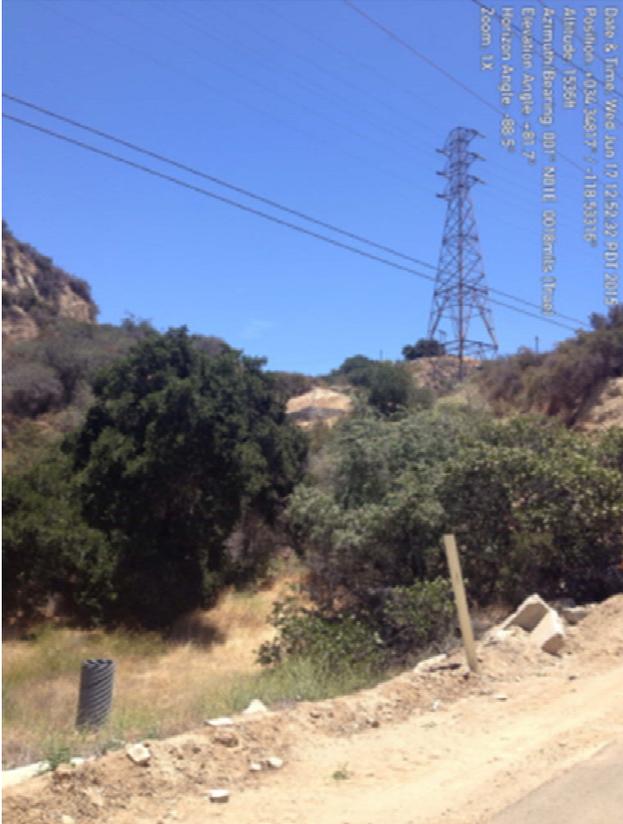
<p> Date & Time: Wed Jun 17 12:52:32 PDT 2015 Position: -034.52837° / -118.53316° Altitude: 1530ft Azimuth/Bearing: 001° N011.000°/000°/000° Elevation Angle: -83.7° Horizon Angle: -88.5° Zoom: 1X </p>	Gabion wall (in center of photo) completed at TSP 26.
6/17/2015	Near TSP 21

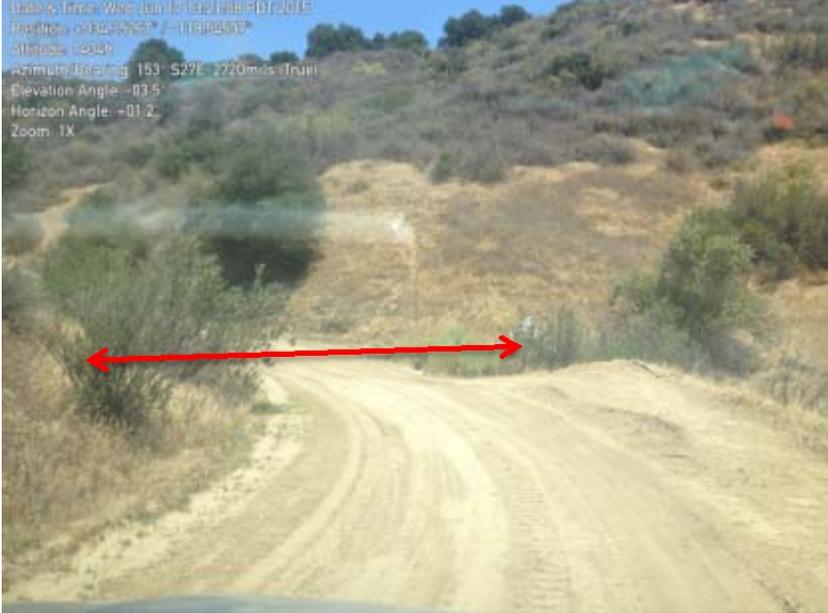
<p> Date & Time: Wed Jun 17 12:21:11 PDT 2015 Position: -034.52837° / -118.53316° Altitude: 1530ft Azimuth/Bearing: 153° S27E / 220m/0.000° Elevation Angle: -03.5° Horizon Angle: -01.2° Zoom: 1X </p>	Jurisdictional drainage (perpendicular to road) where culvert will be installed once approval is received.

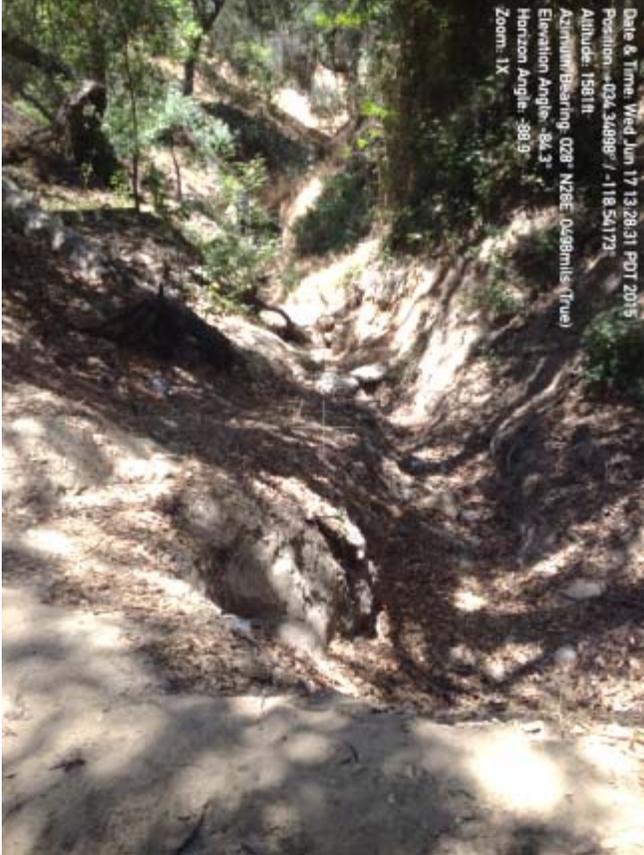
<p style="writing-mode: vertical-rl; transform: rotate(180deg); position: absolute; top: 108px; left: 585px; font-size: small;"> Date & Time: Wed Jun 17 13:28:31 PDT 2015 Position: -024.34899° / -118.54173° Altitude: 1581ft Azimuth/Bearing: 028° N28E 0499mils (True) Elevation Angle: -84.3° Horizon Angle: -88.9° Zoom: 1X </p>	Another drainage (3 and 3.1) that will be culverted and reinforced once approval is received.

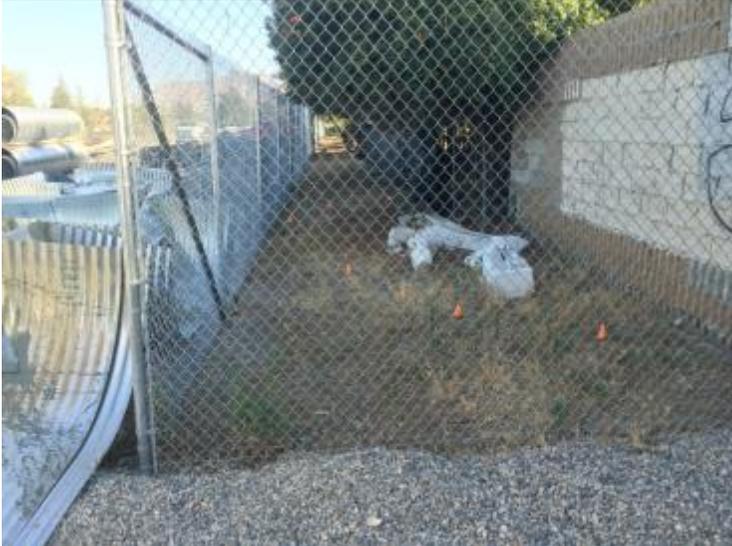
Fenced off cultural artifacts located just north of the construction trailers.
6/25/15	TSP 26

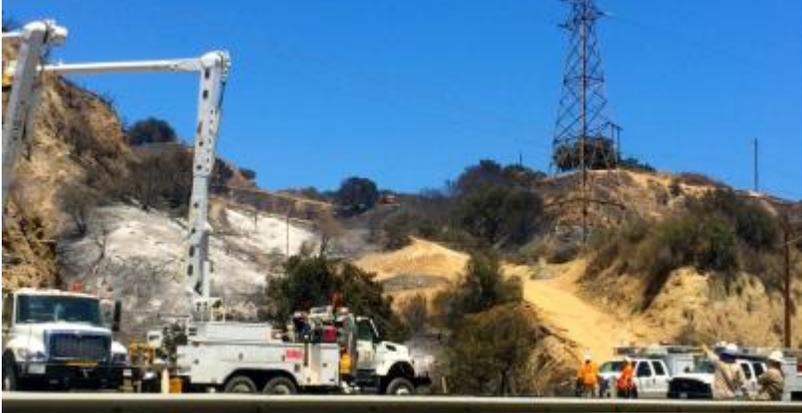
Todd and I traveled to the project site; however, the fire prevented access to TSPs 26 through 32. I took a photo of TSP 26 from the frontage road – see photo. Much of the vegetation around the TSP 26 pole site had been reduced to ash. According to Todd, the construction crews were able to get the drill rig out before the fire, but a small piece of equipment might have burned. Todd would attempt to access the site to determine if hazardous materials were leaking from the piece of equipment.

A fire went through the area the day before, thereby limiting access to the project site.
6/25/15	Access road entry gate

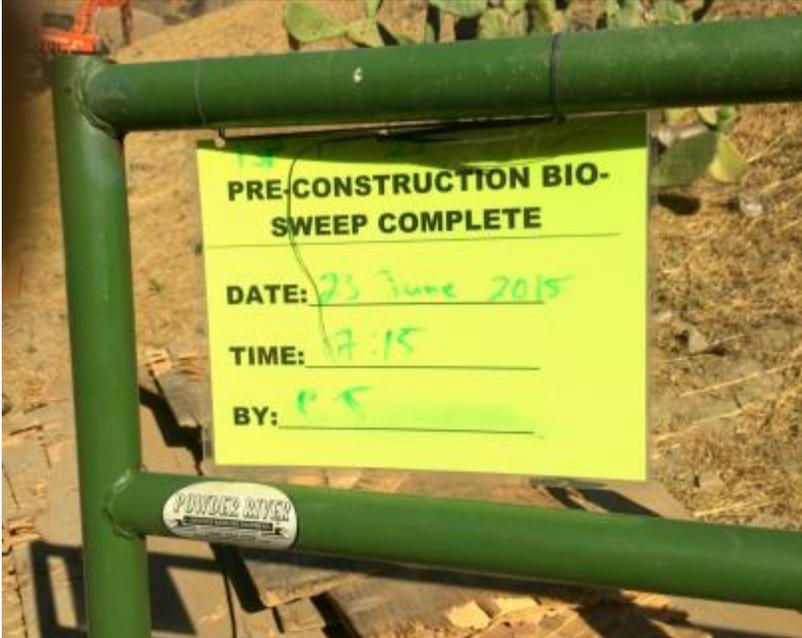
Dry erase signage installed by the monitoring crews to let everyone know if an area has been swept.

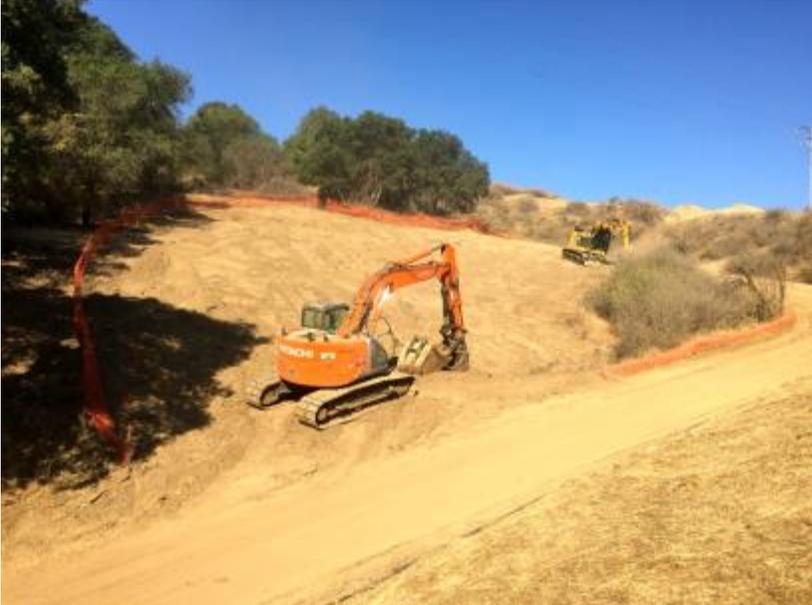
Cleared area for the TSP 21 pull station.
6/25/15	TSP 21

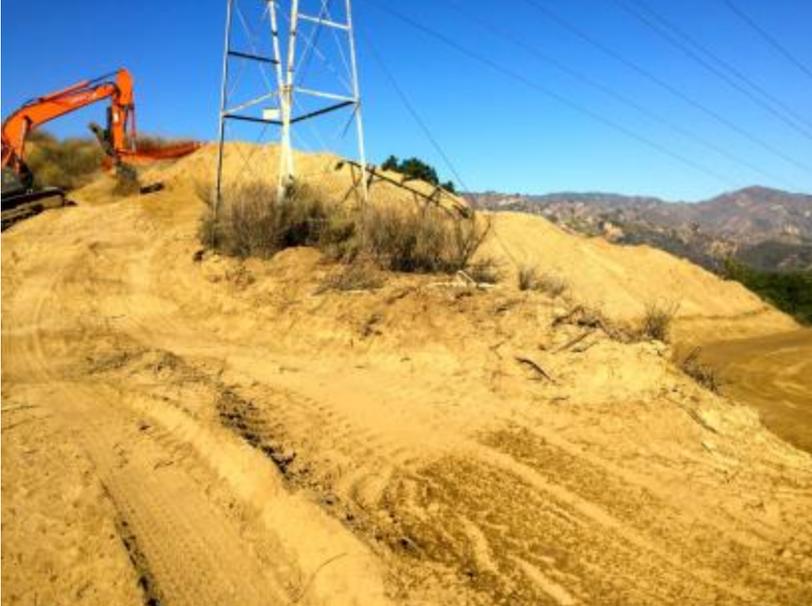
TSP 21 excavation work. Topsoil has been removed and stockpiled. Excess soil will go to TSP 16.

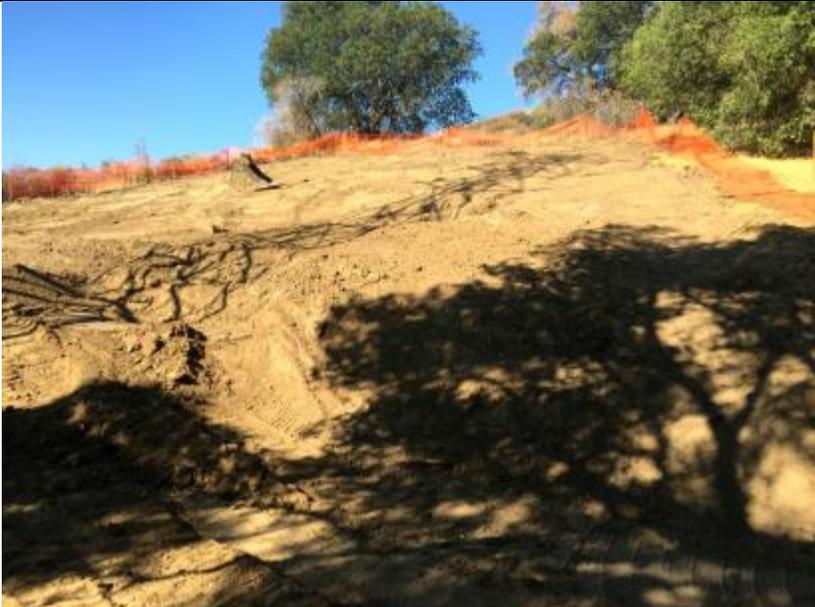
Cleared area for TSP 22.
6/25/15	TSP 11

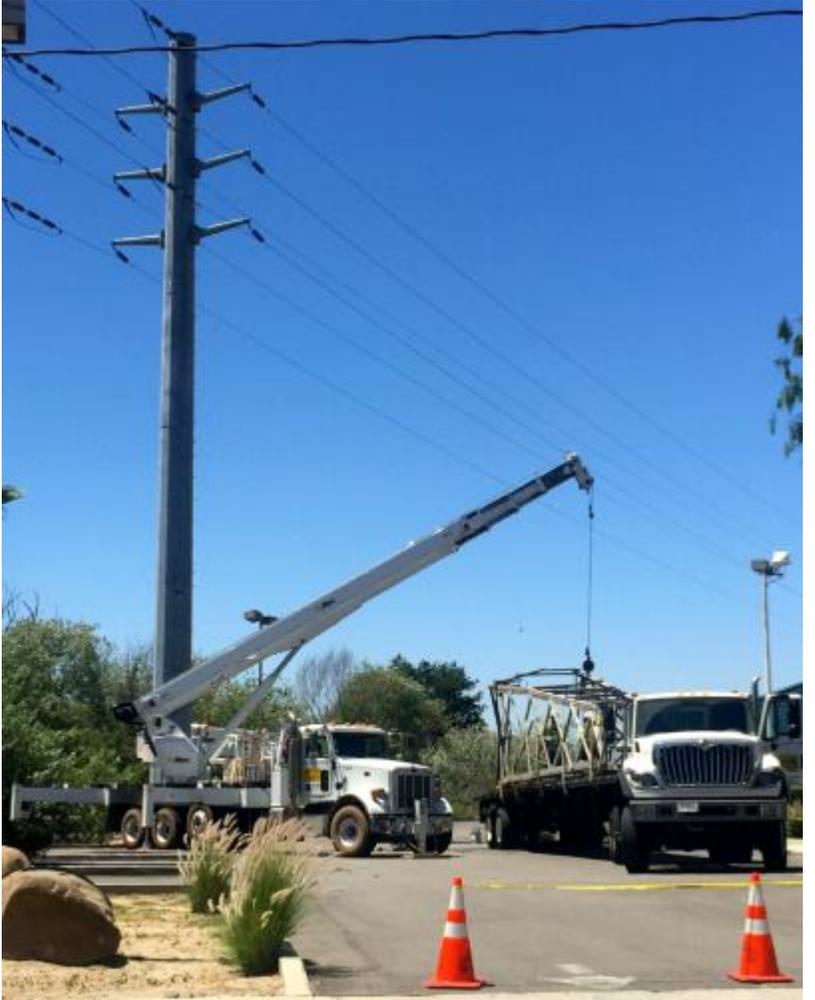
The new pole has been installed, and wires have been transferred; a crew was removing the old lattice tower.

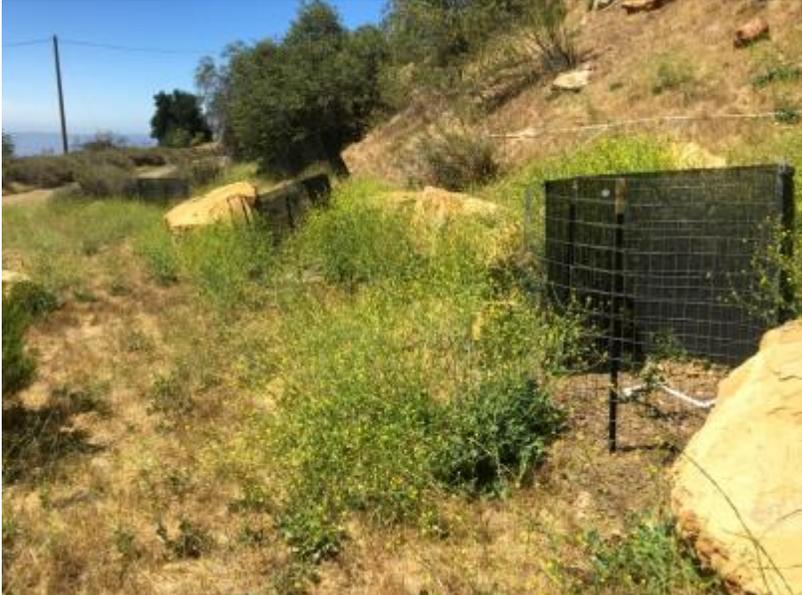
Oak trees are growing – lots of mustard coming up around the cages.
6/25/15	PS-42 Fill Site overview

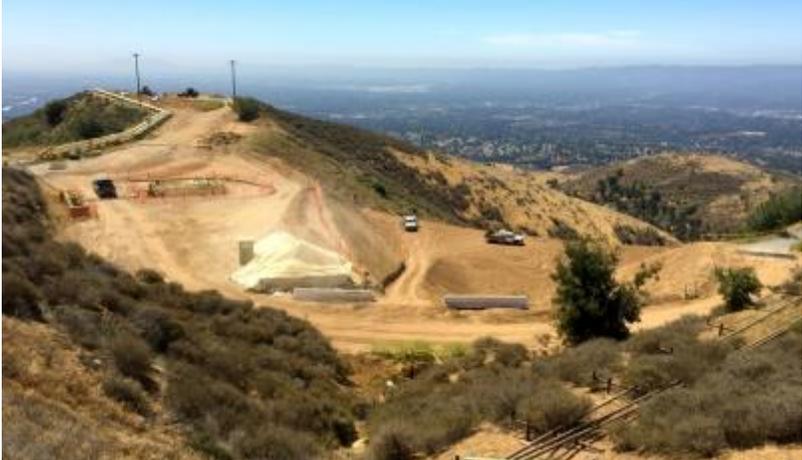
Overview of the PS-42 Fill Site that is now full. All the various spoil piles have been moved into the site.
6/25/15	PS-42 Fill Site

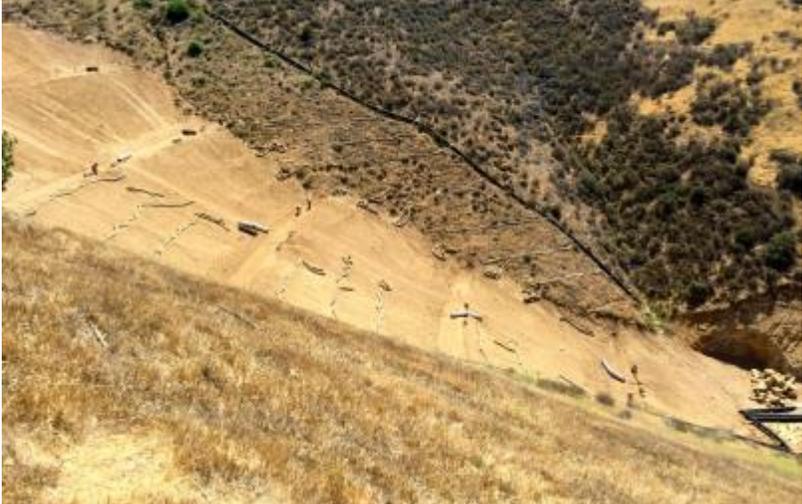
Crews are installing the final drains and "V" ditches down the fill site.

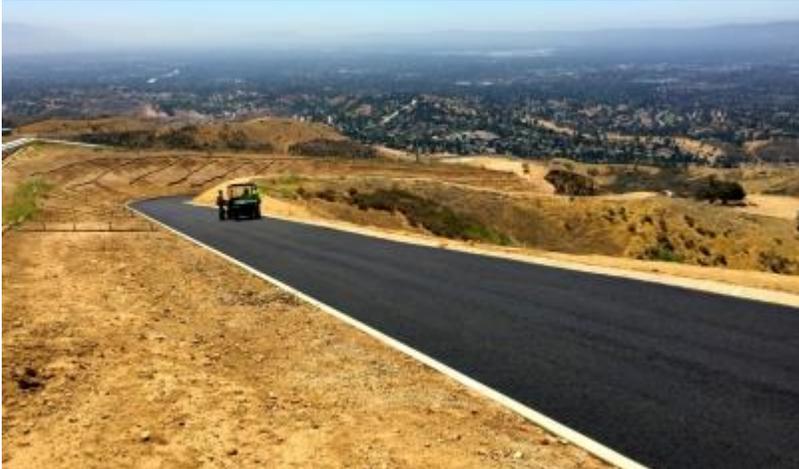
The access road is now paved.
6/25/15	Natural Substation

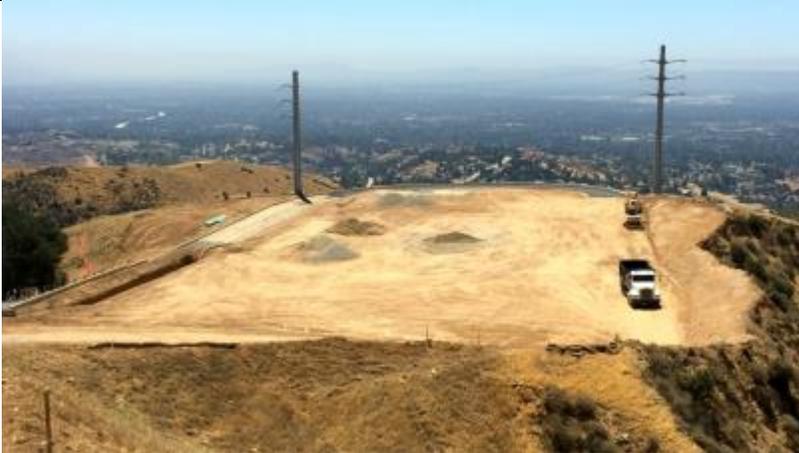
Site overview.
6/25/15	Natural Substation access road

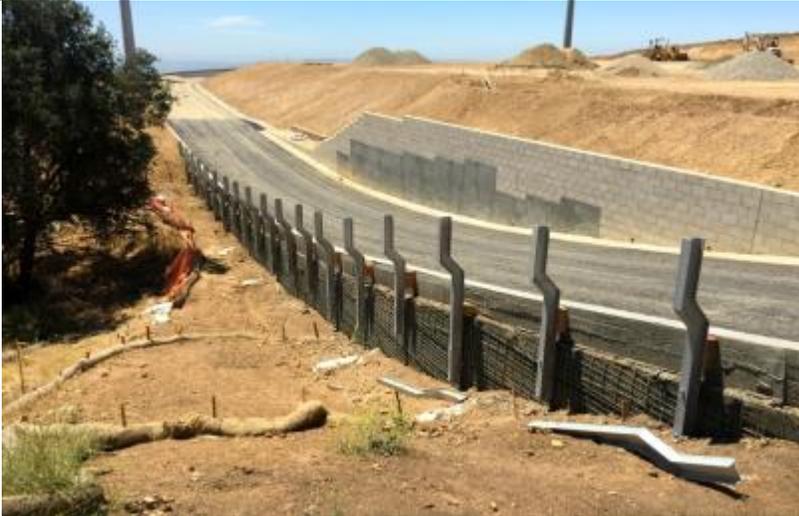
Retaining wall along the oak swale just below the Natural Substation.

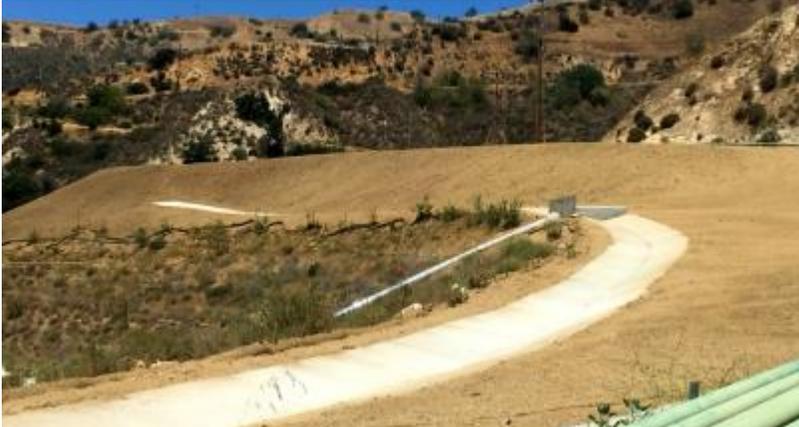
<p>The P-32 Fill Site has been closed out, and the hydroseed was applied yesterday.</p>
6/25/15	Slope above the CCS
