Re: Monthly Report Summary #15 for Aliso Canyon Turbine Replacement Project

Aliso Canyon Turbine Replacement Project CPUC Site Inspection Form

Project:	Aliso Canyon Turbine Replacement	Date:	June 4, 2015
Project Proponent:	Southern California Gas Company and Southern California Edison	Report #:	VS058
Lead Agency:	California Public Utilities Commission	Monitor(s):	Vince Semonsen
CPUC PM:	Andrew Barnsdale, Energy Division	AM/PM Weather:	Overcast, slight drizzle, light breeze, and cool temperatures (60 °F).
E & E CM:	Lara Rachowicz	Start/End time:	0730 - 1030 within Wiley Canyon 1045 - 1330 at the Aliso Storage Field
Project NTP(s):	Guard House and Road Widening (NTP-1). The New Admin/IM Building (NTP-2) and Central Compressor Station (CCS) (NTP-3). P-41 Fill Site (NTP-2), PS-42 Fill Site, P-32 Fill Site (NTP-3), and the Natural Substation (NTP-3, NTP-A, NTP-D). TSPs 2 through 45 and the SCE 210 Freeway Yard (NTP-A, NTP-C, NTP-D).

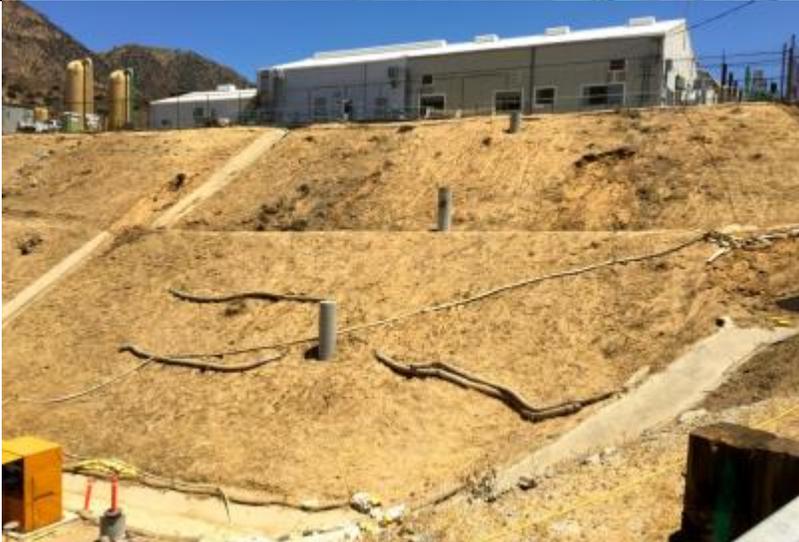
<p>Crews have removed the weedy vegetation on the slope.</p>
6/25/15	CCS

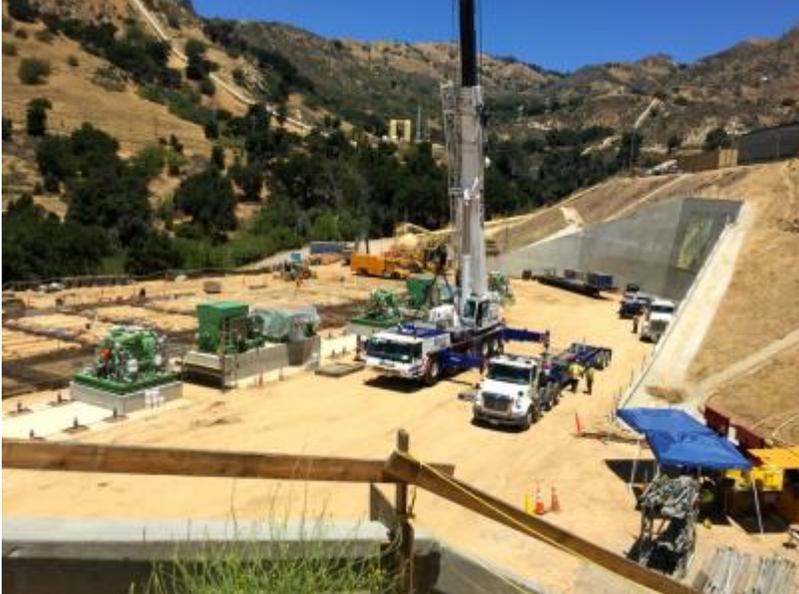
<p>Foundation work and conduit installation continues.</p>

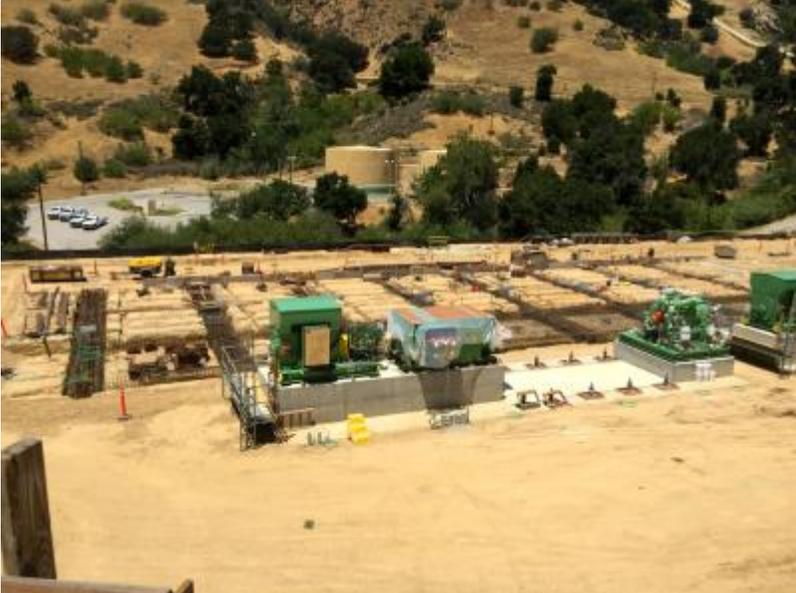
The new compressors are being installed.
