Re: Monthly Report Summary #1 for Aliso Canyon Turbine Replacement Project

Aliso Canyon Turbine Replacement Project CPUC Site Inspection Form

Project:	Aliso Canyon Turbine Replacement	Date:	March 20, 2014
Project Proponent:	Southern California Gas Company and Southern California Edison	Report #:	VS001
Lead Agency:	California Public Utilities Commission	Project Phase/NTP:	Guard House and Road Widening Component (NTP-1)
CPUC PM:	Andrew Barnsdale, Energy Division	AM/PM Weather:	Hazy with no breeze, warm (60°F)
E & E CM:	Jennifer Siu	Start/End time:	0845 to 1230
Monitor(s):	Vince Semonsen		
Project Component(s):	CPUC Oversight: Guard House

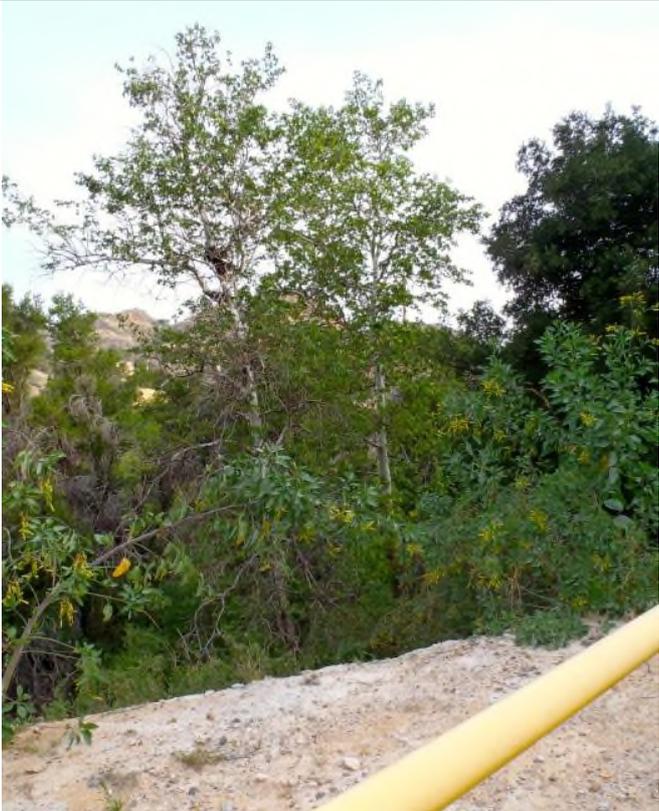
Date	Location	Photo	Description
3/20/14	Limekiln Wash access road approx 300 feet south of the Central Compressor project area.

Looked at an occupied red-tailed hawk nest with SCG and AECOM environmental staff – the nest was located within the Limekiln Creek riparian corridor approximately 300 feet south of the proposed Central Compressor project area. See photo. The nest is fairly close to the roadway (less than 50 feet) but the birds did not seem disturbed by our presence.

An occupied red-tailed hawk nest in a sycamore tree located within the riparian corridor along the Limekiln canyon access road. The nest is no more than 50 feet from the road but the birds do not seem to be adversely impacted by activity along the roadway.
3/20/14	Limekiln Creek access road approx 300 feet south of the proposed Central Compressor project area

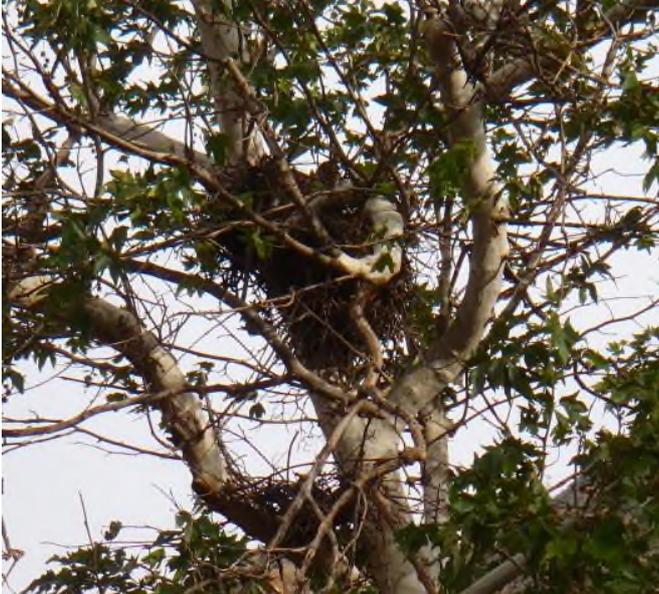
Close-up of the hawk nest in the sycamore tree. A hawk can be seen in the nest.

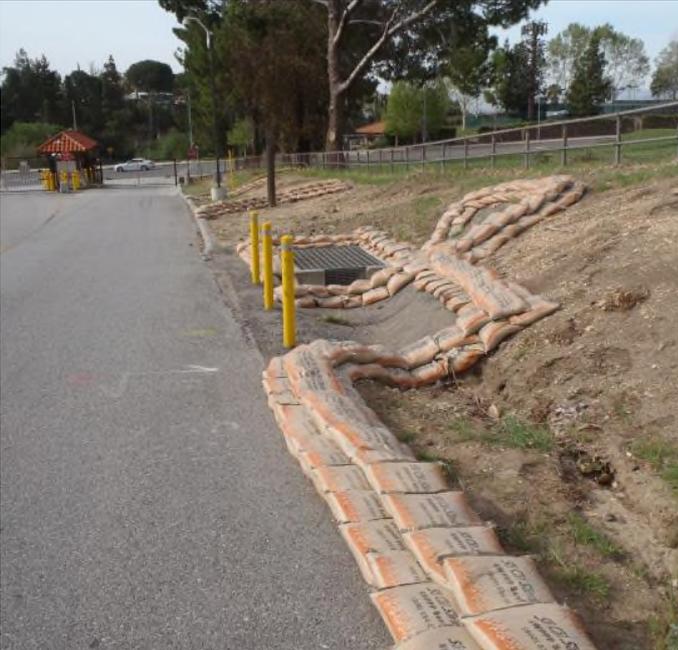
Date	Location	Photo	Description
3/20/14	Guard House

Gravel bags had been installed along the access road to act as sediment control (APM GE-2) – see photo.

BMPs installed along the upslope side of the existing access road near the guard house.
3/20/14	Guard House

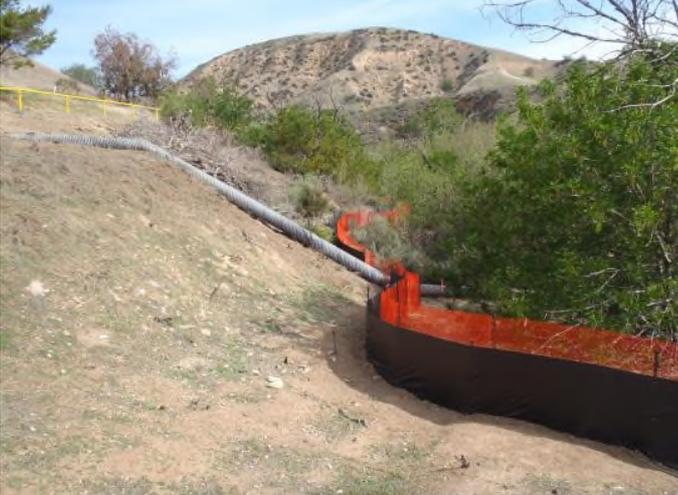
I walked a portion of the exclusionary fencing (APM BR-1b) to check on its installation. All of the fencing was installed properly with minimal earth disturbance – see photos. Two lines of fencing were installed, the first was black silt fence attached to a wire fence anchored with metal “T” posts, the second was orange construction also anchored with “T” posts. Exclusion fencing was also satisfactorily installed around the laydown/staging areas (APM BR-5).

Installed exclusion fencing that delineates the construction area from the sensitive habitat.
3/20/14	Guard House

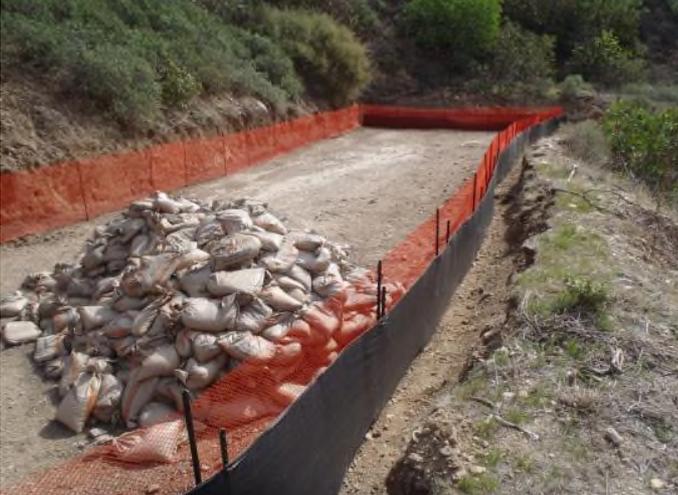
Exclusion fencing installed around the laydown/ staging area. This area is located at the northeastern corner of the construction zone.

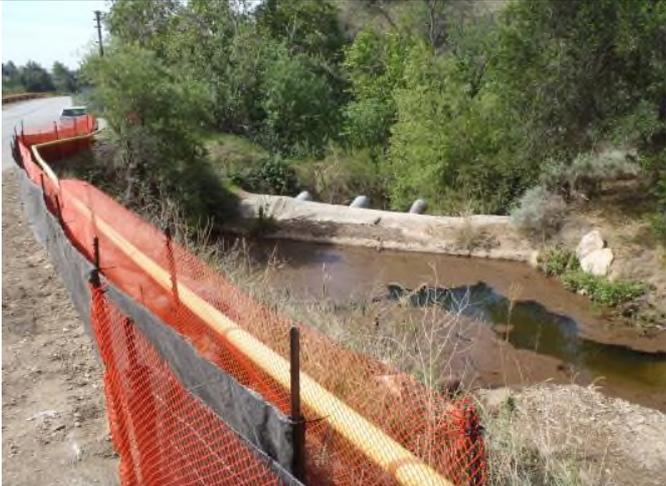
Date	Location	Photo	Description
3/20/14	Guard House

Exclusion fencing installed along the laydown/staging area and near the creek. This area is located at the northwestern end of the construction zone.

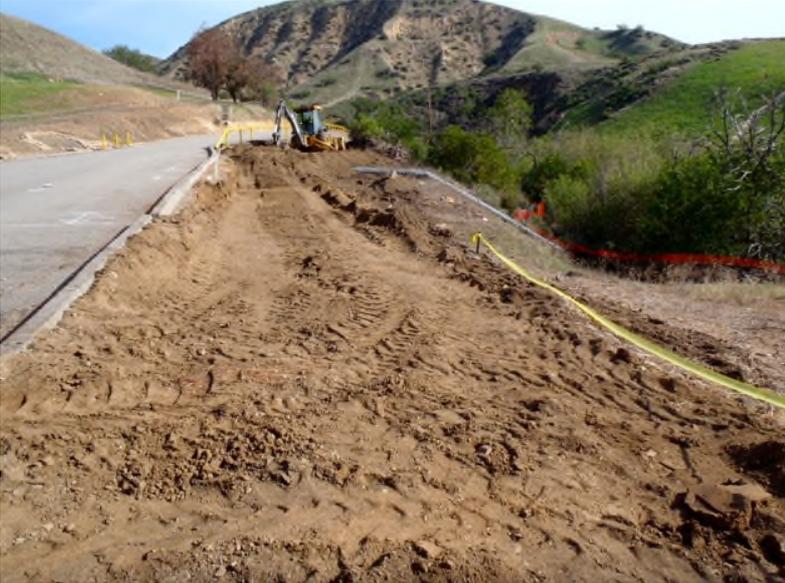
Date	Location	Photo	Description
4/3/14	Area east of Limekiln Canyon Road and just north of the guard shack.

Observed one piece of equipment (small backhoe) cutting a bench along the eastern edge of the access road beginning just north of the existing guard shack – see photos. The equipment appeared to be in good condition (APM AQ-1) and looked to be minimizing the amount of area disturbed (APM AQ-3). The bench was being cut to allow the drilling rig to access the site.

A backhoe is cutting a bench to provide access for the drilling rig. The photo is looking north from near the guard shack.
4/3/14	Area east of Limekiln Canyon Road and just north of the guard shack.

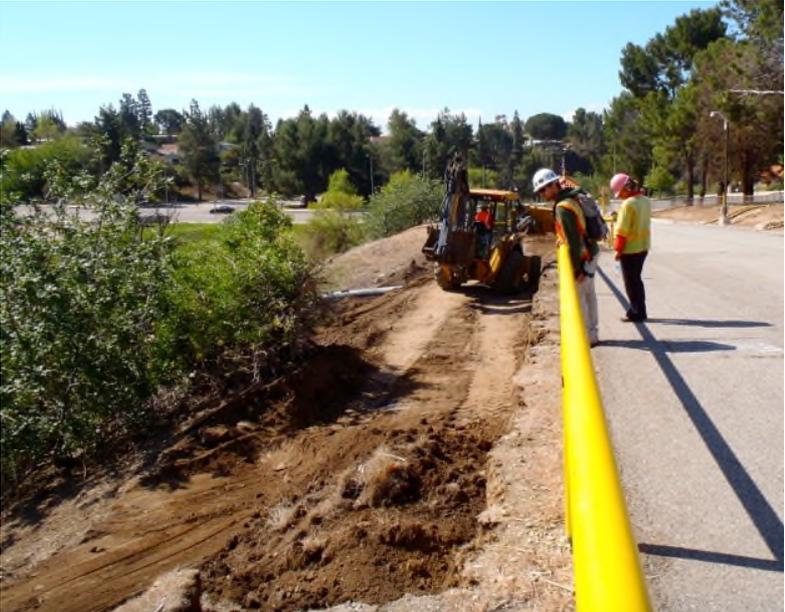
A backhoe is cutting a bench to provide access for the drilling rig. The photo is looking south – note the biological and archeological monitors observing the work.

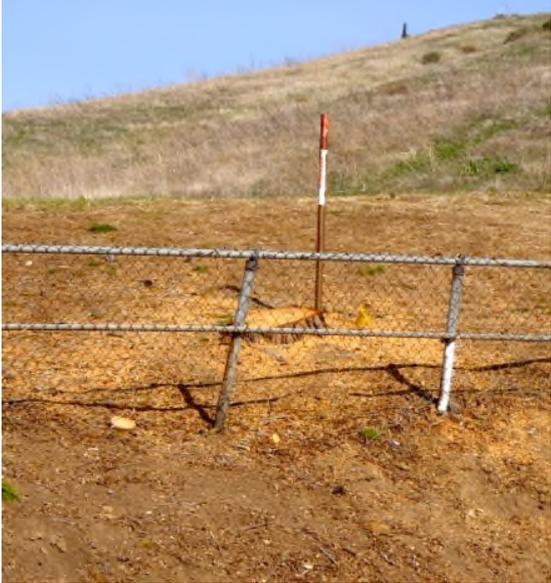
Date	Location	Photo	Description
4/3/14	Pine tree removed from the slope west of the Limekiln Canyon Road.

Mitch Lamons indicated that some fuel modification work had been done earlier in the week, with more to come, and that a large pine tree had been removed from the slope just west of the access road. He also confirmed that rumble plates will be brought onsite once they begin stockpiling dirt, and this will help keep dirt from being tracked on the roadway (APM AQ-7). The exclusion fencing was intact and Mitch said he had patched two holes in it at the request of the monitors (APM BR-5).

Fairly large pine tree removed.
4/3/14	Construction trailer located at the upper northwest corner of the guard house project site.

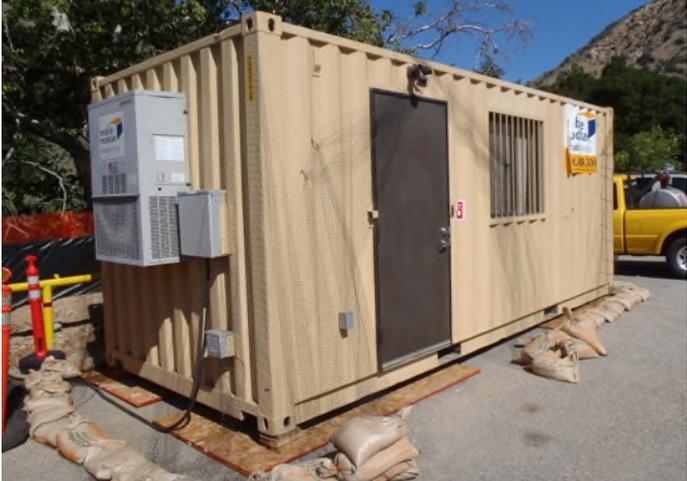
Athena construction superintendent, Mitch Lamons, walked me through the job site, and we discussed the progress of the project. Bird netting had been installed over his construction trailer (MM BR-7) - see photo - and all pertinent documents were available at the trailer. The site did not require watering prior to grading (APM AQ-4) because of the recent rains, and Mitch indicated that water would be available in case of windy conditions (APM AQ-6).

Bird netting has been installed over the construction trailer.

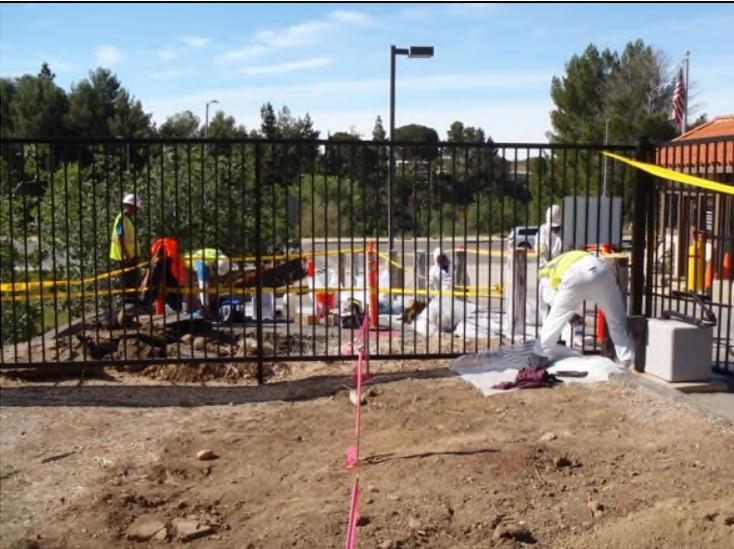
Date	Location	Photo	Description
4/10/14	Guard shack

One crew was removing the lead paint from the posts down by the guardhouse – see photo. All of the crews observed were WEATP trained (APM HZ-6). Biological monitor, Marija Minic, was onsite (APM BR-1d & APM BR-6); there was no cultural monitor onsite today.

Crew removing lead paint from some of the existing poles.
4/10/14	East side of the Limekiln Canyon Road approx. 100 feet from the guard shack

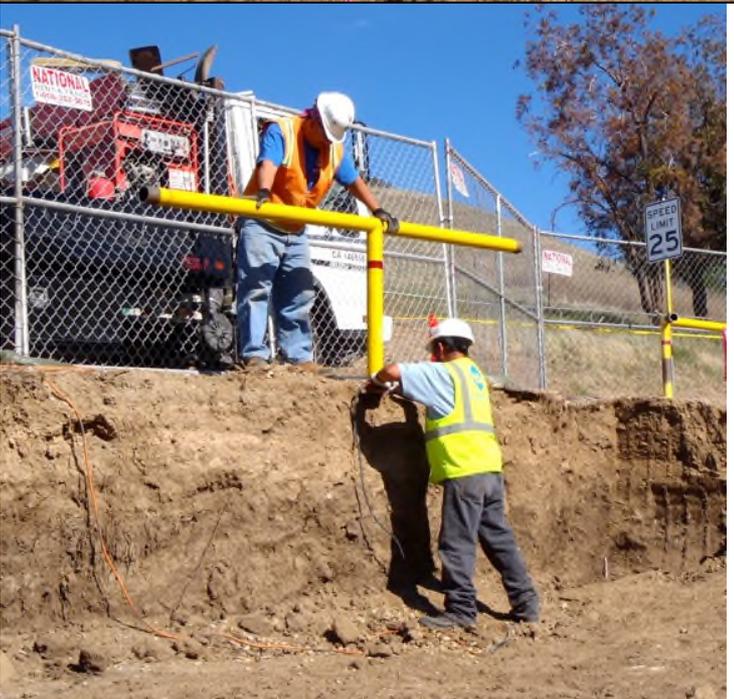
Crew cutting off and removing the existing road railing.

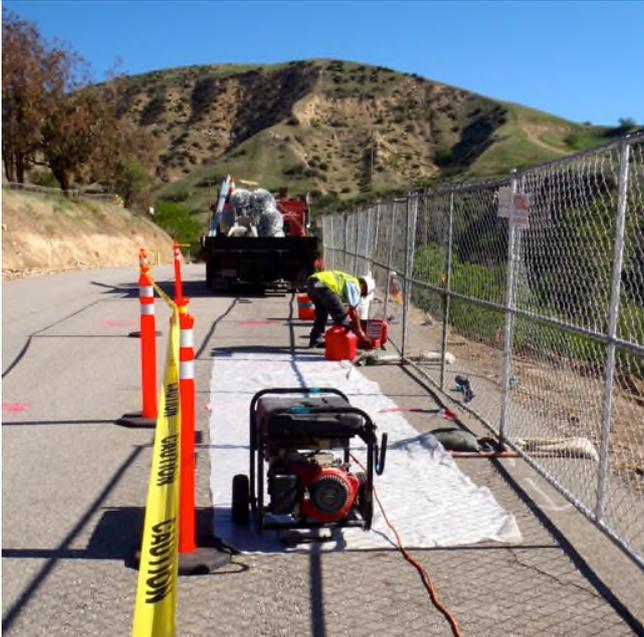
Date	Location	Photo	Description
4/10/14	Limekiln Canyon Road near the guard shack

Gas can and gas powered generator sitting on plastic.
4/10/14	West side of the access road near the guard shack

Recommended follow-up: check the integrity of primary containment for the portable generator and gas can when used again.

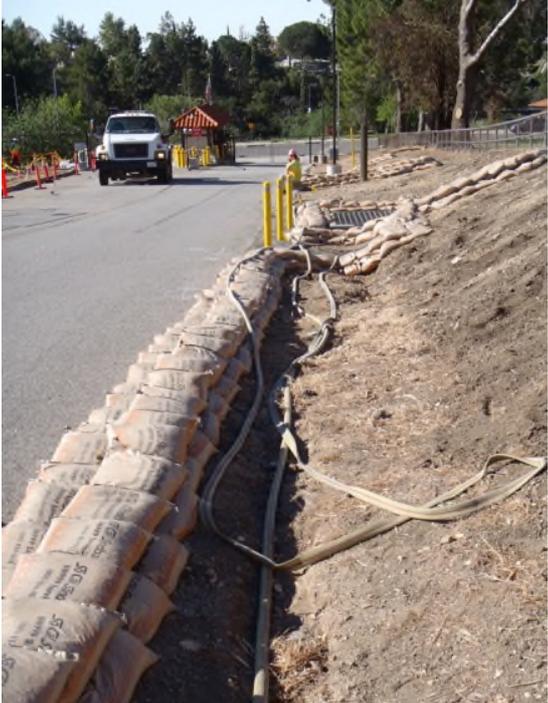
Water hose laid out in case of a dust control need.

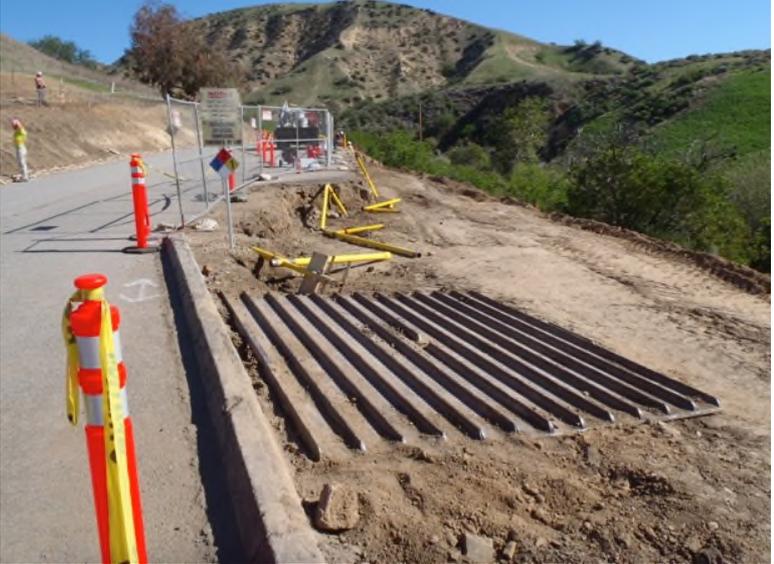
Date	Location	Photo	Description
4/10/14	Main entrance road near the guard shack

Three sets of rumble plates have been installed at locations to prevent dirt from being tracked out onto the roadway.
4/10/14	Slope along the west side of the Limekiln Canyon Rd.

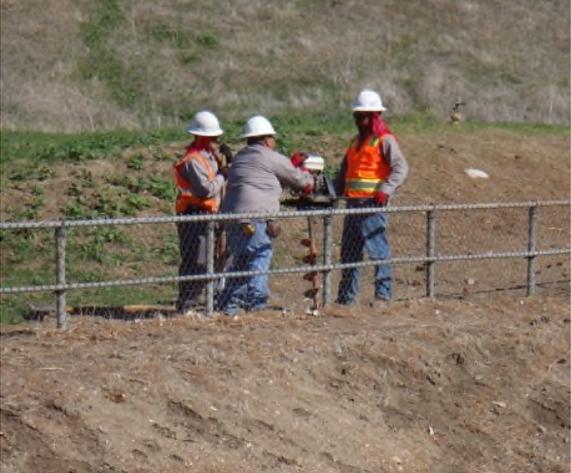
Crews are installing a new fence line using a hand held gas auger to drill holes for the fence posts.

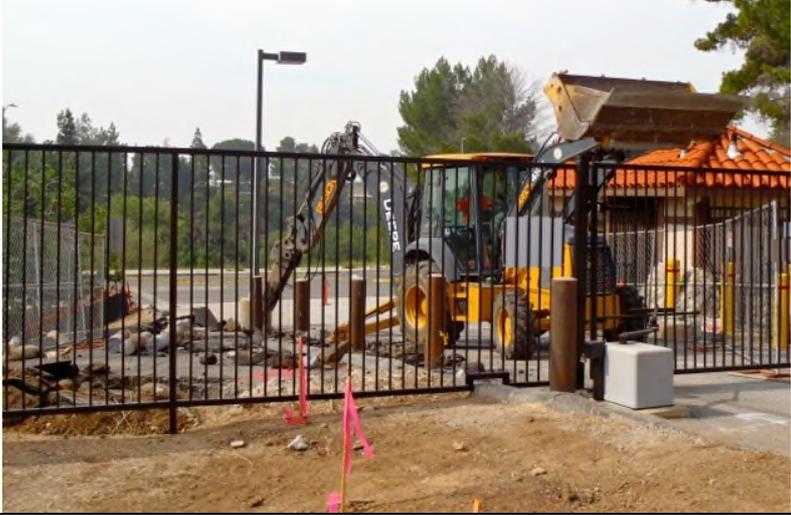
A small backhoe is using a breaker bar to remove large pipe from along Limekiln Canyon Road.
4/17/14	West side of Limekiln Canyon Road within the work site

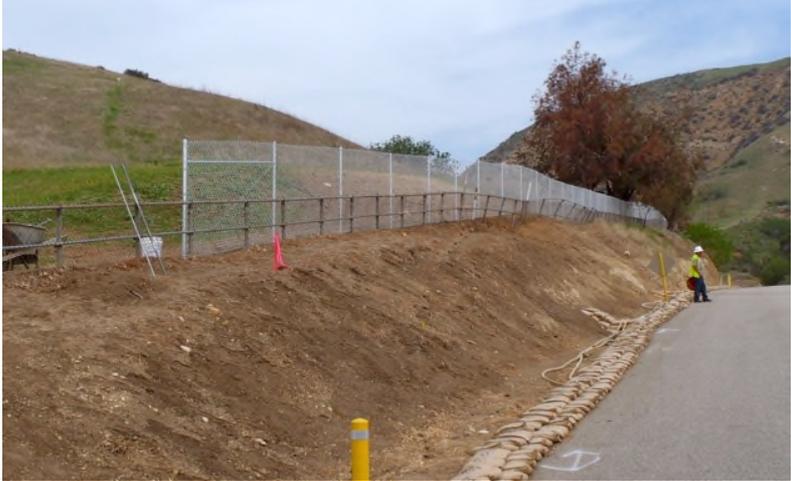
Installation of new chain link fencing along the west side of Limekiln Canyon Road.
4/17/14	Fuel management work within 200 feet of the work site

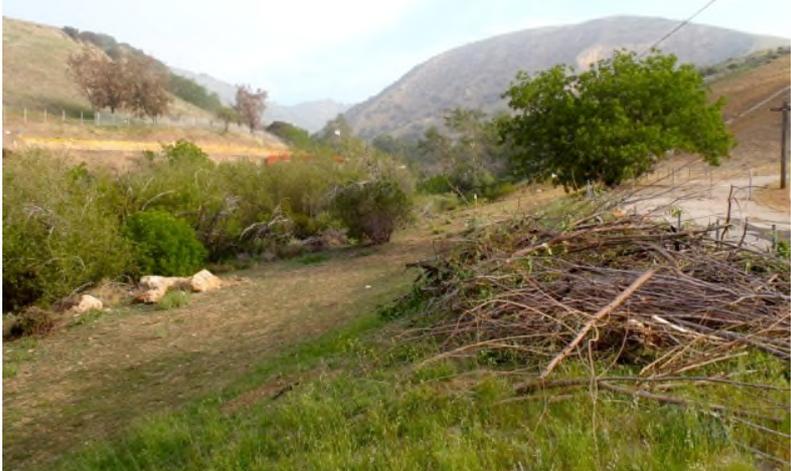
A portion of Limekiln Canyon Wash has been cleared of excess brush and dead and down material; stockpiled material will be removed.

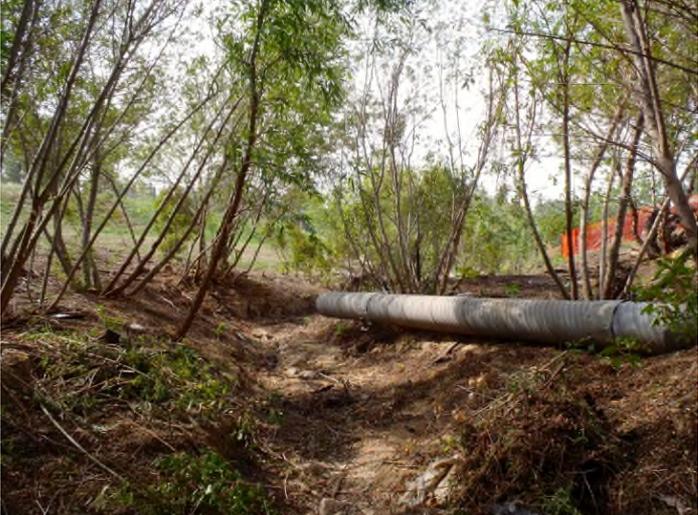
Date	Location	Photo	Description
4/17/14	Within Limekiln Canyon Wash looking downstream (south)

Fuel management work
4/17/14	Near the exclusion fencing at the guard house work area

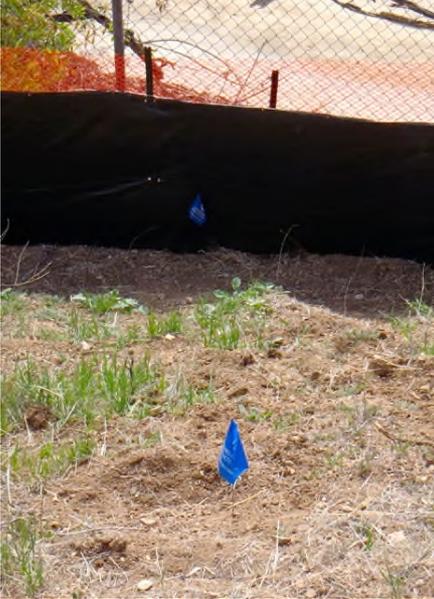
The blue flagging delineates the 200 foot boundary of the fuel management work.
4/17/14	Within Limekiln Canyon Wash

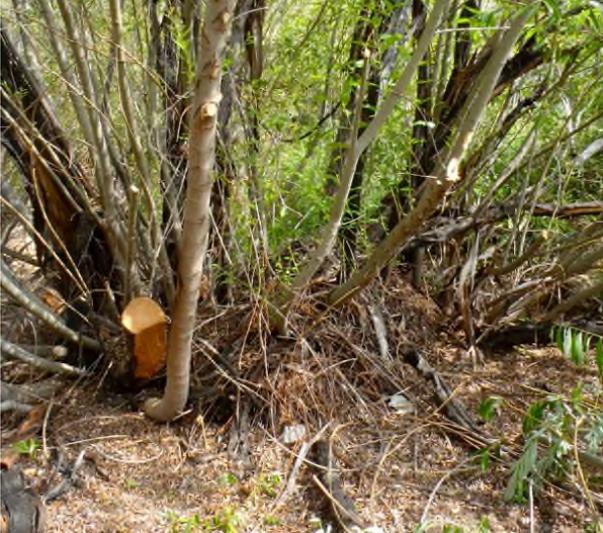
A wood rat nest or midden was observed in the Limekiln Canyon Wash corridor, within the fuel management area, and I inquired as to whether that could be left intact (MM BR-14) – see photos. The nest was a dusky-footed woodrat nest, which is not a sensitive species, but preservation of its nest seems reasonable.

A dusky-footed woodrat nest (or midden) is at the base of a willow tree within the fuel management area.

Recommended follow-up: potential for fuel modification work to leave woodrat nest/midden; check with arborist.
