Re: Monthly Report Summary #31 for Aliso Canyon Turbine Replacement Project

Aliso Canyon Turbine Replacement Project CPUC Site Inspection Form

Project:	Aliso Canyon Turbine Replacement	Date:	October 6, 2016
Project Proponent:	Southern California Gas Company and Southern California Edison	Report #:	VS120
Lead Agency:	California Public Utilities Commission	Monitor(s):	Vince Semonsen
CPUC PM:	Andrew Barnsdale, Energy Division	AM/PM Weather:	Clear and warm with gusty winds later in the morning.
E & E CM:	Lara Rachowicz	Start/End time:	0800 to 1000 at SCE components 1000 to 1130 at the Aliso Canyon Natural Gas Storage Field (Aliso Storage Field)
Project NTP(s):	The new Admin/IM Building (NTP-2), Central Compressor Station (CCS) (NTP-3), and PS-42 Fill Site. Tubular Steel Poles (TSPs) 2 through 42 (NTPs A, C, and D).

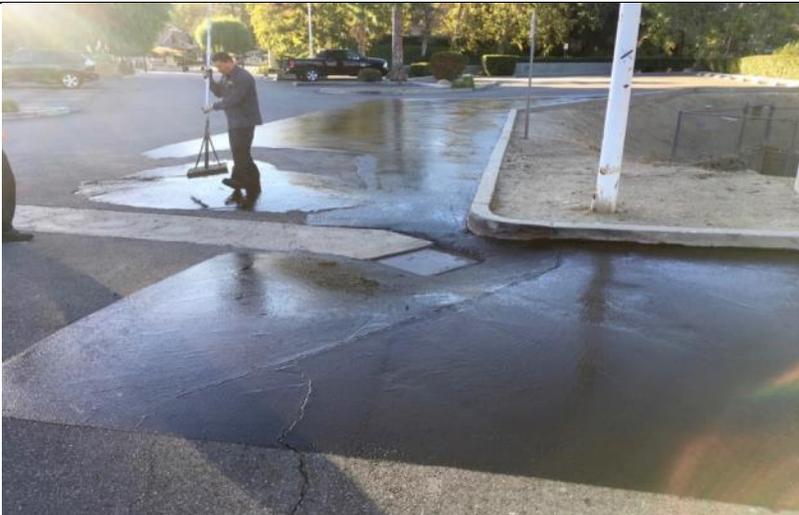
Starting at 0800, my first stop was at TSPs 10 and 11 where a paving crew was applying a fresh coat of tar within the parking areas around the two poles (Photos 1 and 2). The crew was careful to keep the tar within the paved areas and had the parking lot drain inlets covered (Photo 1). I had a concern regarding the location of the paint and painting equipment, which were staged on the ground outside of the asphalt (Photo 3); however, I did not observe any spilled paint.

Photo 1 – Paving work.
10/06/16	TSP 10

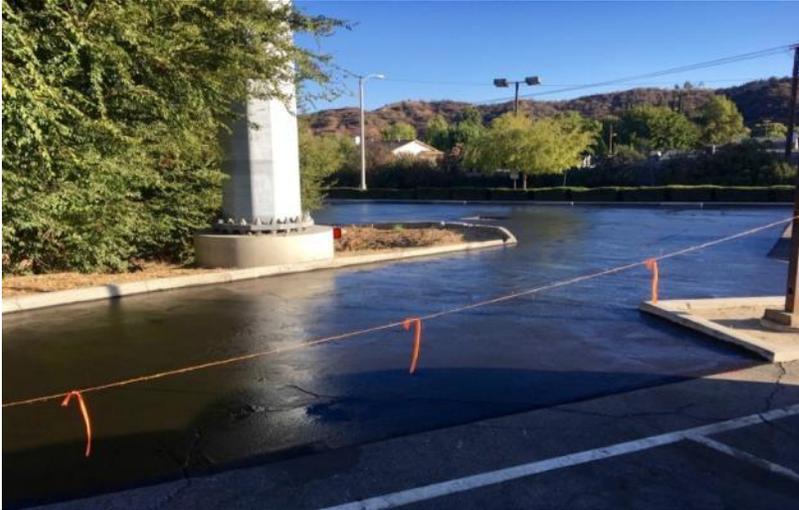
Photo 2 – Paving work.
10/06/16	TSP 10

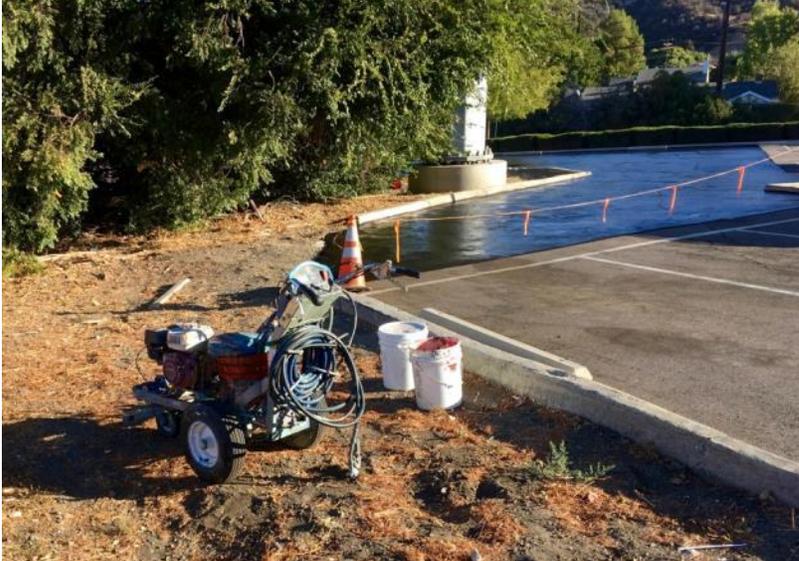
Photo 3 – Paint and painting equipment near TSP 10.

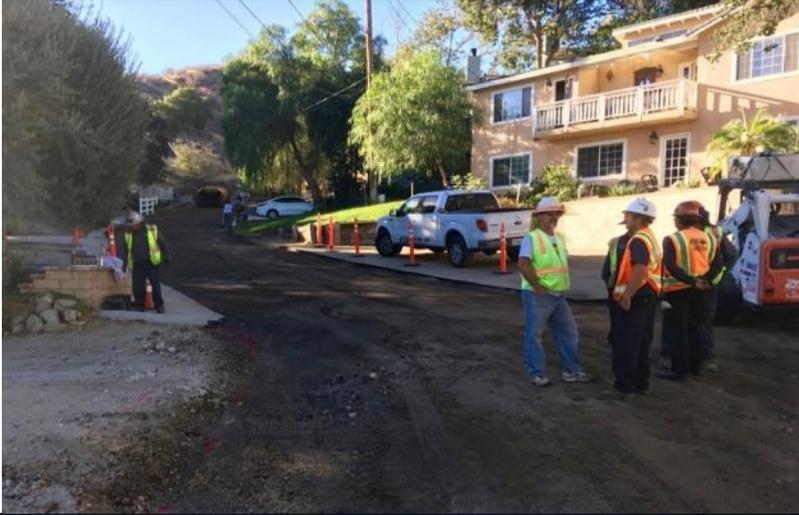
At the TSP 7 access road, crews were working on the roadway below the access road and preparing to repave the road (Photo 4). Crews had removed the old asphalt and prepped the road base, and were preparing to apply new asphalt. A fire crew was onsite, but I did not observe an environmental monitor.

Photo 4 – Paving crews working near the access road.
10/06/16	TSP 32

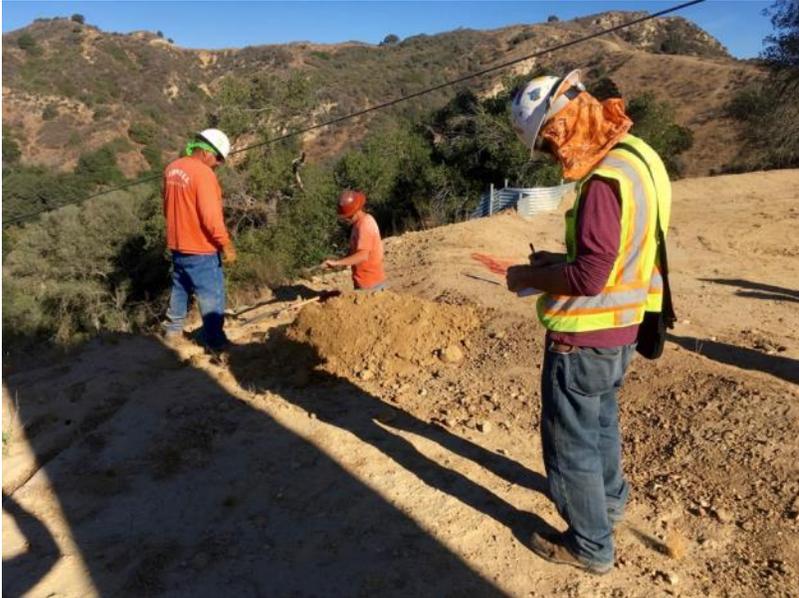
At TSP 32, a SCE crew was installing an interset pole. SCE's paleontological monitor (Joey Raum) was onsite and overseeing the crew hand-excavating the hole for the pole (Photo 5). The SCE Storm Water Pollution Prevention Plan (SWPPP) inspector (Lucy Cortez) was also onsite and was conducting environmental training for the SCE crew (Photo 6). I spoke with Lucy about a number of locations that were in need of best management practices (BMPs) before the upcoming rainy season. Lucy said a project-wide evaluation was planned and would focus on areas that require additional BMPs.

Photo 5 – Hand excavation of the interset pole.
10/06/16	TSP 32

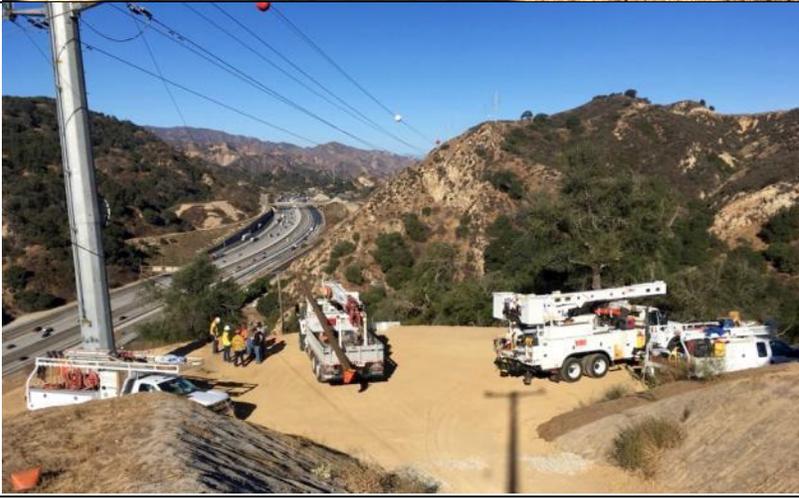
Photo 6 – SCE crew working on the installation of the interset pole.

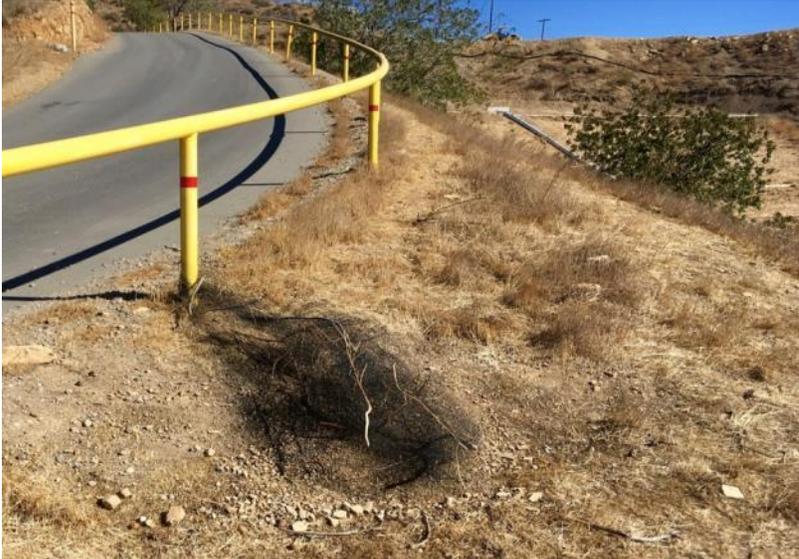
I drove to the Aliso Storage Field and to the PS-42 Fill Site. Upon entering the facility, I noted that Russian thistle remains within Limekiln Creek near the Guard House. Near the PS-42 Fill Site, I found a piece of bird netting wrapped around a pole along the road (Photo 7). I cut the bird netting from the pole and placed it in the trash receptacle—if not collected and properly disposed of, this material could continue to trap animals for years after the project is complete.

Photo 7 – Bird netting found wrapped around a road railing.
10/06/16	PS-42 Fill Site

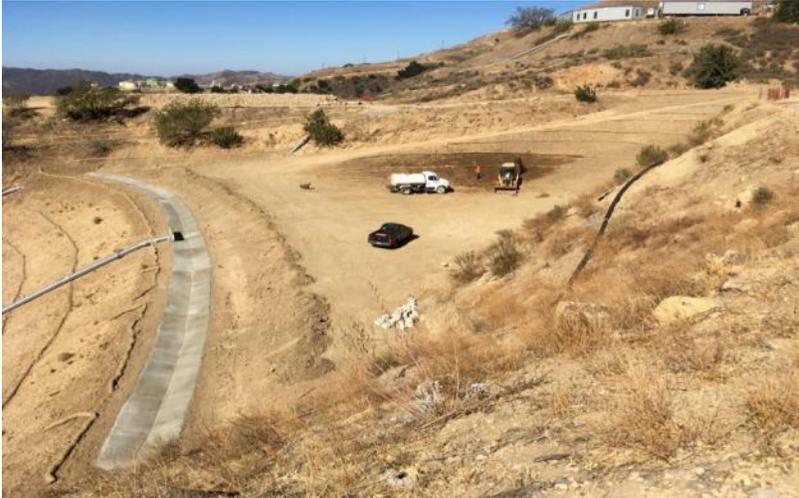
A crew was working at the PS-42 Fill Site and installing BMPs to the bare soil slopes (Photo 8). It appeared that the crew had completed delivering soil to this site, and had installed one more concrete "V" ditch along the last layer of fill dirt.

Photo 8 – “V” ditch has been installed, and crews are installing BMPs.
10/06/16	CCS

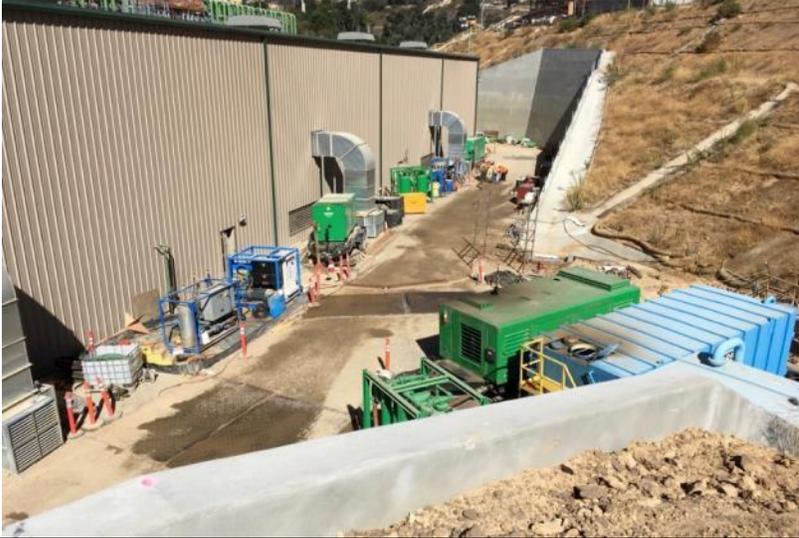
Work continues within the CCS (Photo 9). The blowdown line remained uncovered in the location where it exits in the CCS facility (Photo 10).

Photo 9 – Work continues within the CCS.

An evaluation of the rainwater runoff draining through the CCS facility is recommended.

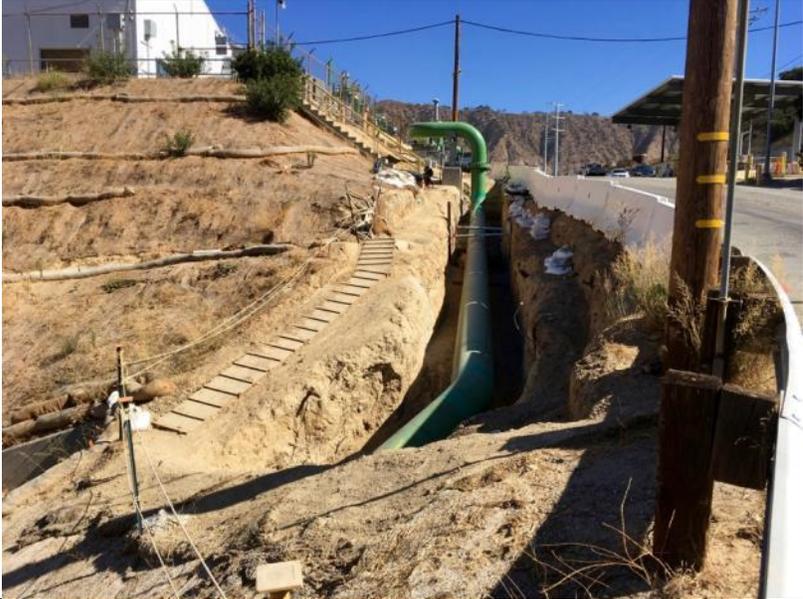
Photo 10 – This section of the blowdown pipe remains open.
10/06/16	12-kV A2 TSP Site

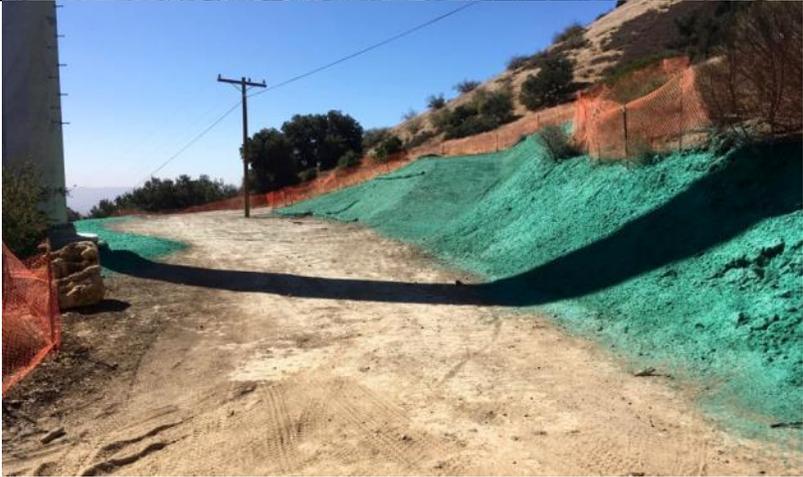
My last stop of the day was at the A2 TSP location where the disturbed areas had been freshly sprayed with a hydroseed mix (Photo 11). Construction fencing will need to be removed, and some selective trimming of the damaged oak sapling should be completed.

Photo 11 – Disturbed slopes have been hydroseeded.

Possible energy dissipater/catch basin where the oak swale drainage meets the A2 TSP access road.

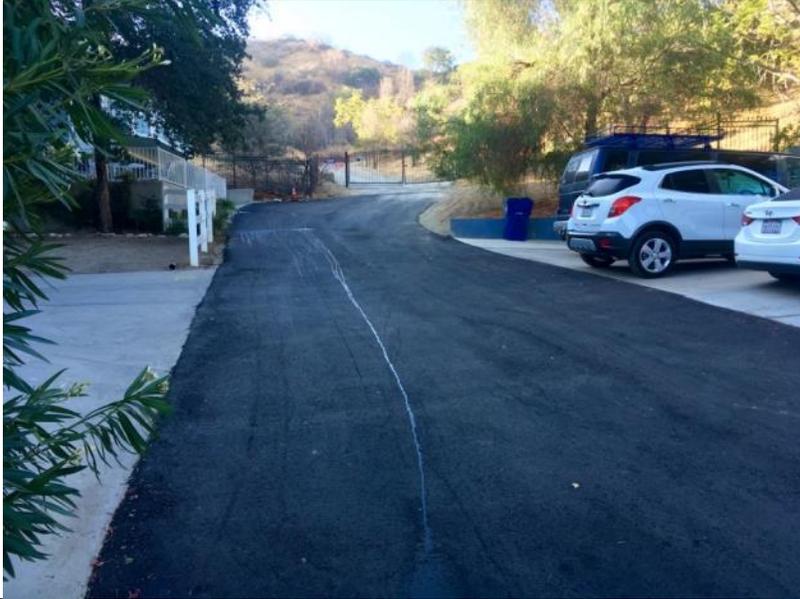
At 0800, I arrived at the TSP 7 access road. The paving work appeared to have been completed. The area was in good condition, with no trash, leftover construction materials, or equipment observed (Photo 1).

Photo 1 – Paving work appears to be finished and it looks good.
10/13/16	PS-42 Fill Site

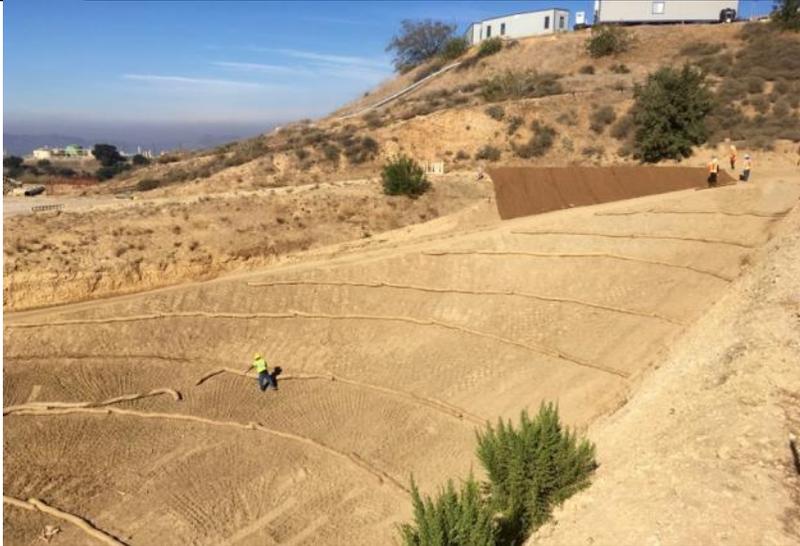
At the PS-42 Fill Site, a crew was removing the straw wattles and installing a coconut erosion blanket on the exposed slopes (Photo 2). I noted that the blanket had plastic netting on one side of the roll (Photo 4). I asked Ray Romero about using this material, and he said that most blanket material has netting to hold it together and that the blanket would be installed with the netting side down. He also explained that excess soil generated from the CCS would be stockpiled on the well pad near the PS-42 Fill Site (Photo 3) until there was enough soil to warrant delivering it into the PS-42 Fill Site.

Photo 2 – Crews are installing an erosion blanket on the slopes of the PS-42 Fill Site.
10/13/16	PS-42 Fill Site

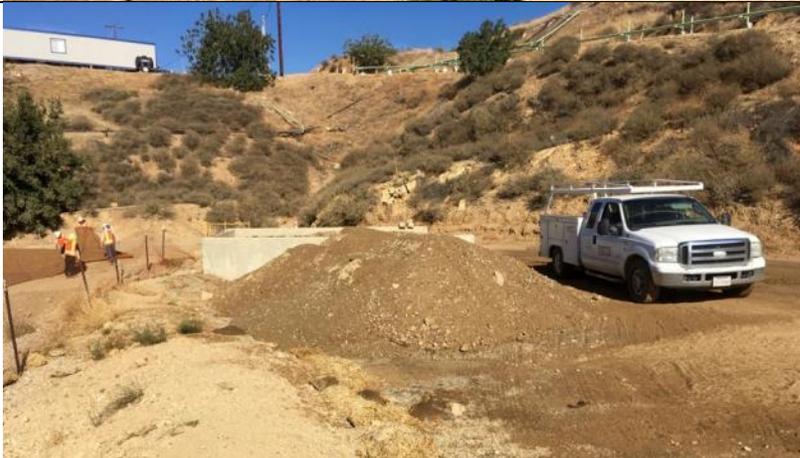
Photo 3 – Soil delivered to the PS-42 Fill Site is being stockpiled on the PS-42 Well Pad.

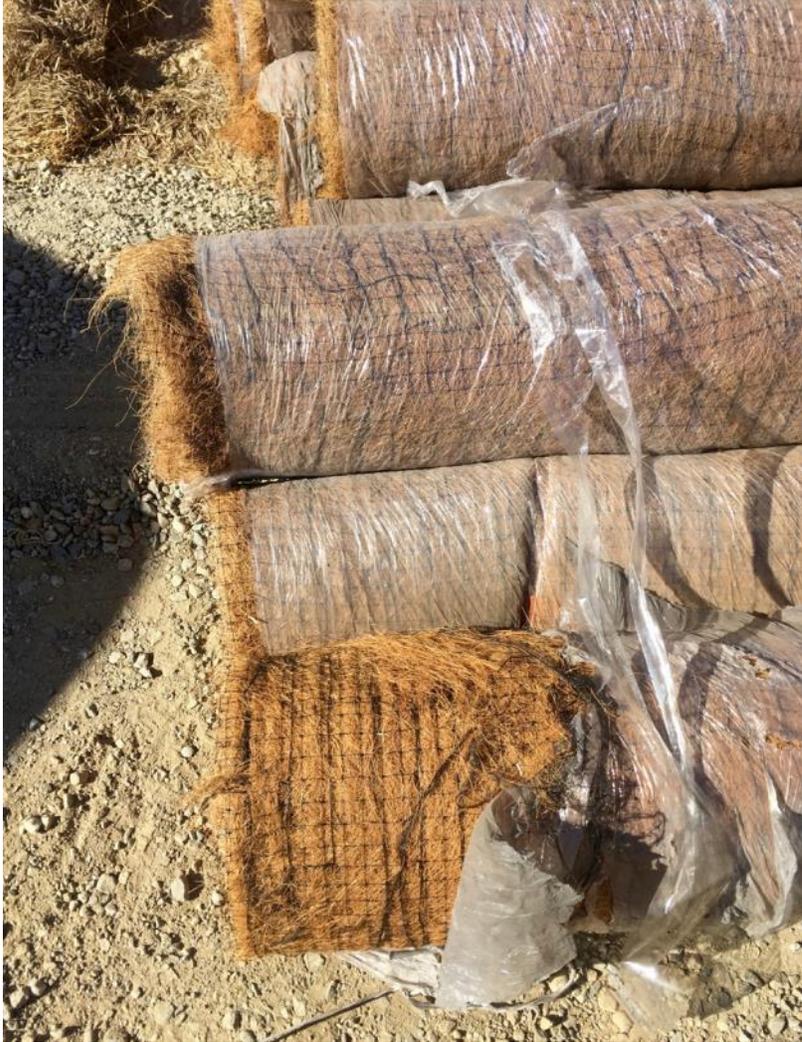
<p>Photo 4 – The coconut blanket has plastic netting on one side of the roll. This side will be placed against the ground.</p>
10/13/16	P-37 Staging Area

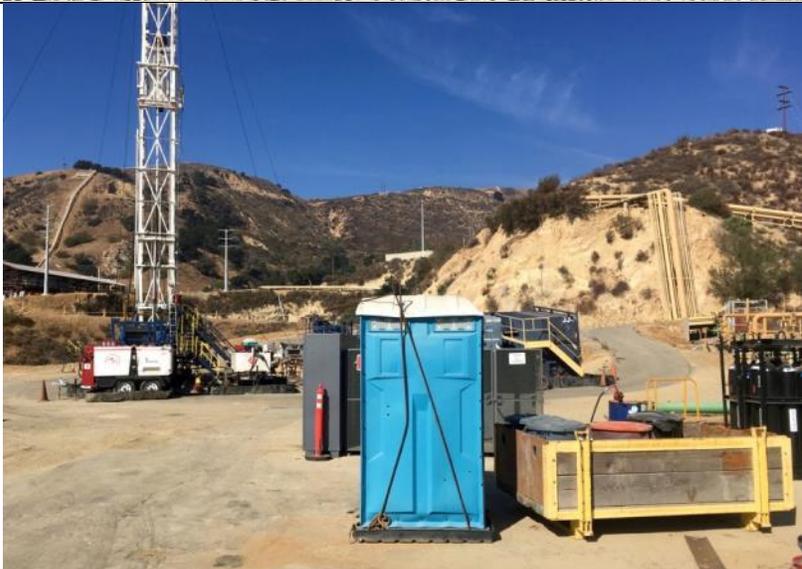
I looked at the P-37 well pad being used as a staging area for Kewit. Much of the Kewit materials had been moved, and half of the well pad/staging area was occupied by a drilling rig and its associated equipment (Photo 5). The one visible drain opening within the staging area remained in the same condition as my previous visit, with no new best management practices (BMPs) around it (Photo 6).

<p>Photo 5 – A drilling operation is now set up on a portion of the well pad.</p>

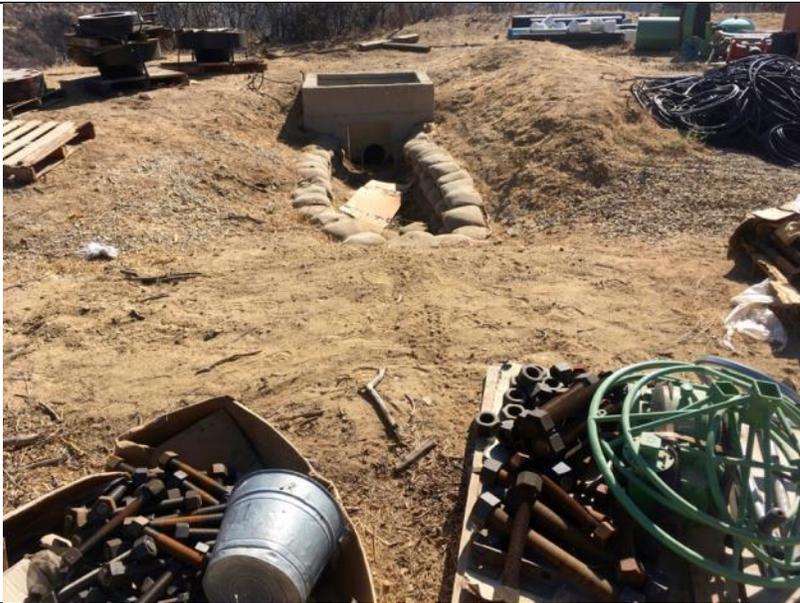
Photo 6 – Upgrades to the BMPs around the drain inlet are recommended.
10/13/16	CCS

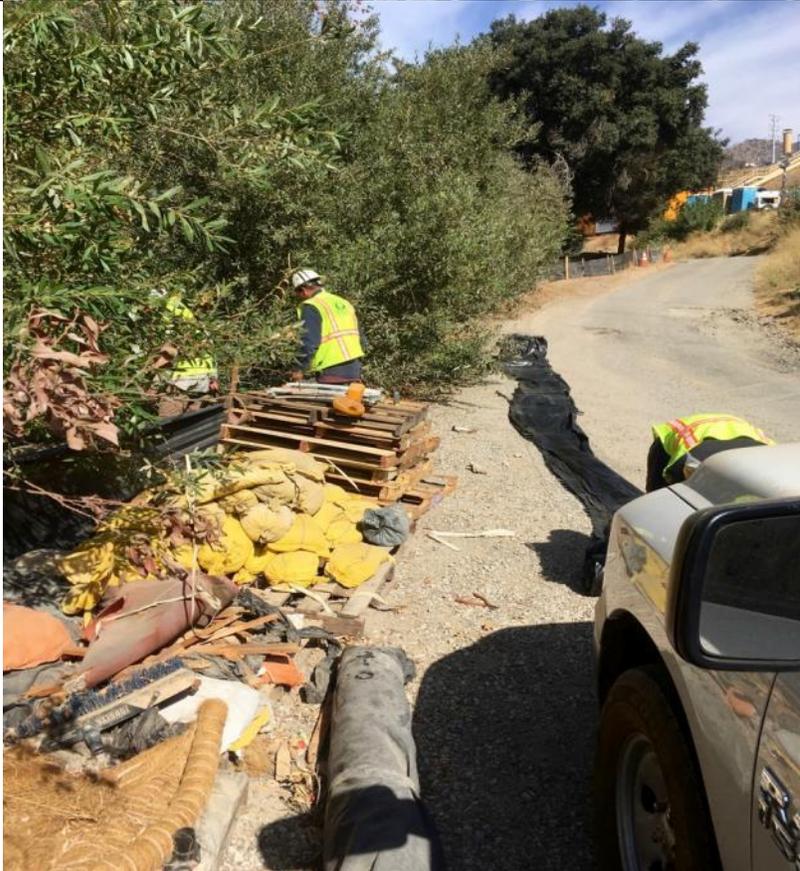
A crew was repairing the silt fence along Limekiln Creek (Photo 7) and replacing sand bags. Ray Romero was onsite with the crew and I pointed out some plastic straw wattle material near the upper sedimentation basin/newt pond that needed to be removed. Ray Romero was going to direct the crew to complete that work.

Photo 7 – A crew is repairing the silt fence along Limekiln Creek.

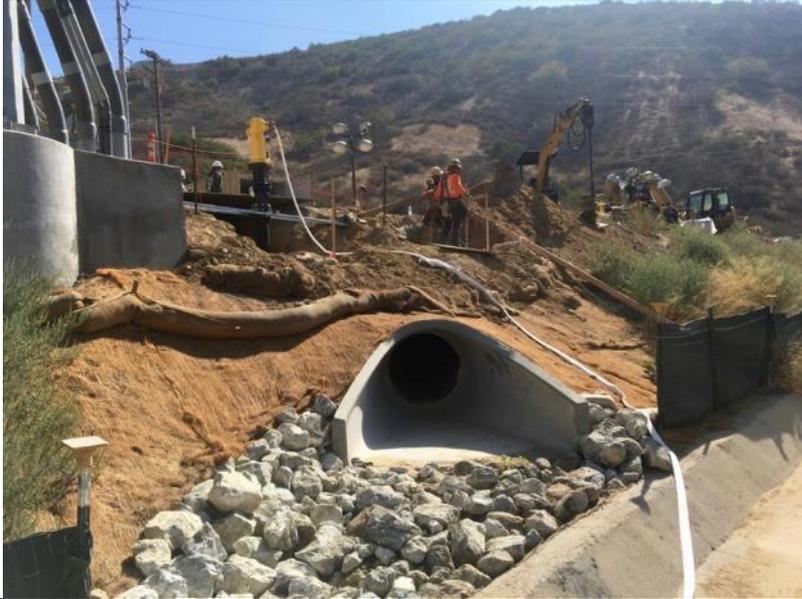
Work was ongoing within the CCS, including the excavation for and installation of a number of fire hydrants (Photo 8).

Photo 8 – Work on the fire hydrants is being conducted near the CCS.

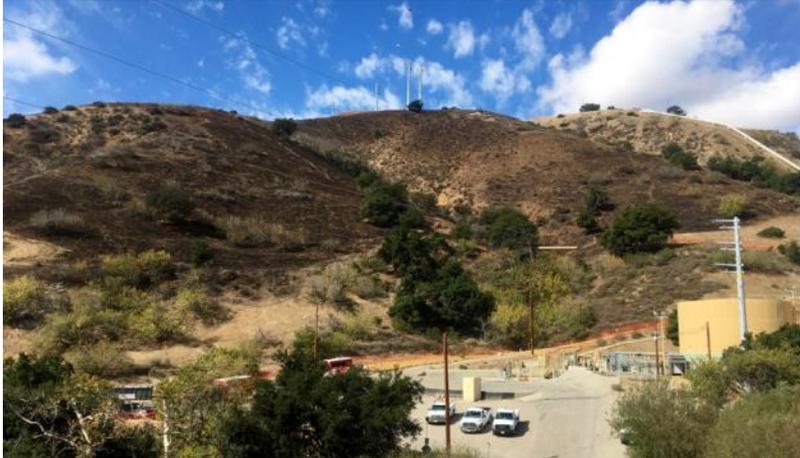
I drove to the Aliso Storage Field at 1000 and noted the recent burn area in the hills just west of the CCS (Photo 1). There were numerous fire crew personnel working in the burn area. The fire had been completely extinguished a few days prior, and the crews were cleaning up the area and collecting the fire hoses. The fire burned the slope to the Natural Substation access road (Photos 4 and 5) and had burned the vegetation and straw wattles on the slope just below the access road. Some crew members were staged on the A2 TSP crane pad.

Photo 1 – The dark area is the burn location.
10/24/16	New Admin/IM Building

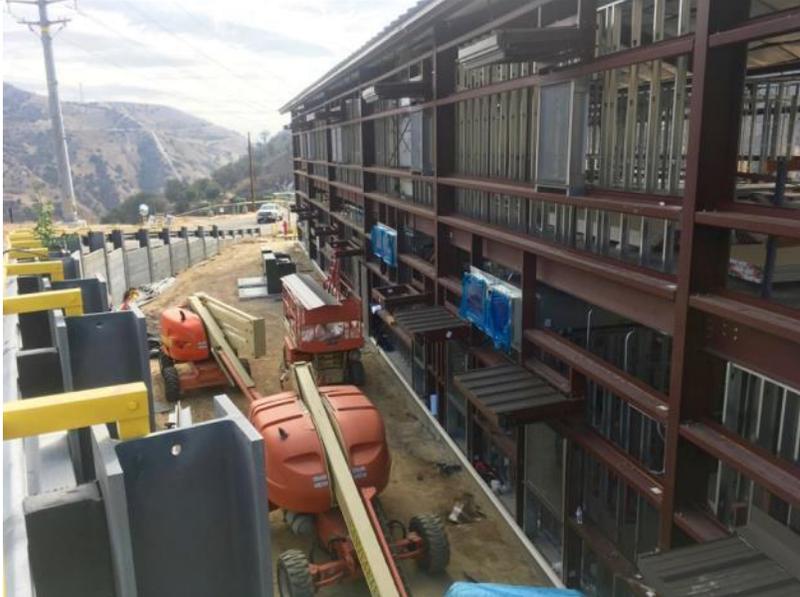
I stopped at the new Admin/IM Building site and briefly observed the construction activities. Crews were working on the building installation (Photo 2).

Photo 2 – Work continues on building construction.
10/24/16	PS-42 Fill Site

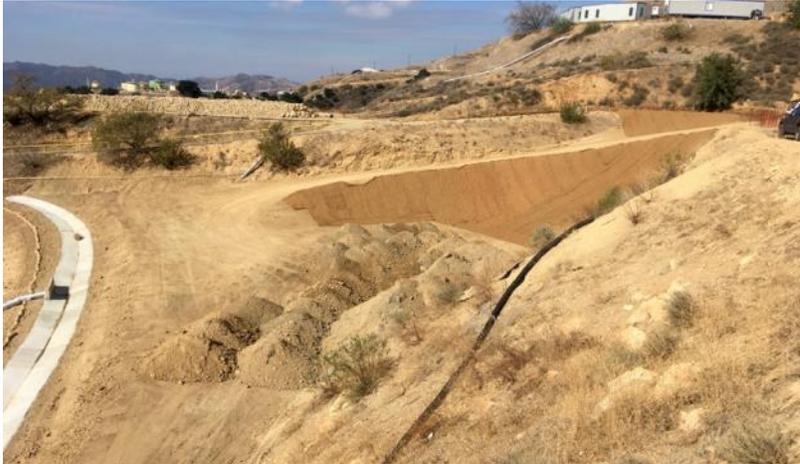
Photo 3 – Soil is stockpiled on the PS-42 Fill Site.

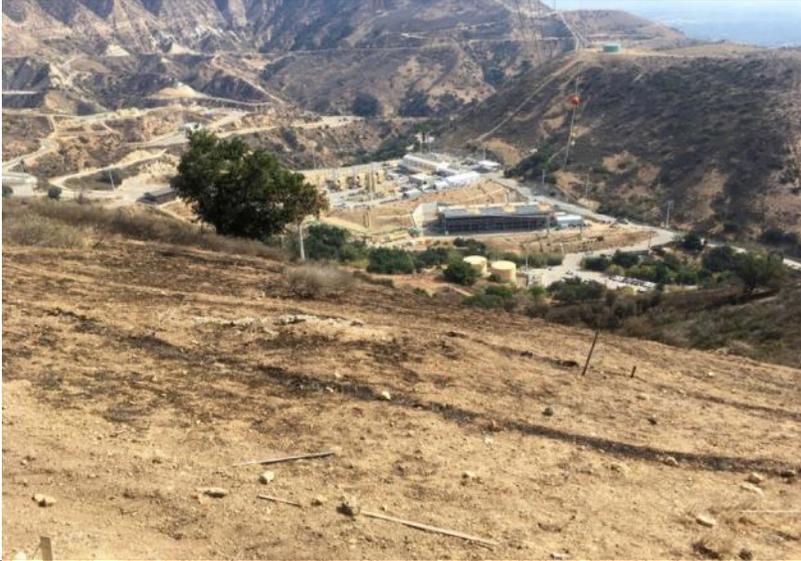
Photo 4 – The fire burned up to the Natural Substation access road.
10/24/16	South Facing Slope below the Substation Access Road

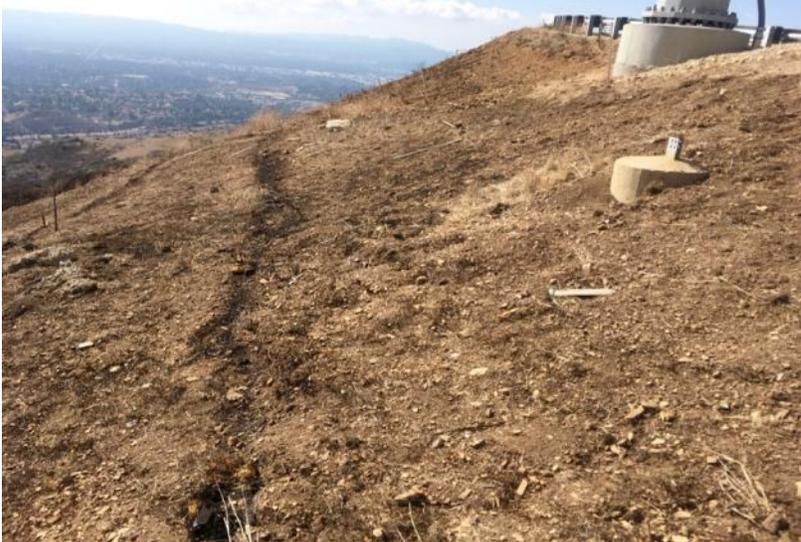
Photo 5 – Note the darkened line where a straw wattle burned.
10/24/16	CCS

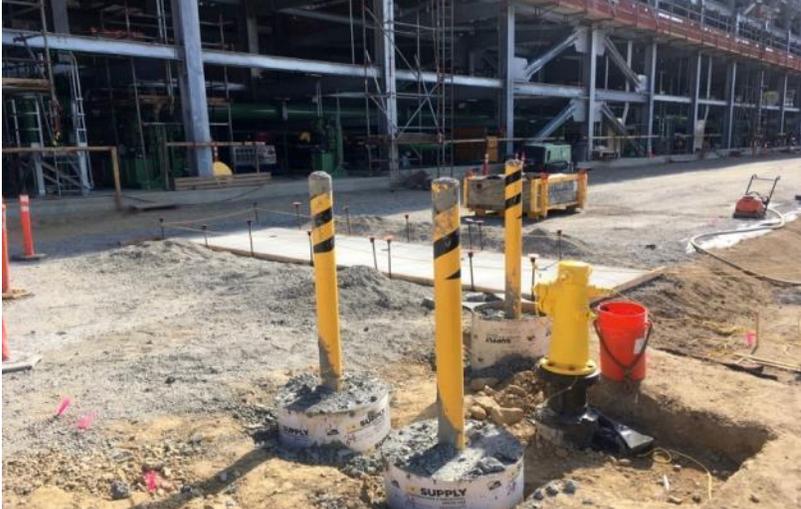
Work was ongoing within the CCS, and crews were installing the fire hydrants and preparing for roadway paving (Photos 6, 7, and 8). The silt fencing repair along Limekiln Creek was done well, and the slope west of the CCS had been weeded of Russian thistle. There was one area adjacent to the CCS entry road that could use some restoration and trash removal (Photo 9).

Photo 6 – Work continues on the fire hydrants near the CCS.

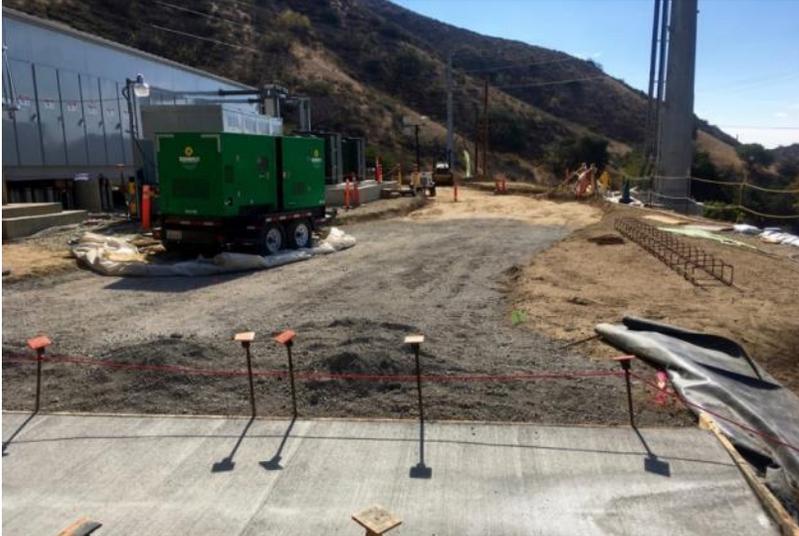
Photo 7 – The area around the CCS is being prepared for paving.
10/24/16	CCS

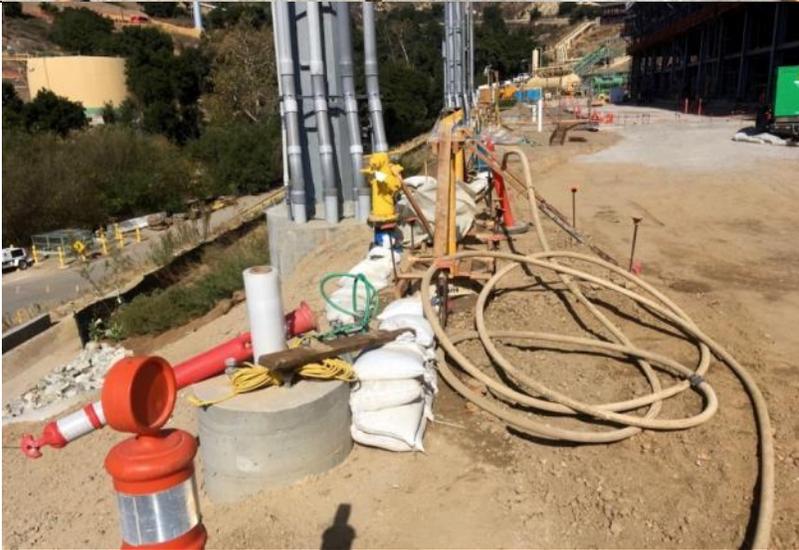
Photo 8 – Work on the fire hydrants.
10/24/16	CCS

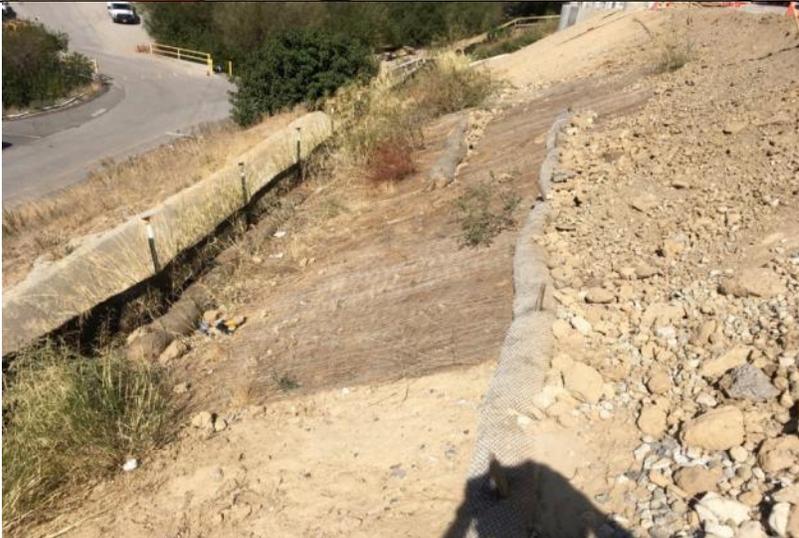
Photo 9 – Slope west of the CCS entrance road could use some trash removal and final grading/restoration.
