Re: Monthly Report Summary #35 for Aliso Canyon Turbine Replacement Project

CPUC Site Inspection Report

February 22, 2017

Aliso Canyon Turbine Replacement Project CPUC Site Inspection Form

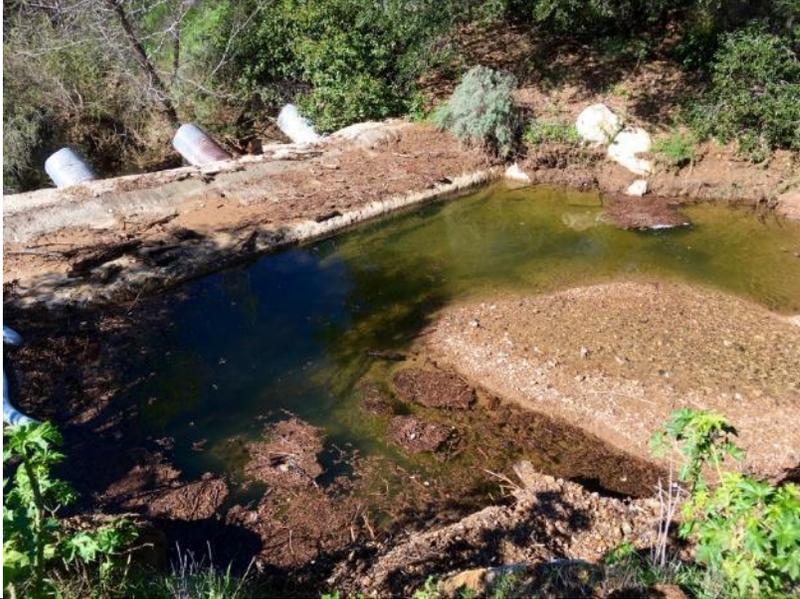
I arrived at the ACTR Project site at 0945 and my first stop was the lower sedimentation basin/newt pond along Limekiln Creek, just upstream of the Guard House (Photo 1). The pond had been recently cleaned out, but additional sediment had been deposited after the recent rains.

Photo 1 – The lower sedimentation basin/newt pond had been cleaned out, but an additional sediment had filled in a portion of it.
2/22/17	PS-42 Fill Site

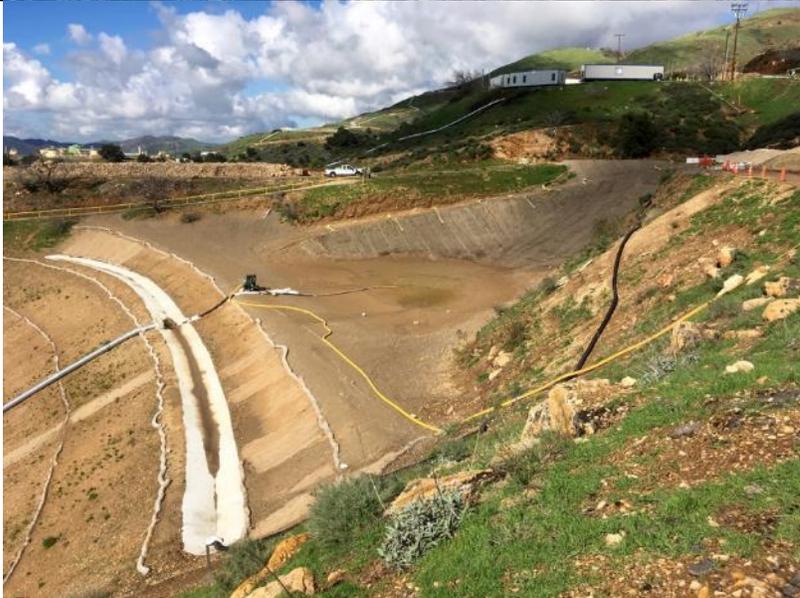
I drove to the PS-42 Fill Site. The top of the site had filled with water (Photo 2), but the water had just been pumped into five baker tanks located on the well pad adjacent to the PS-42 Fill Site. Water from the tanks would be drained into the PS-42 Fill Site drainage system (Photo 3); the water in the tanks looked clear. I spoke with SCG's monitor, Ray Romero (AECOM), about this system. Ray Romero said that the crew was allowing the sediments in the water to settle out in the baker tanks; crews would test the water prior to its release into the culverts. I drove/walked to the box culvert at the bottom of the PS-42 Fill Site noting that the water was flowing as intended (Photo 4), and I did not observe any erosion issues downstream of the riprap. The grate in the box culvert was nearly clogged with soil, rock, debris, and vegetation, although the water was flowing through the grate. I observed a hawk sitting on the existing nest in the big oak tree just downstream of the PS-42 Fill Site; the hawk did not seem disturbed by my presence. I reported this to Ray Romero (AECOM) in case they want to send a crew to clean out the box culvert.

Photo 2 – Overview of the PS-42 Fill Site where accumulated rainwater runoff had been recently pumped.

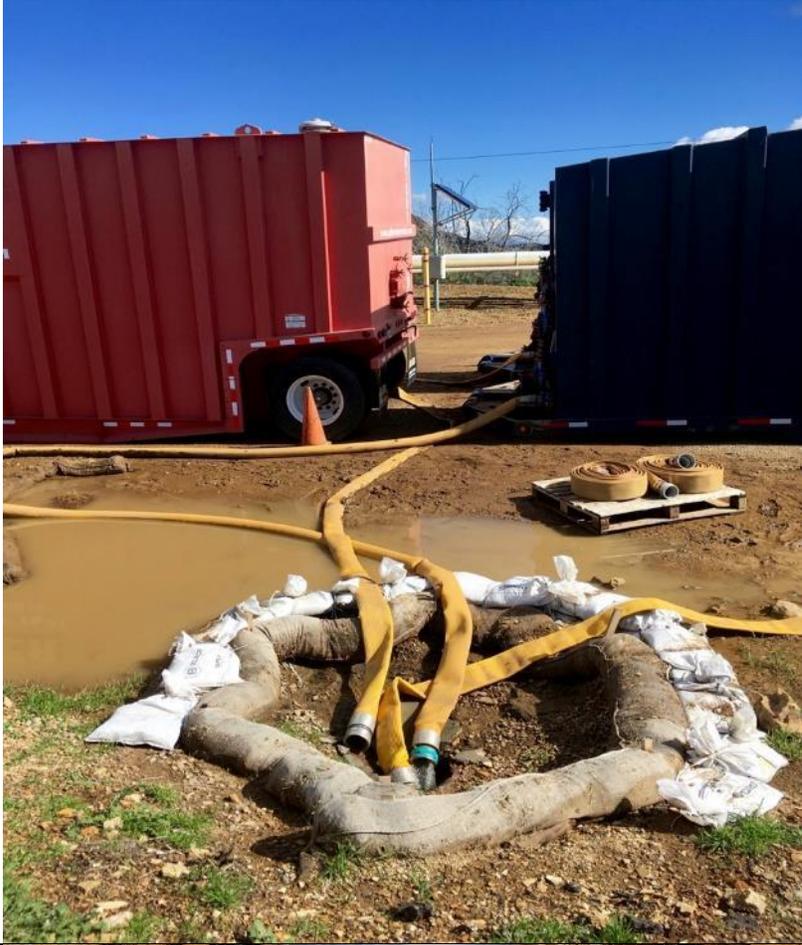
<p>Photo 3 – Water from the PS-42 Fill Site is pumped into baker tanks. The baker tanks are then drained into the PS-42 Fill Site drainage system.</p>
2/22/17	PS-42 Fill Site

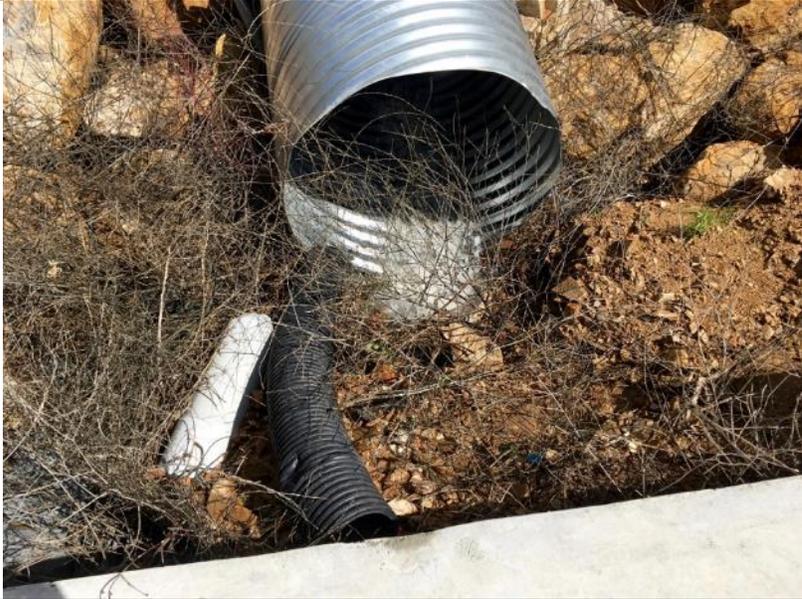
<p>Photo 4 – Water exiting the drainage pipe at the base of the PS-42 Fill Site. Note the rock, mud, debris, and vegetation nearly covering the box culvert grate.</p>

Check the TSP A2 access road and the drain culvert below the PS-42 Fill Site after major rain events.

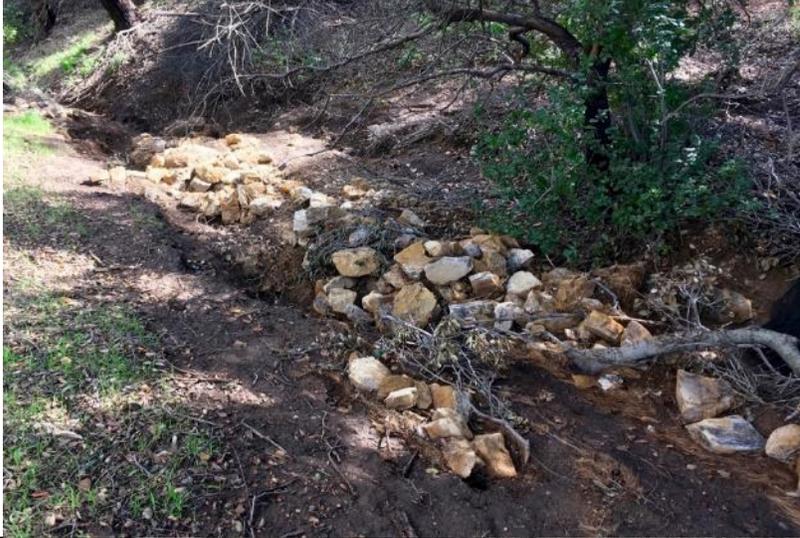
At the Natural Substation, all areas appeared to be in good condition, even after the heavy rains. It appeared that large amounts of water must have flowed through the upper portion of the oak swale since the stabilization best management practices (BMPs) had been compromised (i.e., the rock had been moved and the coconut matting was quite degraded) (Photo 5).

Photo 5 – Drainage stabilization measures (i.e., rock and coconut matting) within the oak swale have been degraded by the high flows of rainwater runoff.
2/22/17	Upper Sedimentation Basin/Newt Pond

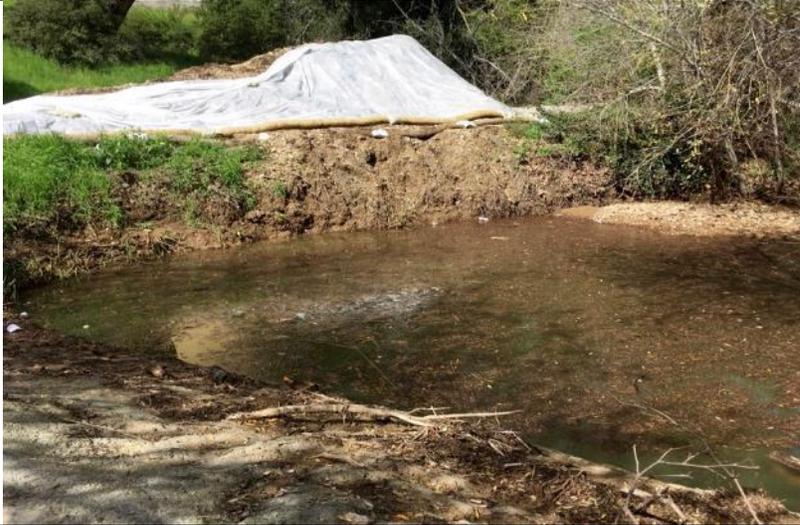
Photo 6 shows the upper sedimentation basin/newt pond; this pond had also been cleaned out. According to Ray Romero (AECOM), this was an O&M operation, but a biologist had been onsite monitoring the sediment removal; no newts were observed. Monitors continue to be present during weekend work, since SCG's construction contractor, Kiewit, needed to drive and park by their trailers.

Photo 6 – Sediment has been cleaned out of the upper sedimentation basin/newt pond.
2/22/17	TSP A2 Access Road

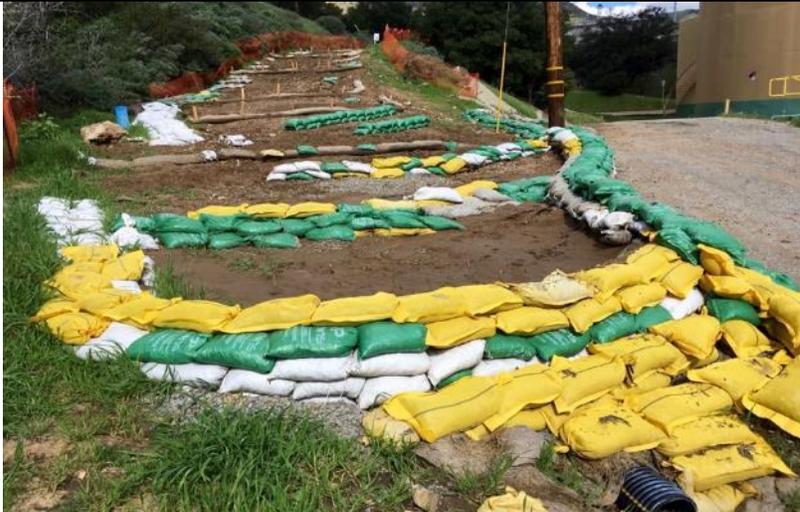
The 12-kV/TSP A2 access road was in good condition, with additional BMPs added along the road (Photo 7). The silt fence diversion structure was in place and appeared to have withstood the heavy rains (Photo 8). Erosion continues to take place within the oak swale drainage, with deepening rills and more rock and mud being deposited downstream of the silt fencing. The fenced-off oak sapling near TSP A2 would benefit from pruning the damaged branches and resetting the fence (Photo 9).

Photo 7 – Enhanced BMPs at the entrance to the TSP A2 access road.

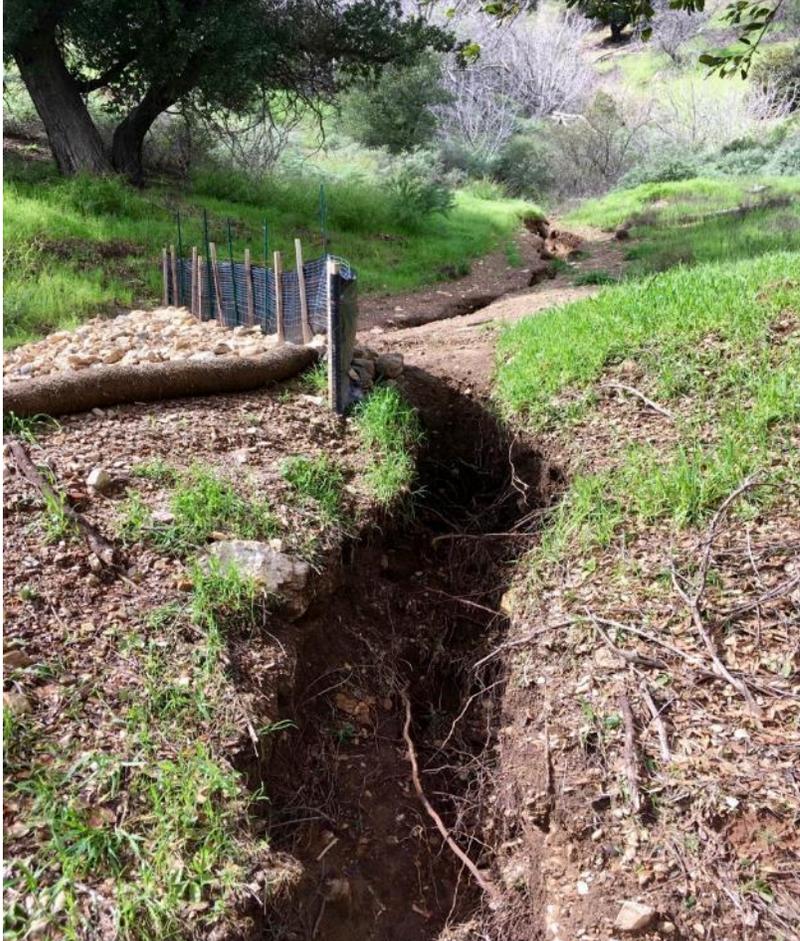
Photo 8 – Silt fencing used to divert water away from the TSP A2 access road. Erosion rills continue to deepen within the oak swale.
2/22/17	TSP A2 Access Road

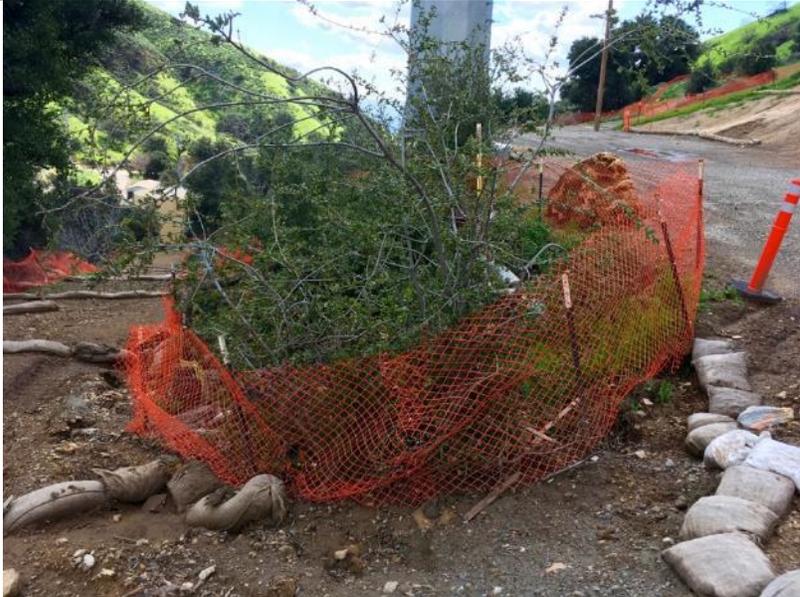
Photo 9 – Oak sapling near TSP A2 could benefit some maintenance (pruning and fence repair).

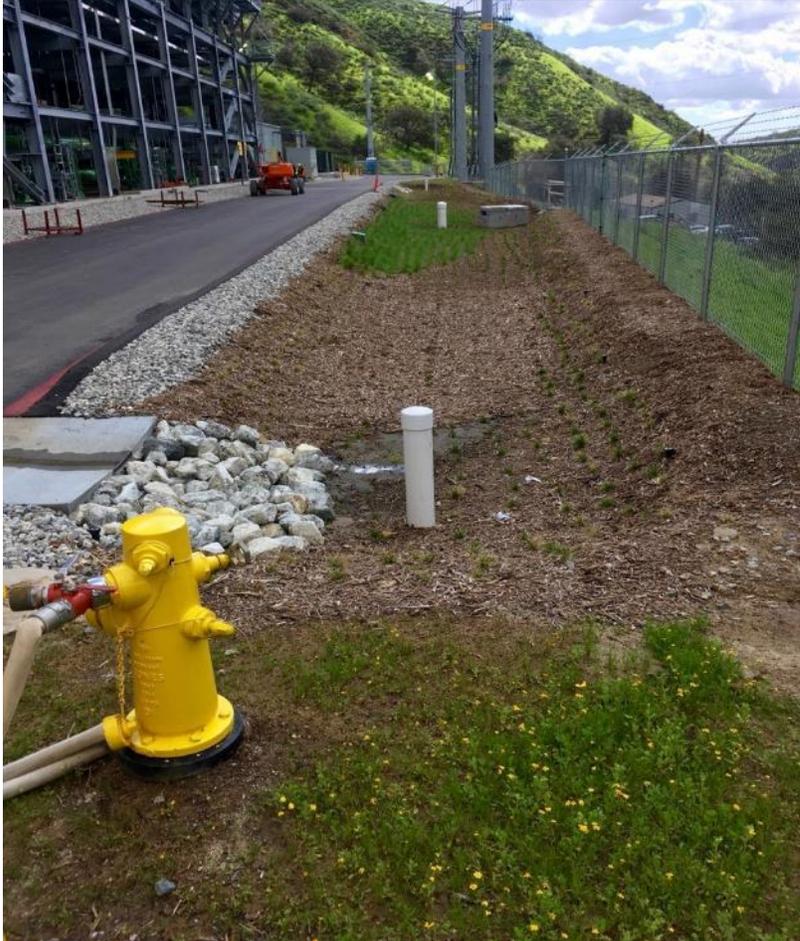
The bioswale in the CCS appeared to be in good condition, with only minimal amounts of sediment noted near the inlets (Photo 10).

Photo 10 – The CCS bioswale is in good condition and well maintained.
2/22/17	CCS

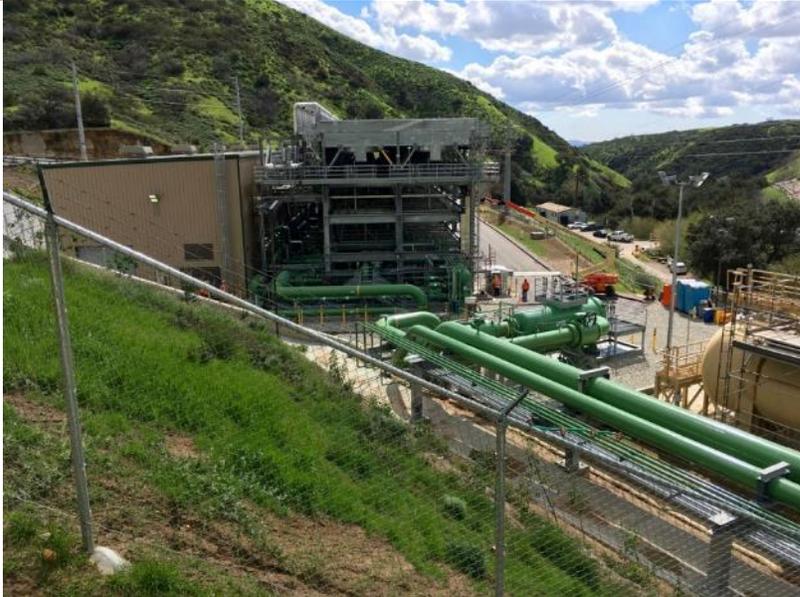
Photo 11 – Overview of the CCS.

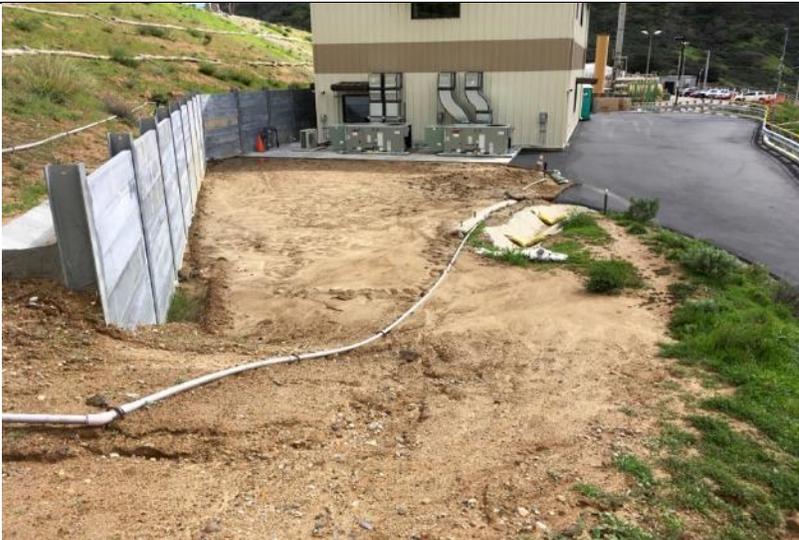
Most of the slopes around the CCS and the new Admin/IM Building appeared stable and had extensive vegetative growth (Photo 11); however, the slope just behind the lower new Admin/IM Building would benefit from BMPs (Photo 12). Paving appears to have been completed around the new Admin/IM Building (Photo 13), and the bioswale is in good condition (Photo 14).

Photo 12 – The slope behind the lower new Admin/IM Building would benefit from some BMPs.
2/22/17	New Admin/IM Building

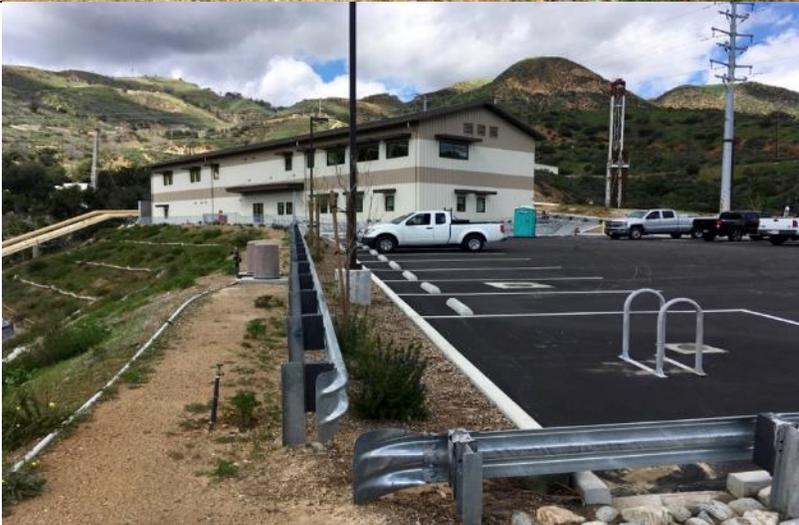
Photo 13 – Paving and landscaping have been completed at the upper new Admin/IM Building.
2/22/17	New Admin/IM Building Bioswale

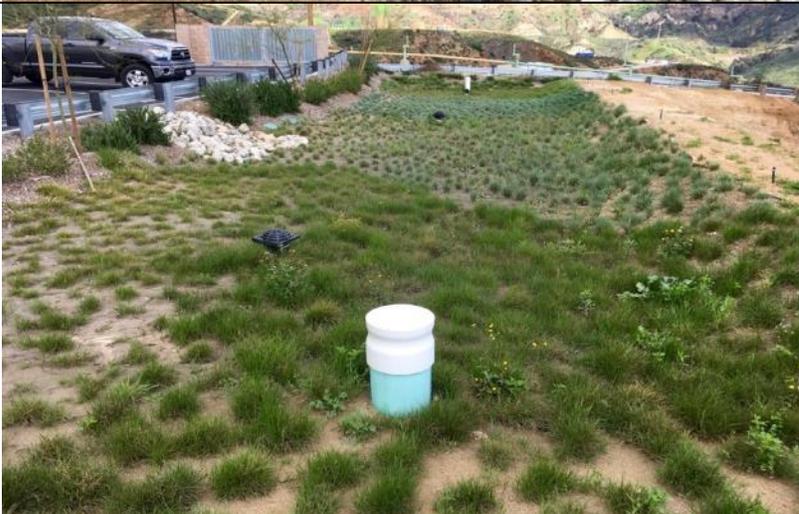
Photo 14 – The bioswale is in good condition.

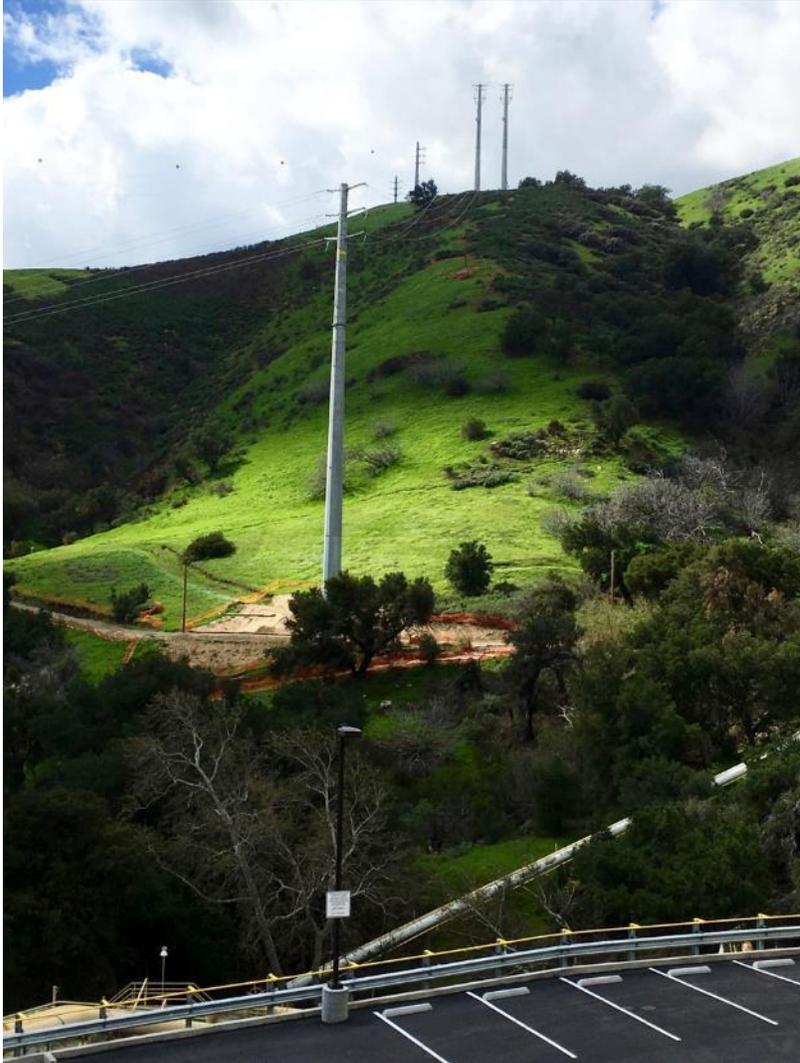
Photo 15 – Overview of the 12Kv poles – the rains have “greened” up the hills.
