**Re: Monthly Report Summary #37 for Aliso Canyon Turbine Replacement Project**

CPUC Site Inspection Report  
May 17 and June 28, 2017

## Aliso Canyon Turbine Replacement Project CPUC Site Inspection Form

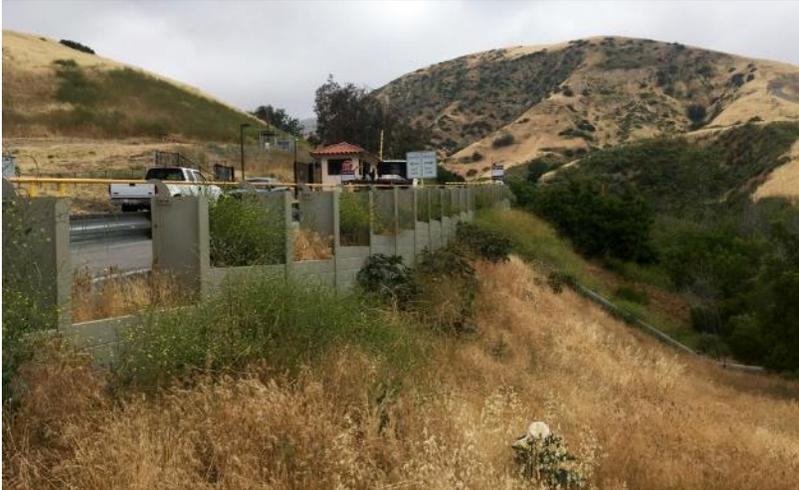
Before entering the Aliso Canyon Natural Gas Storage Field (Aliso Storage Field), I stopped just outside the Guard House to look at the weed growth on the west bank of Limekiln Creek. This portion of the creek had been disturbed as part of the Aliso Canyon Turbine Replacement (ACTR) Project. The bank was stable with large amounts of annual grasses; however, there were healthy stands of non-native species (e.g., mustard, castor bean, and Russian thistle) growing in the area (Photo 1).

Photo 1 – Mustard, castor bean, and Russian thistle are abundant on the west slope of Limekiln Creek near the Guard House.
5/17/17	PS-42 Fill Site

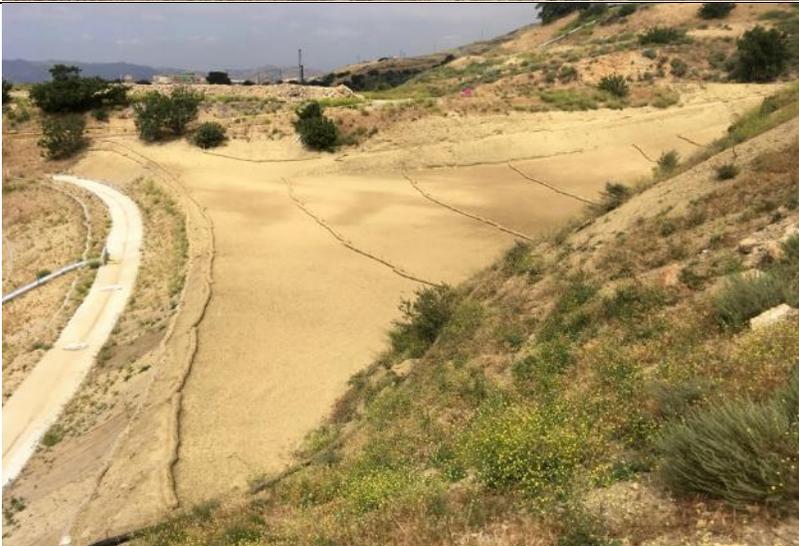
At the PS-42 Fill Site, best management practices (BMPs) are in place and the area has been hydroseeded (Photo 2). A number of old wattles are still lining the paved access road that runs around the PS-42 Fill Site; I had reported this following my last site visit. After my last site visit, I sent a message to Derek Rodgers (SCG) about removing the wattles and he said they would be removed soon.

Photo 2 – Final BMPs have been installed and the PS-42 Fill Site has been hydroseeded.
5/17/17	Oak Tree Mitigation Area

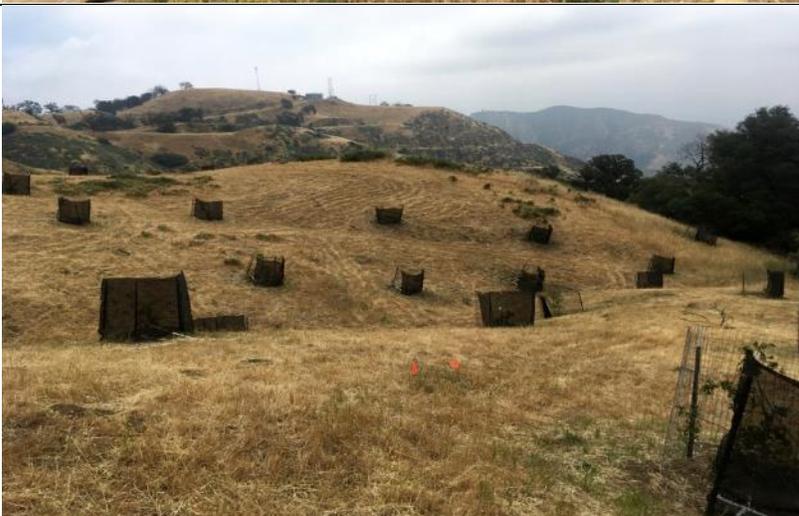
At the Oak Tree Mitigation Site, the grasses around the trees had been recently cut back and the tree cages were well-maintained (Photo 3). Some cages had lost their original oak sapling, but oak seedlings were noted and appeared to be healthy (Photo 4). Both gopher and ground squirrel burrows were abundant in the area, with some burrows noted within the cages (Photo 4). The oak saplings appeared to be healthy and were exhibiting new growth (Photo 5).

Photo 3 – Vegetation around the oak trees has been removed.

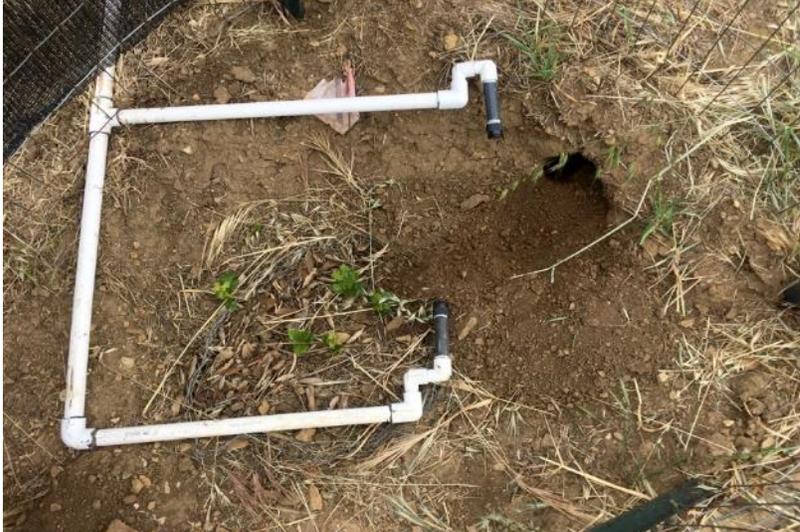
Photo 4 – Burrowing animals are abundant within the oak mitigation area; oak seedlings are coming in.
5/17/17	Oak Tree Mitigation Area

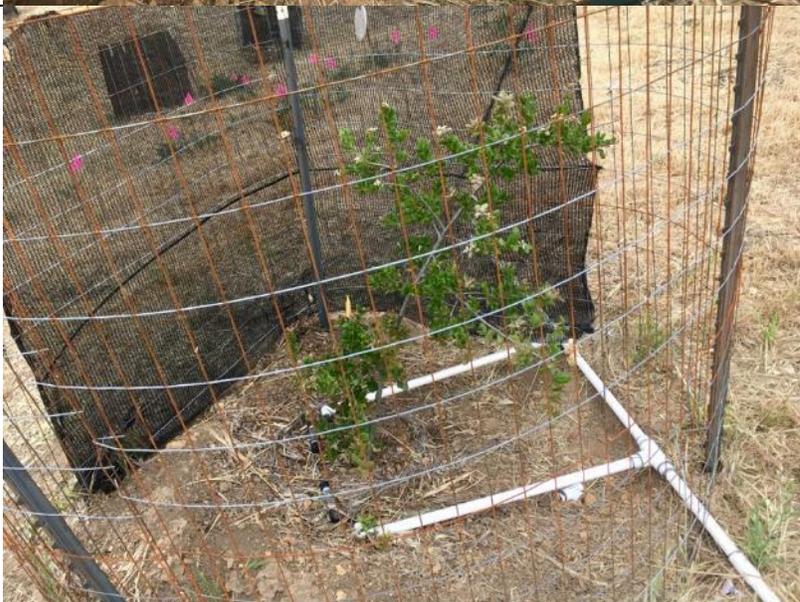
Photo 5 – Oak trees look healthy and are exhibiting extensive new growth.
5/17/17	A2 Access Road

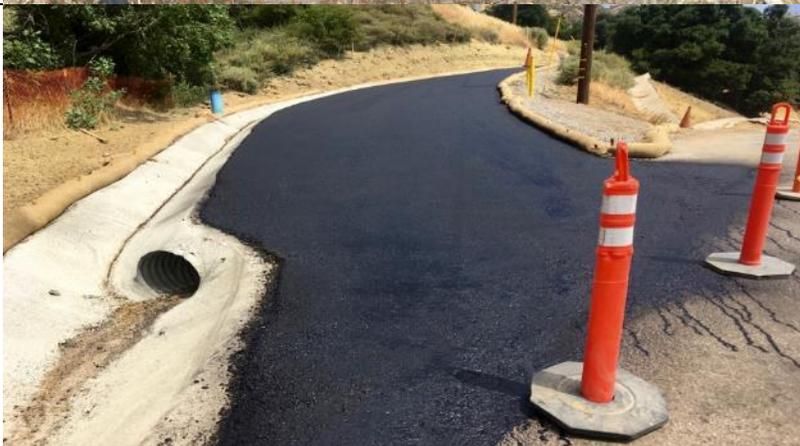
The 12-kV/TSP A2 access road (A2 access road) and crane pad have been paved (Photos 6, 7, and 8). Paving had been completed right up to the oak swale and the diversion fence; the fence remains in place and appears to be in good condition (Photo 9).

Photo 6 – The access road has been paved.

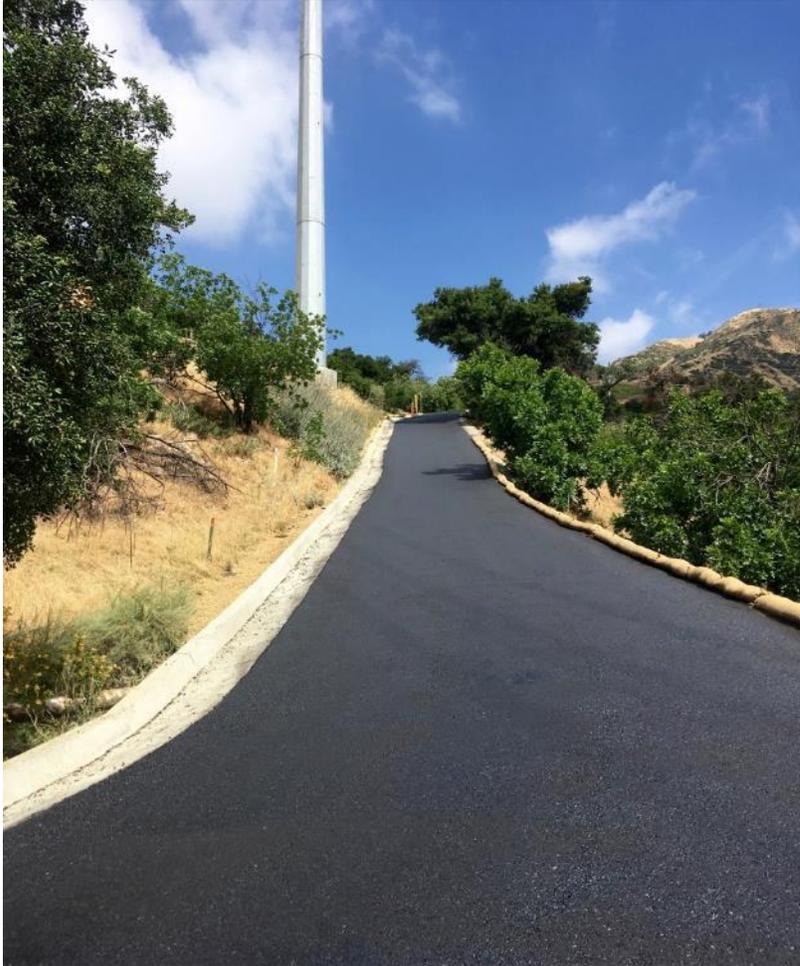
Photo 7 – The access road has been paved.
5/17/17	A2 Pole Site

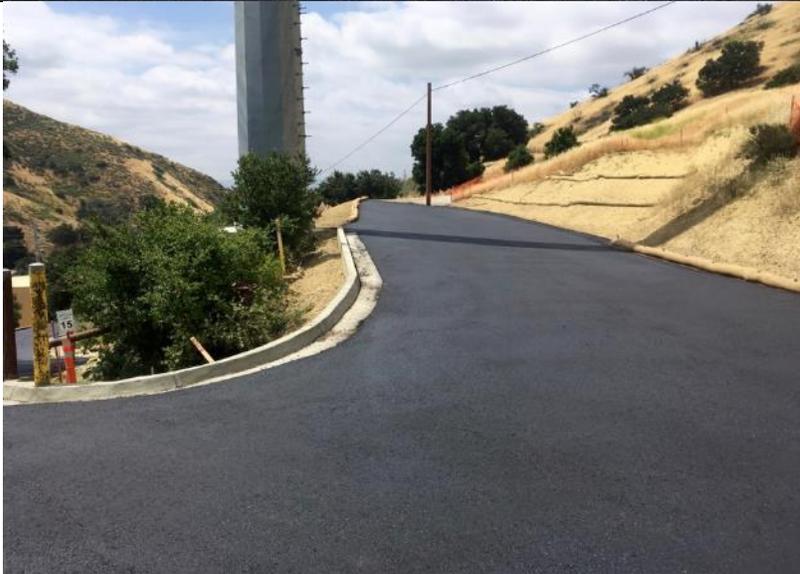
Photo 8 – The crane pad has been paved.

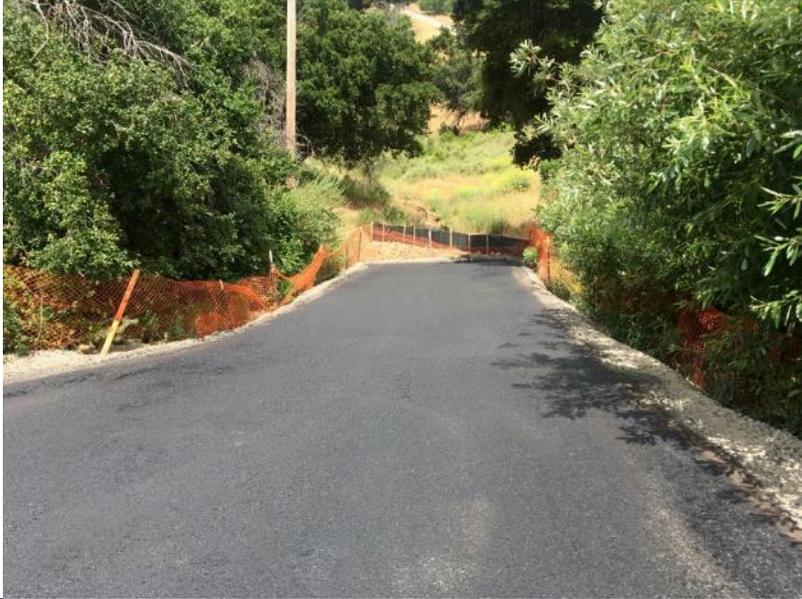
Photo 9 – Paving has been extended up the access road to the oak swale.

Check the oak swale erosion repairs.

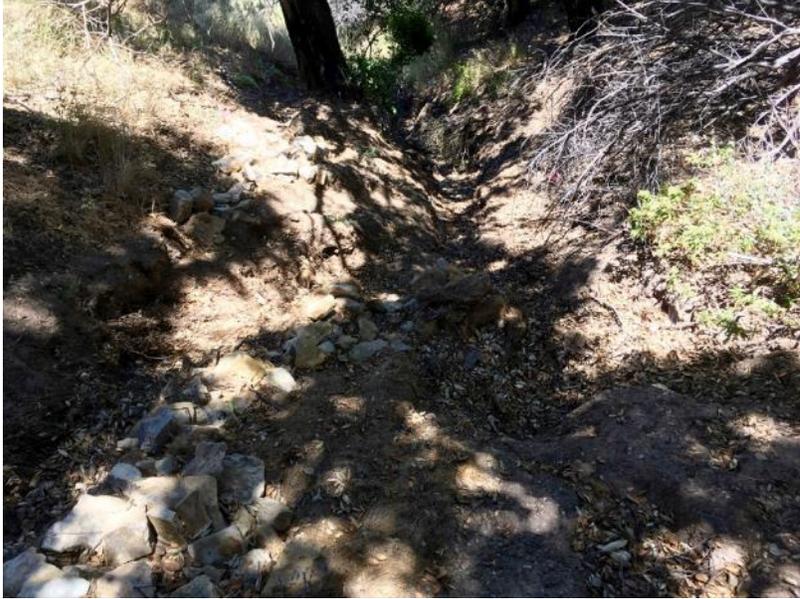
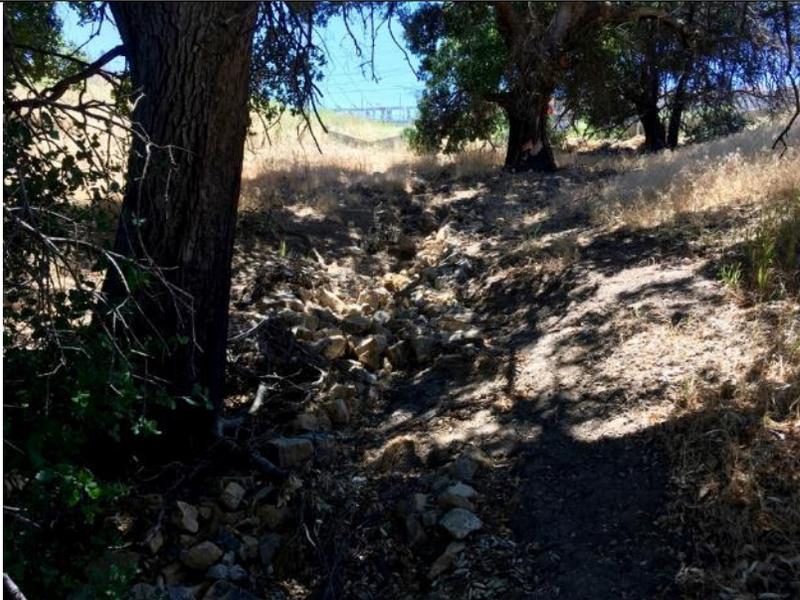
We drove to the Natural Substation and discussed the history of the construction effort and the erosion that had been documented during that time. We looked over the Natural Substation access road and the biofiltration unit and then walked into the oak swale adjacent to the Natural Substation. Erosion control measures (i.e., coconut blanket and rock) that had been installed within the gently sloping portion of the oak swale drainage were evaluated and photographed (Photos 1 and 2). Rainwater runoff flowing through the area had moved and/or had eliminated most of these measures.

Photo 1 – Erosion control measures that had been installed within the oak swale near the Natural Substation. Most of the coconut blanket and rock has been damaged and/or moved by flows of rainwater runoff.
6/28/17	Oak Swale, Looking Up Toward the Natural Substation

Photo 2 – Erosion control measures that had been installed within the oak swale near the Natural Substation. Most of the coconut blanket and rock has been damaged and/or moved by flows of rainwater runoff.

It seems a reduction in the rainwater runoff coming down the oak swale from the Natural Substation could potentially control the erosion problems and the sediment loads being deposited into Limekiln Creek. We discussed the possibility of diverting some of the rainwater runoff above/at the Natural Substation into a different drainage so it does not all flow down into the oak swale.
