Re: Monthly Report Summary #4 for Aliso Canyon Turbine Replacement Project

Aliso Canyon Turbine Replacement Project CPUC Site Inspection Form

Project:	Aliso Canyon Turbine Replacement	Date:	July 3, 2014
Project Proponent:	Southern California Gas Company and Southern California Edison	Report #:	VS013
Lead Agency:	California Public Utilities Commission	Project Phase/NTP:	Guard House and Road Widening Component (NTP-1), The Admin/IM Temporary Trailer Locations (NTP-2), New Storage Container Location (MPR03)
CPUC PM:	Andrew Barnsdale, Energy Division	AM/PM Weather:	Clear & Sunny, mild temps, no wind. Temps warming w/ a nice breeze in the late morning
E & E CM:	Lara Rachowicz	Start/End time:	0730 hrs to 1000 hrs
Monitor(s):	Vince Semonsen		
Project Component(s):	CPUC Oversight: Guard House, Admin/IM Temporary Trailers, New Admin/IM Building, New Storage Containers

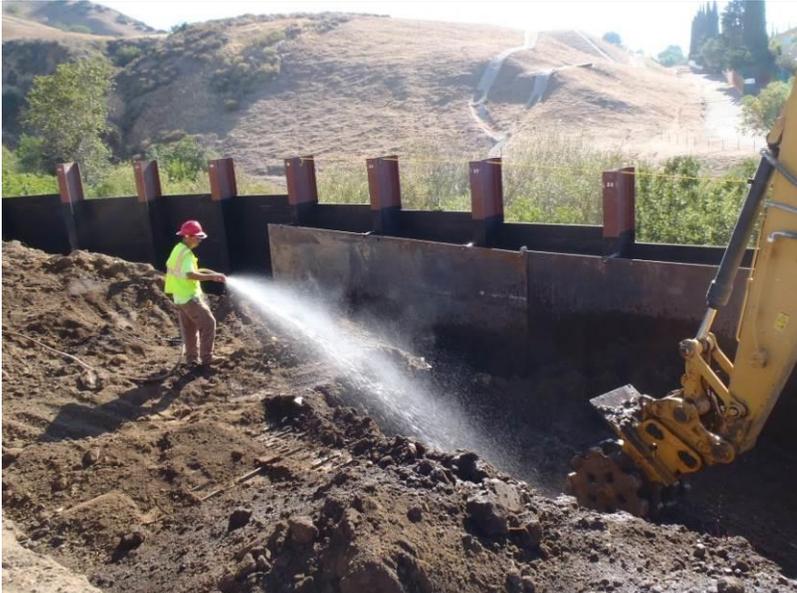
Date	Location	Photo	Description
7/3/14	Guard House

Excavation, backfilling and compaction of soil behind the roadway wall is ongoing.
7/3/14	New Storage Container Location

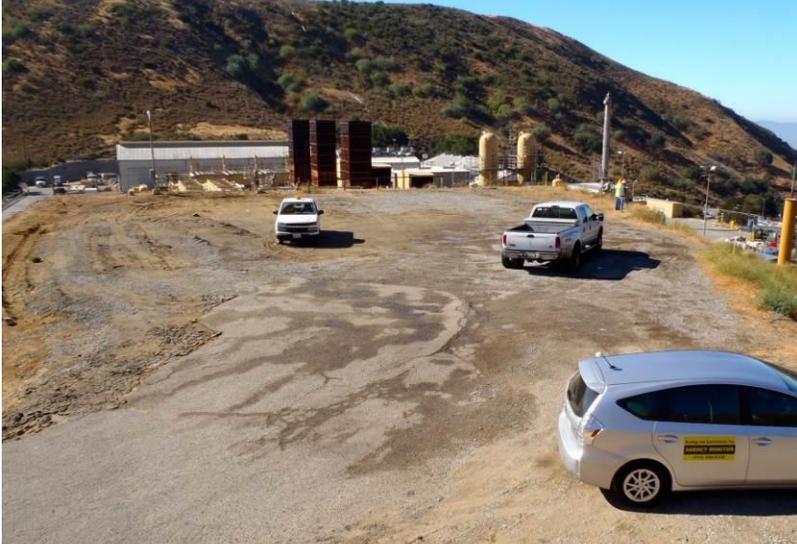
All of the storage units have been moved from the Storage Container location.

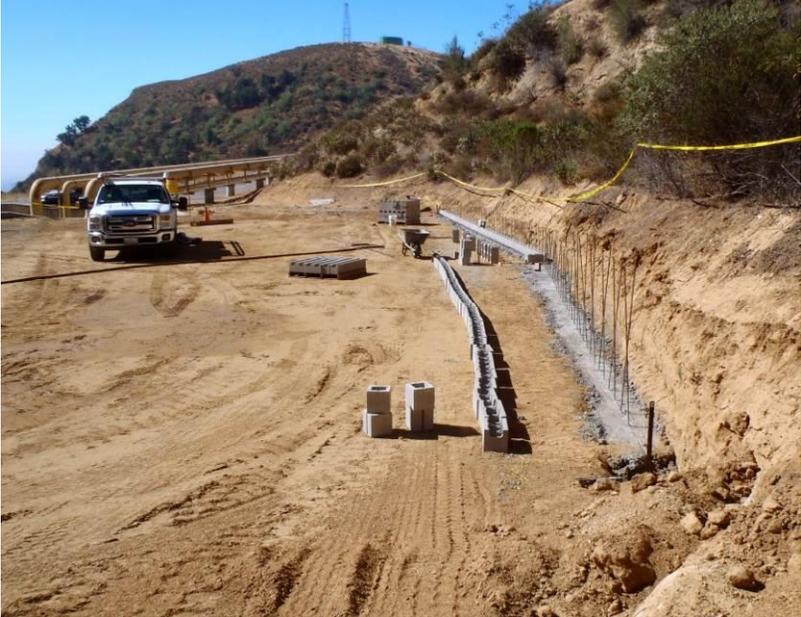
<p>7/3/14</p>	<p>New Storage Container Location</p>

<p>Retaining wall work at the new storage container location. Exclusion tape has been stung along the vegetation to keep workers out of the native habitat.</p>
<p>7/3/14</p>	<p>New Admin/IM Building</p>

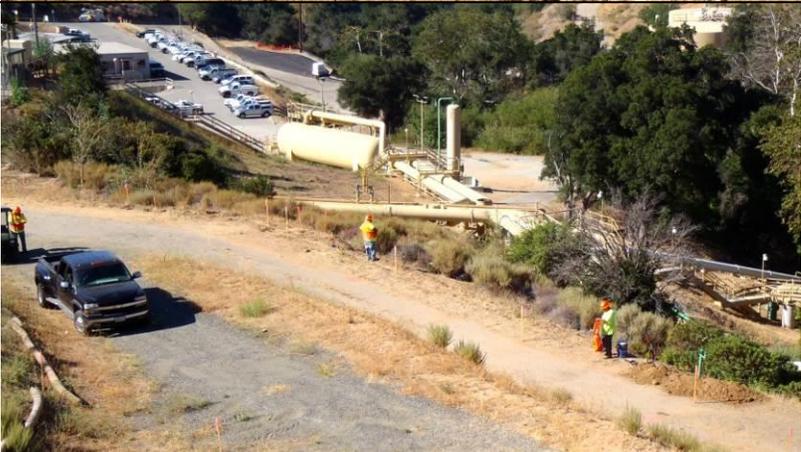
<p>Surveys and potholing are taking place prior to fuel modification work and clearing/grading.</p>

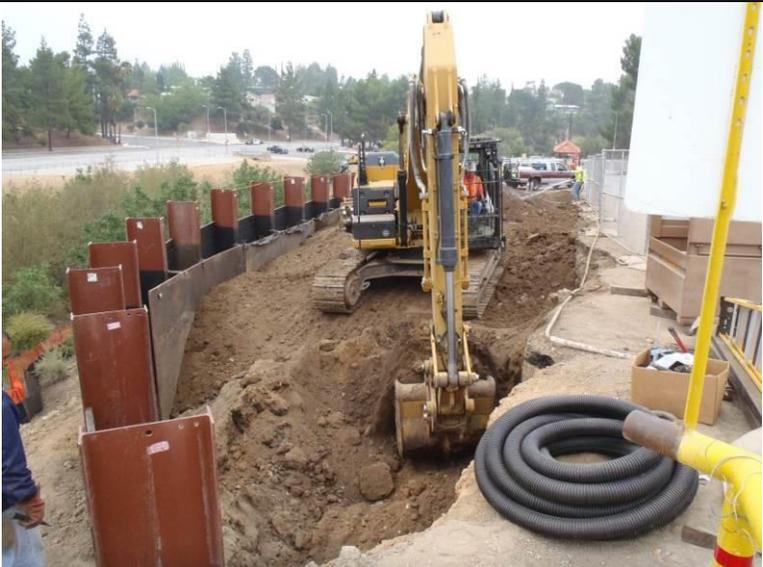
Date	Location	Photo	Description
7/10/14	Guard House

<p>Excavation, backfilling, and compaction of soil behind the roadway wall is nearly done with the final portion of the work being completed.</p>
7/10/14	Guard House

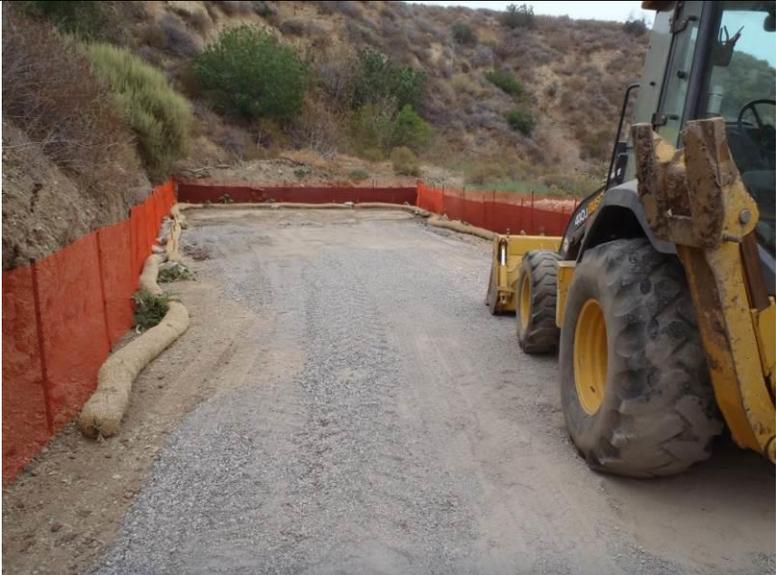
<p>All of the stockpiled soil has been moved from the containment area and placed back into the roadway expansion area.</p>
7/10/14	New Storage Container Location

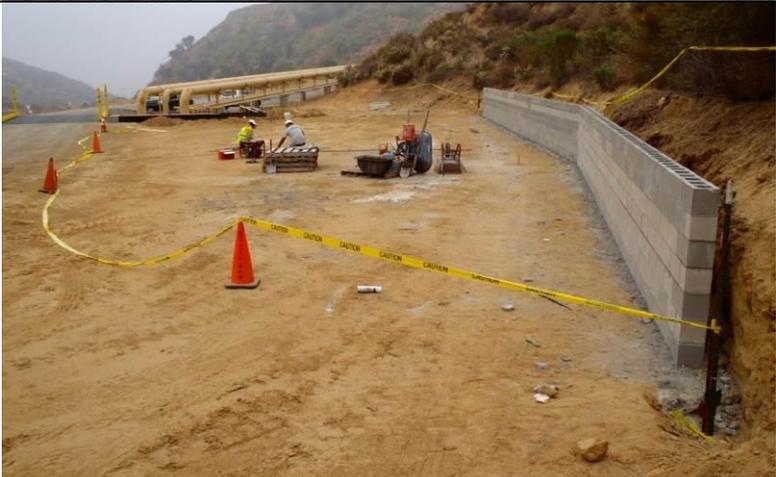
<p>Site preparation continues with retaining wall work nearing completion.</p>

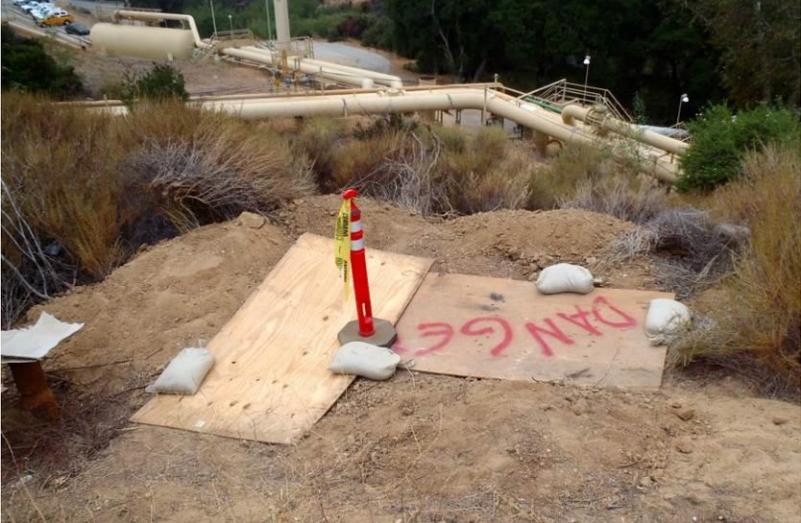
7/10/14	New Admin/IM Building

Surveys and potholing continues with the potholes sealed overnight to prevent animals from falling in.
7/10/14	Proposed Kiewit Staging Area

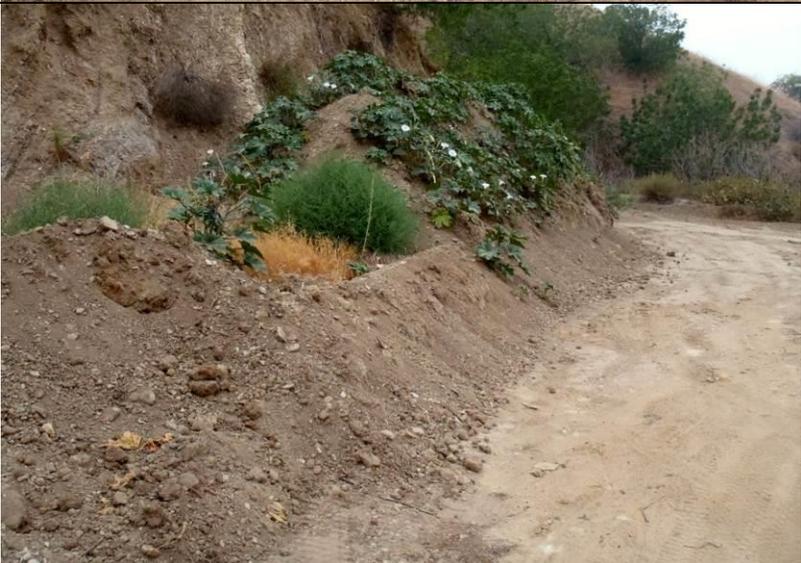
Old berms within the roadway and pad will be removed or smoothed out during the site preparation. These berms are currently supporting a variety of native and non-native vegetation.

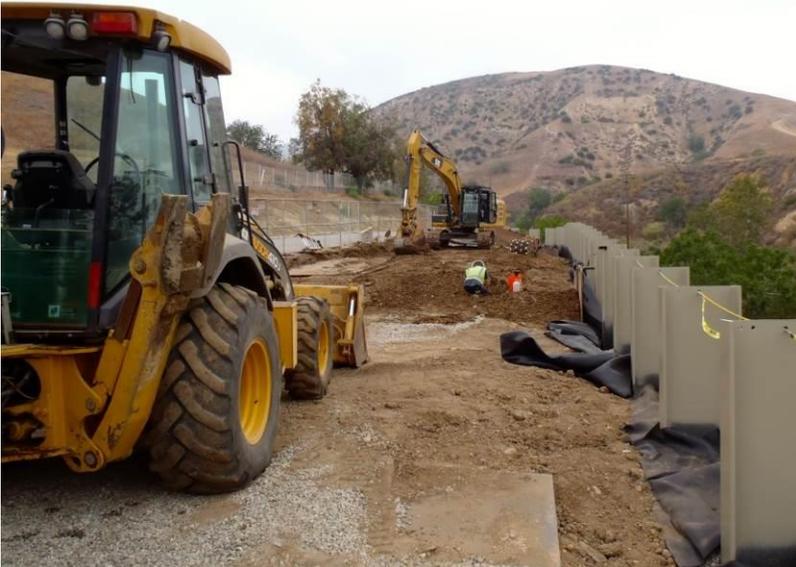
Date	Location	Photo	Description
7/16/14	Guard House

The road widening work continues at the guard house with backfilling of the soil behind the caissons nearing completion – see photo. Archeological and Paleontological oversight continues with monitor Meghan Lamb (MM CR-1, MM CR-3, MM CR-6 & MM CR-8) spot checking the guard house work but spending most of her time checking the other work locations. Jose Lopez is the onsite Biological Monitor (APM BR-1d & APM BR-6); he is spot checking several locations while training a new biological monitor (Mike McGovern). A lesser goldfinch nest was found earlier in the week near the existing guard house with two chicks in it – both were near to fledging. Avian biologist Rob Conoham is onsite monitoring this nest (APM BR-1c, MM BR-7, MM BR-8). The chicks fledged in the morning of my site visit and were not seen in the area. The site looks good with no dust issues or dirt on the roadway, and all of the construction personnel had been trained and displaying hardhat stickers.

Backfilling continues.
7/16/14	P-43 Fill Site

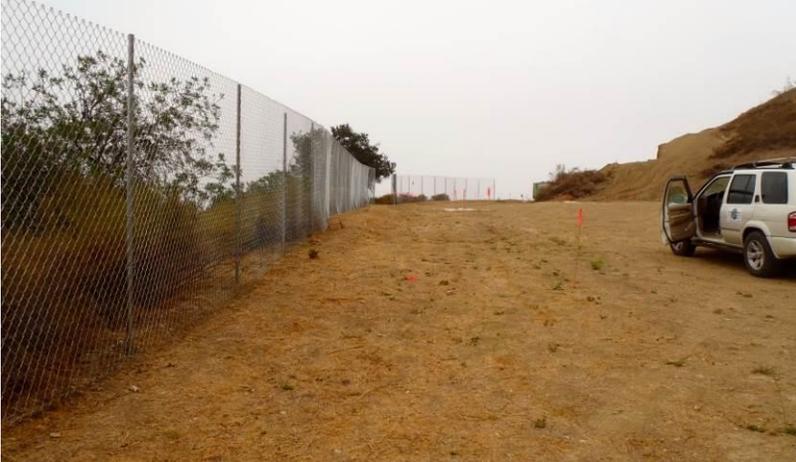
The P-43 fill location is being prepared with chain-link fence installation, followed by silt fence installation in a day or two.
7/16/14	New Storage Container Location

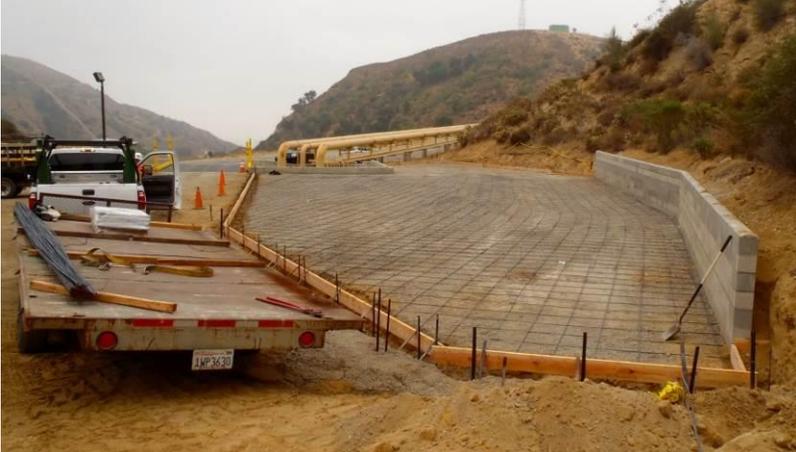
Site preparation continues. The retaining wall is completed and work on the pad continues. The concrete pour is expected soon.

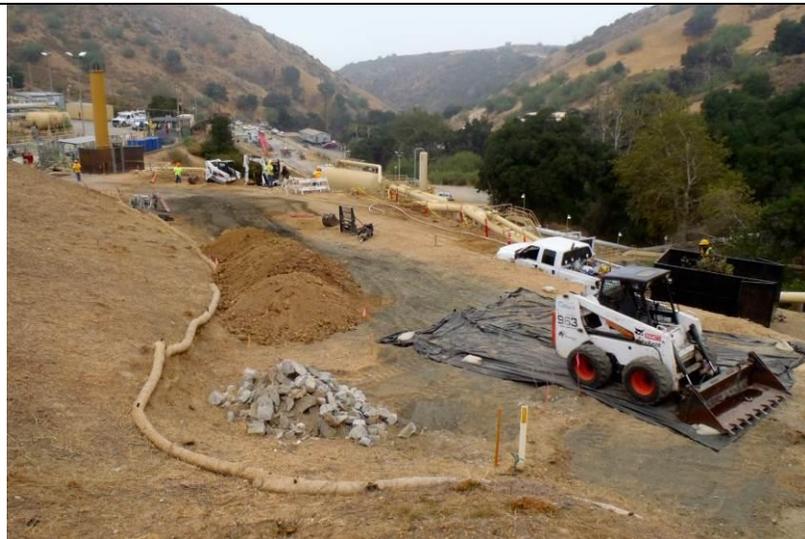
<p>7/16/14</p>	<p>New Admin/IM Building</p>

<p>Fuel modification continues along with pipeline removal.</p>
<p>7/16/14</p>	<p>Temporary Trailer Location</p>

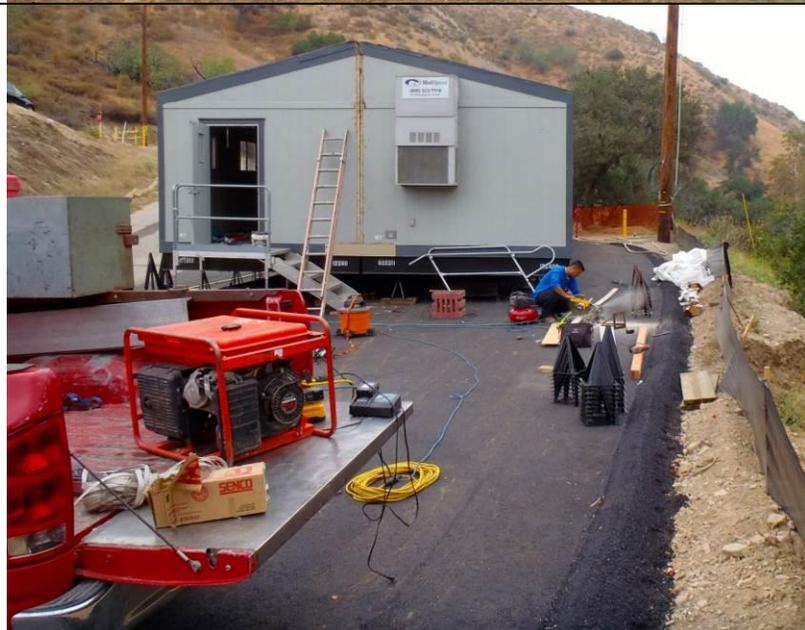
<p>A trailer has been brought onsite and is being set up.</p>

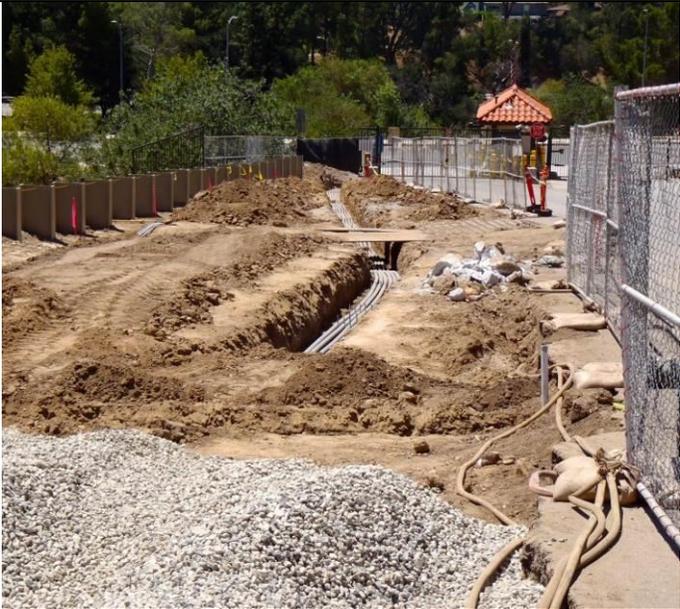
Backfilling has been completed and work has begun on installation of piping and conduit.
7/24/14	P-43 Fill Site

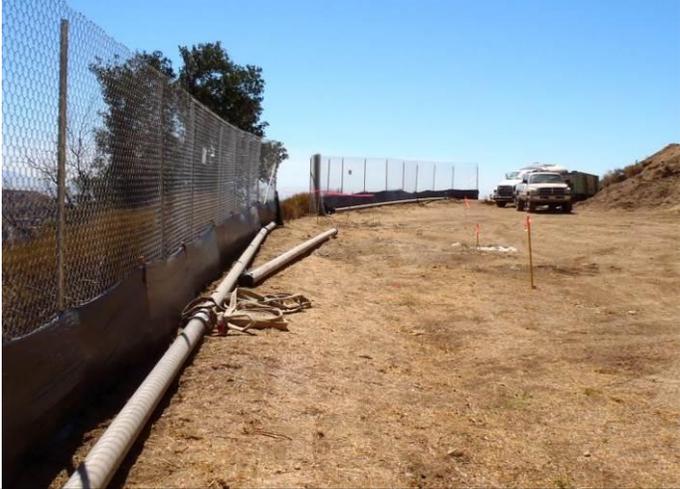
The P-43 fill location is being prepared. Oak tree pruning is complete and silt fencing is installed along the chain link fence.
7/24/14	P-43 Fill Site

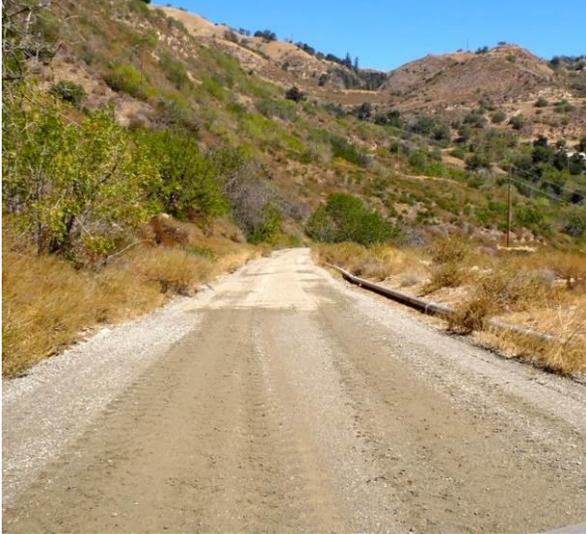
Road base was being laid down along the P-43 access road and work was continuing on tree pruning and the installation of exclusion fencing along the edge of the pad. A water line has also been installed to the site to provide dust control and compaction moisture – see photo. One active cavity nest (an ash-throated flycatcher) was found in an oak tree above the P-43 site. It is not expected to be impacted by the soil import work since it was above and behind the P-43 cut bank and the young may fledge before soil is brought to the site. No buffer/barrier was set up and the nest will be monitored by the onsite biologists; it is the one remaining active nest around the various work sites.

Road base and a water line are being installed along the P-43 access roadway.

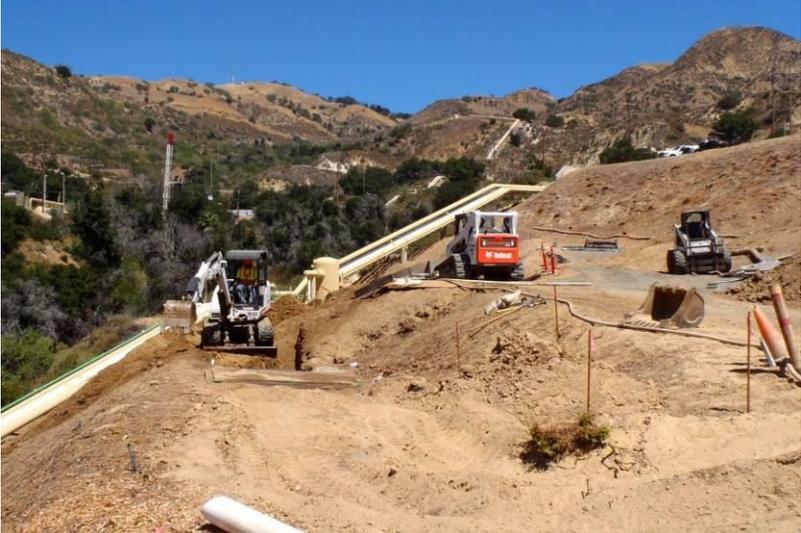
<p>7/24/14</p>	<p>New Admin/IM Building</p>

Vegetation clearing has been completed at the New Admin/IM Building and a crew is finishing up the pipeline removal – see photo. Site preparation is nearly complete and they are waiting for the P-43 site to be ready so they can begin the grading work. One portion of the silt fencing downslope from the pipe removal had collapsed from dirt rolling down the slope – I informed Amandeep of the minor repair work needed. Biologist Johnny Grady said a snake (racer) was seen near the site but it moved off on its own.

A wide-angle photograph of a construction site on a hillside. In the foreground, a large white pipe lies on the ground. In the middle ground, a yellow excavator and a red skid steer loader are working on a dirt path. A yellow pipeline runs diagonally across the hillside. The background shows more of the hillside under a clear blue sky.	<p>Pipeline removal continues as they prepare the site for grading.</p>
<p>7/24/14</p>	<p>Temporary Trailer Location #5</p>

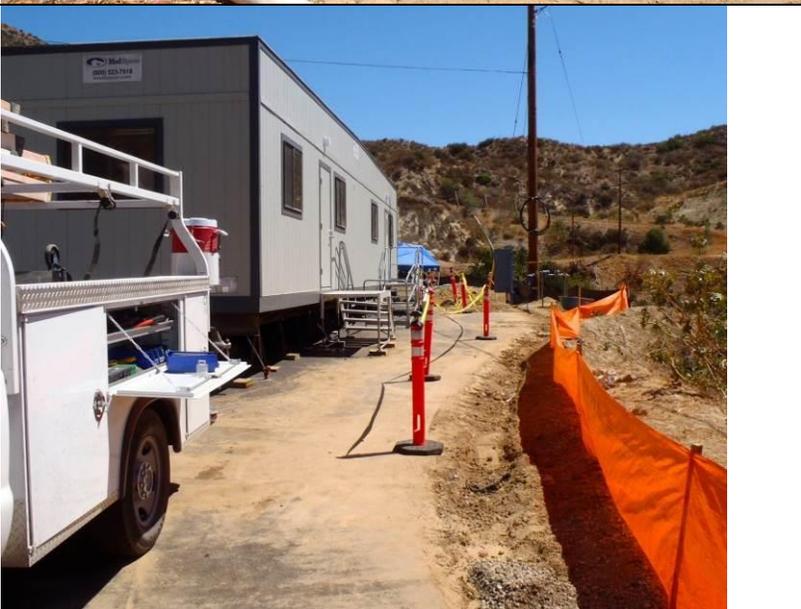
A photograph of a white temporary trailer parked on a dirt area. A white utility truck is parked in front of the trailer. Orange safety flags and a red fire hydrant are visible. A utility pole stands nearby. The background shows a hillside with sparse vegetation.	<p>Trailers at temporary locations #1 and #5 are being set up. Location #5 is shown here with installation of water and electrical ongoing.</p>

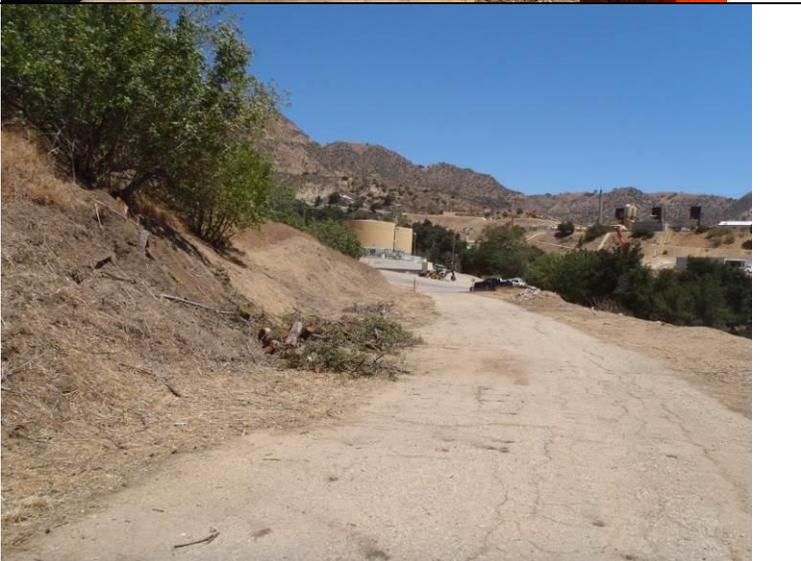
<p>7/24/14</p>	<p>Kiewit Staging Area</p>

A photograph of a dirt access road leading up a hillside. The road is wide and appears to be under construction or recently graded. There are some trees and bushes on the left side of the road. The background shows a hillside with some buildings and a clear blue sky.	<p>The fuel modification work had been completed along the Kiewit access road and within the parking area. Flagging, fencing, and leveling the spoil piles are expected to occur next week.</p>

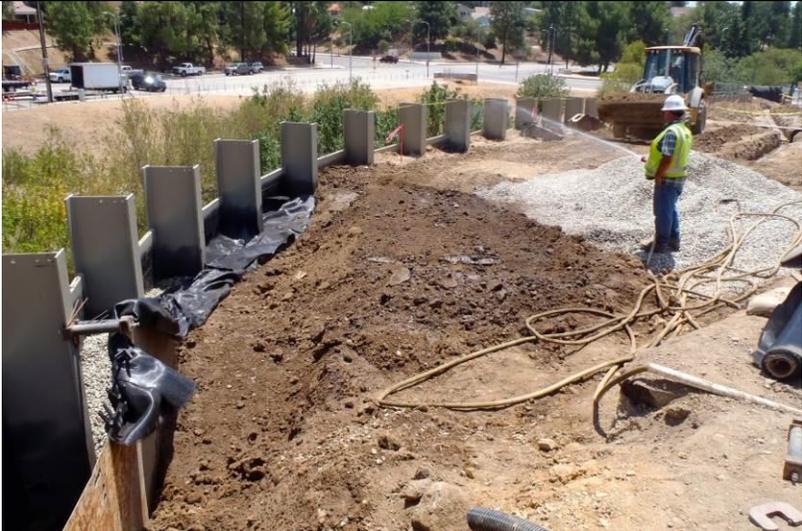
Drain installation and the final backfilling work is taking place.
7/30/14	P-43 Fill Site

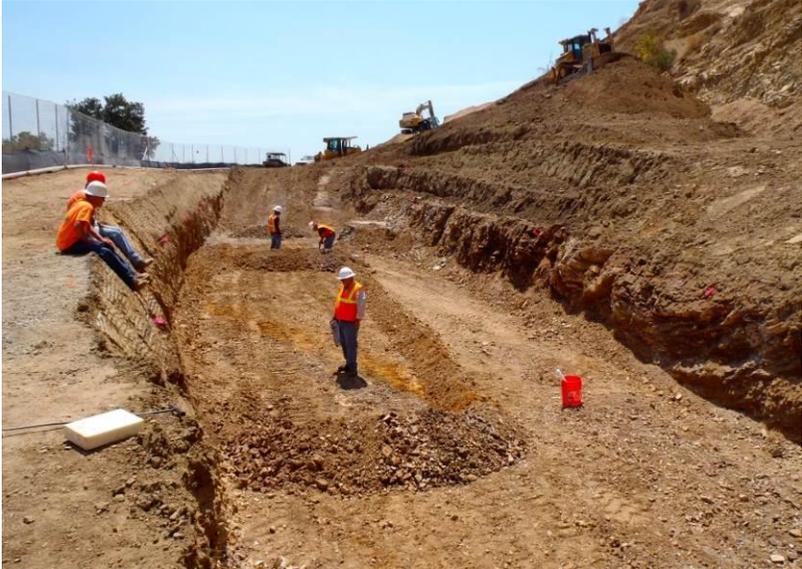
Earth work has begun at the P-43 soil stockpile location. Benching and compaction were occurring in preparation for soil import.
7/30/14	New Storage Container Location

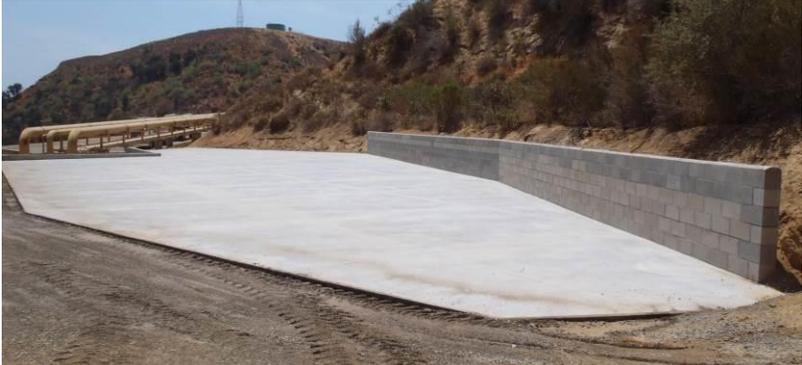
The pad has been poured – no construction activity at this site.

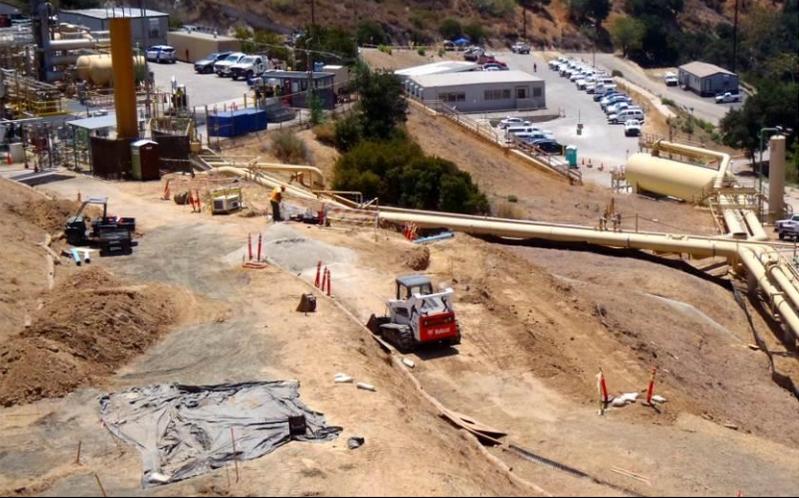
7/30/14	New Admin/IM Building

An aerial photograph of a construction site. In the foreground, a red skid steer loader is parked on a dirt path. To its left, a large grey tarp is spread on the ground. In the background, several large yellow pipes are being removed or repositioned. Further back, there are various construction materials, a parking lot with several cars, and a white building. The site is surrounded by dry, hilly terrain.	Pipeline removal continues as they prepare the site for grading.
7/30/14	Kiewit Parking/ Trailer Site

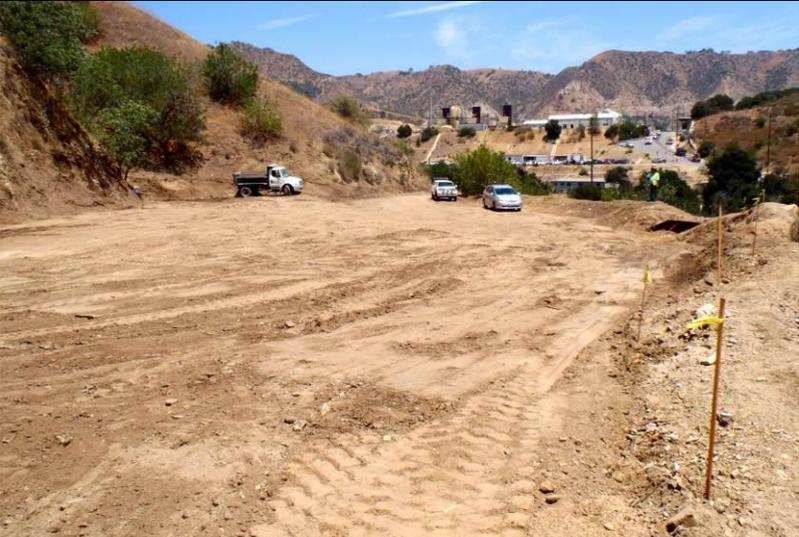
I observed the Kiewit trailer/parking area with Dave Lohr. Most of the soil had been either used to level the site or trucked to an existing pad near temporary trailer site #5. Dust control continued throughout the work and no soil was lost over the berms.

A ground-level photograph of a dirt pad. The ground is uneven and shows tire tracks. In the background, a white pickup truck and a silver car are parked. The site is bordered by a steep, dry hillside on the left and a parking area with several cars on the right. In the distance, there are buildings and hills under a clear blue sky.	Spreading and compaction of existing soil stockpiles began this week and will be completed very soon. Spoils were used to level the pad or were trucked to a location near temporary trailer location #5.
