### **Re: Monthly Report Summary #5 for Aliso Canyon Turbine Replacement Project**

## Aliso Canyon Turbine Replacement Project CPUC Site Inspection Form

Project:	Aliso Canyon Turbine Replacement	Date:	August 7, 2014
Project Proponent:	Southern California Gas Company and Southern California Edison	Report #:	VS018
Lead Agency:	California Public Utilities Commission	Project Phase/NTP:	Guard House and Road Widening Component (NTP-1), The New Admin/IM Building & P-43 Fill Site (NTP-2), New Kiewit trailer/parking location (MPR 04)
CPUC PM:	Andrew Barnsdale, Energy Division	AM/PM Weather:	Hazy and warm (77 to 81 degrees) with an intermittent light breeze (0 – 5 mph)
E & E CM:	Lara Rachowicz	Start/End time:	1230 hrs to 1400 hrs
Monitor(s):	Vince Semonsen		
Project Component(s):	CPUC Oversight: Guard House, New Admin/IM Building, Temp trailer sites, the Kiewit site, & P-43

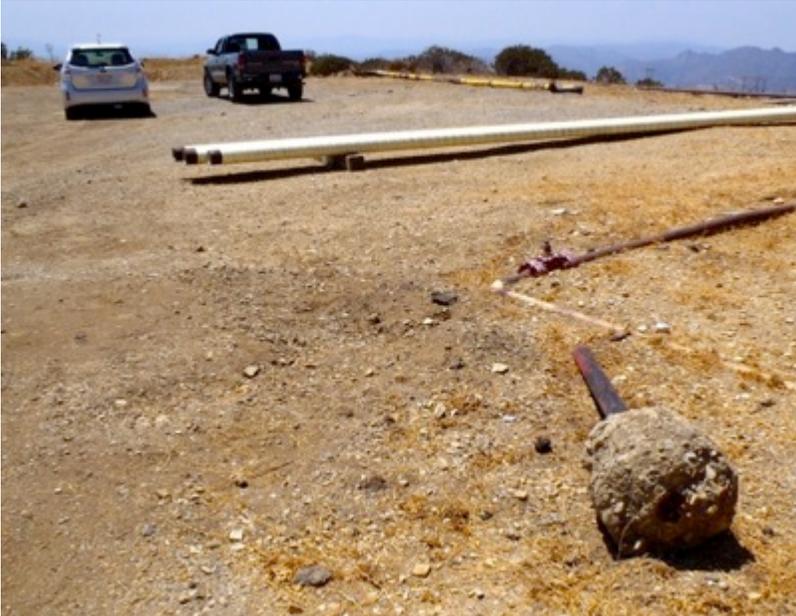
Date	Location	Photo	Description
8/7/14	PS-42 Fill Site

I met with Seth Rosenberg and Amandeep Singh to discuss the current construction activities. Following our meeting we all drove to the PS-42 site where Seth was asking for PUC/EnE approval for installing a bollard to protect an existing pipeline. The pipeline is within the pad to be used as a rock/boulder staging area, there is very little vegetation around the bollard location and the area had been previously disturbed during what looks to be the excavation of an old bollard – see photo.

<p>Rock/boulder stockpile area with existing pipe and valve that will require bollard protection. The bollard is proposed for the area near the 90-degree angle of the existing pipe.</p>
8/7/14	P-43 Fill Site

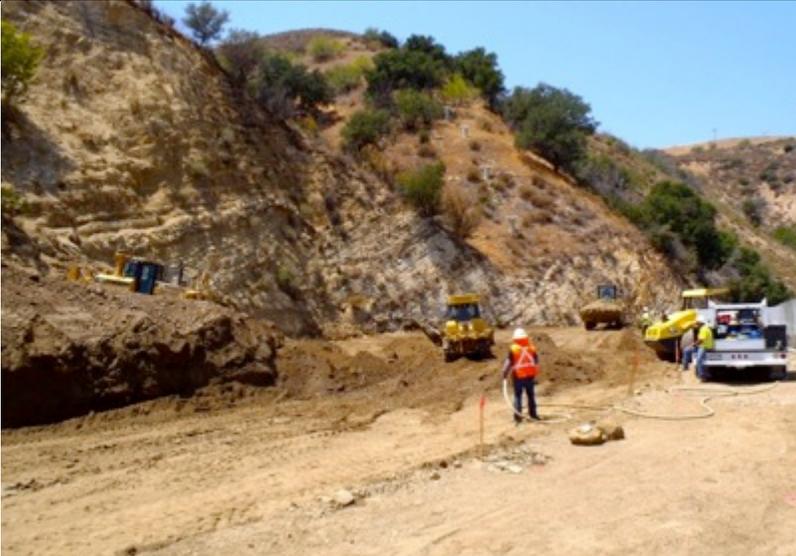
The excavation and compaction work at the P-43 site continues with 2 dozers, a loader, and a roller compactor working to prepare the fill site – see photo. Dust control (APM AQ-4) is not an issue as several crew members are using water hoses to wet down the soil to provide the proper moisture content to the soil. Archeological/Paleontological monitoring continues with Olivia Tierk (MM CR-1, MM CR-3, MM CR-6 & MM CR-8) spot checking the various work locations. Her focus was on the P-43 site and the drilling operation for the New Admin/IM Building. Biological monitors Juan Miranda and Dave Lohr were both onsite (APM BR-1d & APM BR-6) providing oversight at the numerous work locations.

<p>Earth work continues with 2 dozers, a loader and a vibrating compactor preparing the site for soil import.</p>

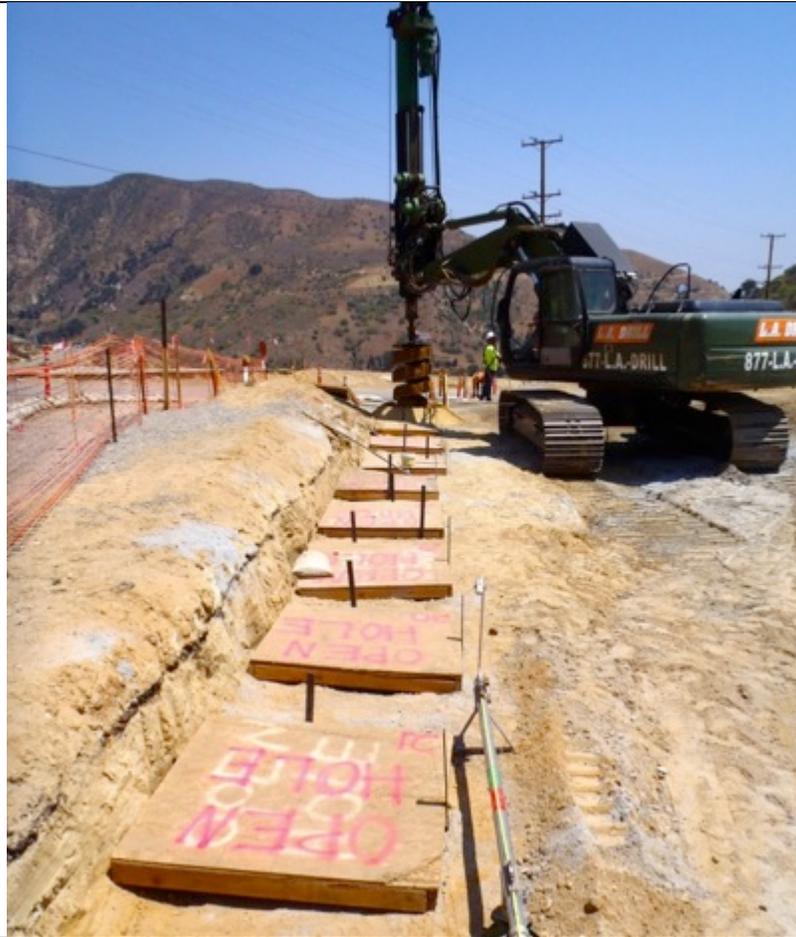
A drilling crew has begun work at the New Admin/IM Building location drilling holes for caissons that will support the roadway - see photo. A number of holes have been drilled down to a depth of 30+ feet. These holes are covered during the day and sealed at night to prevent animals from falling into them (APM BR-7). Dave Lohr said he checks the holes first thing in the morning using a flashlight to examine the bottom of each hole. Both Dave Lohr and Olivia Tierk were observing the drilling operation during the time of my site visit.

Caisson drilling is taking place along the existing roadway with at least 8 thirty-foot holes already dug. The holes are covered for safety reasons and to keep animals from falling in.

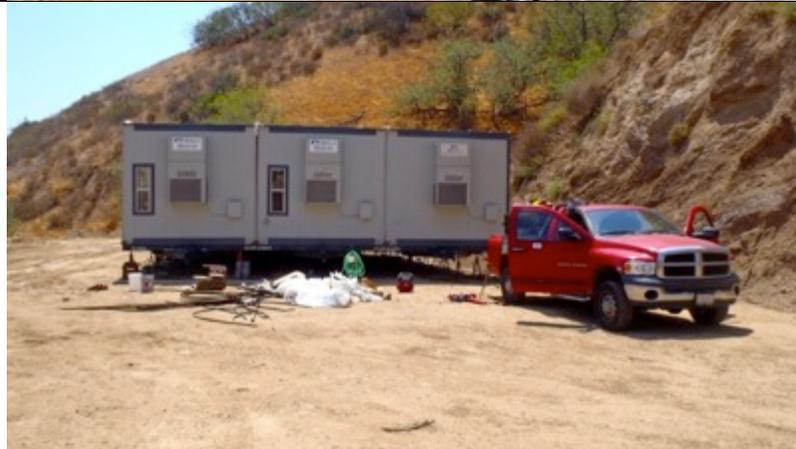
Kiewit Parking & trailer site

I looked over the Kiewit trailer/parking area where three of the four trailers have been brought in and are being set up. According to the Kiewit representative onsite some additional work is still needed for the drainage inlet along the edge of the pad.

Site preparation has been completed and three of the four trailers are being installed.

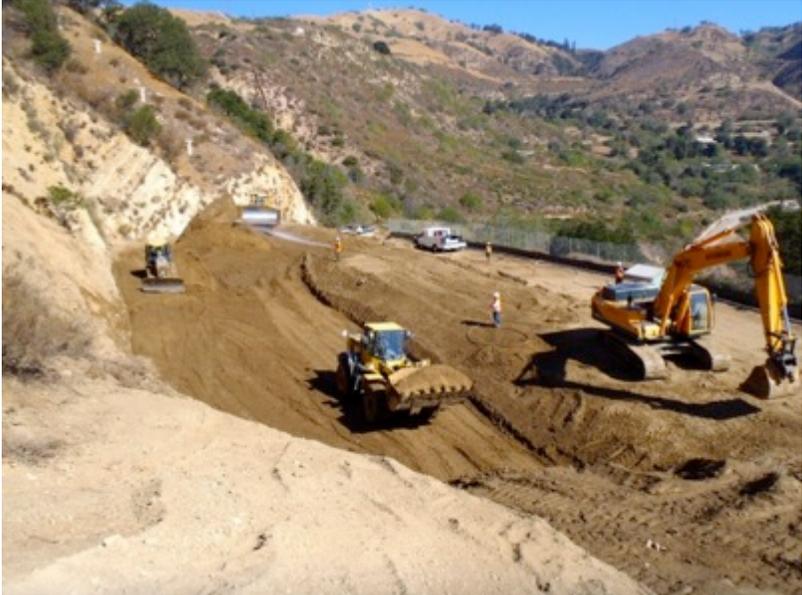
Date	Location	Photo	Description
8/13/14	P-43 Fill Site

The excavation and compaction work at the P-43 site continues with equipment working to prepare the fill site for soil import – see photo. Dust control (APM AQ-4) is ongoing at the site and the work is being overseen by Biological monitor Juan Miranda (APM BR-1d & APM BR-6) and Archeological/Paleontological monitor Olivia Tierk (MM CR-1, MM CR-3, MM CR-6 & MM CR-8). Both monitors felt that the contractors have been very cooperative and the communication between all parties has been good.

<p>Earthwork continues with equipment compacting the bench in preparation for its use as a fill site.</p>
8/13/14	New Admin/IM Building

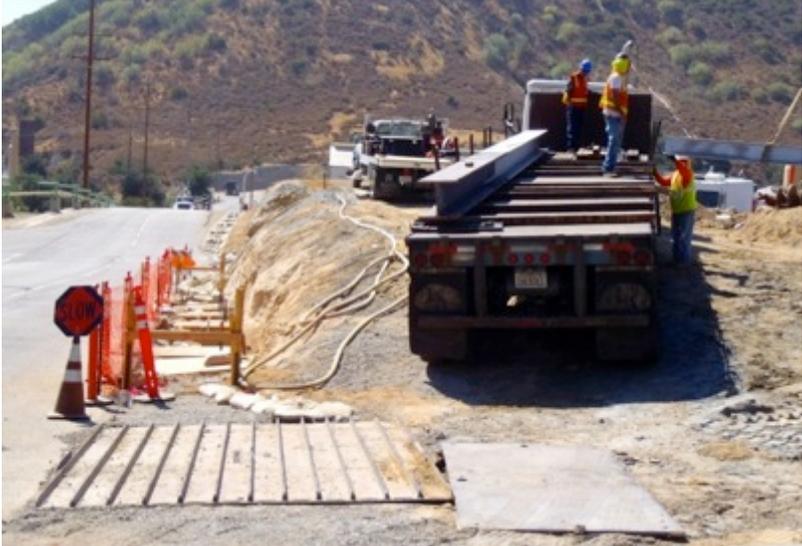
A drilling crew continues to work at the New Admin/IM Building location drilling holes for caissons that will support the roadway - see photo. At the time of my site visit the crew was off-loading steel I-beams at the site. The holes remain covered during the day and sealed at night to prevent animals from falling into them (APM BR-7). Biological monitor Jose Lopez is onsite, providing oversight monitoring for the work here and at the other work locations.

<p>Caisson drilling continues with steel I-beams being brought to the site.</p>
8/13/14	Kiewit Parking & trailer site

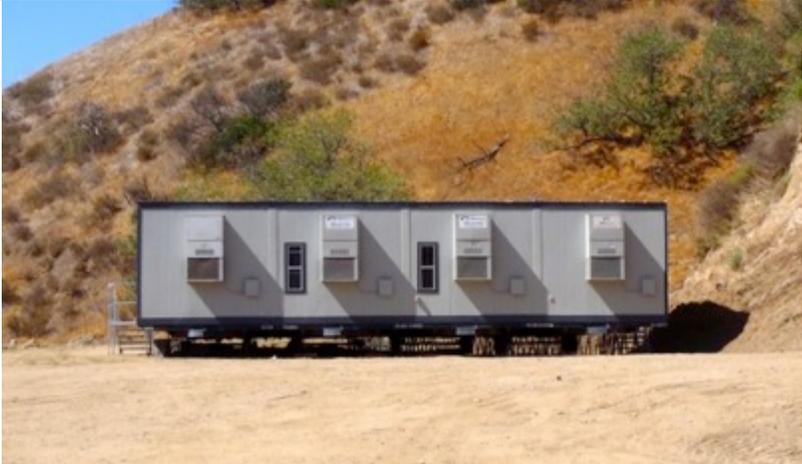
I looked over the Kiewit trailer/parking area where all four of the trailers are in and are being set up – see photo. I also drove by the temporary trailer locations where parking striping is underway, and finally I checked the new storage container location where a number of storage containers have now been installed. Everything looked satisfactory.

<p>All four trailers have been brought in and are being installed.</p>

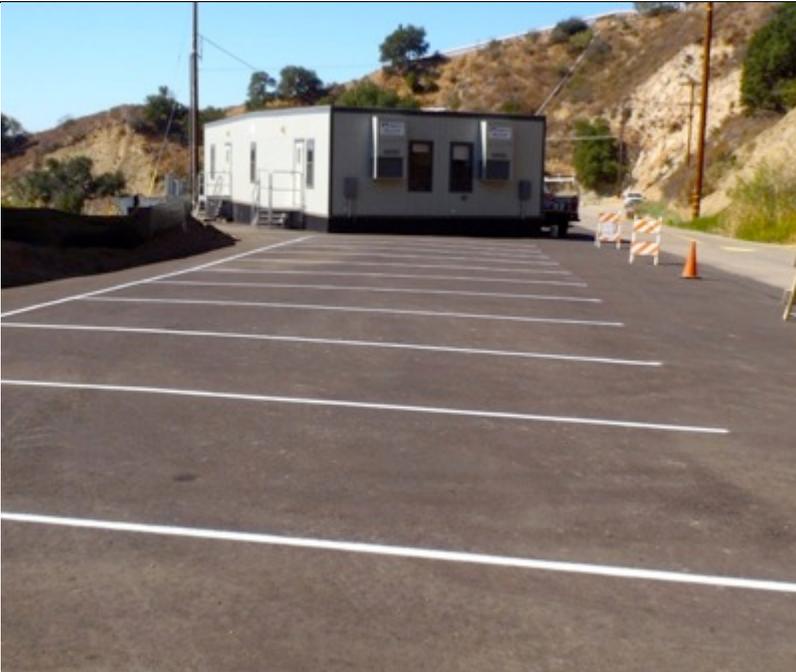
<p>8/13/14</p>	<p>Temporary trailer site #5</p>

<p>Road striping and final preparation of the temporary trailers is ongoing.</p>
<p>8/13/14</p>	<p>New Storage Container location</p>

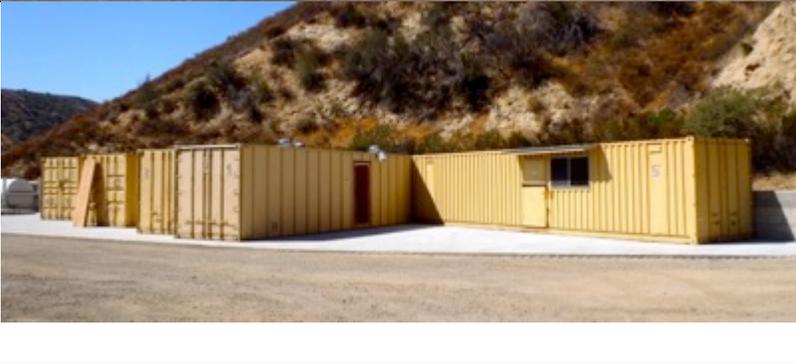
<p>Storage units have been brought into the new location – no construction activity</p>

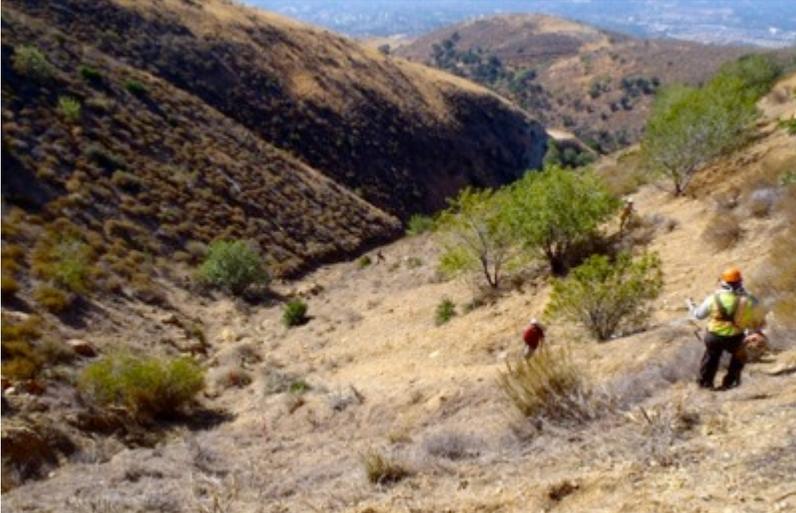
Date	Location	Photo	Description
8/21/14	PS-42 Fill Site

I talked with Amandeep Singh and Johnny Grady about current construction activities and then drove to PS-42 where a crew is removing vegetation within the approved fill site – see photo. The area to be cleared had been delineated with flagged stakes (APM BR-1b) and nesting bird surveys had been conducted earlier in the week (APM BR-1a & APM BR-1c). All the crew have been trained (APM HZ-6) but did not have hard hat stickers. It was explained to me that crews wear orange hard hats when hand-clearing vegetation, and the stickers don't adhere well to those helmets. Biological monitor Juan Miranda (APM BR-1d & APM BR-6) was onsite with the clearing crew but had not seen any nesting birds or any wildlife other than an alligator lizard.

Brush clearing at the PS-42 fill site.
8/21/14	P-43 Fill Site

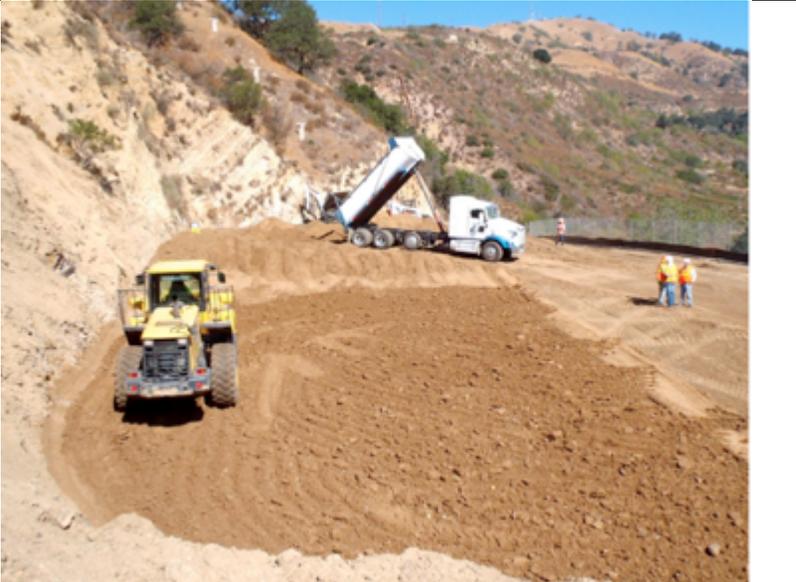
At the P-43 site, soil is being brought in from the New Admin/IM Building location using dump trucks that are covered while in transit. The dirt is dumped, watered, and compacted – see photo. This area is being spot-checked by the monitoring crew, but none of the AECOM crew were onsite during my site visit.

Soil is being brought to the site - it is dumped, spread and compacted.
8/21/14	New Admin/IM Building

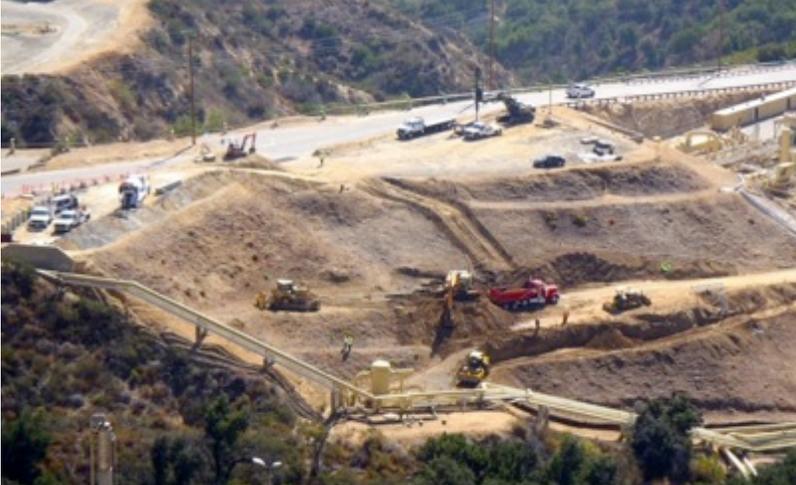
View of the New Admin/IM Building Area from the P-43 fill site.

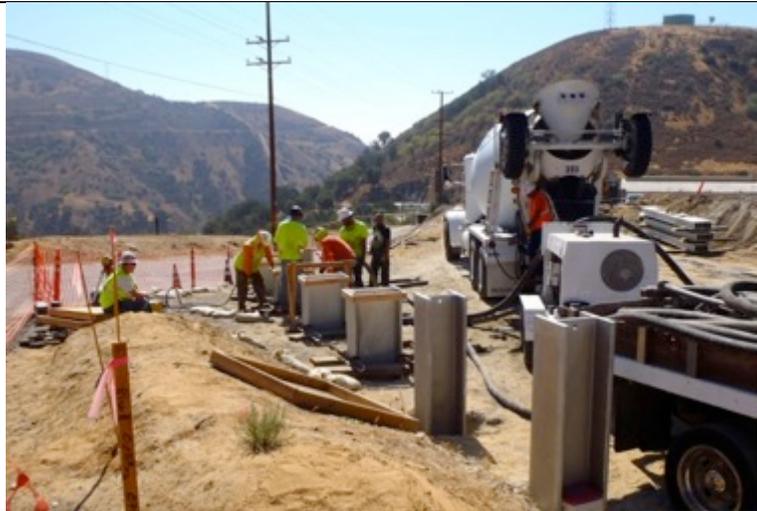
New Admin/IM Building

Steel I- beams are being set.

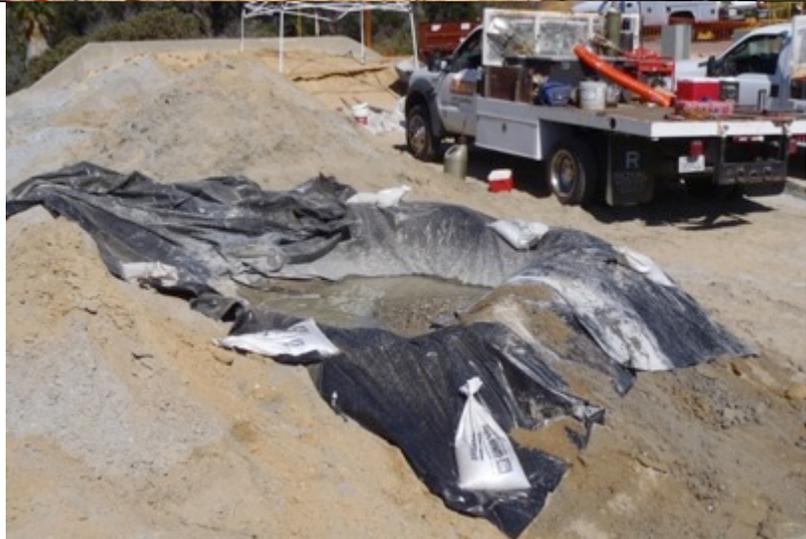
New Admin/IM Building

Concrete trucks are washing out in a plastic lined basin built in the spoil piles.

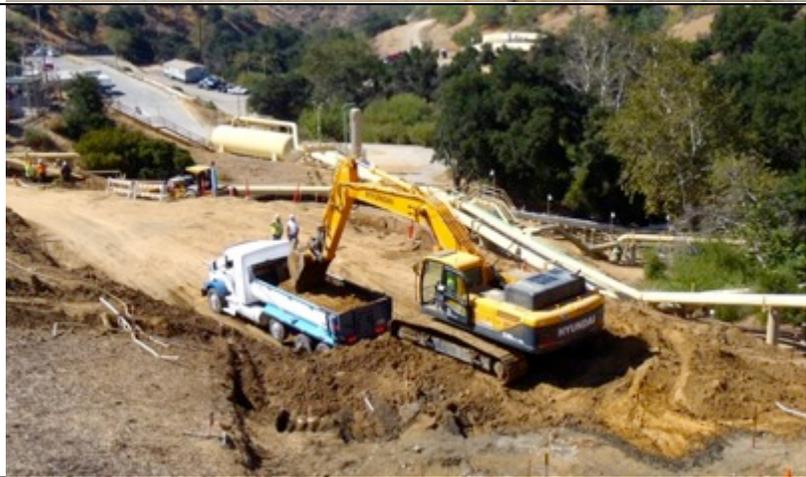
New Admin/IM Building

Excavator filling dump trucks for transport up to the P-43 fill site.

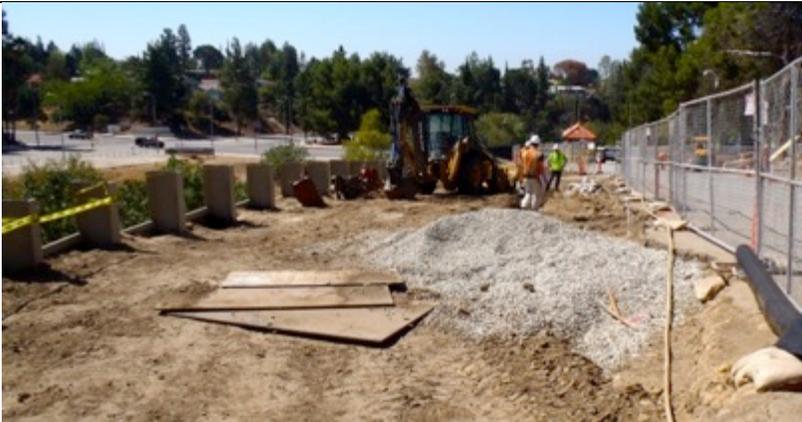
Guard House

At the guard house construction area, crews were working to fill in a shallow conduit trench. I observed no fugitive dust or dirt on the roadway (APM AQ-7) – see photo. A new biological monitor, Eric Dugan, is overseeing the guard house work. He was WEATP-trained that morning.

Crews are filling a shallow trench.

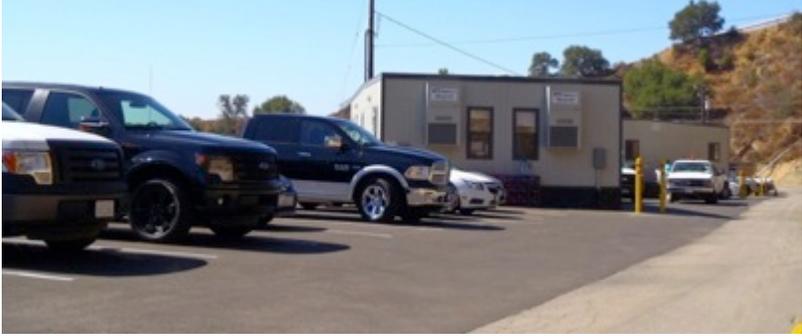
Temporay Trailer Location

Vehicles are now parking at the temporary trailer locations and using the facilities.

Vehicles are now parking at the trailers.

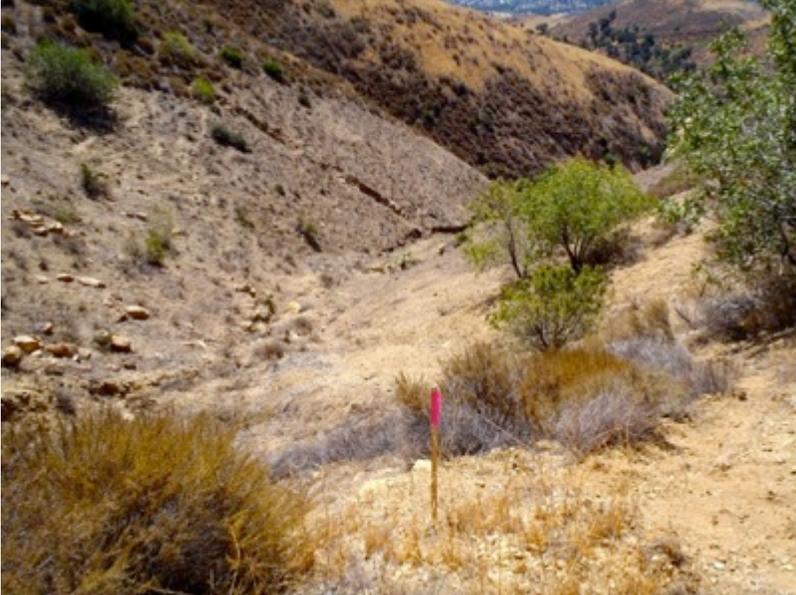
Date	Location	Photo	Description
8/28/14	PS-42 Fill Site

Brush clearing at the PS-42 fill site.
8/28/14	P-43 Fill Site

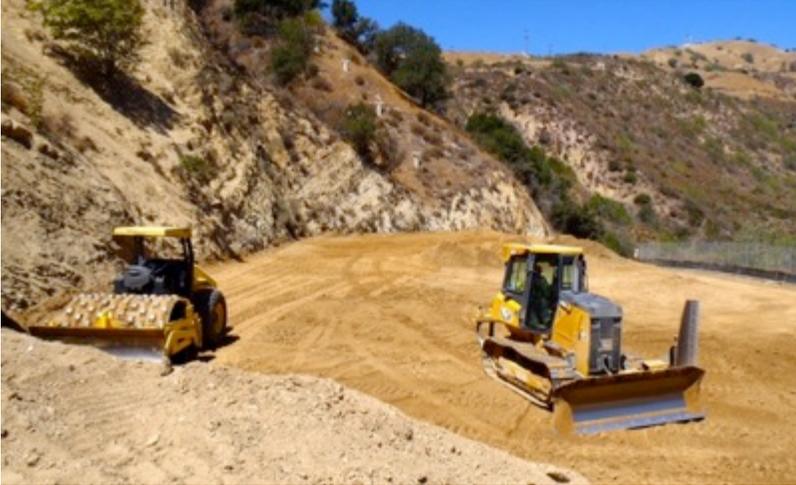
Soil continues to be brought to the site - it is dumped, spread and compacted.
8/28/14	New Admin/IM Building – Leach field

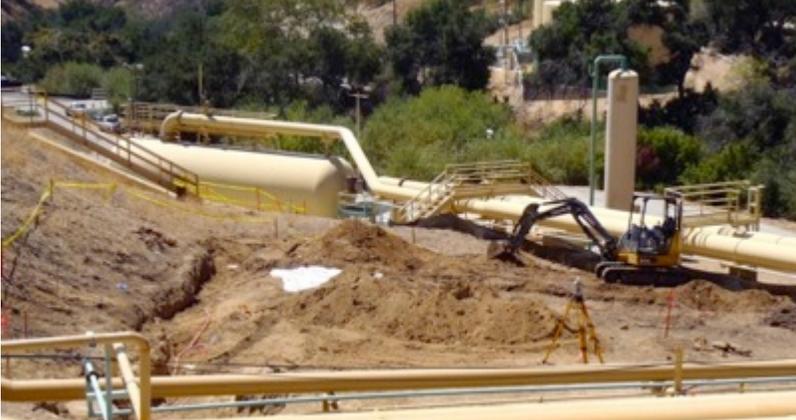
A view of the leach field work area.

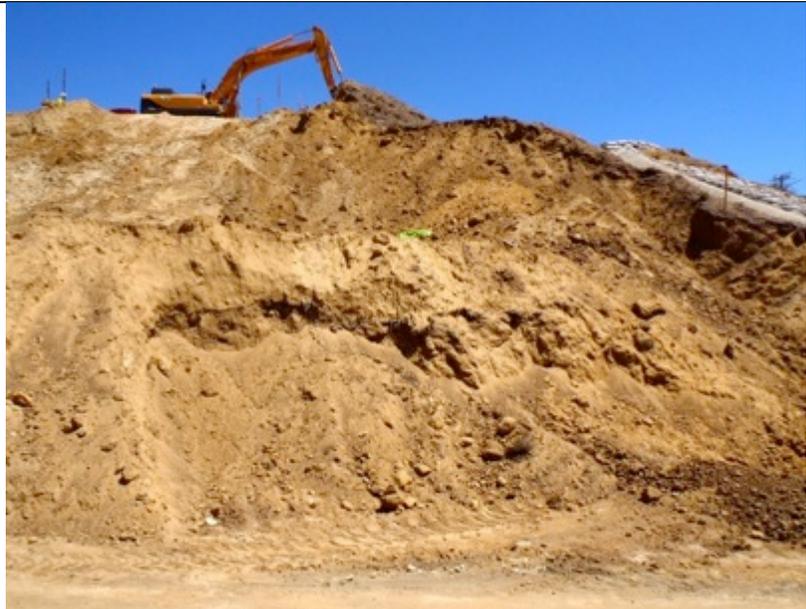
New Admin/IM Building

An excavator continued to load dump trucks with dirt for transport to the P-43 fill site.

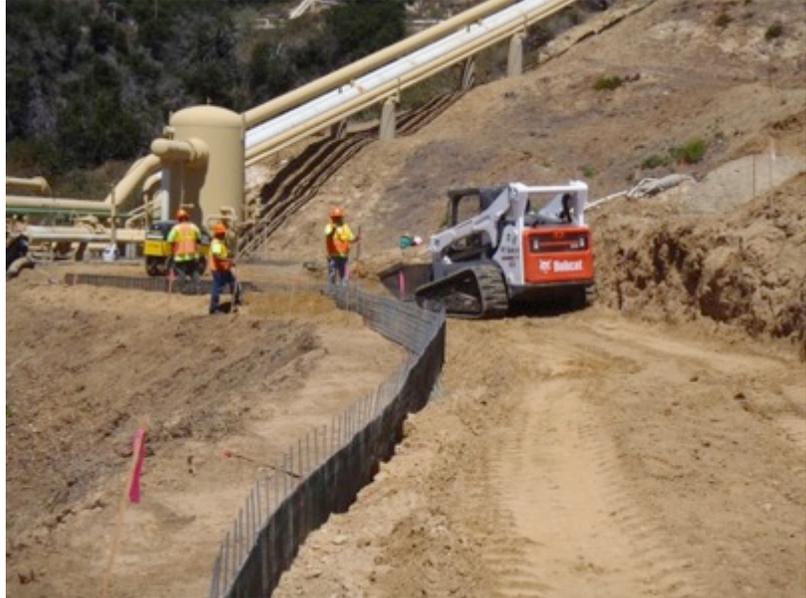
New Admin/IM Building

Crews are working on building a roadway.

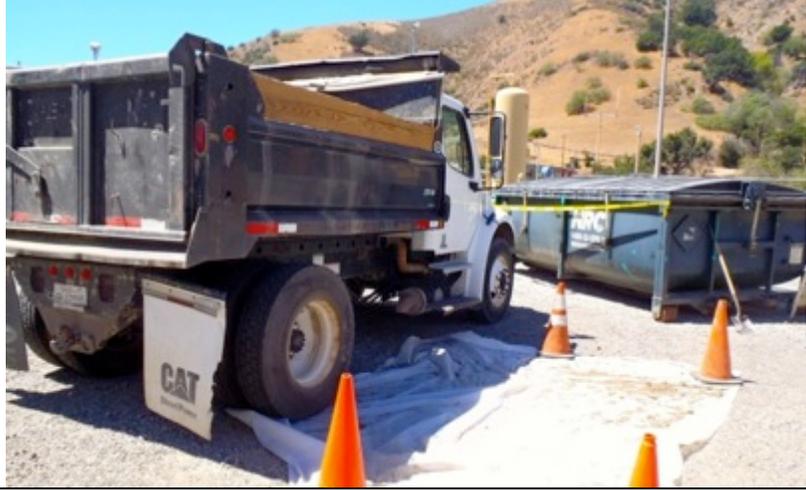
New Admin/IM Building

Some "tainted/discolored" soil was found and removed. It was placed in a special dumpster and dump truck.

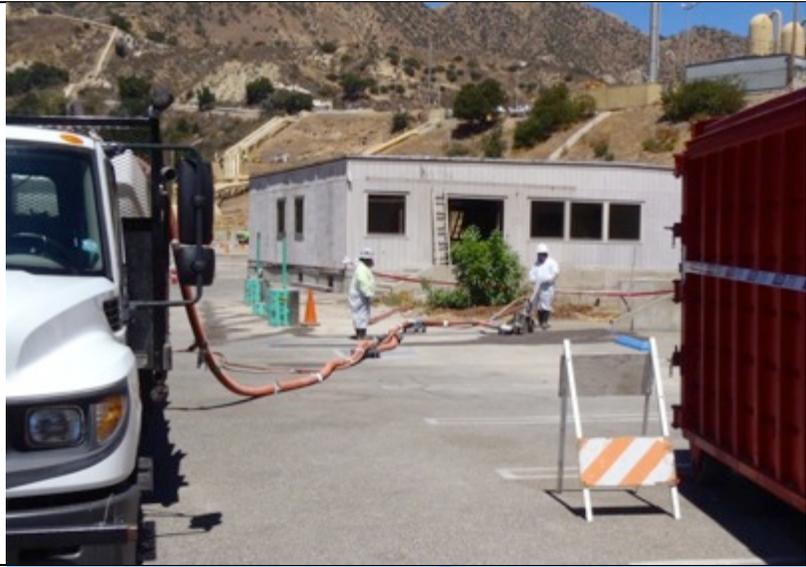
Main office  
& Existing  
trailers

Crews are dismantling  
and cleaning up the  
old existing trailers.

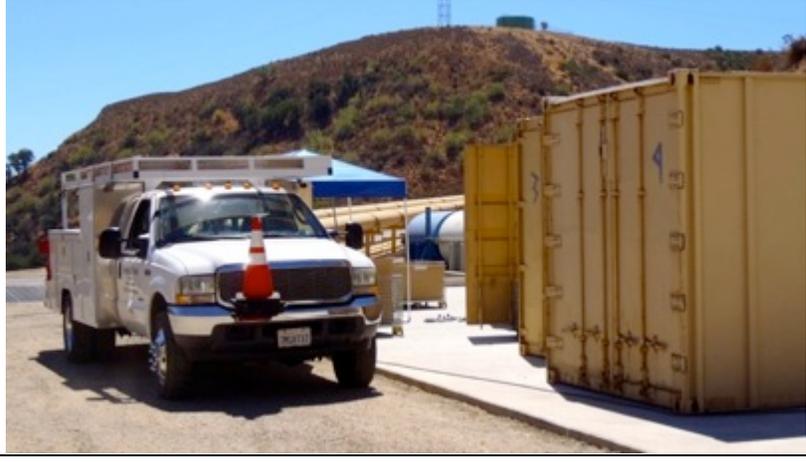
New  
Storage  
Location

Some electrical work  
taking place at the  
storage location.
