**Re: Monthly Report Summary #8 for Aliso Canyon Turbine Replacement Project**

## Aliso Canyon Turbine Replacement Project CPUC Site Inspection Form

Project:	Aliso Canyon Turbine Replacement	Date:	November 6, 2014
Project Proponent:	Southern California Gas Company and Southern California Edison	Report #:	VS030
Lead Agency:	California Public Utilities Commission	Project Phase/NTP:	Guard House and Road Widening Component (NTP-1). The New Admin/IM Building (NTP-2) and the CCS Site (NTP-3). P-41 and P-43 fill sites (NTP-2), PS-42 Fill Site & the PS-42 rock site and temporary fill site. PS-32 fill site (NTP-3). Natural Substation (NTP-3, NTP-A)
CPUC PM:	Andrew Barnsdale, Energy Division	AM/PM Weather:	Clear and breezy (3 to 5 mph) with mild temperatures (71 degrees). No change during the site visit.
E & E CM:	Lara Rachowicz	Start/End time:	0745 hrs to 1100 hrs
Monitor(s):	Vince Semonsen		
Project Component(s):	CPUC Oversight: Guard House, New Admin/IM Building, P-41, PS-42, P-43 and PS-32 (SCG). Natural Substation (SCE and SCG).

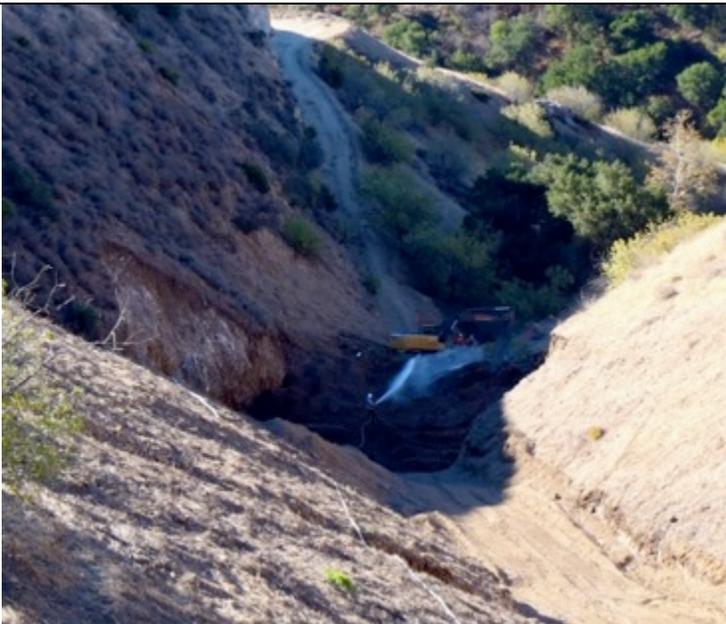
At the PS-42 fill site equipment continues to work on the first fill key at the bottom end of the site – see photo. Straw wattles remain stockpiled at the top of the site - no erosion control measures have been installed within the fill site.

Work continues on the fill key at the bottom of the PS-42 fill site.
11/06/14	Natural Substation Access Rd.

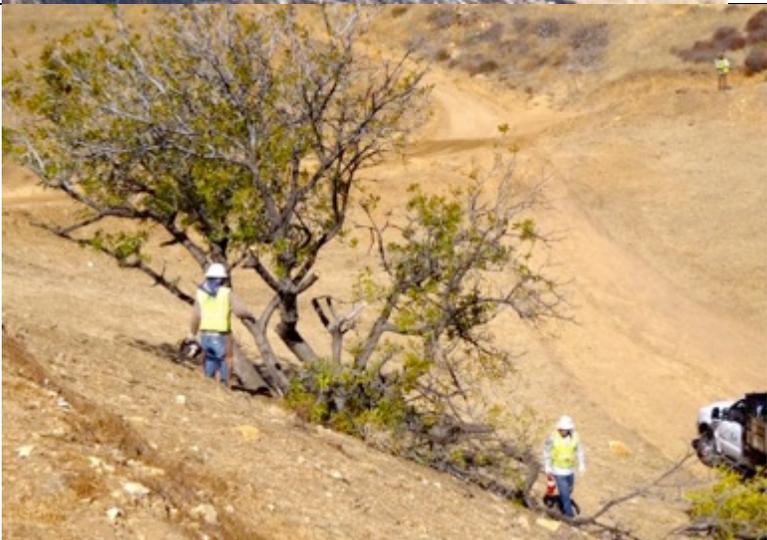
Vegetation clearing continues along the Natural substation access road with removal of the walnut trees starting today – see photo. Able (Quality Ag crew foreman) said he expects to have a crew onsite through next week.

Quality Ag is clearing vegetation within the new Natural substation access road – they are removing the walnut trees.
11/06/14	Natural substation

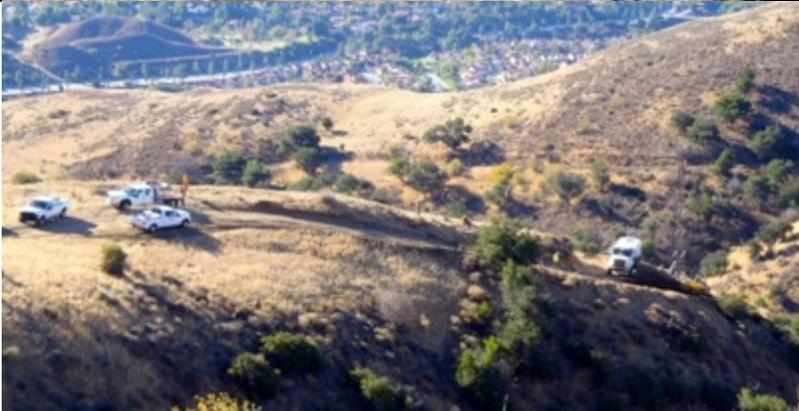
SCE crews cutting access road and preparing the pad for the TSP 49 installation work.

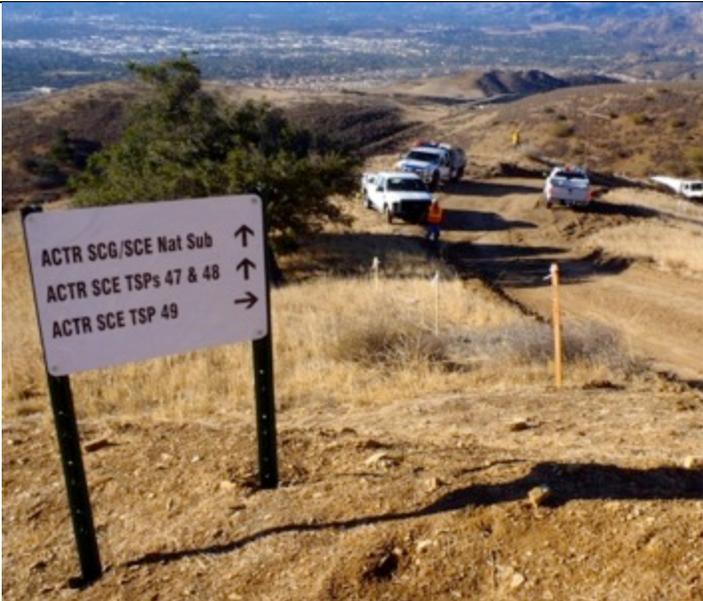
<p>Signage installed along the roadways.</p>
<p>11/06/14</p>	<p>Natural Substation</p>

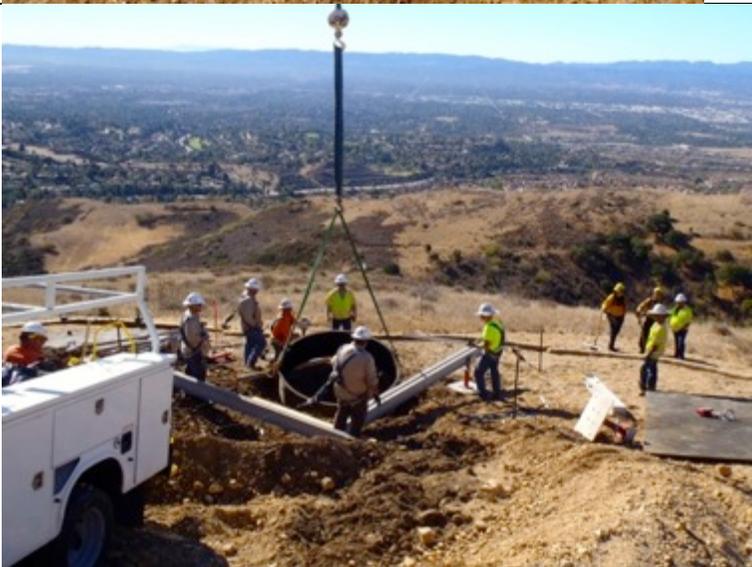
<p>SCE crews preparing to pour the foundation for TSP 48.</p>
<p>11/06/14</p>	<p>Natural Substation</p>

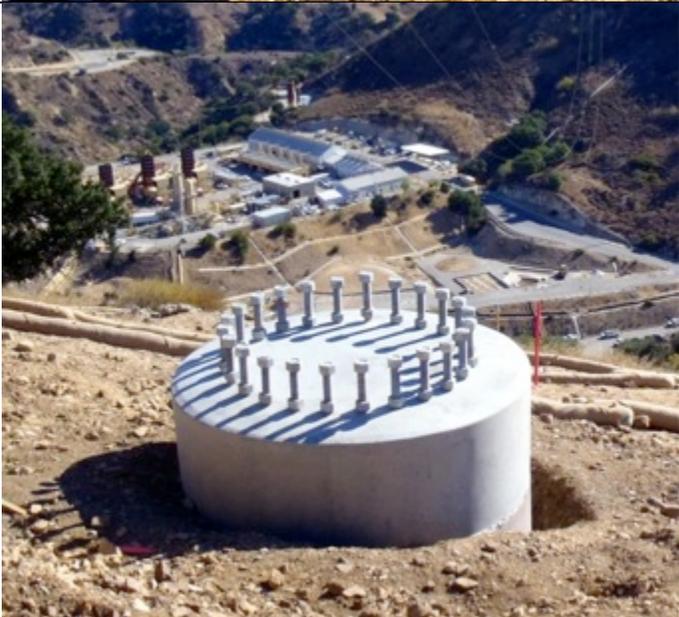
<p>TSP 47 foundation</p>

The TSP 47 foundation has been poured and is ready for the pole installation – see photo. Lastly, the road signs directing traffic to all the SCE sites have now been installed throughout Aliso canyon.

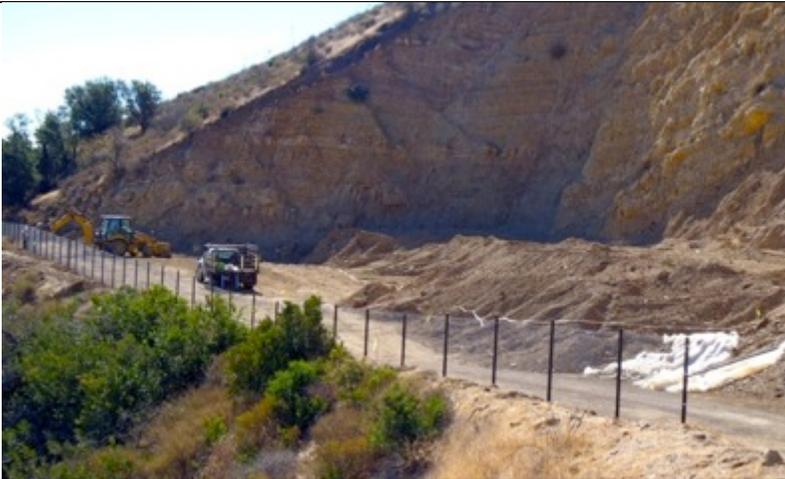
At P-41 a crew continues to install the chain link fence - see photo. Olivia Tierk the Arch/Paleo monitor (MM CR-1, MM CR-3, MM CR-6 & MM CR-8) is spot checking all of the SCG project activities.

A crew continues to work on the chain link fencing.
11/06/14	P-43

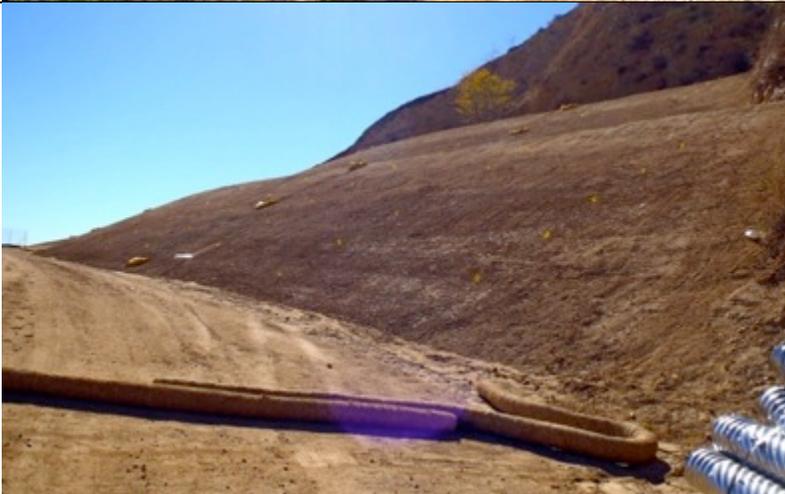
At P-43 the dirt work appears to be nearly complete; final restoration will occur once all dirt work on the fill site is complete – see photo.

Fill material at P-43 ready for restoration and reseeding.
11/06/14	New Admin/IM Building

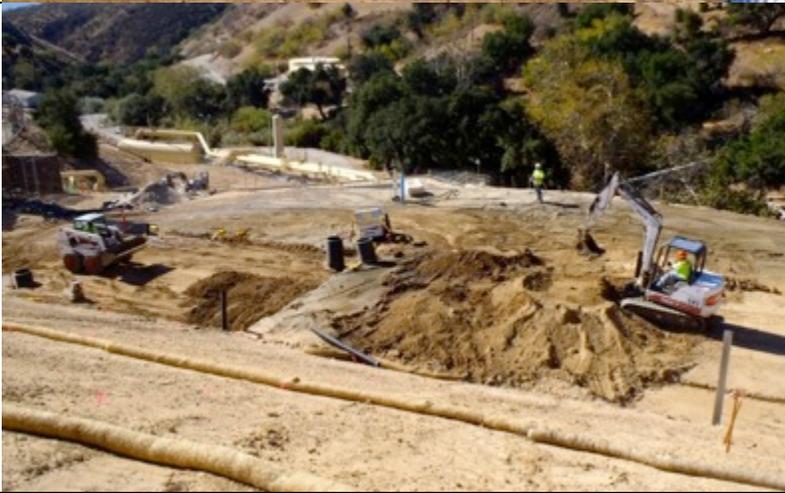
Dirt work for the Bio-filtration feature.

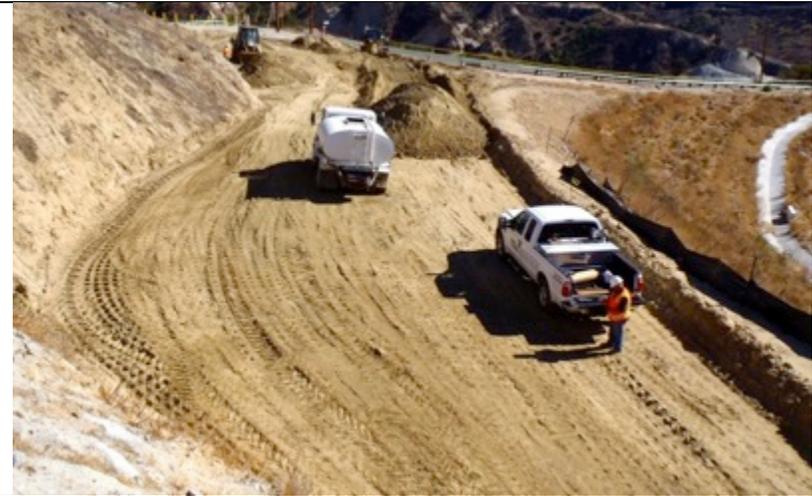
At the PS-32 fill site a crew is working on compaction and testing of the existing fill material – see photo.

Crews continue to work the PS-32 site to prepare it for accepting fill material.
----------	-----------------	--	--

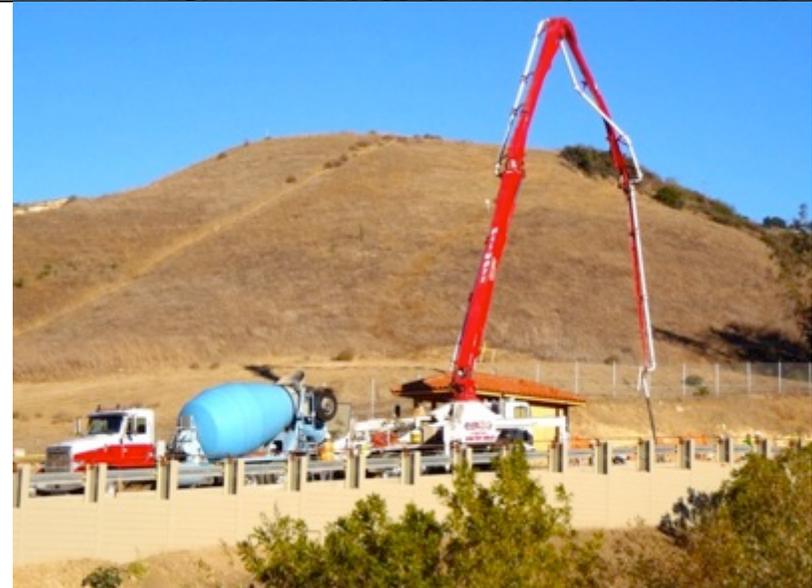
The roadway is being poured with a pumper truck onsite and concrete trucks coming regularly.
----------	-------------	---	--

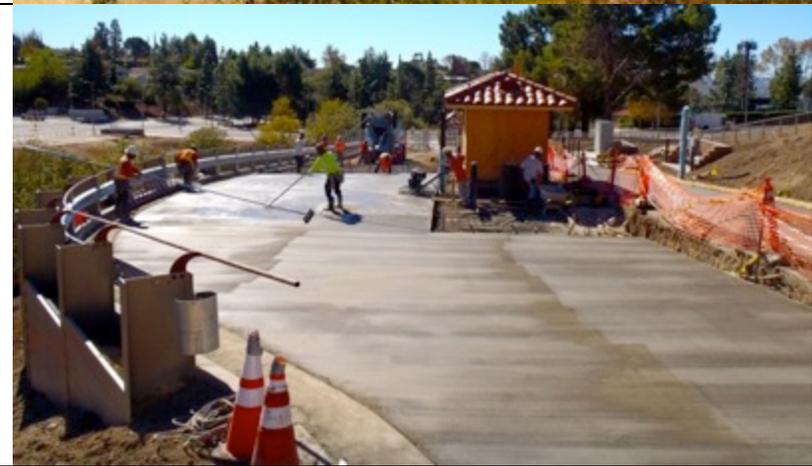
The new roadway is being poured around the new guard house.
----------	-------------	--	---

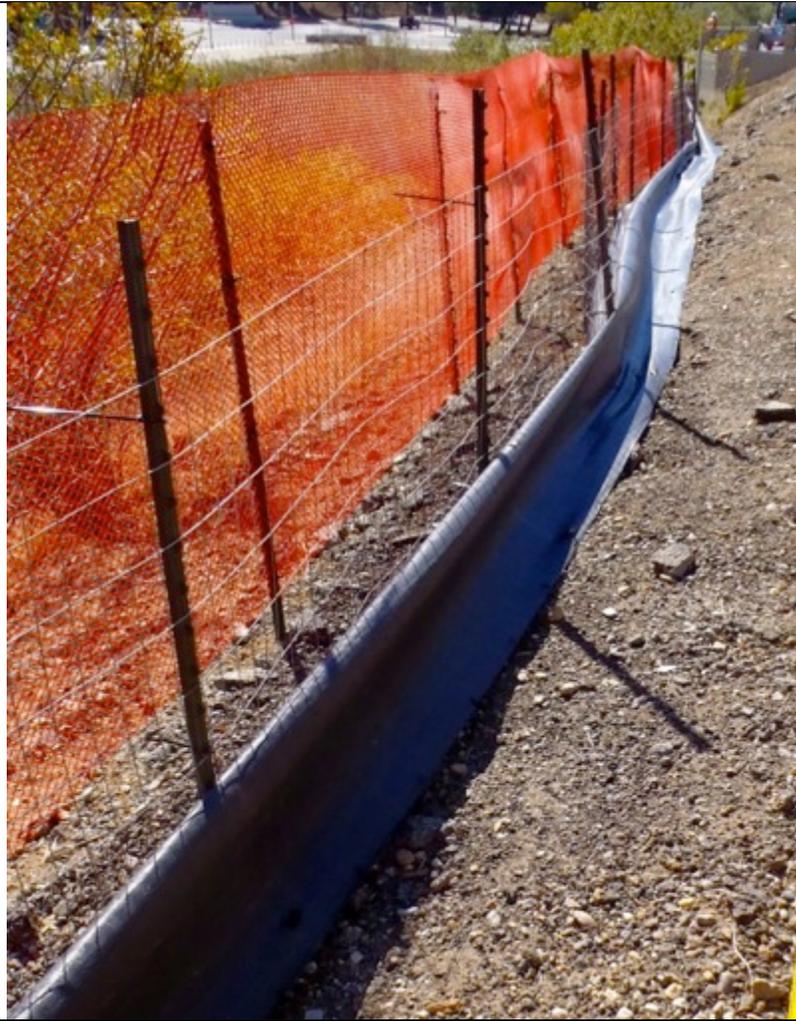
Finally, at the guard house a crew is pouring the roadway, with a pumper truck onsite and concrete trucks coming and going – see photos. The site looks good although some of the silt fencing is in need of some repair.

Silt fencing between Limekiln creek and the guard house.

Silt fencing at the guard house has been repaired.

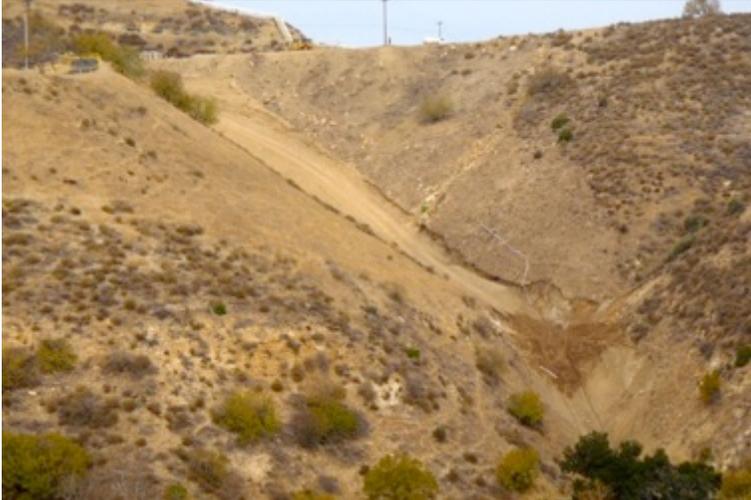
View of the PS-42 fill site looking east back toward the site from across the arroyo.
11/13/14	PS-42 Fill Site

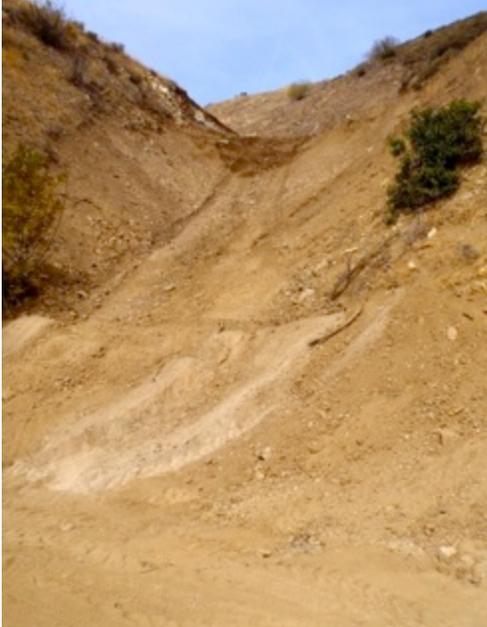
Looking up at the PS-42 fill key (dark soil) from the lower access road.
11/13/14	PS-42 Fill Site

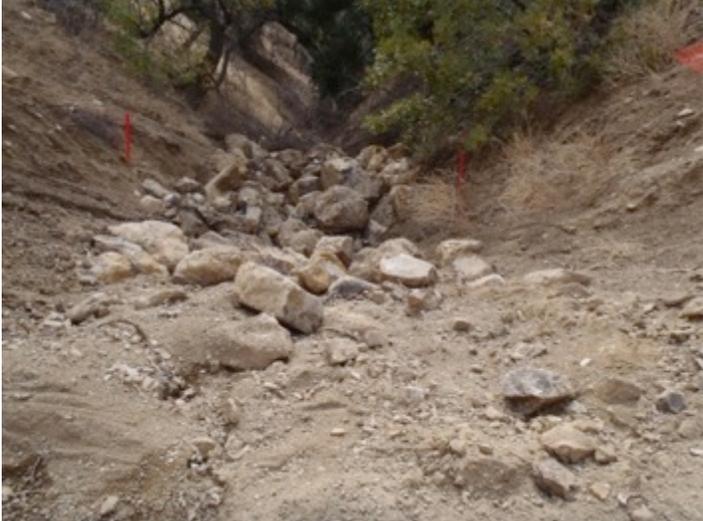
Riprap placed in the valley just below the lower access road.

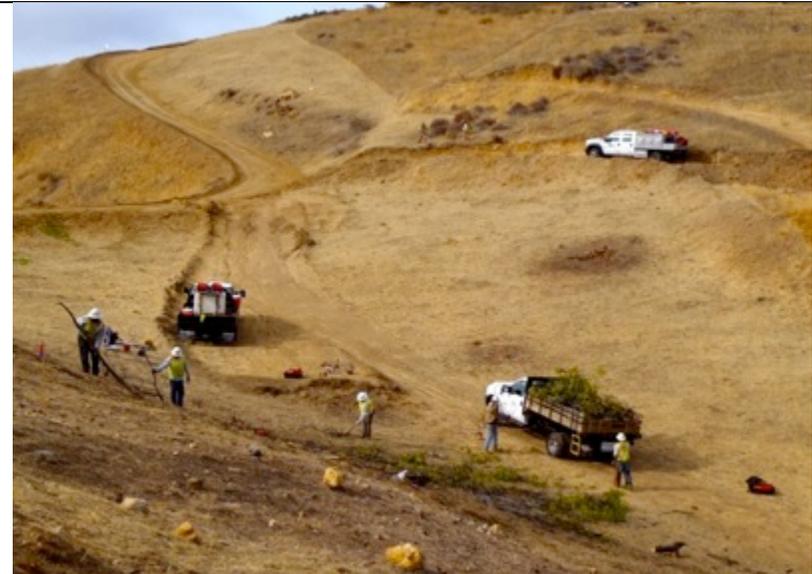
<p>Quality Ag continues to clear vegetation within the new Natural Substation access road – they have just finished removing the walnut trees.</p>
<p>11/13/14</p>	<p>Natural Substation</p>

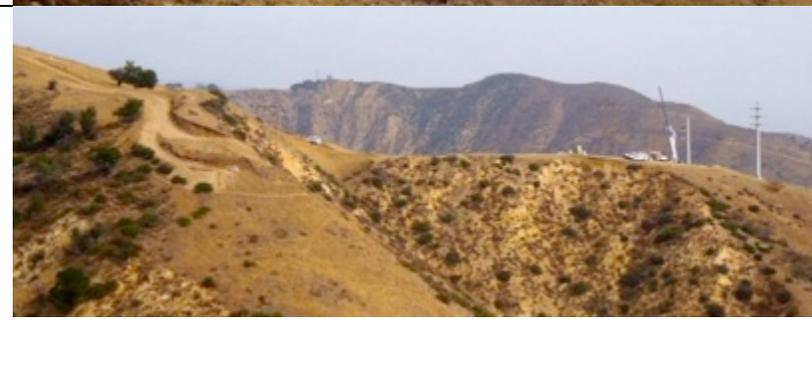
<p>SCE work at TSP 49 and the Natural Substation - looking east back toward the site from across the arroyo.</p>
<p>11/13/14</p>	<p>Natural Substation</p>

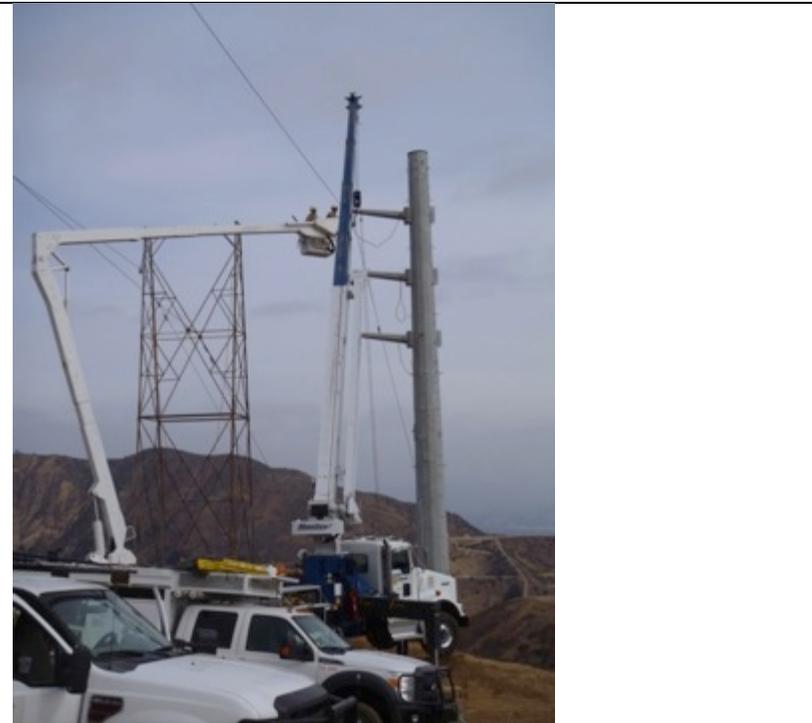
<p>SCE crews moving lines to the newly installed TSP 47.</p>

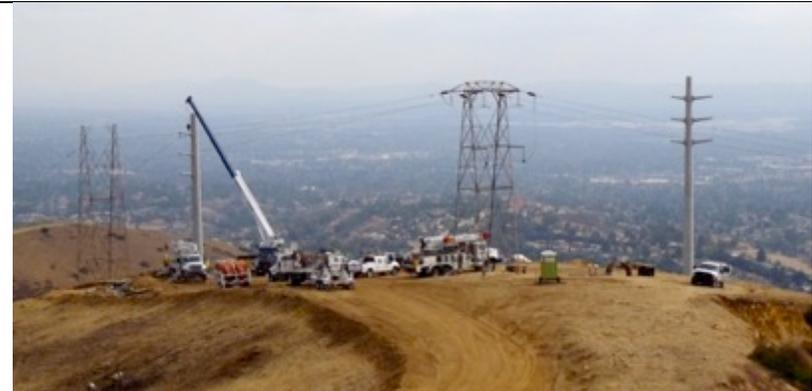
The TSP work continued at the Natural Substation. TSPs 47 and 48 have been installed, and the foundation has been poured for TSP 49 – see photo. I talked with Ray (SCE foreman) about when they would set TSP 49 and he said they are waiting on the concrete testing. Crews are working on moving wires to the new poles and have begun dismantling one of the old structures – see photos.

TSPs 47 & 48 have been installed – lines are being restrung and one of the old towers is being dismantled.
11/13/14	Natural Substation

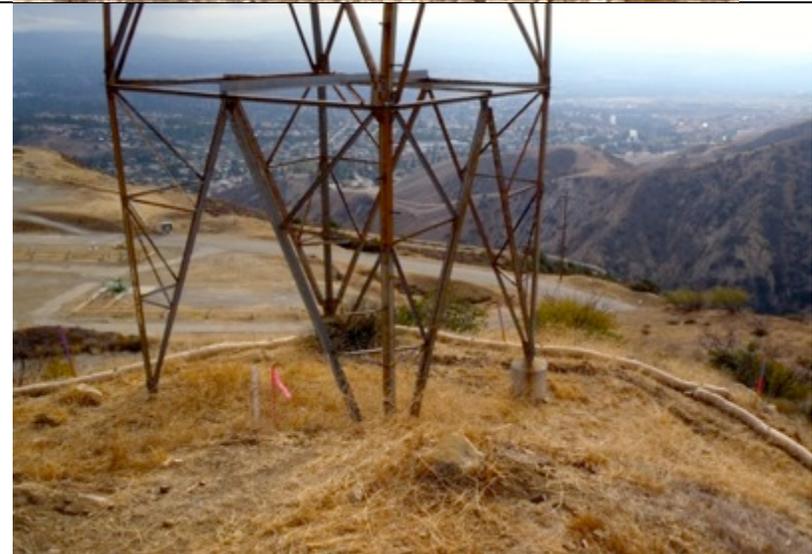
The TSP 45 site has been surveyed and straw wattle installed. Topsoil is to be salvaged prior to any earthwork.

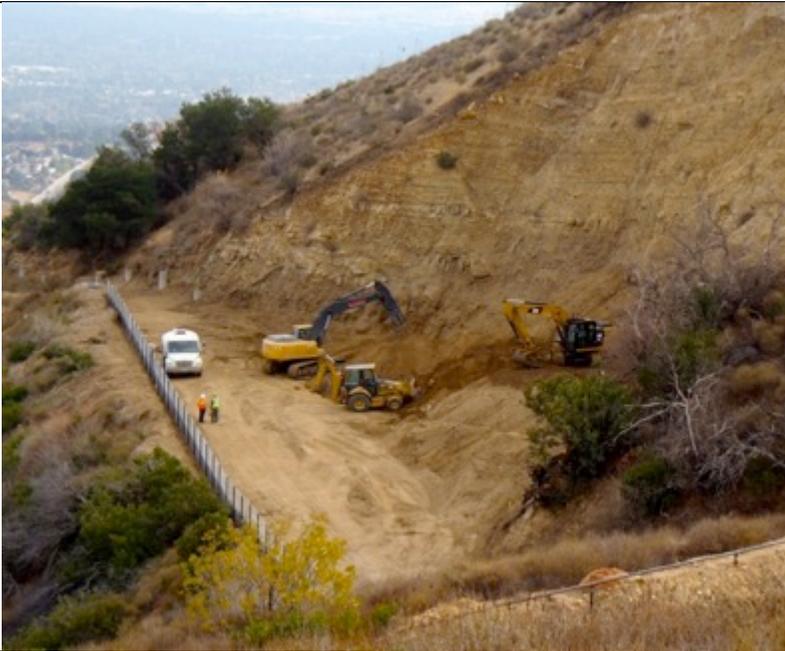
At P-41, the chain link fence has been installed and equipment is working on the loose spoil - see photo. Olivia Tierk, the SCG Arch/Paleo monitor (MM CR-1, MM CR-3, MM CR-6 & MM CR-8), is spot-checking project activities.

<p>The fence has been completed and a crew is working on stabilization of the loose dirt at the site.</p>
<p>11/13/14</p>	<p>New Admin/IM Building</p>

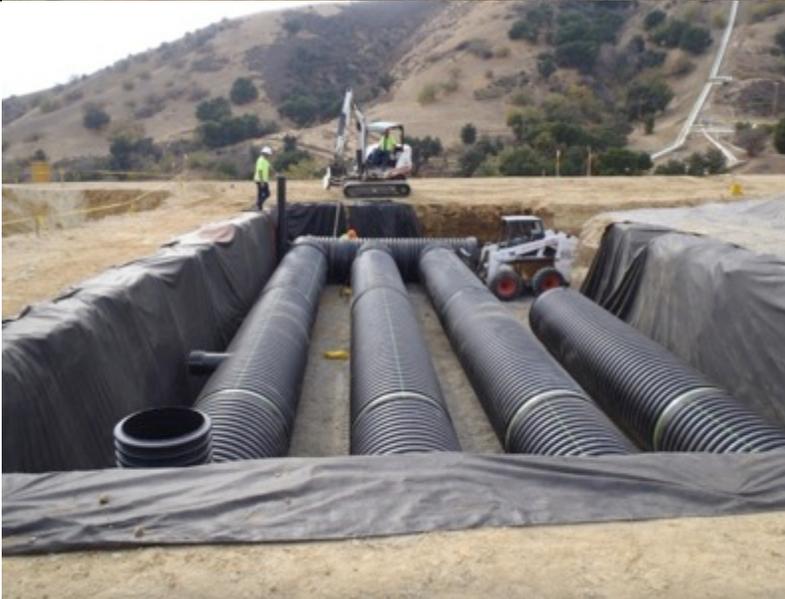
<p>Installation of the underground infrastructure for the bio-filtration feature.</p>
<p>11/13/14</p>	<p>Central Compressor Station</p>

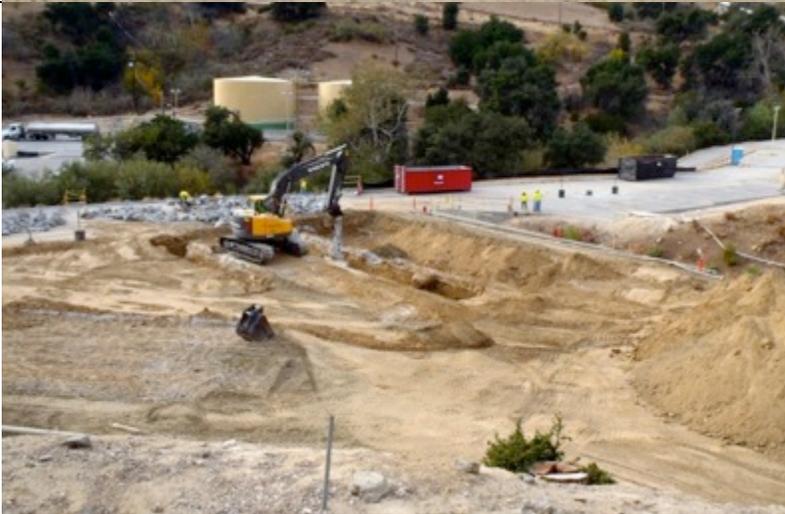
<p>An excavator is breaking up and removing concrete from the project site.</p>

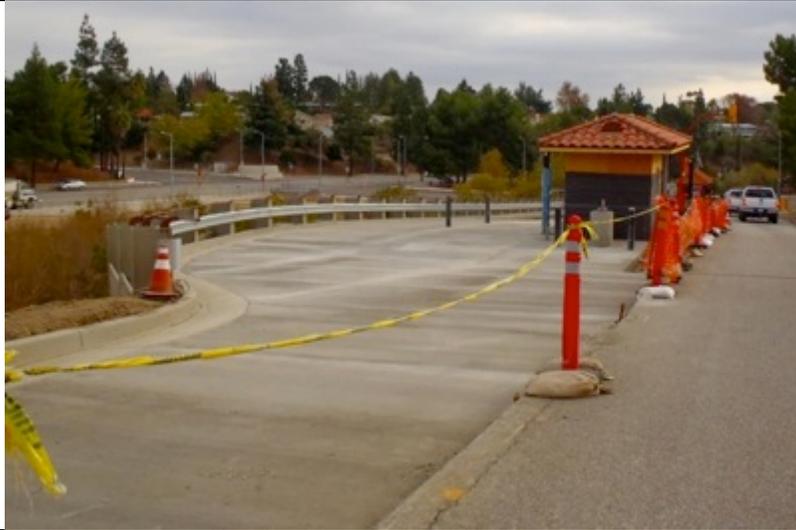
The new roadway has been poured around the new guard house.

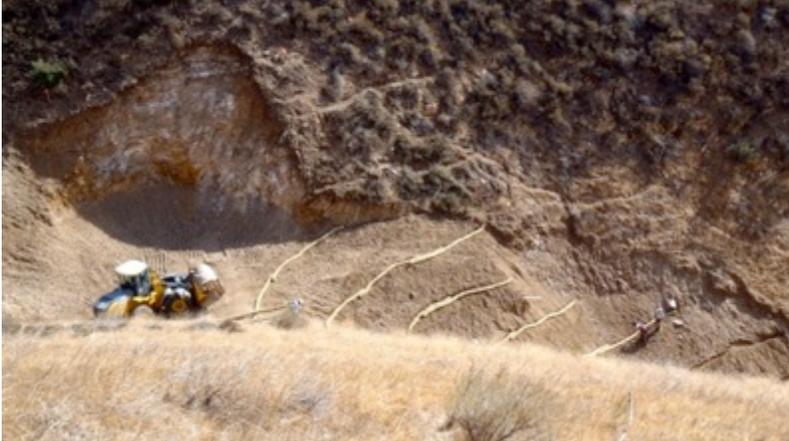
View looking down into the PS-42 fill site with the fill key on the left and the BMP installation taking place on the slope below the fill key.
11/19/14	PS-42 Fill Site

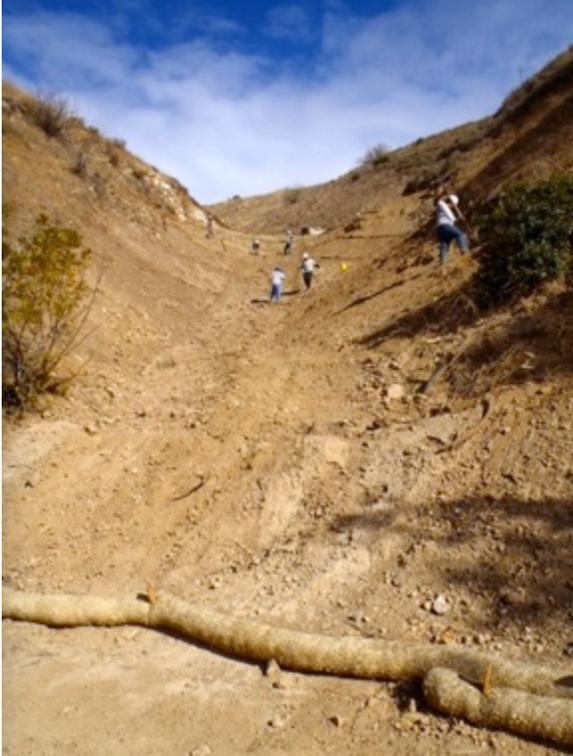
Looking up at the PS-42 fill key from the lower access road. A crew is installing BMPs on the slope below the fill key.
11/19/14	PS-42 Temporary Fill Site

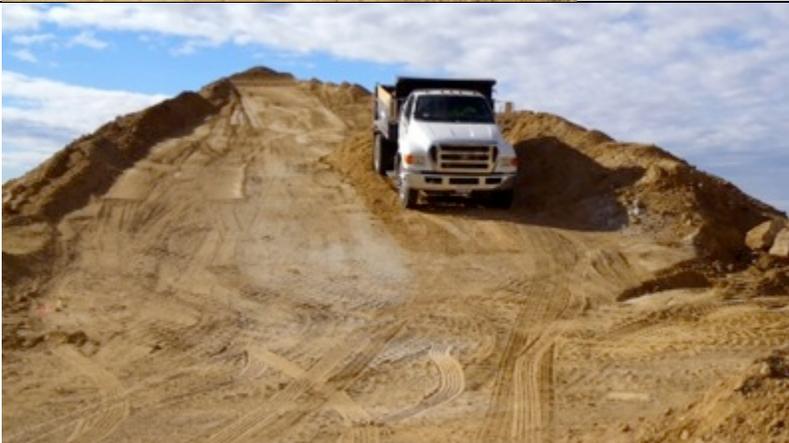
Rock and dirt is still being brought to the temporary fill site from the P-43 site.

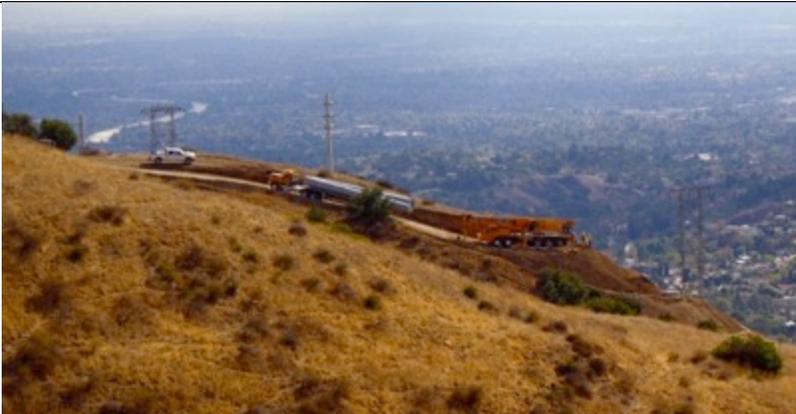
Work at TSP 49 where a crane is setting up in preparation for installing the TSP 49 pole.
11/19/14	Natural Substation

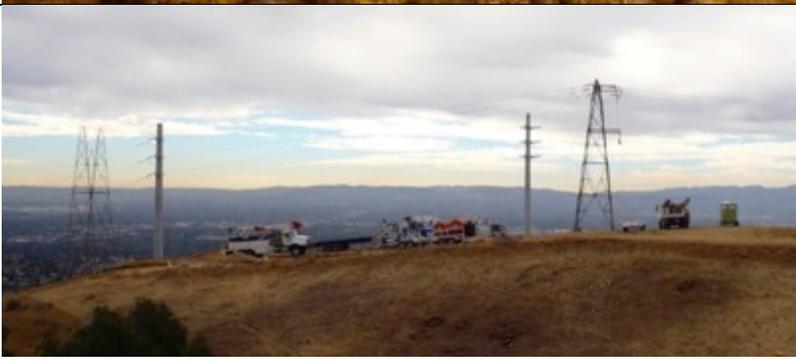
No work is being done at the Natural Substation but equipment is parked at the site in preparation for restringing lines and old tower removal.
11/19/14	P-41

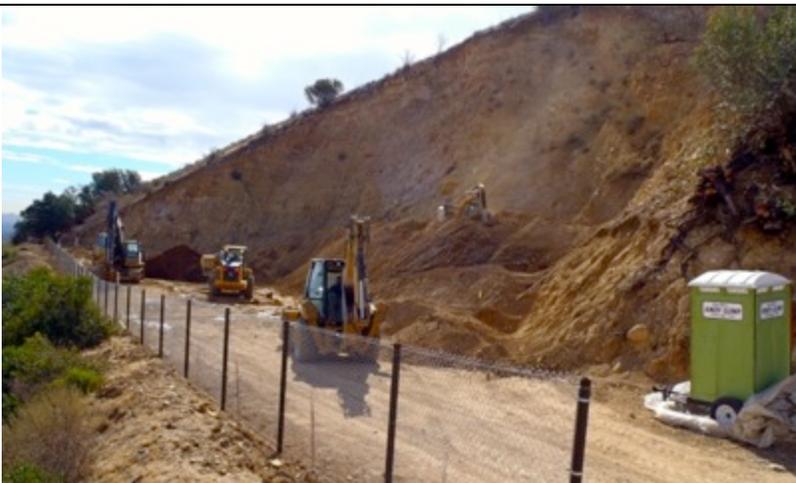
At P-41 five pieces of equipment are compacting dirt into the fill key – see photo. A water truck is onsite to provide moisture to the soil for compaction and to keep the dust down (APM AQ-6). Olivia Tierk is the SCG onsite Arch/Paleo monitor (MM CR-1, MM CR-3, MM CR-6 & MM CR-8) and is spot-checking all of the project activities.

A backhoe, two loaders, and two excavators are compacting soil into the fill key at the far end of the fill site.
11/19/14	New Admin/IM Building

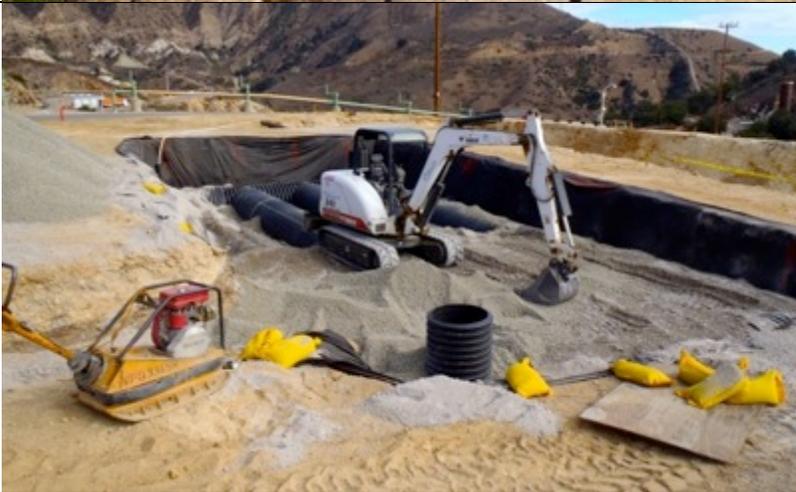
Installation of the underground infrastructure continues for the bio-filtration feature.

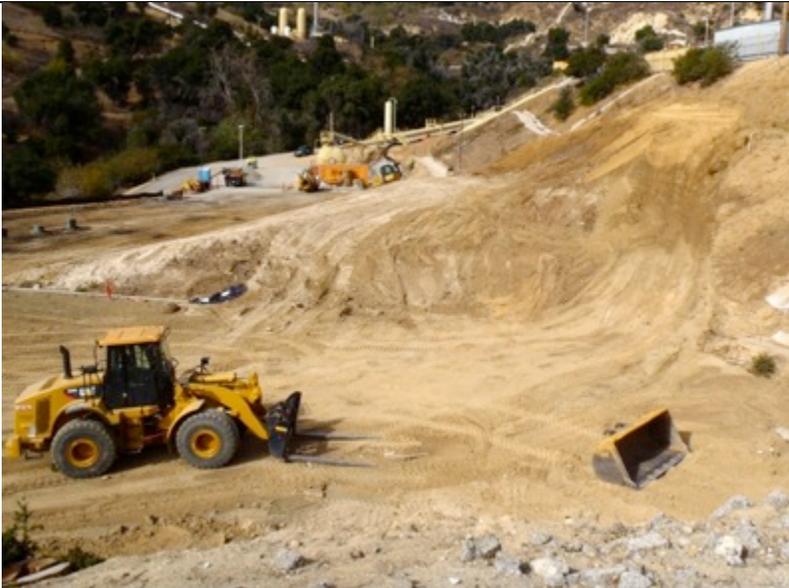
<p>Concrete removal continues and equipment is moving dirt at the project site.</p>
<p>11/19/14</p>	<p>Central Compressor Station</p>

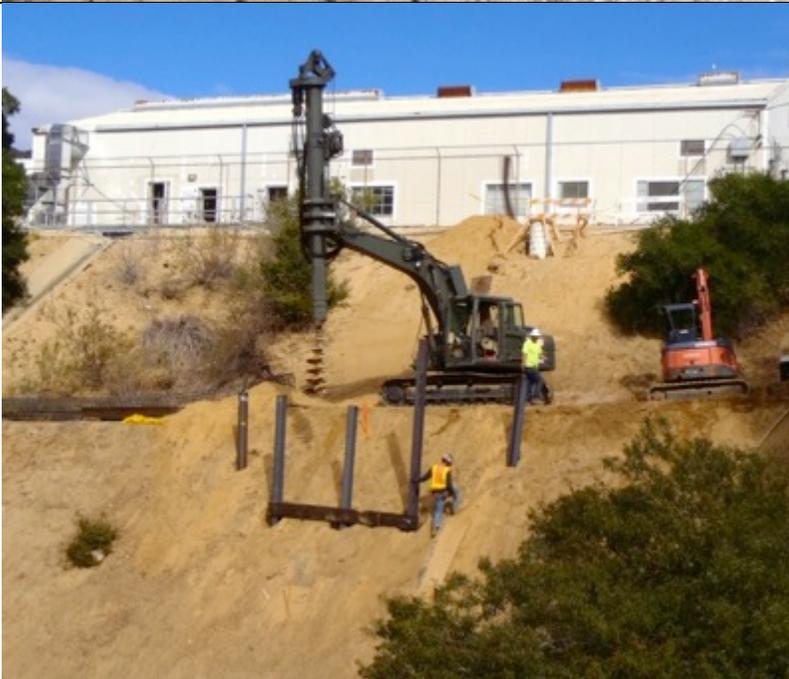
<p>A drilling rig is setting caissons within the CCS area.</p>
<p>11/19/14</p>	<p>Guard House</p>

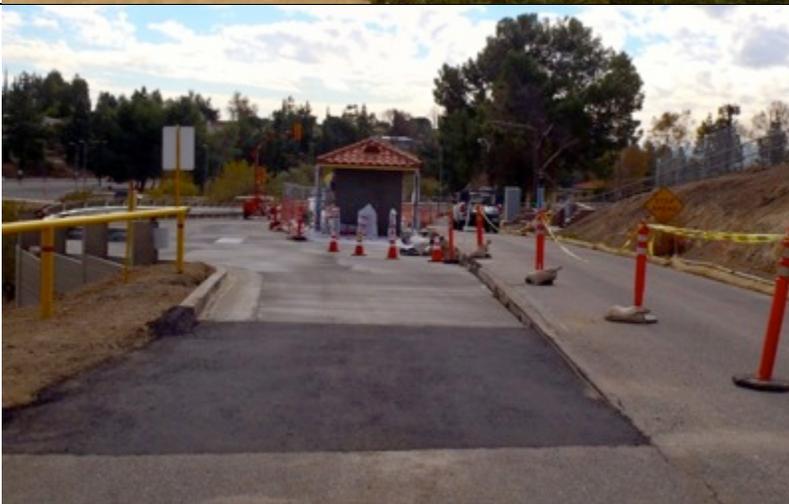
<p>Work on the guard house continues with stucco being applied to the building.</p>

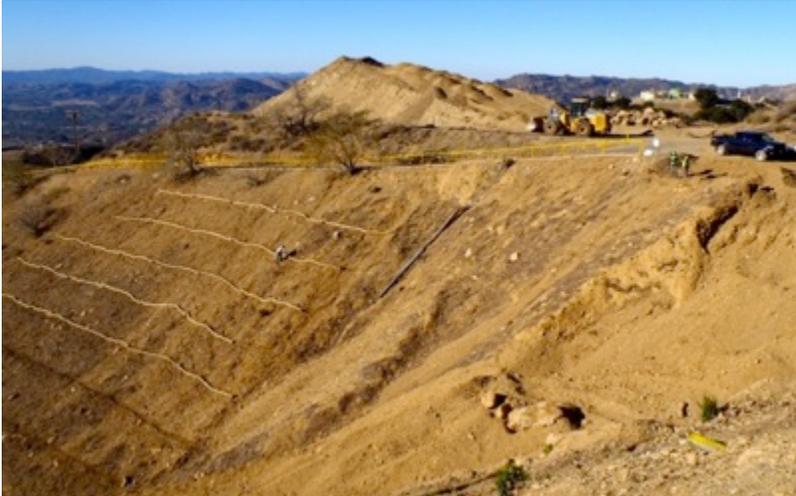
PS-42 Fill Site showing the straw wattle installation. The large pile of fill is the PS-42 temporary rock fill site.
11/25/14	PS-42 Fill Site

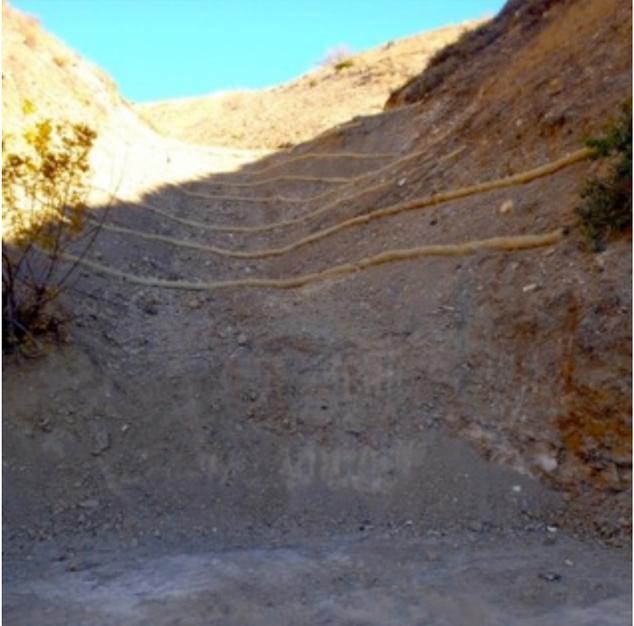
Looking up at the PS-42 fill key from the lower access road. Crews continue to install BMPs on the slope below the fill key.
11/25/14	PS-42 Fill Site

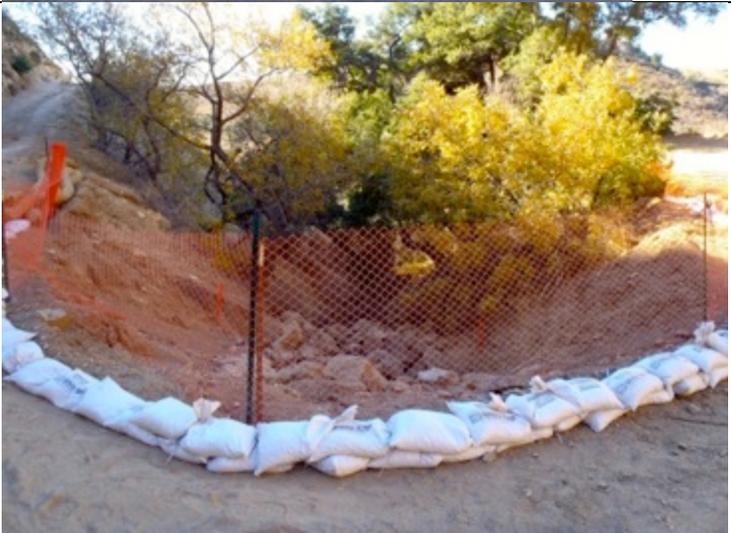
Riprap site below the lower access road and BMPs placed along the edge of the road above the site.

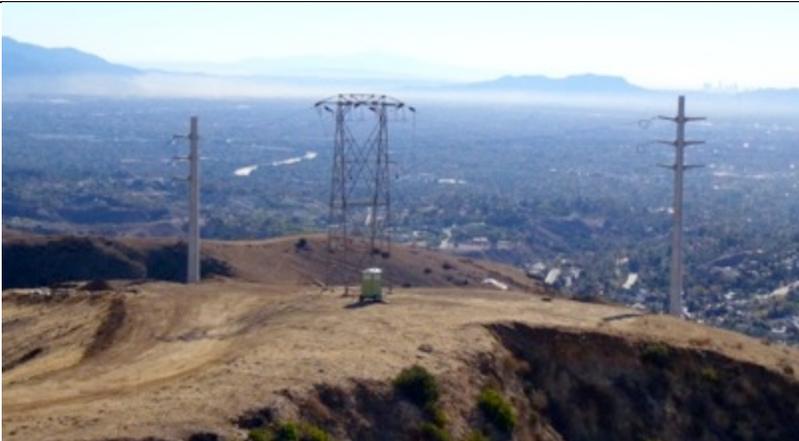
No work is being done at the Natural Substation site. TSPs 47 and 48 can be seen in the photo along with one old tower remaining at the site.
11/25/14	TSP 45

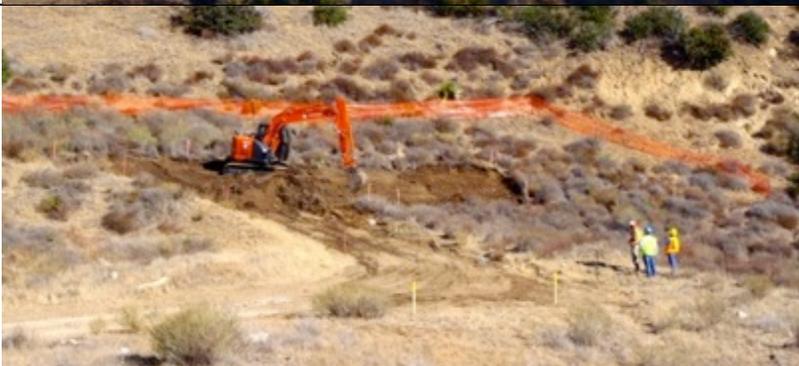
Topsoil salvage at the TSP 45 pull site. Oversight is being provided by both biological and paleo monitors.
11/25/14	TSP 45

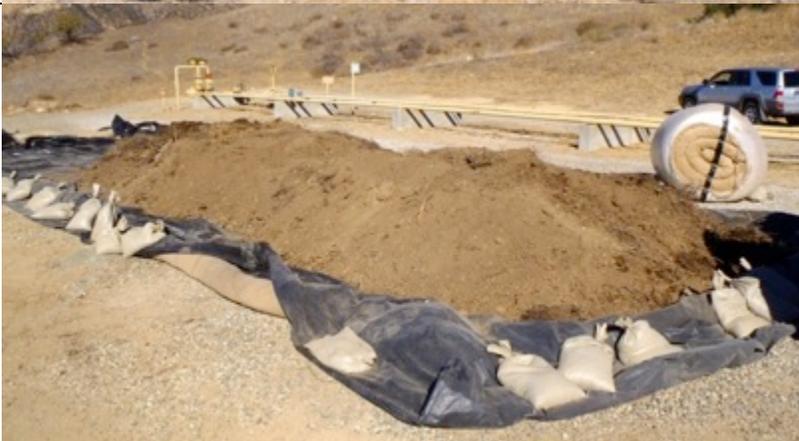
Stockpiled topsoil from the TSP 45 pull site.
11/25/14	P-41

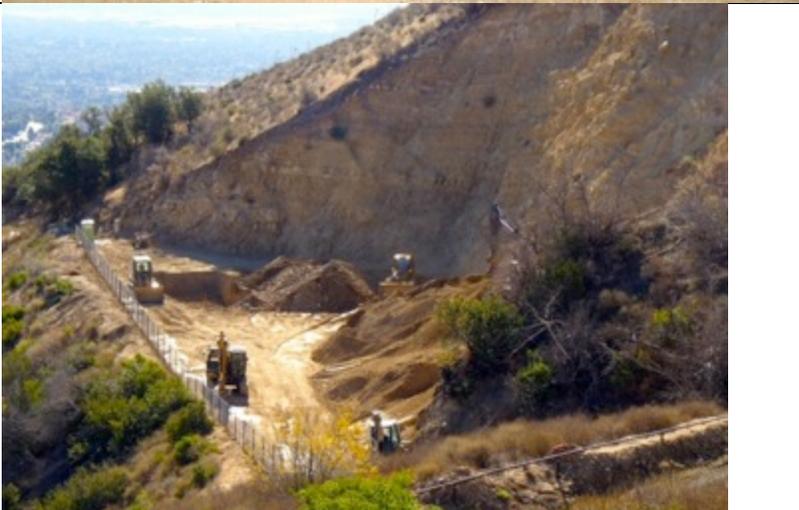
Equipment continues to excavate and recompact the fill key.

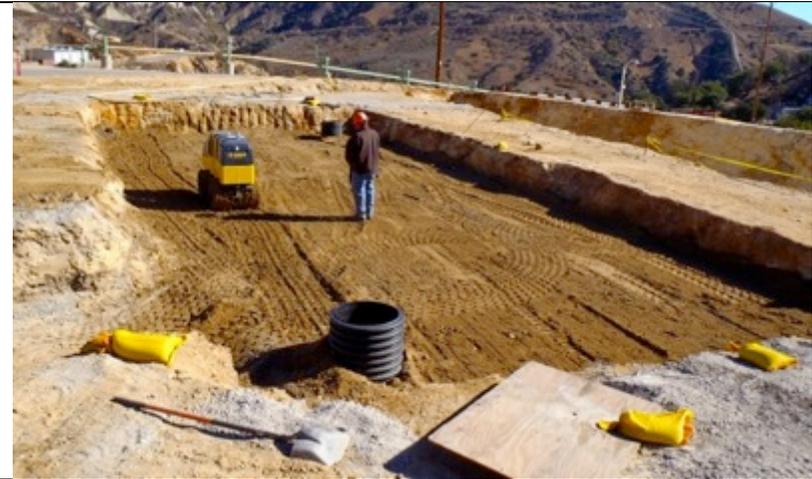
<p>Installation of the underground infrastructure continues for the bio-filtration feature.</p>
<p>11/25/14</p>	<p>Central Compressor Station</p>

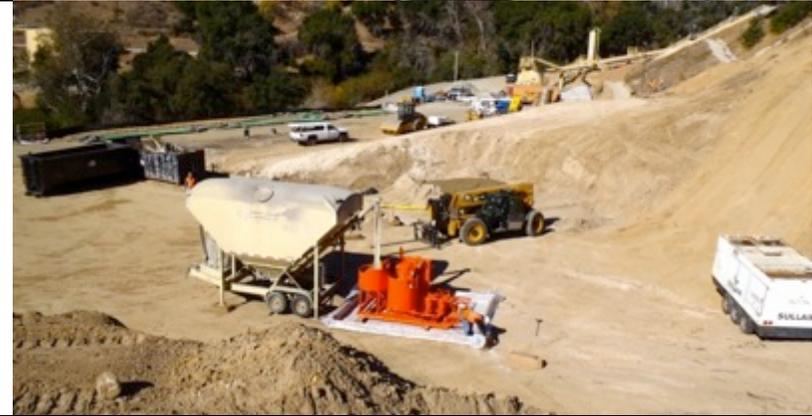
<p>Work within the CCS area.</p>
<p>11/25/14</p>	<p>Central Compressor Station</p>

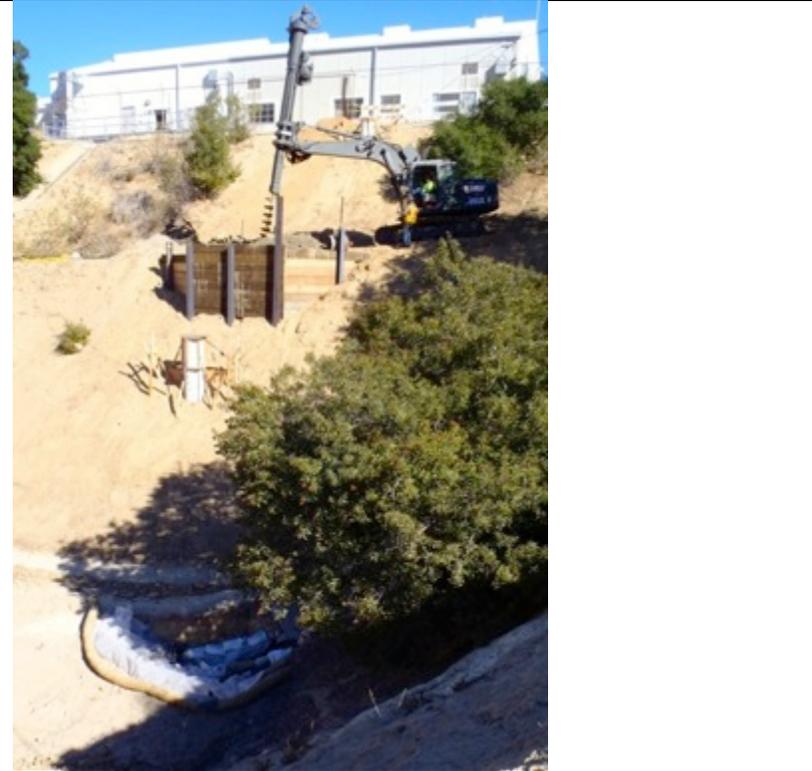
<p>A drilling rig continues to work in the CCS area, with work being done on the retaining walls. Note the BMPs installed around the drain inlet below the work.</p>

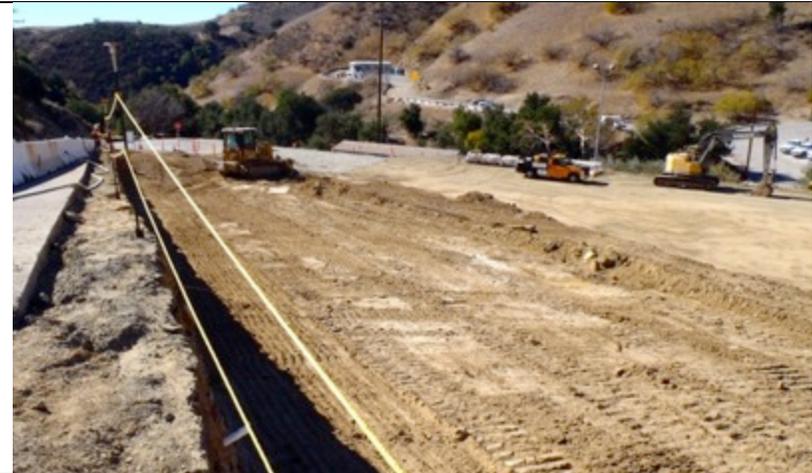
A photograph showing a long, narrow dirt path or trench being graded. A yellow surveying line is stretched across the path. In the background, there are hills, some trees, and a few vehicles parked on a dirt area.	Grading work within the CCS area. The work was being overseen by a paleo monitor.
11/25/14	Guard House

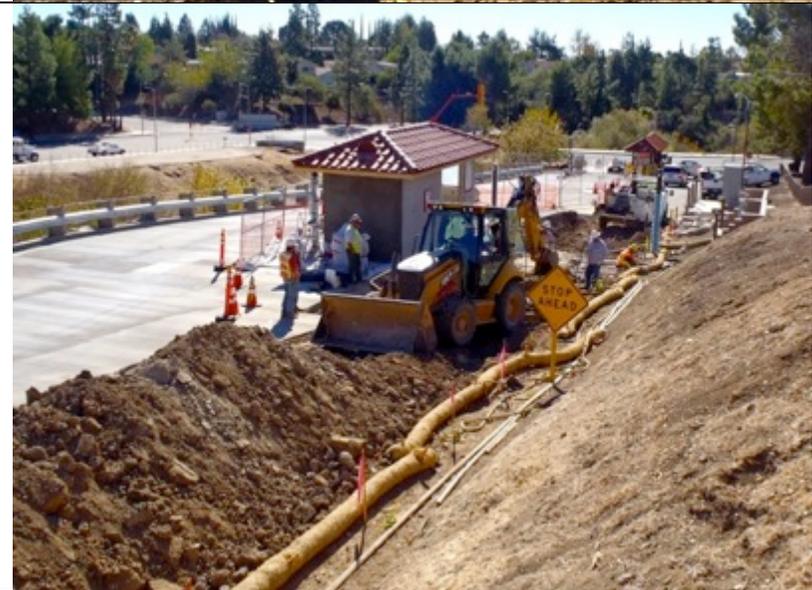
A photograph showing a small, square guard house with a brown roof. A yellow backhoe loader is positioned in front of it. Several workers in safety gear are visible. A yellow sign with the text "STOP AHEAD" is placed on the ground. The area is surrounded by dirt and some trees.	Work on the guard house continues and equipment working on the road.
