Re: Monthly Report Summary #16 for Aliso Canyon Turbine Replacement Project

Aliso Canyon Turbine Replacement Project CPUC Site Inspection Form

Project:	Aliso Canyon Turbine Replacement	Date:	July 2, 2015
Project Proponent:	Southern California Gas Company and Southern California Edison	Report #:	VS061
Lead Agency:	California Public Utilities Commission	Monitor(s):	Vince Semonsen
CPUC PM:	Andrew Barnsdale, Energy Division	AM/PM Weather:	Calm, partly cloudy, warm and humid – 20% chance of thundershowers.
E & E CM:	Lara Rachowicz	Start/End time:	0700 - 1100 in Wiley Cyn. 1130 - 1330 at the Aliso Gas Storage Field.
Project NTP(s):	Guard House and Road Widening (NTP-1). The New Admin/IM Building (NTP-2) and Central Compressor Station (CCS) (NTP-3). P-41 Fill Site (NTP-2), PS-42 Fill Site, P-32 Fill Site (NTP-3), and the Natural Substation (NTP-A, NTP-D). TSPs 11 through 33 (NTPs A, C, and D) and the SCE 210 Freeway Yard.

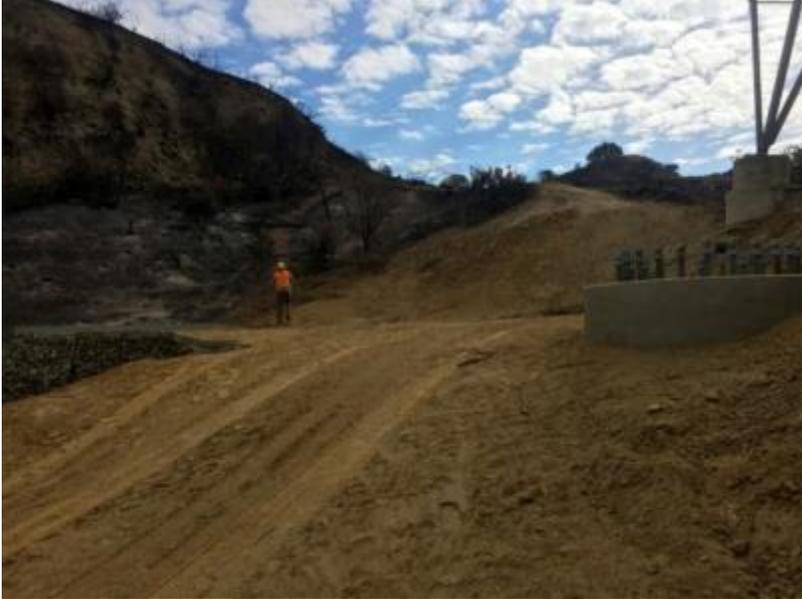
<p>Crew is preparing to install temporary poles to prevent wires from falling onto the road.</p>
7/02/15	TSP 26

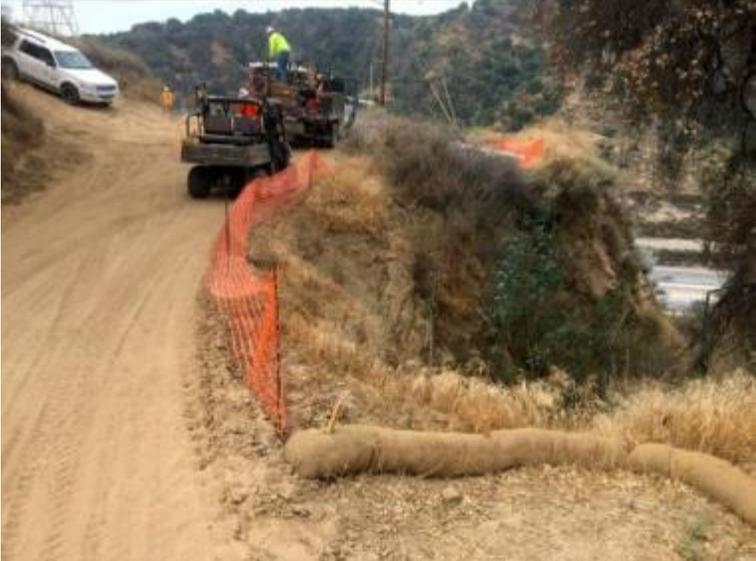
Date	Location	Photo	Description
7/02/15	Access road to TSP 30

Jurisdictional drainage.
7/02/15	TSP 30

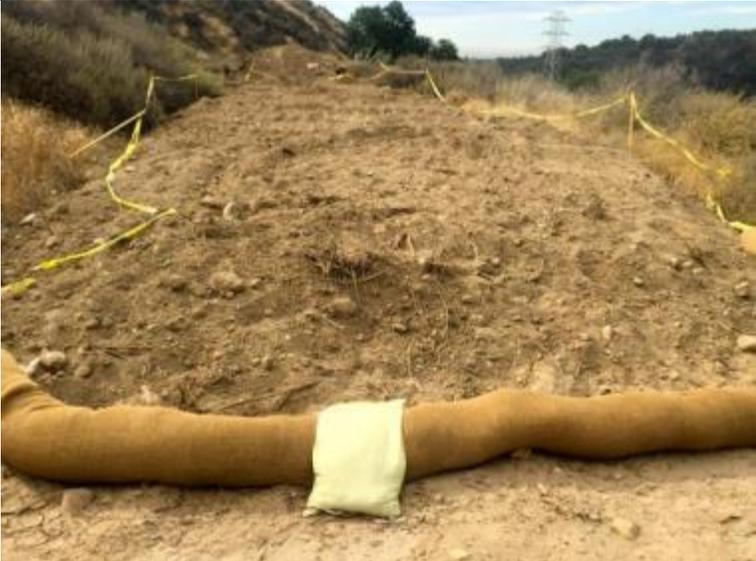
Stockpiled topsoil.
7/02/15	TSP 30

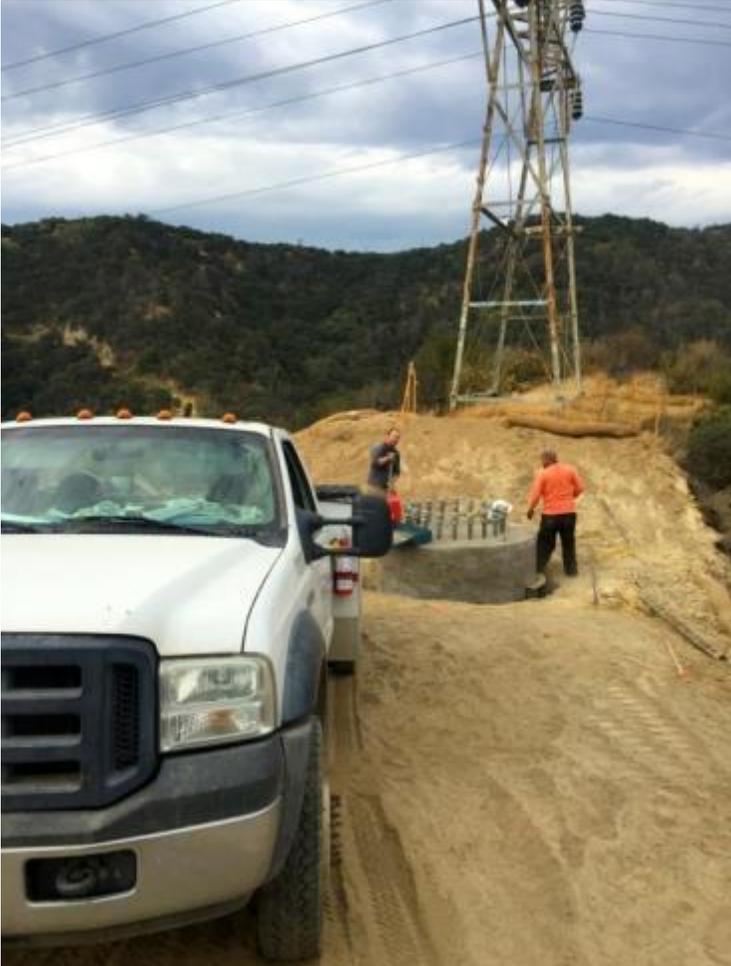
Date	Location	Photo	Description
7/02/15	TSP 28

A small crew was carrying out the finish work on the TSP 28 foundation. The access road to this site was extremely dusty and needed to be serviced by a water truck. Later in the day, Todd talked with Lucy about implementing dust control measures along this section of the access road.

Clean-up work around the new TSP foundation.
7/02/15	TSP 24 access road

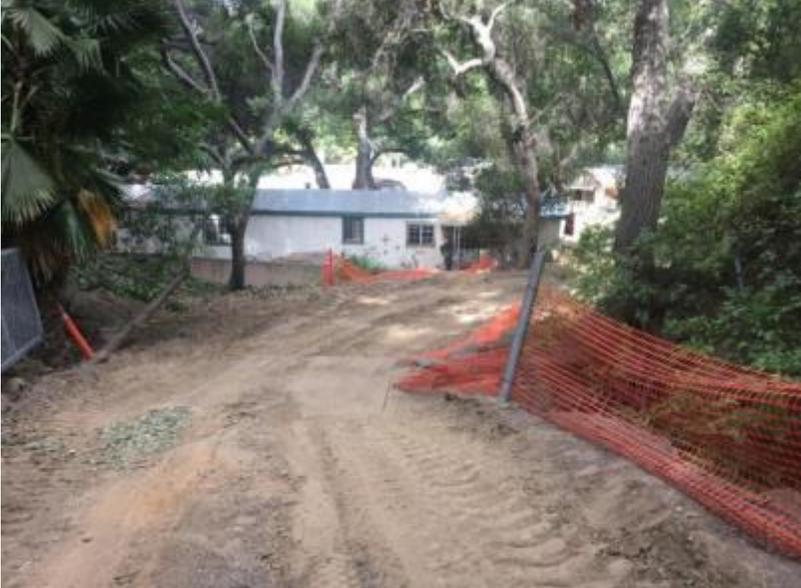
At TSP 24, the new pole was being installed and very little grading was needed at this site; however, access was difficult due to the steep, twisting access road. The jurisdictional drainage near Crescent Valley Mobile Estates (Estates) was checked – see photo. No work was taking place there. The burnt watershed will complicate runoff into this drainage once rain falls again.

Jurisdictional drainage near Crescent Valley Mobile Estates.

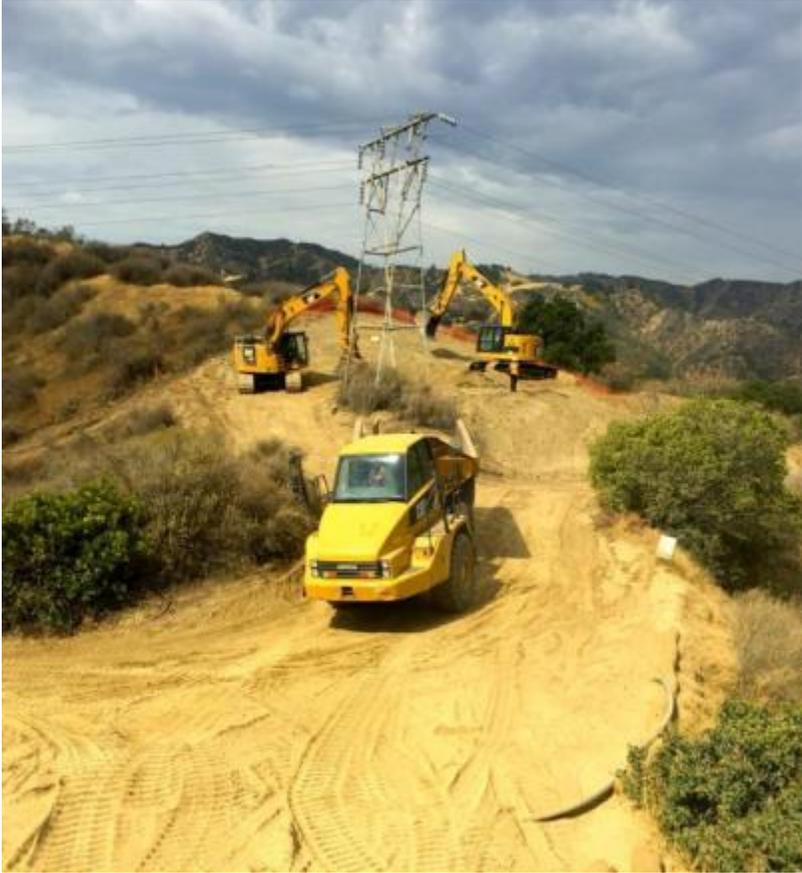
TSP 21 excavation work continues. Topsoil has been removed and stockpiled at TSP 15; excess spoil is being hauled off.

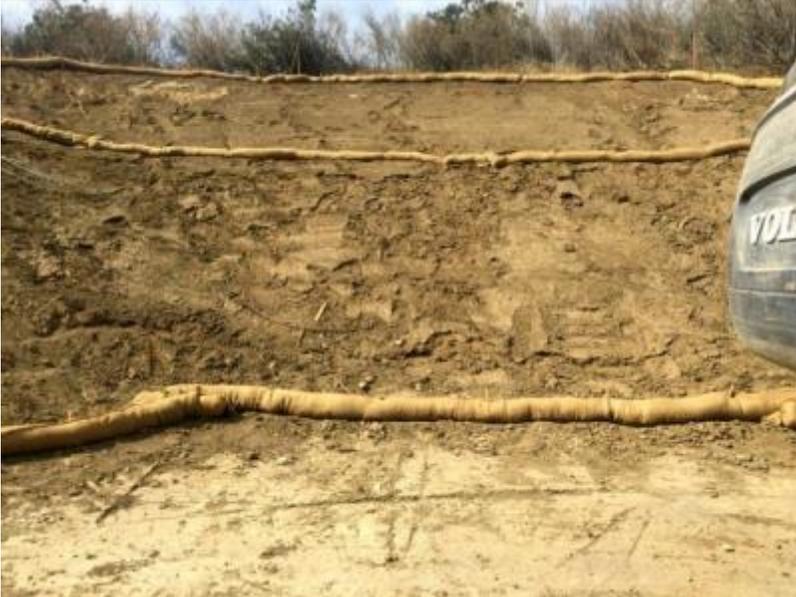
Date	Location	Photo	Description
7/02/15	TSP 18

The TSP 18 site was ready for drilling, with the drill rig parked onsite. Topsoil has been restored on the cut banks, with the addition of some BMP materials – see photo. The new TSP 14 pole has been installed, wires have been relocated, and some of the old tower has been removed. TSP 13 is partially complete, and the TSP 12 foundation has been installed – see photos. The small eroded area along the access road to TSP 12 has been repaired – see photo. The access road from TSP 14 to TSP 12 was in immediate need of watering to settle the dust.

<p>TSP 18 has been cleared and graded for drilling – the topsoil has already been restored to the cut bank.</p>
7/02/15	TSP 15

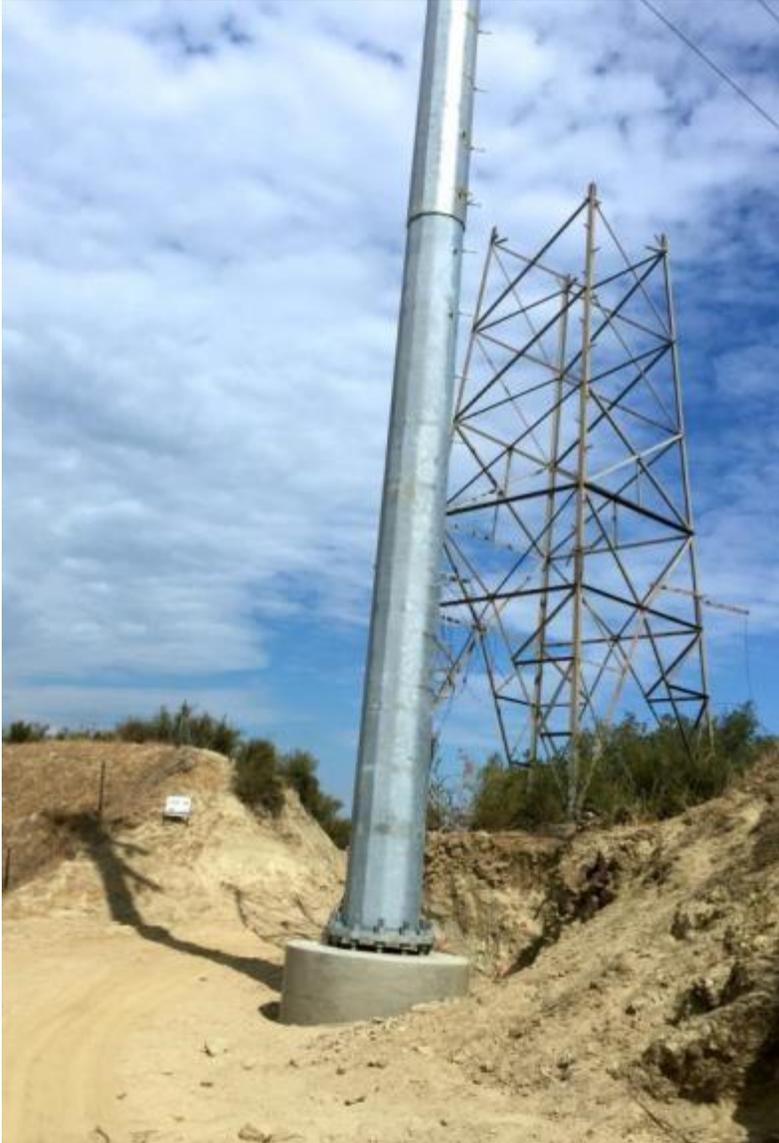
Date	Location	Photo	Description
7/02/15	TSP 14

The new pole has been installed, wires have been transferred, and a portion of the old lattice work tower has been removed.

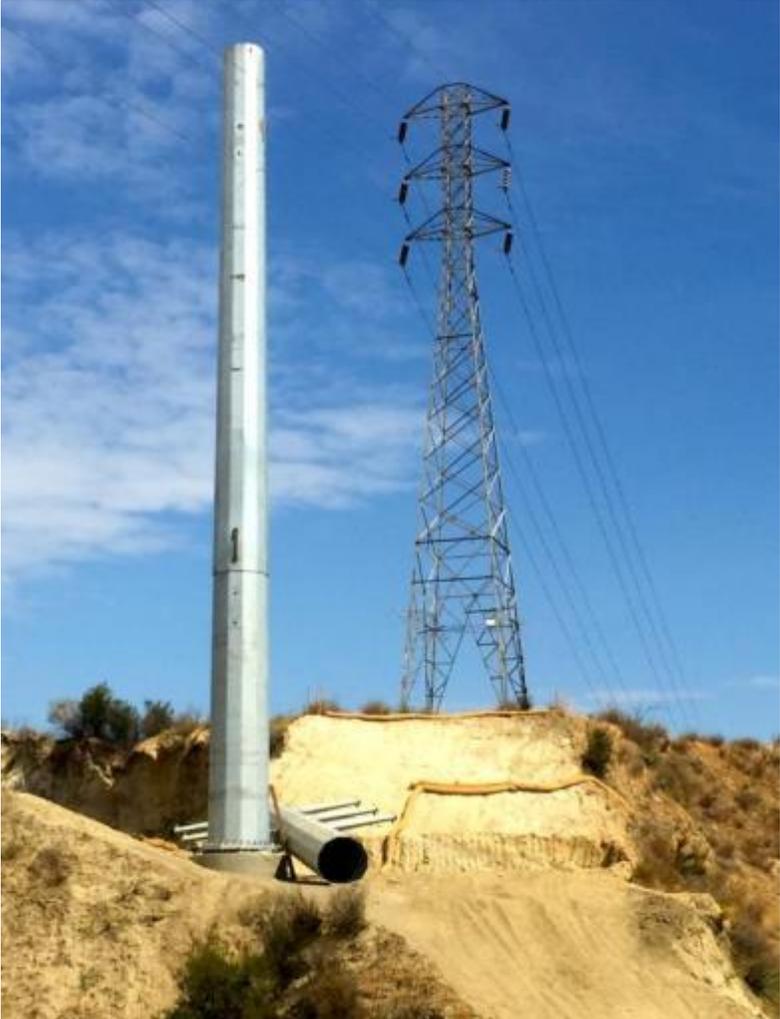
Date	Location	Photo	Description
7/02/15	TSP 13

A portion of the TSP has been installed.
7/02/15	Access road to TSP 12

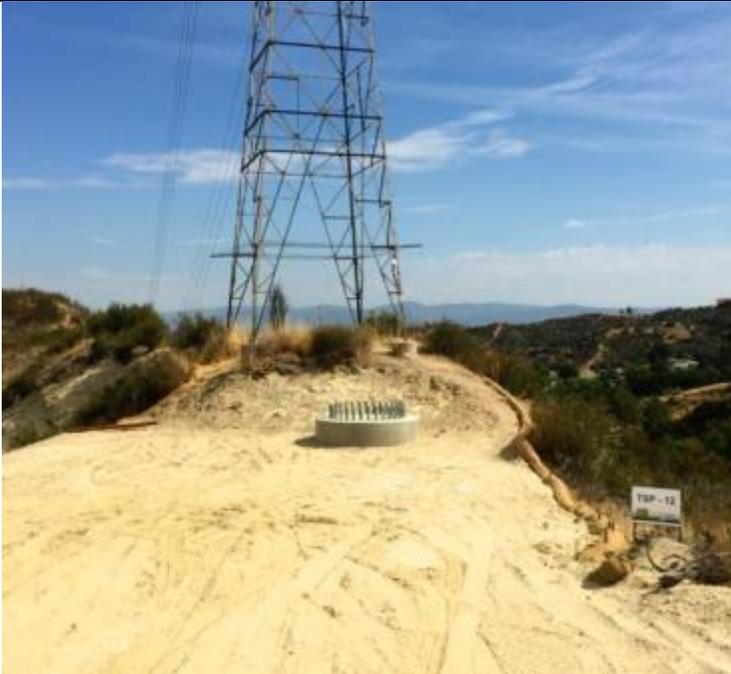
Date	Location	Photo	Description
7/02/15	TSP 12

The foundation has been poured
7/02/15	PS-42 Fill Site

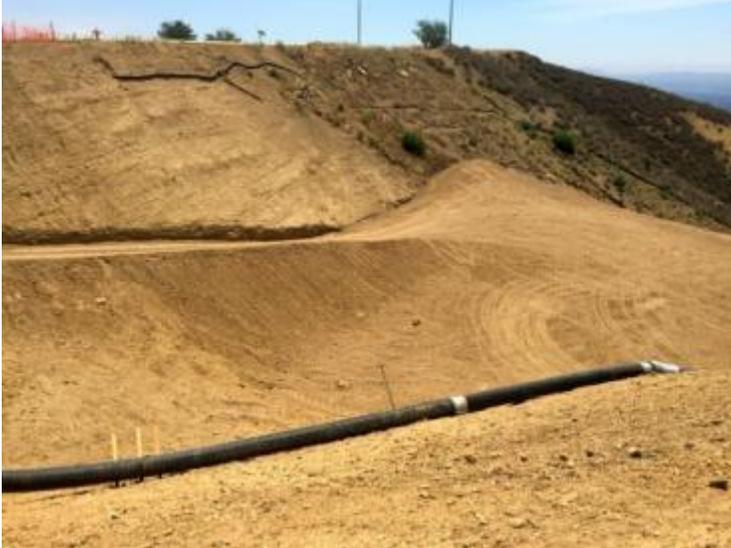
Work to seal up the fill site continues, with hydroseeding expected in the next few days.
7/02/15	PS-42 Fill Site

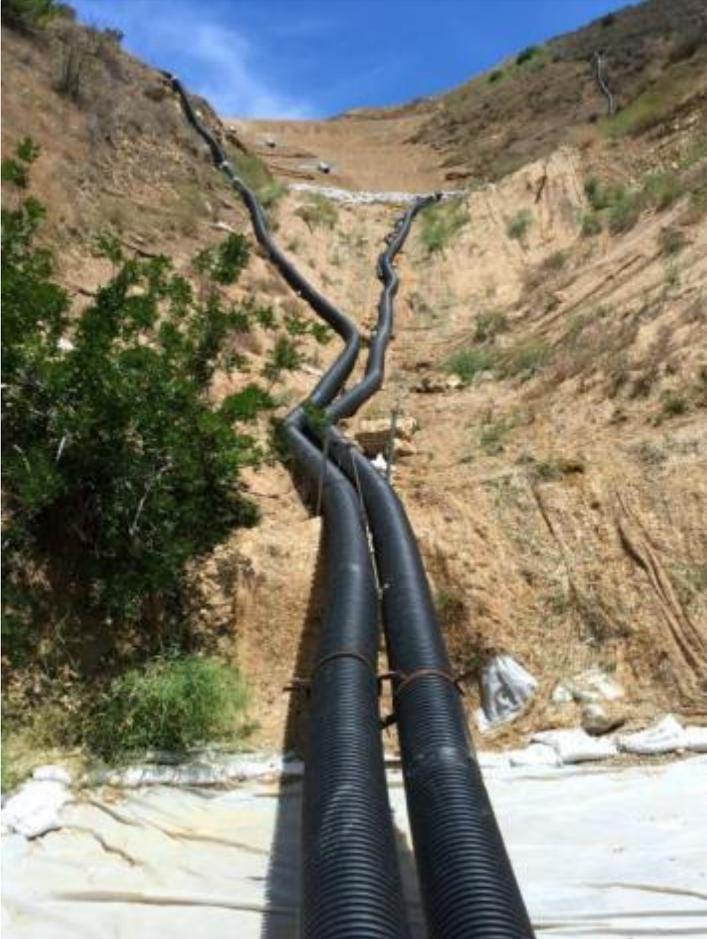
Looking up the slope from the lower access road.
7/02/15	Natural Substation

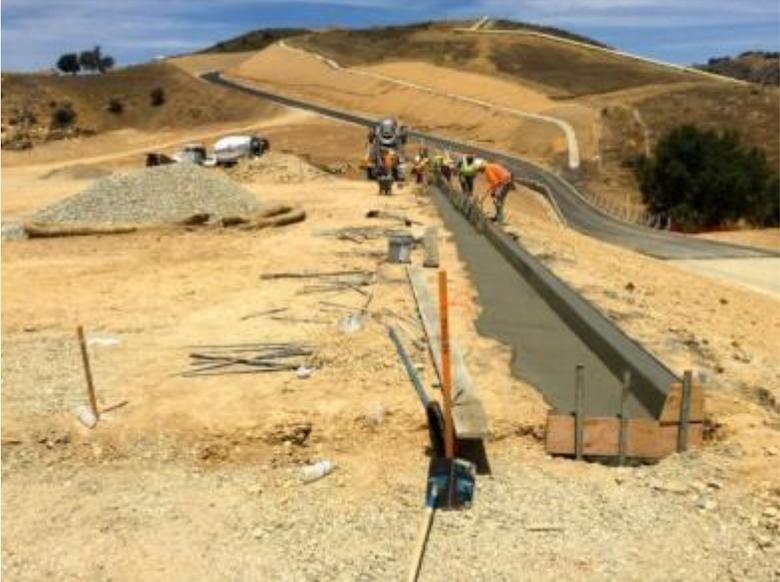
Crews are pouring the concrete curb.

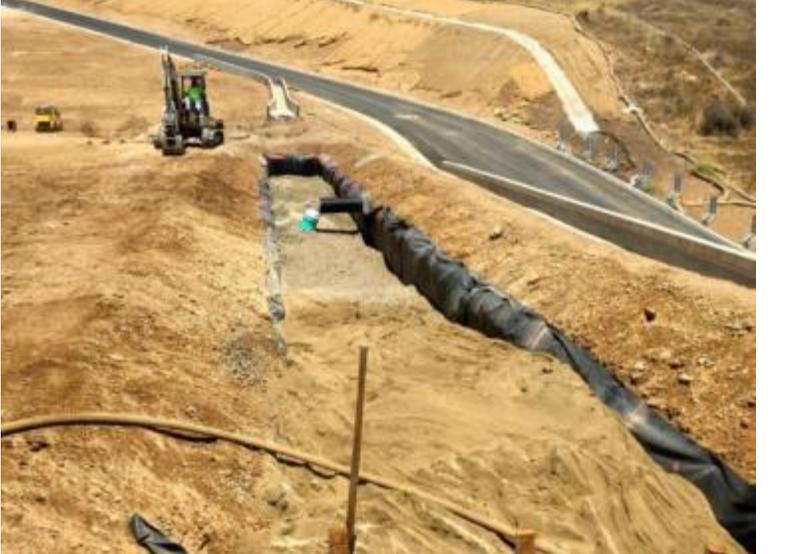
Work continues on the biofiltration unit.
7/02/15	CCS

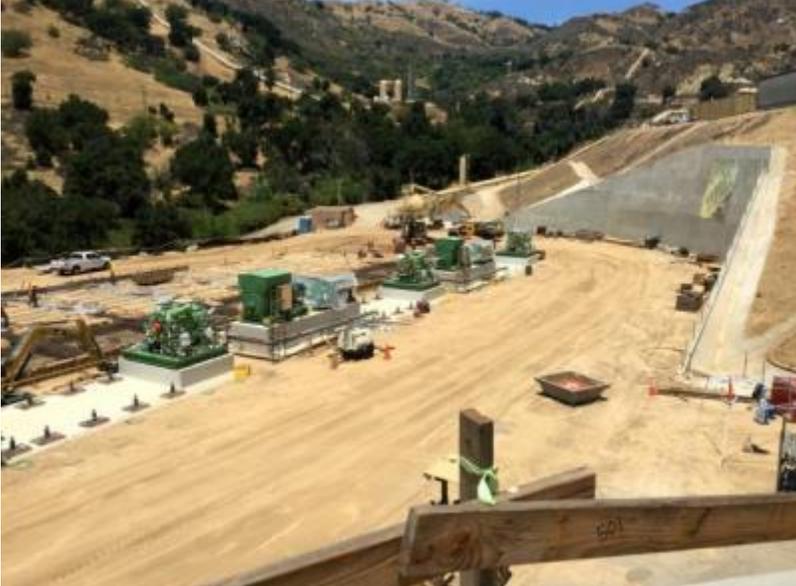
Ongoing equipment installation.

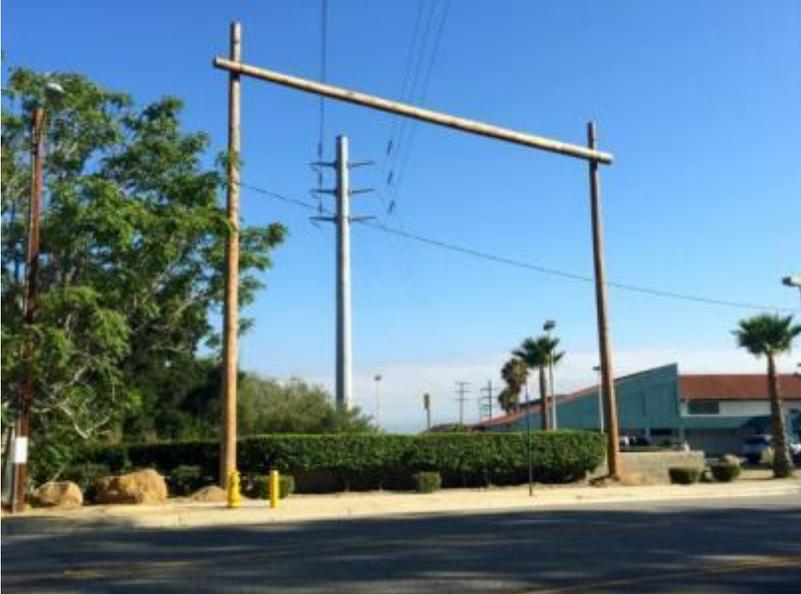
Temporary poles prevent wires from falling onto the road.
7/10/15	TSP 22

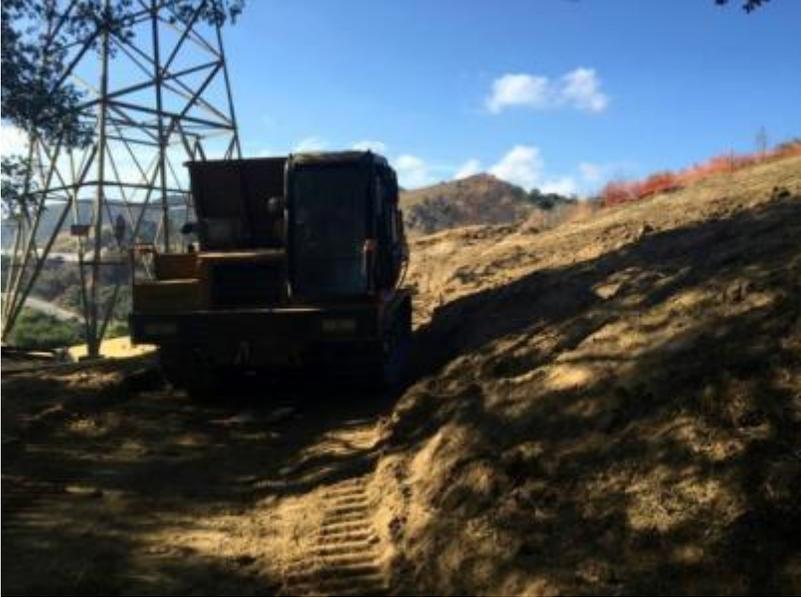
Work continues on the pole site.

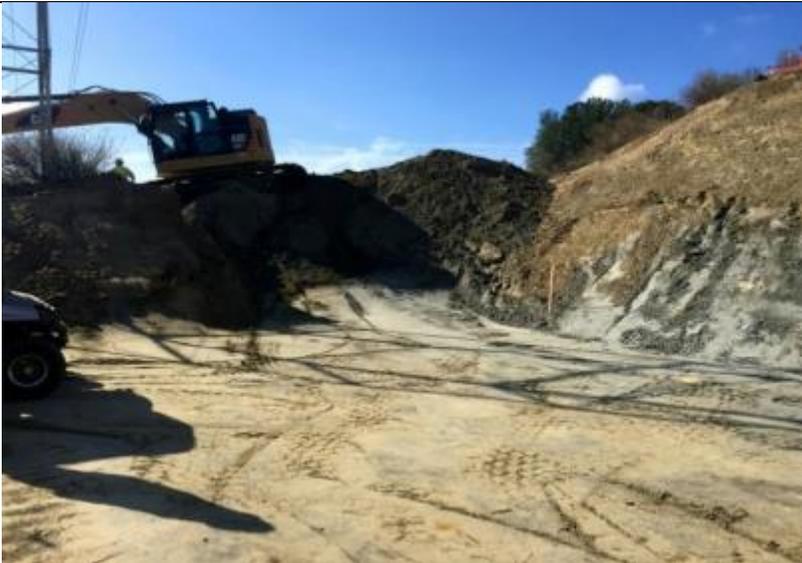
North side pull site and pad for the new pole.
7/10/15	TSP 21 Pull Site

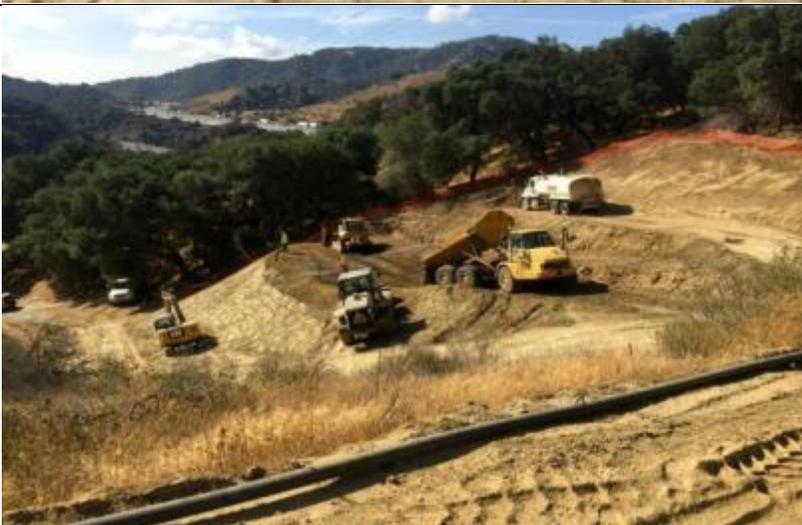
Pull site between TSP 21 and 22.
7/10/15	TSP 32

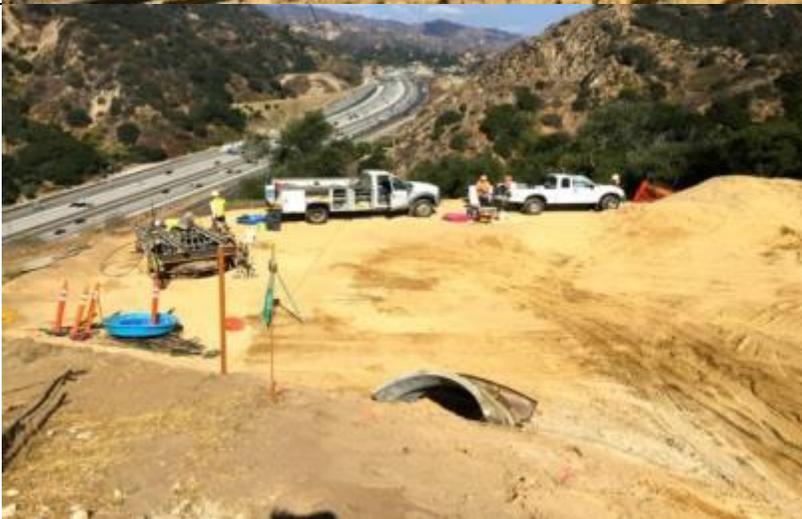
At TSP 32, the site had been drilled, the cage had been set, and the crew was pouring the foundation while I was onsite - see photo. The excess spoil had been hauled off and a fire crew was onsite.

The site has been drilled and concrete trucks are coming in to pour the foundation.

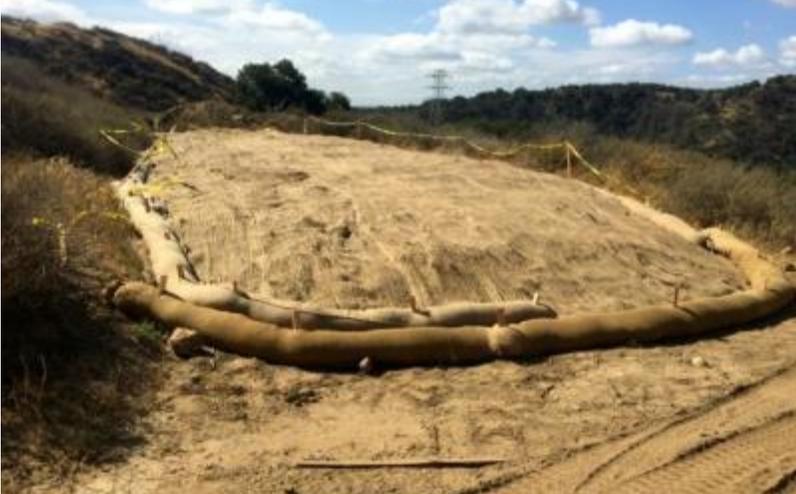
Stockpiled topsoil has been covered with jute netting.
7/10/15	TSP 30

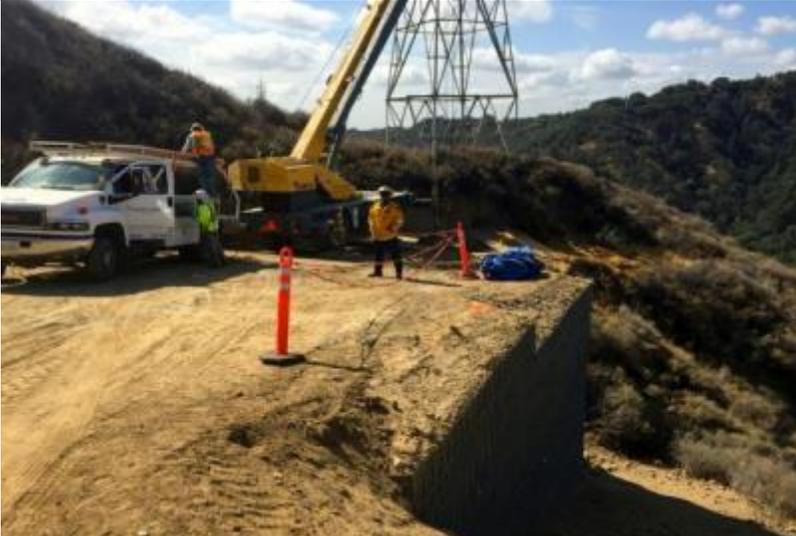
At TSP 30 the Hillfiker wall had been finished and the foundation hole had been drilled – see photo. A crew was setting the rebar cage, with the concrete to be poured soon. The topsoil piled had been covered with jute netting.

Hillfiker wall was finished and the hole has been drilled. Crews are setting the rebar cage.
7/10/15	Natural Substation access road

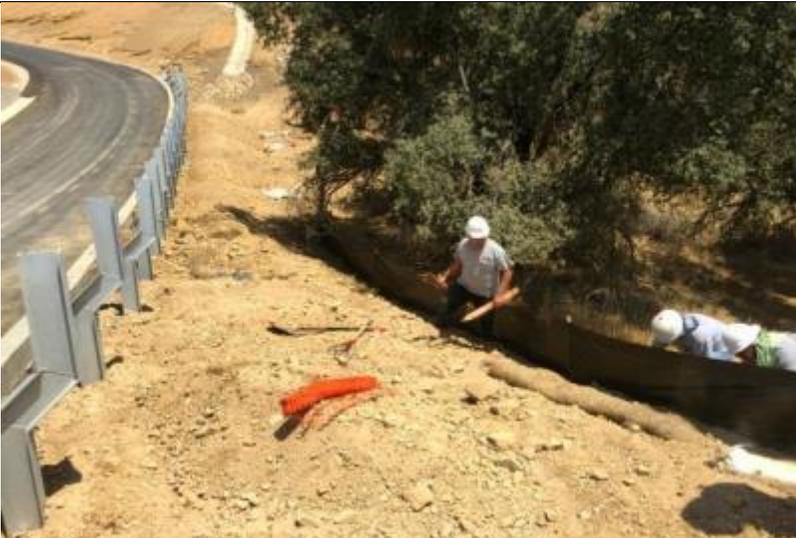
7/10/15	Natural Substation

A crew is installing BMP materials near the oak swale area below the access road.
7/10/15	CCS

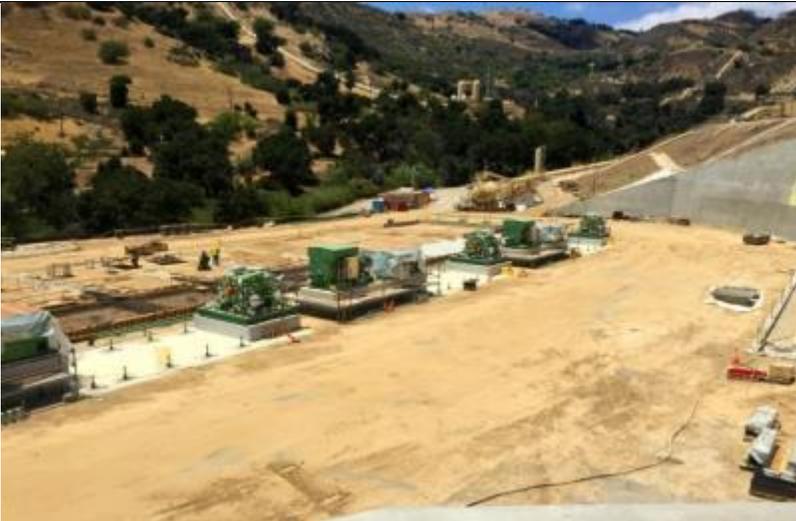
Ongoing equipment installation.
7/10/15	CCS

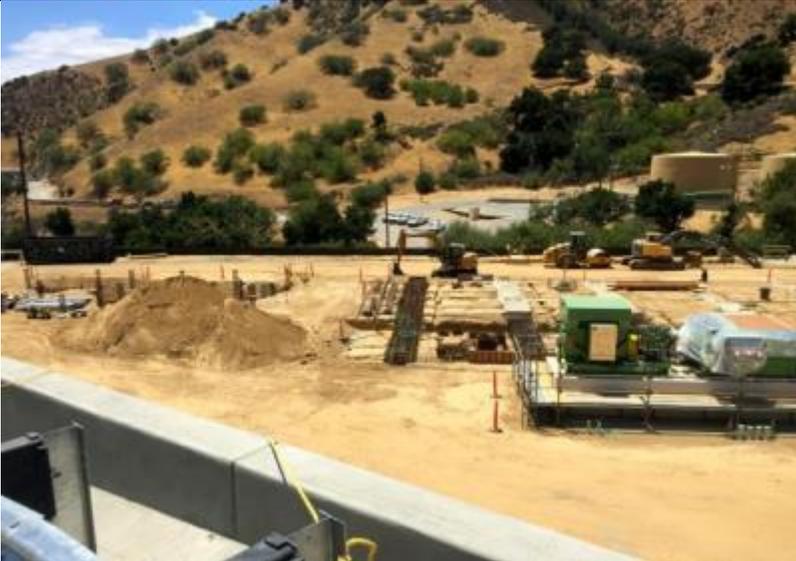
Southern end of the CCS area.

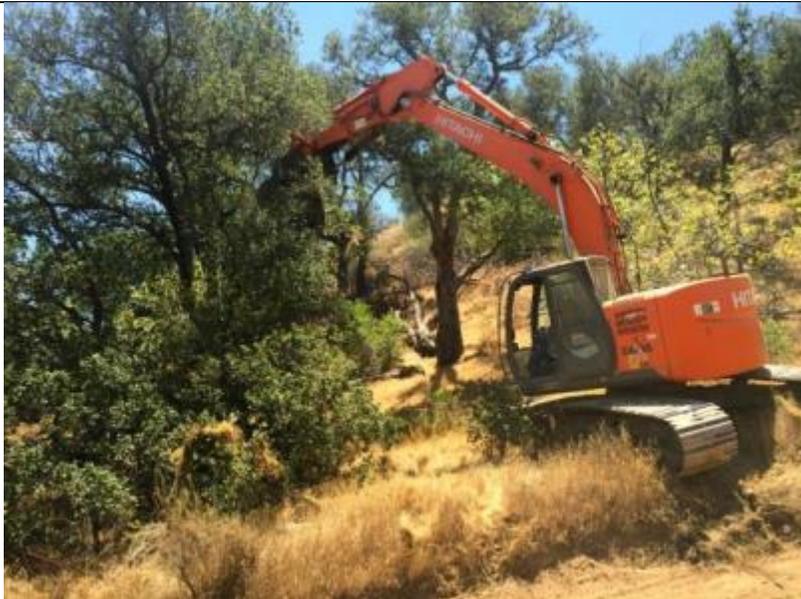
<p>Excavator removing an oak tree.</p>
<p>7/10/15</p>	<p>Access road between TSP 40 and TSP 42</p>

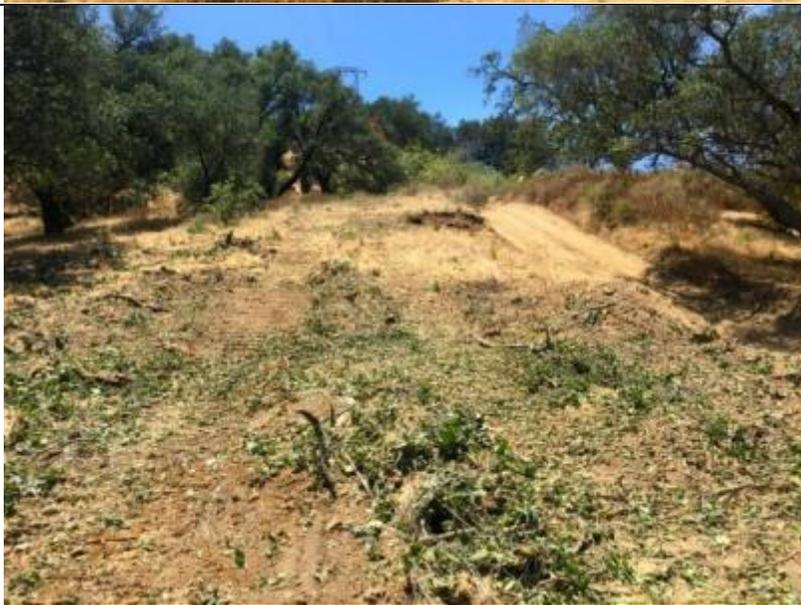
<p>Newly cleared section of the access road – looking up the hill toward TSP 42.</p>
<p>7/10/15</p>	<p>Access road between TSP 40 and TSP 42</p>

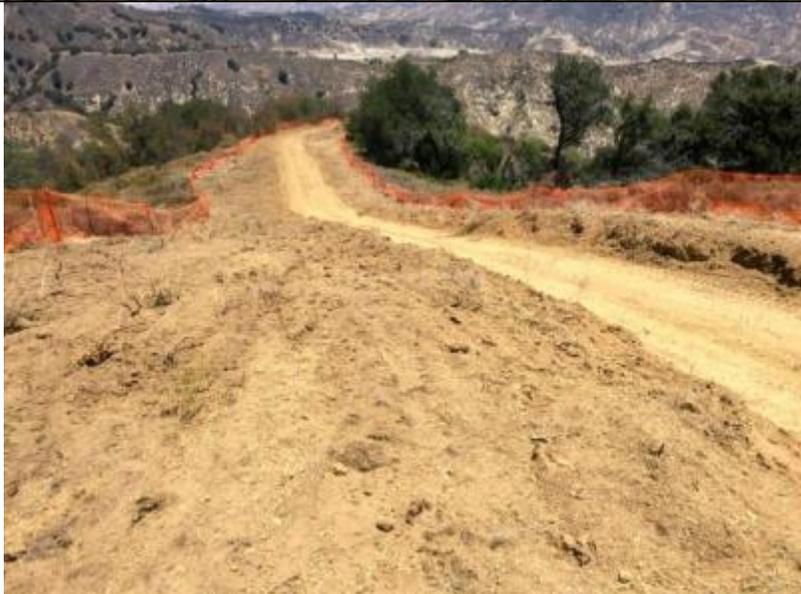
<p>Cleared area that has now been fenced.</p>

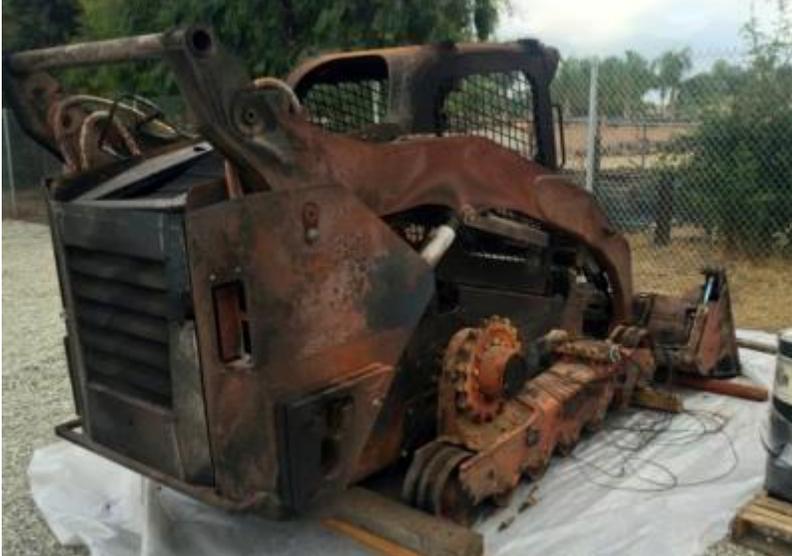
SCE has cleared, fenced, and laid gravel in the expanded 210 Freeway Yard. SCE is now using the site – see photo. The piece of equipment (a bobcat) that burned during the June fire is stored in the yard – see photo.

<p>Equipment (bobcat) that was burned during in the June fire.</p>
7/15/15	TSP 22

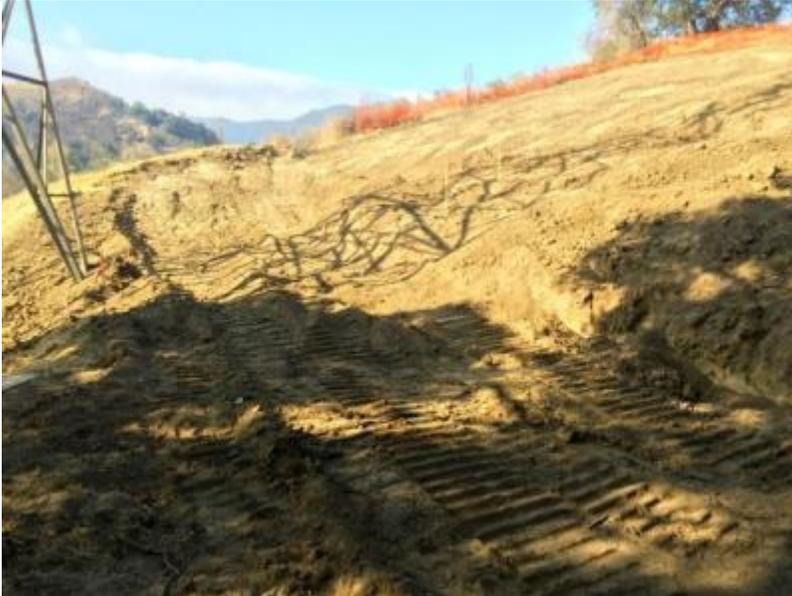
<p>Work continues on the pole site.</p>

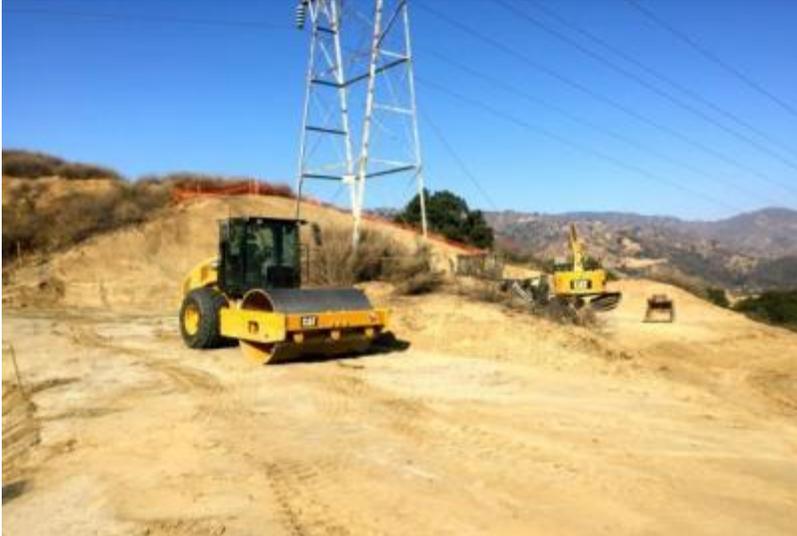
Date	Location	Photo	Description
7/15/15	TSP 21

Grading and site preparation is nearly complete for the pull site and pad at TSP 21.
7/15/15	TSP 21 Pull Site

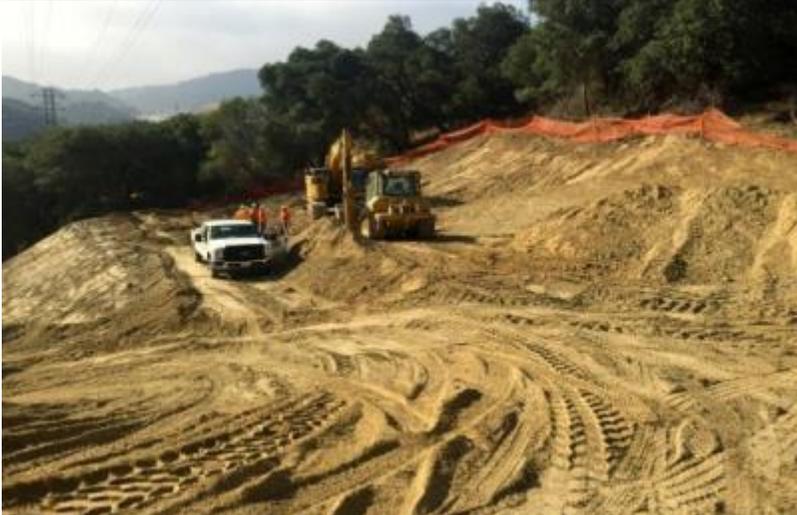
Pull site between TSP 21 and TSP 22. Note the loose dirt/dust on the access road.
7/15/15	Access road to TSP 24 and TSP 25

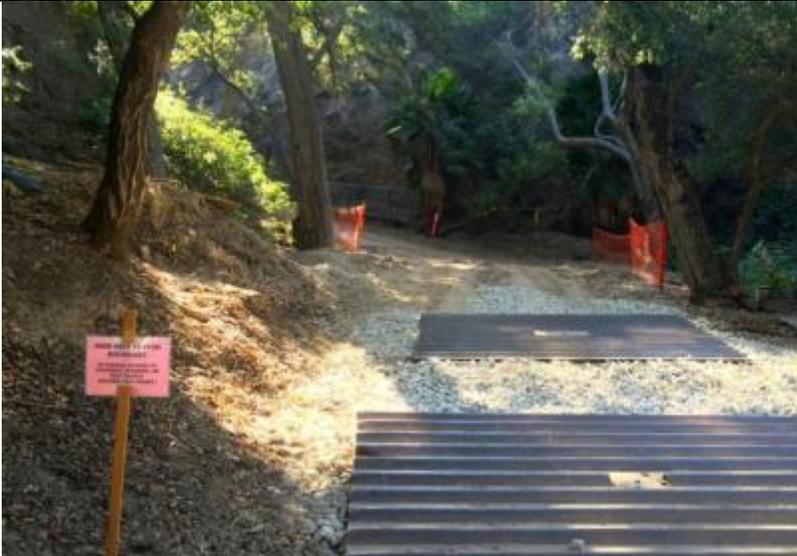
Rumble plates and nest buffer at the entrance to the TSP 24 and TSP 25 access road.

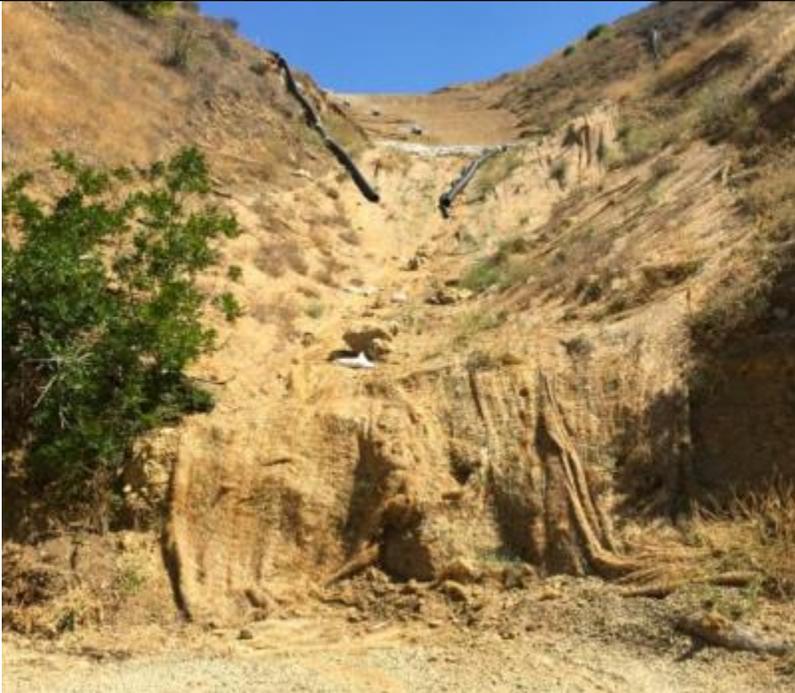
Fill slope looking up from the lower access road.
7/15/15	PS-42 Fill Site

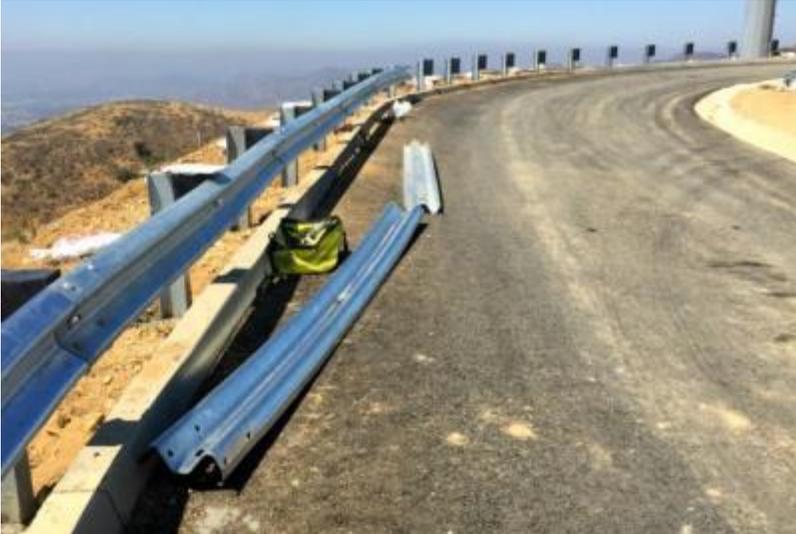
Date	Location	Photo	Description
7/15/15	Natural Substation access road

Installation of the guard rail.
7/15/15	Natural Substation

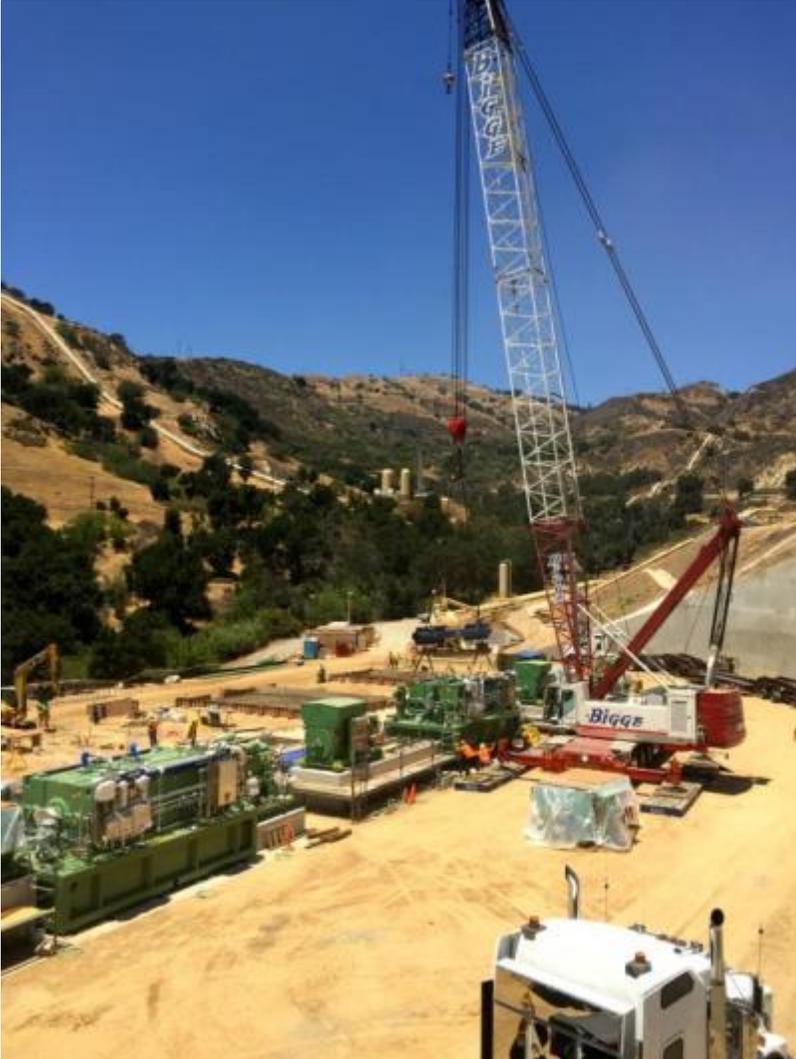
Date	Location	Photo	Description
7/15/15	CCS

Ongoing equipment installation.
7/15/15	Access road to TSP 40 and TSP 41

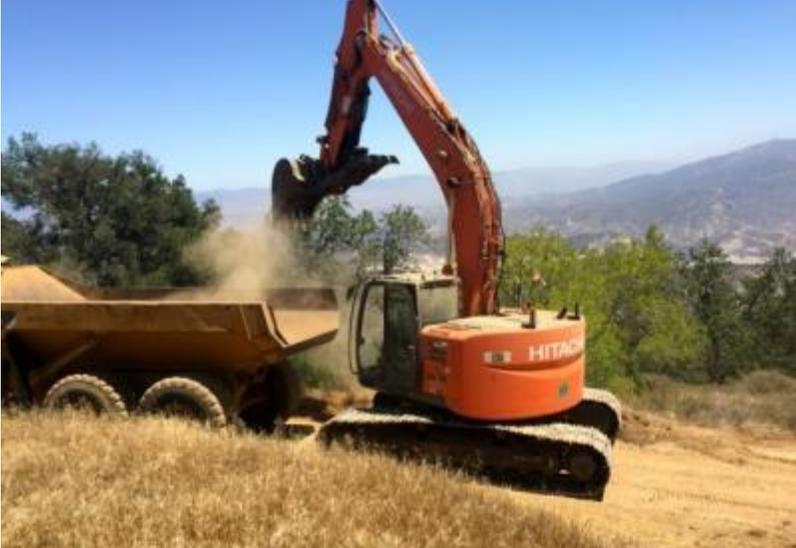
Excavator is stripping topsoil in an area with Mariposa lilies.

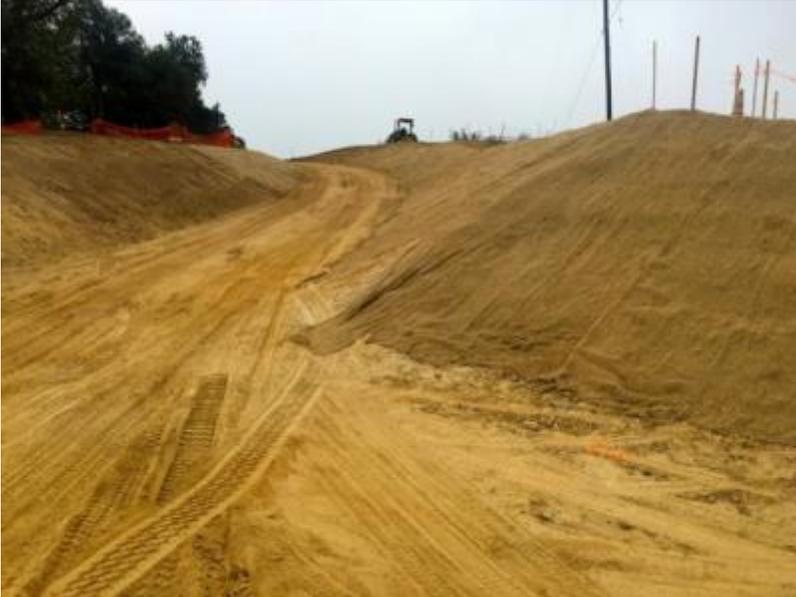
Date	Location	Photo	Description
7/23/15	TSP 32

<p>Access road to the TSP 32 pad has had jute netting installed on one of the cut banks.</p>
7/23/15	TSP 30

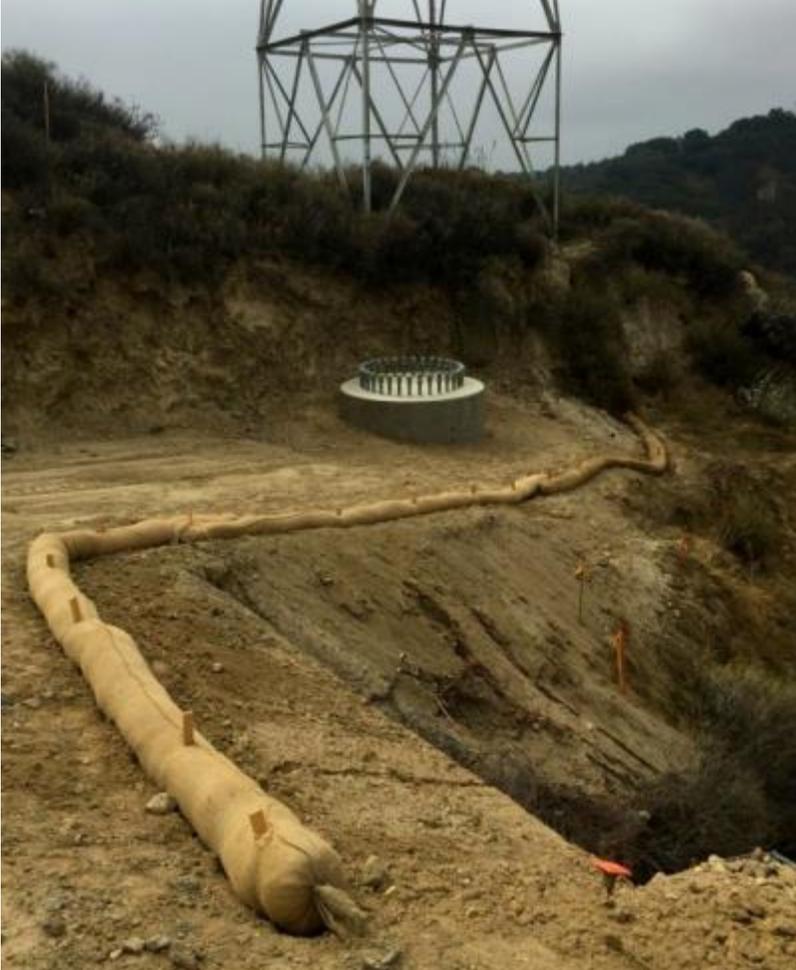
<p>The site is ready for the pole installation. Final restoration, including topsoil replacement, is still needed.</p>

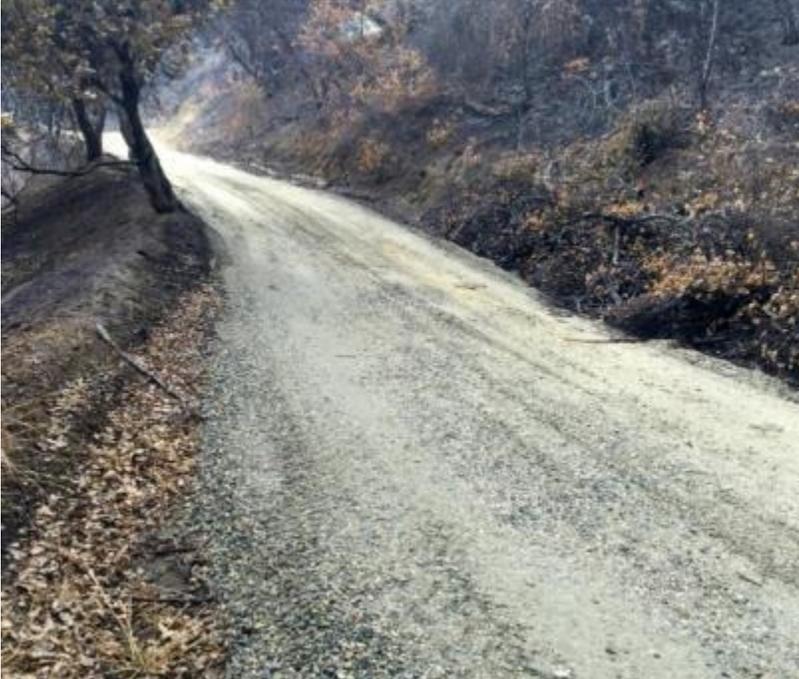
Date	Location	Photo	Description
7/23/15	Access road to TSPs 24 and 25

Road base has been laid down on the access road to improve vehicle access and to prevent dust.
7/23/15	TSP 24

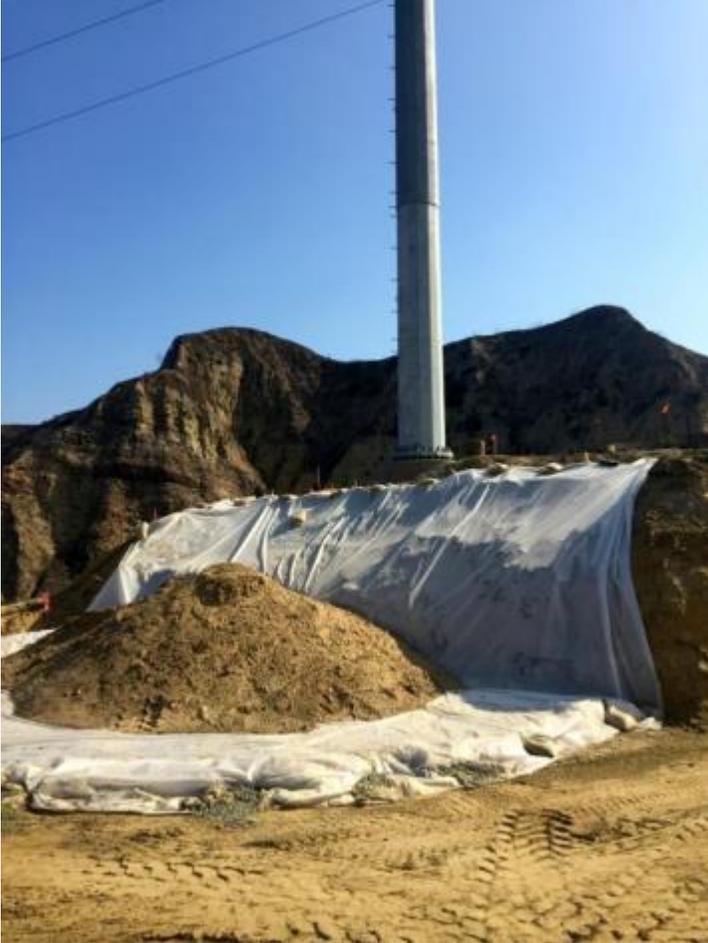
Some hydrocarbon contaminated soil was unearthed near TSP 24. The soil has been stockpiled on visqueen. The soil has been tested, and results will determine how the soil will be disposed of.
