Re: Monthly Report Summary #16 for Aliso Canyon Turbine Replacement Project

Aliso Canyon Turbine Replacement Project CPUC Site Inspection Form

Project:	Aliso Canyon Turbine Replacement	Date:	July 2, 2015
Project Proponent:	Southern California Gas Company and Southern California Edison	Report #:	VS061
Lead Agency:	California Public Utilities Commission	Monitor(s):	Vince Semonsen
CPUC PM:	Andrew Barnsdale, Energy Division	AM/PM Weather:	Calm, partly cloudy, warm and humid – 20% chance of thundershowers.
E & E CM:	Lara Rachowicz	Start/End time:	0700 - 1100 in Wiley Cyn. 1130 - 1330 at the Aliso Gas Storage Field.
Project NTP(s):	Guard House and Road Widening (NTP-1). The New Admin/IM Building (NTP-2) and Central Compressor Station (CCS) (NTP-3). P-41 Fill Site (NTP-2), PS-42 Fill Site, P-32 Fill Site (NTP-3), and the Natural Substation (NTP-A, NTP-D). TSPs 11 through 33 (NTPs A, C, and D) and the SCE 210 Freeway Yard.

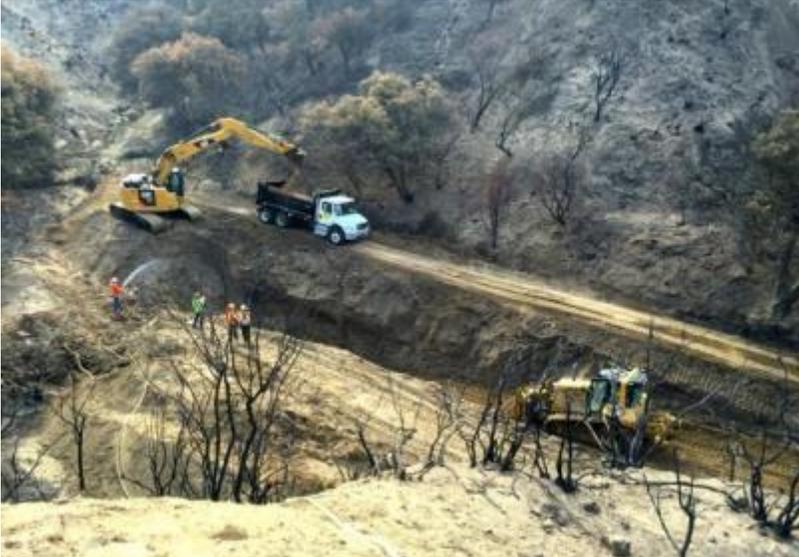
Date	Location	Photo	Description
7/23/15	Access road to TSP 25

Equipment is working along the access road and preparing the area for a long Hillfiker wall.
7/23/15	TSP 22

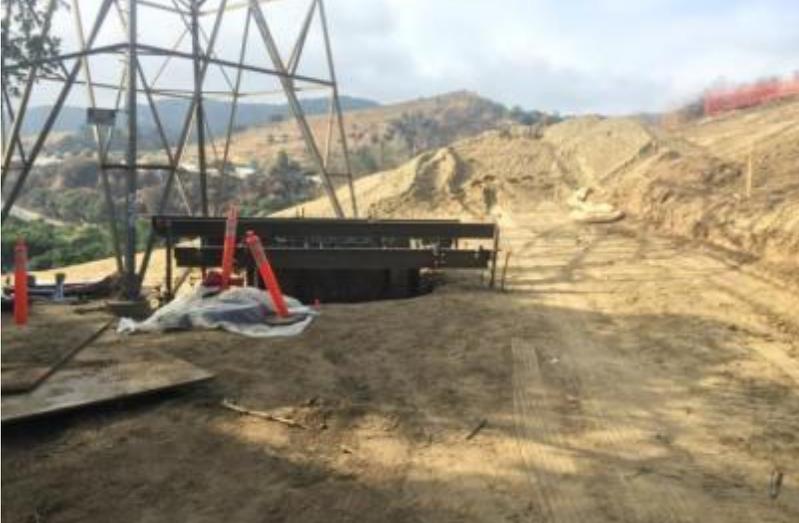
The foundation for TSP 22 was newly poured; forms remain to be stripped.
7/23/15	Pull site between TSP 22 and TSP 21

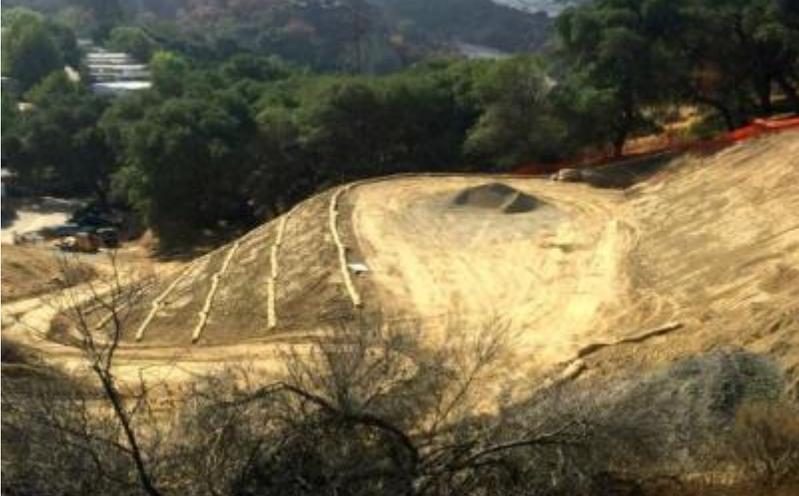
The grading for the pull site has been finished, with some of the BMP materials installed. Topsoil still needs to be returned to the slopes.

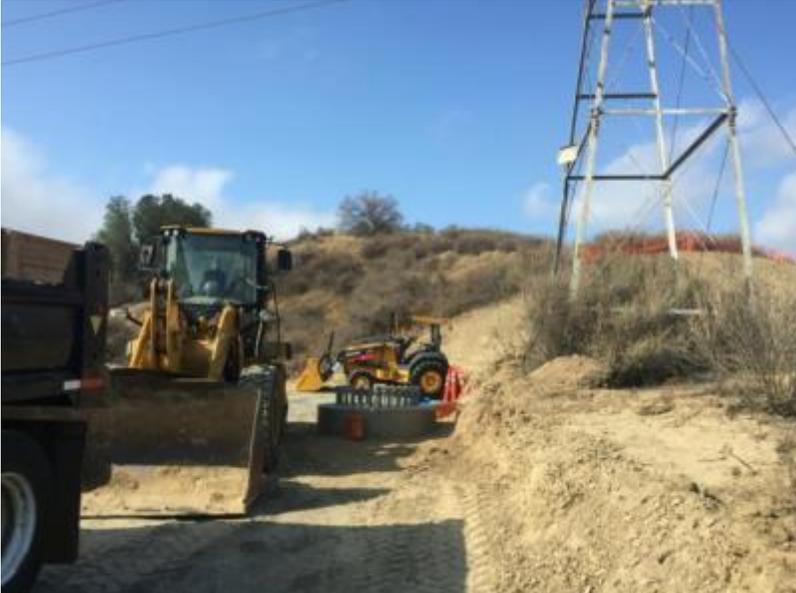
Date	Location	Photo	Description
7/23/15	TSP 21

The foundation for the new pole has been drilled and poured.
7/23/15	TSP 18

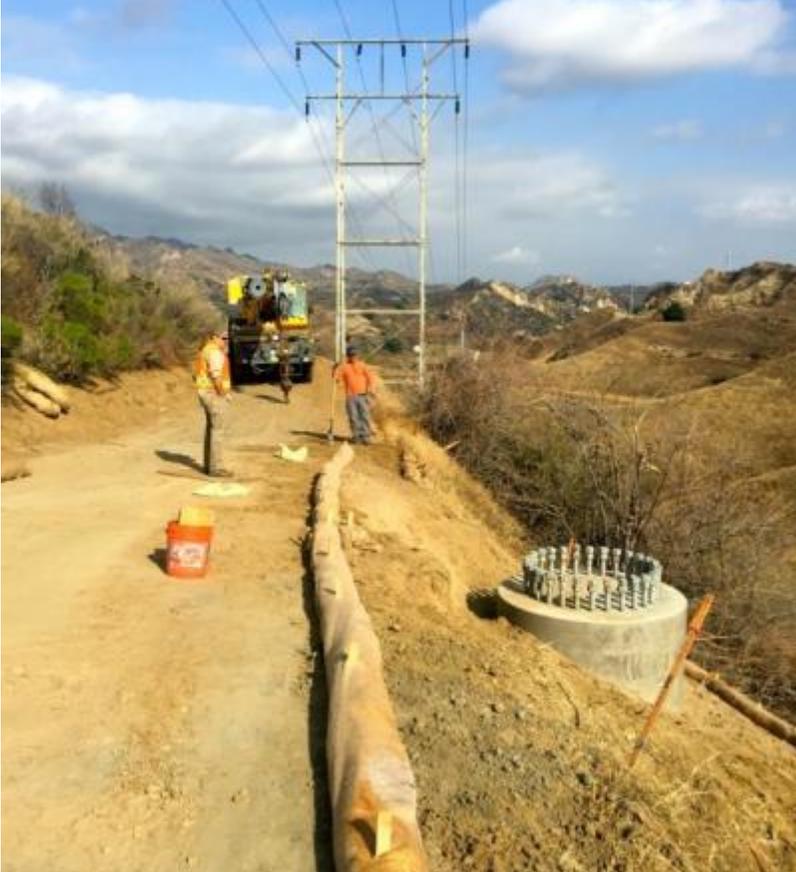
The foundation has been drilled and poured.

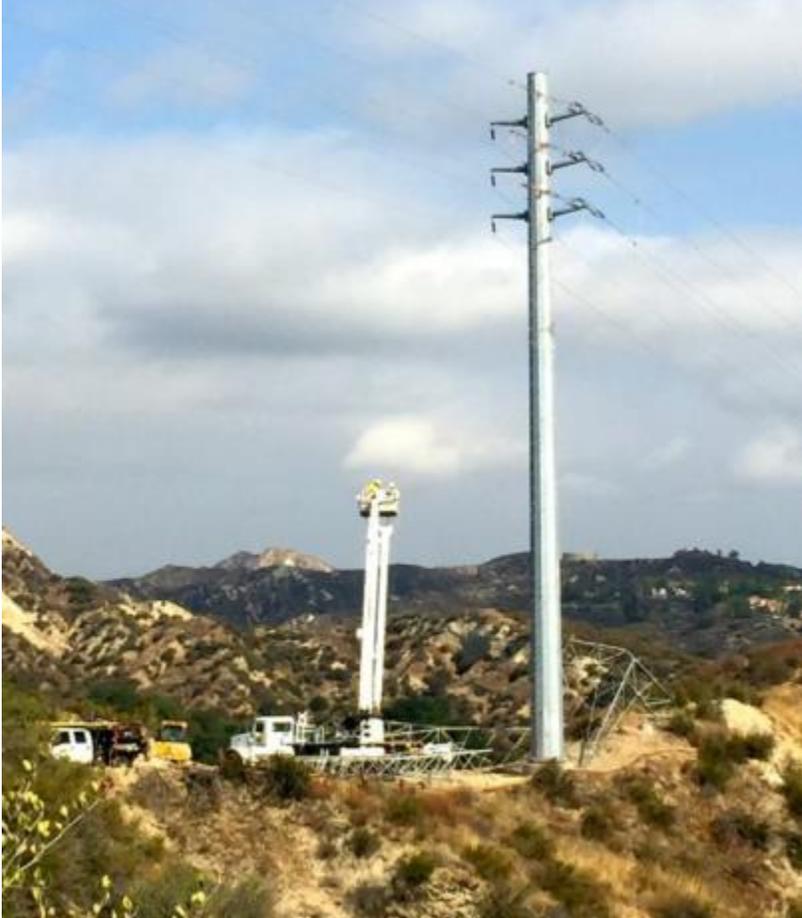
<p>A crew is working on the wires and taking down the old lattice work tower.</p>

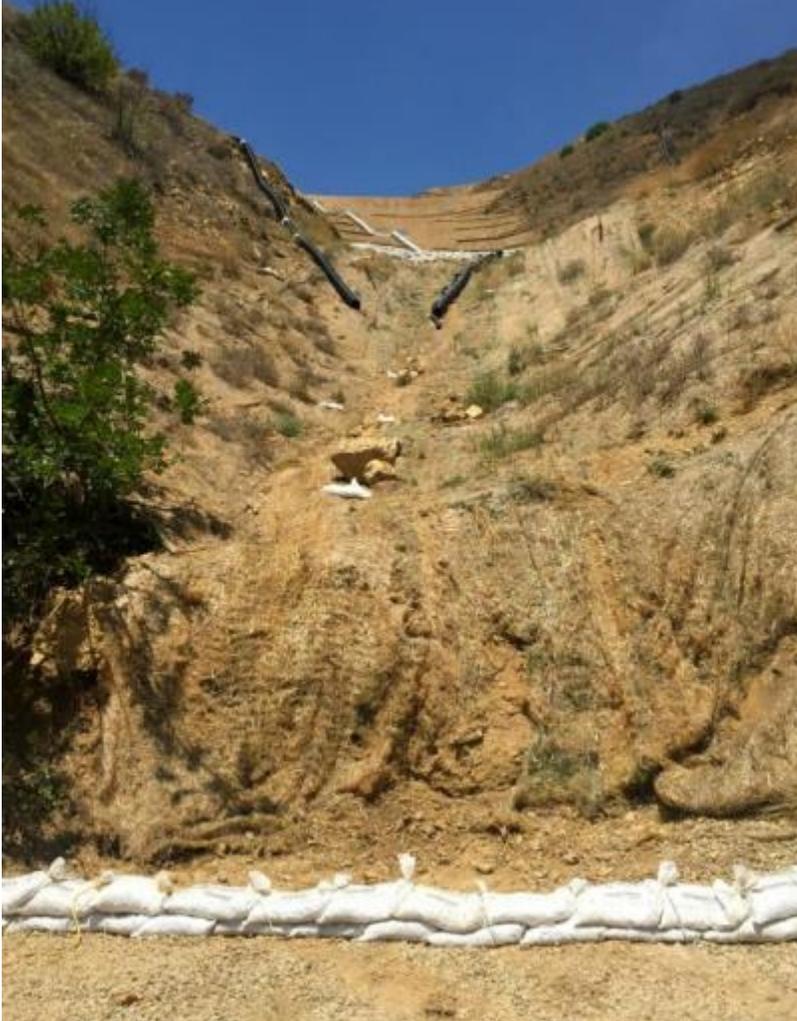
Lower portion of the fill site; some BMP materials were installed prior to the rain event that came through over the weekend.

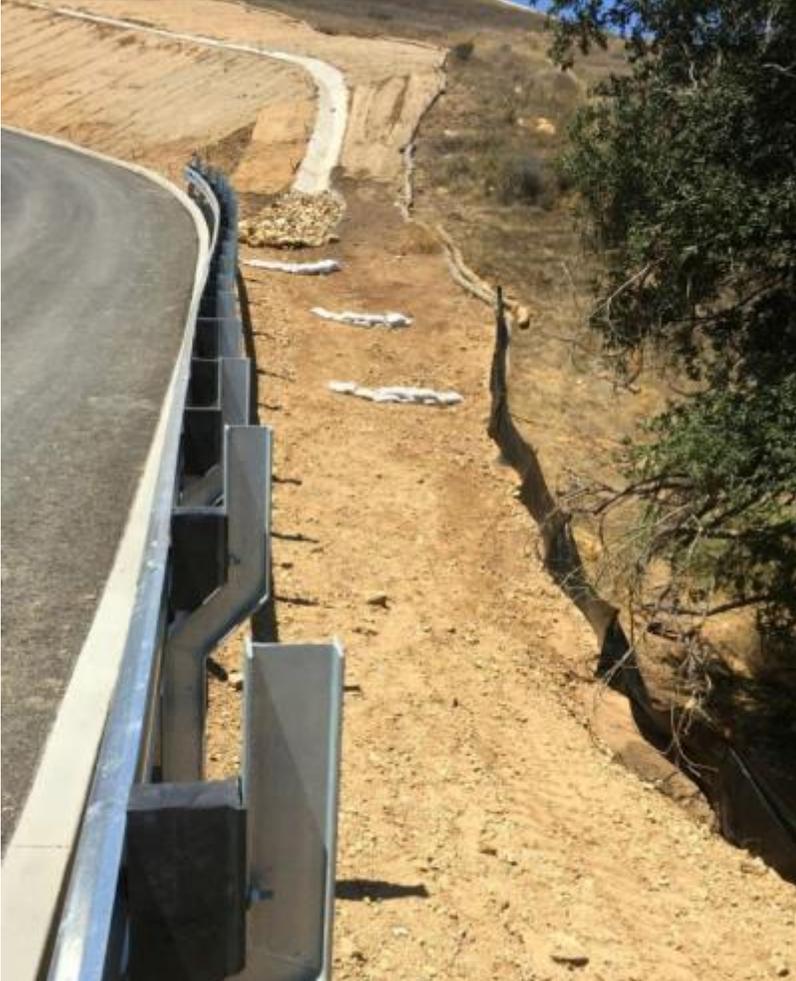
Date	Location	Photo	Description
7/23/15	Natural Substation access road

Rainwater runoff moved sediment along the outside of the access road; the sediment was caught by the silt fence.
7/23/15	Natural Substation

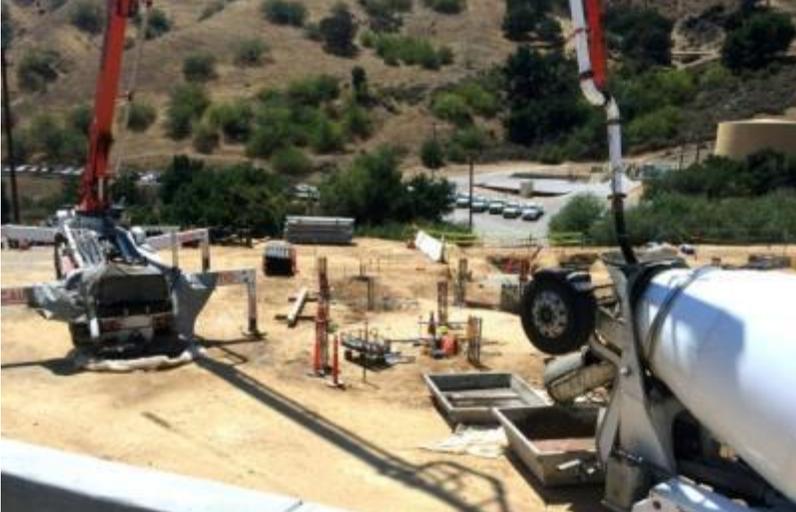
Concrete and slurry pours are ongoing.
7/23/15	TSP 40

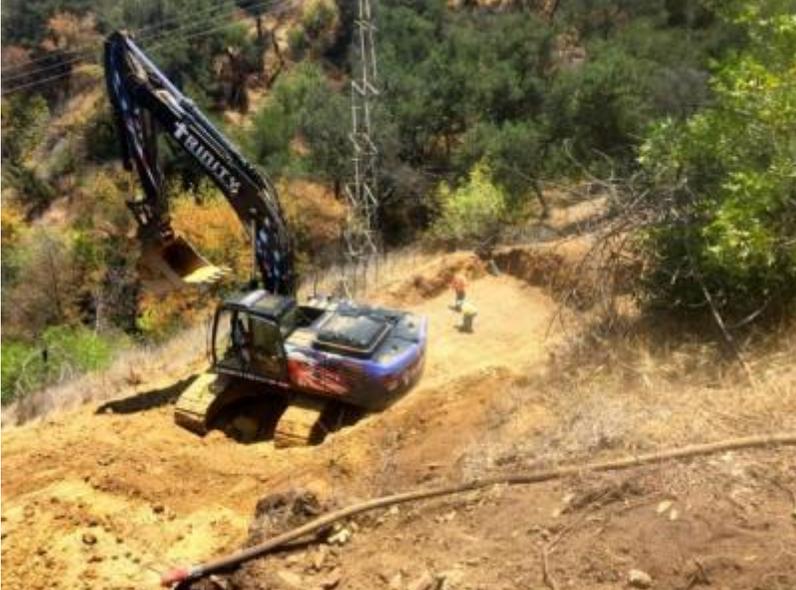
An excavator has cleared out the area for the Hillfiker wall and is now getting ready to begin backfilling the wall.

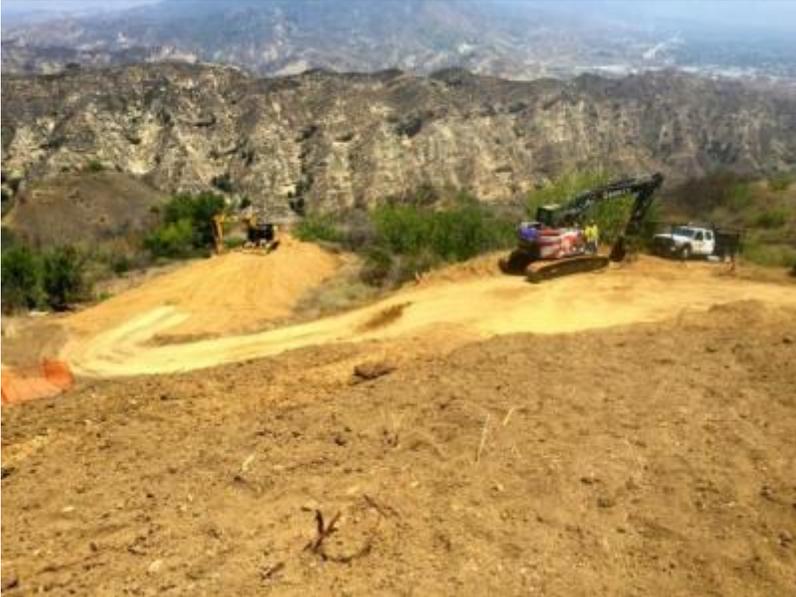
Date	Location	Photo	Description
7/23/15	Access road at TSP 40

The access road and extra work space has been cleared; the crew is stockpiling excavated soil along the old access road.
7/23/15	Access road near TSP 41

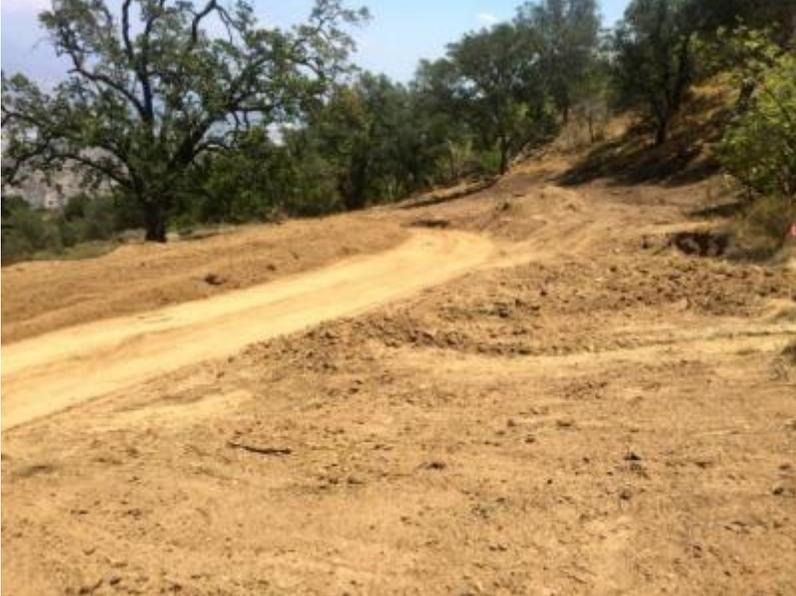
Topsoil has been stripped and stockpiled.

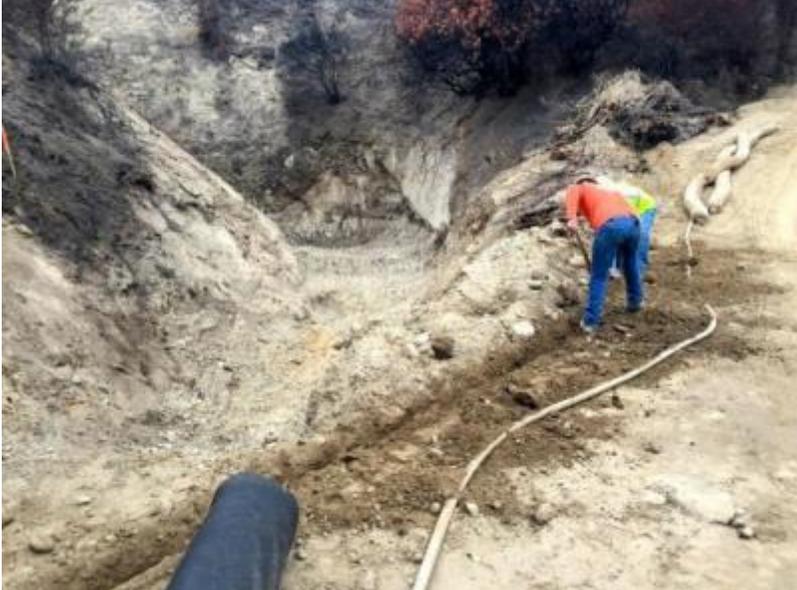
BMP material installation along the access road, above the jurisdictional drainage.
7/30/15	Access road to TSP 25

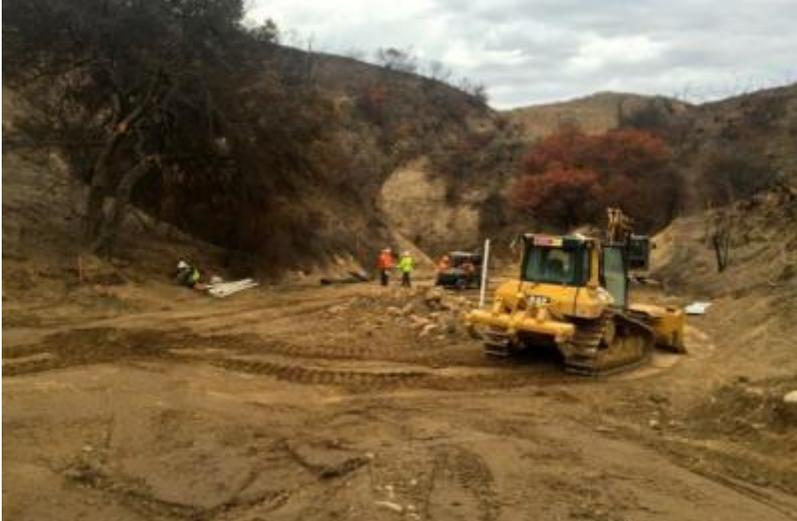
The drainage along the access road has been excavated and backfilled with more soil coming in from TSP 22.

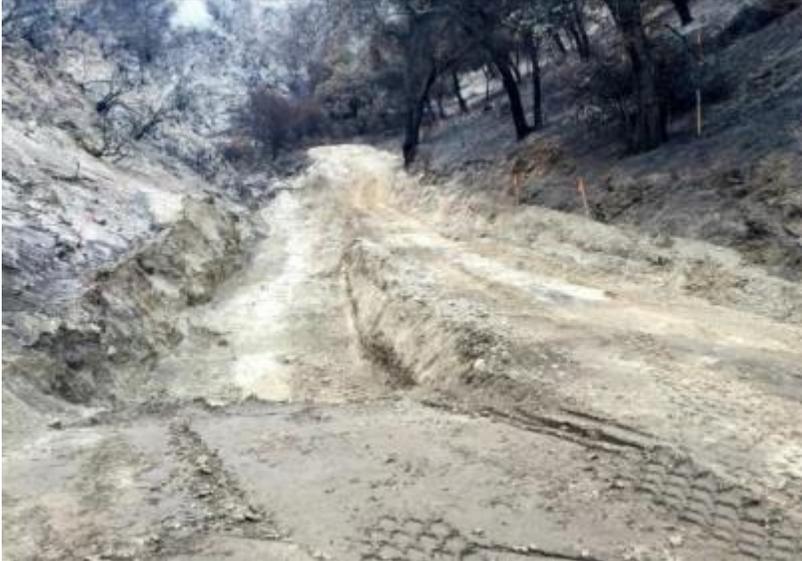
Date	Location	Photo	Description
7/30/15	Access road to TSP 25

Looking up the access road from the jurisdictional drainage.
7/30/15	TSP 22

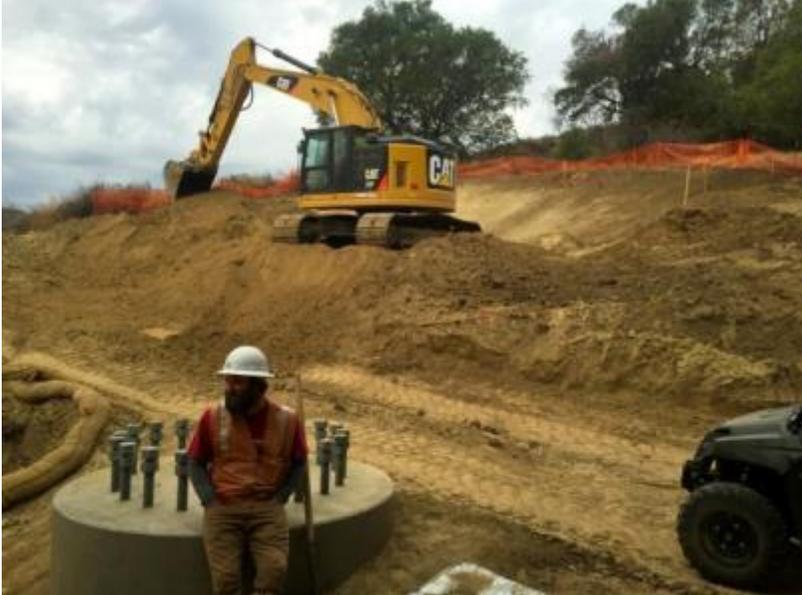
Excavation of the pull site is taking place with soil being transported to the TSP 25 area.
7/30/15	Pull site between TSP 21 and TSP 22

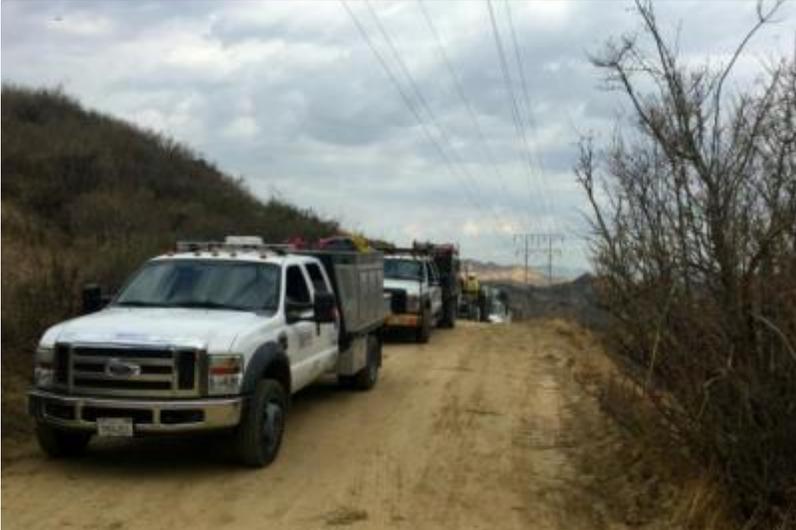
Date	Location	Photo	Description
7/30/15	TSP 18

Pole installation and wire stringing is ongoing.
7/30/15	TSP 19

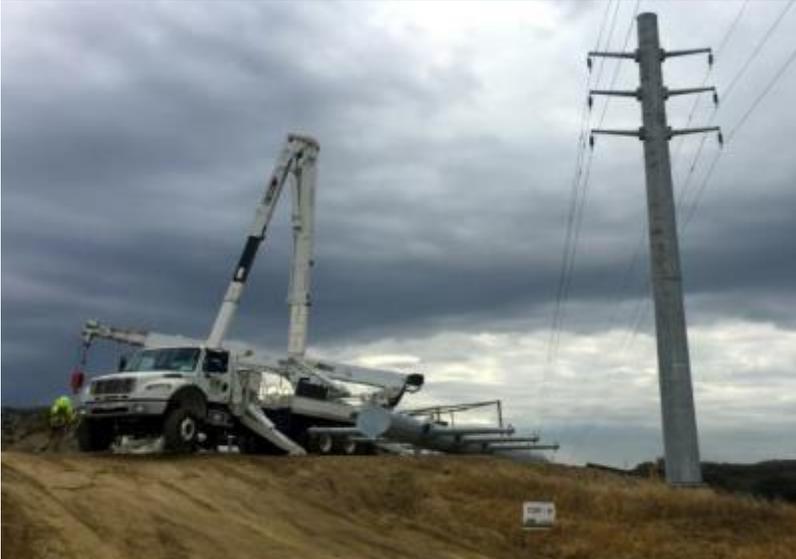
Pole installation and wire stringing is ongoing.
7/30/15	TSP 35

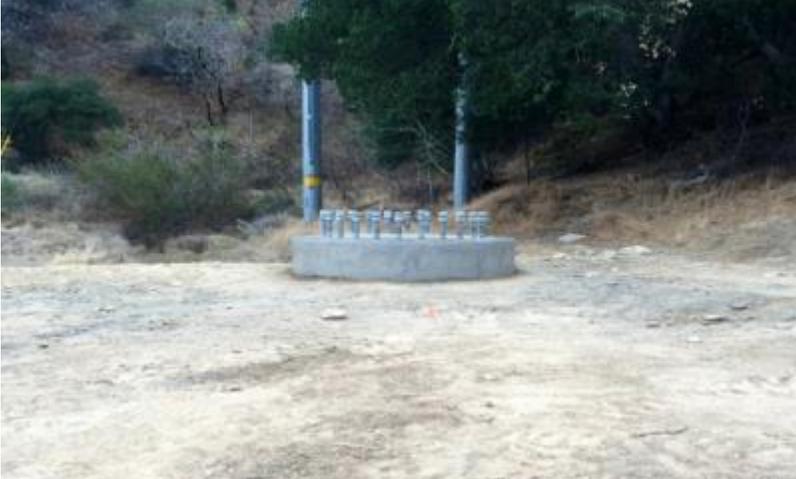
The foundation for the new pole has been drilled and poured.

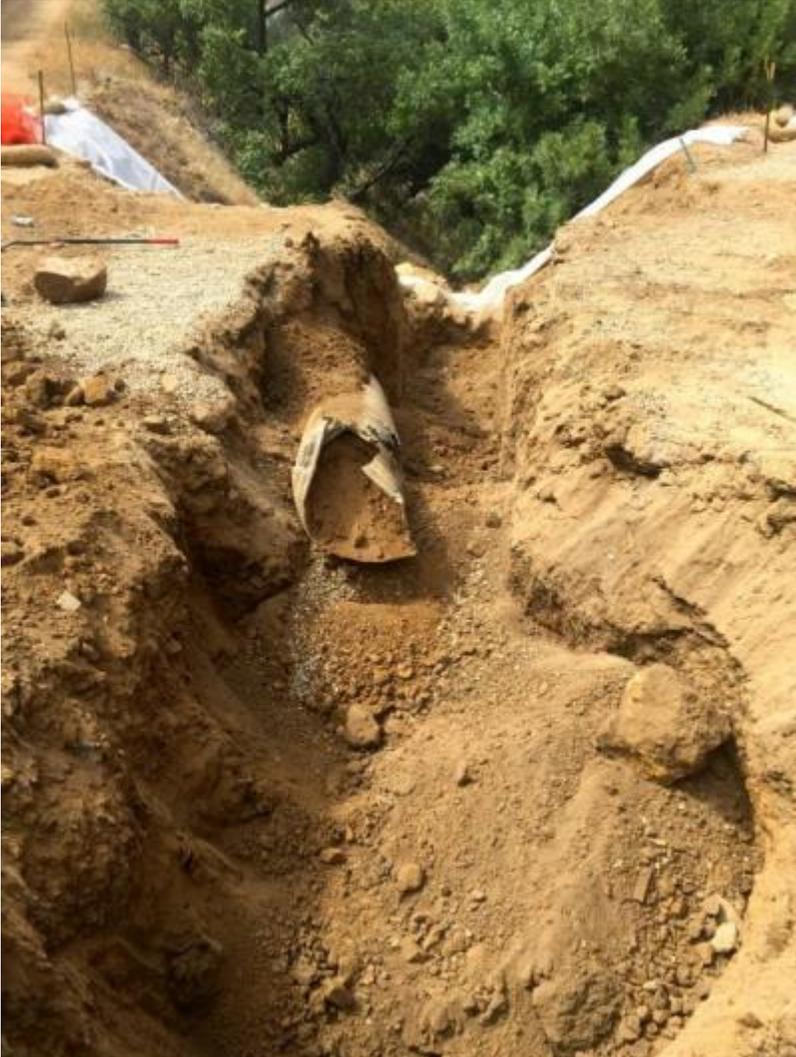
Date	Location	Photo	Description
7/30/15	PS-42 Fill Site

The culvert trench was being excavated, beginning with the removal of the old pipe.

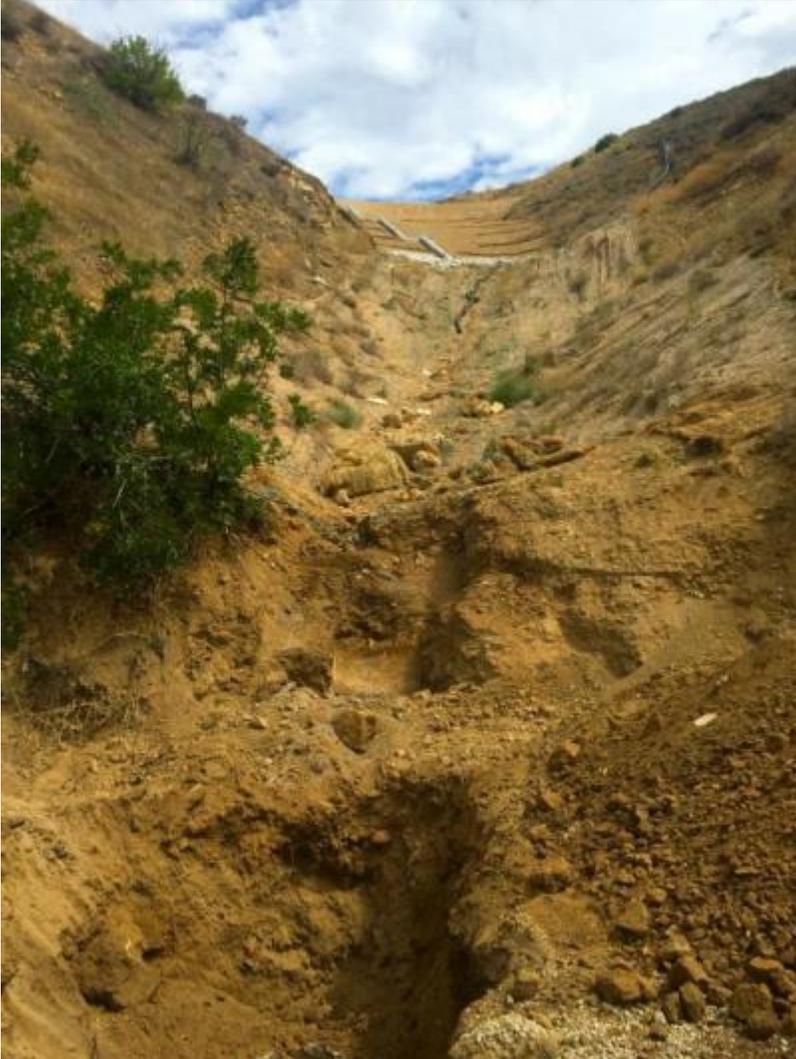
Date	Location	Photo	Description
7/30/15	PS-42 Fill Site

Lower portion of the fill site – work on the box culvert and drain pipe has been initiated.
7/30/15	Natural Substation

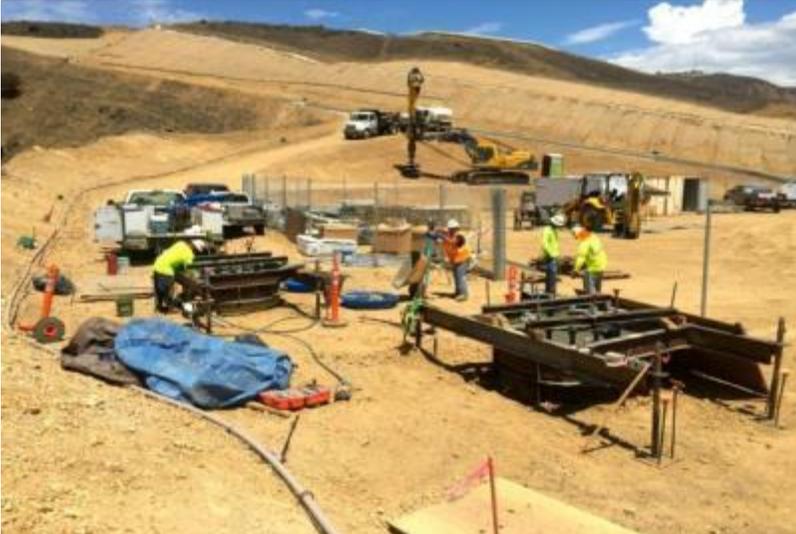
Date	Location	Photo	Description
7/30/15	Natural Substation

Two additional pole foundations have been drilled and poured.
7/30/15	Natural Substation

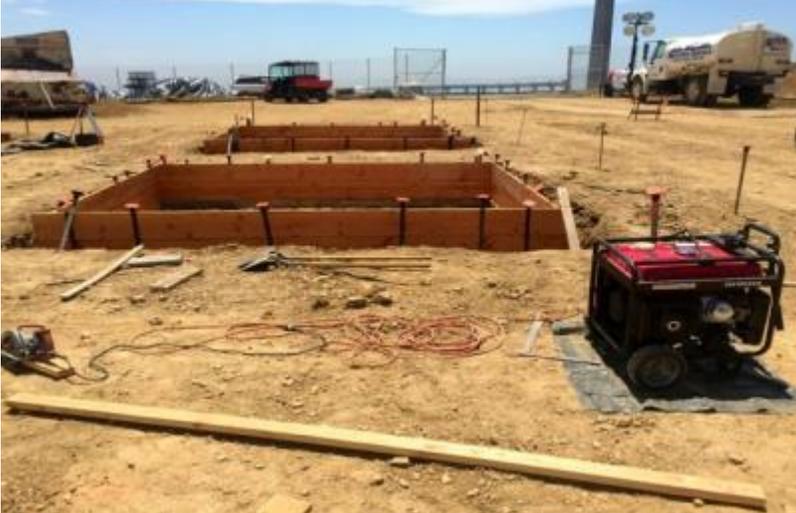
Forms have been built within the Natural Substation.
7/30/15	CCS

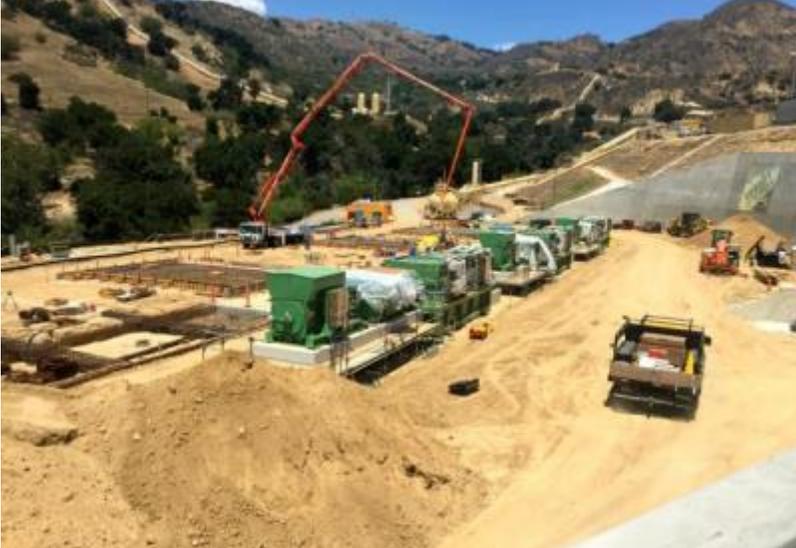
Equipment continues to be transported to the site for additional excavation and concrete pours.

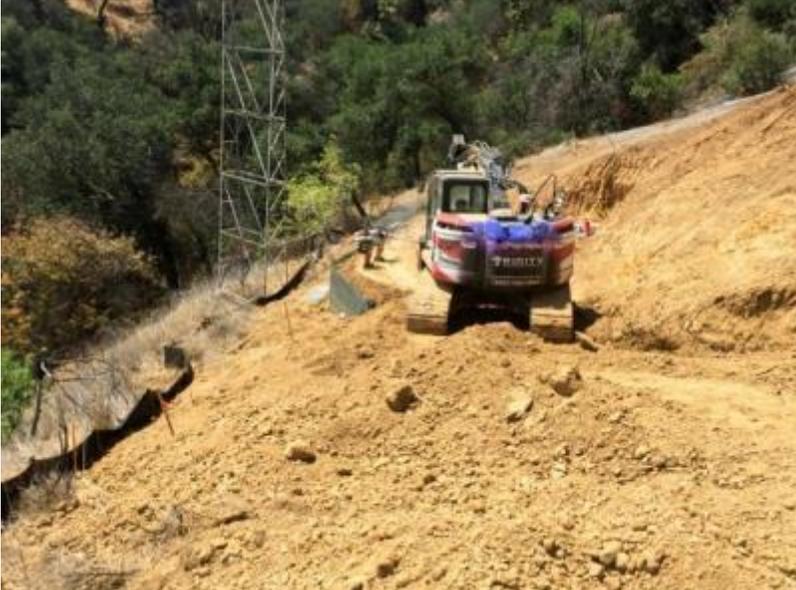
Date	Location	Photo	Description
7/30/15	TSP 40

<p>An excavator continues to build the Hillfiker wall next to the pole site – exclusion fencing has been installed.</p>
7/30/15	Access road at TSP 40

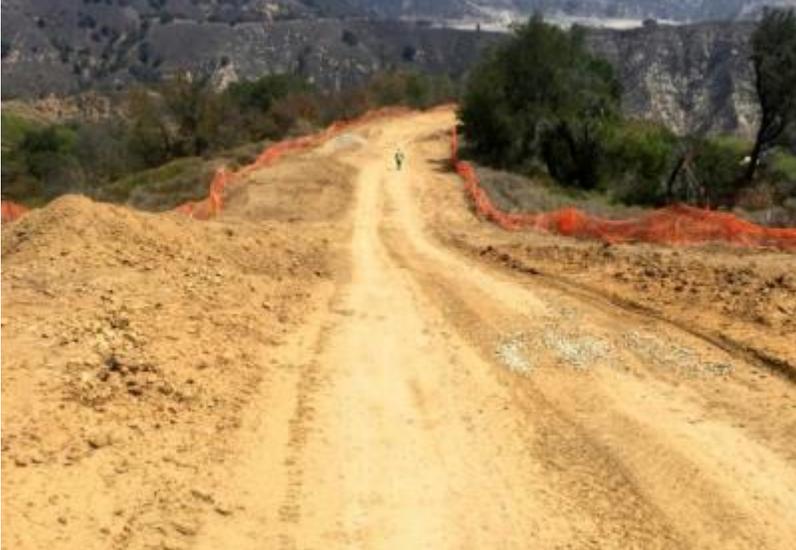
<p>The access road to TSP 40 has been cleared and fenced.</p>
