Re: Monthly Report Summary #7 for Aliso Canyon Turbine Replacement Project

Aliso Canyon Turbine Replacement Project CPUC Site Inspection Form

Project:	Aliso Canyon Turbine Replacement	Date:	October 2, 2014
Project Proponent:	Southern California Gas Company and Southern California Edison	Report #:	VS025
Lead Agency:	California Public Utilities Commission	Project Phase/NTP:	Guard House and Road Widening Component (NTP-1), The New Admin/IM Building and the CCS Site (NTP-3). P-43 Fill Site (NTP-2), PS-42 Fill Site, and the PS-42 rock site and temporary fill site.
CPUC PM:	Andrew Barnsdale, Energy Division	AM/PM Weather:	Sunny, clear day with mild temps (80 to 85 degrees) – windy with gusts up to 35 mph.
E & E CM:	Lara Rachowicz	Start/End time:	0930 hrs to 1145 hrs
Monitor(s):	Vince Semonsen		
Project Component(s):	CPUC Oversight: Guard House, New Admin/IM Building, CCS Site, P-41, PS-42 & P-43. Kiewit area.

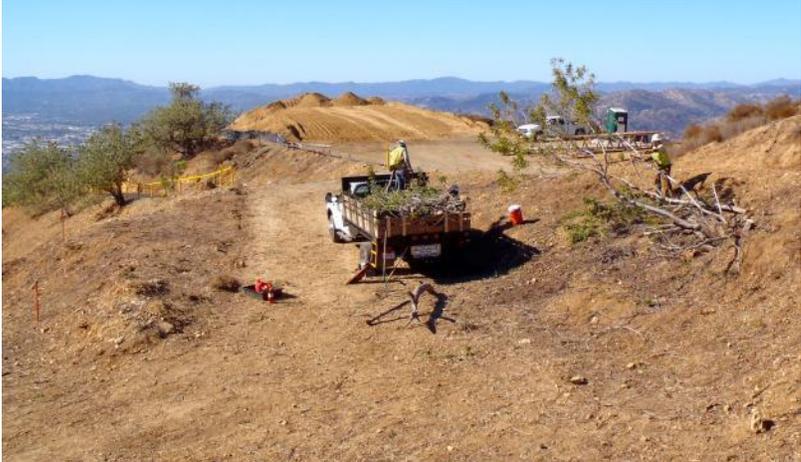
REPRESENTATIVE SITE PHOTOGRAPHS			
Date	Location	Photo	Description
10/2/14	PS-42 Fill Site

Vegetation clearing within the PS-42 fill site is nearly complete with crews clearing the last walnut trees - see photo. This activity is being overseen by Biological Monitor Juan Miranda (APM BR-1d & APM BR-6); no wildlife have been recently seen and/or relocated during the oversight of this work. Able - the crew foreman – expects the work to be completed by Monday of next week. No gas powered equipment is being used because of the hot and windy conditions.

Brush clearing continues at the PS-42 fill site with crews working on tree removal. They expect to finish on 10/6/14.
10/2/14	PS-42 Fill Site

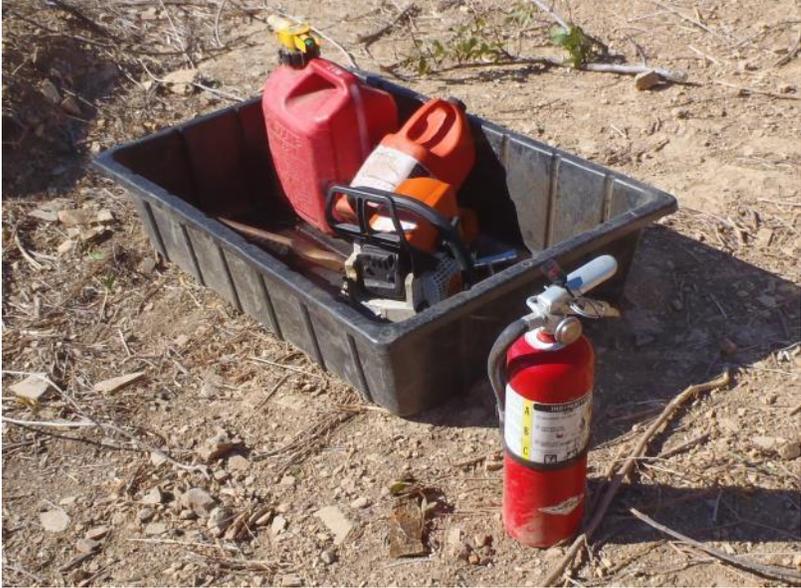
Veg clearing crews have a fire extinguisher onsite and keep all of their fuel and gas powered equipment in a plastic container. Power equipment was not being used because of the high winds and extremely hot and dry conditions.
10/2/14	PS-42 Rock Site and Temporary fill site.

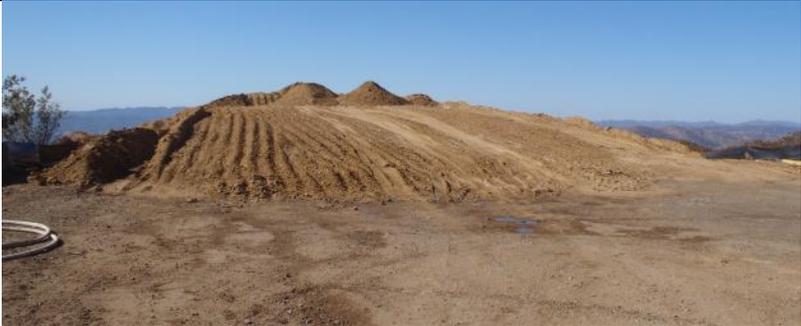
Rocky soil has been brought up to the PS-42 site. The pile has been kept wet to prevent dust during the hot and windy conditions.

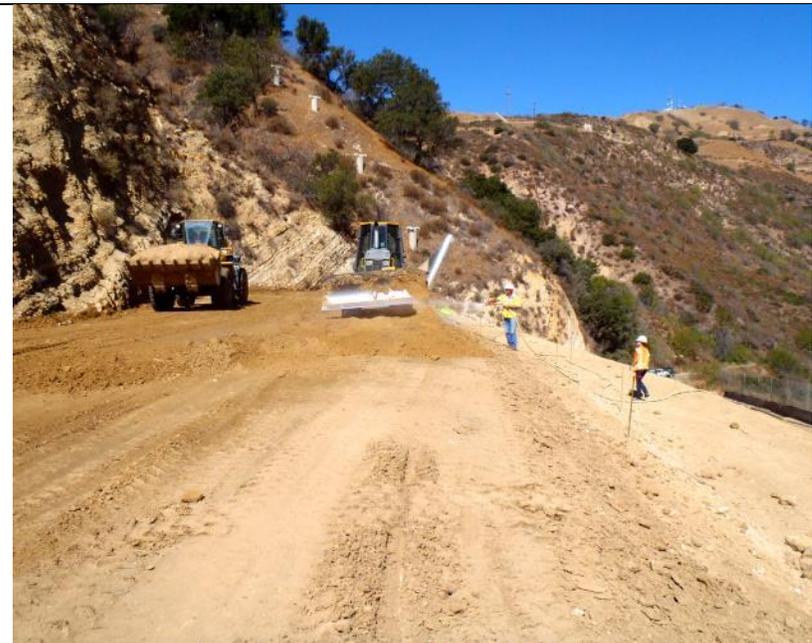
<p>10/2/14</p>	<p>P-43 stockpile area</p>

<p>Work at the P-43 stockpile site continues with soil again being brought to the site from the New Admin/IM Building.</p>
<p>10/2/14</p>	<p>New Kiewit Parking and Trailer Area</p>

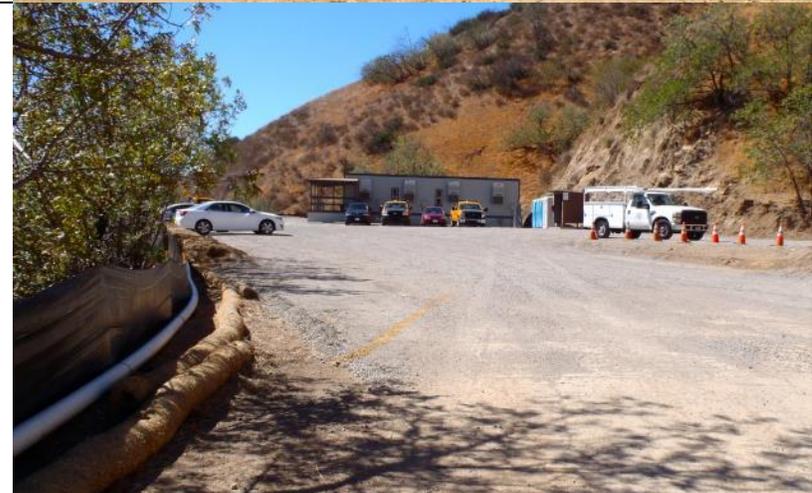
<p>An above ground water line has been installed to the Kiewit trailers.</p>
<p>10/2/14</p>	<p>New Admin/IM Building</p>

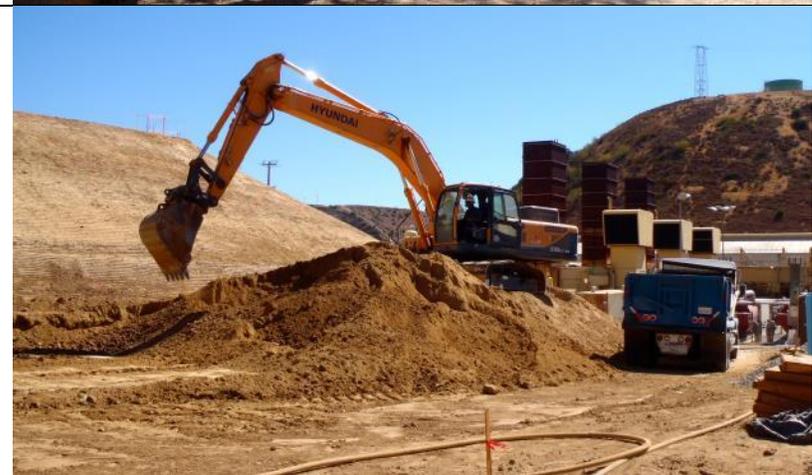
<p>Soil continues to be excavated and loaded into dump trucks for transport to the PS-42 sites.</p>

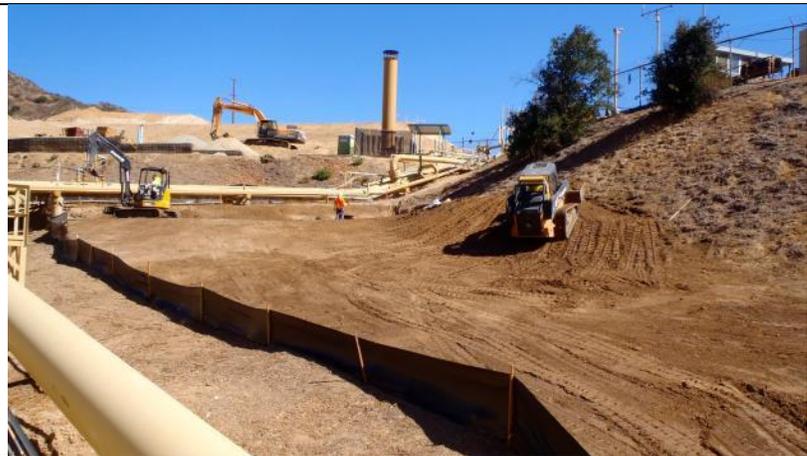
10/2/14	CCS Site

<p>The geotech drilling finished on the day of my site visit. The drill rig moved off the site and a crew was restoring and recontouring the area.</p>
10/2/14	Guard House

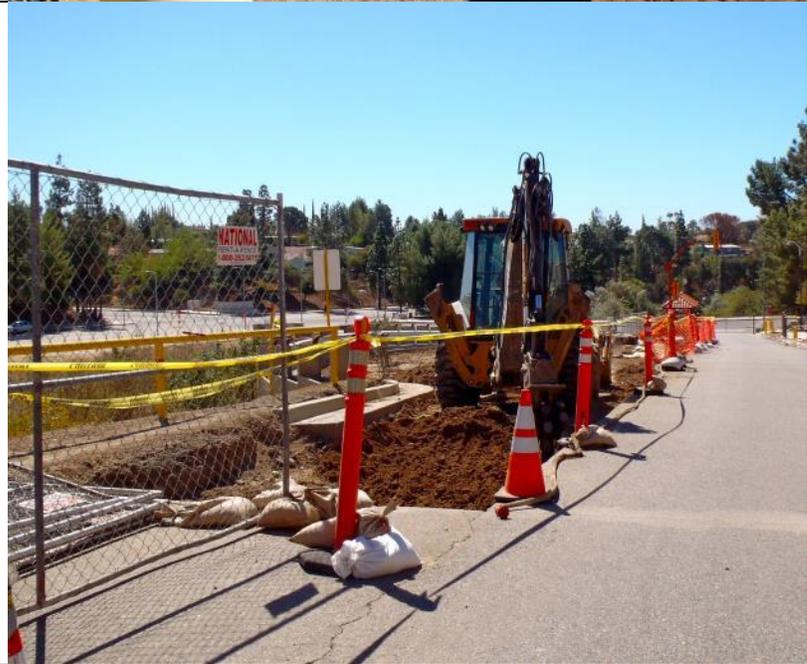
<p>Work at the guard house continues under the existing roadway.</p>

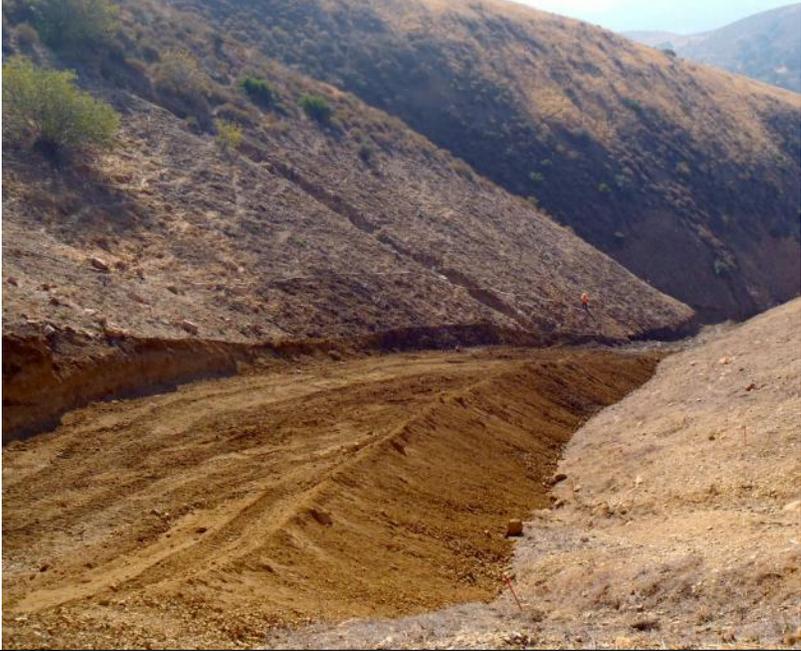
REPRESENTATIVE SITE PHOTOGRAPHS			
Date	Location	Photo	Description
10/9/14	PS-42 Fill Site

A D-8 dozer has cut a road down through the bottom of the PS-42 fill site.
10/9/14	PS-42 Fill Site

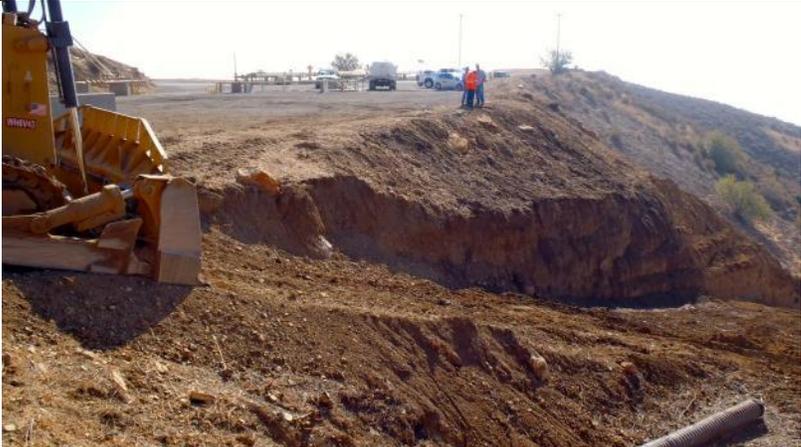
The dozer sitting at the top of the fill site.
10/9/14	PS-42 Rock Site & Temporary fill site.

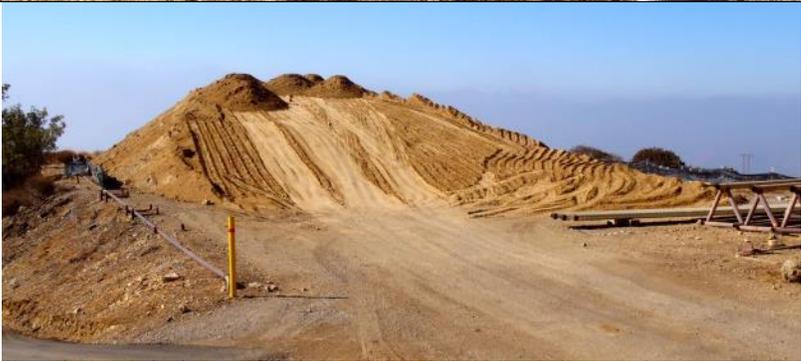
Rocky soil continues to be brought up to the PS-42 site.

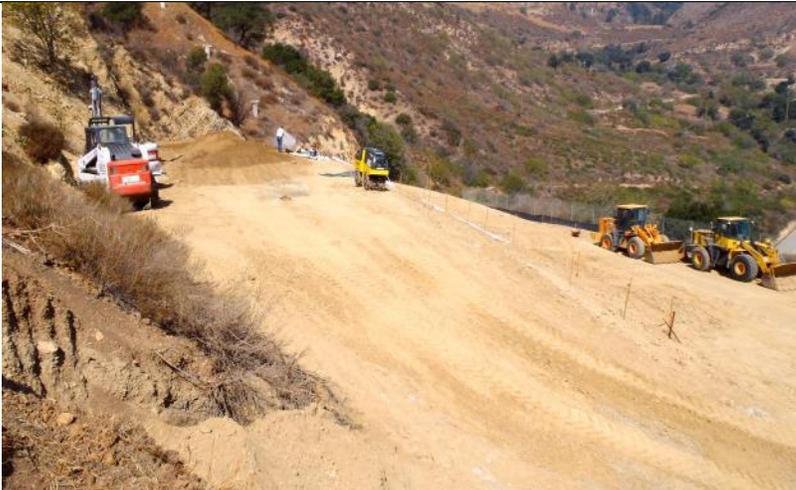
10/9/14	P-43 stockpile area

Work at the P-43 stockpile site continues with soil again being brought to the site from the New Admin/IM Building.
10/9/14	New Admin/IM Building

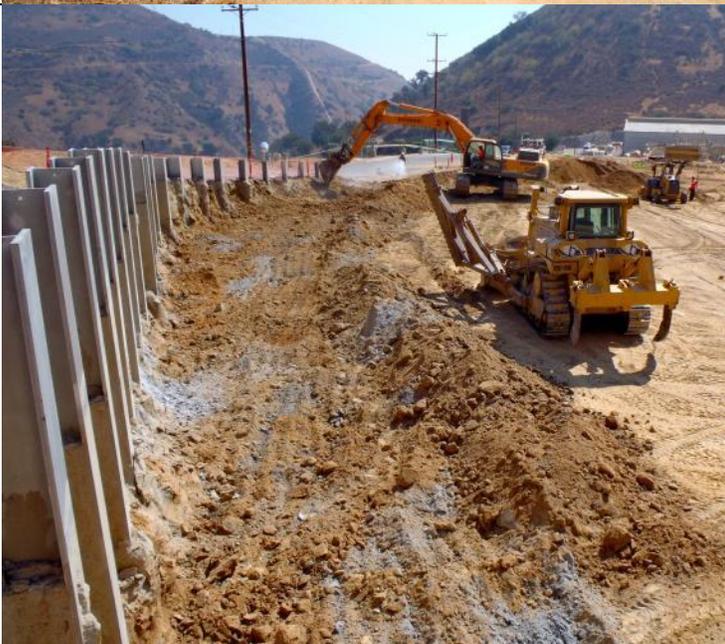
The area continues to be prepared with soil being pulled away from the caissons.
10/9/14	New Admin/IM Building

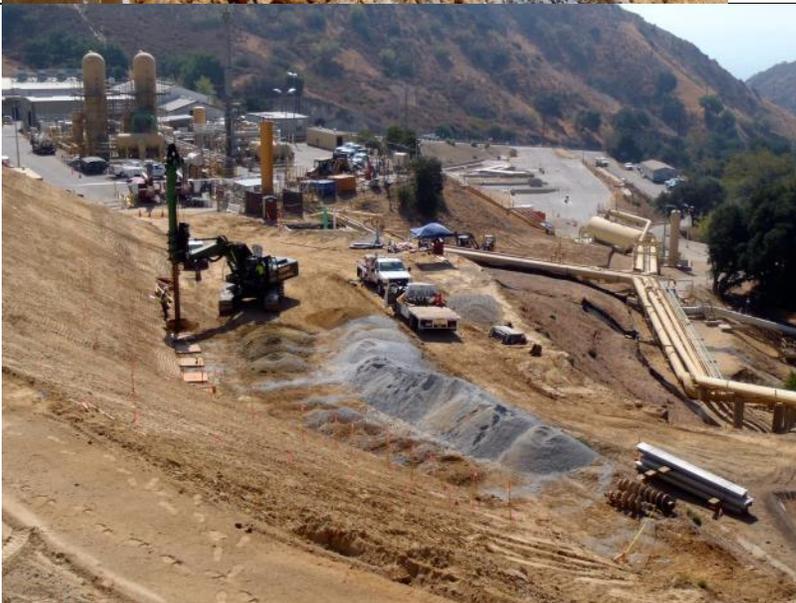
A drilling rig is excavating holes for additional caissons at the mid slope location within the Admin/IM Building site.

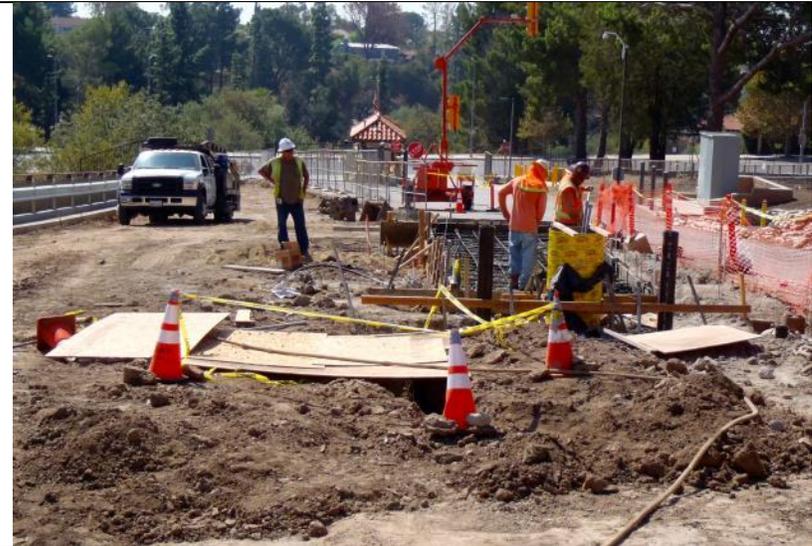
Work continues at the guard house with concrete being poured for the new guard house foundation. The concrete trucks are washing out in an established basin within an existing soil stockpile location – see photos.

<p>Crews are pouring the foundation of the new guard house.</p>
<p>10/9/14</p>	<p>Guard House</p>

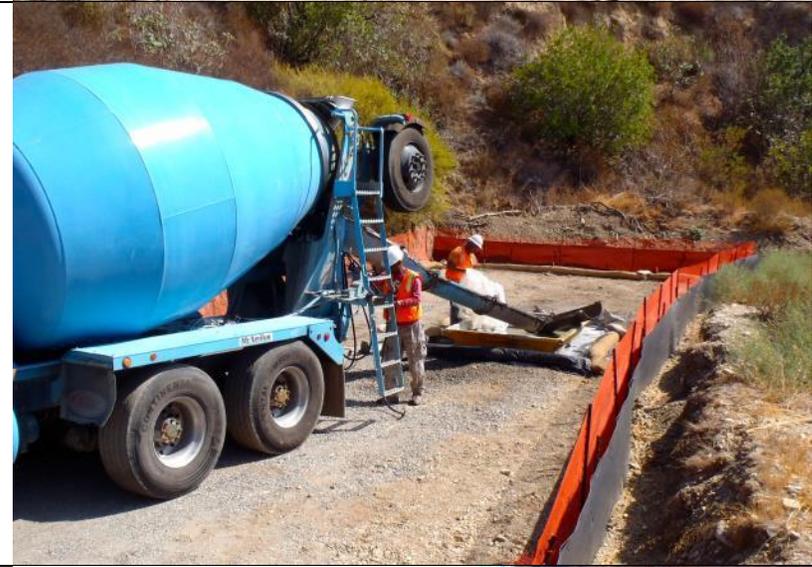
<p>A concrete washout catch basin has been set up in one of the soil stockpile areas.</p>
<p>10/9/14</p>	<p>P-41</p>

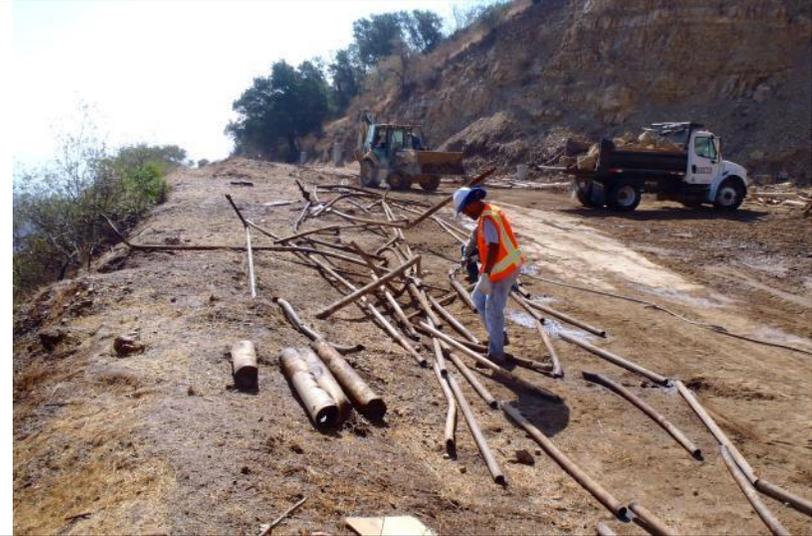
<p>Crew hot cutting piping at the P-41 site.</p>

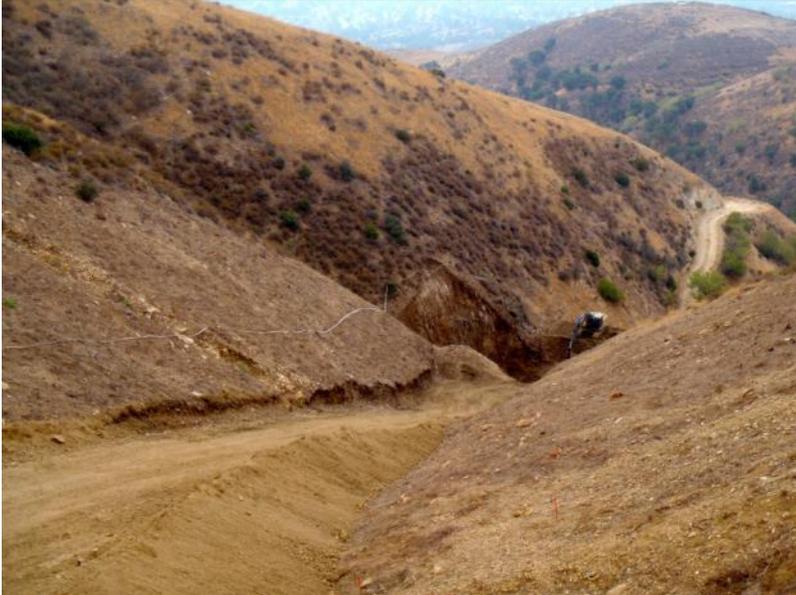
Date	Location	Photo	Description
10/17/14	PS-42 Fill Site

An excavator is cutting the first fill key at the bottom of the PS-42 fill site.
10/17/14	PS-42 Fill Site

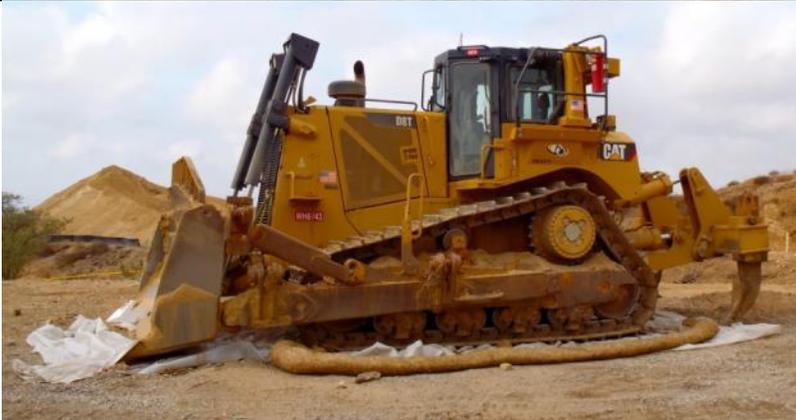
The D-8 is parked on the well pad. It is parked on visqueen and ringed with wattles.
10/17/14	PS-42 Rock Site & Temporary fill site.

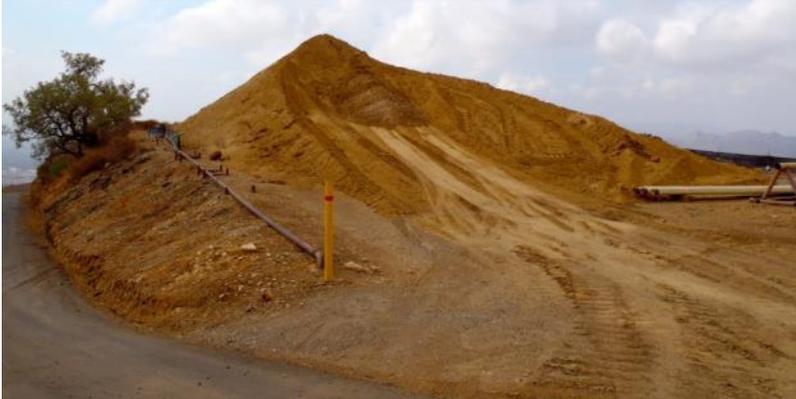
Amount of stockpiled rocky soil similar to the previous week.

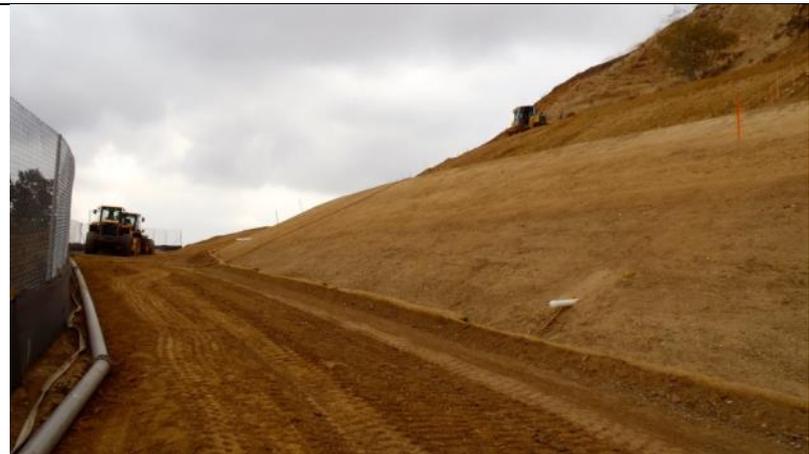
<p>10/17/14</p>	<p>P-43 stockpile area</p>

<p>They are finished bringing soil to the P-43 stockpile site – crews are just cleaning up the area.</p>
<p>10/17/14</p>	<p>New Admin/IM Building</p>

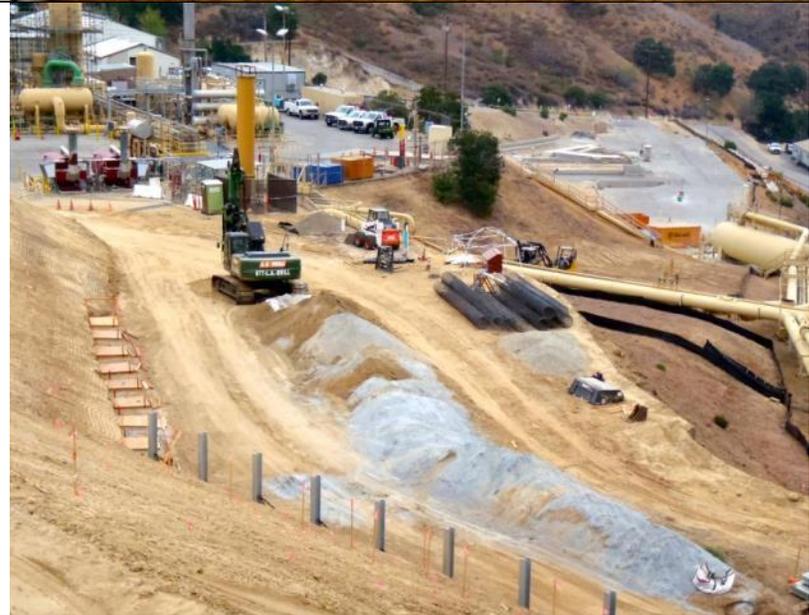
No work was being done at the New Admin/IM Building area. Several crews have shifted to a 4-10's schedule. A drilling rig was parked and I noted that a number of the caissons had been set and the other drilled caisson holes had been covered, per MM BIO-11.

<p>A drilling rig is onsite but no work is being done. Some caissons have been installed and the remaining open holes have been filled.</p>
<p>10/17/14</p>	<p>P-41 fill site.</p>

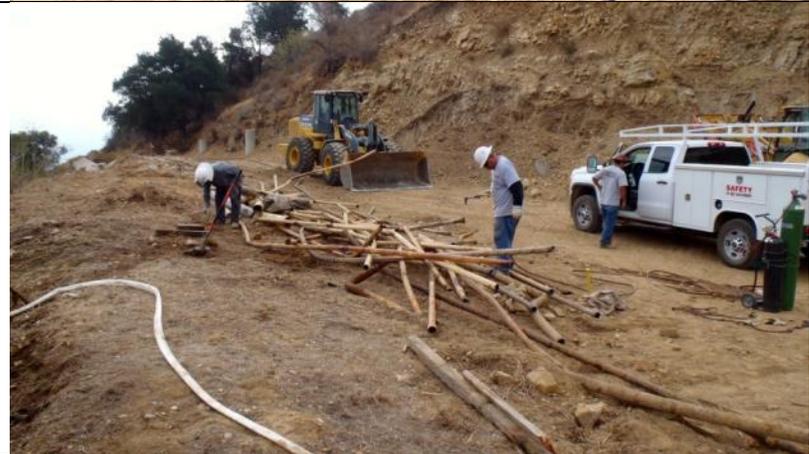
<p>Crews continue to hot cut piping at the P-41 site. Adequate fire prevention precautions appear to be in place.</p>

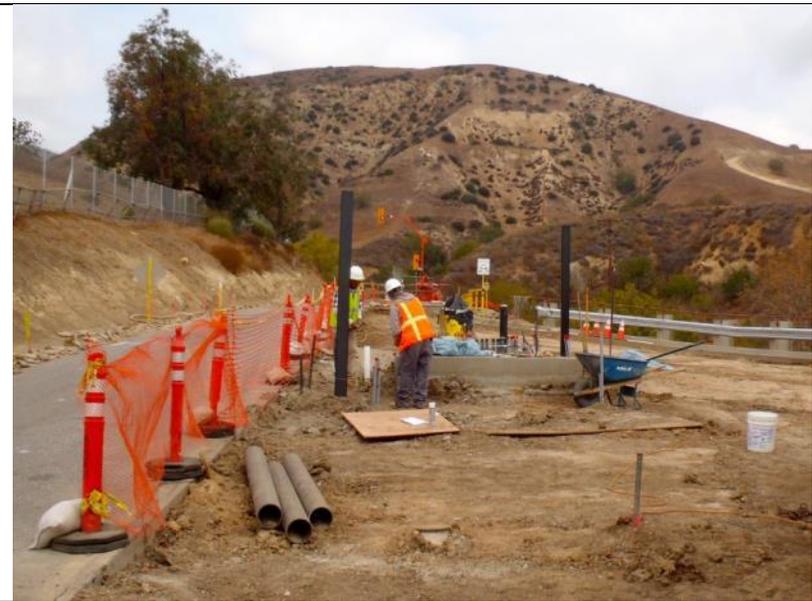
<p>10/17/14</p>	<p>Guard House</p>

<p>Crews are cleaning up the site following the pouring of the foundation for the new guard house.</p>
<p>10/17/14</p>	<p>PS-32 fill site.</p>

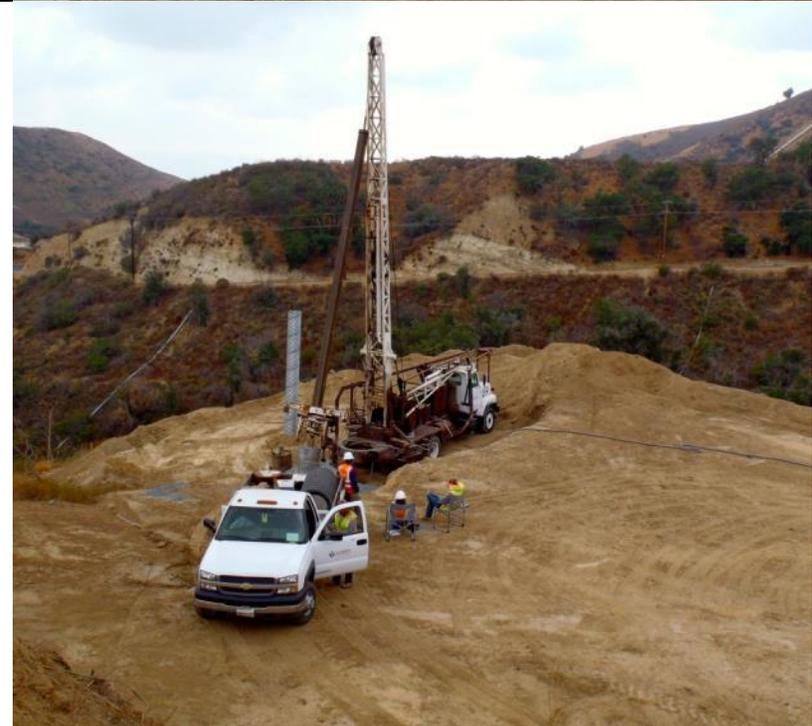
<p>Two geotech holes are being drilled at the PS-32 site.</p>
<p>10/17/14</p>	<p>PS-32 fill site.</p>

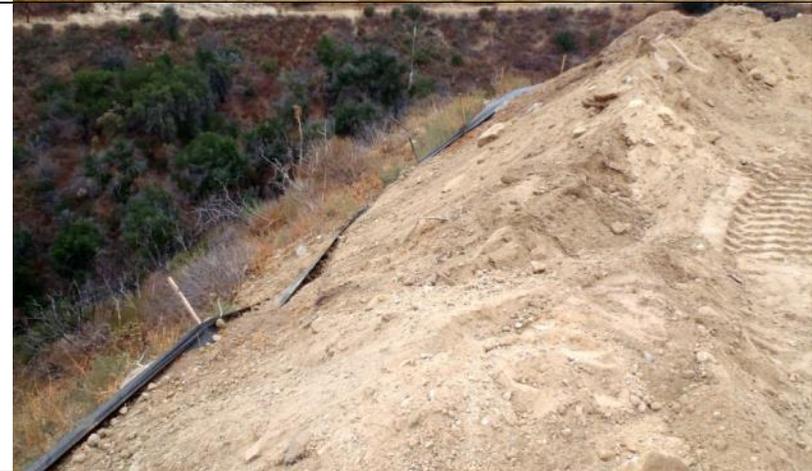
A drilling rig was working at the PS-32 fill site drilling two geotech holes – see photos. The silt fencing surrounding the work area was much degraded and needs to be repaired or replaced. I discussed this with Ms. Tierk and she was going to look into the issue.

<p>The silt fencing around the PS-32 site is in need of repair or replacement.</p>

The repair or replacement of the silt fencing at PS-32 should be checked.

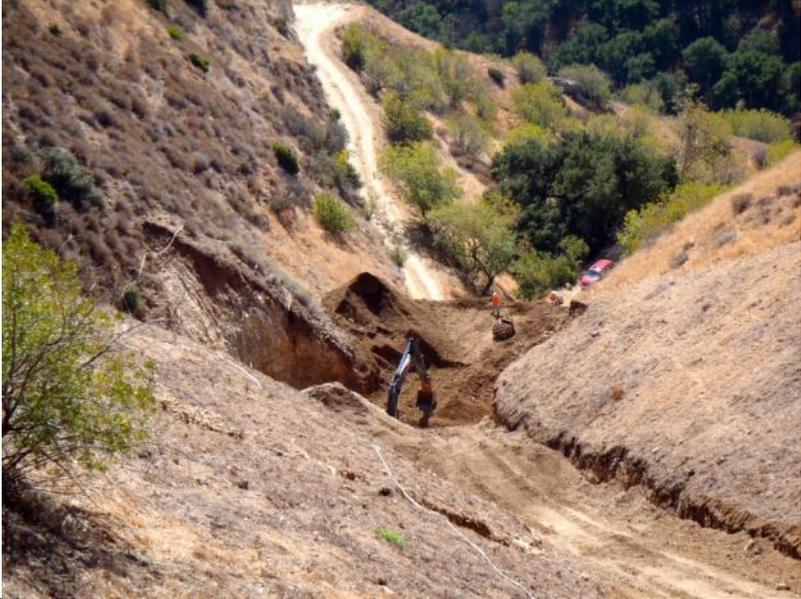
REPRESENTATIVE SITE PHOTOGRAPHS			
Date	Location	Photo	Description
10/23/14	PS-42 Fill Site

At the PS-42 fill site an excavator continues its work on the fill key at the bottom of the site - see photo. Biological Monitor Juan Miranda (APM BR-1d & APM BR-6) was spot checking the activities, along with Olivia Tierk the Arch/Paleo monitor (MM CR-1, MM CR-3, MM CR-6 & MM CR-8). No new discoveries of significance had been found by either monitor.

Work continues on the fill key at the bottom of the PS-42 fill site.
10/23/14	P-41 and P-43 Fill Sites

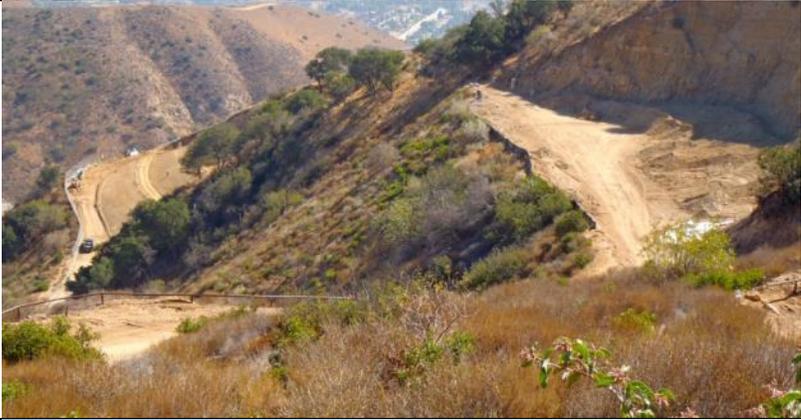
Photo taken from the P-41 access road showing both the P-41 and P-43 fill sites. No construction activity at P-41. Some clean-up of the P-43 site is ongoing.
10/23/14	Natural Substation.

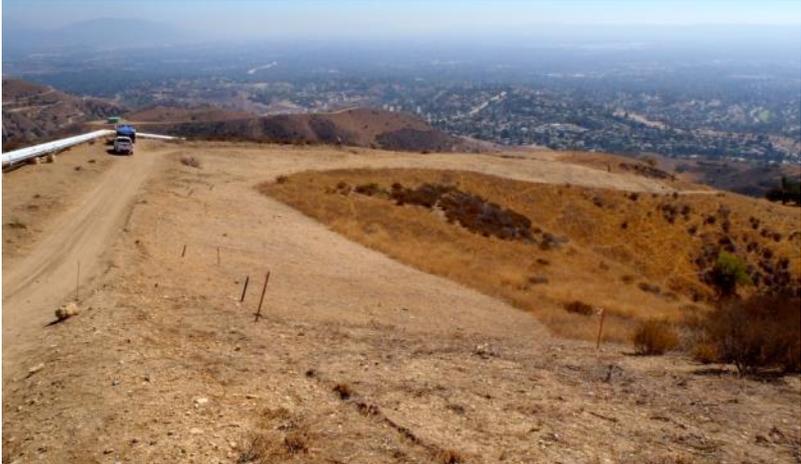
The new access route to the Natural Substation is being cleared of vegetation. Photo taken from the top of the road looking to the south and down toward the substation.

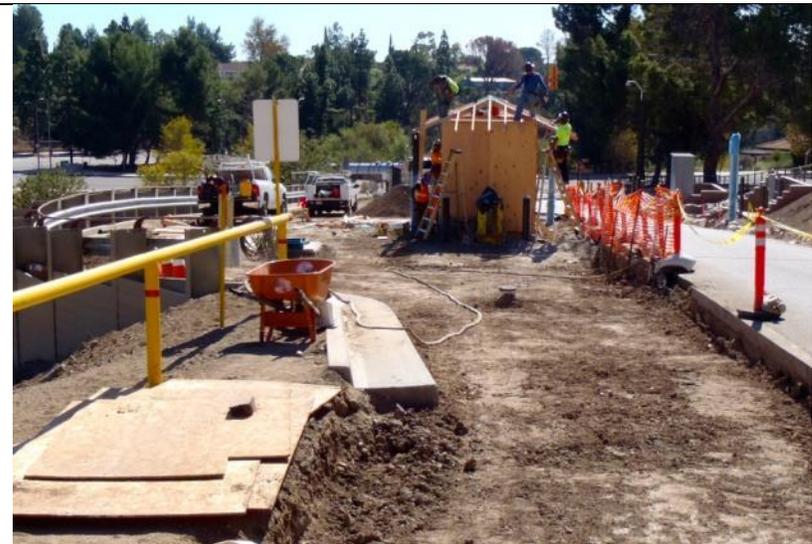
<p>10/23/14</p>	<p>Guard House</p>

<p>Crews are framing the new guard house.</p>
<p>10/23/14</p>	<p>PS-32 fill site.</p>

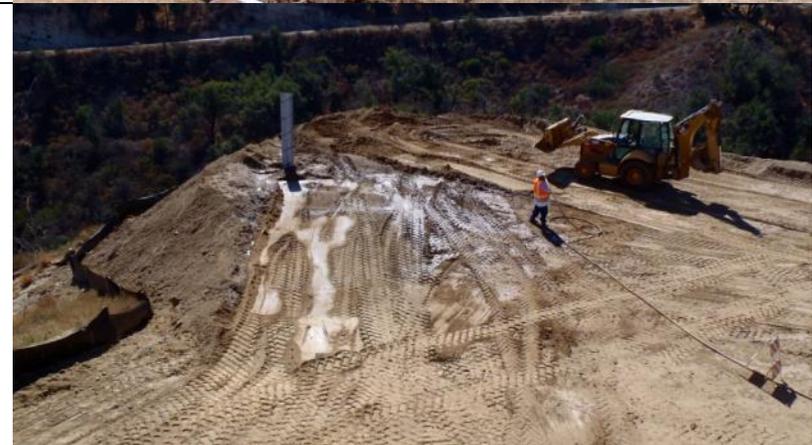
<p>Equipment is onsite and a crew is preparing the PS- 32 fill site.</p>
<p>10/23/14</p>	<p>PS-32 fill site.</p>

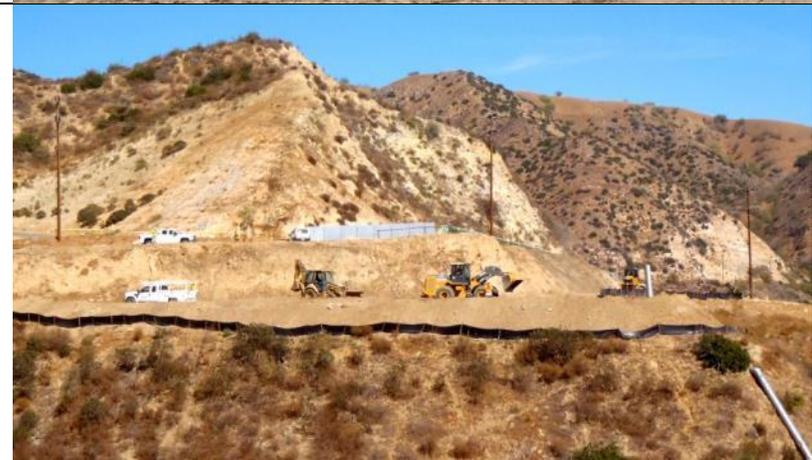
At PS-32 fill site, a small crew is moving and compacting dirt in preparation for accepting fill material. The silt fencing around the fill site has been replaced (APM BR-5) – see photos.

<p>New silt fencing has been installed around the PS-32 site. The photo was taken from a roadway to the west and across a small arroyo from the fill site.</p>

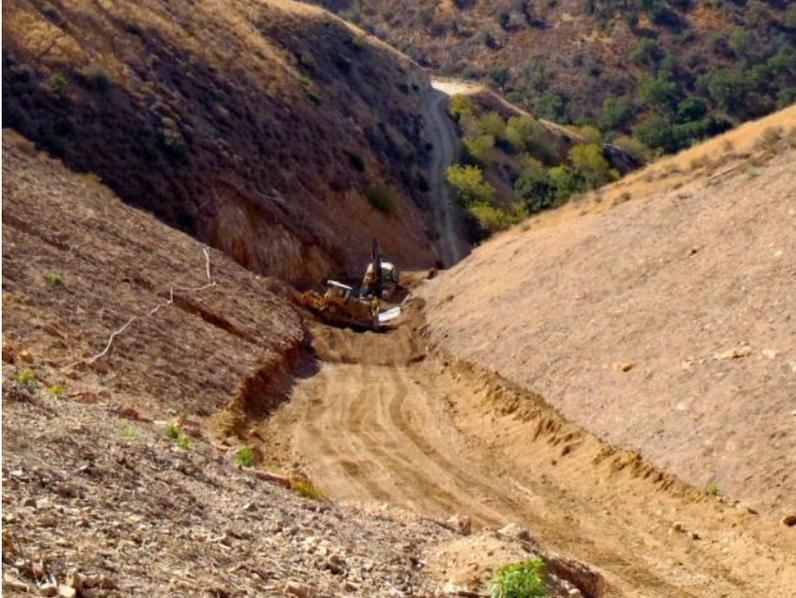
Date	Location	Photo	Description
10/30/14	PS-42 Fill Site

<p>Work continues on the fill key at the bottom of the PS-42 fill site with installation of drains and backfilling with pea gravel.</p>
10/30/14	PS-42 Fill Site

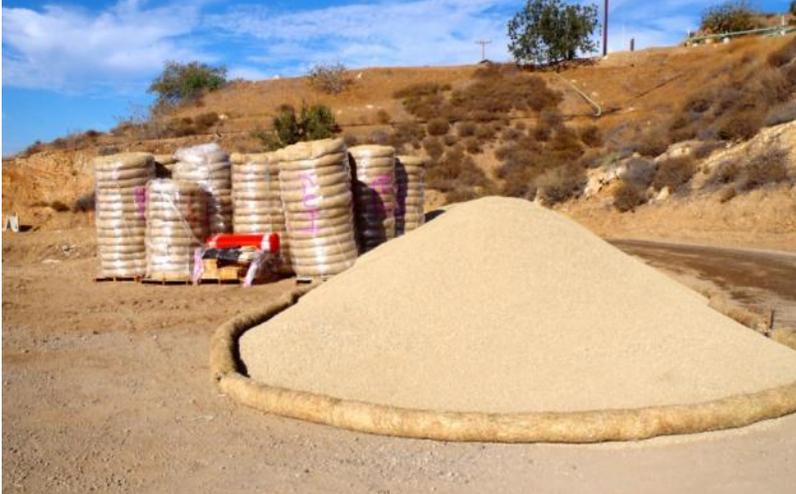
<p>Straw wattles have been stockpiled onsite but none have been installed on the steep, cleared PS-42 slopes.</p>
10/30/14	Natural Substation.

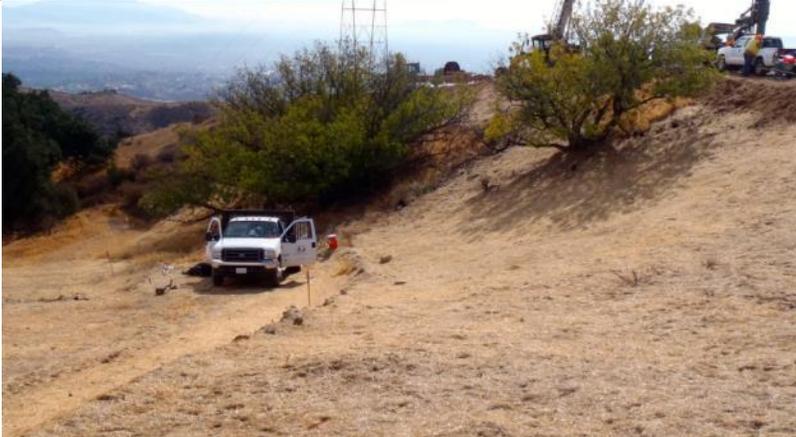
<p>The Quality Agriculture crews continue to clear the access route to the Natural Substation. Most of the grass and scrub vegetation has been removed and they are nearing the walnut trees. No animals have been relocated.</p>

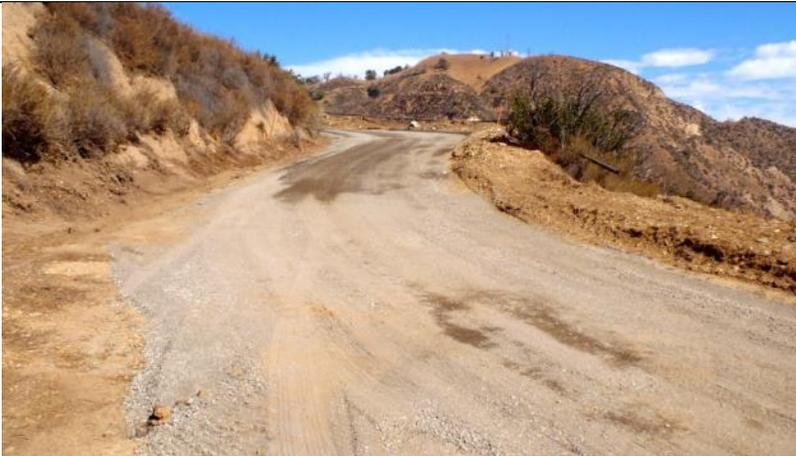
Road base has been layed down on the P-41 access road.
10/30/14	P-41

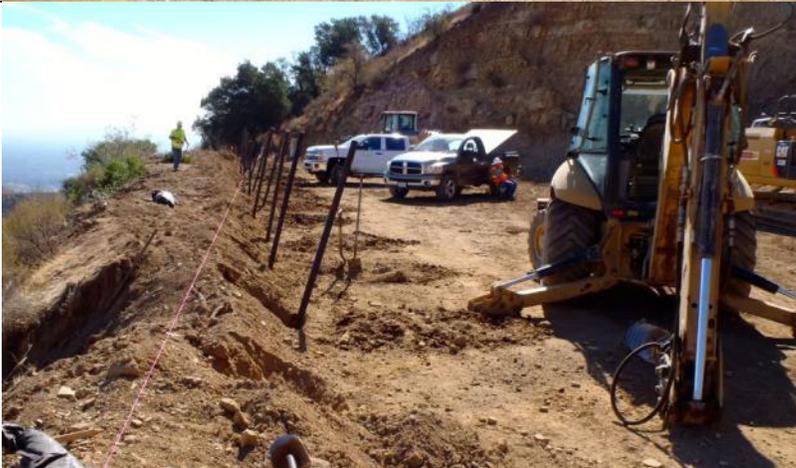
Holes have been drilled for a chain link fence. The pipe has been placed in the holes and according to the crew they should be poured by the end of the day.
10/30/14	New Admin/IM Building

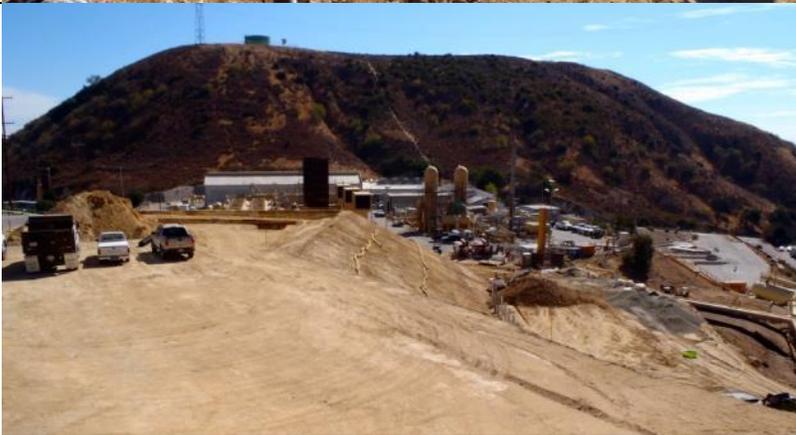
The New Admin/IM Building area did not have any work taking place – see photo. I noted that straw wattles have been installed on and at the base of the steeper cleared slopes.

No activity at the Admin/IM building site. Some BMPs are being installed.

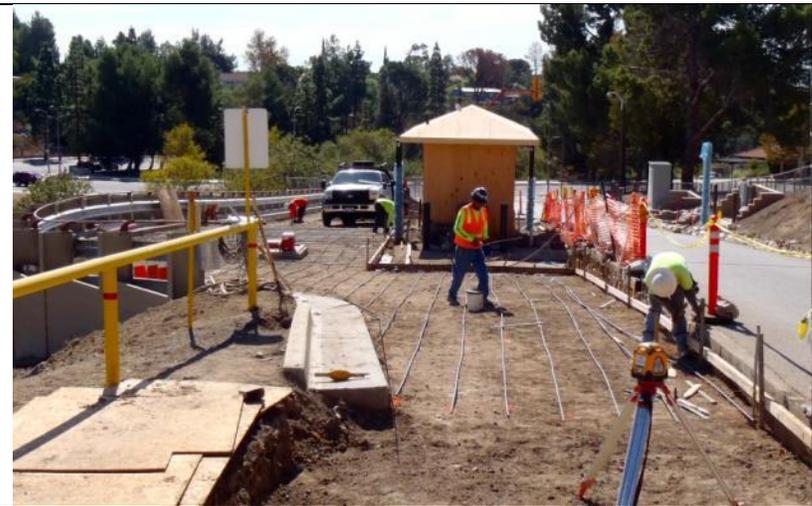
<p>10/30/14</p>	<p>Guard House</p>

<p>The framing is nearing completion and the crews are putting rebar down within the roadway in preparation for pouring the road.</p>
<p>10/30/14</p>	<p>PS-32 fill site</p>

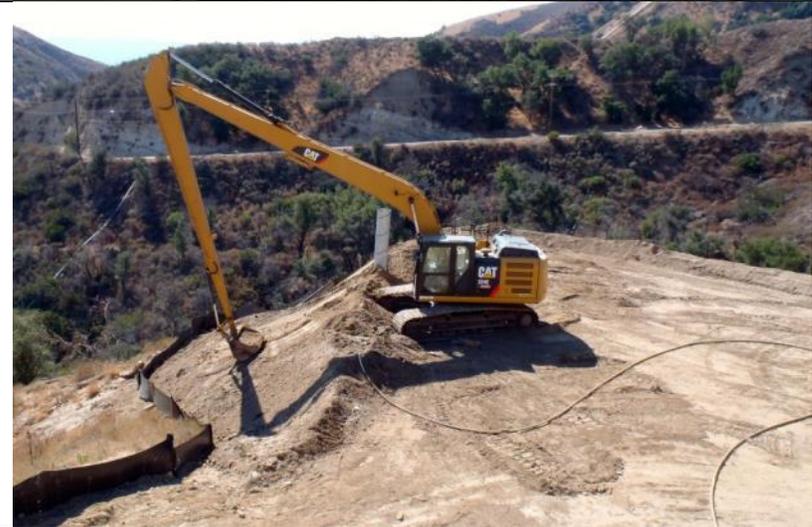
At PS-32 fill site an excavator is pulling back loose fill material from around the edges of the pad – see photo.

<p>Equipment continues to work the site with loose material being pulled back from the edges of the fill pad.</p>
<p>10/30/14</p>	<p>SCE – Natural substation</p>

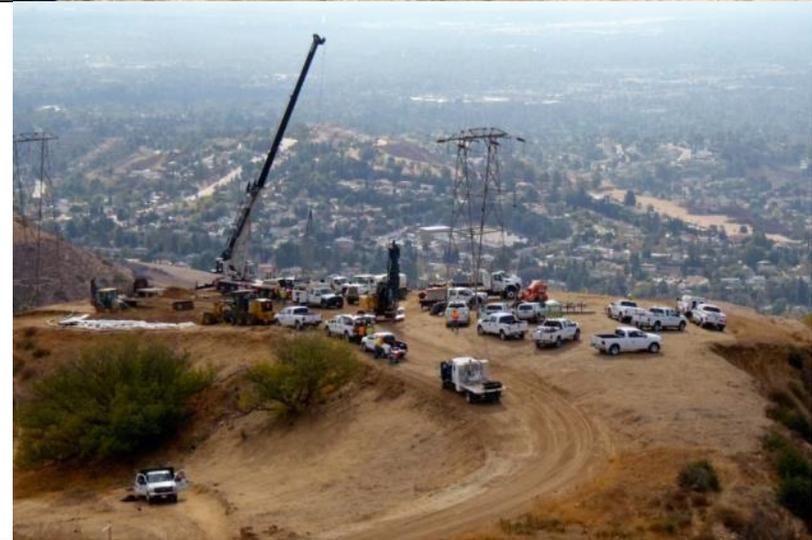
<p>SCE crews have begun work at the Natural substation. They have drilled TSP 47 and are dropping in the rebar cage. The photo was taken from the access road looking south toward the San Fernando Valley.</p>

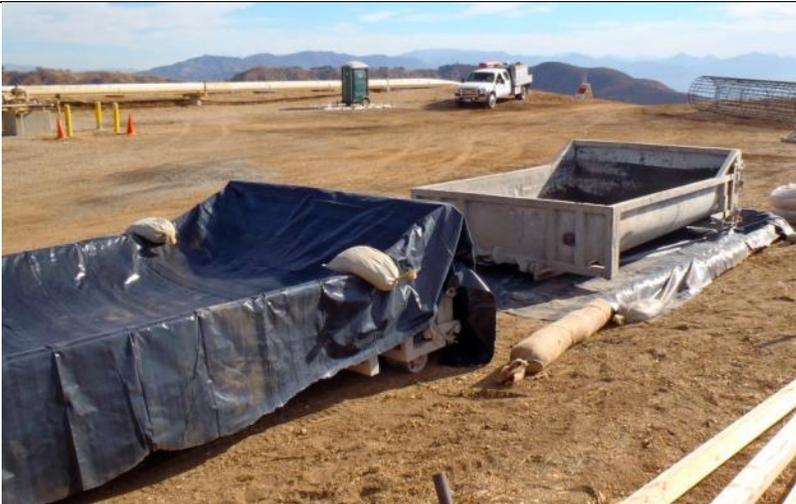
Concrete washout bins are in place on the well pad at the top of the slope above the Natural substation.
10/30/14	SCE – Natural substation

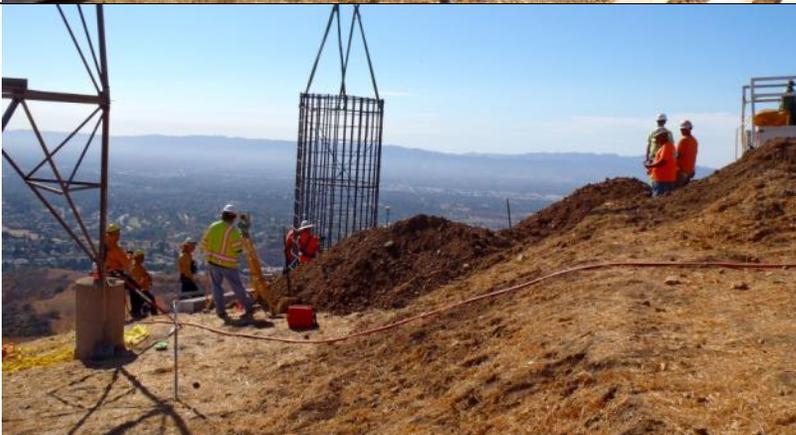
SCE Crews are installing the cage for the TSP 47 pole.
10/30/14	SCE – Natural substation

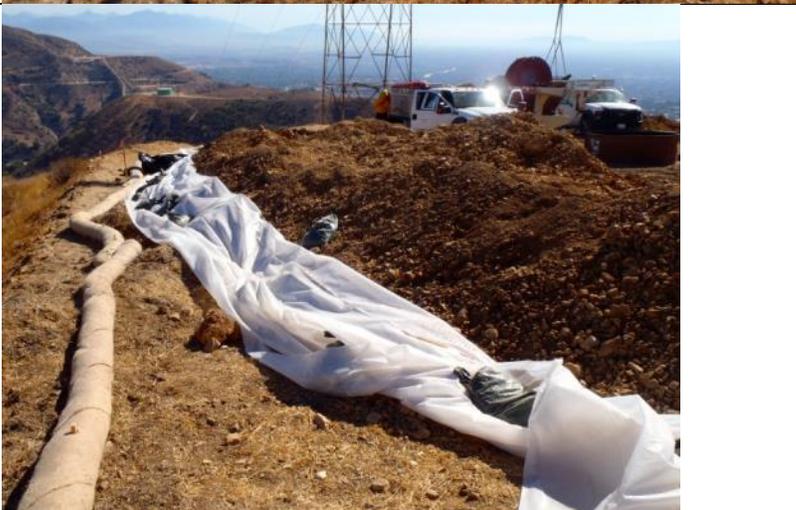
Spoil from the TSP 47 hole has been stockpiled to the side of the site with straw wattle installed around it and plastic ready to cover the pile.
