**Re: Monthly Report Summary #26 for Aliso Canyon Turbine Replacement Project**

## Aliso Canyon Turbine Replacement Project CPUC Site Inspection Form

Project:	Aliso Canyon Turbine Replacement	Date:	May 5, 2016
Project Proponent:	Southern California Gas Company and Southern California Edison	Report #:	VS102
Lead Agency:	California Public Utilities Commission	Monitor(s):	Vince Semonsen
CPUC PM:	Andrew Barnsdale, Energy Division	AM/PM Weather:	Overcast, cool, and breezy with a chance of rain overnight.
E & E CM:	Lara Rachowicz	Start/End time:	0900 to 1030 checked SCE work. 1045 to 1300 at the Aliso Storage Field.
Project NTP(s):	The new Admin/IM Building (NTP-2), Central Compressor Station (CCS) (NTP-3), PS-42 Fill Site, and the Natural Substation (NTP-3 and NTP-A). TSPs 2 through 42 (NTPs A, C, and D) and the SCE 210 Freeway Yard. Telecommunications Route 2 (NTP-E).

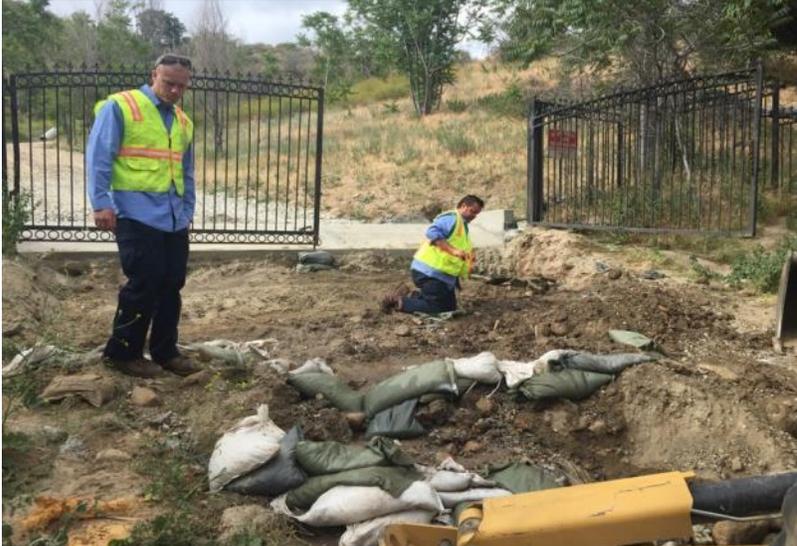
I drove to the TSP 7 site where a crew was working on the concrete apron near the entrance road gate. The backhoe had hit a water line earlier that morning and water was flowing into the street. Several local water district representatives were onsite; they had just shut off the water and were discussing measures for the water line's repair – see Photo 1. One of the crew was advising residents at nearby homes that their water service may be temporarily interrupted. SCE's SWPPP inspector (Siti) arrived onsite to assess and monitor the situation.

<p>Photo 1 – Work being conducted on the access road; the crew had just hit a water line.</p>
5/05/16	TSP 7 access road

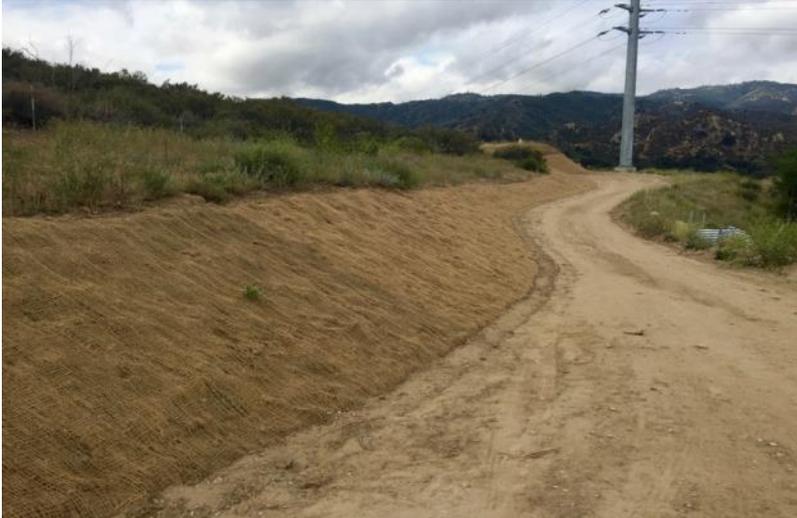
<p>Photo 2 – Topsoil replacement and jute netting has been added to the cut bank into TSP 7.</p>
5/05/16	TSP 7

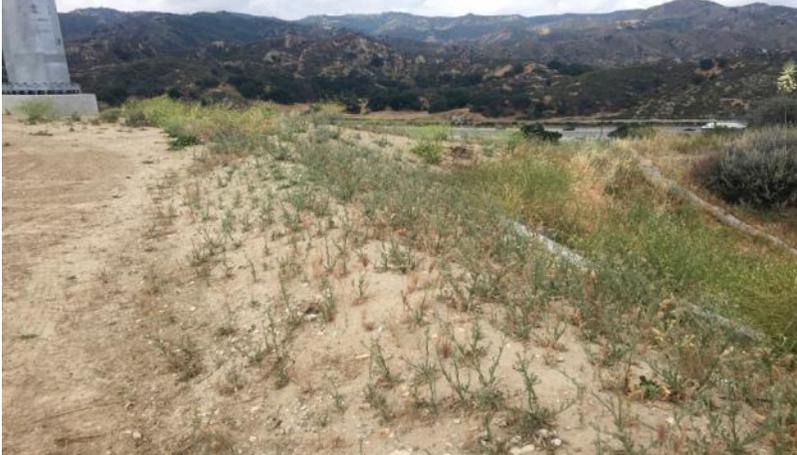
I walked along the TSP 7 access road to look at the restoration work. The stockpiled topsoil had been restored to some of the cut banks and covered with erosion blankets, and some restoration/best management practice (BMP) materials remained at the TSP 7 staging area – see Photos 2 and 4. The access road had been regraded, thereby removing the large rills, and gravel bag check dams were added in certain locations – see Photo 5. I noted numerous invasive plants growing along the access road – see Photo 3.

<p>Photo 3 – Weeds growing on the access road berm.</p>

Removal of weeds at a number of locations is recommended.

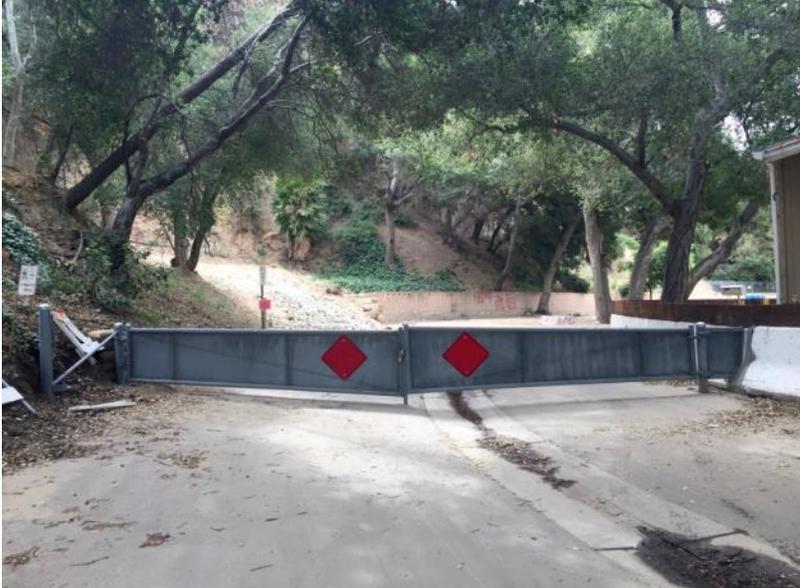
A new gate has been installed at the entrance to the TSP 24/25 access road – see Photo 6. I checked the entrance to the TSP 12-22 access road; the rumble plates have been removed, and asphalt has been added to the entrance – see Photo 7. I noted invasive plants growing on the restored slopes.

<p>Photo 6 – A new gate has been added to the TSP 24/25 access road.</p>

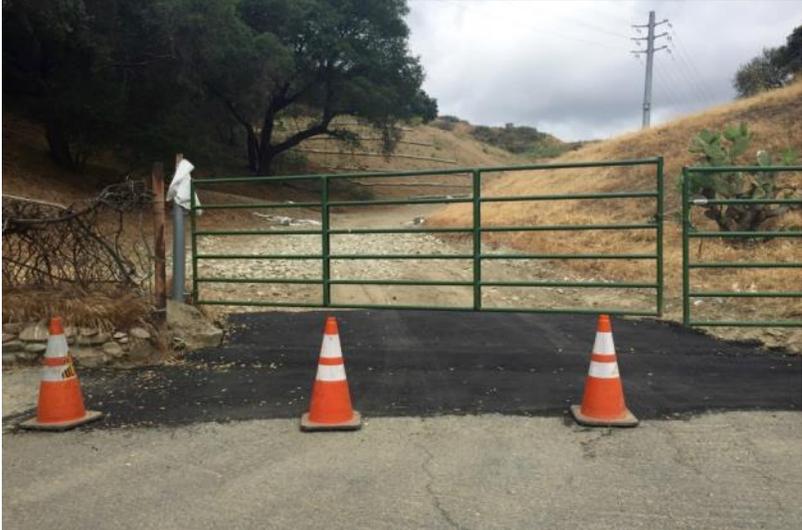
Photo 7 – Asphalt has been added to the entrance.
5/05/16	Oak Tree Mitigation Site

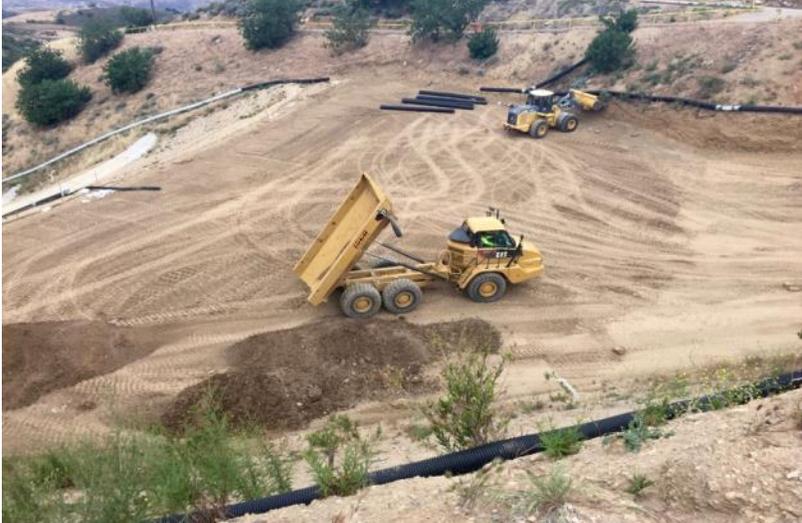
During my site visit, soil from the TSP 49 access road work (see Photo 11) was being delivered to the PS-42 Fill Site (see Photo 9). The drainage pipe had been temporarily disconnected at the PS-42 Fill Site; however, according to Seth Rosenberg (SCG), the pipe was scheduled to be reconnected by the end of the day, as there was a 50% chance of rain. Biological monitor Jasmin Byrd (Jericho Systems) and paleontological monitor Olivia Tierk (PaleoSolutions) were onsite and overseeing the work at TSP 49. Jasmin Byrd had seen several garter snakes, and Olivia Tierk had found a small, fossilized leaf earlier in the week. Some restoration of the TSP 49 access road shoulders had been implemented by the SWPPP crew – see Photo 12.

Photo 9 – Soil from TSP 49 access road work is being delivered to the PS-42 Fill Site.

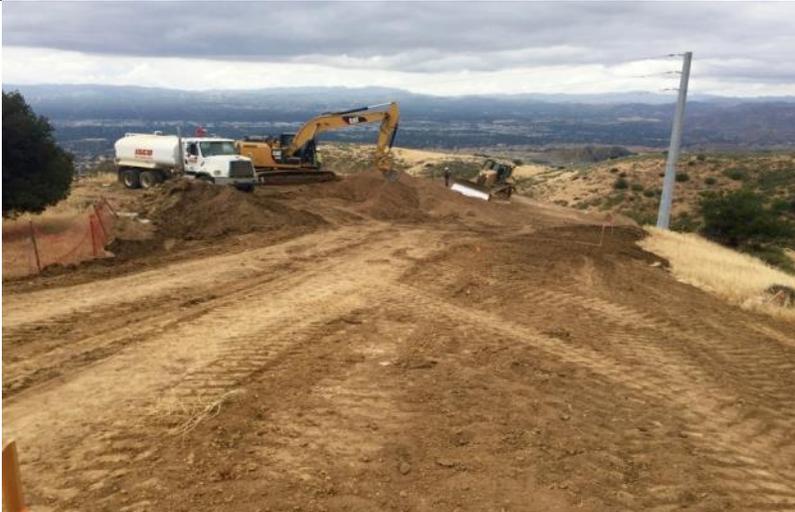
<p>Photo 11 – Excavation of the access road to TSP 49 off of the Natural Substation access road.</p>
5/05/16	TSP 49

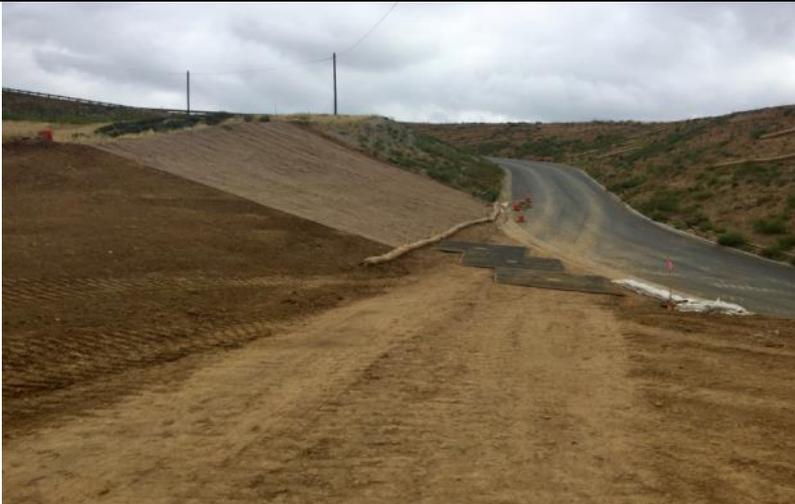
<p>Photo 12 – Some restoration has been completed along the TSP 49 access road.</p>

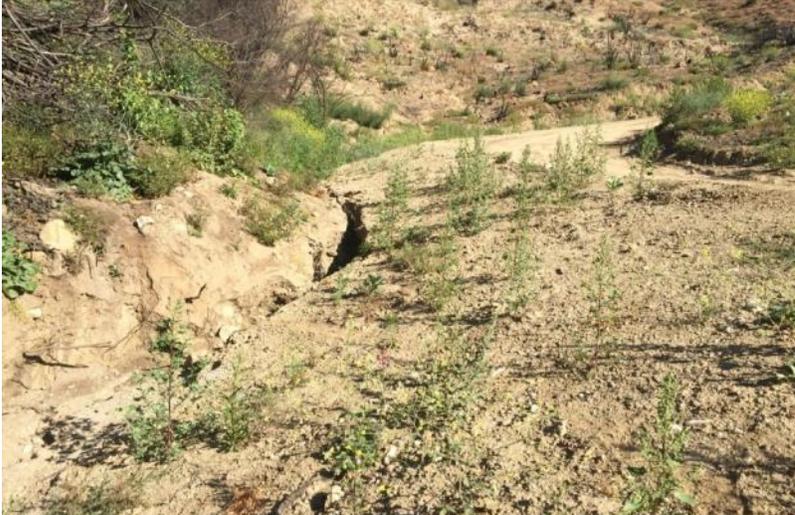
I walked to Drainage #4 along the TSP 24/25 access road to look over the area. Some erosion repair and revegetation was needed on the downstream side of the access road where it crosses the new culverts – see Photo 2. There were some construction materials remaining, including a soil pile, riprap rock, and plastic sheeting near the Hilfiker wall – see Photos 3 and 4. At TSP 25, some stakes and wood blocks were stockpiled at the pole. Mustard is growing around the pole site, especially at the base of the Hilfiker wall; there is much more mustard at this location than observed on the surrounding hills – see Photo 5.

Photo 2 – Erosion rill along the access road where it runs into Drainage #4.
5/12/16	TSP 24/25 access road

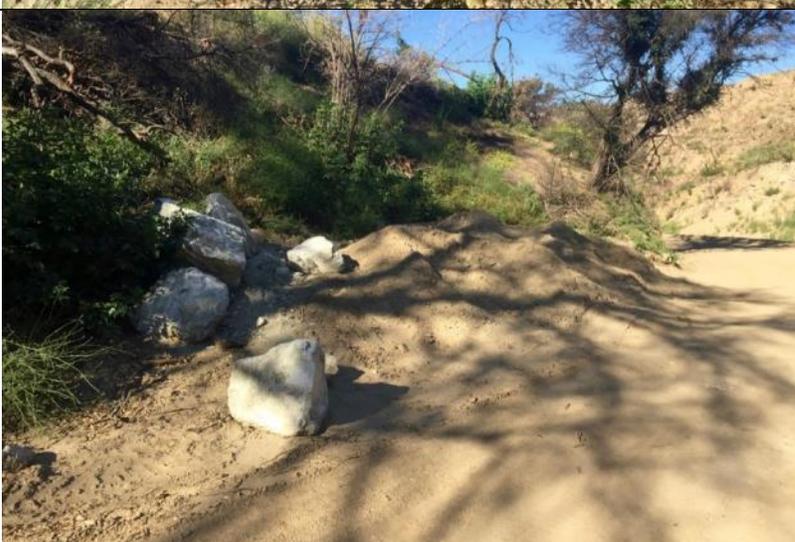
Photo 3 – Dirt and riprap remains along the access road.

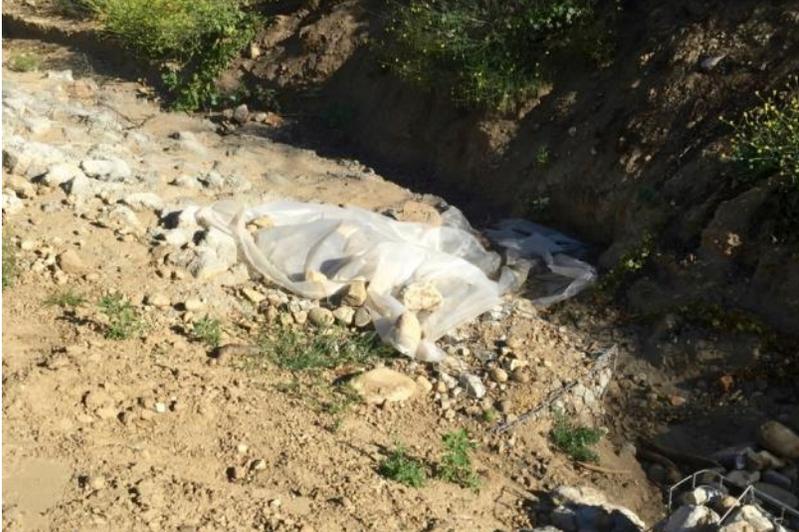
Photo 4 – Construction debris remains along the access road.
5/12/16	TSP 25

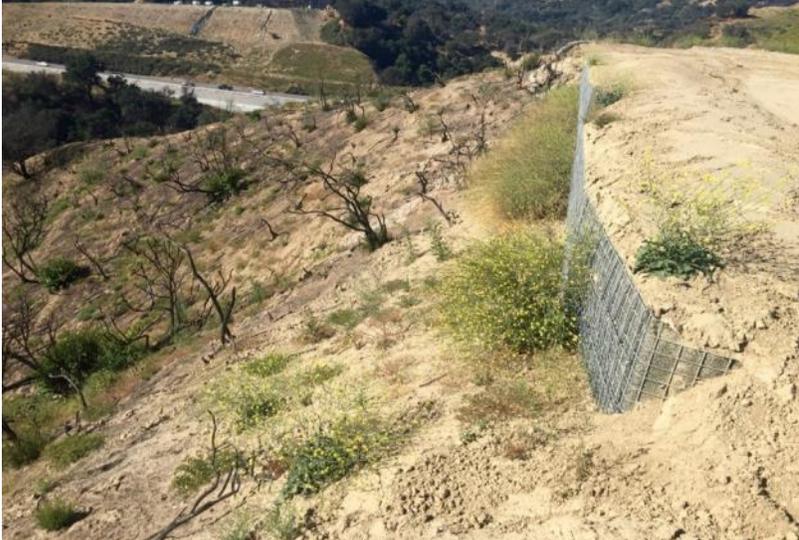
Photo 5 – Mustard growing along the base of the Hilfiker wall.
5/12/16	PS-42 Fill Site

Removal of invasive plants at a number of locations is recommended.

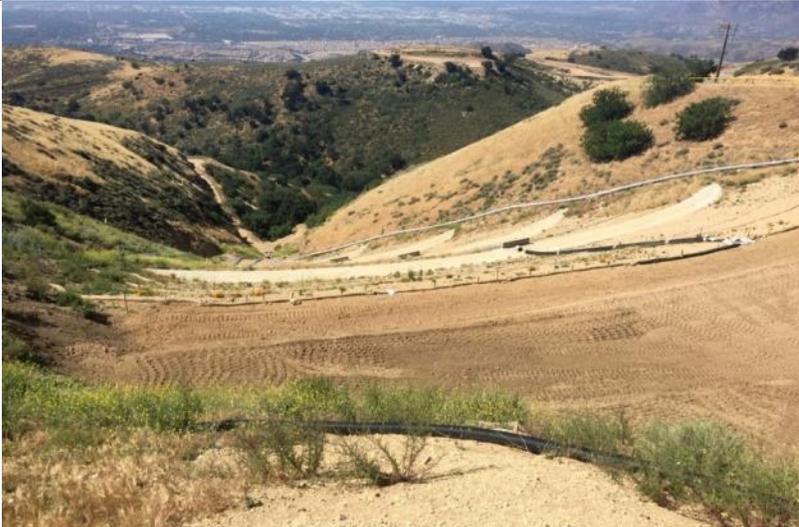
Photo 6 – Some of the PS-42 Fill Site has large amounts of mustard growing.

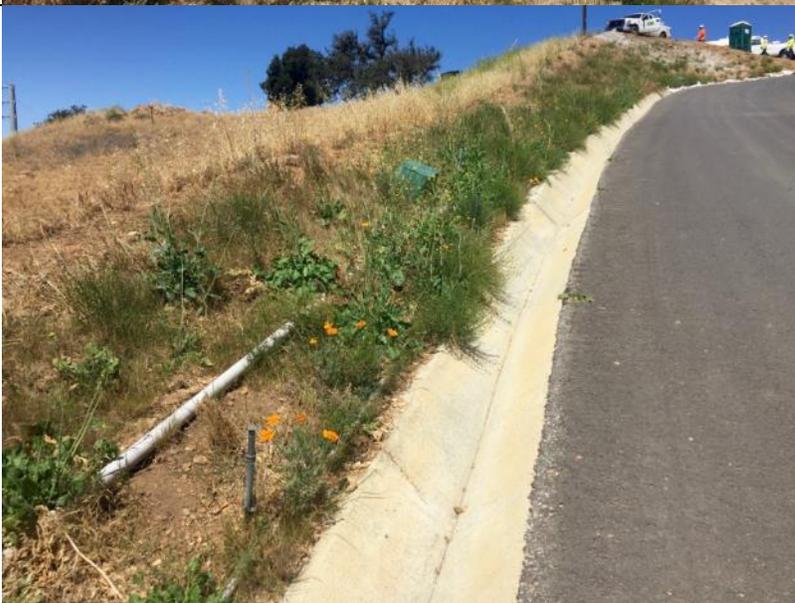
Photo 8 – Mustard is re-emerging along the access road.

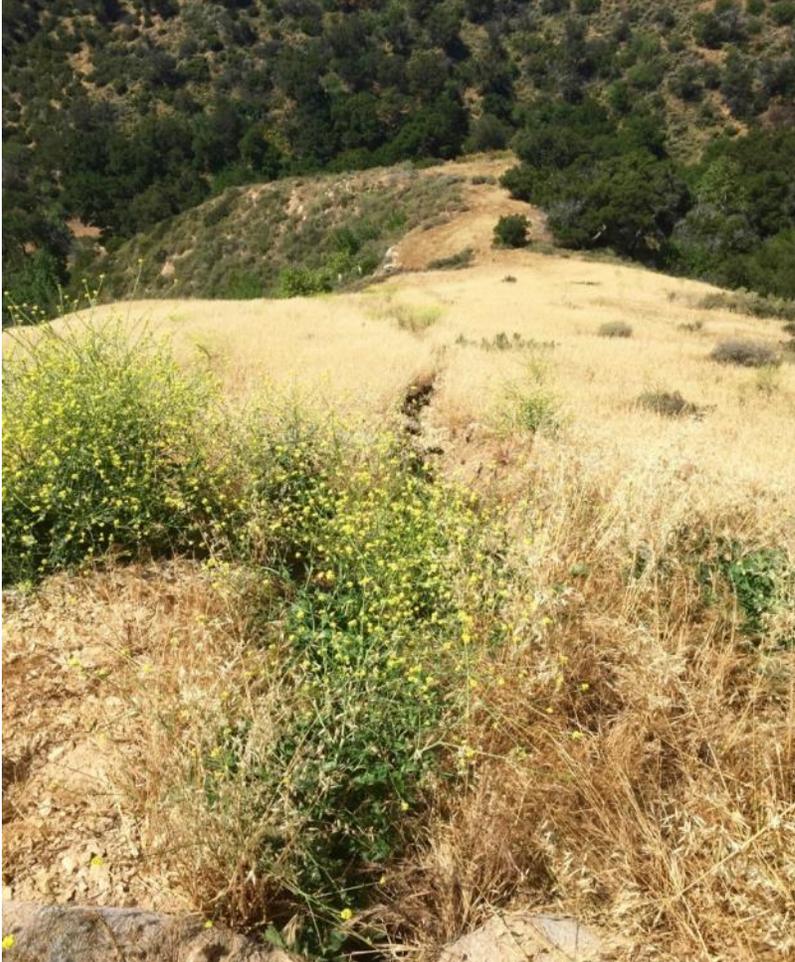
Photo 11 – Erosion rill below the pole site.
5/12/16	New Admin/IM Building

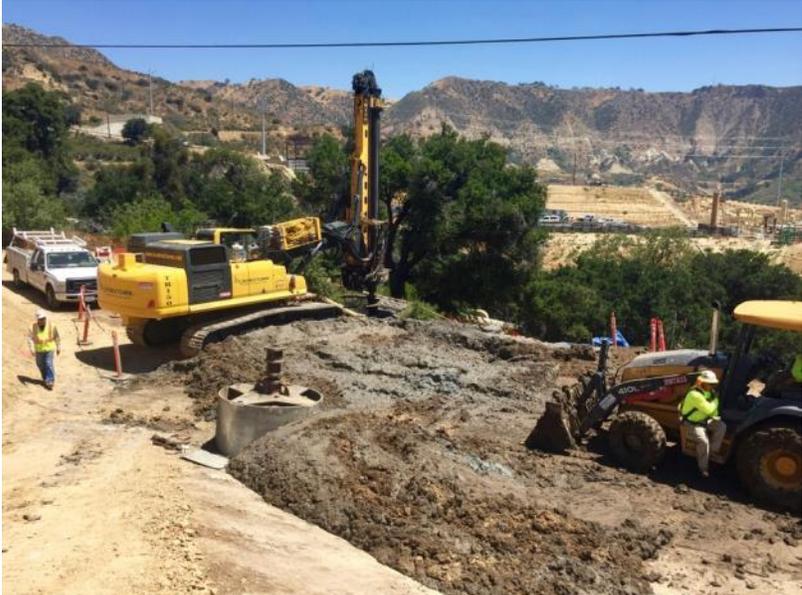
The drilling crew had almost completed the first foundation for the 12 kV A2-1 pole located across Limekiln Creek from the CCS – see Photo 13. The foundation was 12 feet in diameter by 60 feet deep, and the crew had drilled to 56 feet deep. The tailings were being stockpiled along an old access road – see Photo 14. The crews were adding water to the hole, so the tailings were quite wet/muddy; however, everything was well contained. AECOM environmental manager, Amandeep Singh, and biologist, Ray Romero, were onsite checking the activities.

Photo 13 – Drilling rig and tailings from the foundation hole.
5/12/16	12 kV work at the A2-1 location

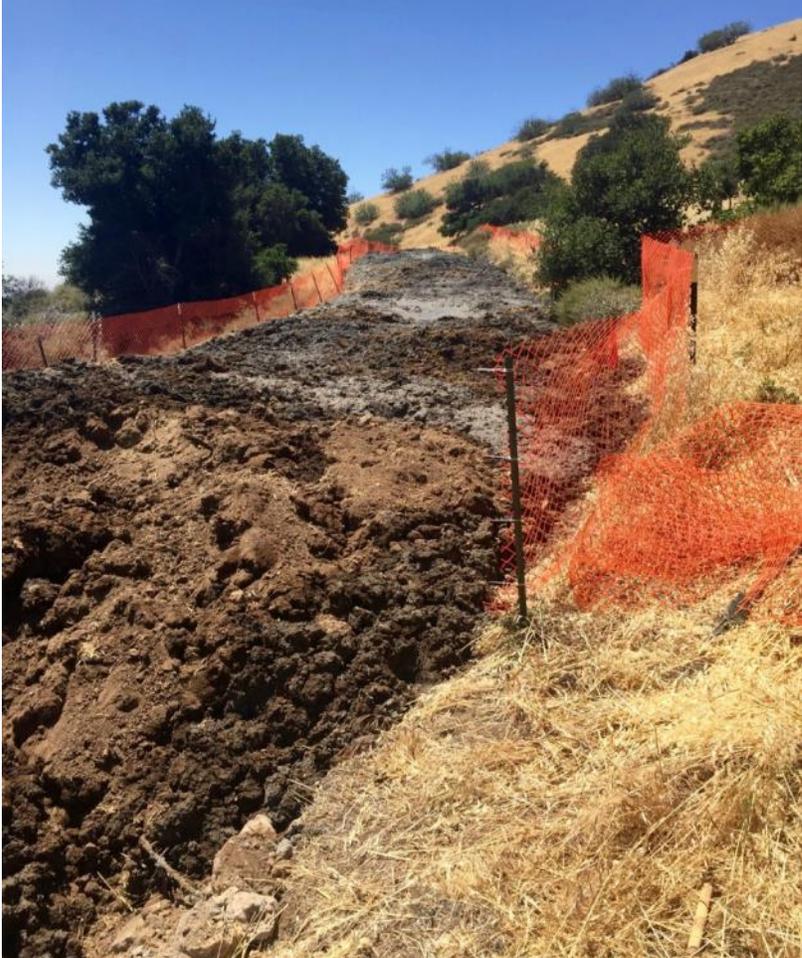
Photo 14 – Tailings from the drilling operation stockpiled along an existing access road.

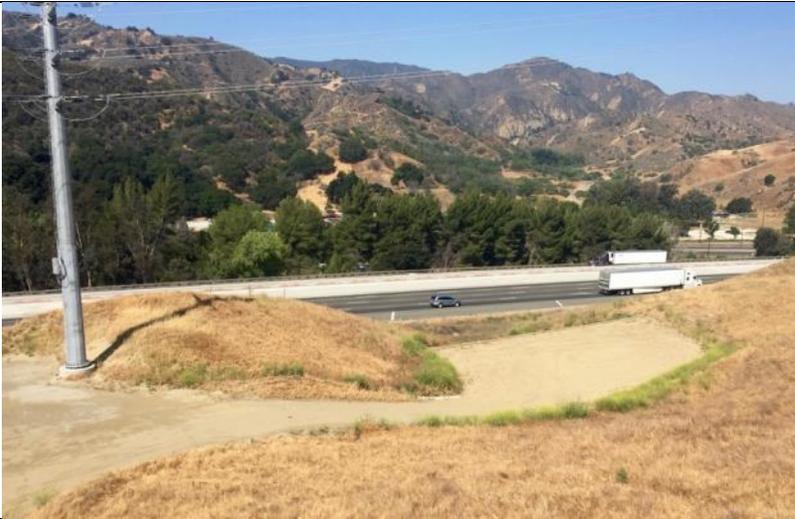
Photo 2 – Site is in good condition, with some mustard ringing the staging area.
5/17/16	TSP 21

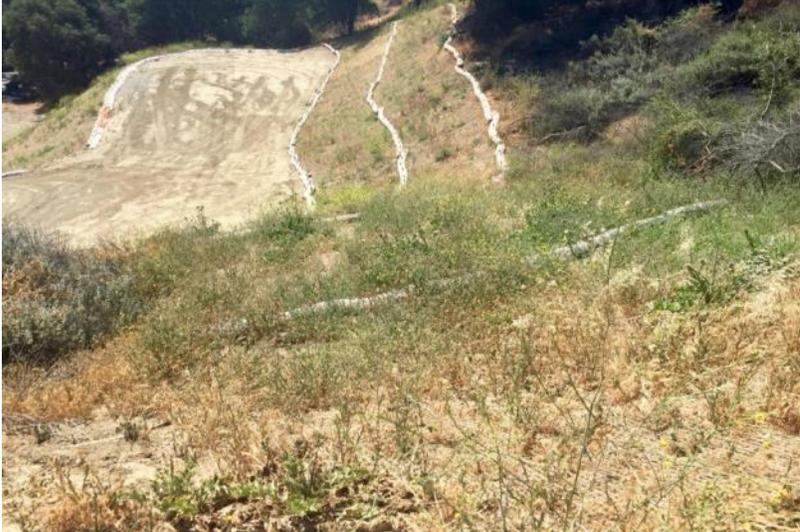
<p>Photo 4 – Weeds growing on a portion of the work site; this area was 100% native vegetation before the project.</p>
5/17/16	12 kV work at the A2-1 location

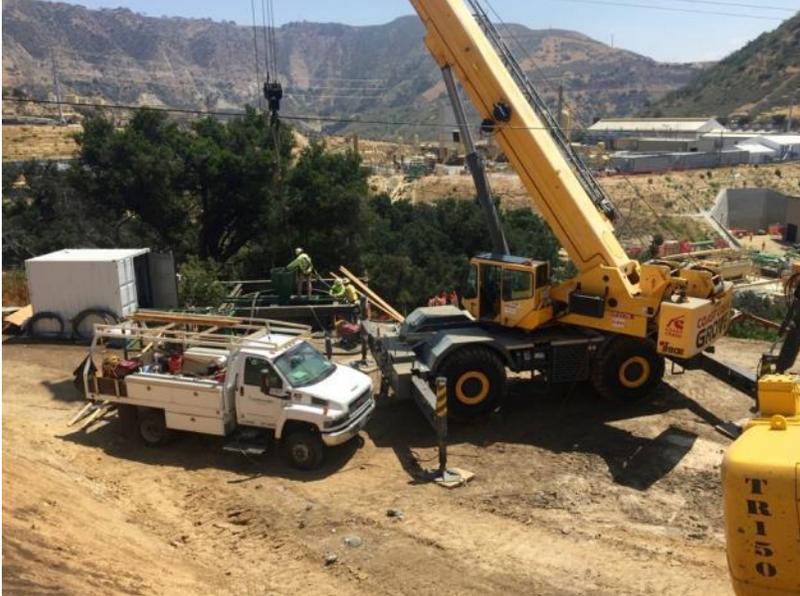
My first stop was the 12 kV A2-1 drilling site where crews were pumping slurry into the foundation hole see – see Photos 5 and 7. The crew foreman (Marc) said they had drilled down to 60 feet, but the incoming water was causing the walls to sluff in, so they decided to fill the hole with slurry and then drill it again. The crews had pumps, hoses, and a baker tank set up in case they needed to pump water out of the hole; water was sitting on top of the slurry – see Photo 6. SCG's biological monitor Juan Miranda was onsite, along with SWPPP inspector Trevor Marshall.

<p>Photo 5 – Drilling team working on the foundation.</p>
5/17/16	12 kV work at the A2-1 location

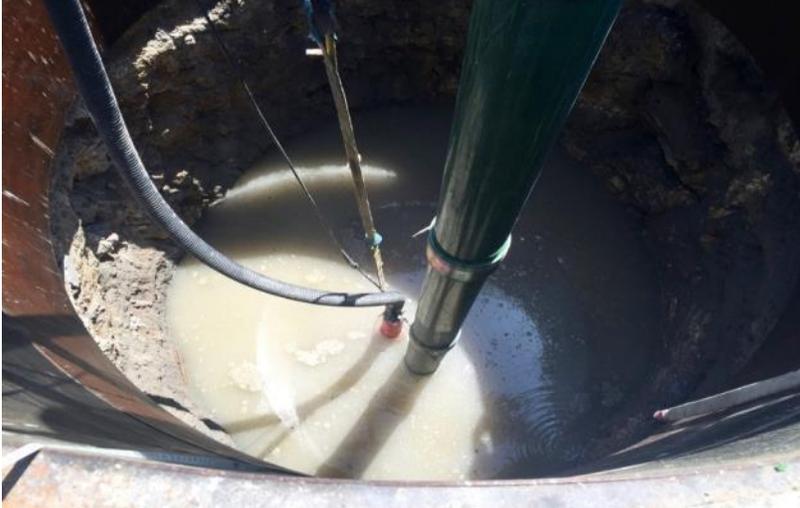
<p>Photo 6 – Looking down into the foundation hole as slurry is being pumped in; note the sump pump next to the green slurry injection pipe.</p>

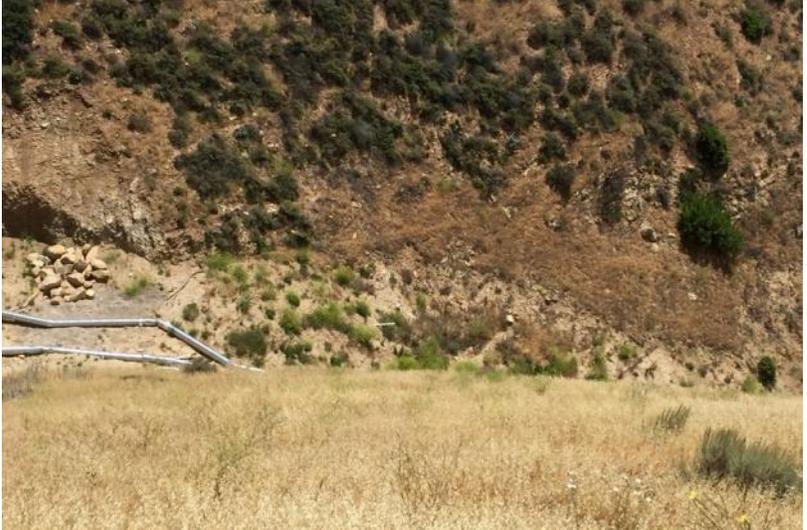
I checked the PS-42 Fill Site; however, no work was being conducted at that time. I noted numerous Mediterranean mustard plants coming in along the edges of the fill slope all the way down to the lower road – see Photos 14 and 15.

<p>Photo 14 – Mustard growing on the lower portion of the PS-42 Fill Site.</p>
5/17/16	PS-42 Fill Site

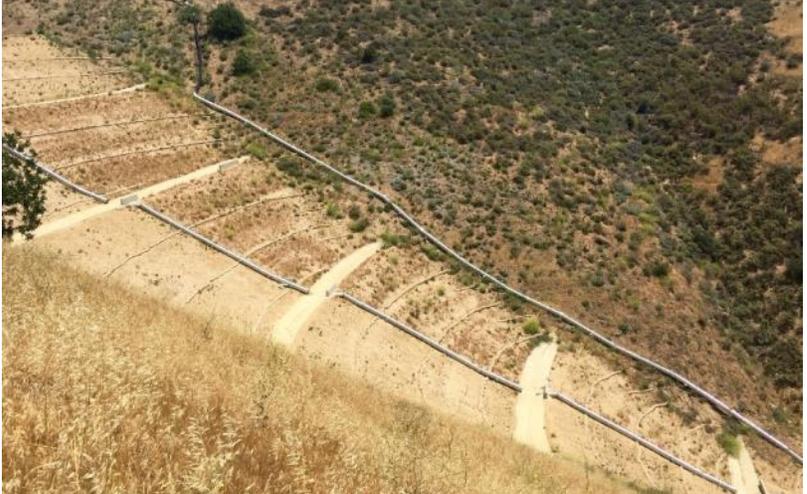
<p>Photo 15 – Mustard along the edge of the fill slopes.</p>

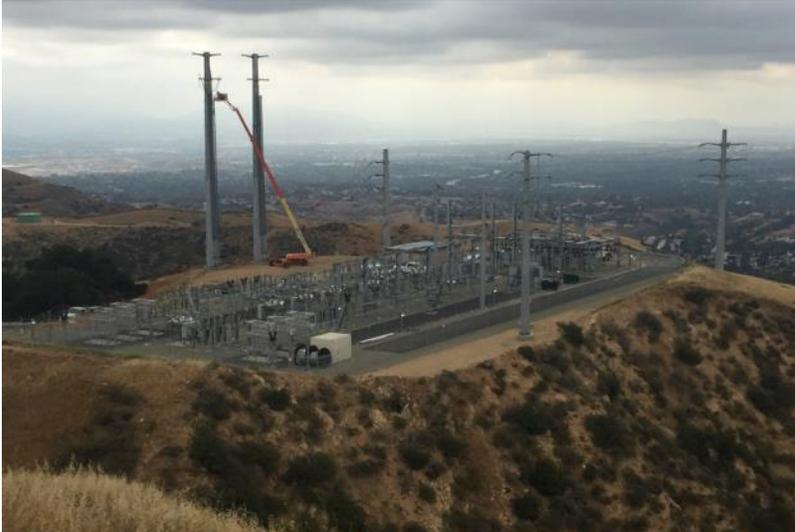
At the Natural Substation, work continued on testing the electrical equipment. A crew was working on the A1-1 and A1-2 12 kV poles – see Photo 1. I met with biological monitor Juan Miranda and avian biologist Rob Conohan (both of SCG) and we discussed project activities. According to Rob Conohan, most of the chicks within the identified nests were near fledging. I noted that the red-tailed hawk chicks in the sycamore along the main access road were fully feathered and very close to fledging.

Photo 1 – Overview of the Natural Substation also showing some of the work on the A1-1 and A1-2 12 kV poles.
5/24/16	TSP 49

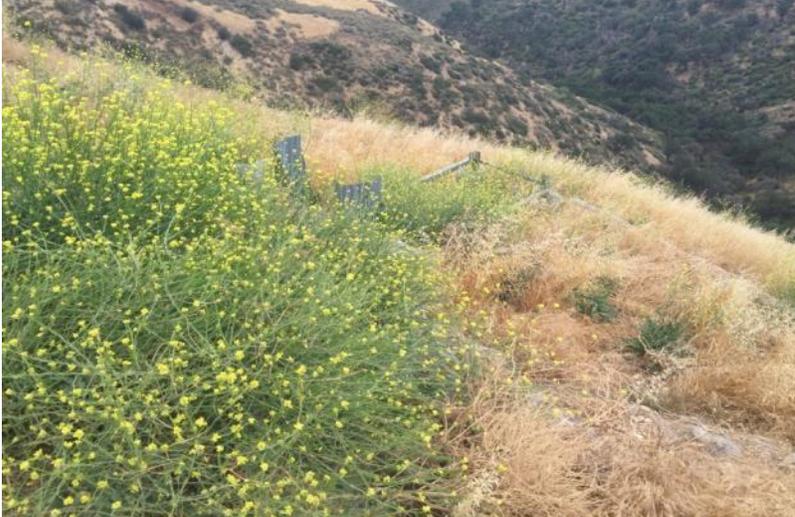
The TSP 49 access road work had been completed; I did note that the old tower foundation was still present – see Photo 2.

Photo 2 – Some of the old tower foundation below the new pole.
5/24/16	Well pad above the Natural Substation access road

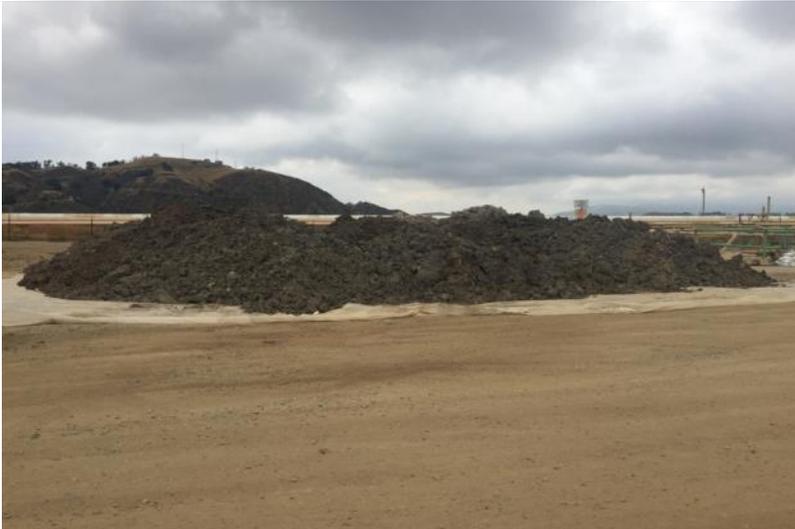
Photo 3 – Stockpiled tailings from the 12 kV drilling operation.
