**Re: Monthly Report Summary #13 for Aliso Canyon Turbine Replacement Project**

## Aliso Canyon Turbine Replacement Project CPUC Site Inspection Form

Project:	Aliso Canyon Turbine Replacement	Date:	April 6, 2015
Project Proponent:	Southern California Gas Company and Southern California Edison	Report #:	VS052
Lead Agency:	California Public Utilities Commission	Project Phase/NTP:	Guard House and Road Widening (NTP-1). The New Admin/IM Building (NTP-2) and Central Compressor Site (NTP-3). P-41 Fill Site (NTP-2), PS-42 Fill Site, P-32 Fill Site (NTP-3) and the Natural Substation (NTP-3, NTP-A). TSP-45 & 49, and the San Fernando Substation (NTP-A). Oak Tree Mitigation Area.
CPUC PM:	Andrew Barnsdale, Energy Division	AM/PM Weather:	Partly cloudy and cool (54 degrees) and a bit blustery. A storm is predicted for Tues/Wed.
E & E CM:	Lara Rachowicz	Start/End time:	0915-1300 hrs. at the Aliso Storage Field. Then, drove to the SCE 210 Freeway Yard.
Monitor(s):	Vince Semonsen		
Project Component(s):	Storage Field components, 66-kV Subtransmission Line, Telecommunications Route #1 and 3

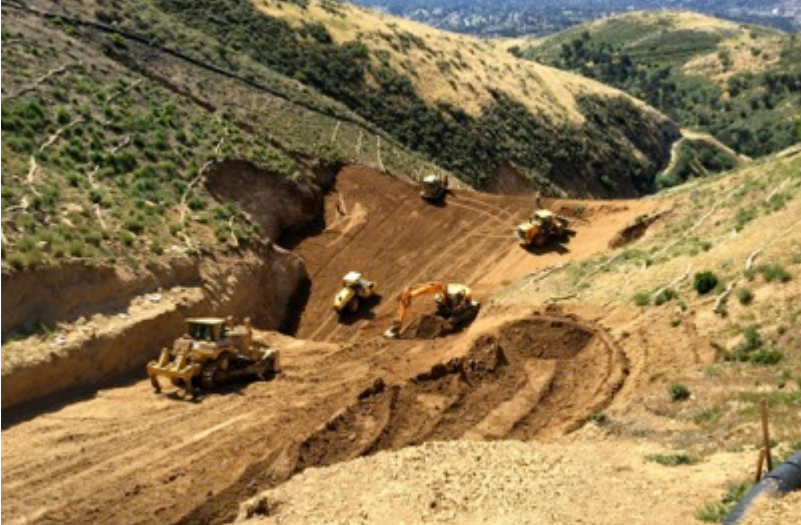
Date	Location	Photo	Description
4/06/15	PS-42 Fill Site

<p>Equipment continues to work the soil – they are sloping the fill key to create a catch basin for possible rainwater runoff.</p>
4/06/15	PS-42 Fill Site

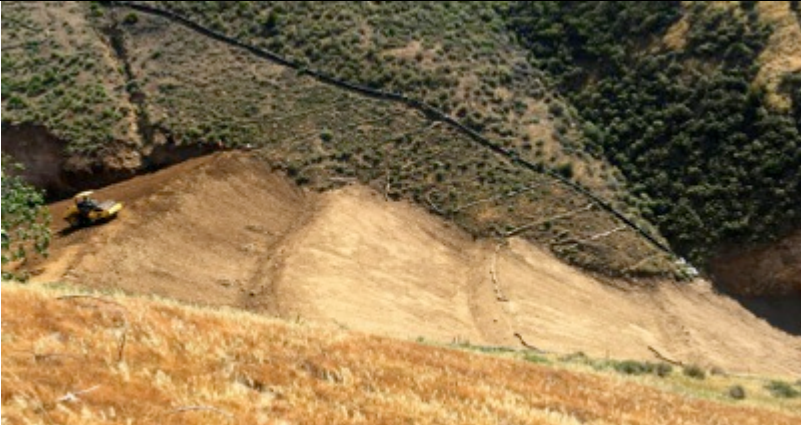
<p>Fill site below the latest fill key showing the permanent slopes. BMPs are to be installed in preparation for the storm.</p>
4/06/15	Natural Substation Access Road

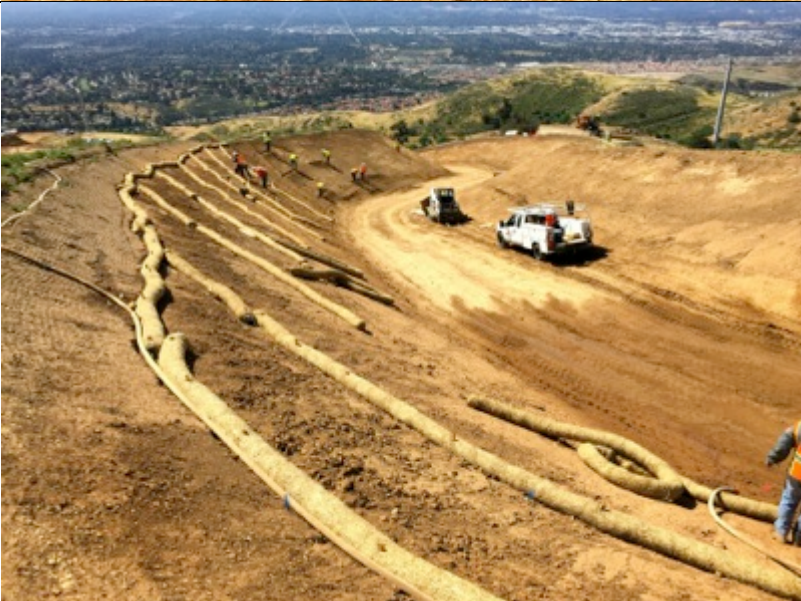
<p>BMP installation along the Natural Substation Access Road.</p>

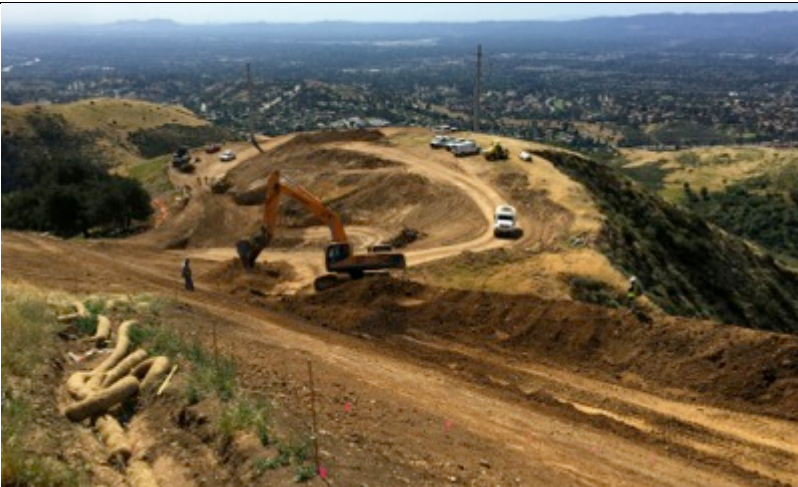
<p>4/06/15</p>	<p>Natural Substation</p>

<p>Overview of the substation – excavator continues to work on the access road.</p>
<p>4/06/15</p>	<p>Natural Substation Access Road</p>

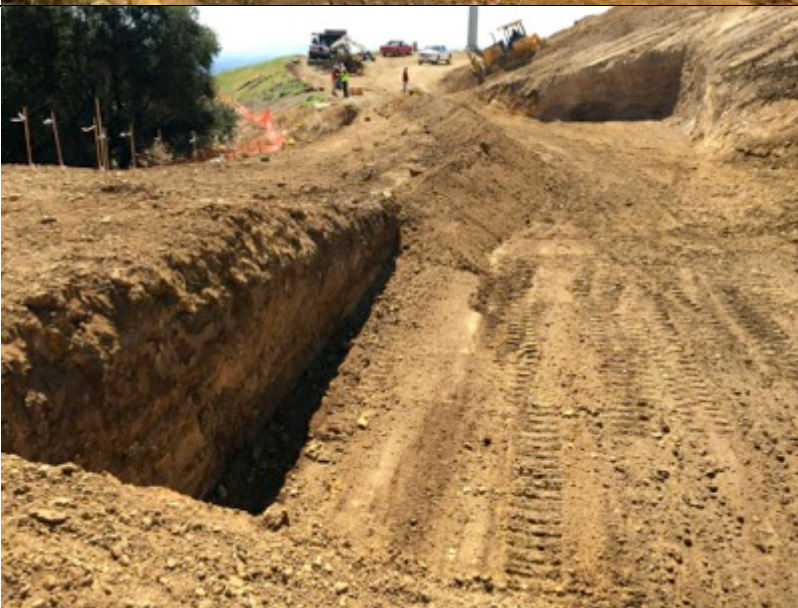
<p>At the bottom of the access road an excavation hole exists for the biofiltration unit. Crews are adding a berm to create a larger catch basin for any stormwater runoff.</p>
<p>4/06/15</p>	<p>Natural Substation Access Road</p>

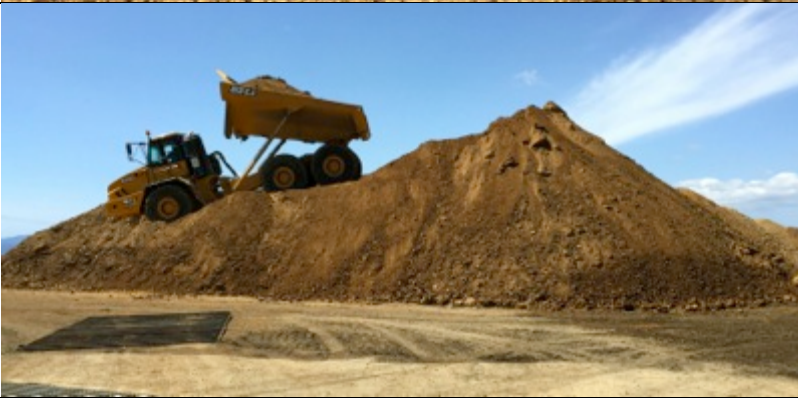
<p>Fill material from the access road is being stockpiled on the well pad above PS-42. Soil piles are to be covered prior to the storm event.</p>

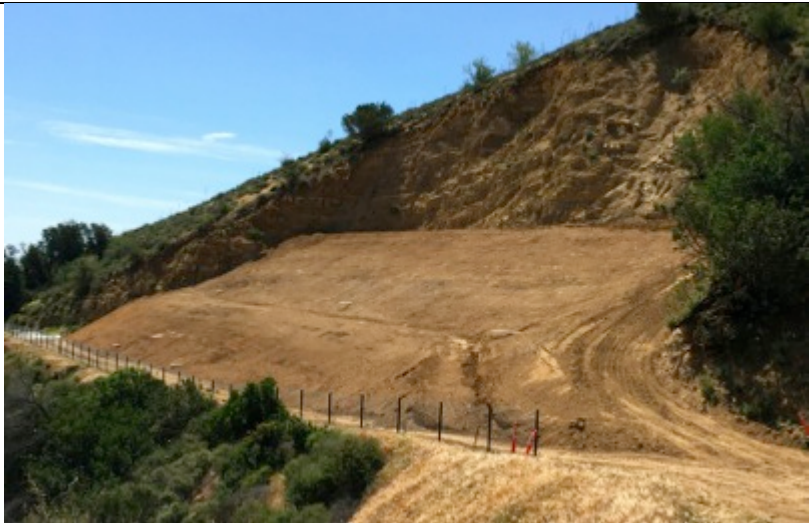
4/06/15	P-41 Fill Site

No work is being done at the P-41 fill site but, according to Amandeep, temporary BMPs are to be installed on the fill slopes – see photo.

<p>The site is full and work has begun on permanently closing up the site. BMPs are to be installed in advance of the storm.</p>
4/06/15	P-32 Fill Site

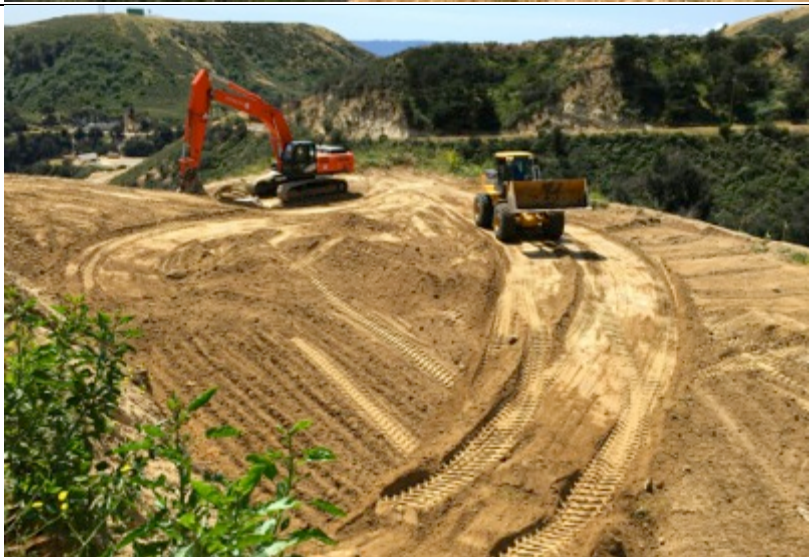
<p>Grading/recompaction of the dirt from the Central Compressor Station continues. BMPs are being upgraded at the site.</p>
4/06/15	Central Compressor Station

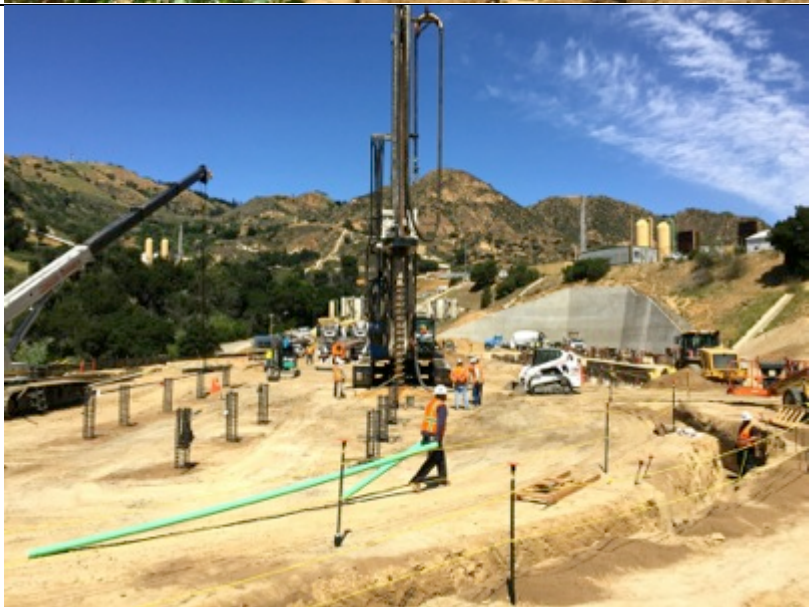
<p>Drilling continues along with work on the concrete walls.</p>

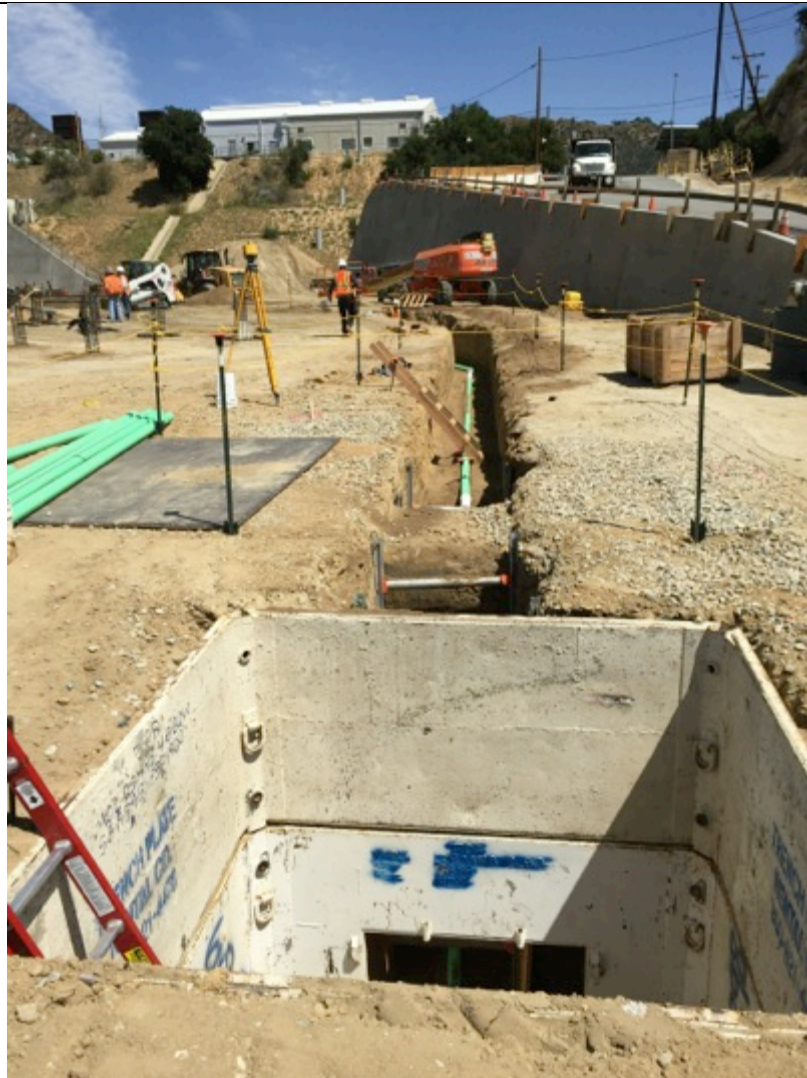
Central  
Compressor  
Station

Trenching and conduit  
installation within the  
CCS.

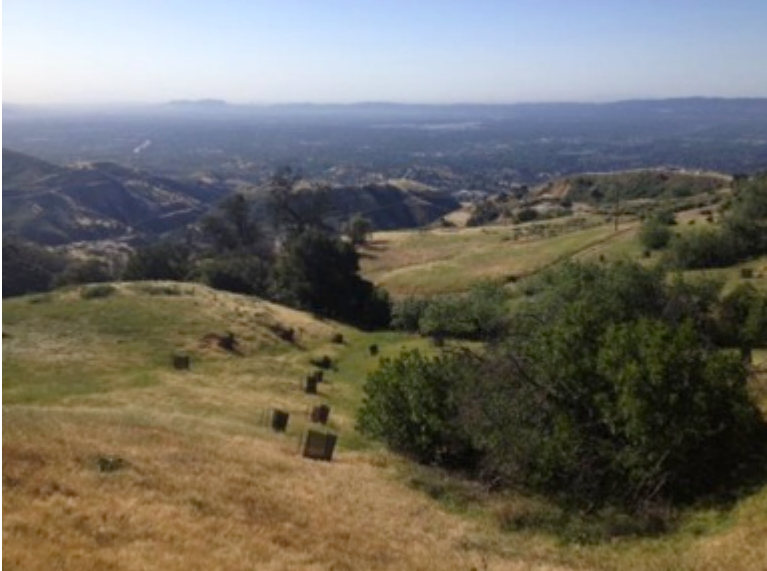
Date	Location	Photo	Description
4/16/15	Oak Tree Mitigation Site

View from top of oak tree mitigation site, looking down onto oak seedlings.
4/16/15	PS-42 Well Pad

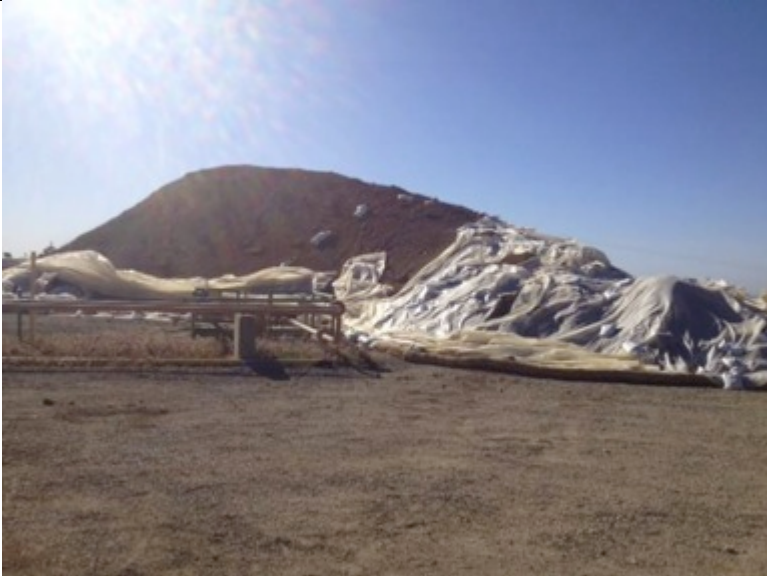
At the PS-42 fill site, high winds had blown the plastic sheeting off the stored materials piles (photo). Seth Rosenberg, SCG's Environmental Coordinator, said they would be reinstalling the sheeting that day, or as soon as the winds died down. Crews were moving soil within PS-42.

Plastic sheeting that had blown off in high winds.

The plastic sheeting on the temporary soil pile on the PS-42 well pad needed repair or replacement on the April 16, 2015 site visit. During today’s site visit, jute netting is being installed on the soil pile.

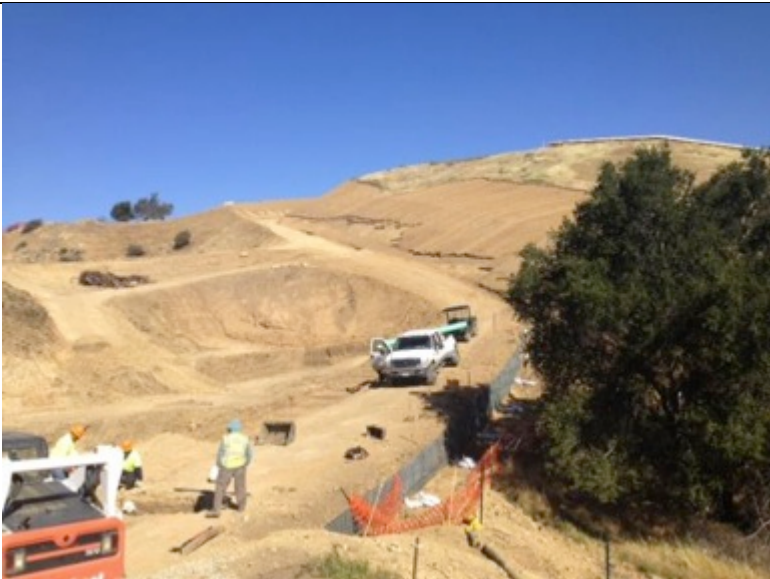
4/16/15	Natural Substation

View from the substation site looking back up access road
4/16/15	P-41 Fill Site

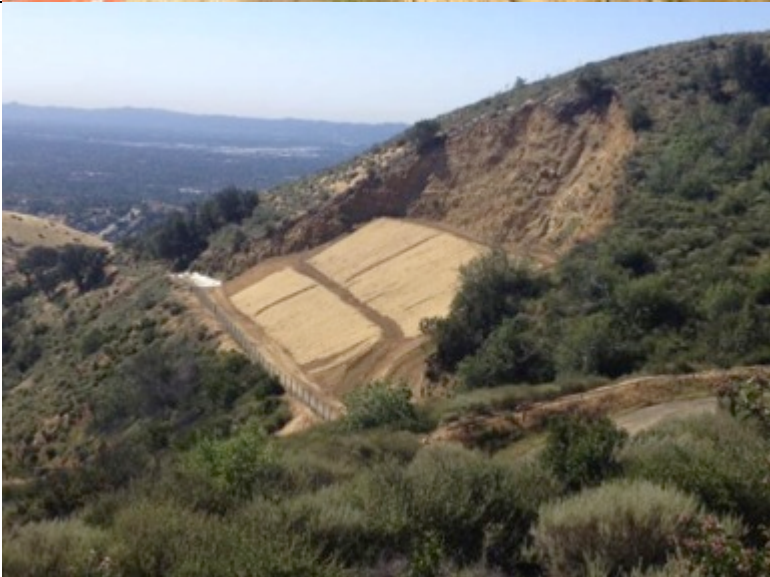
P-41 fill site is finished and covered. Drains and v-ditches still need to be added, and the site must be hydromulched to prevent erosion (photo).

P-41 covered with jute netting
4/16/15	Guardhouse/ Limekiln Canyon Wash

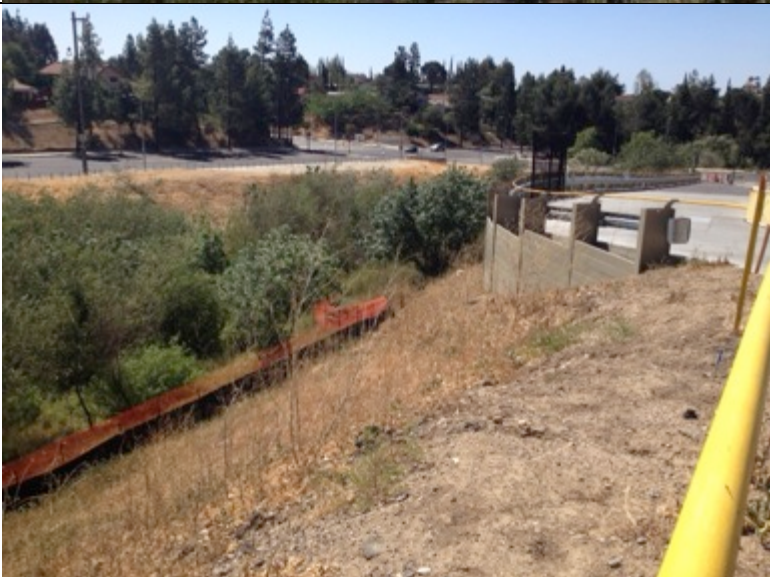
Area above Limekiln Canyon Wash adjacent to guardhouse that will be cleared of brush for fire prevention (between orange fence and yellow rail)

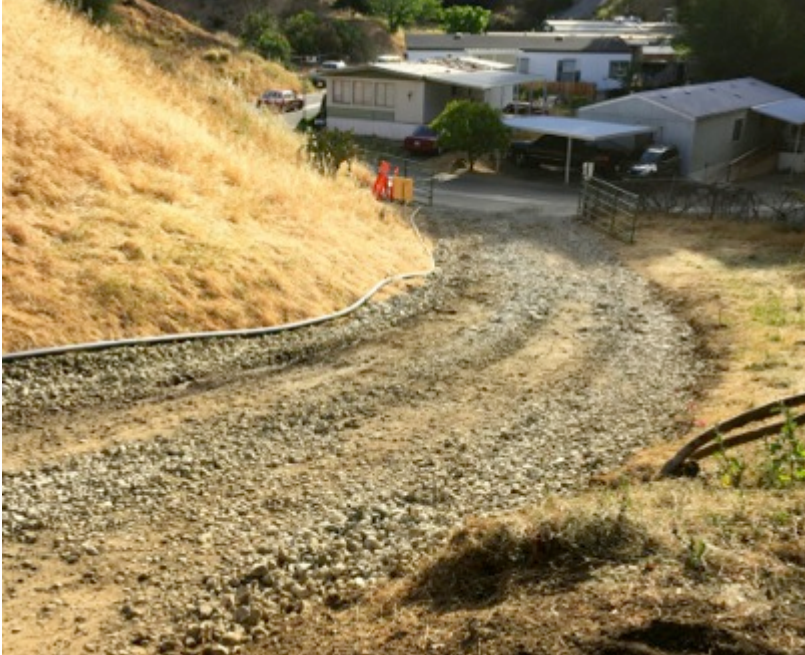
Date	Location	Photo	Description
4/30/15	Wiley Canyon Access Road

<p>Entrance to the Wiley Canyon access road. Gravel has been laid down to keep dirt and mud from being tracked onto the paved roads.</p>
4/30/15	Wiley Canyon Access Road

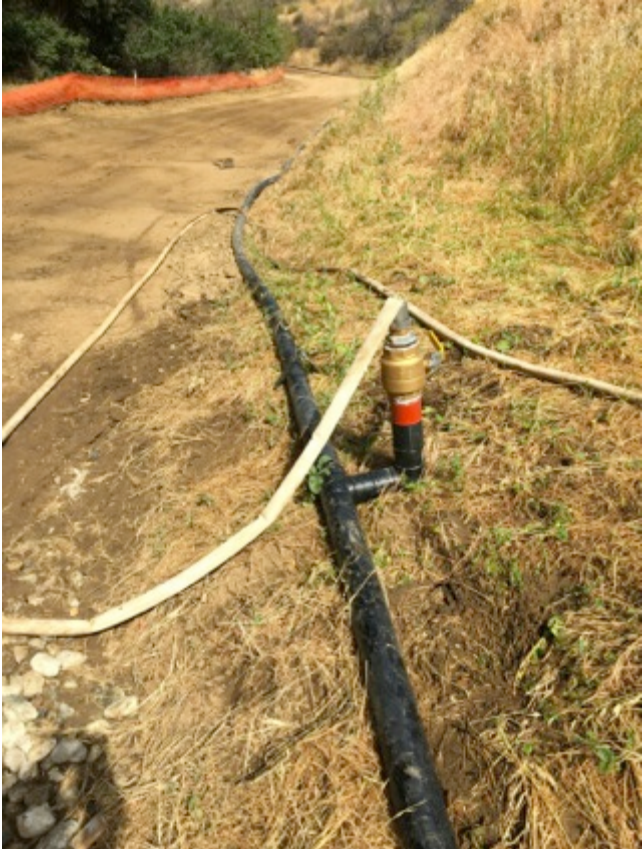
<p>Plastic piping coming from the fire hydrant and placed along the access road, providing water to the water trucks and for dust suppression along the road.</p>

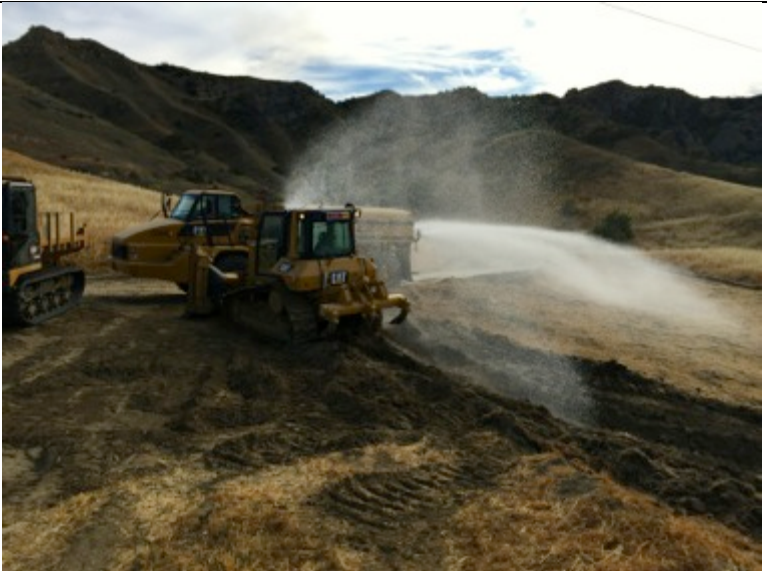
<p>A water truck is spraying the newly graded area at TSP 16.</p>
<p>4/30/15</p> <p>Wiley Canyon Access Road</p>

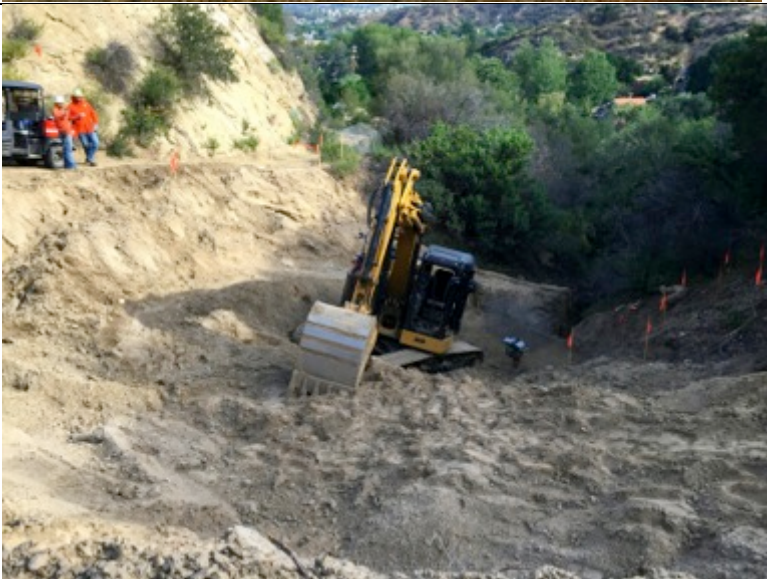
<p>Shoring and culvert installation is being done on the access road between TSPs 12 and 13.</p>

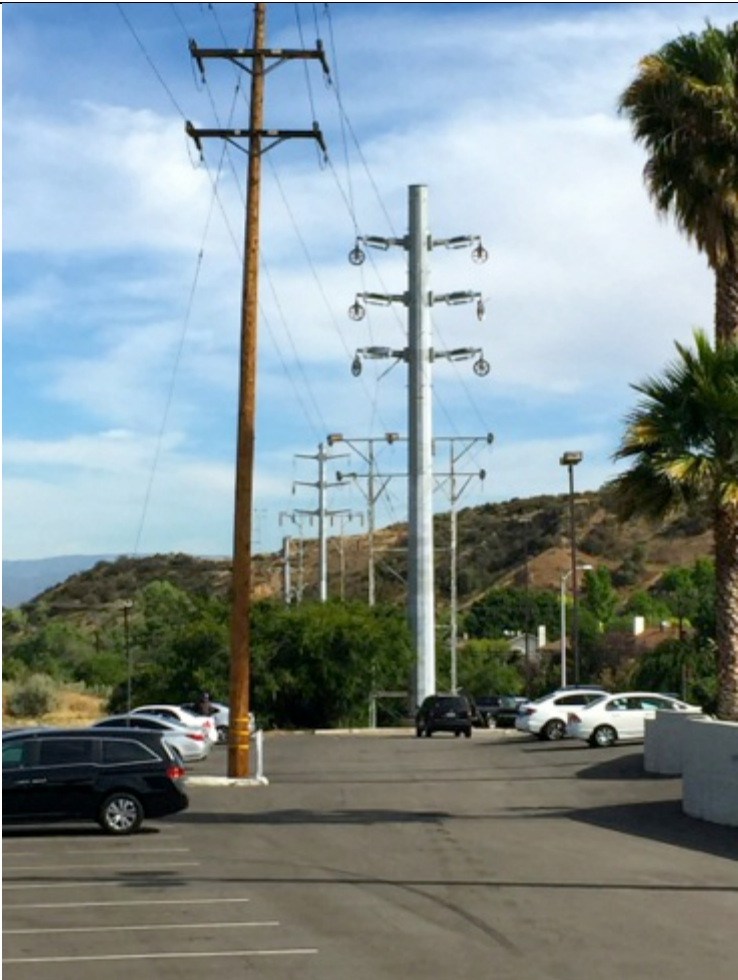
TSPs 9 and 10 have been installed and can be seen in this photo.

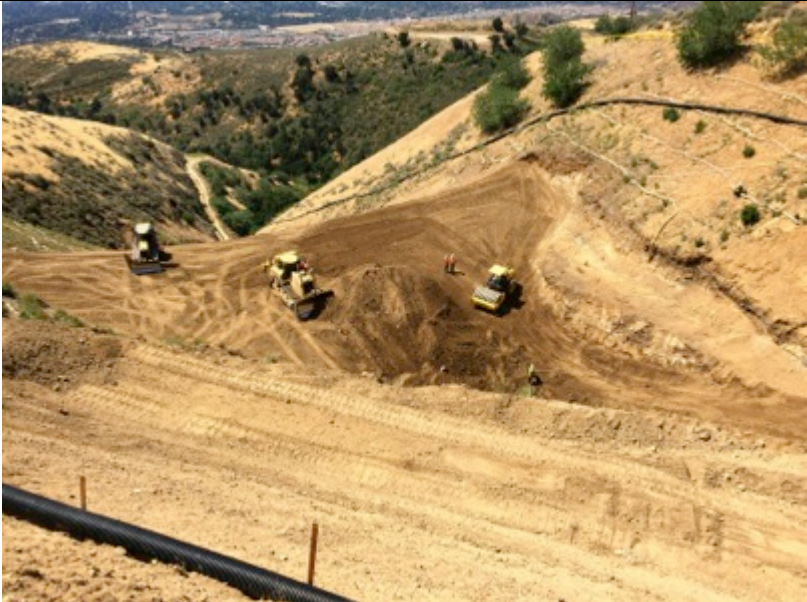
PS-42 Fill Site

Equipment continues to work the imported soil.

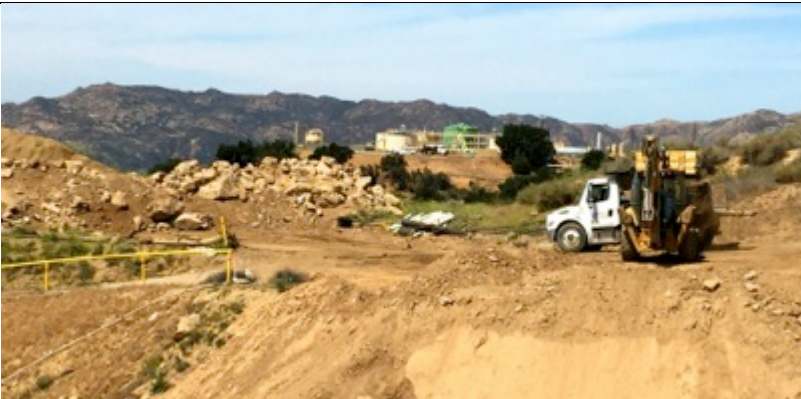
4/30/15	PS-42 Temporary Fill Site

The rock in the temporary fill site is being separated out and transported to the staging area near the P-41 fill site.
4/30/15	PS-42 Well Pad

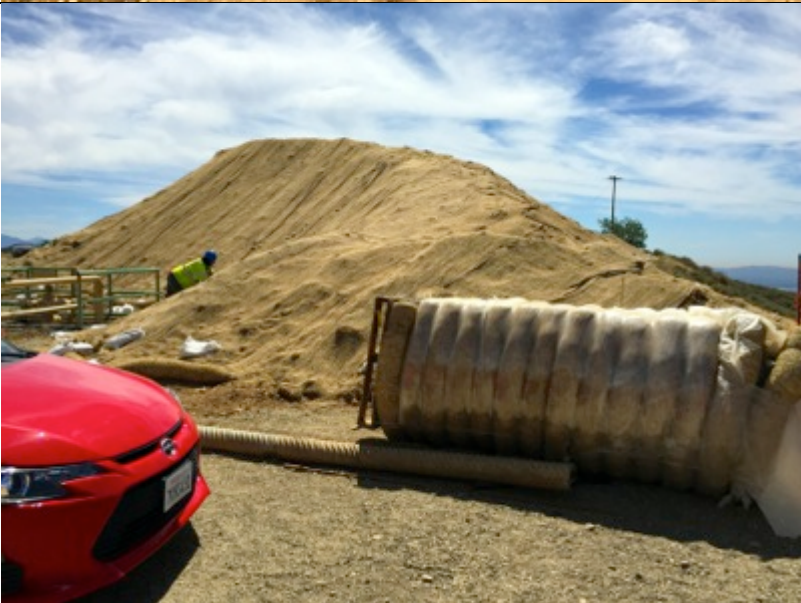
Stockpiled soil on the well pad above the PS-42 fill site is being covered with jute netting.
4/30/15	PS-42 Well Pad

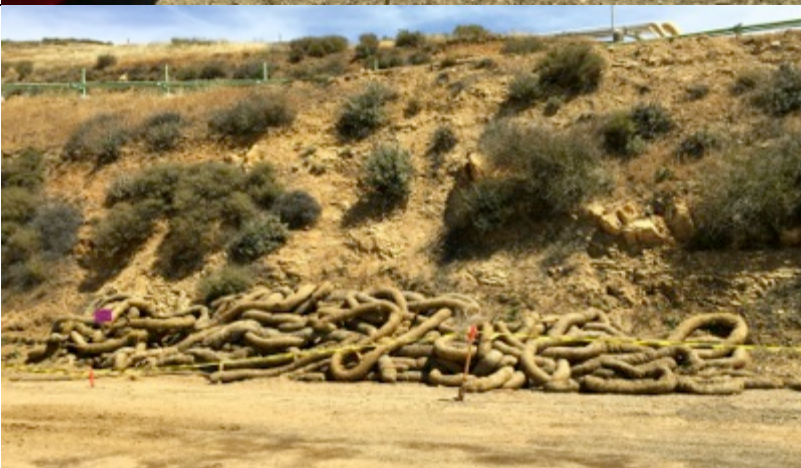
Straw wattle stockpiled along the PS-42 well pad has a nesting bird in it. Additional wattle was added, violating the small buffer area.

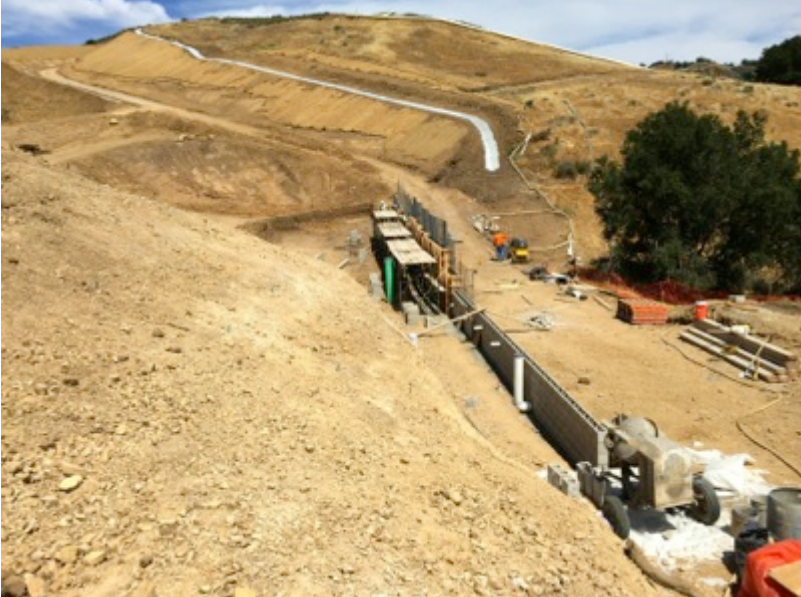
Looking up along the access road from the Natural substation. A concrete "V" ditch has been added. Work continues on the retaining wall.
4/30/15	Natural Substation Access Road

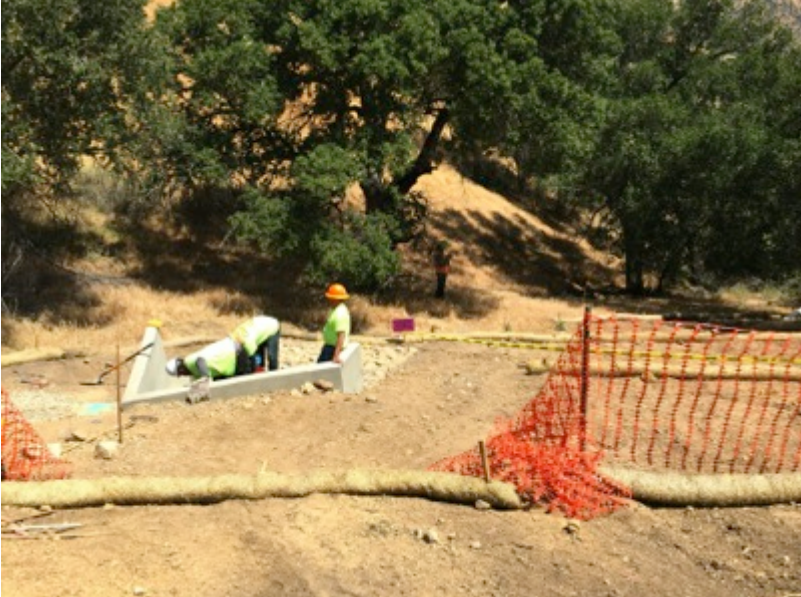
A crew is working on the drain outfall near the oak swale. A biological monitor is onsite observing the bird nest.
4/30/15	P-32 Fill Site

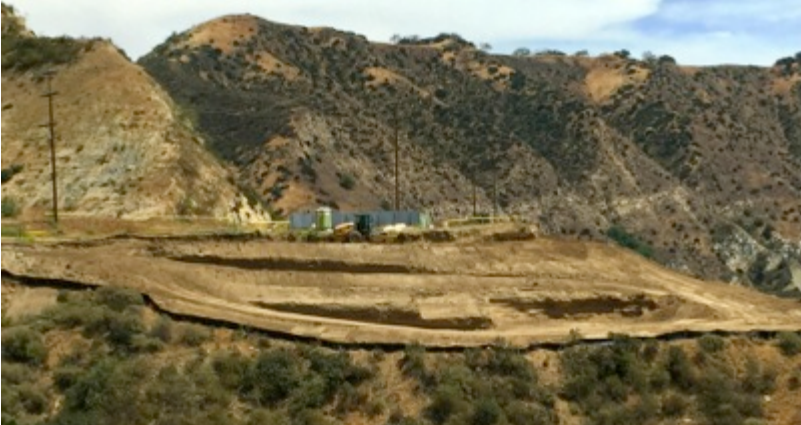
Grading/recompaction of the dirt from the CCS continues.

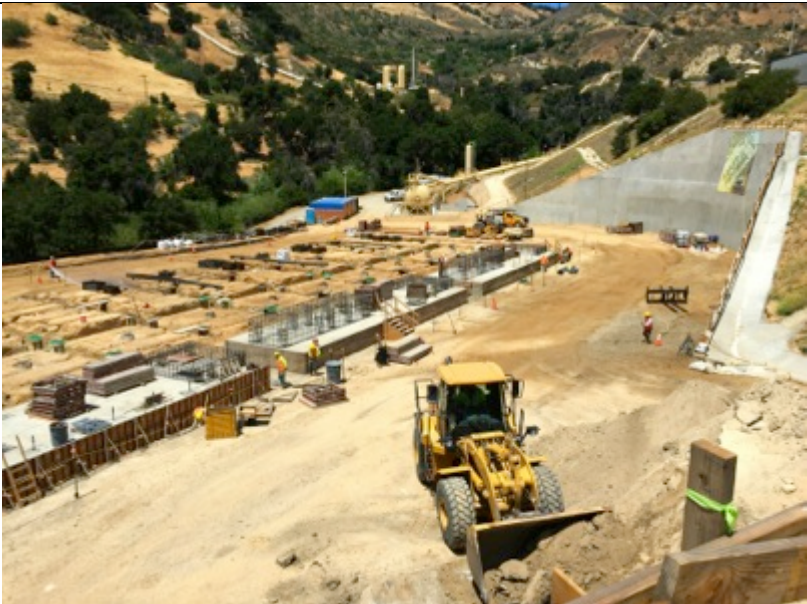
Compressor foundation work continues. Soil is being exported to P-32.
4/30/15	Central Compressor Station

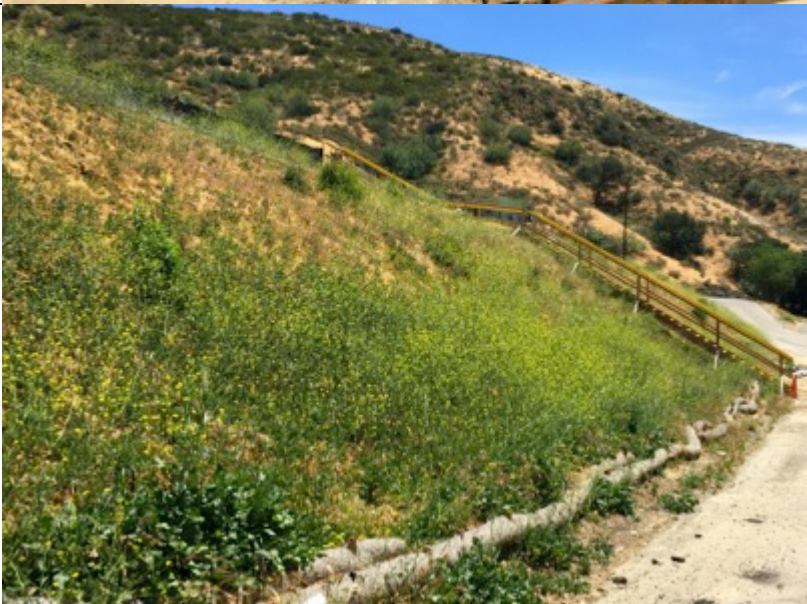
Hydroseeded bank below the main CCS area. Black mustard is fairly abundant in this area.
