**Re: Monthly Report Summary #1 for the Valley-Ivyglen 115-kV Substation (VIG) Project**

CPUC Site Inspection Reports  
July 15 and 21, 2020

## Valley – Ivyglen Subtransmission Project CPUC Site Inspection Form

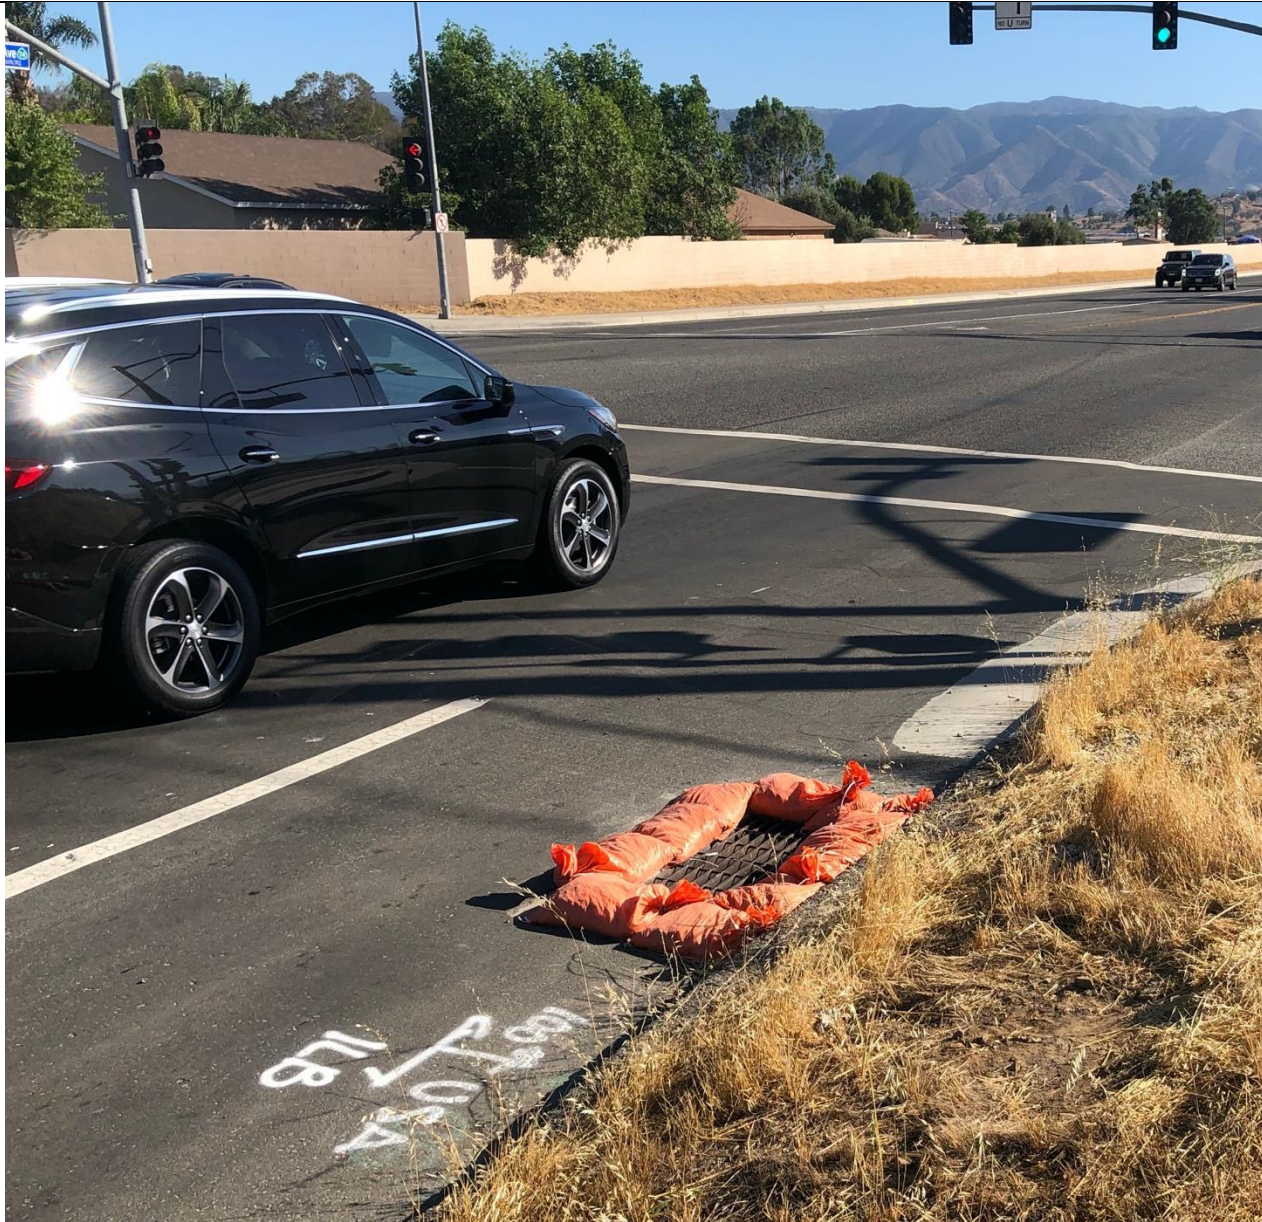
Photo 4 –  
BMPs in the  
roadway at site  
302E. Photo  
facing west

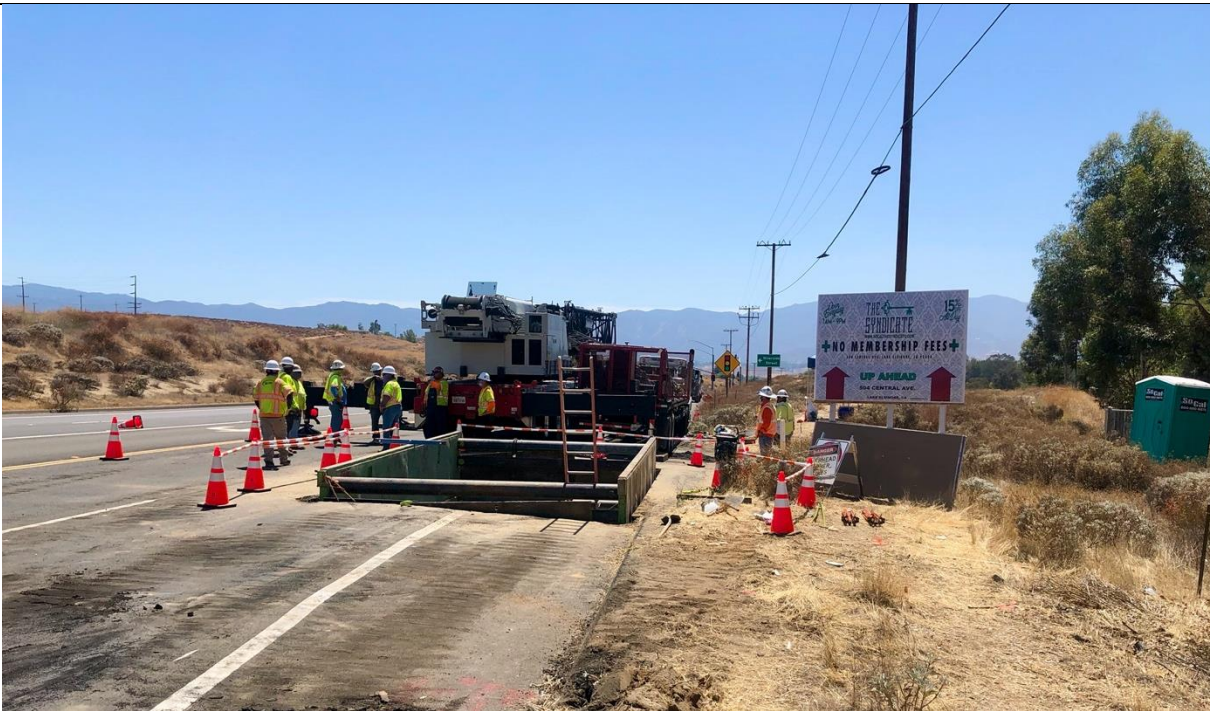
Photo 3 – Segment 2 vault installation near pole site 242E. Photo facing west
