Re: Monthly Report Summary #5 for the Valley-Ivyglen 115-kV Substation (VIG) Project

CPUC Site Inspection Reports

Valley – Ivyglen Subtransmission Project CPUC Site Inspection Form

Project:	Valley – Ivyglen Project	Date:	November 4, 2020
Project Proponent:	SCE	Report #:	VS009
Lead Agency:	California Public Utilities Commission	Monitor(s):	Vincent Semonsen
CPUC PM:	Patricia Kelly, Energy Division	AM/PM Weather:	Sunny and hot with a slight breeze
CPUC-CM (WSP):	Chuck Cleeves	Start/End time:	1345 hrs – 1630 hrs
Project NTP(s):	NTP-1.

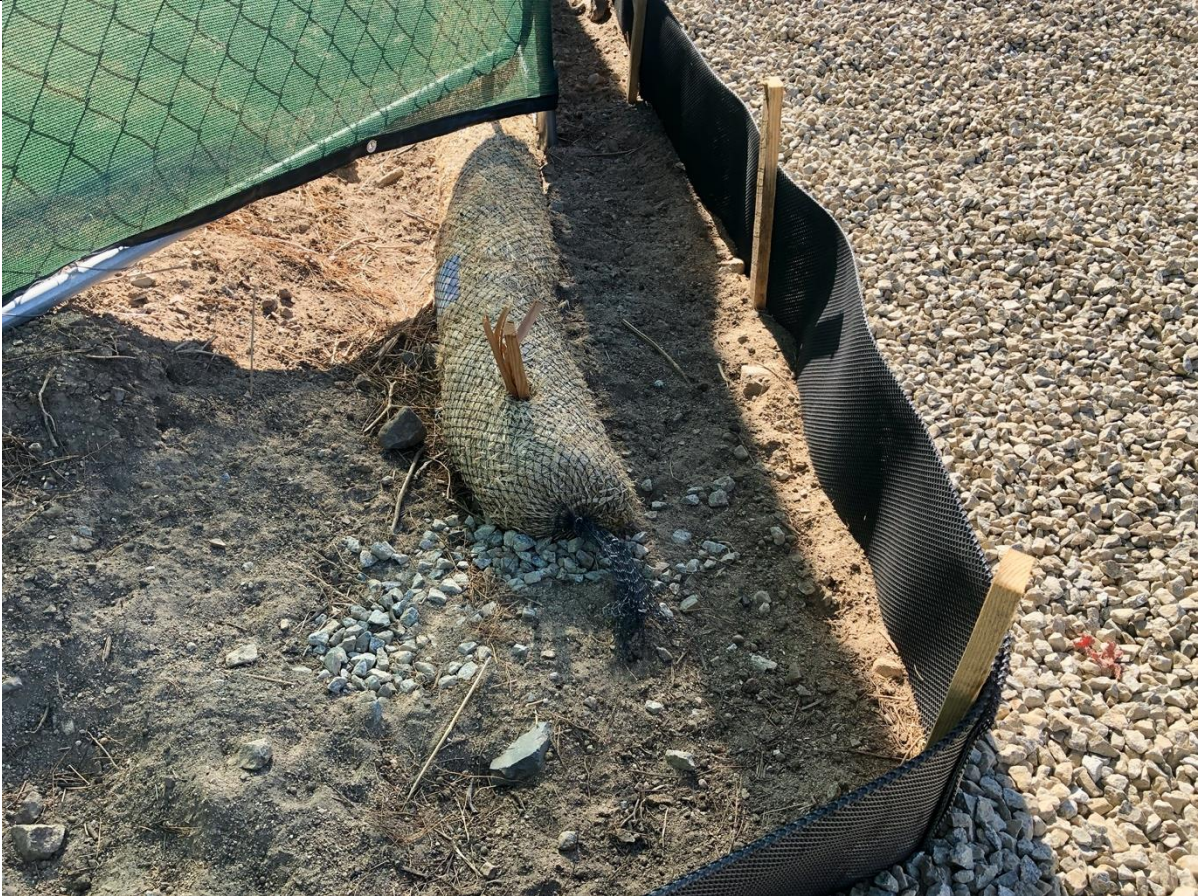
Photo 2 – Straw wattle was added to the Concordia yard BMPs at a number of locations.

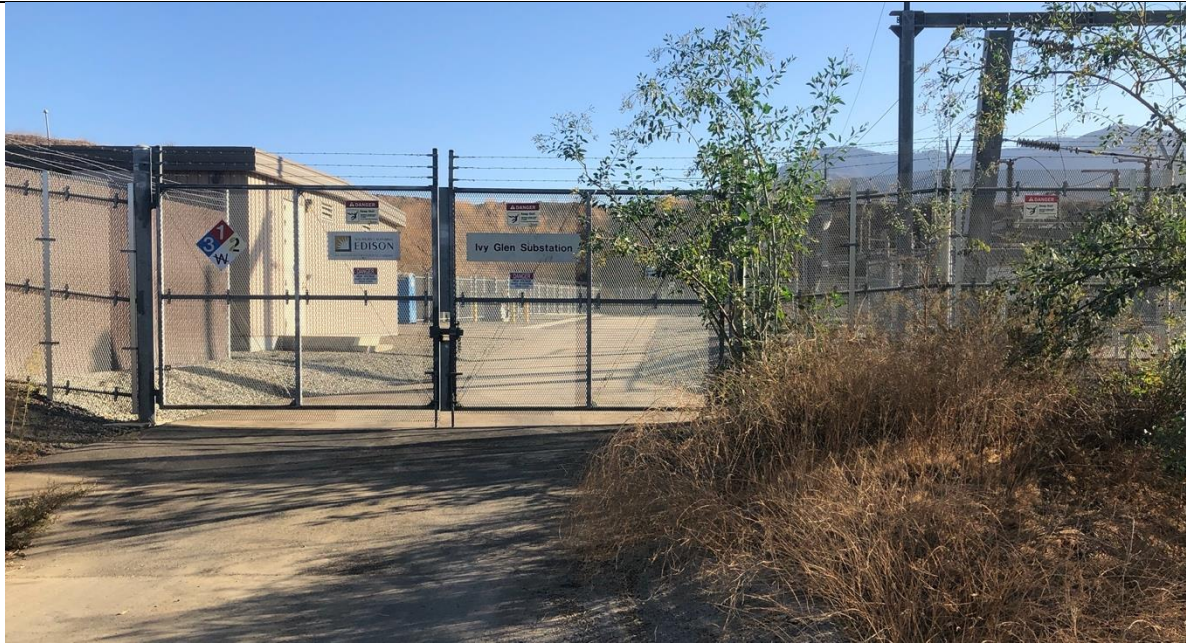
Photo 4 – Entrance
to the Ivy Glen
Substation. Photo
facing southwest

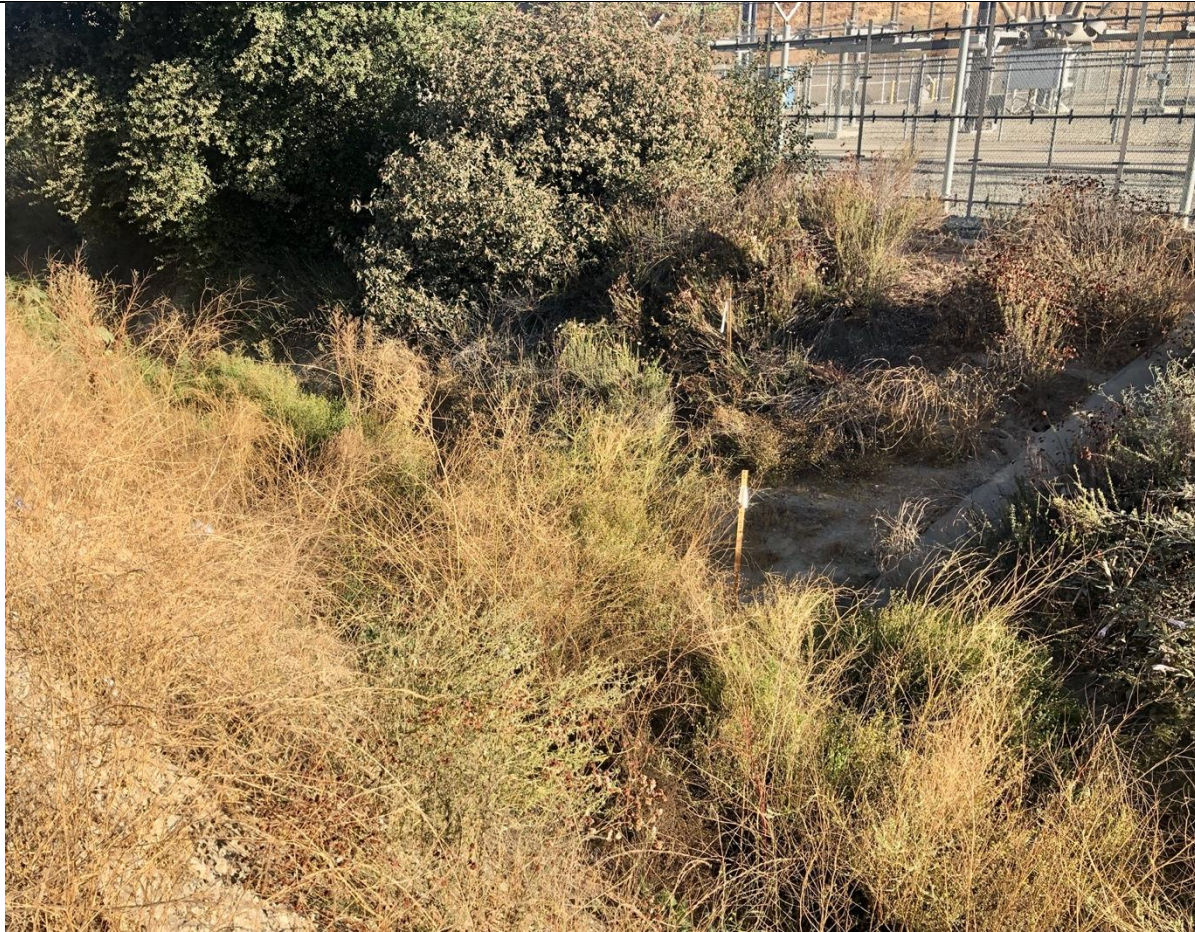
Photo 5 – Pole locations within the drainage just outside of the Ivy Glen Substation. Photo facing south

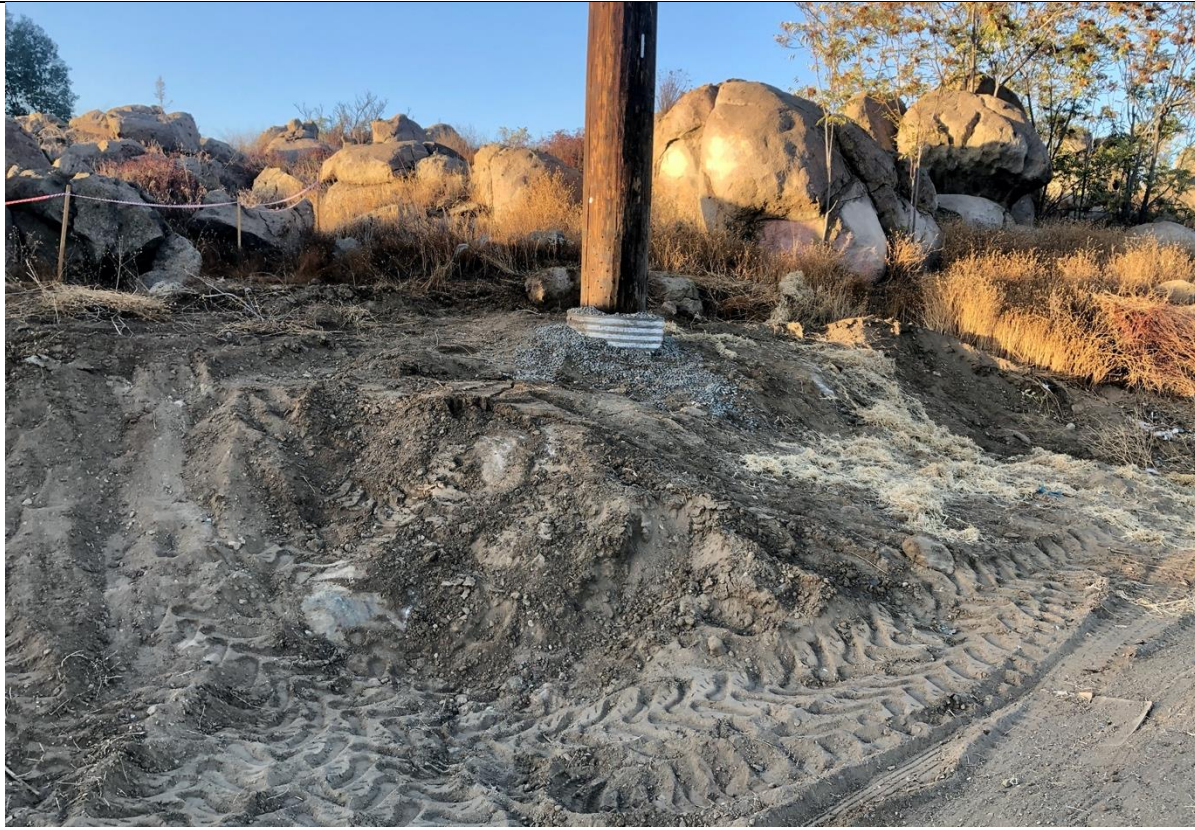
Photo 6 – The pole
has been set at site
#213. Photo facing
north

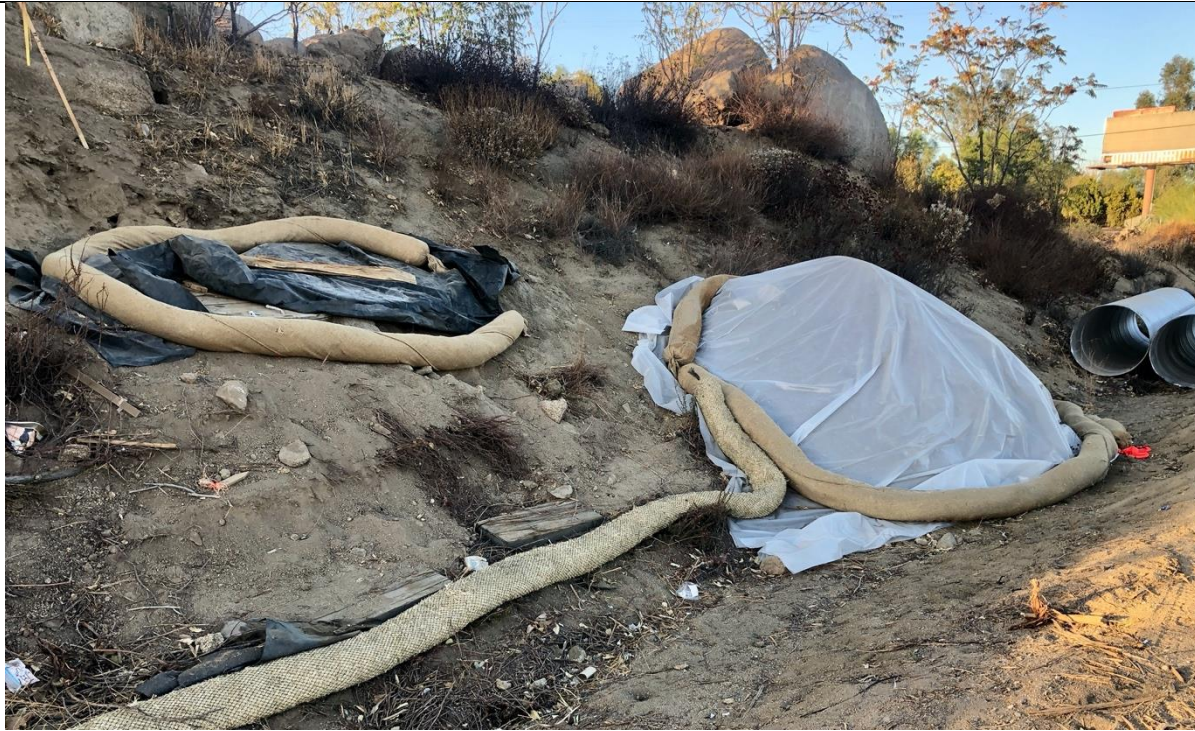
Photo 7 –
Foundation work at
Pole site 212. Photo
facing northeast

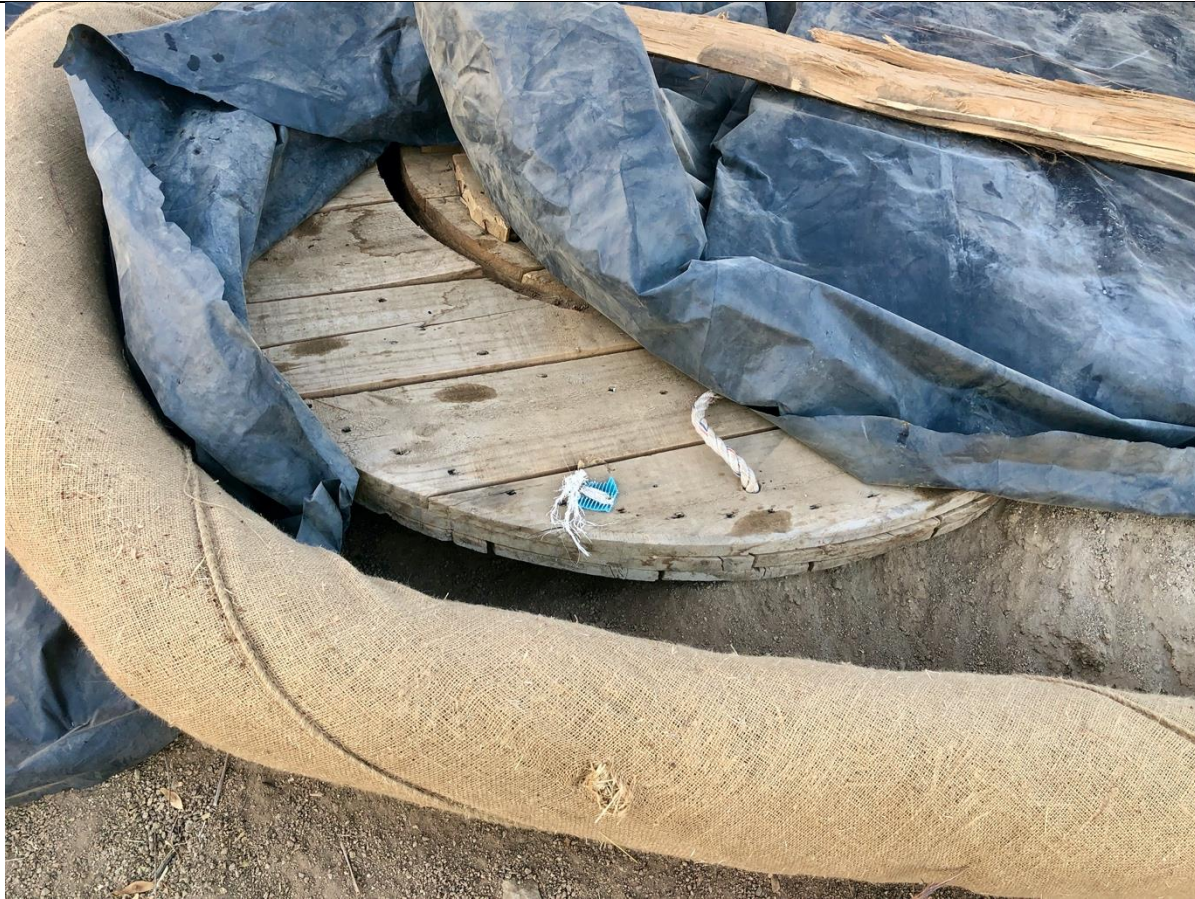
Photo 8 – The
foundation hole at
pole site 212 is not
very well covered.

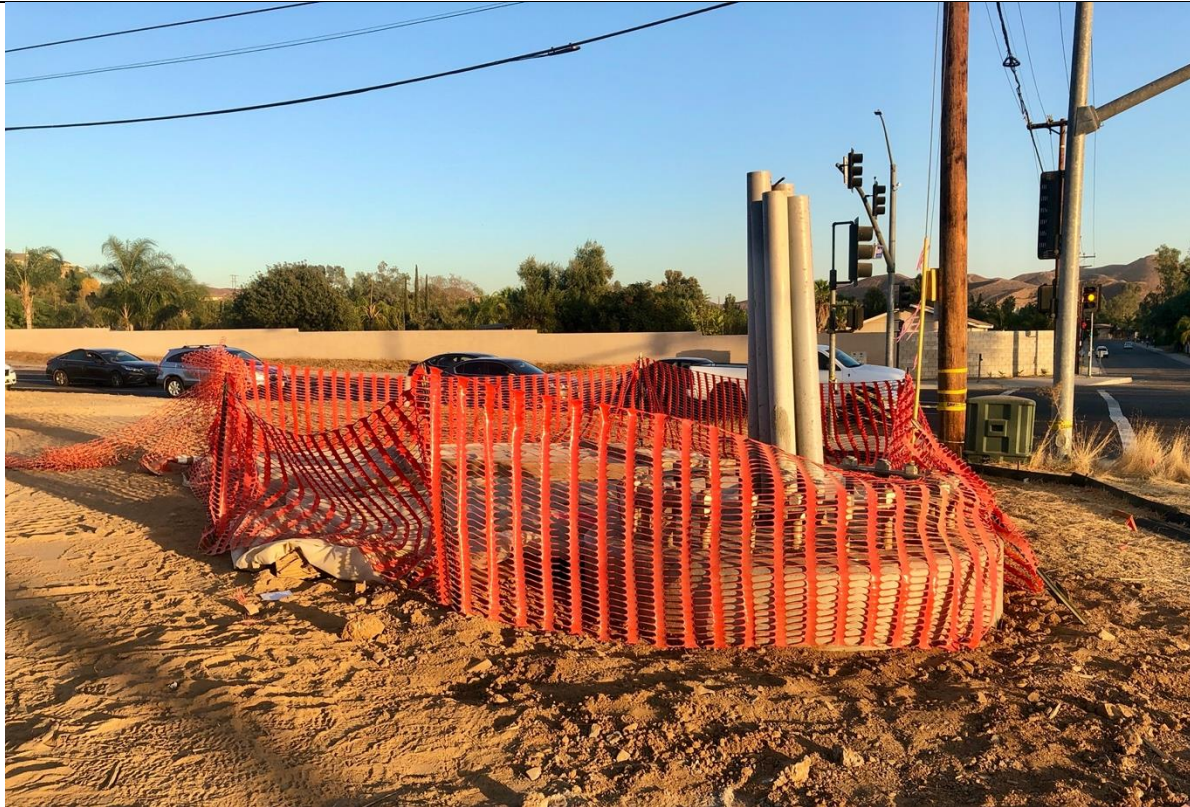
Photo 9 – At TSP
#302E the
foundation has been
poured and some
fencing installed.
Photo facing south

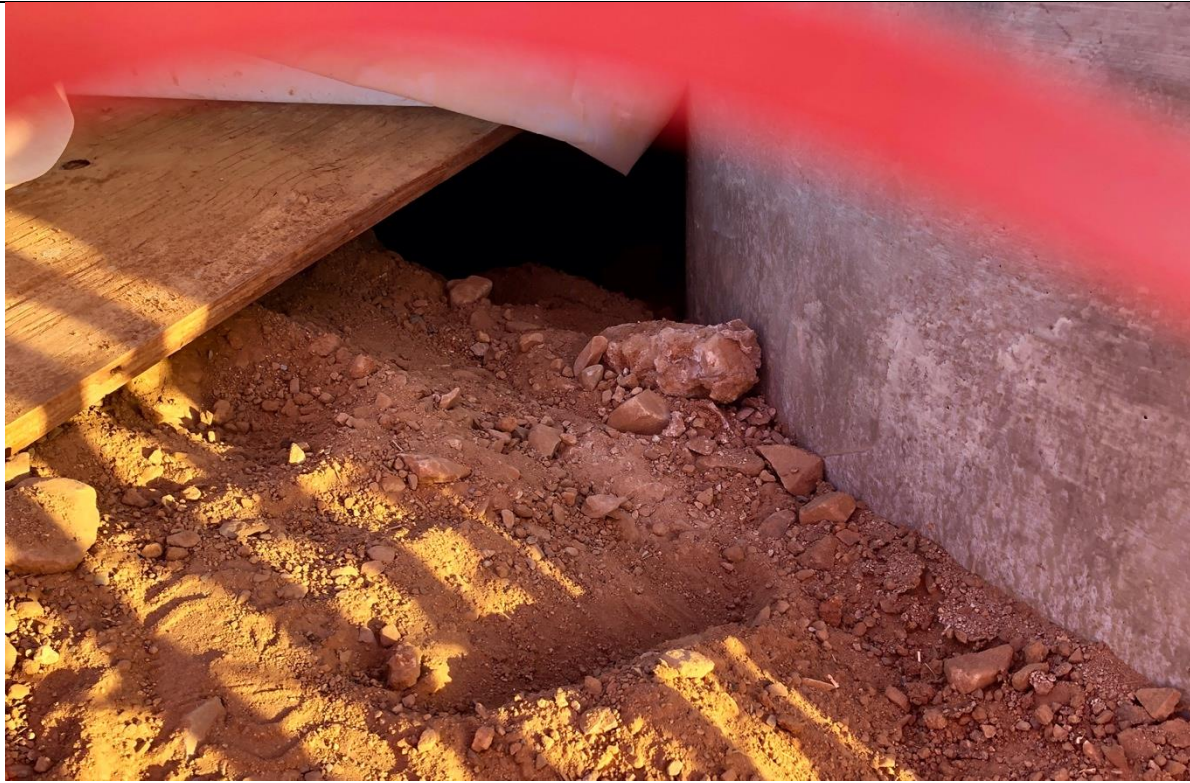
Photo 10 – The excavation next to TSP #302E is covered but there were several openings visible.

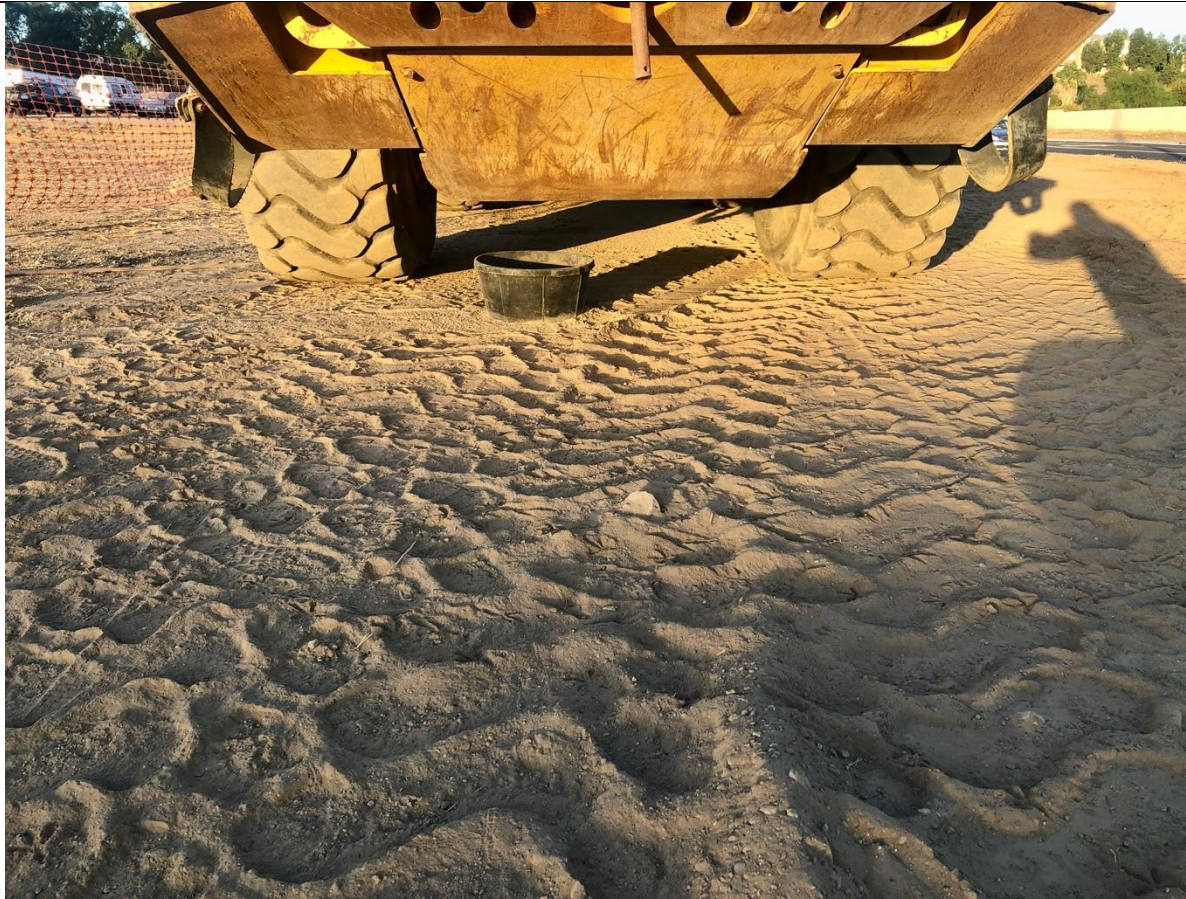
Photo 11 –
Secondary
containment under
some equipment –
note the small size.
The area could use
some dust control.

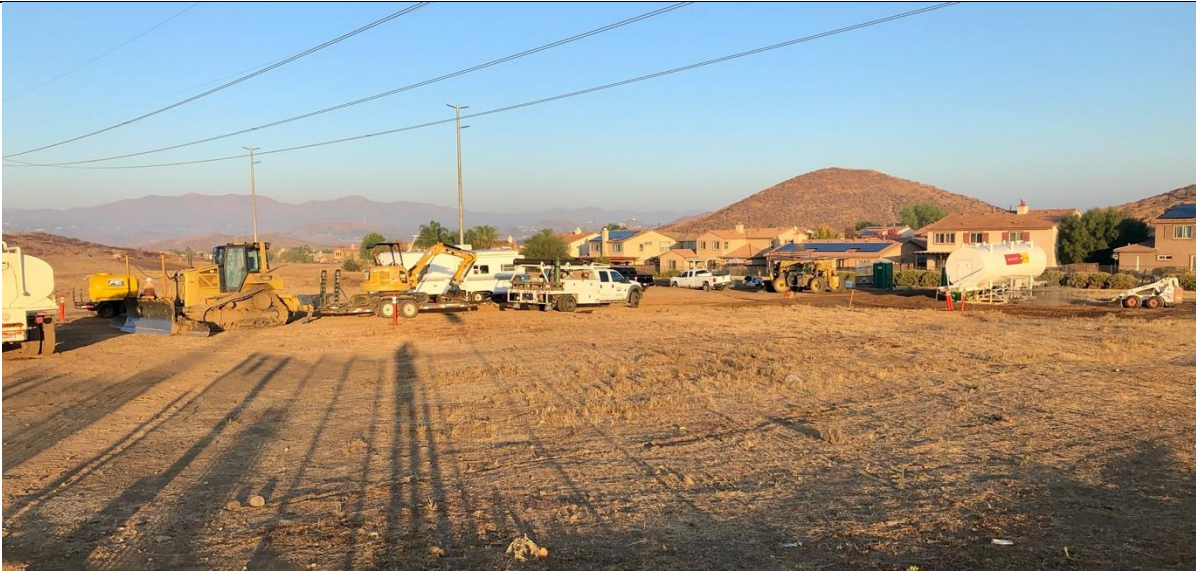
We drove to the staging area at tower site 103E, where construction equipment was left overnight, a water tank was installed, and the security trailer was parked (Photo 1). The EPM said they were demobilizing here since most of the work was concentrated at the western end of Segment VIG1. The access point into the transmission corridor has some entry/exit BMPs, but they needed upgrades (Photo 2). The EPM said they would be adding some more rock to the BMPs. Water trucks were regularly spraying the dirt access roads.

Photo 1 – Staging area along Segment 1, near the 103E tower site. Photo facing northwest

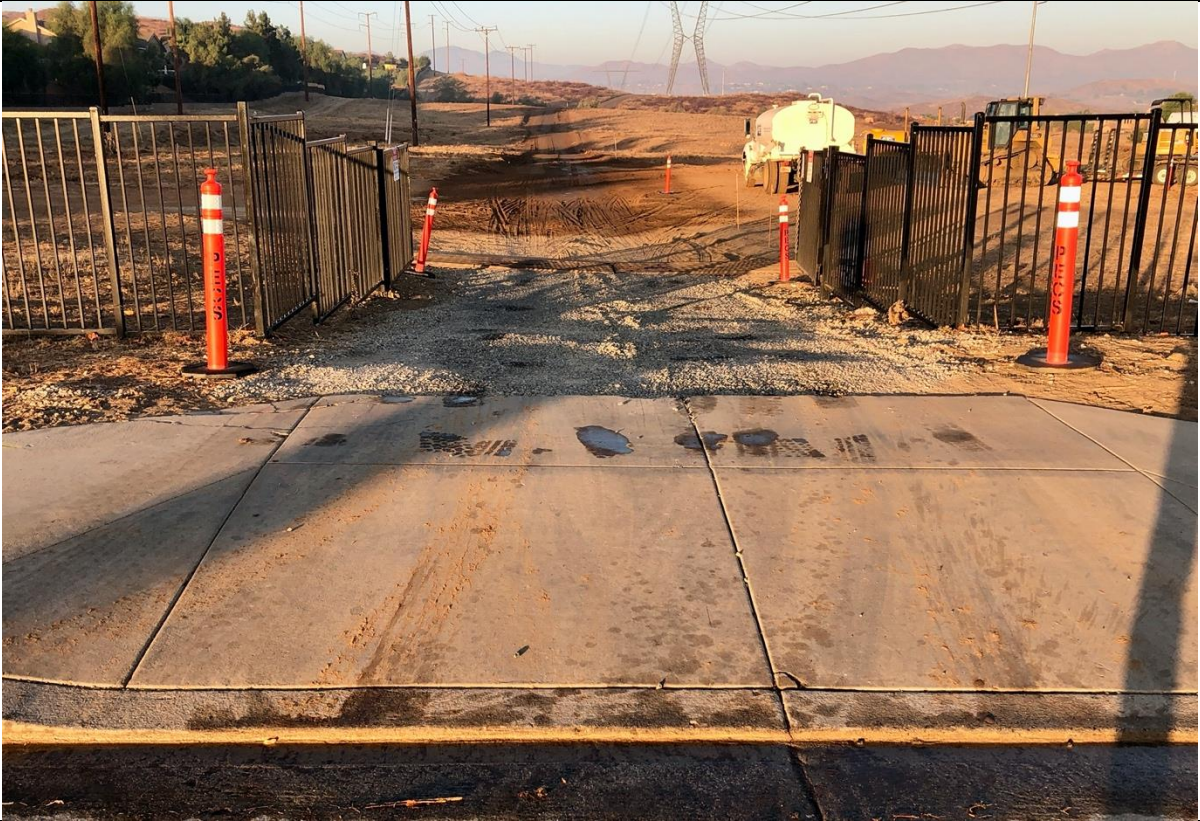
<p>Photo 2 – Exit/entry BMPs for the transmission corridor from tower site 103 to Hwy 74. Photo facing west</p>

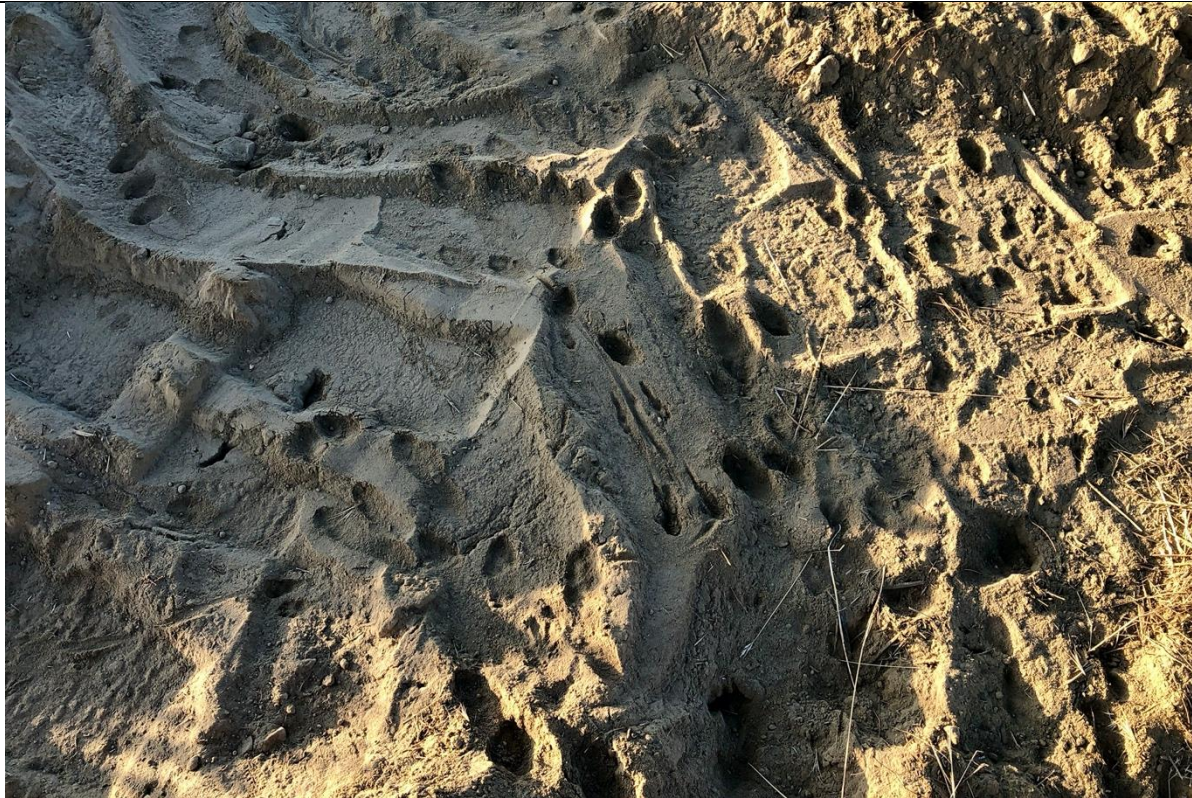
This section of the transmission corridor supports some excellent habitat, and at several locations, I noticed a lot of small mammal and reptile tracks in the dirt (Photo 4). Some mammal tracks had a kangaroo rat's diagnostic tail drag. Sealing up holes to prevent animal entrapment was essential, even more so through this section of the transmission corridor.

Photo 4 – Small mammal tracks in the dust around a pole site along Segment 1.

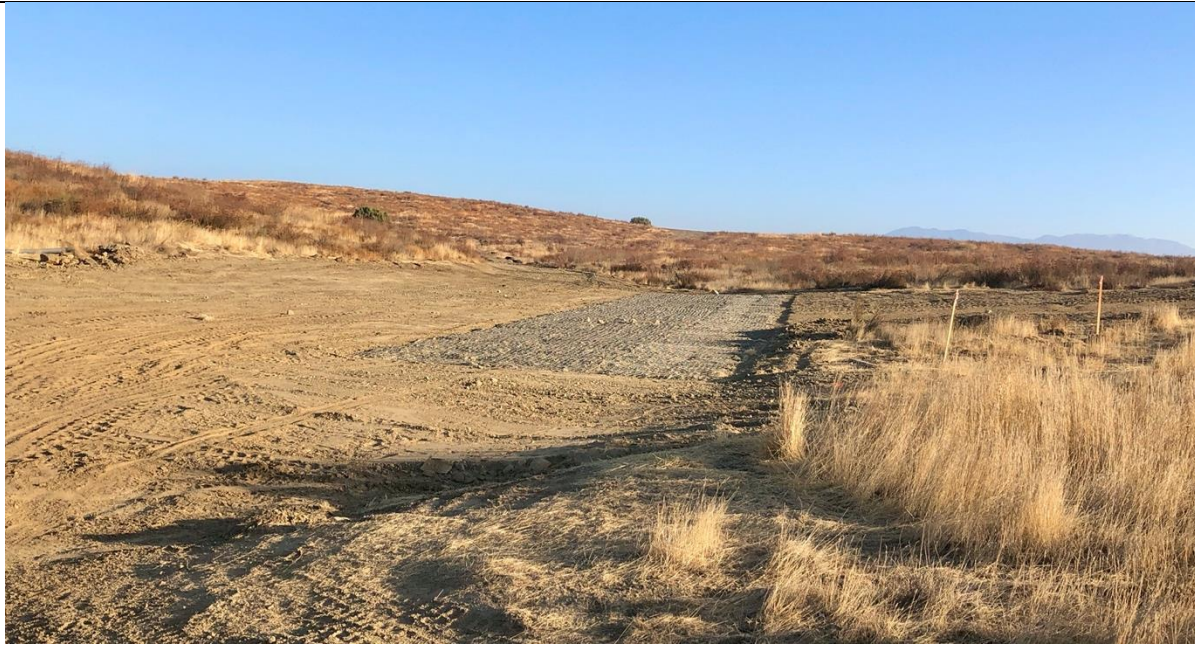
Several crews had been out along the access road installing stabilization structures like gabion baskets, wire blankets, and filter fabric lined w/ rock (Photos 5 & 6). In addition, wire-backed silt fence was installed below some of the steeper, newly constructed slopes, and then the dirt was sprayed with a tackifier/mulch mixture (Photo 7). Crews had poured most of the new slopes and berms with the tackifier now that we had entered the rainy season. The first rain event came through the area last weekend, but the site only received 0.2 inches of rain.

Photo 5 – A wire
blanket structure
installed to stabilize
the access road.
Photo facing north

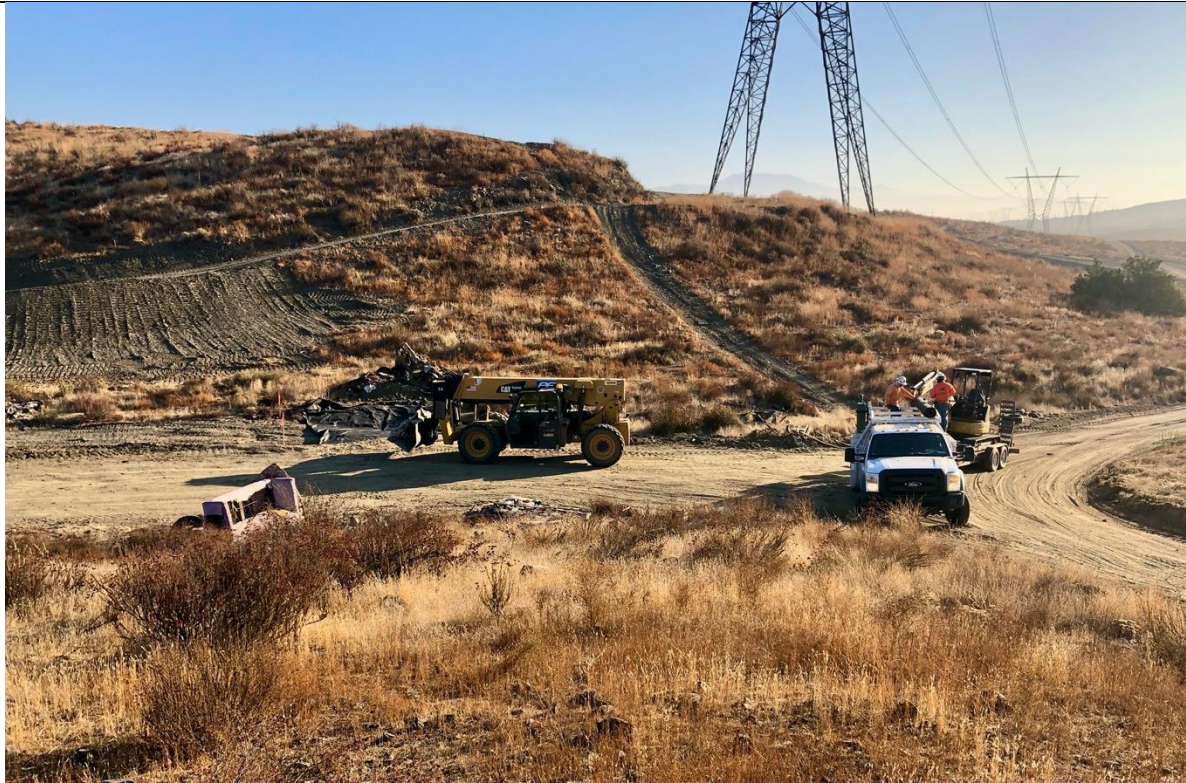
Photo 6 – Filter fabric is being installed at this location along the access road. Photo facing east

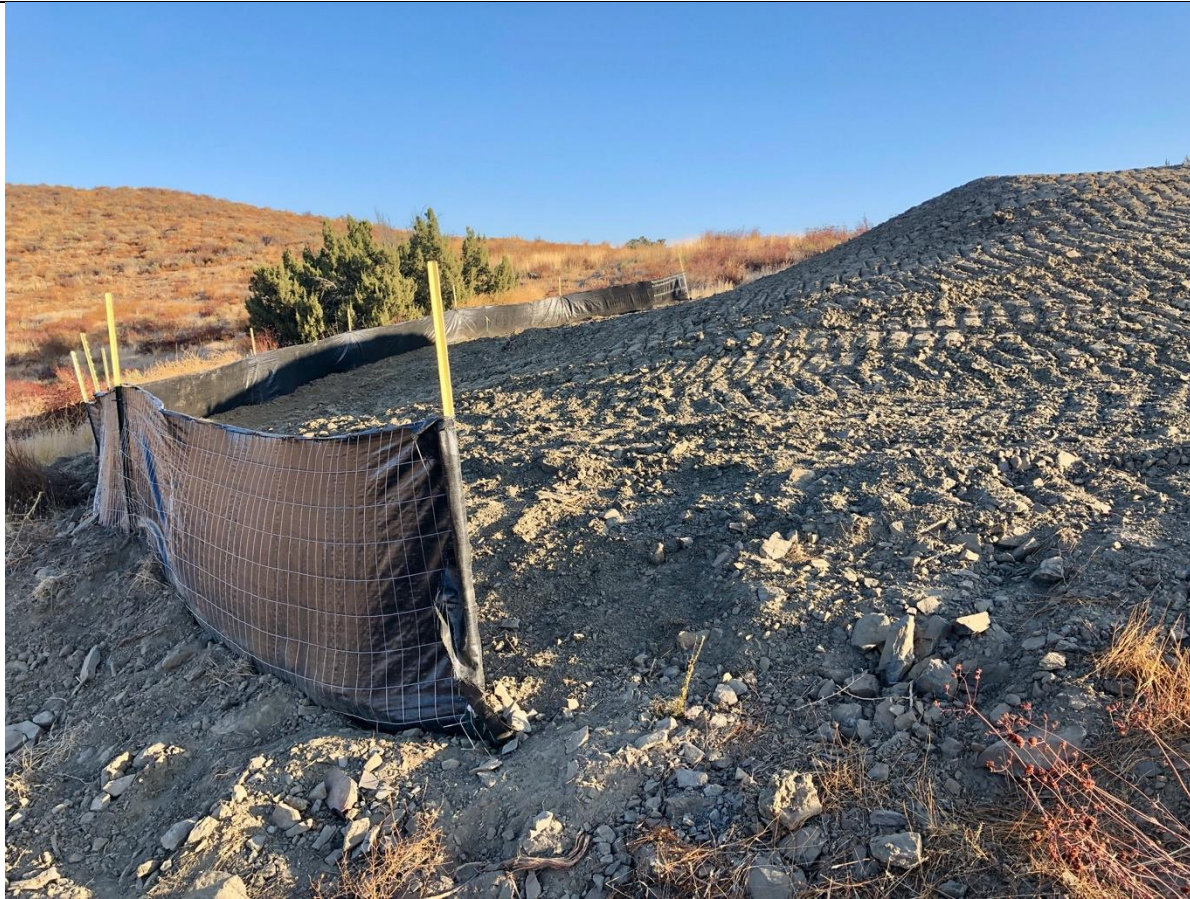
Photo 7 – BMPs for
the grading work at
tower site 129.
Photo facing
northeast

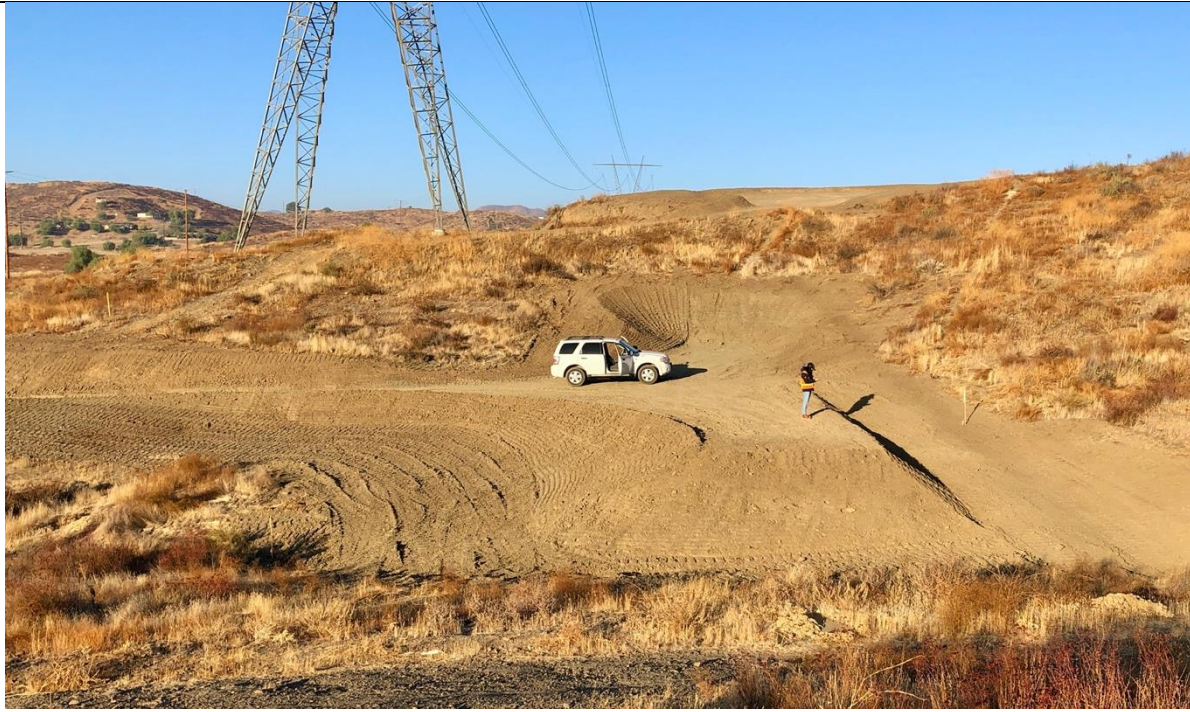
We stopped at tower site 130; the tower pad had been graded, but they still needed to install the TSP (Photo 8). The EMP and I heard a California gnatcatcher in the vegetation north of the tower site.

Photo 8 – The
grading work for
tower pad #130.
Photo facing west

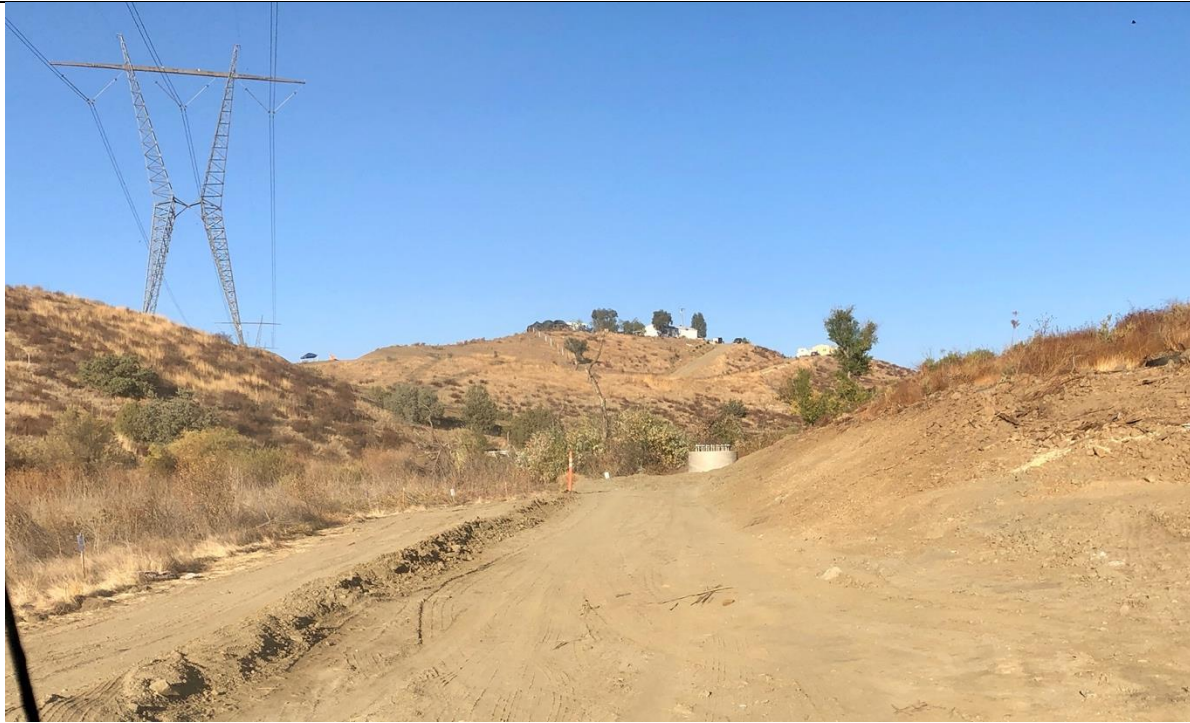
A large TSP foundation had been drilled and poured at site number 135 (Photo 9).

Photo 9 – At TSP
#135E the
foundation has been
drilled and poured.
Photo facing west

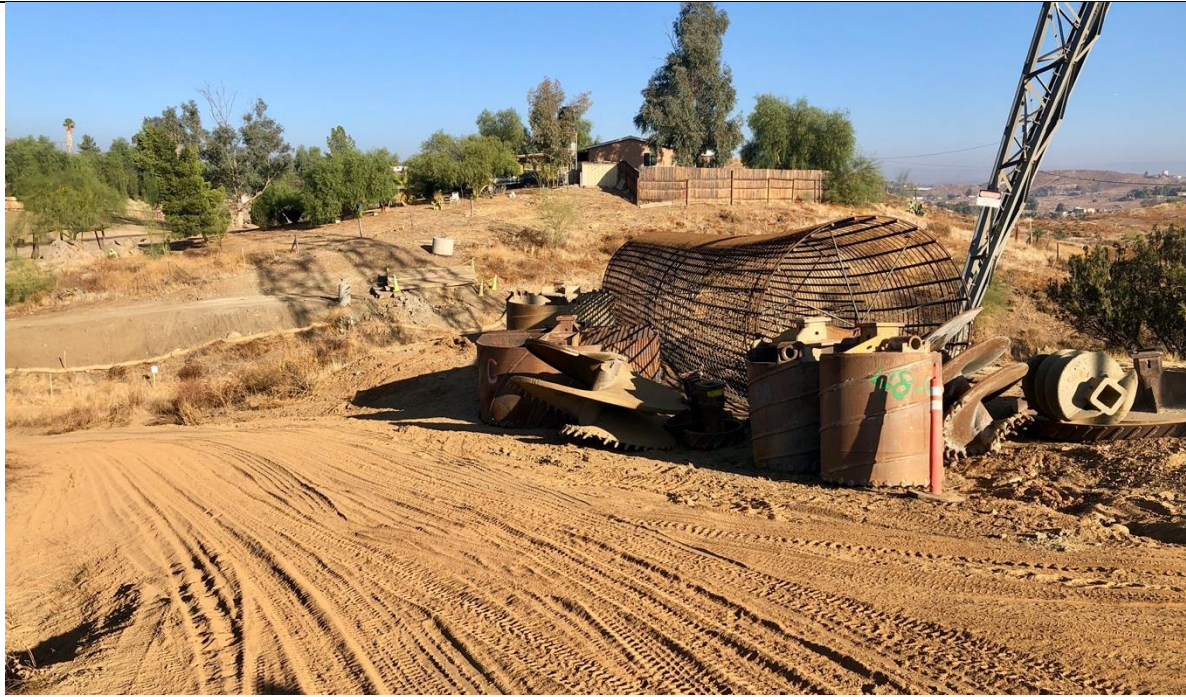
At tower site 144E, the foundation hole drilling had been temporarily suspended due to the hard substrate. The drill bits and rebar cage were stockpiled nearby, and the hole was covered with wooden mats (Photo 10). The mats protect the hole but leave small openings that would allow animals to fall in. I indicated to the EPM that they should cover these with plastic. A small ephemeral drainage next to the drilling site was staked with signage showing its sensitivity (Photo 11).

Photo 10 – Access
road to tower site
144 with staged drill
bits and rebar cage.
Photo facing north

Any foundation holes left open should be completely covered to prevent animals from entering.

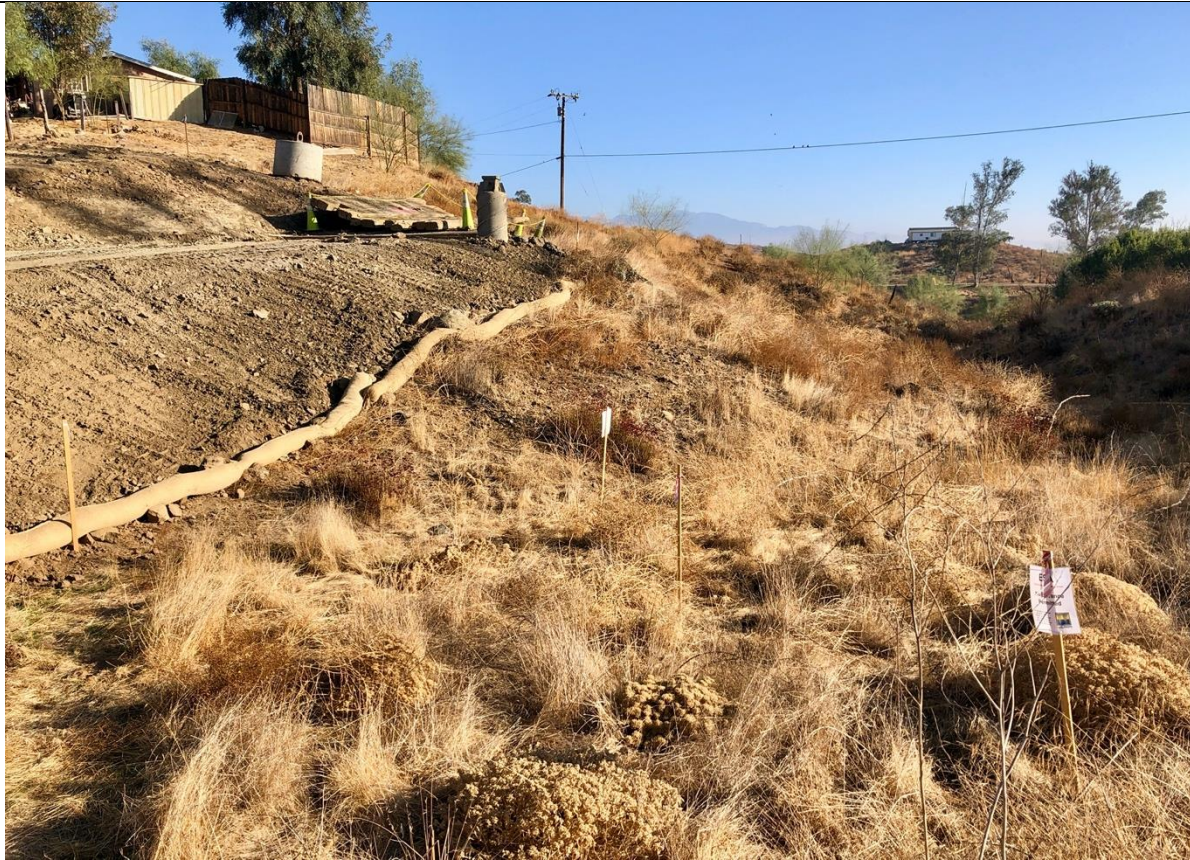
Photo 11 – Tower
site 144 with BMPs
and ESH signage.
Photo facing east

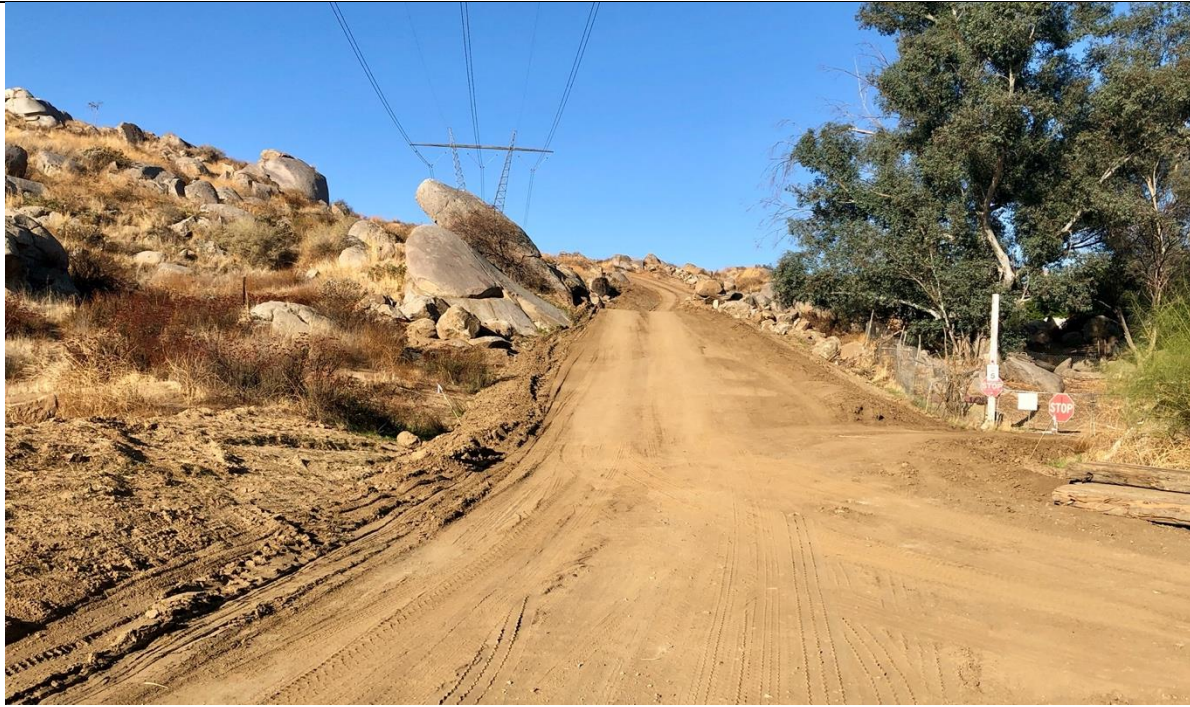
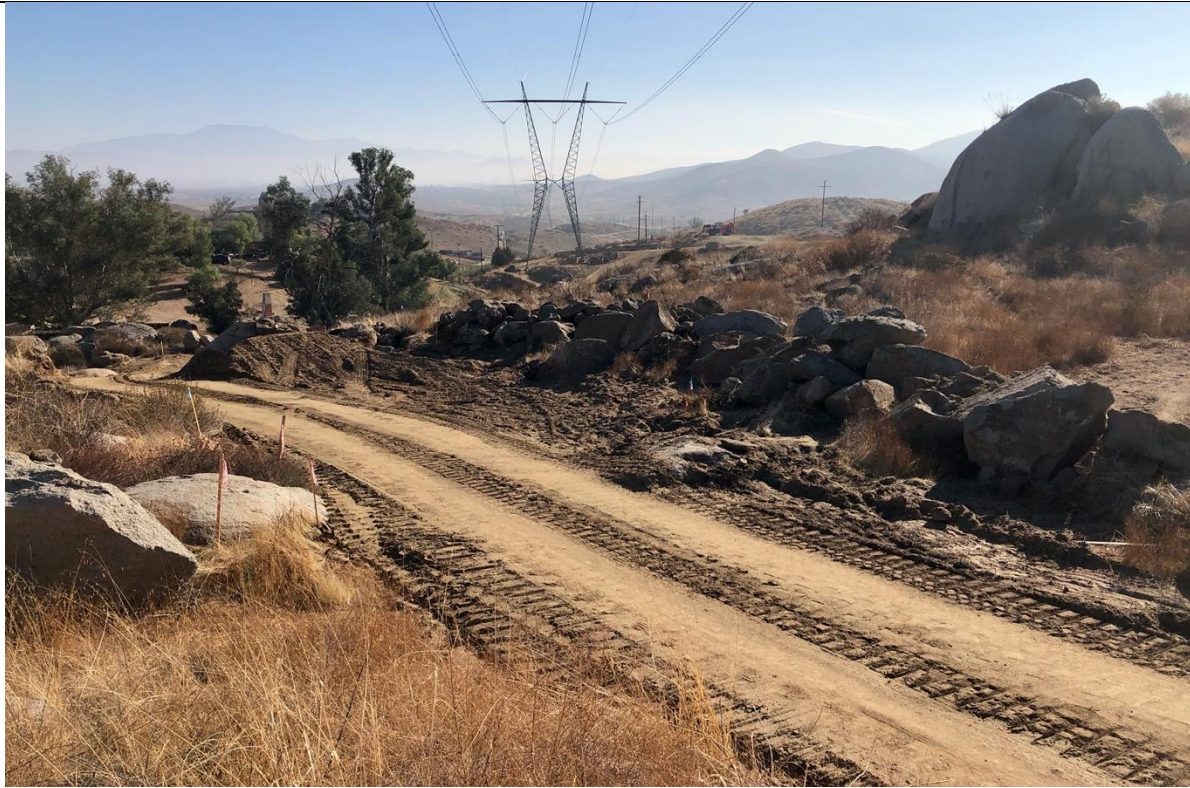
A portion of the access road between towers 144 and 145 had been built (Photos 12 & 13). However, road work through this area has been put on hold due to cultural and archeological issues.

Photo 12 - Access
road work between
towers 144 and 145.
Photo facing west

Photo 13 – Access
road work between
towers 144 and 145.
Photo facing east

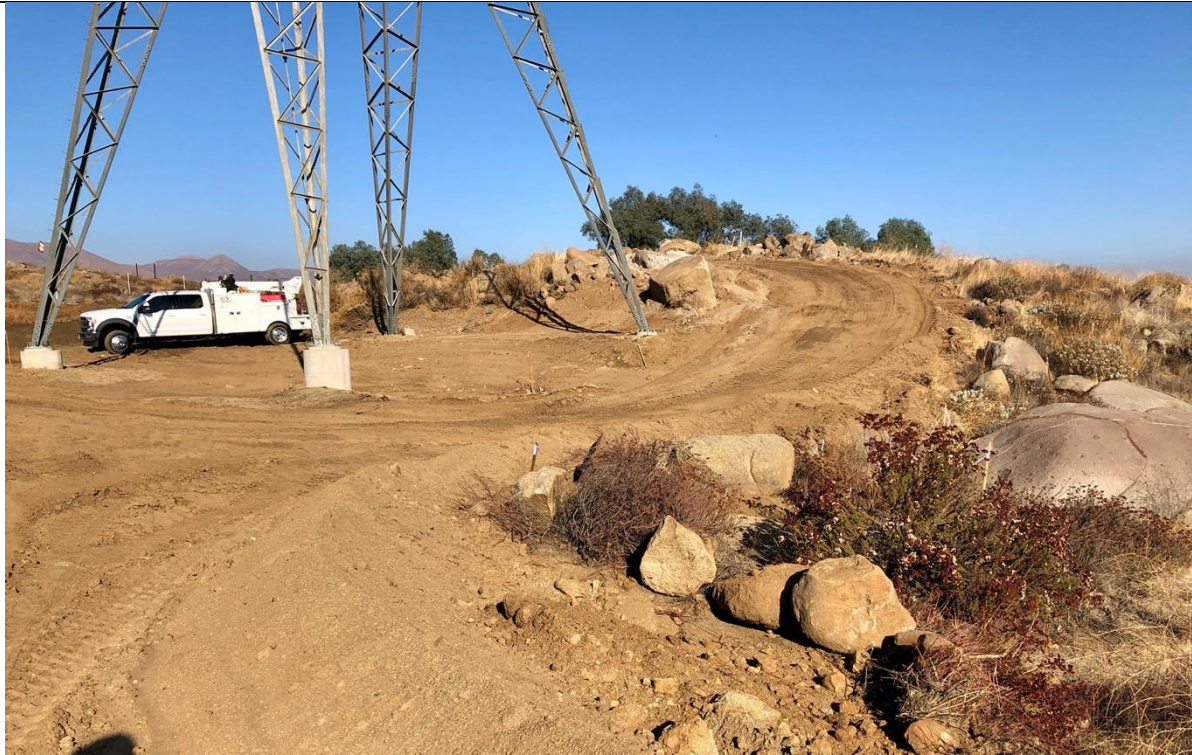
Crews continue to work on the access road from tower site 145 west toward Hwy 74 (Photo 14).

Photo 14 – Access
road work around
tower site #145.
Photo facing
northwest

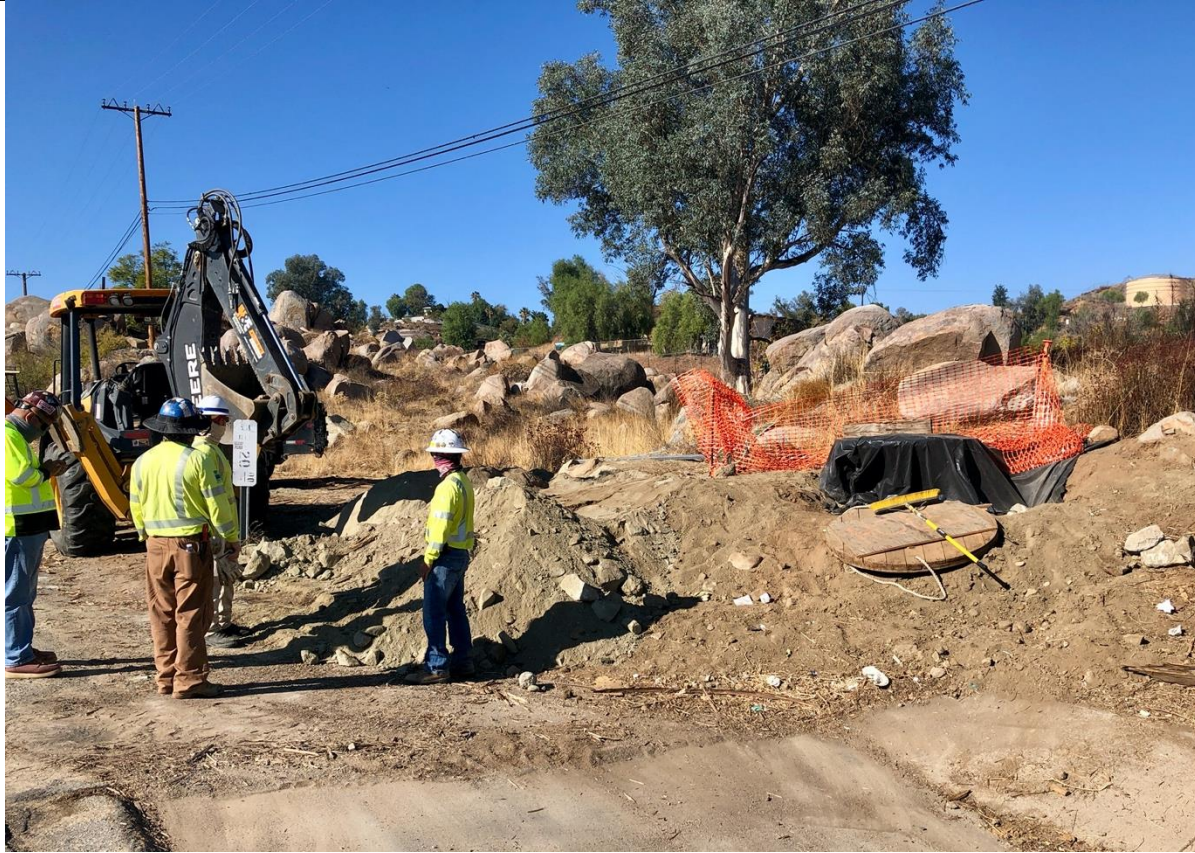
I stopped to observe the work at pole sites 218 and 229 in Segment VIG2 along Hwy 74. One of the Environmental Inspectors was onsite with the crew at tower site 229 doing cleanup work (Photo 15).

Photo 15 – Cleanup
work at tower site
229 along Hwy 74.
Photo facing west
