Re: Monthly Report Summary #9 for the Valley-Ivyglen 115-kV Substation (VIG) Project

Valley – Ivyglen Subtransmission Project CPUC Site Inspection Form

Project:	Valley – Ivyglen Project	Date:	April 15, 2021
Project Proponent:	Southern California Edison (SCE)	Report #:	VS020
Lead Agency:	California Public Utilities Commission (CPUC)	Monitor(s):	Vincent Semonsen
CPUC PM:	Patricia Kelly, Energy Division	AM/PM Weather:	Partly cloudy, cool, and calm
CPUC-CM (WSP):	Chuck Cleeves	Start/End time:	0600 to 1030
Project NTP(s):	Notice to Proceed (NTP-1), NTP-2, and NTP-3.

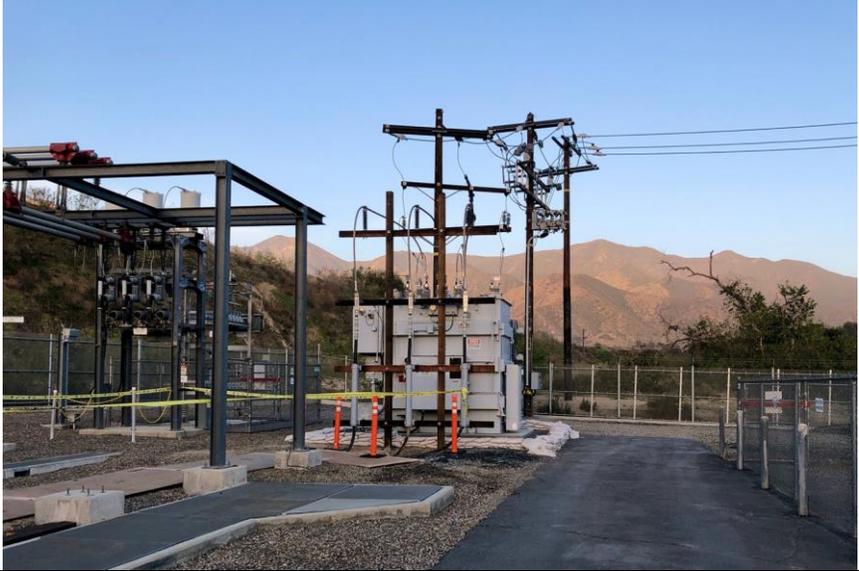
Photo 1 – Newly installed equipment within the Ivyglen Substation. Photo facing west.
4/15/21	VIG Project

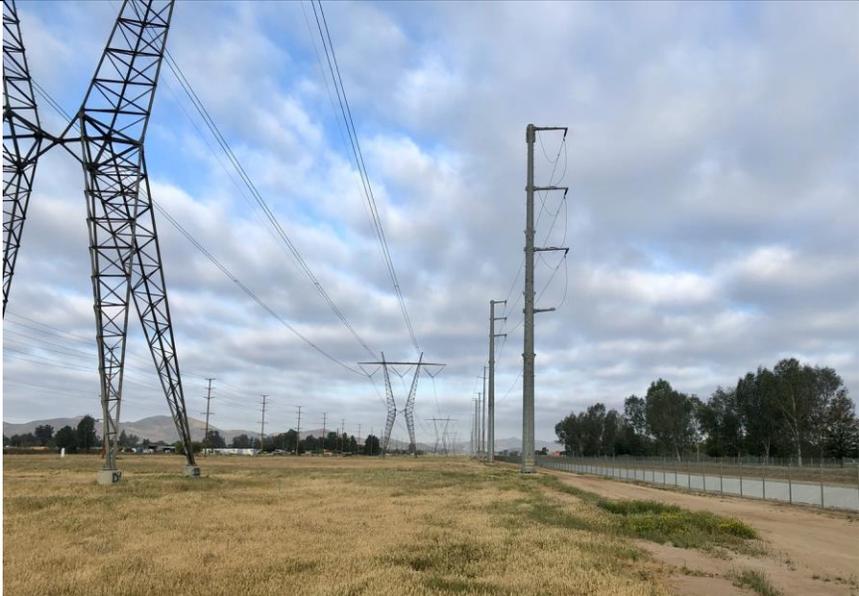
Photo 2 – Wire pulling was underway at TSP 17 and 18 within segment 1. Photo facing northwest.

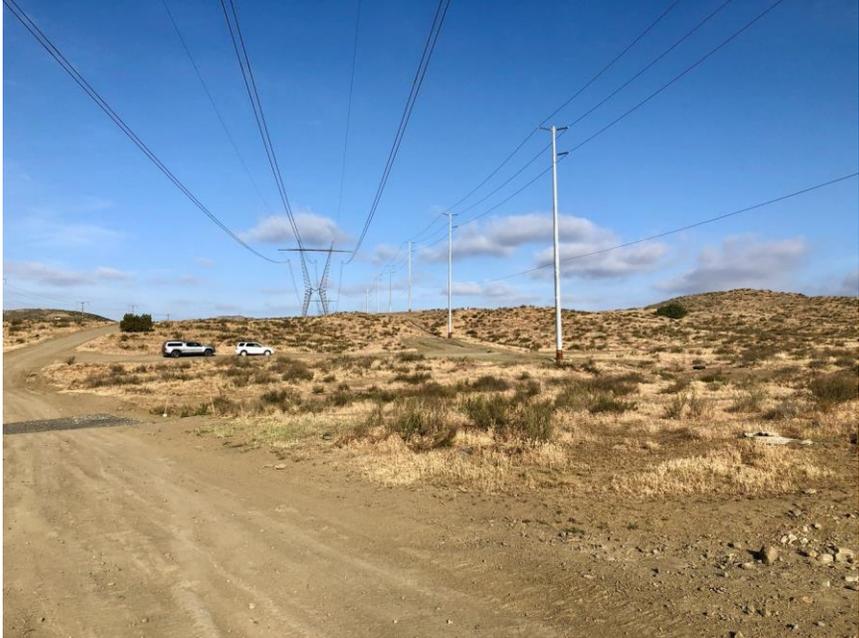
Photo 3 – Access road and transmission corridor east of Highway 74. Photo facing west.

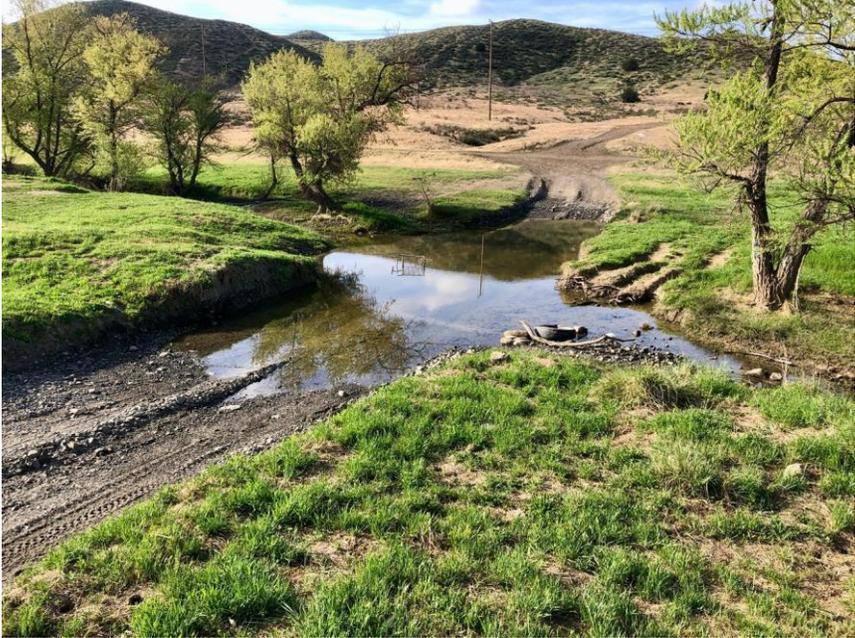
Photo 4 – The river crossing near TSP 120. Photo facing south.

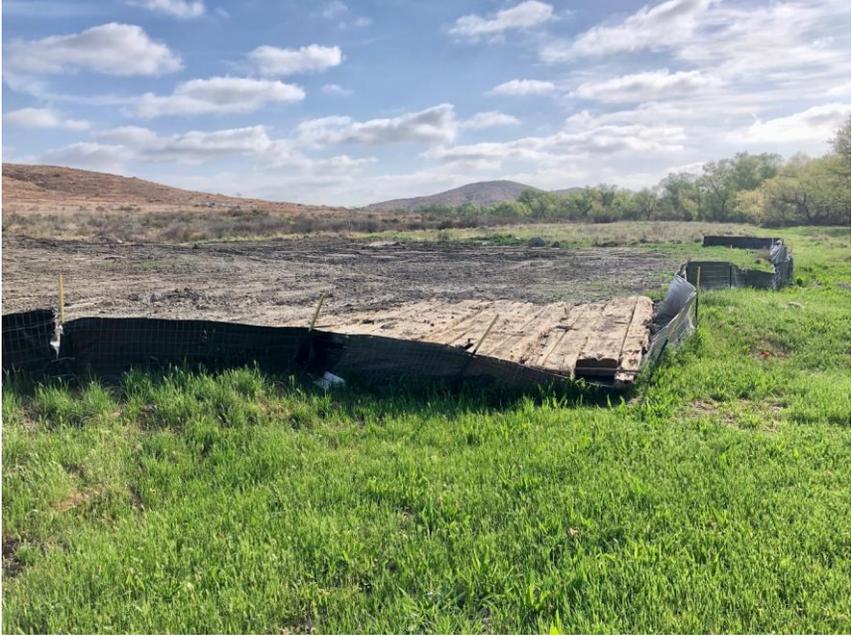
Photo 5 – The TSP 120 work area. Photo facing east.

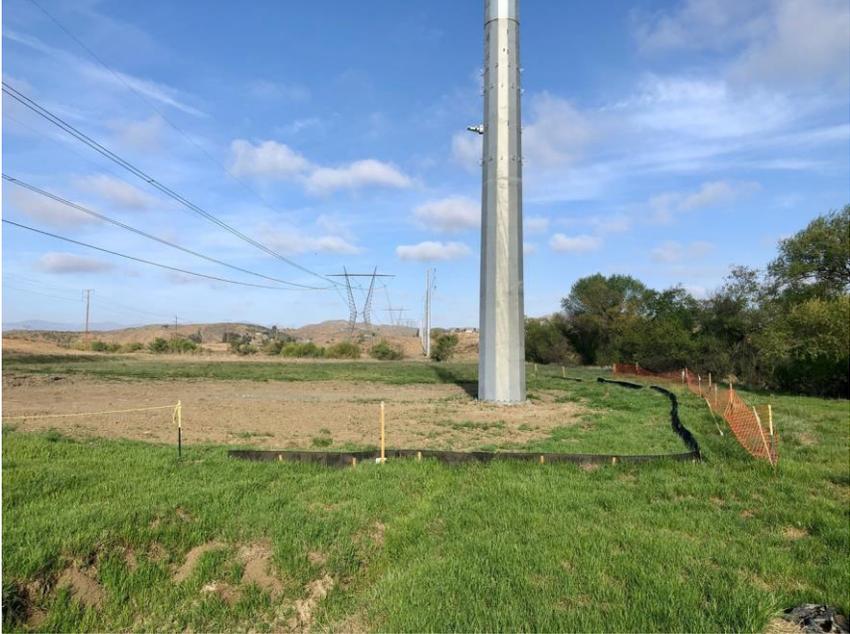
Photo 6 – TSP 119 located on the south side of the river channel. Photo facing west.

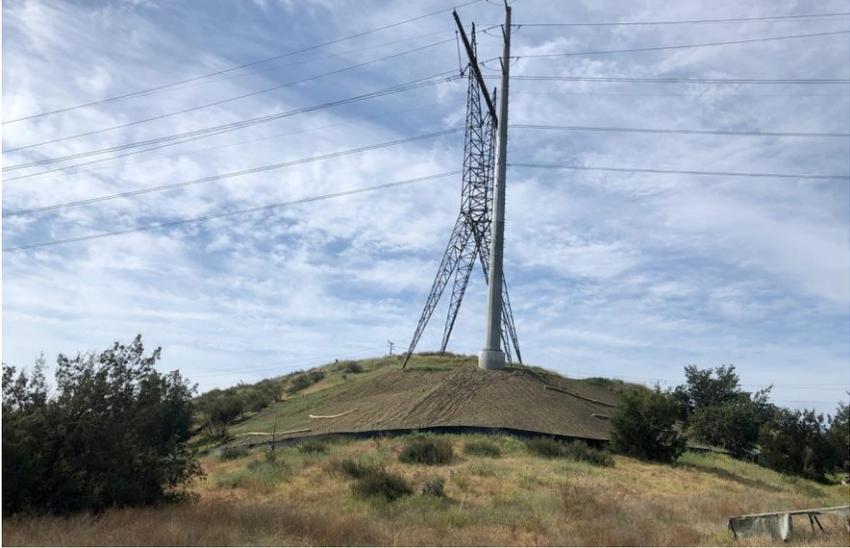
<p>Photo 7 – TSP 137 with BMPs on the slopes of the tower pad. Photo facing south.</p>

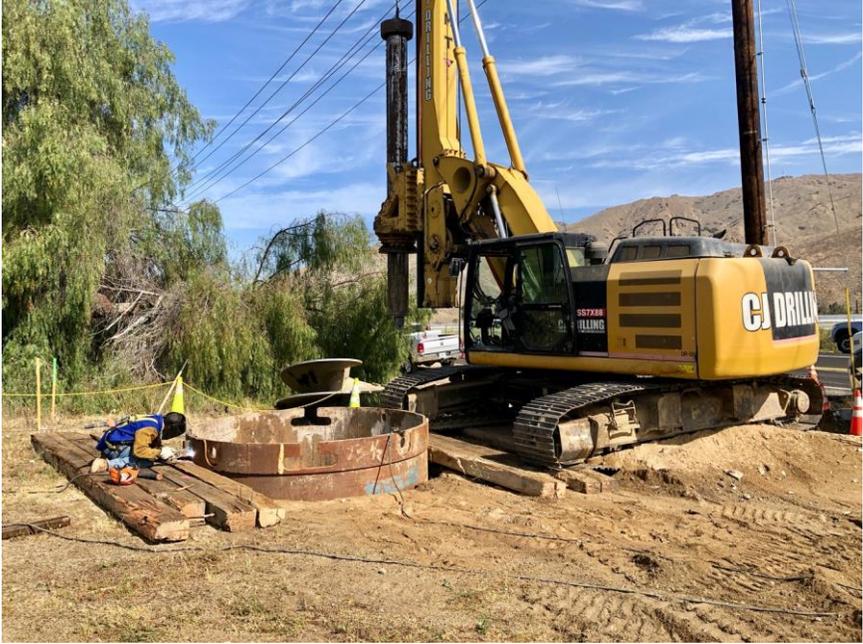
Photo 8 – Drilling equipment at TSP 537E. Photo facing north.
